COURTHOUSE AND ADJACENT BARN RANGE
TO EAST OF COLBURN HALL,
COLBURN, NORTH YORKSHIRE

ARCHITECTURAL AND
ARCHAEOLOGICAL SURVEY

Report no: 2009/361.R01
Version: Final
Date: February 2012
Authors: Shaun Richardson & Ed Dennison

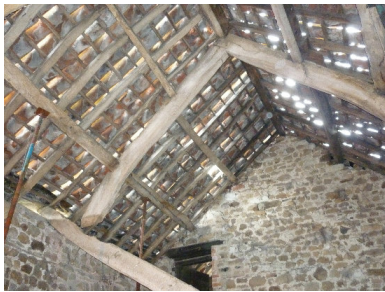
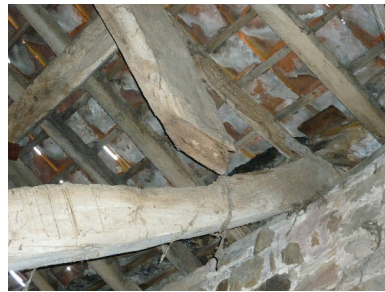
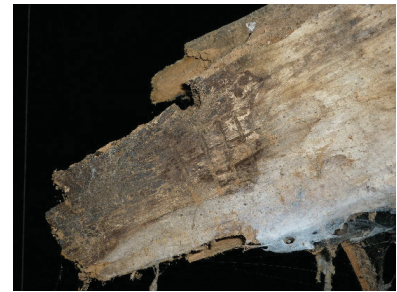
1-527.JPG

- 3.36 The barn is crossed by four hardwood trusses, all of the same form and set at equal centres [3/832, 3/844, 3/847, 3/850, 5/331 and 5/338]. The west face of each truss is numbered sequentially from 'I' to 'IIII' using incised numerals, from east to west, and all pegs are driven from the same face. Each truss comprises a slightly cambered tie-beam, resting on small timbers at either end rather than a wall plate, with slightly curved and diminished principal rafters (see figure 11). Each principal supports a pair of trenched purlins for the common rafters. Almost all of the feet of the common rafters rest on the wall plate, whereas some of the ends of the tie-beams now fall short of it, presumably as a result of decay/settlement of the roof structure. The trusses are of pegged construction throughout; the principals are halved and pegged at the apex, where there is a diamond-set ridge piece [5/335]. The ridge piece has been replaced to the two end bays and repaired/replaced over truss 'II', where a splayed scarf joint is visible. At the time of the EDAS survey, truss 'IIII' had partly collapsed and the roof structure was propped here [1/527 to 1/531] (see plate 12).

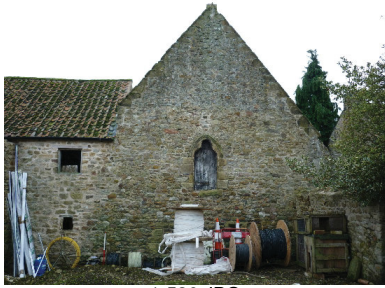
1-535.JPG

- 3.32 The smaller cell to the west has a ground floor doorway with quoined jambs and a timber lintel (see plate 10). One of the quoins to the east jamb retains a small oval recess, and also some very worn carved graffiti perhaps reading 'W C I'. The doorway has a small square window to the west. Below the window, this part of the elevation again rises from a shallowly projecting plinth, while above it appears to be slightly inset at first floor level, with the face built of slightly smaller stones. There is a loading door to the centre of the first floor [1/535]. As has already been noted above, the doorway could have been moved to this position after 1718, perhaps as a result of external steps formerly leading to the first floor of the medieval building being removed. The ground floor doorway to the cell below the hayloft can be seen on Buck's 1718 sketch, as can the tall double doors of the cart entrance (see figure 3).

Plate 10: Barn, west end of south elevation, looking N (photo 1/535).

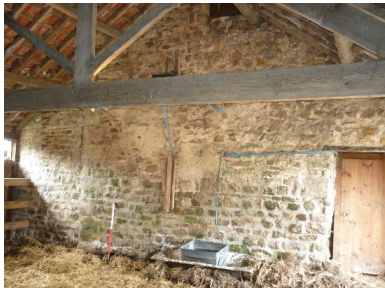
1-539.JPG

- 3.30 The east gable of the barn is partly obscured by the single storey structure abutting it, described above. Within this structure, the east gable of the barn rises from a projecting plinth, and has an inserted ground floor doorway with a timber lintel at the very north end [1/540]. There appears to be a small blocked opening, perhaps a window, to the immediate south of the doorway and there is further disturbance beyond this although no other features are clearly visible. There are edge-laid quoins to the south end of the elevation, where it is butted by the structure to the south. A tall opening survives towards the apex of the gable, which resembles a loading doorway [1/541] (see plate 9).

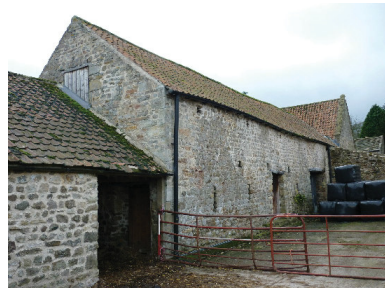
1-540.JPG

Plate 9: Barn, east gable and north elevation, looking SW (photo 1/541).

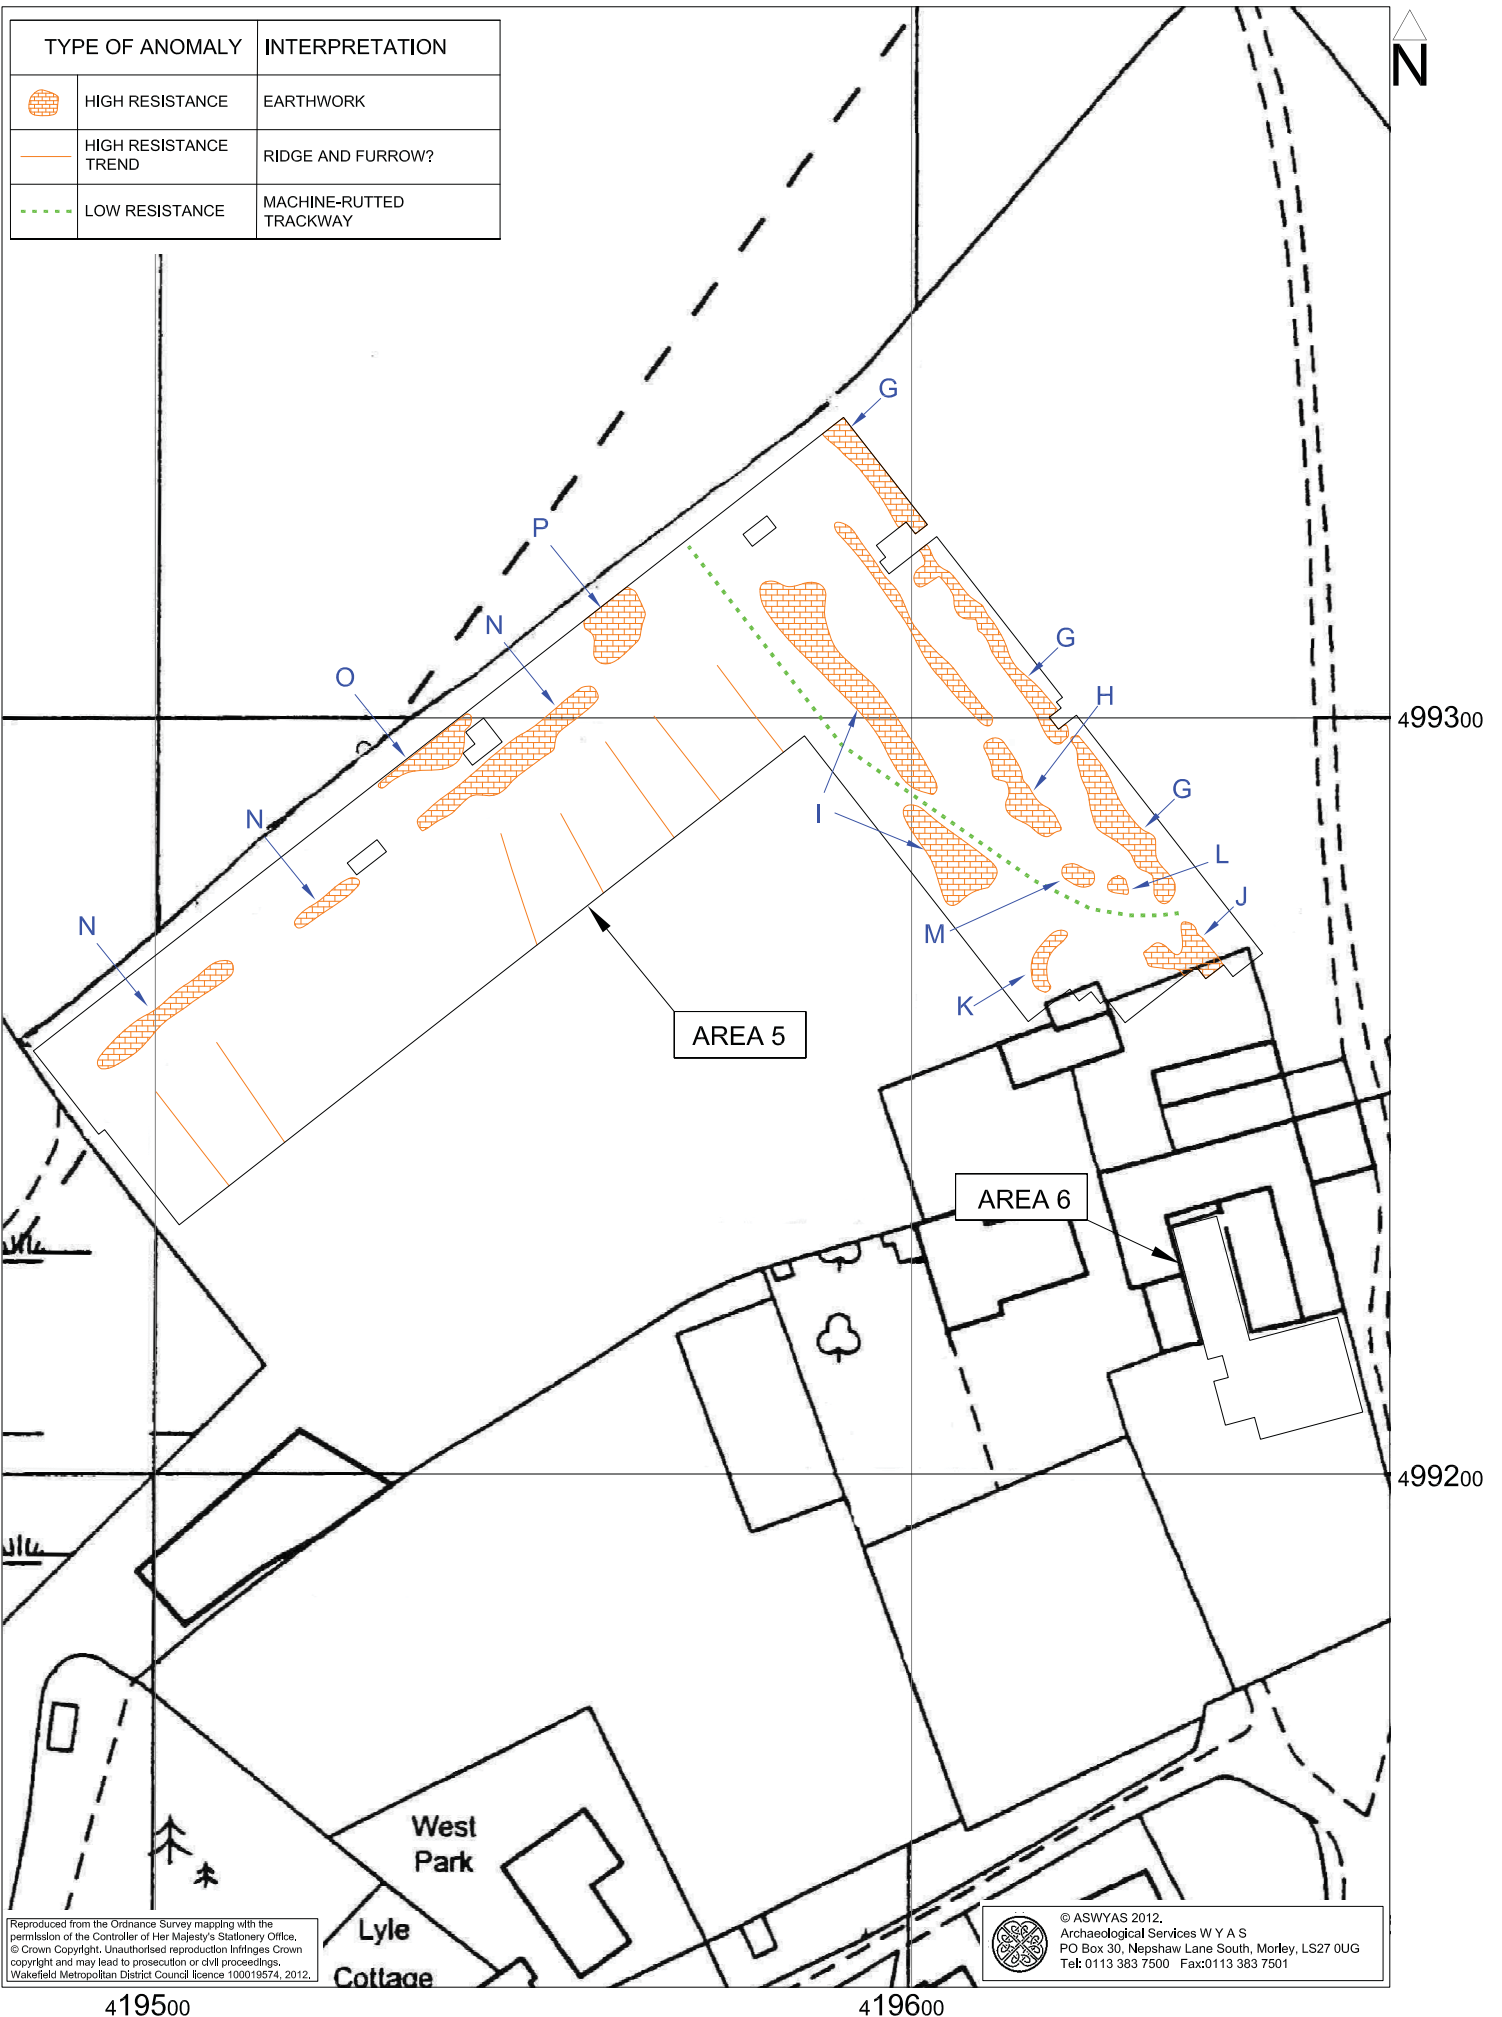
Fig. 9. Interpretation of resistance data; Areas 5 and 6 (1:1000 @ A4)

In conclusion, either one or both of the non-intrusive surveys have clearly identified most, if not all of, the upstanding features which have been interpreted during the earthwork survey, undertaken immediately prior to the geophysical survey. Unfortunately neither the magnetometer or resistance surveys has identified any additional sub-surface features or provided any additional detail to the above-ground features.

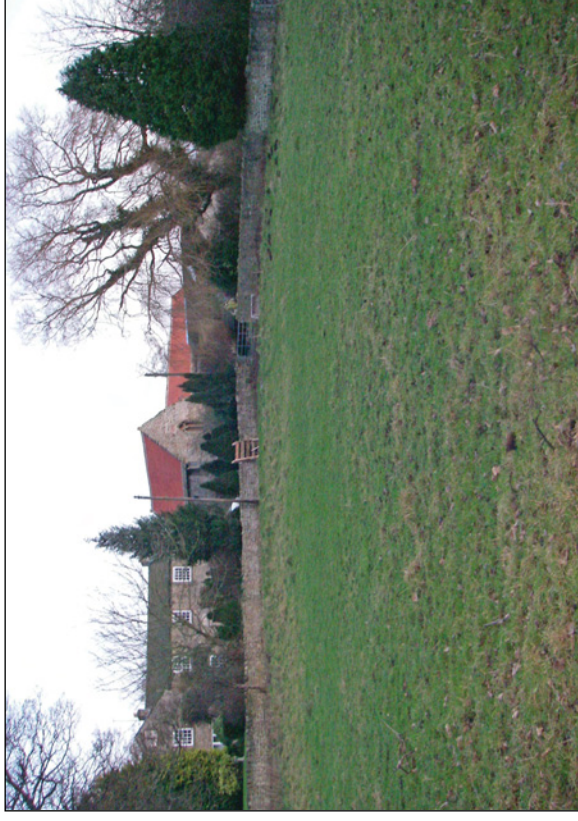
Plate 4. Area 3, looking north-east
