**SCAR NAVVY CAMP, SCAR HOUSE RESERVOIR**

**NIDDERDALE, NORTH YORKSHIRE**

**HISTORIC ENVIRONMENT SURVEY**

August 2013

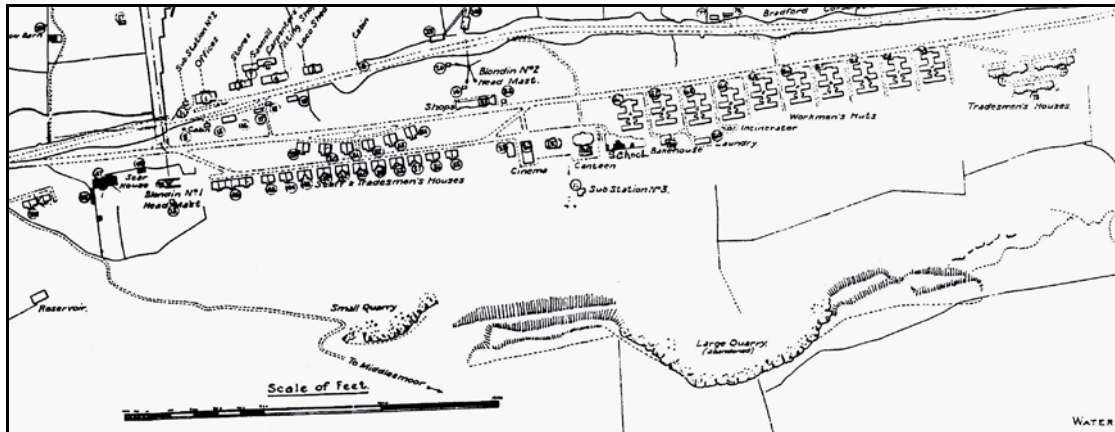
Figure 3. Extract from Bradford Corporation Waterworks. Scar House Reservoir  
Taken from Scar Village Remembered – Calvert et al (1991) Nidderdale Museum Archives

- 4.6 The ‘old road to Middlesmoor’ (Site 8) shown on Figure 3 could be the route of the medieval (or even earlier) track between the now submerged Haden Carr and Middlesmoor. The site visited recorded that the track-way appeared to have the remains of a surface, which had been cobbled with small water rolled stones (Figure 4) in a very similar manner to Carle Fell Road (Buglass, 2011). It also appeared to have the remains of a possible stone trod (Figure 4) along the north-eastern side of a section of the track – again very similar to the one seen on Carle Fell Road. It is possible that this line of stones is the remains of a dry-stone wall along the side of the track. However this would not seem to be the case here. Firstly, there was not the amount of tumbled stone that would normally be expected if this was the case, and secondly, the stones appear to be spaced slightly too far apart to be from a wall base. If these two features are similar to Carle Fell Road and therefore possibly contemporary, it is quite possible that they have a medieval origin, as has been suggested for Carle Fell Road.

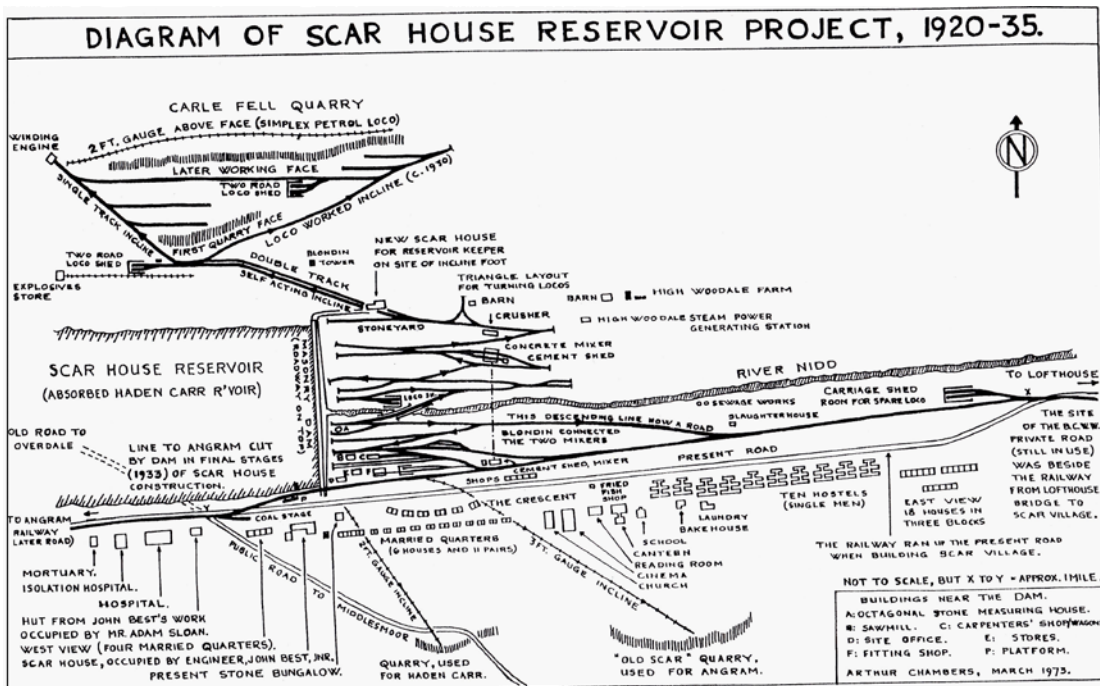
Figure 5. Plan of Scar Village

- 4.10 From the current examination of the readily accessible material it would appear that the most comprehensive source for information is the volume by Bolt (*A Walk in the Past*, 2007) with some significant additional information in the booklet produced by the Nidderdale Museum (Moody, 2009, *Scar House Village*). In addition to these there are at least three, subtly different plans showing the village (the one reproduced in Bolt and Figures 3 and 5). Many of the difference are probably due to differing levels of accuracy required when they were originally drawn up and the buildings are actually the same but their locations are slightly at odds with reality. However, it may be that some of the differences represent different phases of the settlements development. From the site visit it was also noted that there is much more detail to the buildings and associated infrastructure than is shown on these plans. It should be noted that Bolt's volume does include detailed plans of many of the individual structures of the village. It may be possible to unravel

elements of this by carrying out a detailed map regression over a modern OS digital map base. This would highlight any differences that could then be investigated on the ground.
