ARCHAEOLOGICAL WATCHING BRIEF

SKIPTON CASTLE

GATEHOUSE

SEPTEMBER 1998

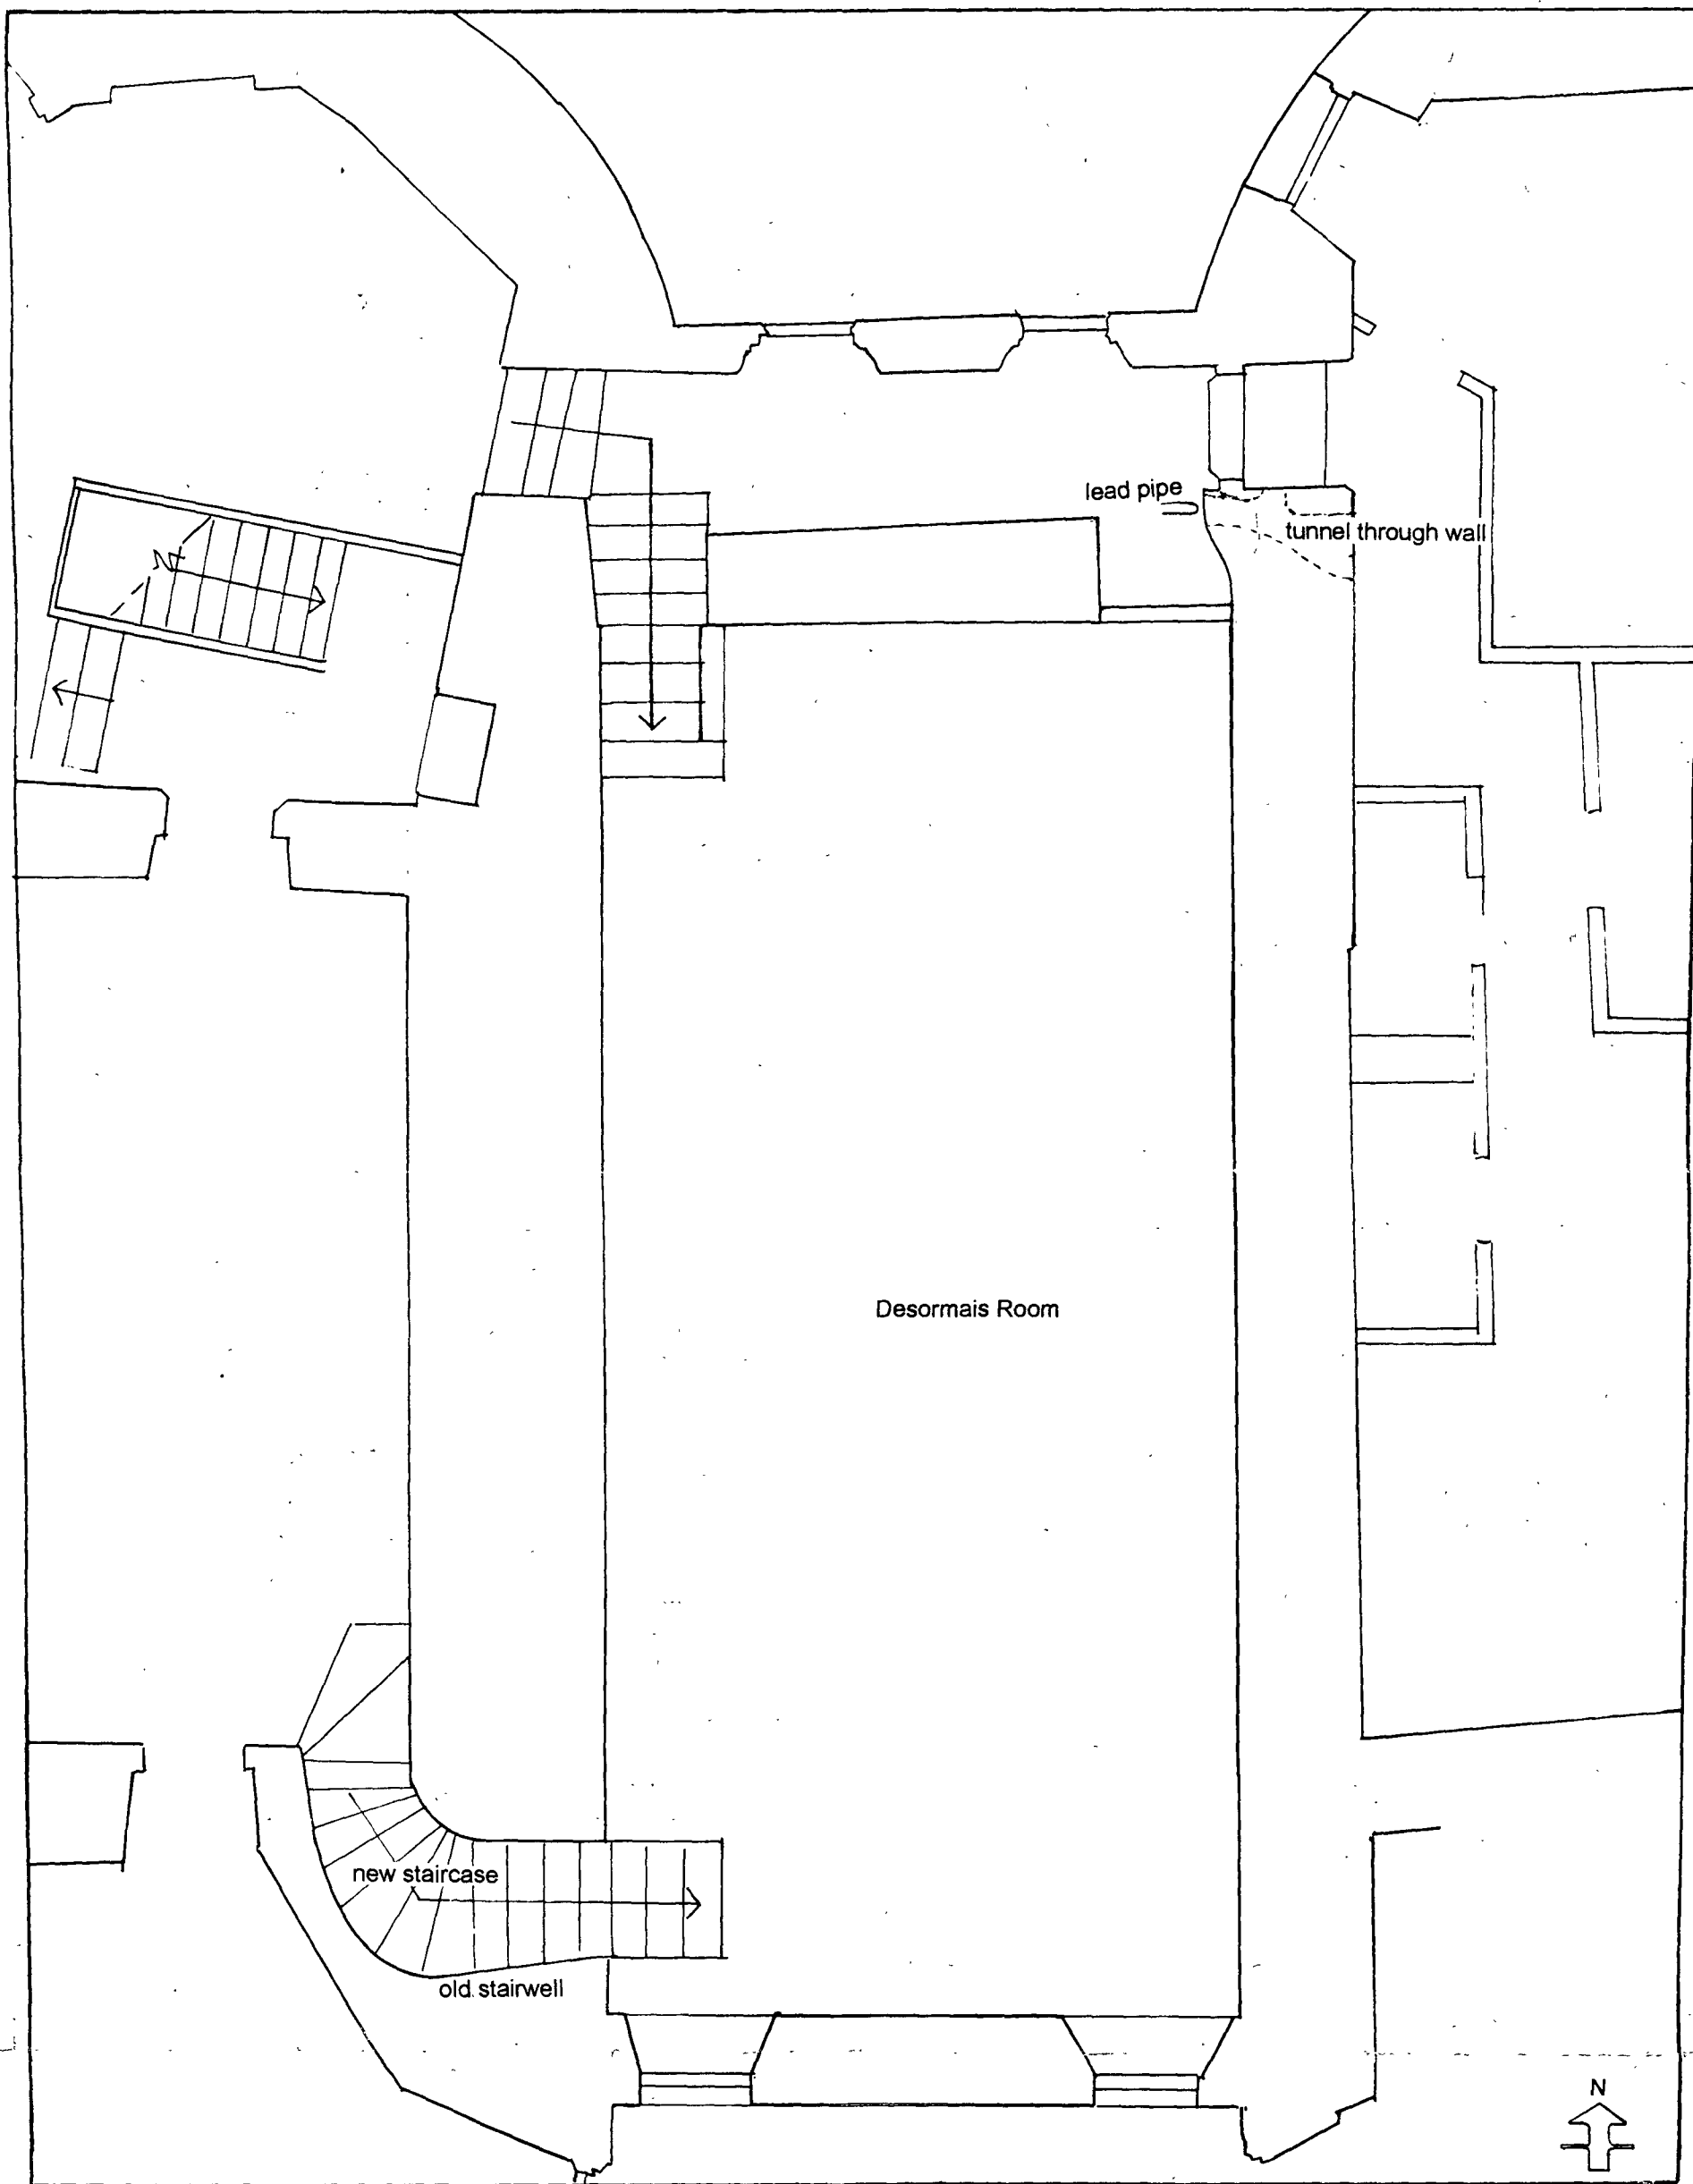
SKIPTON CASTLE GATEHOUSE PLAN 2 SITE

- 1.1 The first part of the work involved cutting through the inner wall of the eastern half of the gatehouse at first floor level to insert a drain (Plan 2, 4). The new drain was to connect with an existing lead drain (Plate 10) which runs down the channel of the former portcullis on the eastern side of the central opening of the gatehouse. The material was removed by electric drill and hand.

- 1.2 The channel was cut immediately above the level of the existing floorboards to avoid having to cut through joists, and adjacent to an existing doorway between the eastern half of the gatehouse and the central portion. At its eastern end the hole was 32cm high, with 7cm of this height below the level of the floorboards, and 50cm wide (Plate 11). At the western end the hole was 27cm high and 23cm wide. Its size varied along its length, and in the centre where it was cut through from the side of the doorway it was 34cm high (Plate 12). The level of the base of the hole gradually dropped from west to east by approximately 10cm relative to the floorboards.

- 1.3 The material of the wall which was removed consisted of roughly dressed stones at the outer faces of the wall, with stone rubble and mortar infill. The rubble consisted of stones up to 12cm long randomly set in a pale yellow mortar which occupied up to 50% of the space within the wall. The dressed stones at the surface were fully dressed only on their outer edges, and were up to 40cm in length. At the eastern face there were signs of some disturbance, with brick fragments and a piece of wood immediately behind the plaster of the wall. The central part where it was broken through from the doorway appeared to have a

missing dressed stone at the surface, and the space was filled in with rubble and mortar.

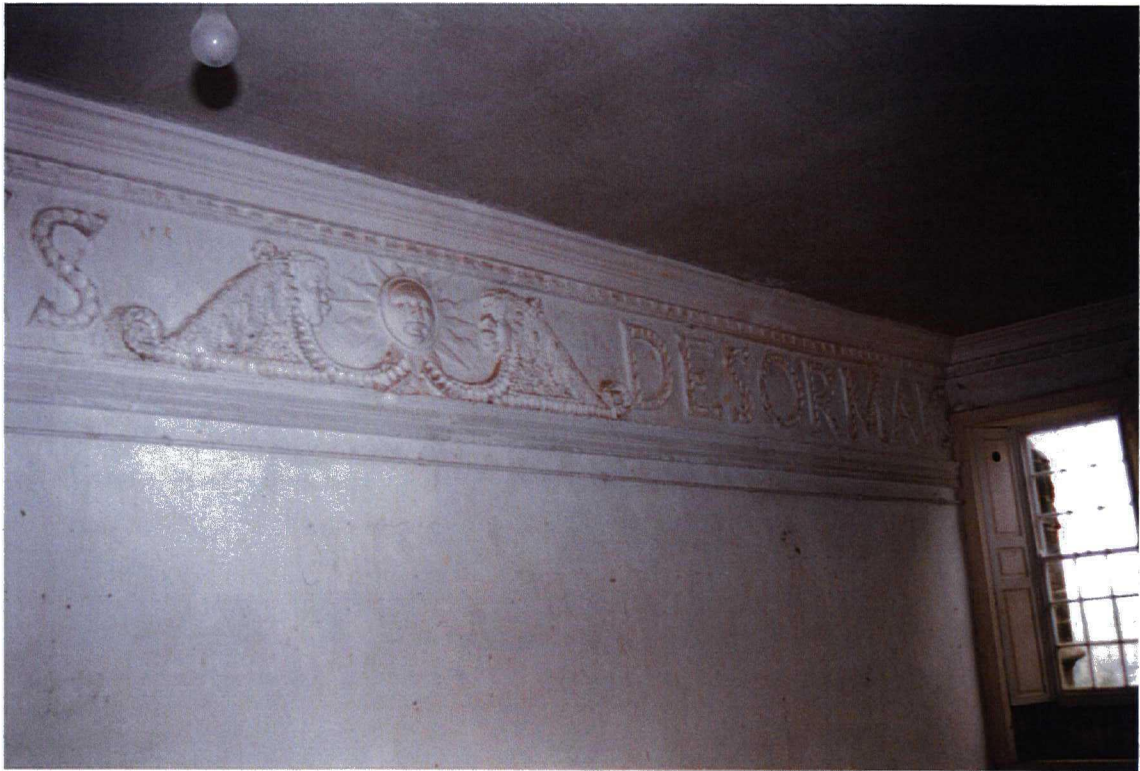
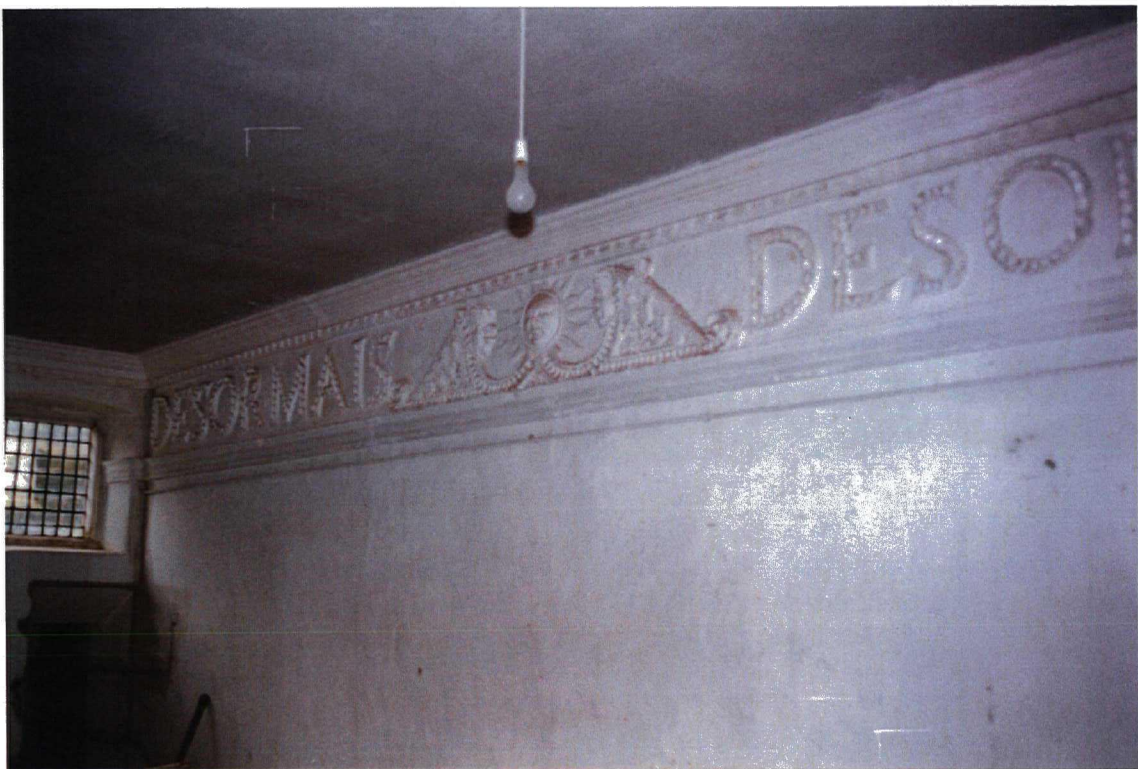
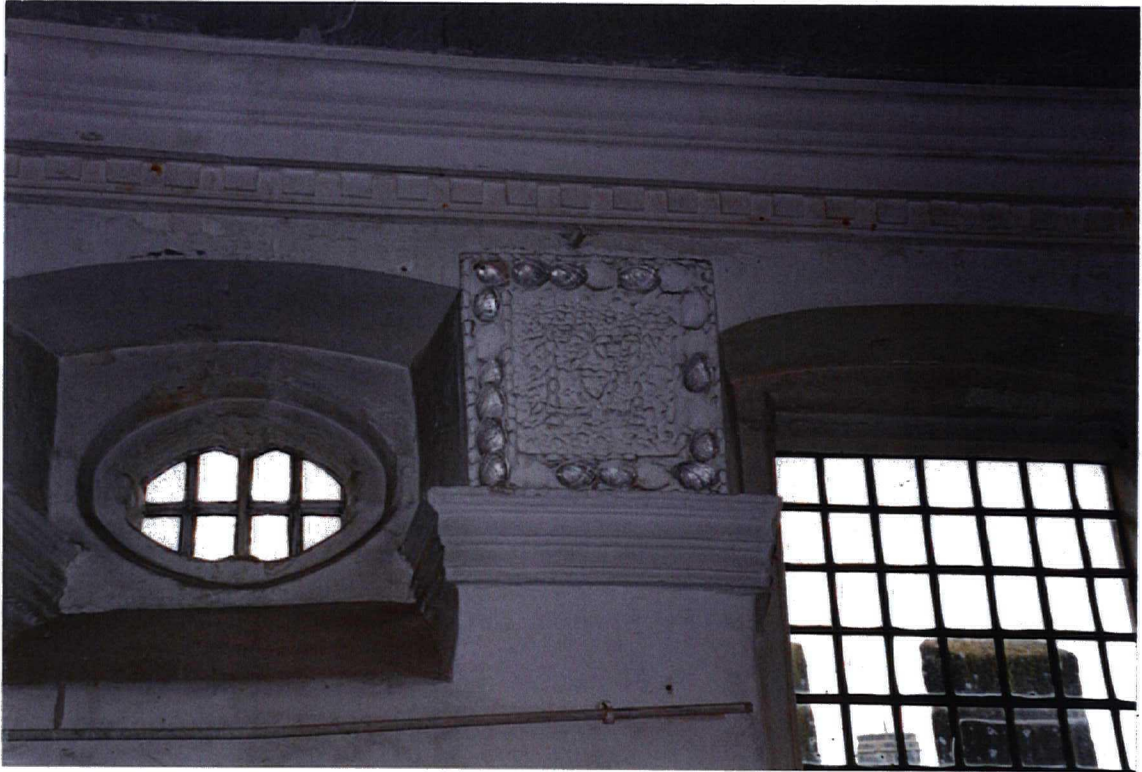
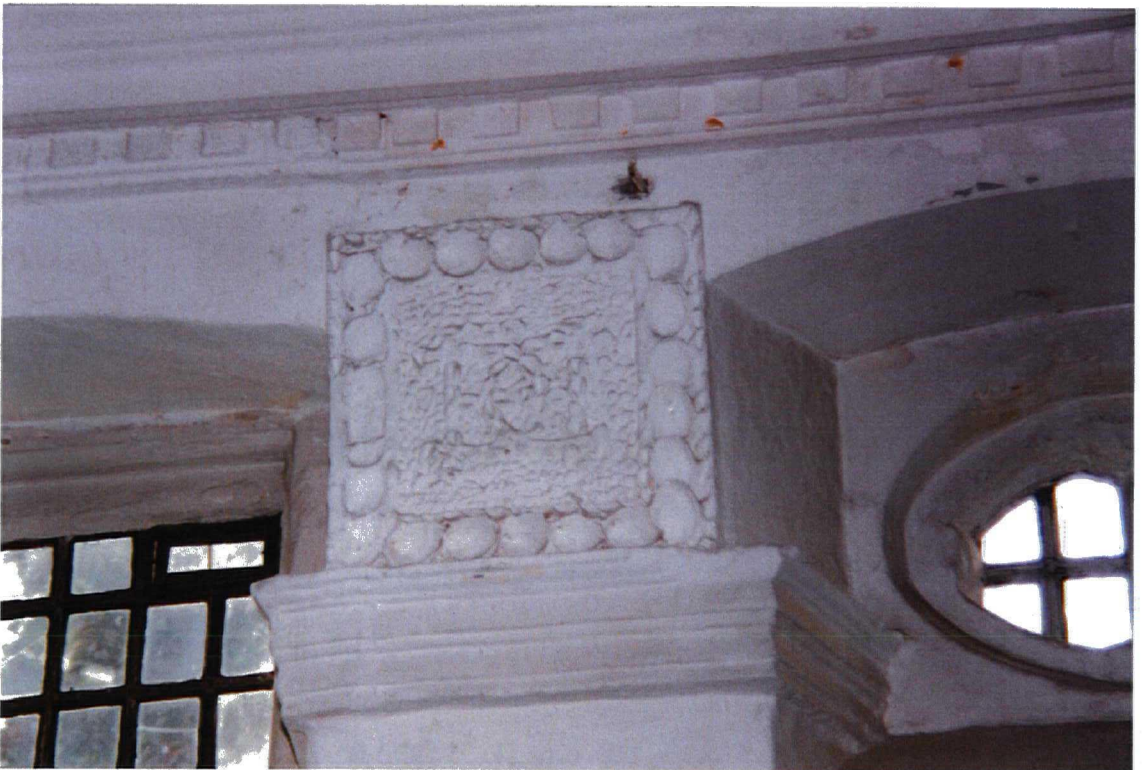
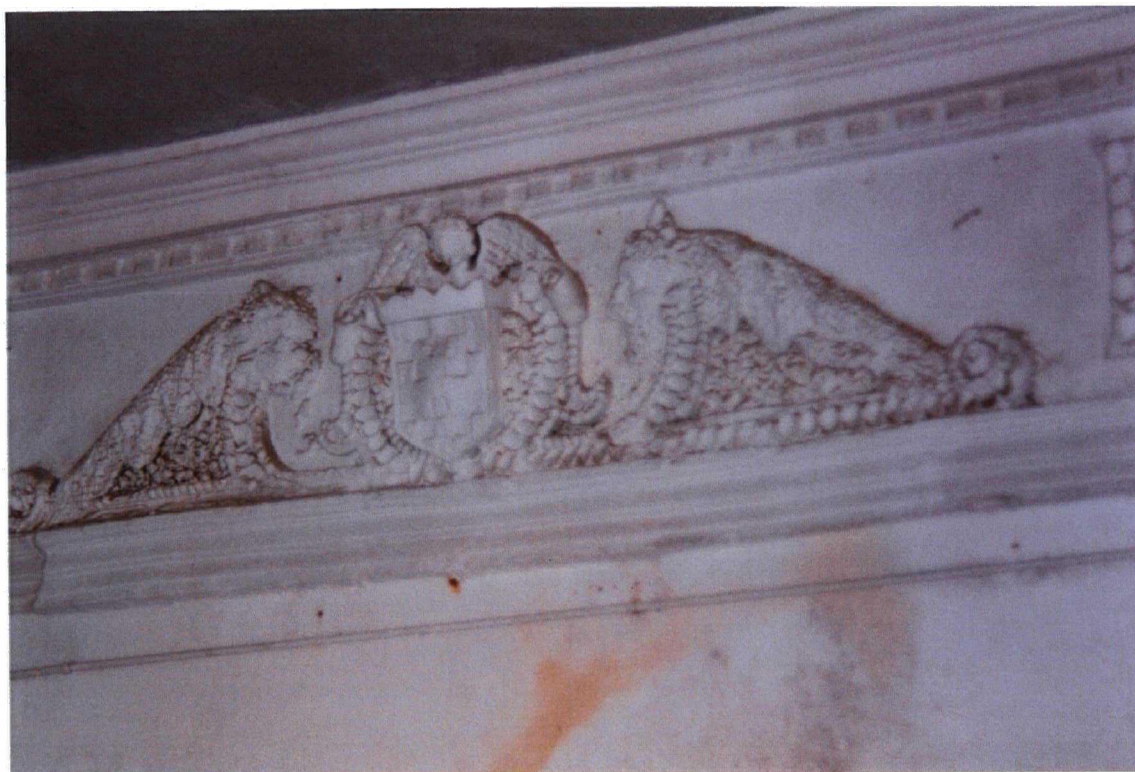
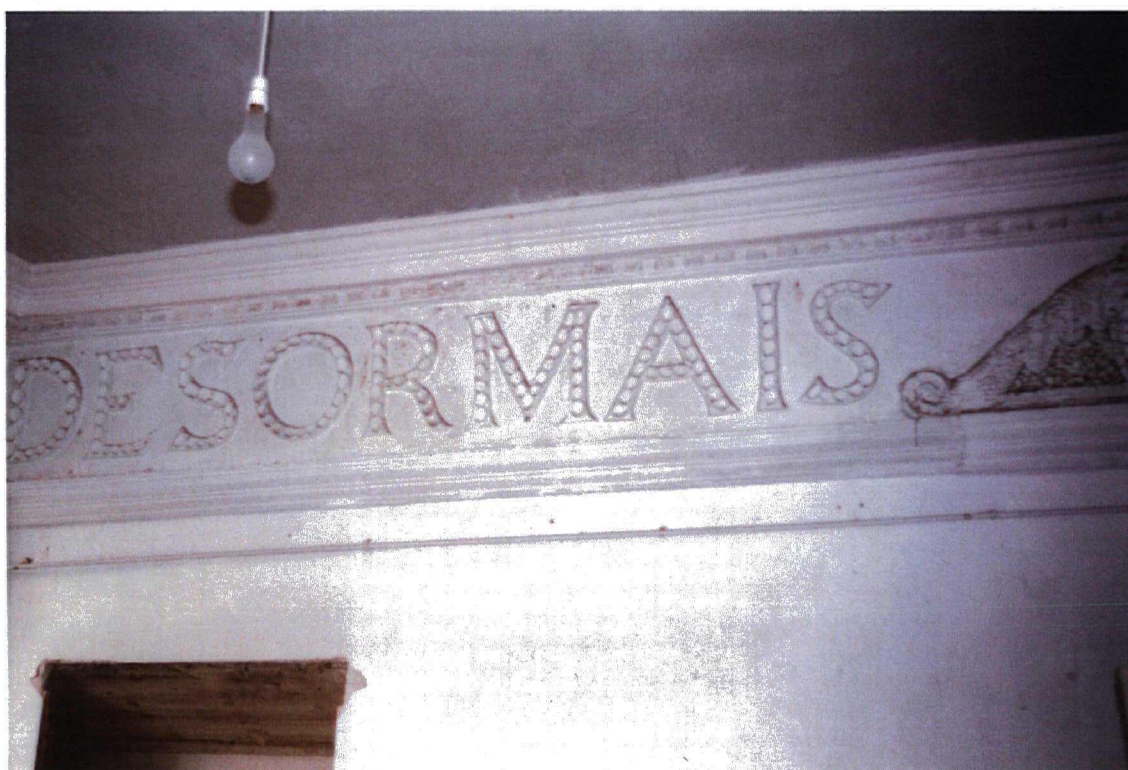
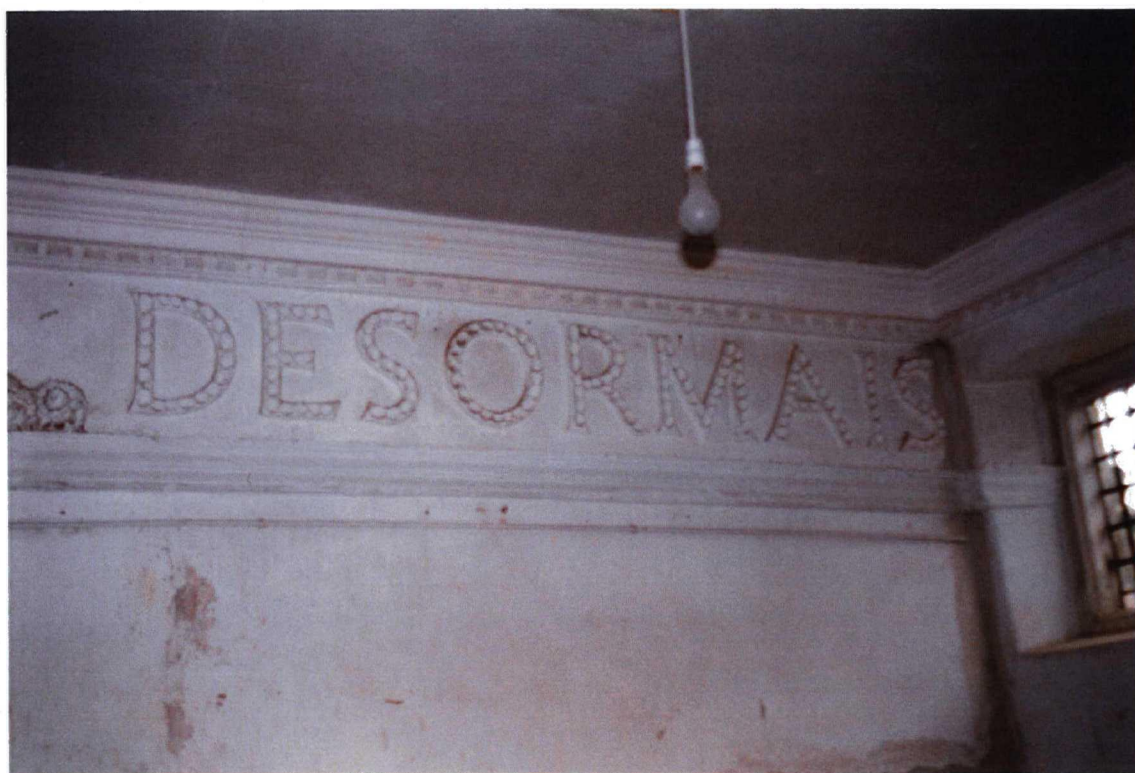
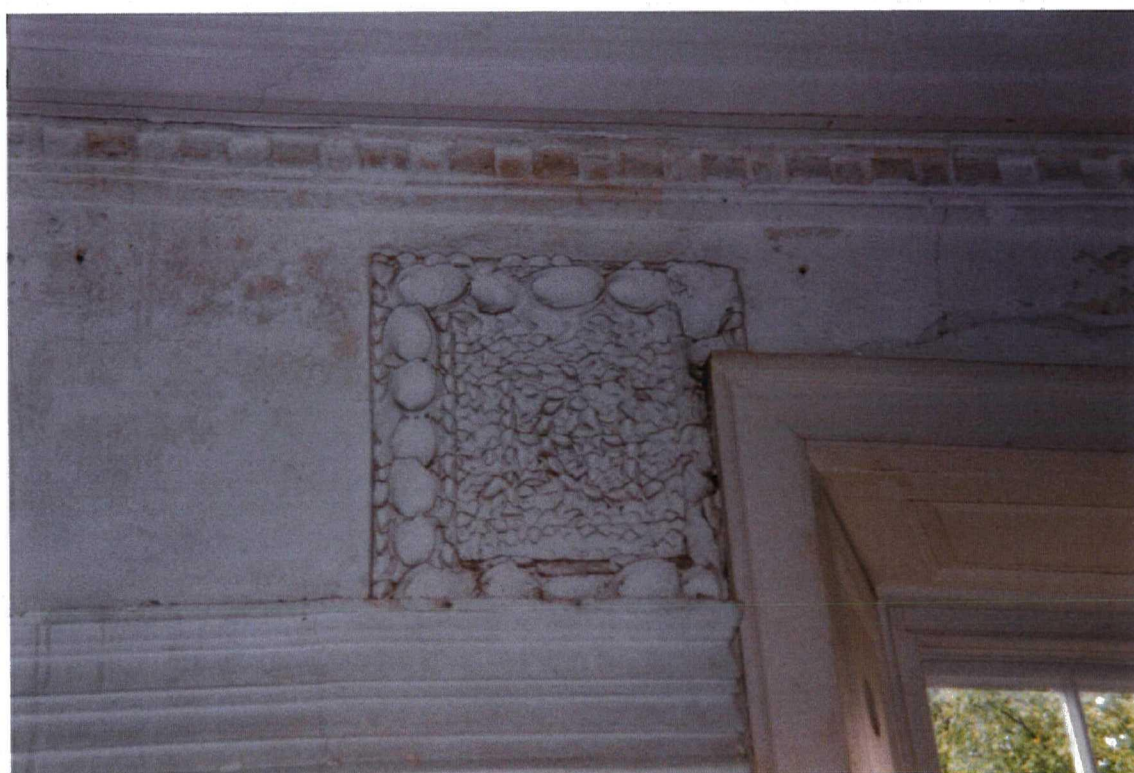
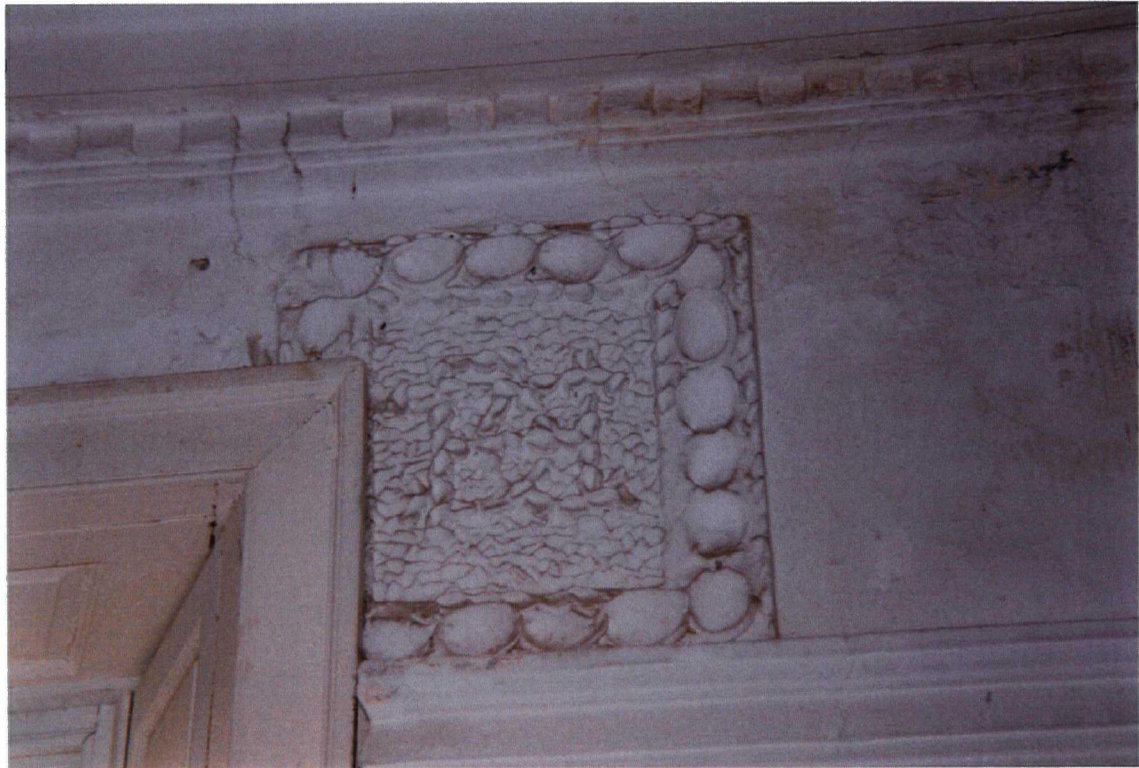
All the work was internal and mainly involved the removal of material from walls within the structure of the Gatehouse. In addition, the plaster and shell work in the central room above the gate was to be cleaned. This was photographed prior to cleaning (Plates 1-9).
