Cross Butts, Whitby
Historic Building
Recording

Client: THE INN COLLECTION GROUP

AB Heritage Project No: 62021

Level 2 – 3 Historic Building Recording

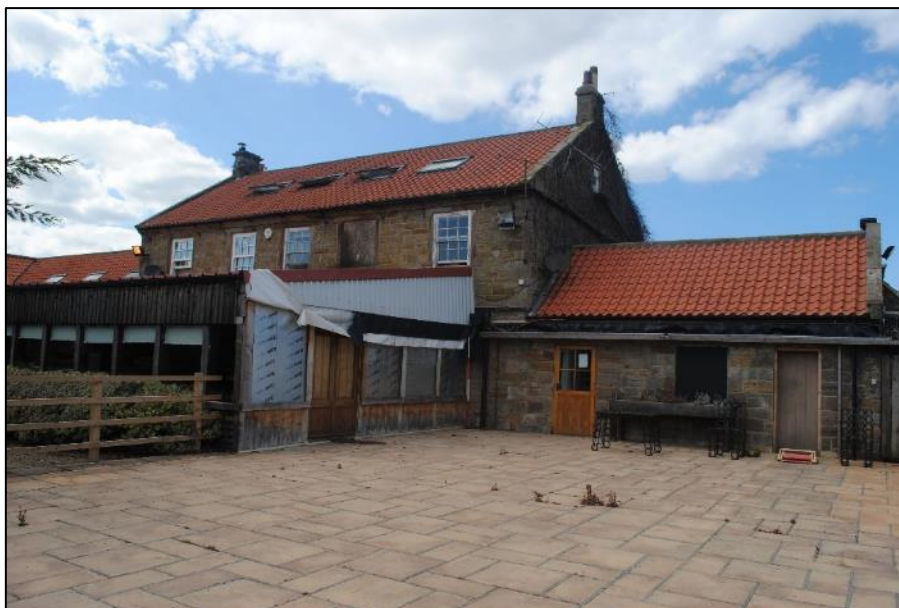
Photo 4. Cross Butts [AB 1] south elevation; view north/northwest

- 4.3.7 **South elevation:** The ground floor of the south elevation is obscured from view by the large modern Sun Terrace (S1). On the first-floor level there are five window openings; one of which has been blocked. On the attic level there are four rooflights.

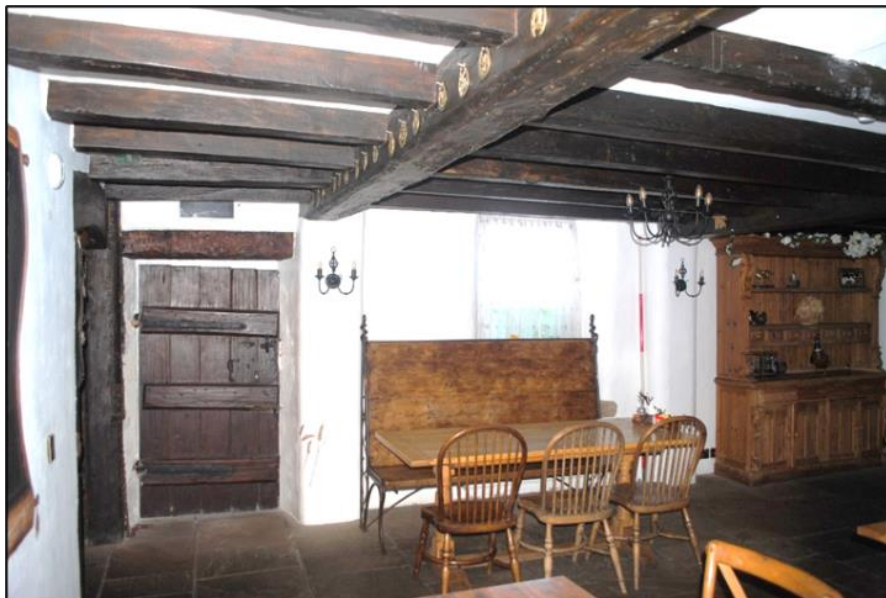
Photo 6. North wall [AB1 – G1] with the front door of Cross Butts on the left

- 4.4.8 **Door and window - North Wall:** The original main entrance of the building is sited on the north wall of G1 (Photo 6). The present varnished timber plank door is assessed to be a modern replacement. There is a timber lintel above the door. To the east of the doorway are two sash-windows (one shown on the right on Photo 6) with an outlook to the farmyard.

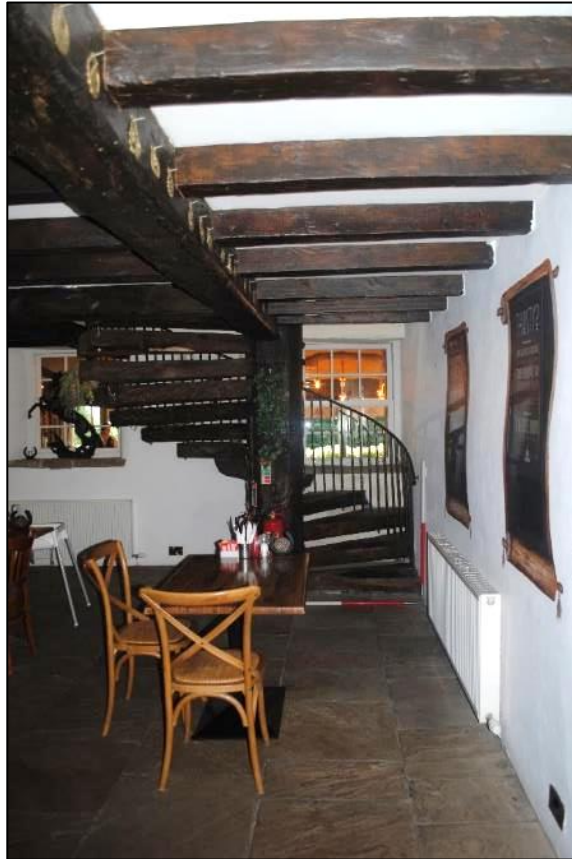
Photo 7. AB1 – G1; modern spiral staircase from ground to first floor; view south

- 4.4.9 **Door and windows - South Wall:** SW corner; a doorway leading out to the modern Sun Terrace (S1) and as shown on Photo 7 two sash-windows are sited behind the current staircase. These windows would have had an outlook towards the rear-garden, however after the construction of S1 Sun Terrace, there is an outlook into this room instead.

- 4.4.10 **Staircase:** Based on observations from the site visit it is thought that current spiral staircase dates from the 1980s but located in a position opposite the front entrance and Porch [P1] of the building, where an original 17th century staircase would most likely have been sited.

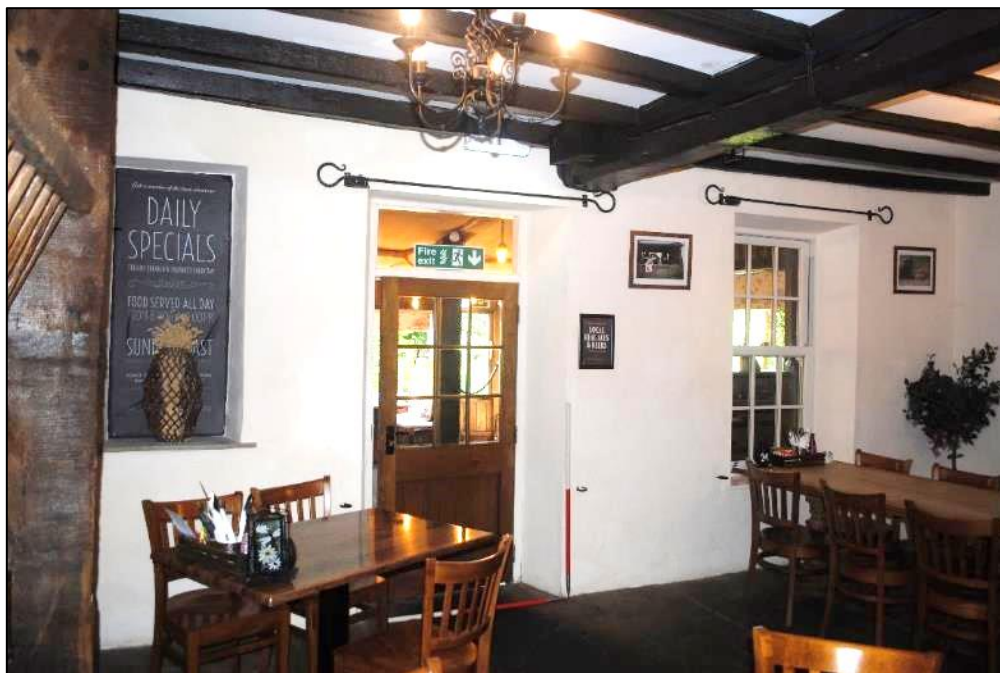
Photo 9. AB1 – G2; south wall; the current doorway to the Sun Terrace and enlarged window

4.4.17 **Door and windows - South Wall:** Broadly centrally placed doorway leading out to the modern Sun Terrace (S1) and as shown on Photos 8 to 9; sash-windows are sited to the east and west of this doorway. These windows would originally have had an outlook towards the rear-garden, however after the construction of S1 Sun Terrace, there is an outlook into this room instead.

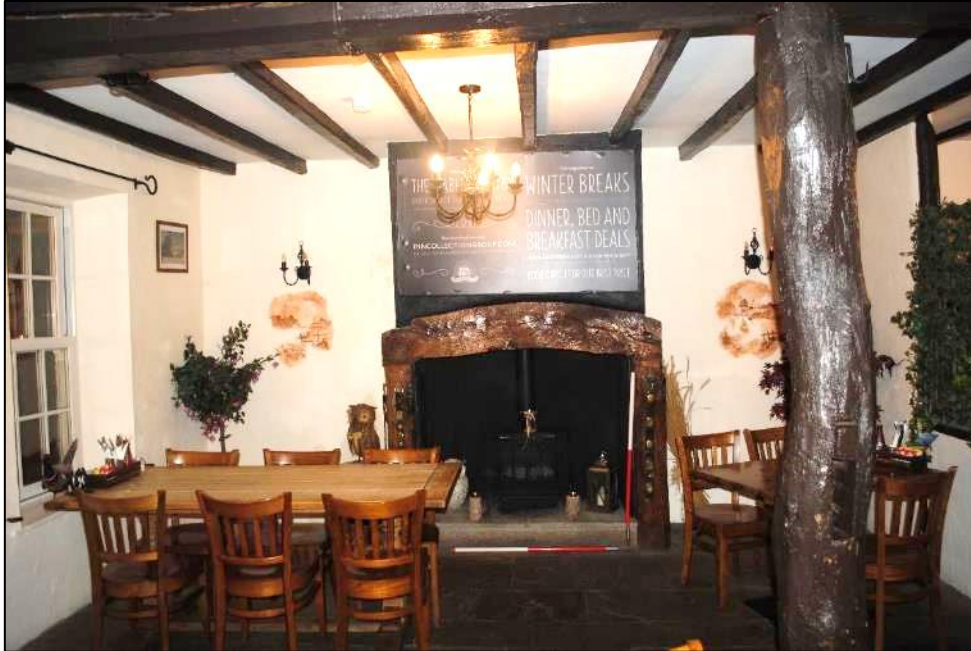
Photo 10. AB1- G2; west wall; modern fireplace; with additional metal flue

- 4.4.18 **Door and other features- West wall:** The west wall would originally been an exterior wall, and it is of substantial masonry construction, now with chimney breasts within room G2 (Photo 10) and in the adjoining former Stable (R1) also.

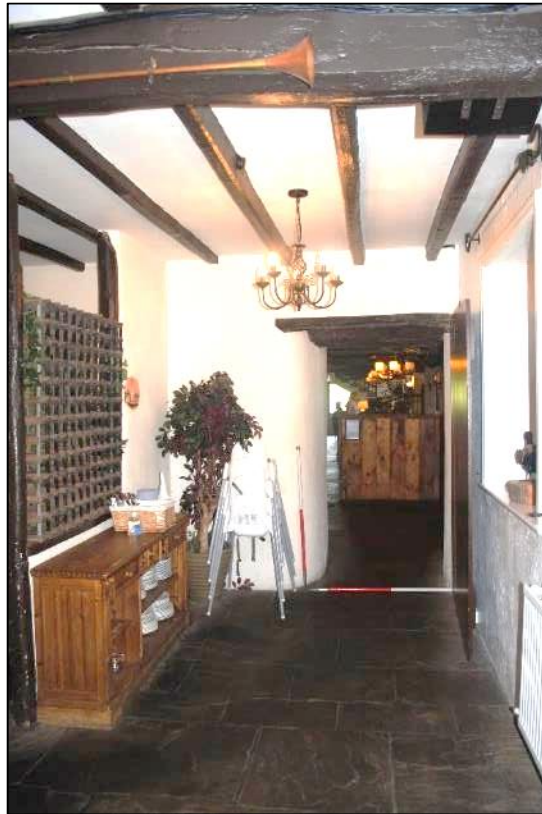
Photo 11. Doorway between G2 and R1; view west

- 4.4.19 **Other features:** As shown on Photos 10 and 11 the passage from R1 through to G2 and onto G1 is partially partitioned off by a modern screen and a lower than half-height partition wall.

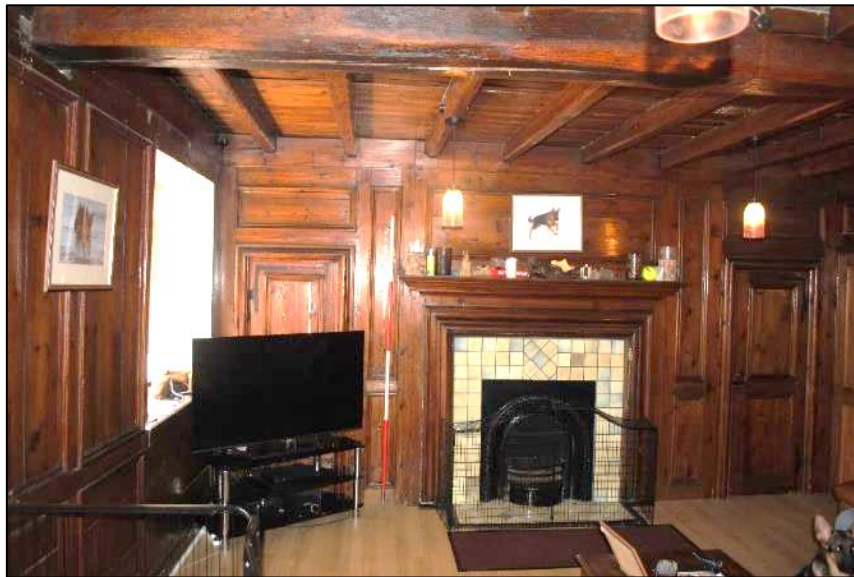
Photo 14. Room F1; view west

4.4.25 **Interior Walls:** Heavily panelled in varnished pine. This scheme of panelling has been assessed to be of late 19th or early 20th century date, possibly using fully or parts of older timbers (Photo 14).

- 4.4.26 **Ceiling:** Exposed timber beams, joists and underside of upper floor floorboards; some of possible historical date, others likely to be modern replacements. Mid-brown/dark varnish to timber elements; otherwise plaster painted white (Photo 14).
- 4.4.27 **Doors and other features - West Wall:** The western wall (Photo 14) features a centrally placed fireplace of late 19th to early 20th century date. On both sides of the chimney breast are two small 'cupboards' where a toilet and a shower room have been fitted during the late 20th century.
- 4.4.28 **Doors and other features - North Wall:** The NE corner of this wall features a doorway leading into entrance vestibule (F2) (on the left on Photo 15) and secondary smaller door leading to a storage space (not accessible during HBR works).

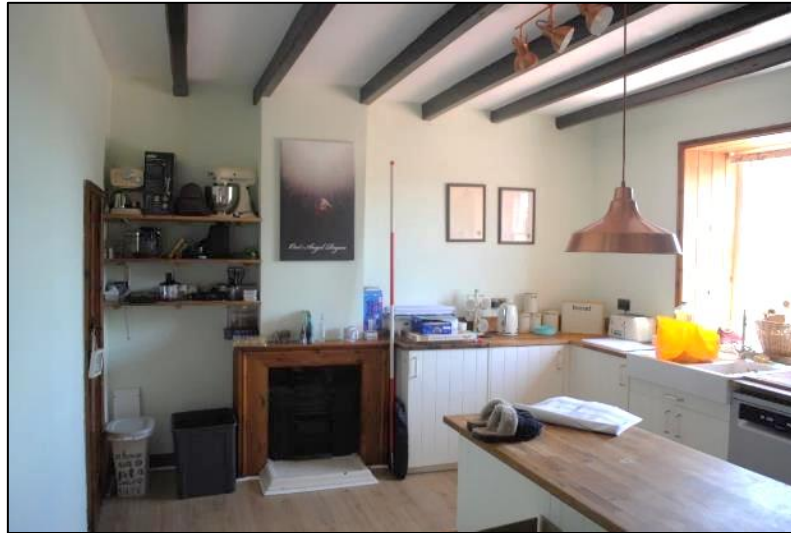
Photo 18. East wall of the kitchen (F2)

- 4.4.33 **Doors and other features:** The east wall (Photo 18) has a centrally placed small fireplace of 20th century date. There are windows on the south wall overlooking the S1 Sun Terrace and the rear garden. The kitchen is modern throughout and there are no notable historical features in this room. Doorway on the north wall leads into Room F3.

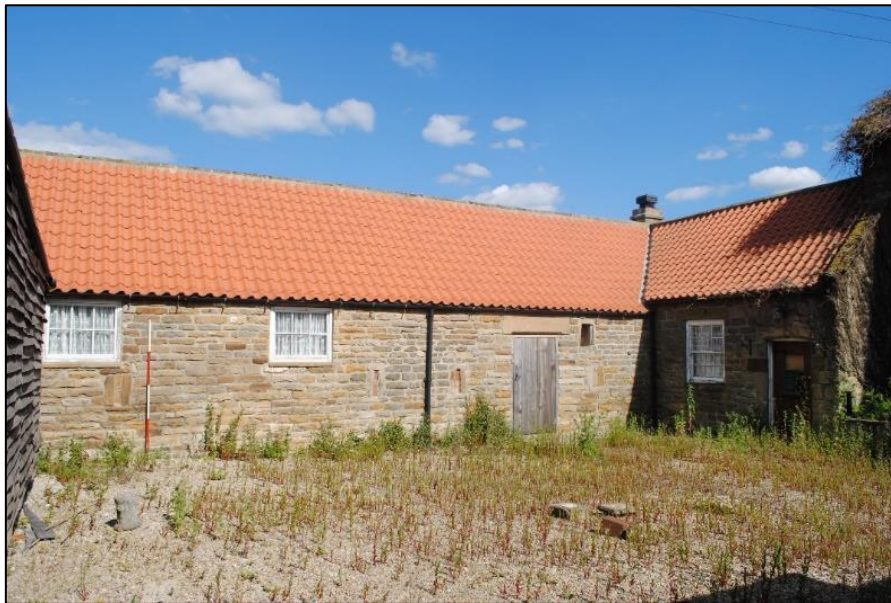
Photo 22. AB 2 west wall; view E/SE from the farmyard

- 4.5.6 **West Wall: Doorways:** As described on the Listed building description and shown on Photos 22 and 24, there are two doorways into the farmyard on this elevation. The northern most doorway has however lost its original stone lintel, and has a timber replacement inserted (Photo 24).

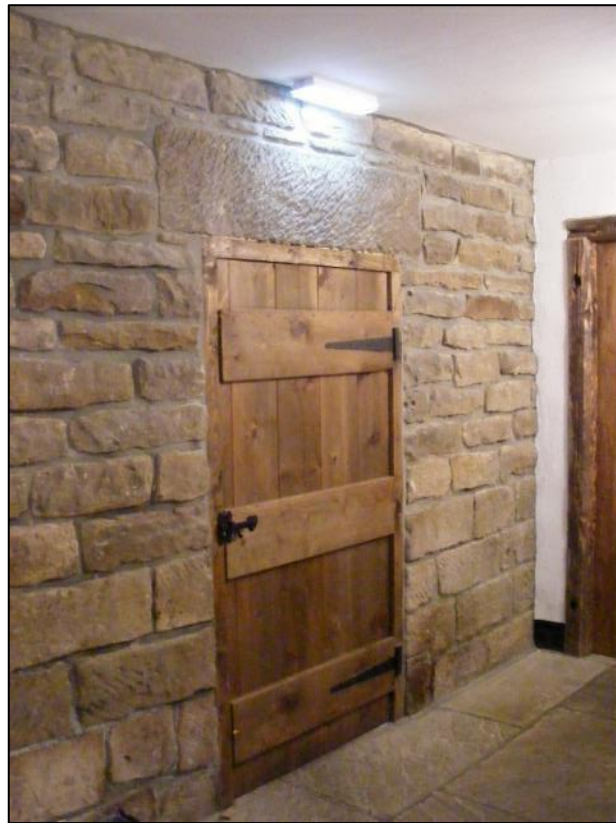
Photo 26. East wall of the Barn [AB 2]; view NE

- 4.5.8 **East Wall:** As shown on Figures 2, 5 and 6 the east facing wall of the Listed Barn [AB 2] has been incorporated into a 20th century agricultural shed adjoining the structure to the east. The later shed has been built partially into the roof structure of the barn and as such the east elevation of the building has been an interior wall for many of years, and Consequently, this elevation is less weathered and cleaner than its western counterpart (Photo 26).

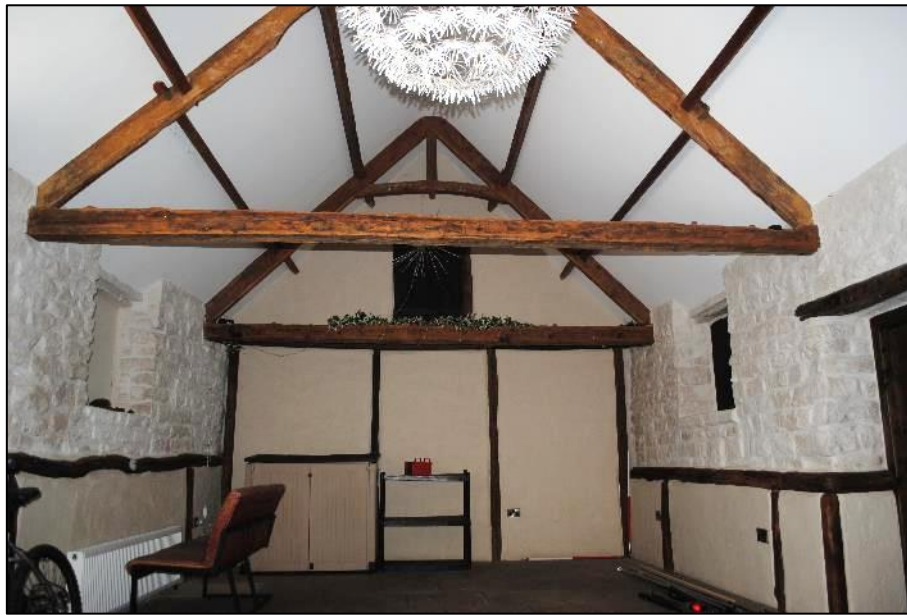
4.6.2 **Roof timbers:** Despite the roof of the building having been replaced with modern pantiles, the barn retains the historic roof trusses as shown on Photos 27 and 30. The purlins and rest of the roof structure are modern.

4.6.4 **North Wall:** The north wall of the Ceremony Room (Photo 27) is a modern partition separating the northern bay (G5) of the building from the rest of the barn. Room G5 functions as the current laundry.

Photo 27. Room G4 – north wall; view north

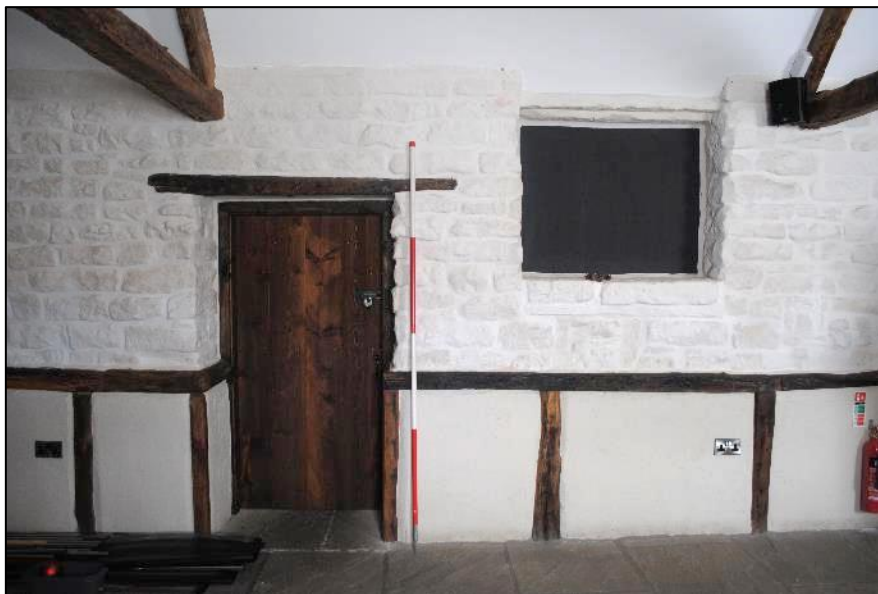
- 4.6.5 **East wall:** East wall is rendered to the height of c. 1m with painted exposed masonry above. There are three timber doors on this elevation and a blocked window (Photo 28).

Photo 28. Room G4 – east wall; northern doorway and blocked window

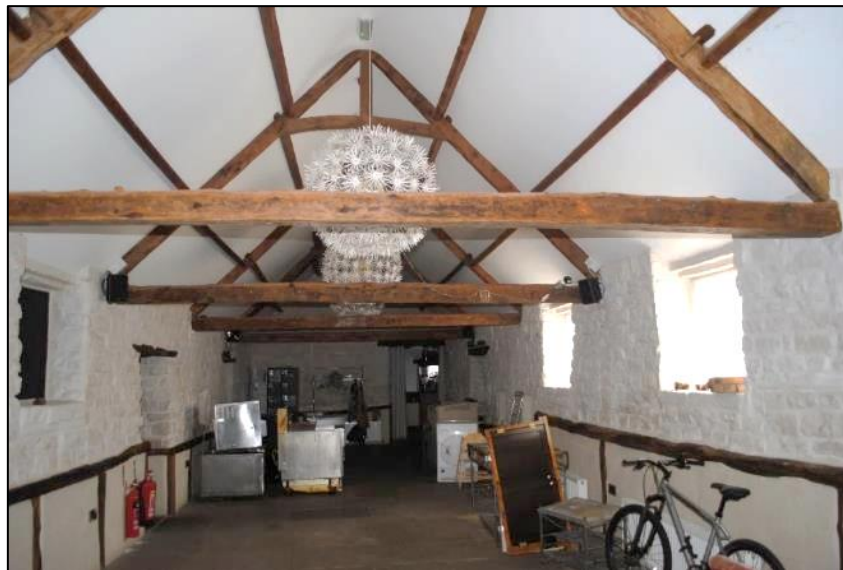
- 4.6.7 **South Wall:** The south gable (Photos 30) of the building features on its SW corner a doorway leading into the Cottage [AB 3] (Photo 31).

Photo 30. Room G4 – south gable; view south

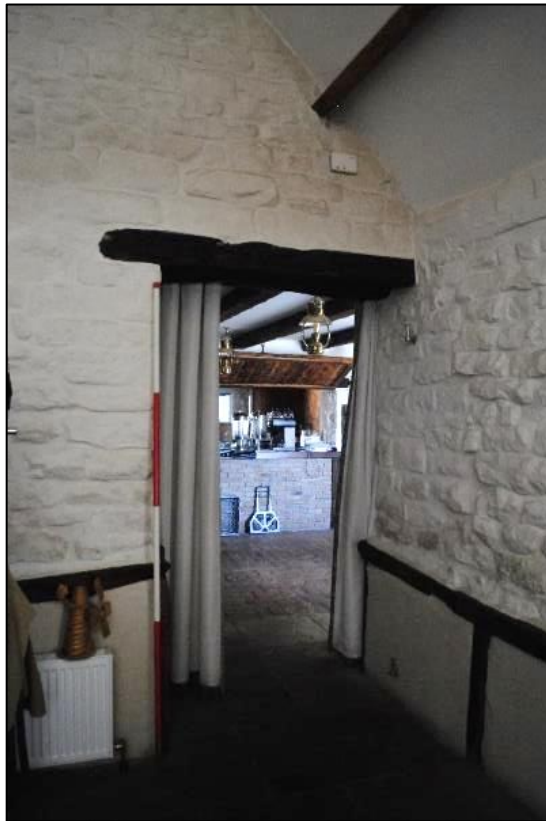
Photo 31. Doorway from G4 into the Cottage [AB 3]; view S/SW

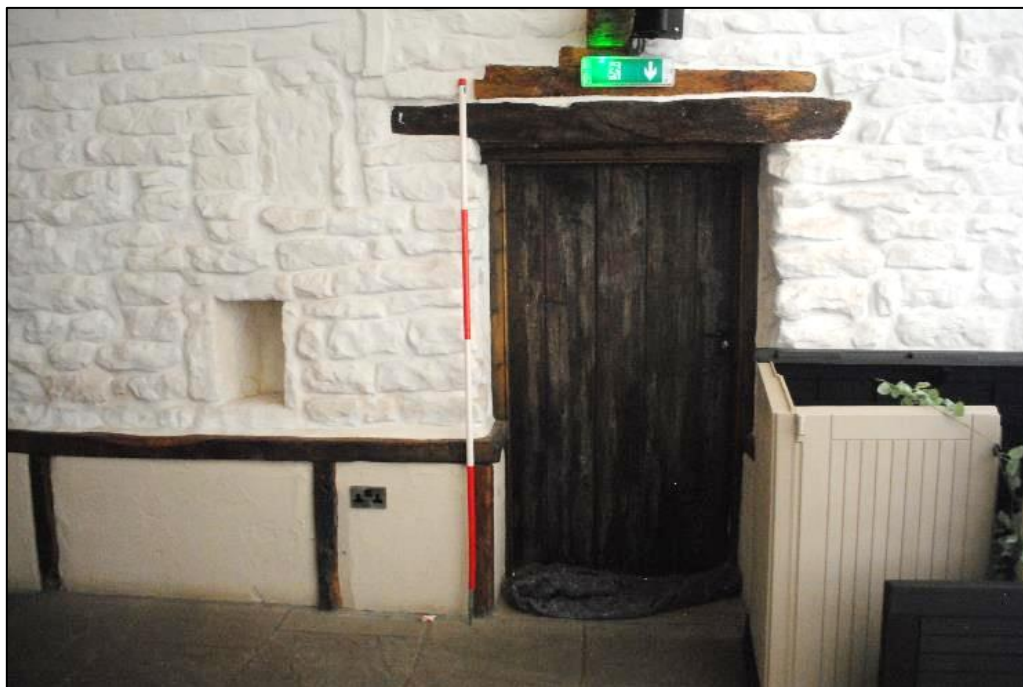
- 4.6.8 **West Wall:** The West wall shares many of the features of the east wall, including the painted exposed stone work, part-rendering and the stone niches (Photo 32).

Photo 32. Room G4, west wall, south doorway and stone niches to the left

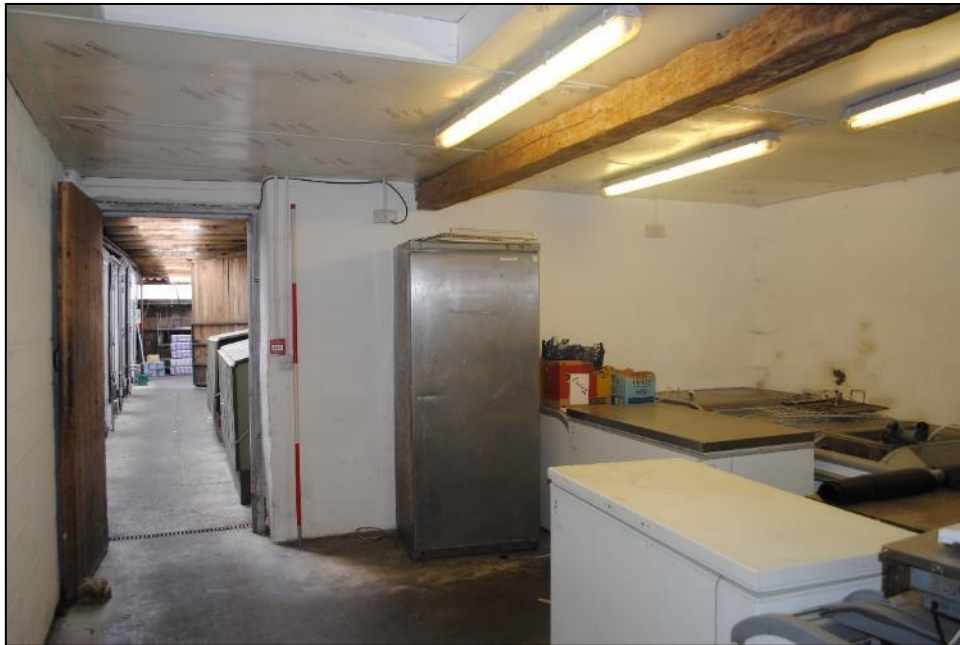
- 4.6.9 The modern laundry room (Photo 33) in the northern bay of the barn is accessed via the doorway shown on Photo 24 above.

Photo 33. Room G5 – view NW

- 4.6.10 The modern interior fit-out of this space obscures any historical features that may be retained behind the installed wall and ceiling materials. The floor is of poured concrete.

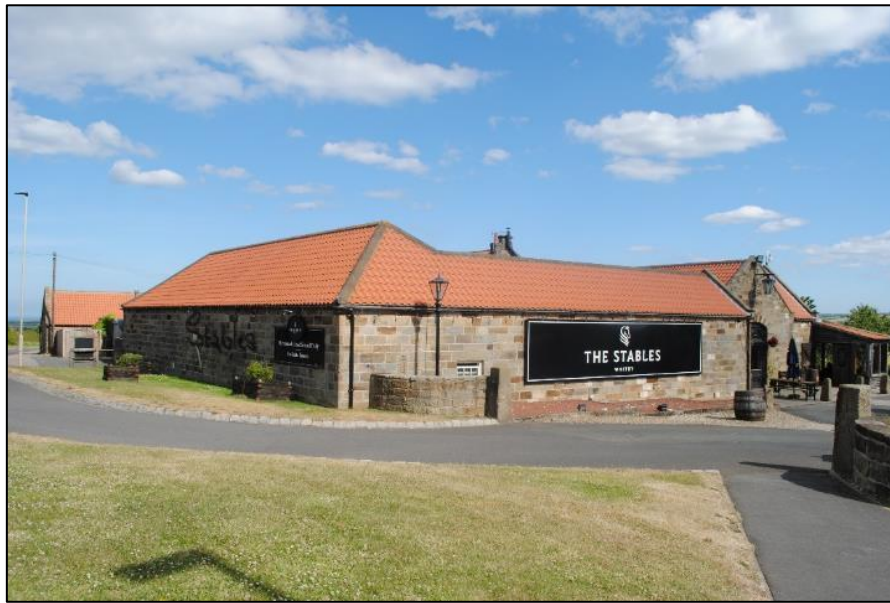
- 4.7.2 Based on the Listing description the Farm Building to Cross Butts (west) should therefore be a mirror image of barn [AB 2]. However, extensive redevelopment which commenced in the 19th century and most significantly during the 20th and 21st centuries, has substantially affected the historic authenticity of the former barn (Photo 34).

Photo 34. The range of current bedrooms; view SE

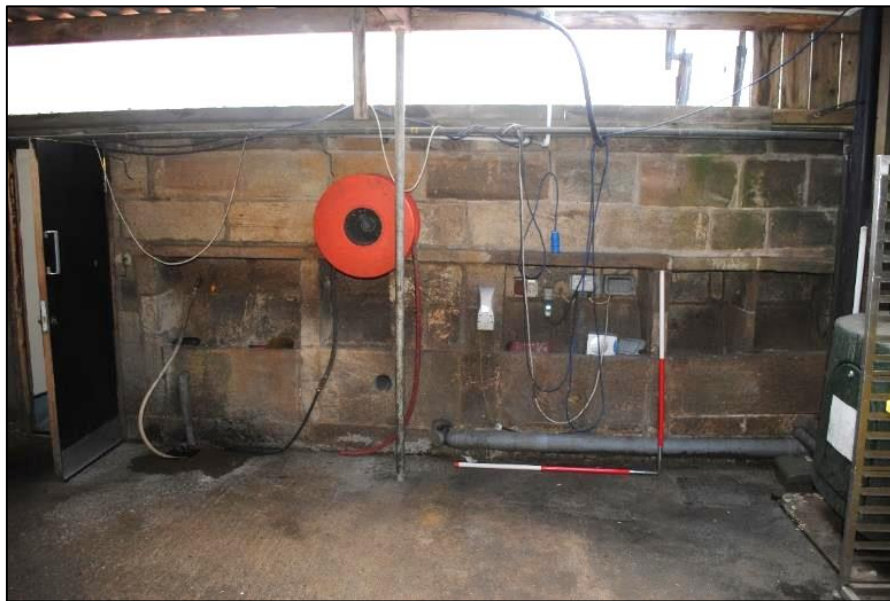
Photo 37. Stone troughs in the east wall of the Kitchen (K1); view west

- 4.8.2 The kitchen (K1) is assessed to date from the late 20th century and while it is possible that its current east facing wall has been built re-using historical masonry formerly incorporated in the east wall of the west barn (such as the animal throughs shown on Photo 37) the character of the building is fundamentally modern.
- 4.8.3 The interior fit out of the kitchen utilises easy to clean materials suitable for hygiene requirements in a restaurant kitchen and as such there are no historical interior features to be observed.
- 4.8.4 The kitchen includes a food preparation and serving area adjoining the restaurant space (R1) at the southern end of the room (Photo 41).

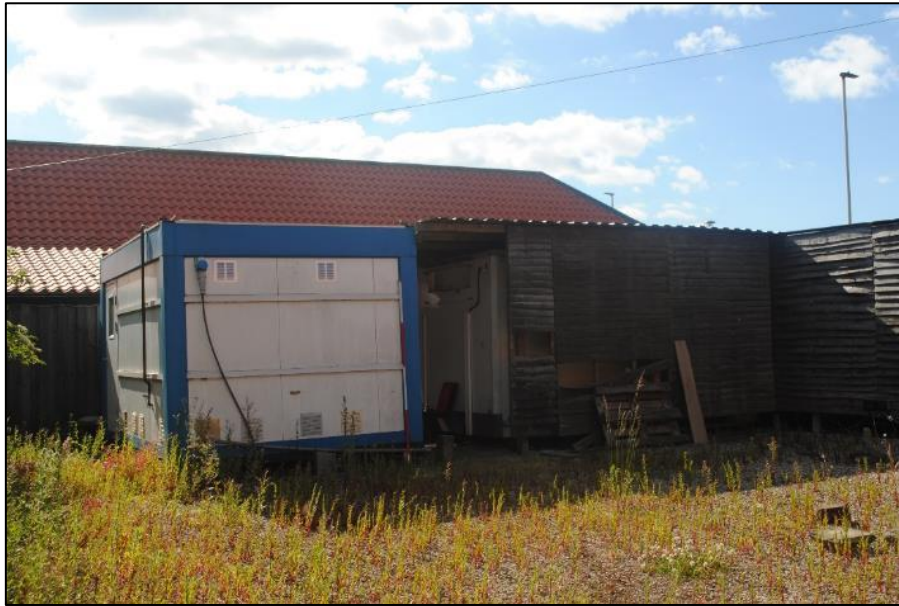
- 4.7.8 As shown on Figures 2 and 5 the east wall of the kitchen faces onto the former farmyard and that this space is at present partially occupied by a series of modern chiller units relating to the functioning of the site as a pub hotel (Photo 38).

Photo 38. Modern ancillary structures on the farmyard; view NW towards the Kitchen (K1)

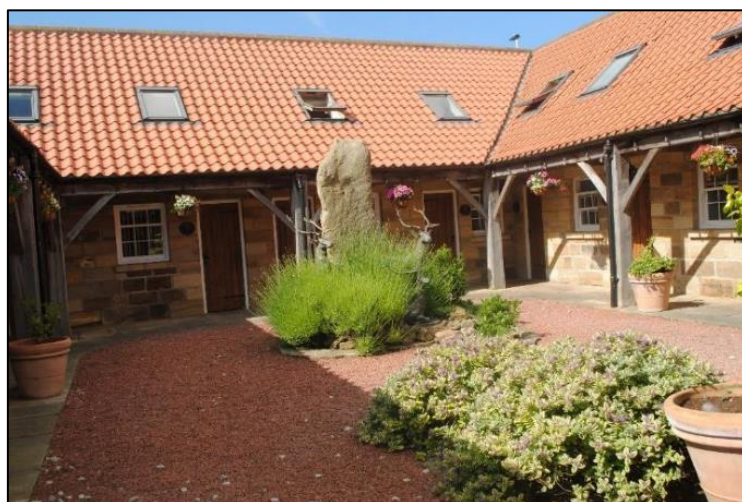
- 4.7.9 The former west barn (on the left on Photo 39) is the structure parallel to the Kitchen extension (K1) and internally currently features a cloakroom, a guest lift, a stairwell (R5) leading to the first floor and four of the nine guest-bedrooms.
- 4.7.10 **Roof:** The modern pantile roof has extended eaves facing the accommodation range courtyard, so that a cloister type covered area is formed over the bedroom entrances (Photo 39). Conservation type rooflights have been included in the roof to provide additional lighting into bedrooms.
- 4.7.11 **Doors and windows:** Plan of doorways and windows is modern, as the siting of these openings does match the corresponding series of doors and windows on the east wall of the of the east Barn (**AB 2**; Room G4).

Photo 39. Accommodation range; courtyard; view N/NE

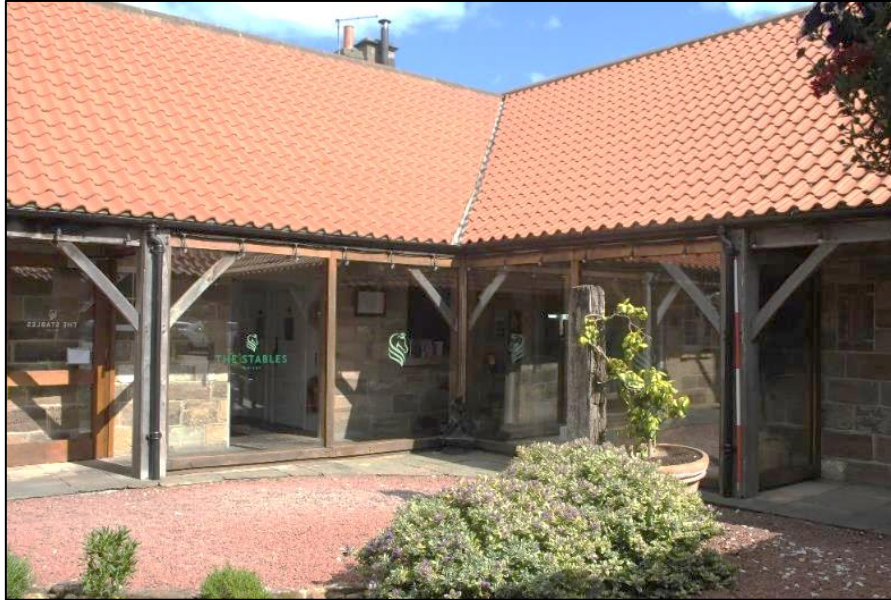
- 4.7.12 **Glass porch:** The southeast corner of the accommodation range courtyard features a modern glass porch (Photo 40) sheltering the guest access into the current Bar / Restaurant space (R1).

Photo 40. Glass porch; view SE; the former stables building on the left

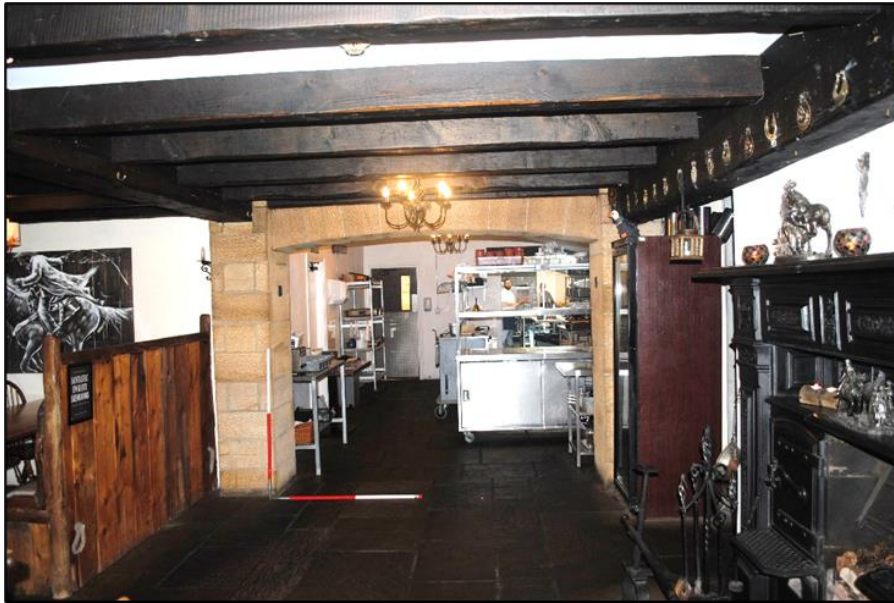
Photo 41. View from restaurant (R1) into the Kitchen (K1); view north

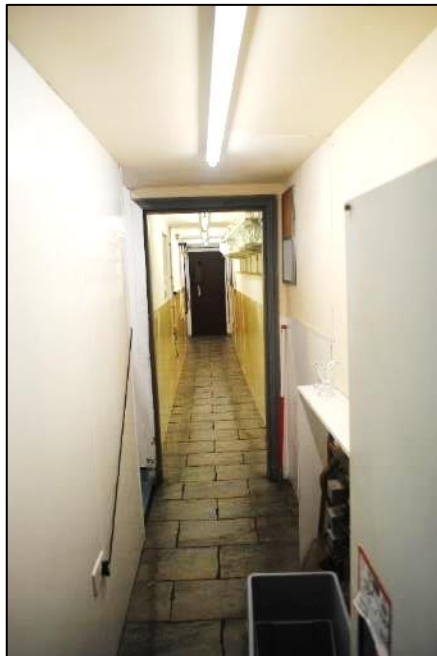
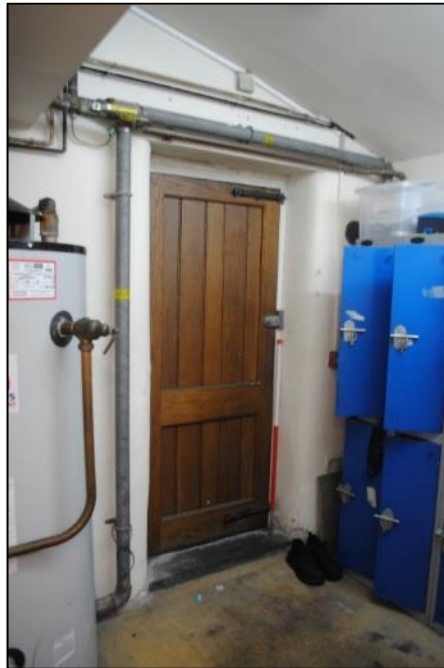
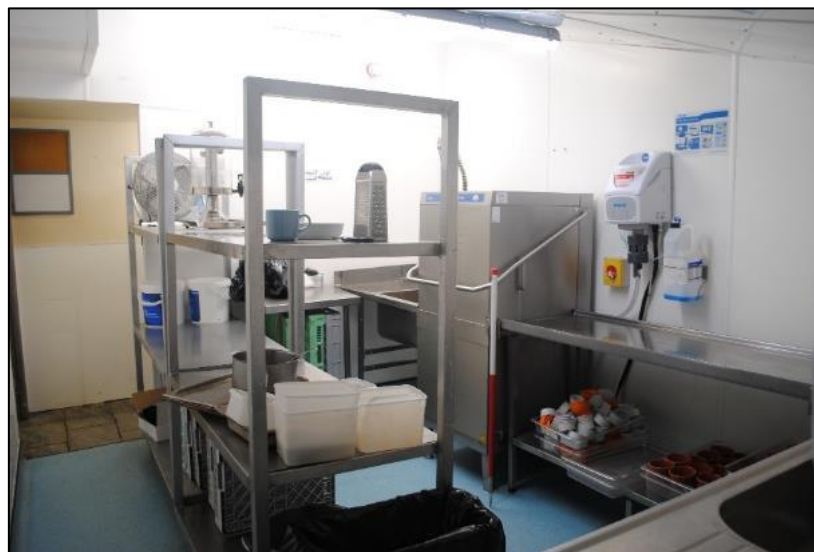
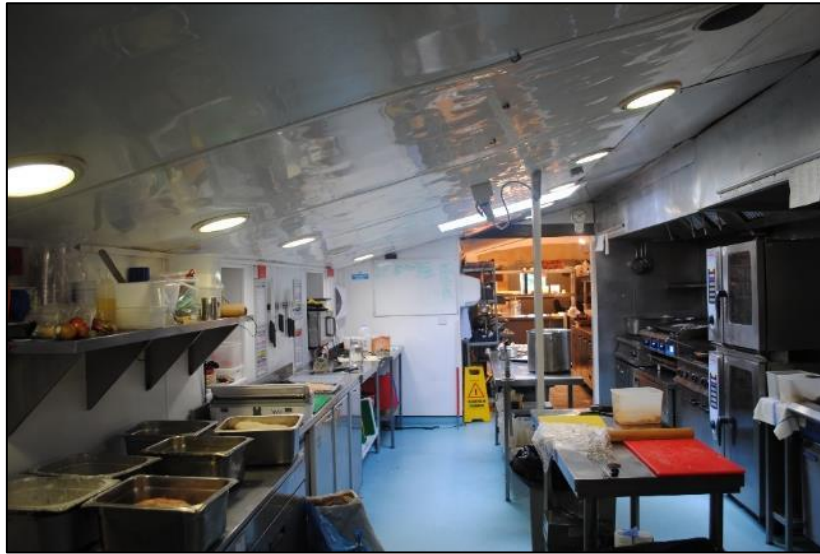
- 4.8.5 **Layout:** The kitchen is divided into the food preparation area (shown on Photo 41); and an access corridor running north-south along the west wall of the room (Photo 42), a staff changing room and toilet area (Photo 43); a food storage area (Photo 44) and the main kitchen (cooking) space (Photo 45).

- 4.8.6 As shown on Photos 41 to 45; the interior of the Kitchen (K1) is modern.

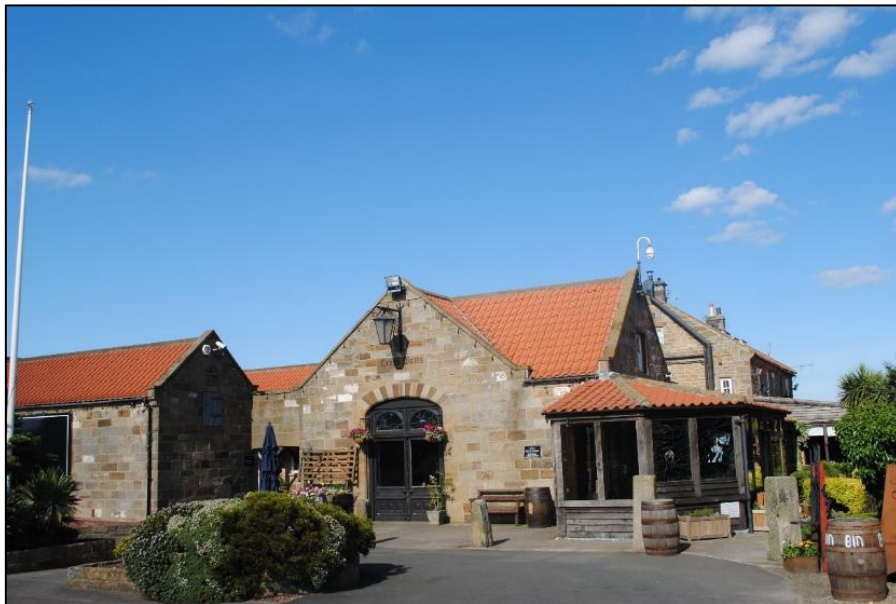
- 4.9.1 As with the Kitchen (K1) and the accommodation range the former Stables (Photo 46) has been extensively re-modelled in the 20th century and it is assessed that although the quality of the stonework is high, the construction has been carried out in part re-using the historic ashlar blocks and in part using new matching stone
- 4.9.2 **Exterior walls:** Structural masonry
- 4.9.3 **Roof:** Modern pantiles

Photo 46. Stables building; overview towards NE from the car park

- 4.9.5 Externally the south facing wall of the Stables is largely obscured from view by the extensive range of modern timber porches (As shown on Photos 46; outlined further in Section 4.10 below).

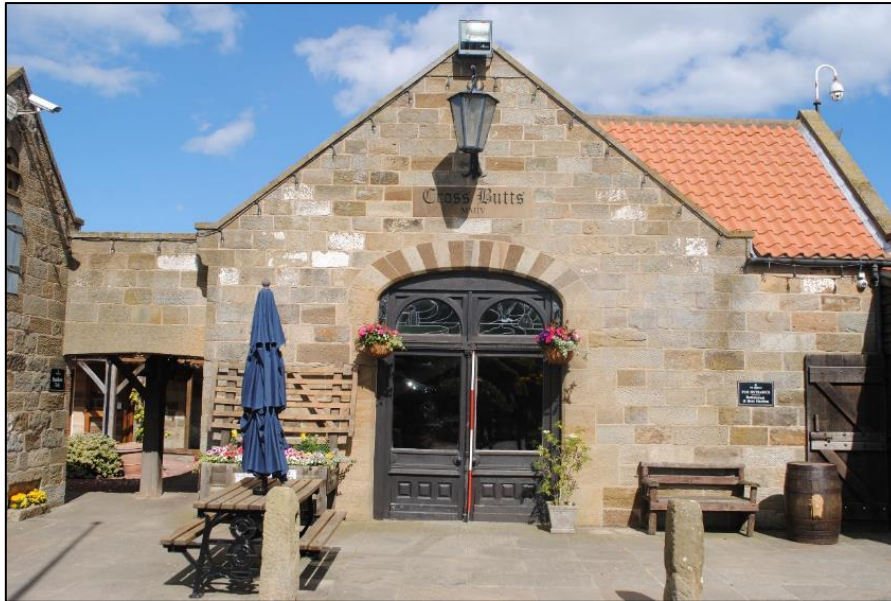
- 4.9.4 The west facing gable of the Stables has a modern date stone (for 2004) above the large, modern stable doors with the words 'Cross Butts' also inscribed (Photo 47).

Photo 47. Stables; west gable with doors and date stone; view east

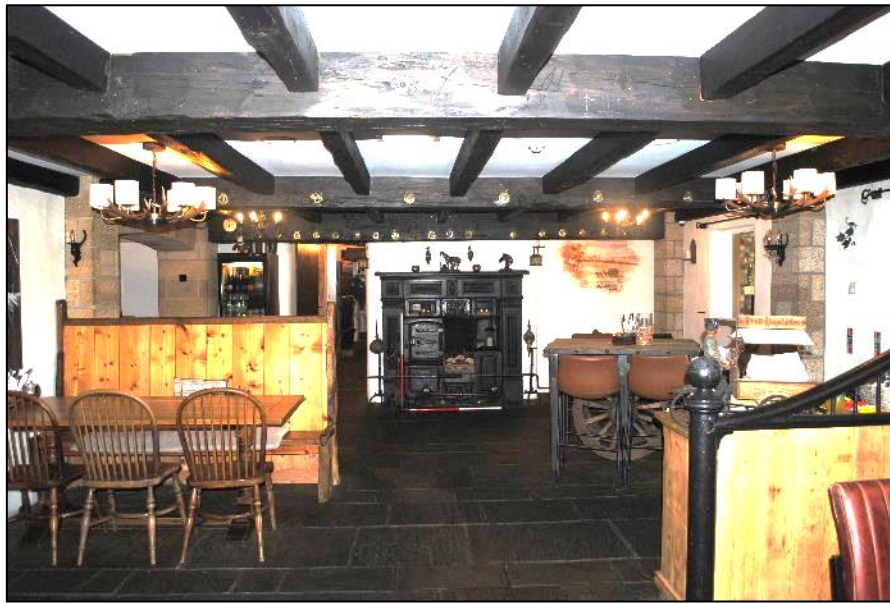
- 4.10.1 Based on the condition of the building in 2002 (shown on aerial image on Plate 4; section 3) all interior features of the building (with the possible exception of the stone flagged floor) are assessed to be of 21st century in date, or retro-fitted architectural salvage brought into the building from elsewhere.
- 4.10.2 **Flooring:** Stone flags
- 4.10.3 **Walls:** N/S/E/W: Structural Masonry, plastered and painted; exposed stonework to the stone pilasters supporting the upper floor (as shown on Photo 48).
- 4.10.4 **Ceiling:** Plastered with exposed timber beams and joists; dark varnish to timber elements; otherwise plaster painted white.
- 4.10.5 **East Wall:** Features a centrally placed large cast-iron range-type fire place and on the NE corner a doorway leading into the second dining room (G2)

Photo 48. Room R1; view east

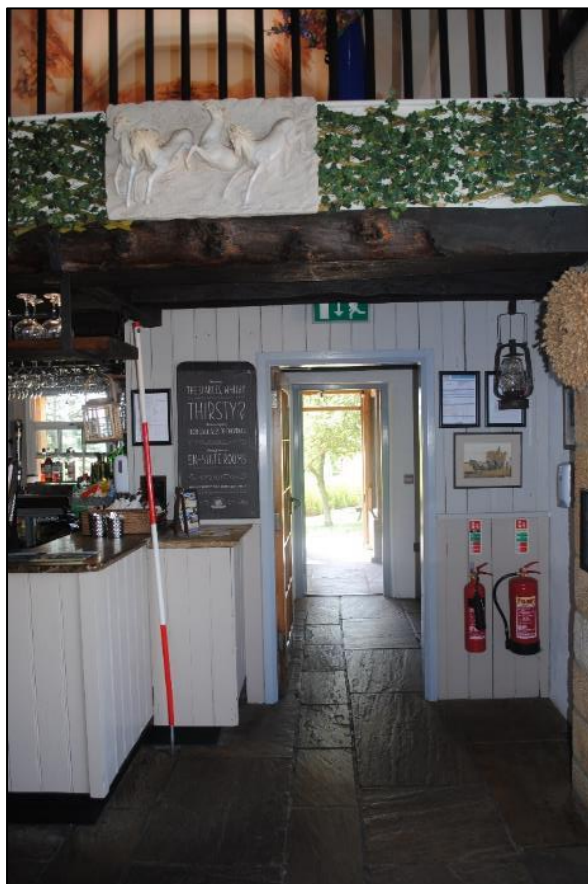
4.10.6 **South wall:** There are three doorways leading out into the Garden Room (R2) and also two windows overlooking it. To the SE corner of Room R1 are the main entrance customer entrance lobby (Photo 49) and a bar area (Photo 50).

Photo 49. View from R1 into the main customer entrance lobby; view south

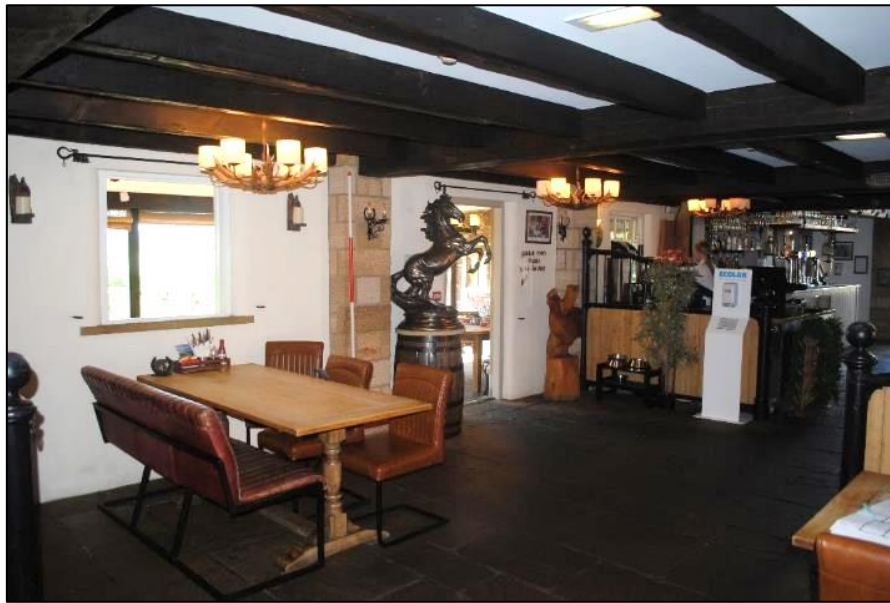
Photo 50. View SW within Room R1; including the bar area on the right

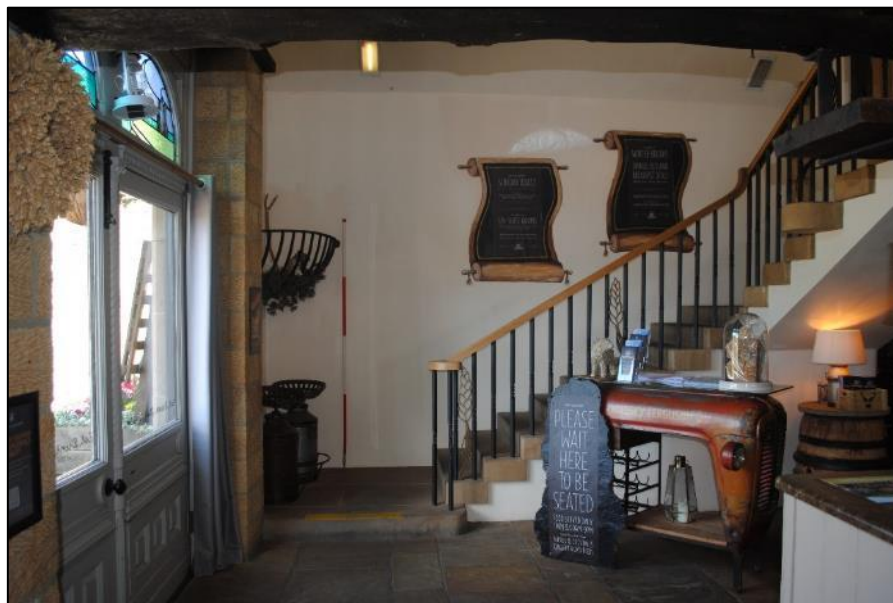
- 4.10.7 **West wall:** Shown on the left on Photo 51, this wall features the modern main stable doors.
- 4.10.8 **North Wall:** A modern stone staircase rises along the north wall in the NW corner of Room R1, leading into the upper floor (Room R3) (Photo 51).

Photo 51. Room R1; staircase; view north

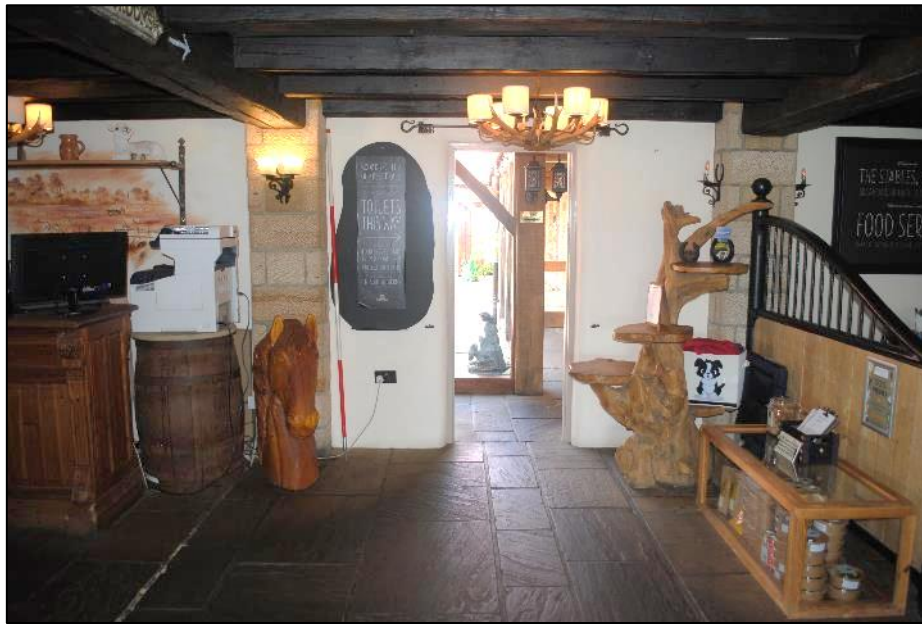
- 4.10.9 Other features along the north wall include the entrance towards the accommodation range (Photo 52) and the large arched access to the Kitchen (K1; shown on Photo 41).

Photo 52. Room R1; view north into the modern glass porch

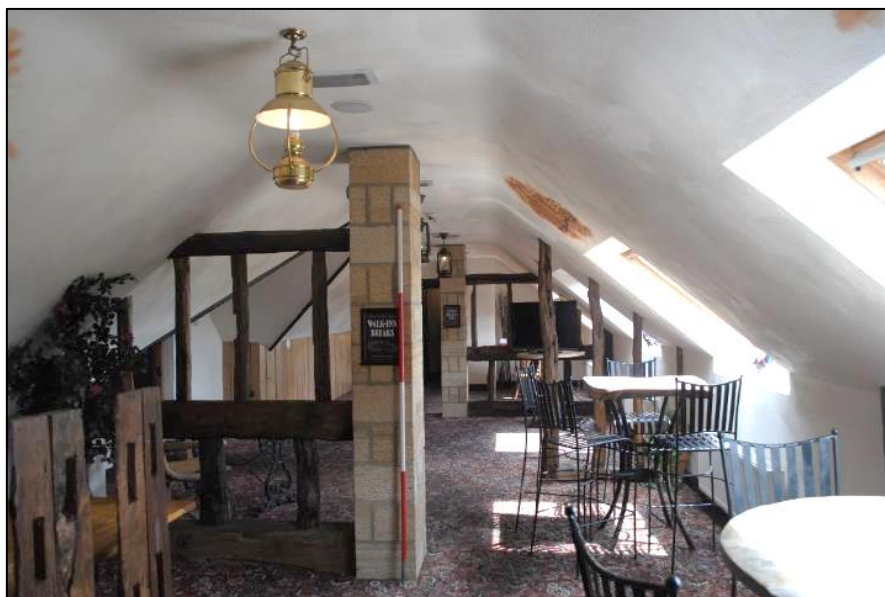
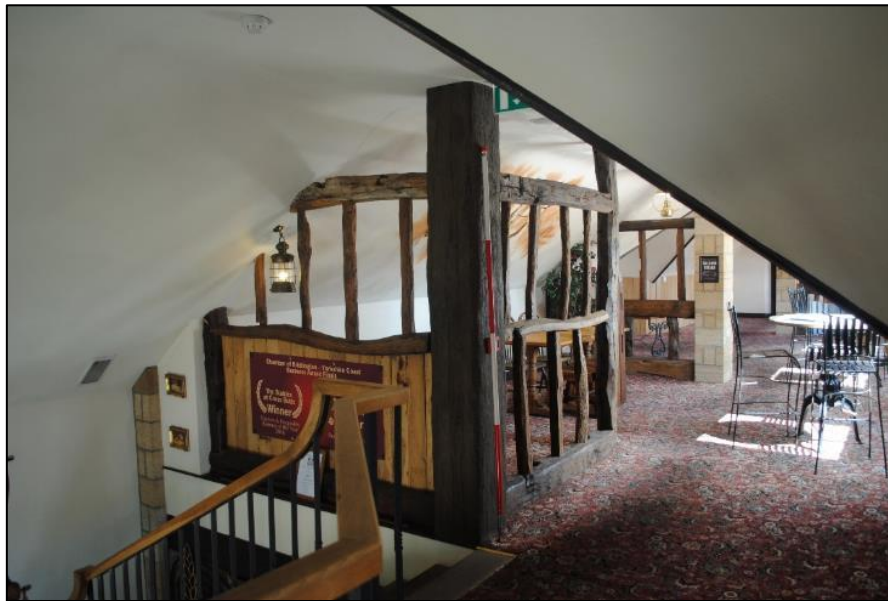
4.10.10 The Stables first floor interior (Room R3) is assessed to be modern throughout. The timber framing shown on Photos 53 and 54 might be historical timber, but it is assessed to be a decorative device installed during the 21st century re-fitting of the building.

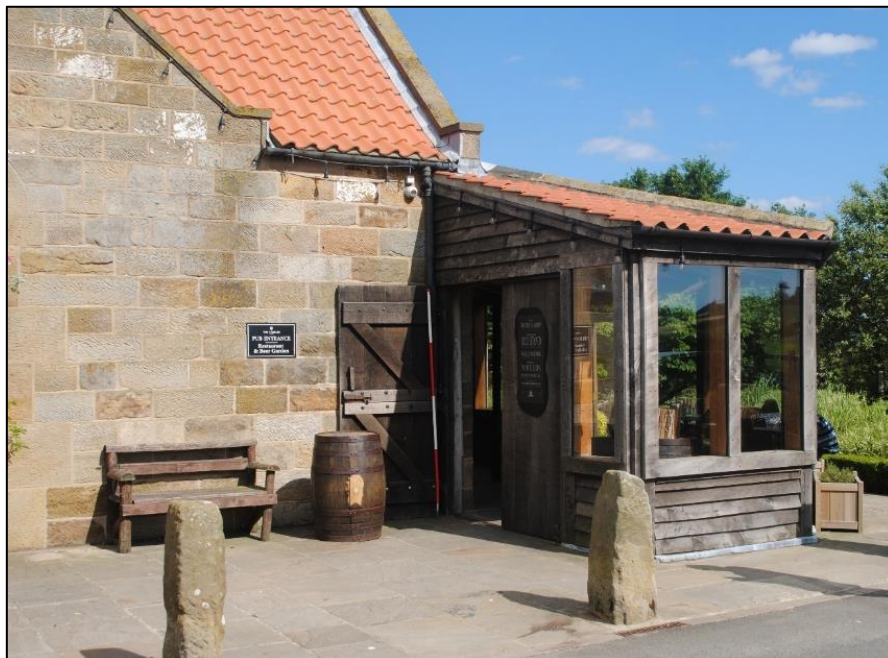
- 4.11.1 **Exterior:** Modern, single storey, timber framed and glazed porch structure abutting the south facing cross-wing gable of the Stables buildings. Currently acts as the main customer entrance point into the restaurant.

Photo 55. Structure E1 on the left; view SE

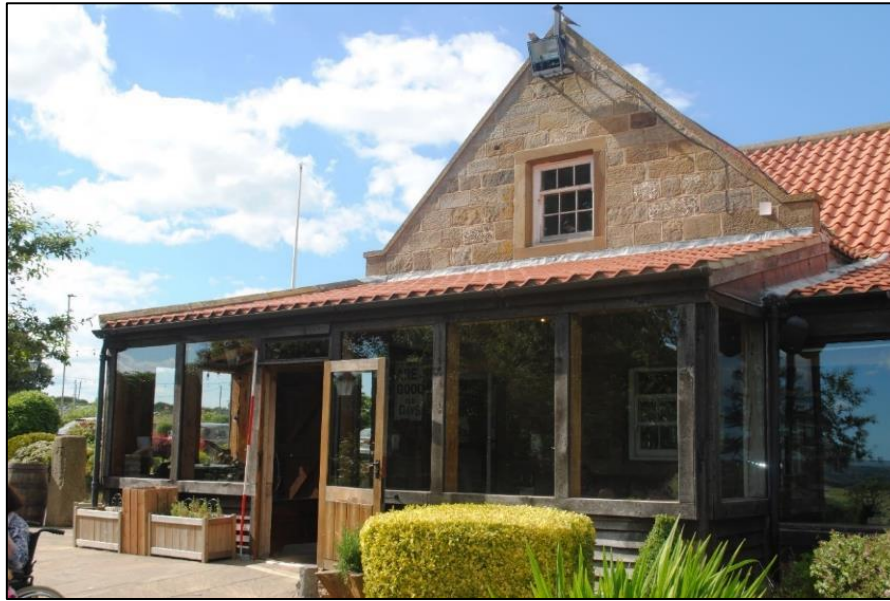
- 4.11.2 As shown on Photo 56, the south facing cross-wing gable of the Stables building can be observed above the entrance porch (Structure E1).

Photo 56. Structure E1; view NW from the beer garden
