Cross Butts, Whitby
Historic Building
Recording

Client: THE INN COLLECTION GROUP

AB Heritage Project No: 62021

Level 2 – 3 Historic Building Recording

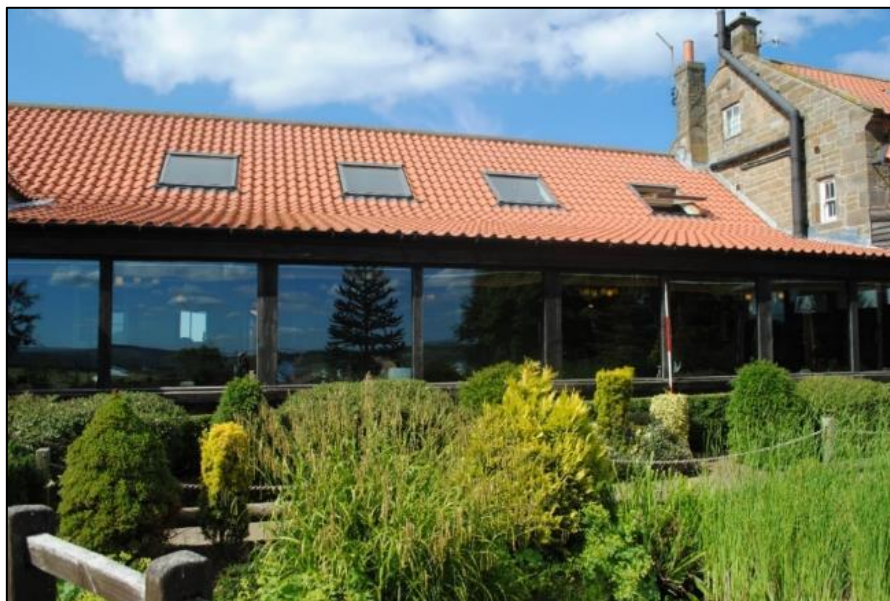
- 4.11.3 To the east of entrance lobby (Structure E1) and south of the restaurant (Room R1) is the modern Garden Room (R2). As shown on Photo 57 the Garden Room (R2) is also a modern, single storey, timber framed and glazed construction. The roof of the building is covered with pantiles matching the roof of the Stables building.

Photo 57. Garden Room (R2); view north

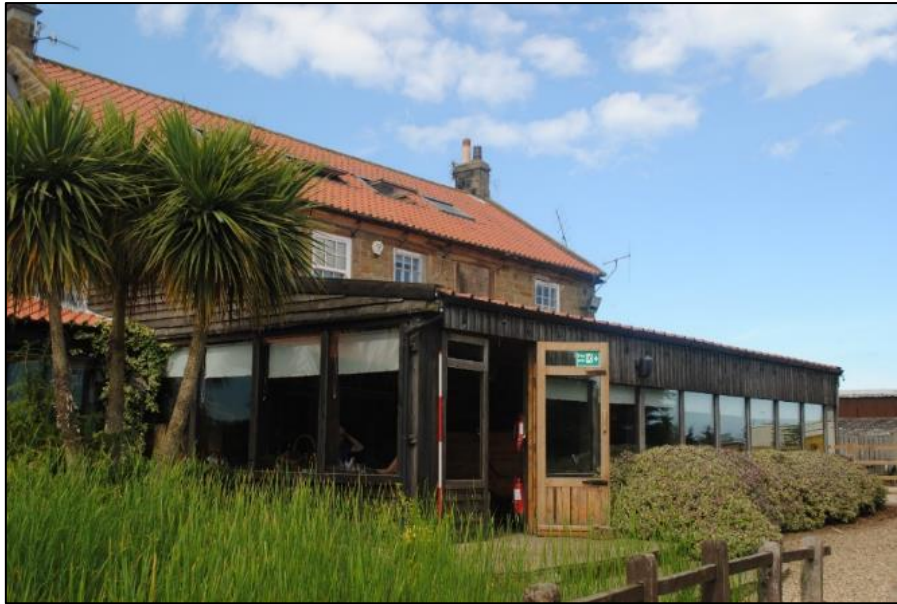
- 4.11.4 To the east of the Garden Room (R2) and south of Cross Butts farmhouse [**AB 1**] is a further porch type structure known as the Sun Terrace S1. Compared to the two other porch

structures (E1 and R2) the Sun Terrace (S1) is of less substantial and lower quality construction; as shown on Photos 58 and 59

Photo 58. Sun Terrace (S1); view NE

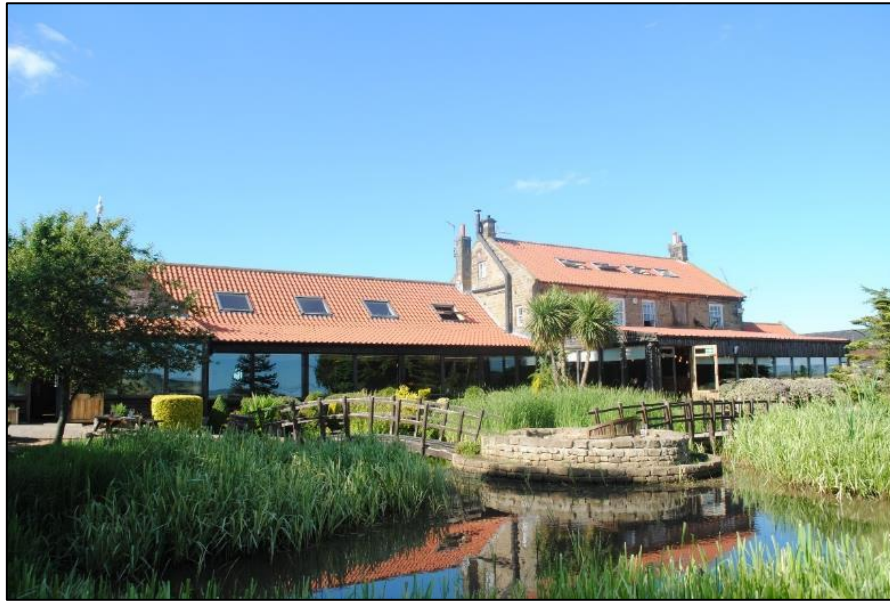
- 4.11.5 As an overview Photo 60 shows the modern extension along most of the south facing elevation of the Cross Butts complex of buildings, obscuring the external masonry envelope of the buildings.

Photo 60. View of the modern extension; view N/NE

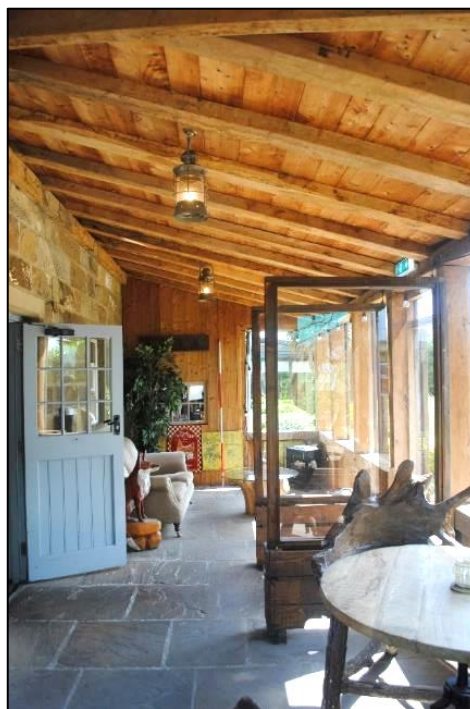
- 4.11.6 The interiors of these extensions are of no great design or historical interest in themselves. The most notable features to be found within these spaces relate to elements, for example the south wall of the Cross Butts farmhouse [AB 1], that originally were a feature on the exterior wall of the Listed building, but are now sited within the Sun Terrace (S1).
- 4.11.7 Photo 61 depicts the interior of the entrance lobby (E1) and Photo 62 the interior of the Garden Room (R2).

Photo 61. Entrance lobby (E1) interior; view east

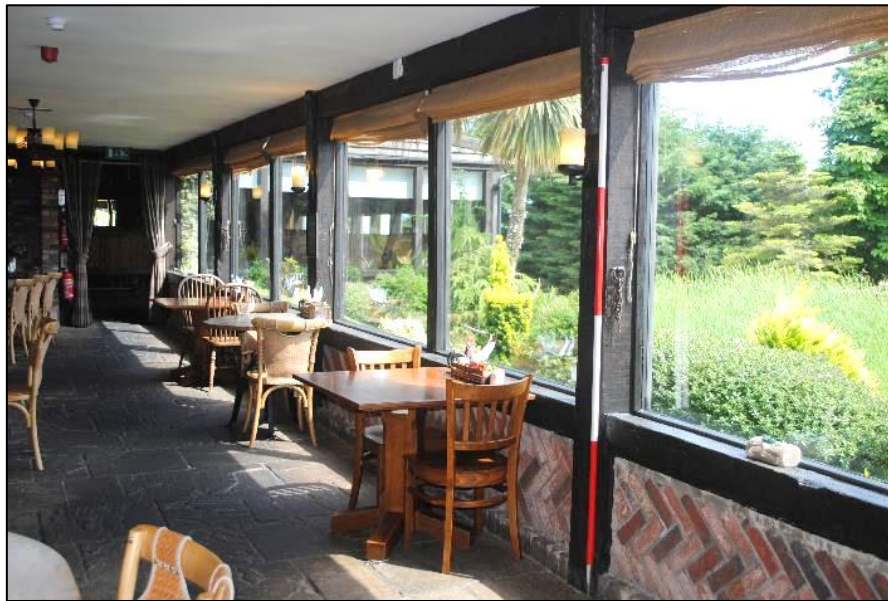
Photo 62. Garden Room (R2) interior

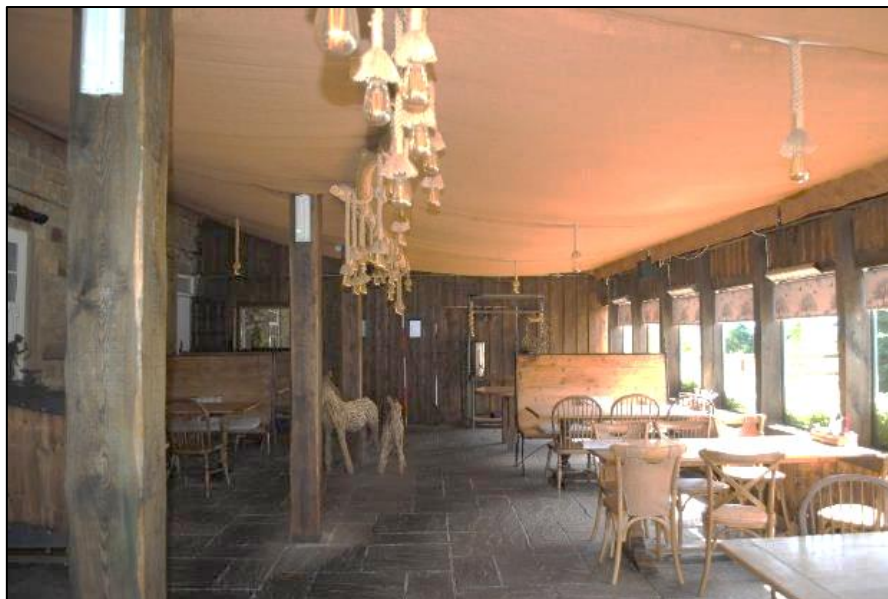
4.11.8 While the modern elements of the Sun Terrace (S1) are of poor-quality construction, the north wall is the former exterior south wall of the Listed Cross Butts farmhouse [AB 1] (Photo 63).

Photo 63. Interior of the Sun Terrace; view east

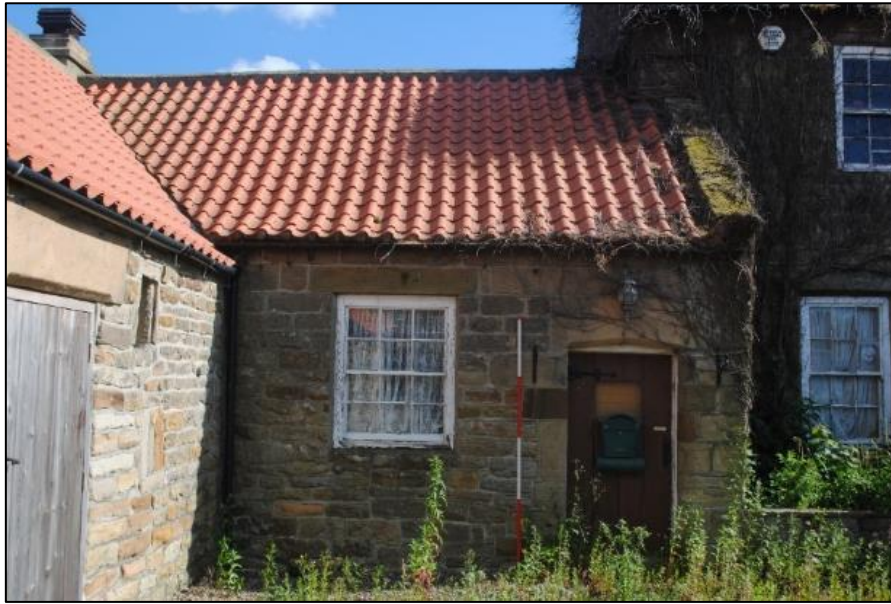
4.12.1 As depicted on Figures 2, 3 and 8 the small curtilage Listed Cottage [AB 3] connects to the Listed farmhouse [AB 1] and the Barn [AB 2] (Photo 67).

4.12.4 **North Wall:** Featuring a door and window assessed to be in their original locations. The wooden sash is not original but is of some age (Photo 67).

Photo 67. North elevation of the Cottage [AB 3]

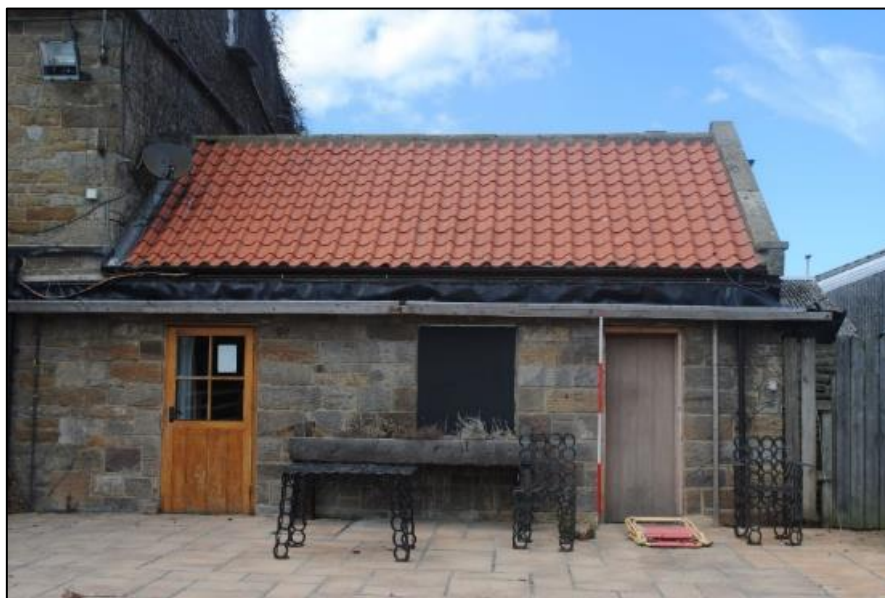
4.12.5 **South wall:** the original south wall of the cottage was demolished for a southerly extension which was built during the late 20th century. The present-day south exterior wall dates from this modern period of construction and uses stonework that is sympathetic (Photo 68). There are two doorways and a boarded window along this elevation.

Photo 68. The modern south elevation of the Cottage [AB3]

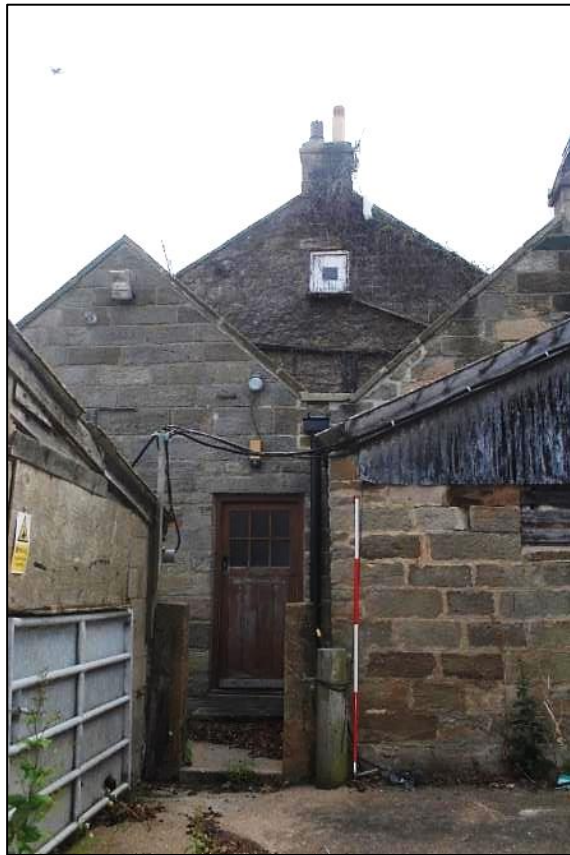
4.12.7 The east facing wall is formed of the two gables of the original cottage (on right on Photo 69) and the 20th century extension (on the left on Photo 69). The two storey east facing gable of the Cross Butts farmhouse [AB 1] can be seen to the rear on Photo 69.

- 4.12.8 The east gable of the original cottage is partially obscured by the later Outhouse (the structure with a lower pitched roof on the right on Photo 69).

Photo 69. East gable of the Cottage [AB 3]; view west

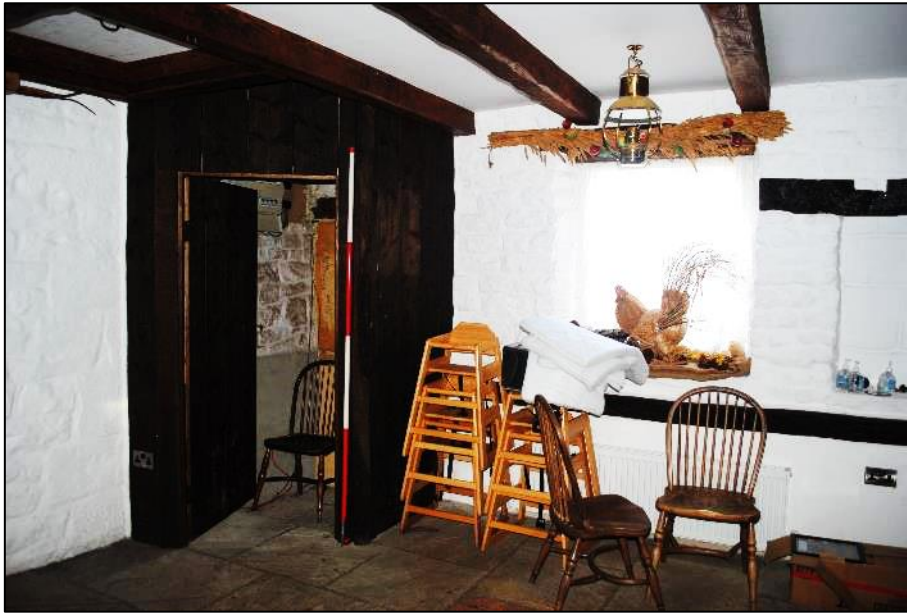
- 4.12.9 Interior of this small cottage retains some characterful historical features and despite having had almost its entire south facing wall removed as the late 20th century extension was created, the cottage retains hints of historical character better than much of the rest of the site at Cross Butts.
- 4.12.10 **Ceiling:** Exposed timber joists with dark varnish and painted plaster. The ceiling in this space is quite low.
- 4.12.11 **Floor:** Stone flags
- 4.12.12 **North Wall:** The north wall of the cottage features a small internal porch and two front doors leading to the former farmyard. There is also a small sash-window and smaller blocked opening to the east of the window, and finally there is also a doorway leading into the Barn [AB 2]. All features depicted on Photos 70 and 71.

Photo 70. Cottage [AB 3] north wall; view NW

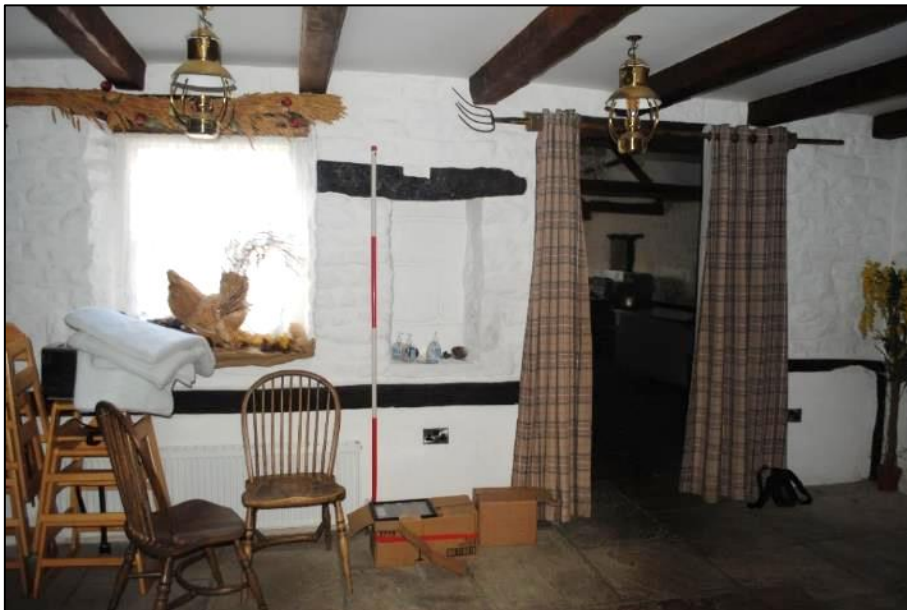
Photo 71. Cottage [AB 3] north wall; view NE

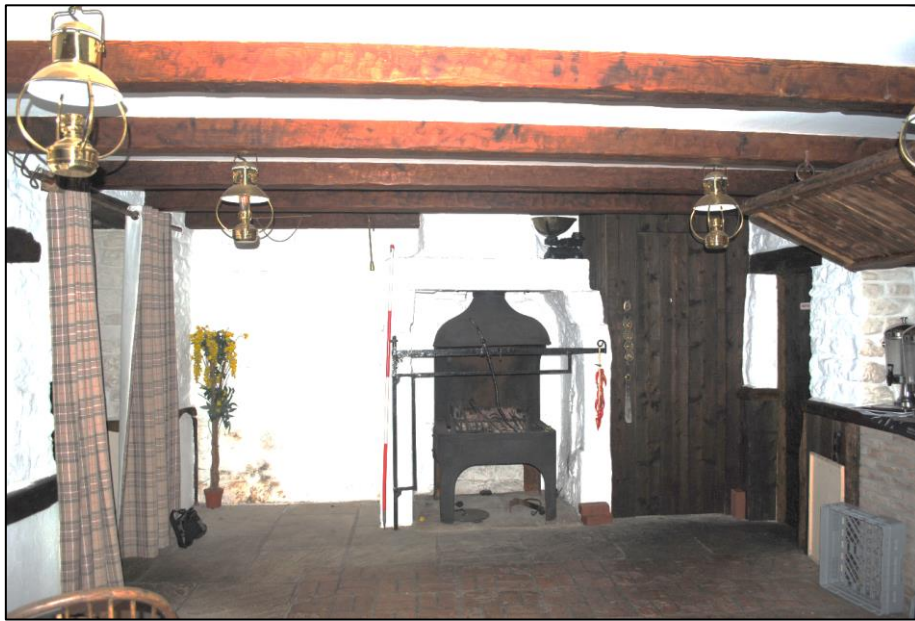
4.12.13 **East Wall:** The short east wall has a small brick-built fireplace with a cast-iron spit. To the south (right) of the fireplace is a small modern timber storage cupboard (Photo 72).

Photo 72. Cottage [AB 3], east wall; view east

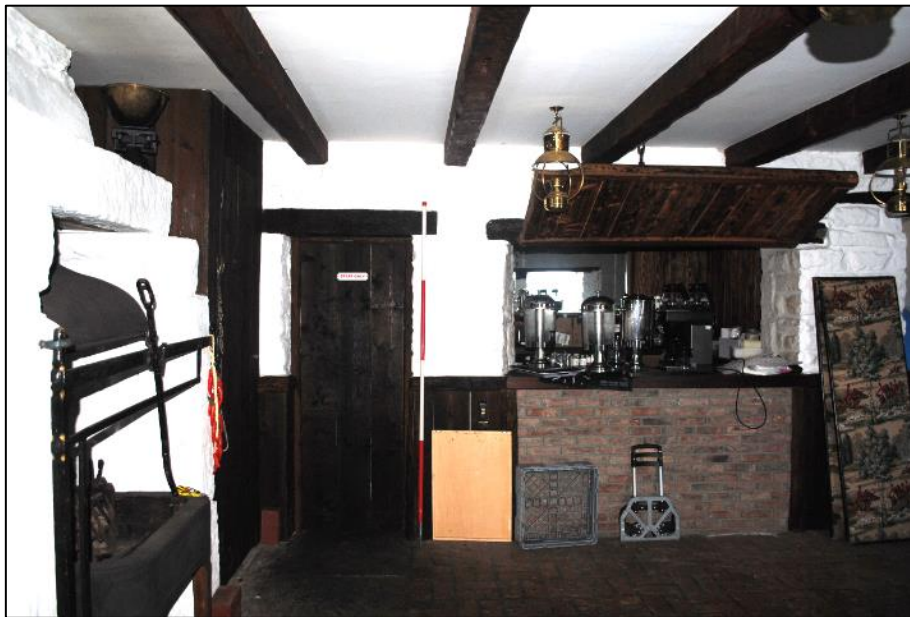
4.12.14 **South Wall:** The former exterior south wall of the cottage has been substantially rebuilt as an internal partition, which now houses a door leading to the bar and keg-room area in the 20th century extension to building. There is also a large bar-serverly hatch (Photo 73).

Photo 73. Cottage [AB 3] south wall; view south

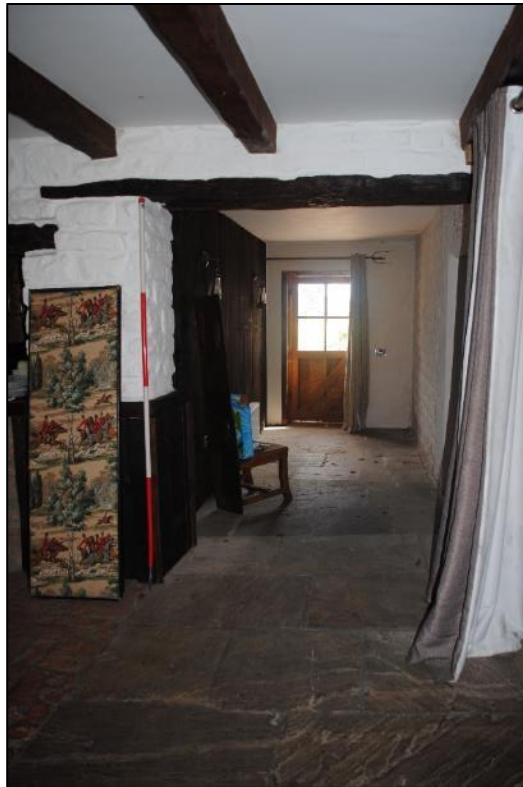
4.12.15 To the west (right) of these is a large timber lintelled opening to an exit corridor to the back terrace. It is assessed that this flagged area would have originally been at the exterior of both the Cottage [AB 3] and the Cross Butts farmhouse [AB 1] (Photo 74).

Photo 74. Cottage [AB 3]; south wall; view south

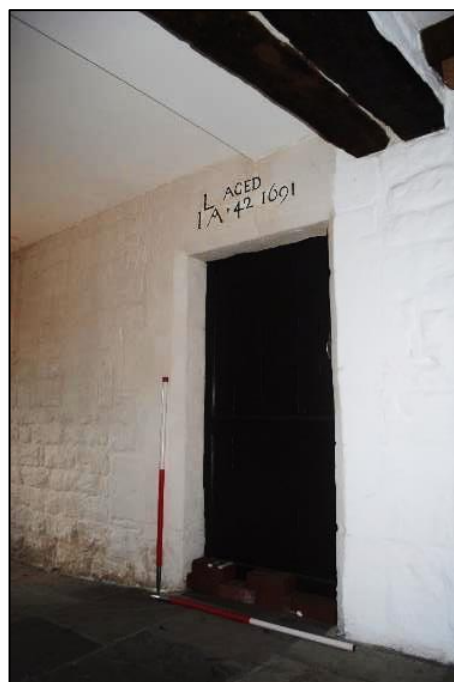
4.12.16 There is a doorway between this corridor and the Room G1 (Photo 75) with a date stone for 1691. It is not clear to whom lettering *L.I.A. Aged 42* refers to, or how authentic this stone lintel is.

Photo 75. Date stone; view SW from within the Cottage [AB 3]

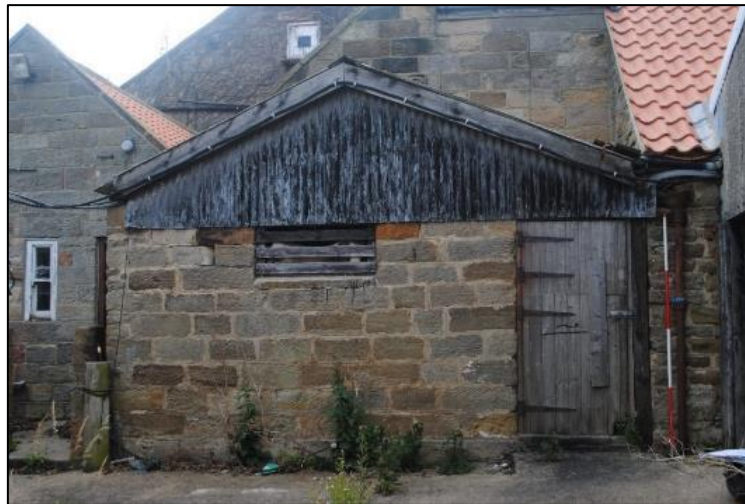
4.13.1 Already depicted in part on Photo 69 above, the outhouse is assessed to be an early 20th century addition to the Cross Butts complex of buildings. This small building has masonry walls and a shallow pitched roof covered in sheet material (Photo 76).

Photo 76. East wall of the Outhouse

4.13.2 The building is accessed via a door on the north end of the east wall. There is an unglazed window opening on the east wall (Photo 76).

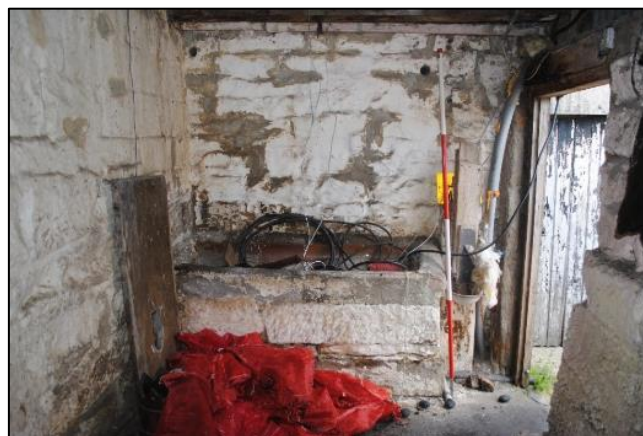
4.13.3 Inside the building the character of structure is very utilitarian, there is stone trough with a ceramic basin on the north wall (Photo 77).

Photo 77. Interior of the Outhouse

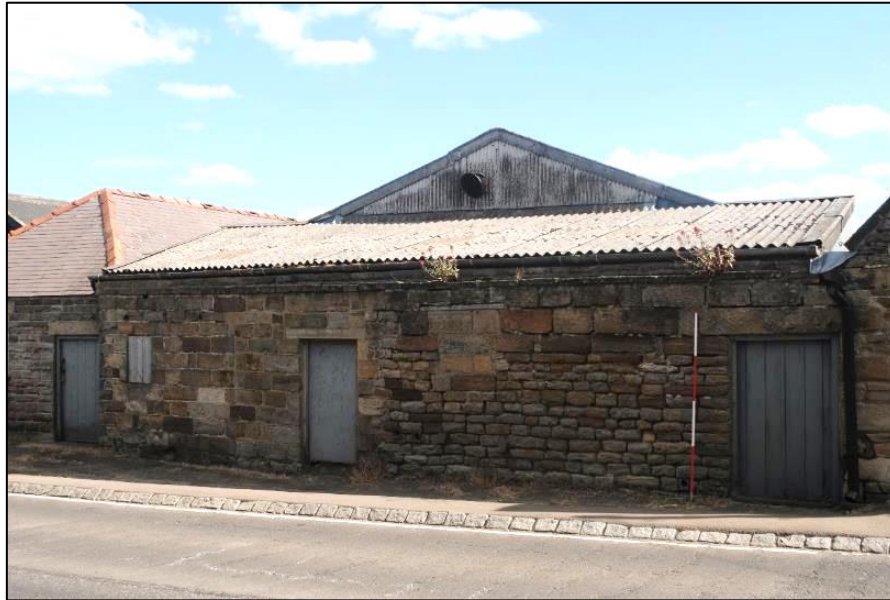
- 4.14.1 The historic masonry wall which runs from the northeast corner of the Barn [AB 2] to the northwest corner of the 20th century Barn to the east of the site for a distance of c. 10m and of c. 2.5m in height (Photo 78) is to be dismantled, the stones preserved and then rebuilt in-situ as part of the new hotel design.

Photo 78. Boundary wall; view SE across Guisborough Road

- 4.14.2 As shown on Photo 78 the wall is constructed from two different types of ashlar blocks (smaller ones to the lower and western parts and more substantial ones towards the east end and for the two top-courses). It is assessed that this variety would indicate the former presence of perhaps another ancillary structure here and there appears to be a blocked door or a window at the centre of the wall.
- 4.14.3 Of the current doors, the western one has a stone lintel and the more easterly one has a narrow concrete lintel.
- 4.14.4 At present a lean-to roof resting on top of the wall incorporates the wall into the larger agricultural shed of 20th century date that can be seen to rear of the wall on Photo 78.
- 4.14.5 The south facing elevation of the boundary wall is wholly obscured by the modern sheeting material used on the interior of the adjoining shed-structure.

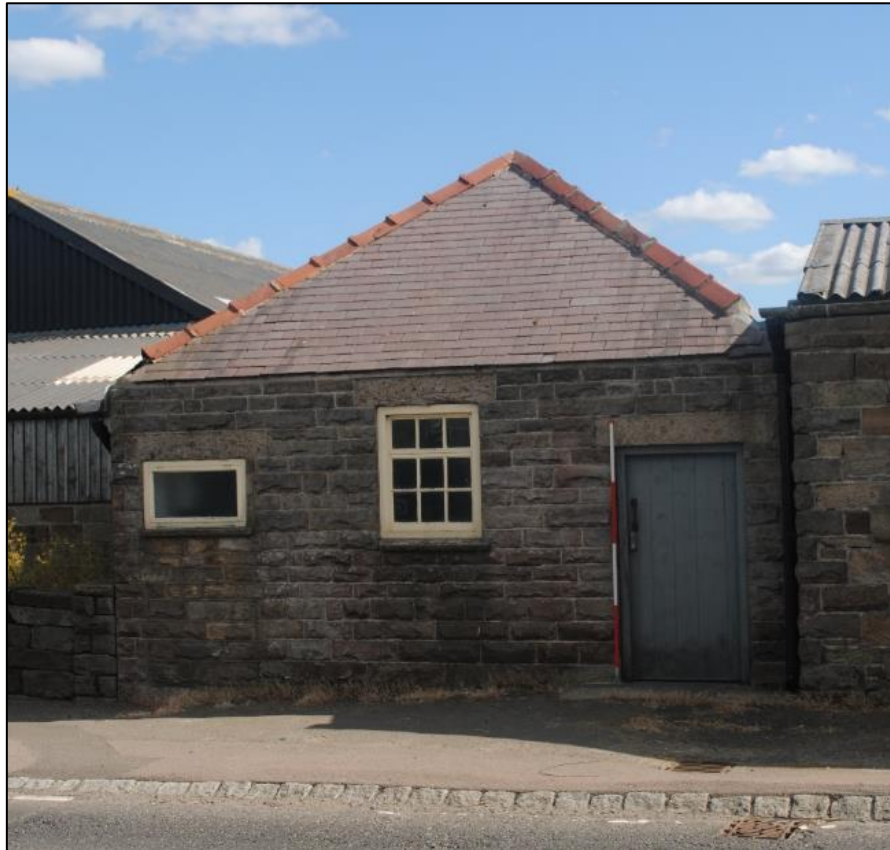
- 4.15.1 **Roof:** Hipped roof with slate covering and with clay ridge tiles.
- 4.15.2 **Walls:** Structural masonry of small, close bonded block work
- 4.15.3 **North Wall:** Facing onto the Guisborough Road the north facing gable of the barn features two small windows with concrete lintels and a doorway also with a concrete lintel (Photo 79).
-

Photo 79. North gable; view S/SE

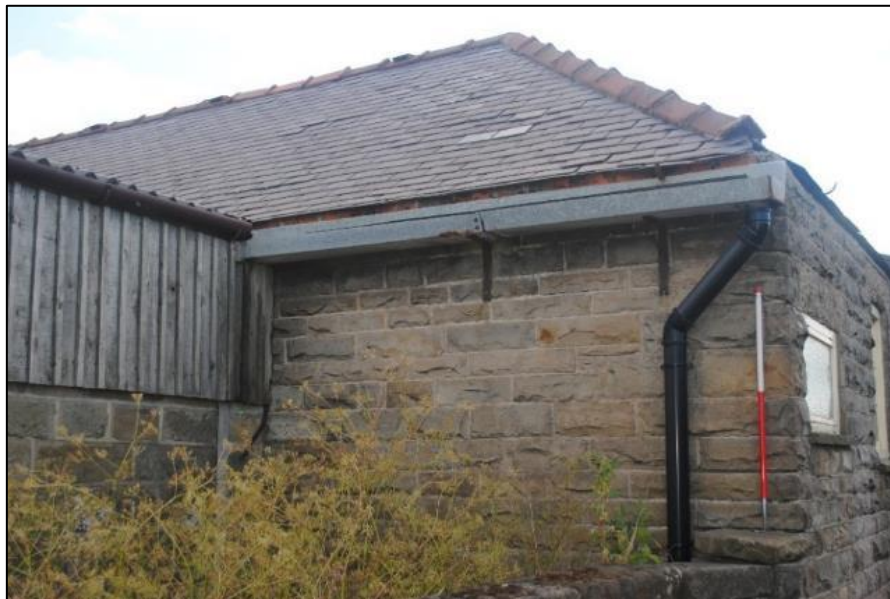
- 4.15.4 East and west elevations: These are largely obscured by surrounding later built forms, with including the agricultural buildings belonging to the neighbouring farm (shown on the left on Photos 79 and 80) and the 20th century agricultural building.

Photo 80. NE corner of the Barn; view SE

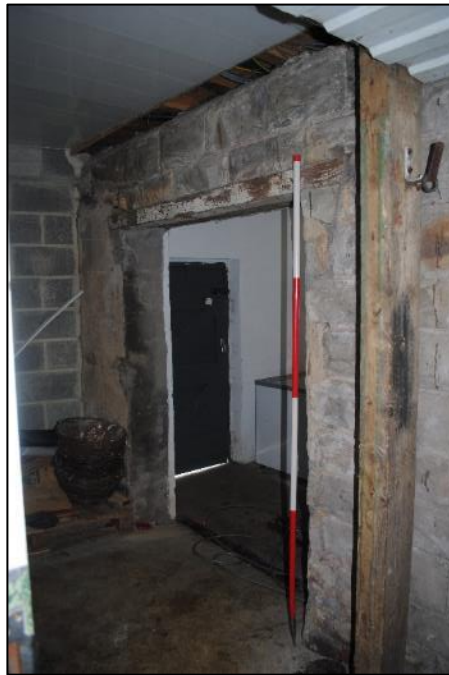
4.15.5 Photo 81 shows a 20th century doorway at the northern end of the west facing wall of the barn (B1).

Photo 81. Entrance from the west into the room at the north end of the barn

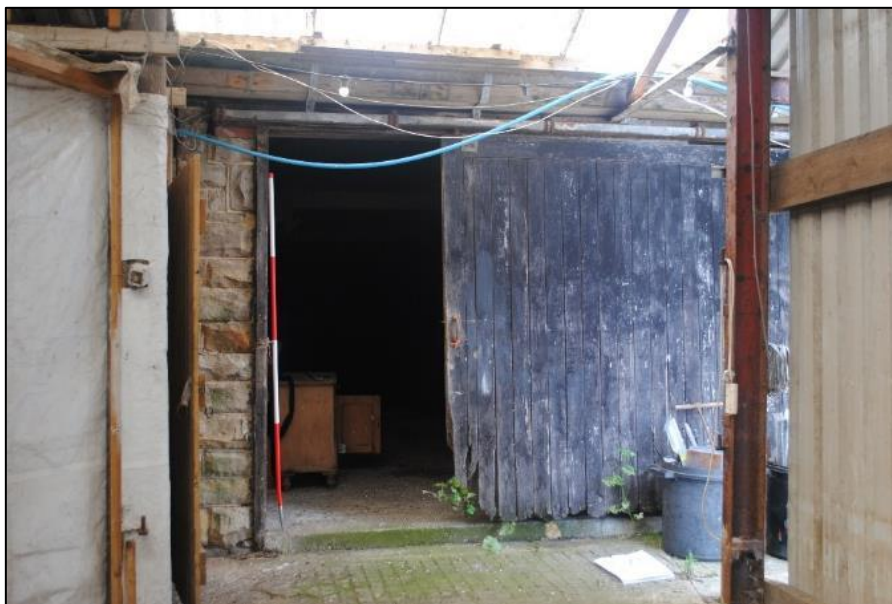
4.15.6 There is a late 20th century canopy and agricultural structure to the south of the barn (B1) which hinders photography of the southern gable end. There is nevertheless a large wooden sliding door on this elevation (Photos 82 and 83).

Photo 82. Barn, south elevation; large sliding cart-door; view N/NE

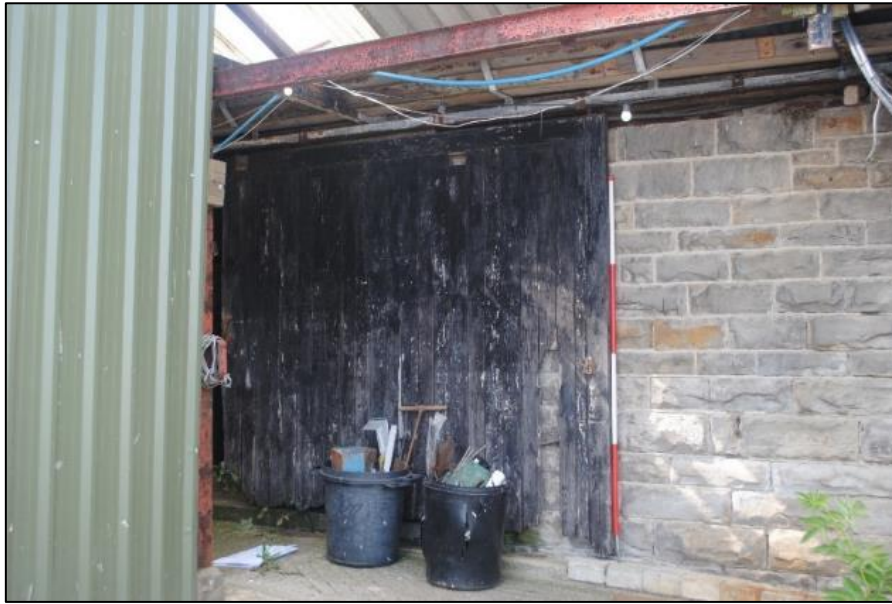
Photo 83. Barn, south elevation, view N/NW

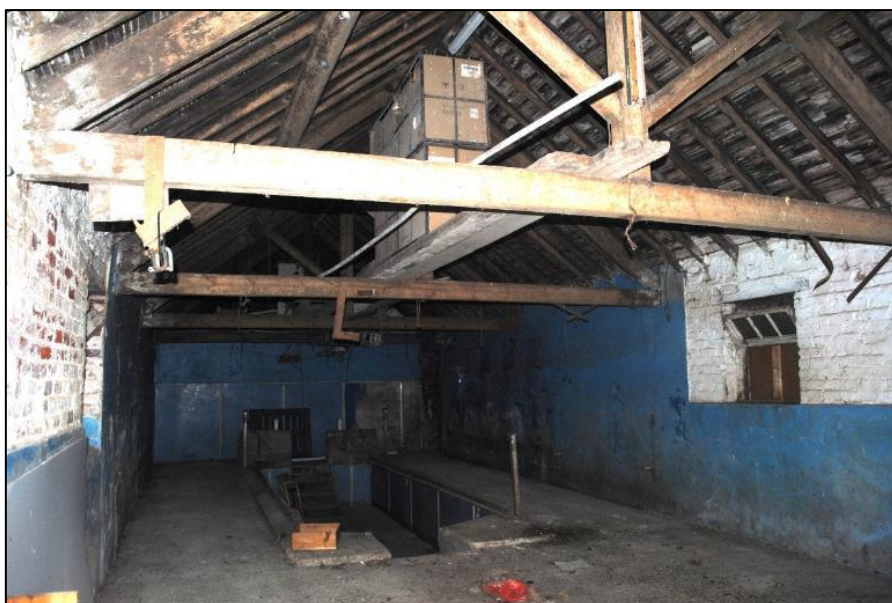
4.15.10 **Walls:** Partly exposed painted masonry, partly rendered and painted blue and partly covered in sheet material, also painted in blue (Photo 84).

Photo 84. Interior of the barn, view NE

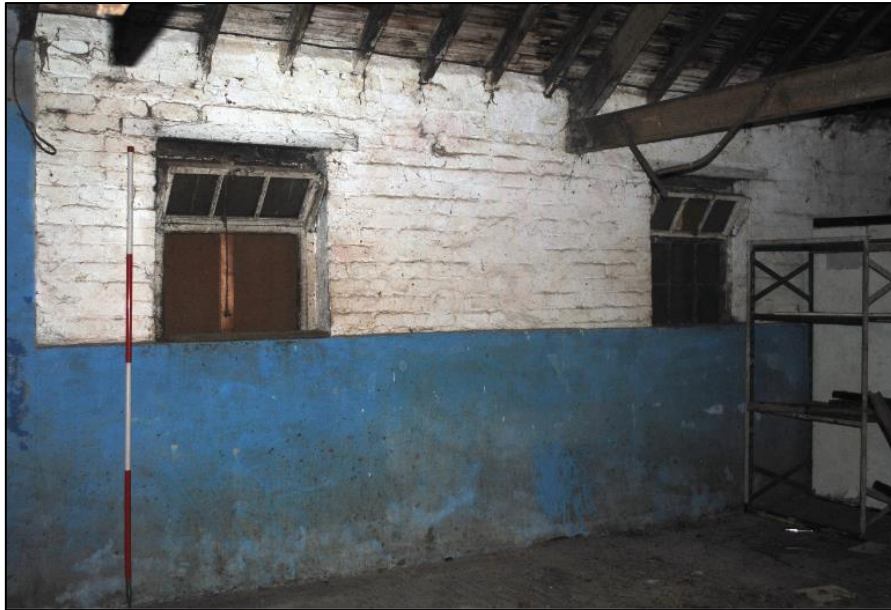
4.15.11 **Windows:** Metal framed with upper sections hatch-style opening from the bottom for ventilation (see Photo 85).

Photo 85. SE corner of the east wall of the Barn; examples of early 20th century windows

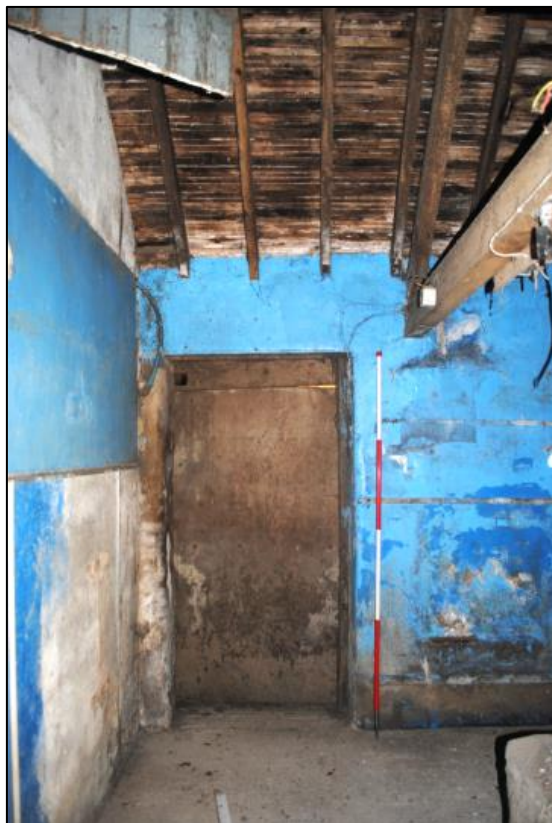
4.15.12 In the northeast corner of the main room (with the vehicle inspection pit) there is a boarded up / blocked doorway (Photo 86).

Photo 86. Blocked doorway leading to the neighbouring property

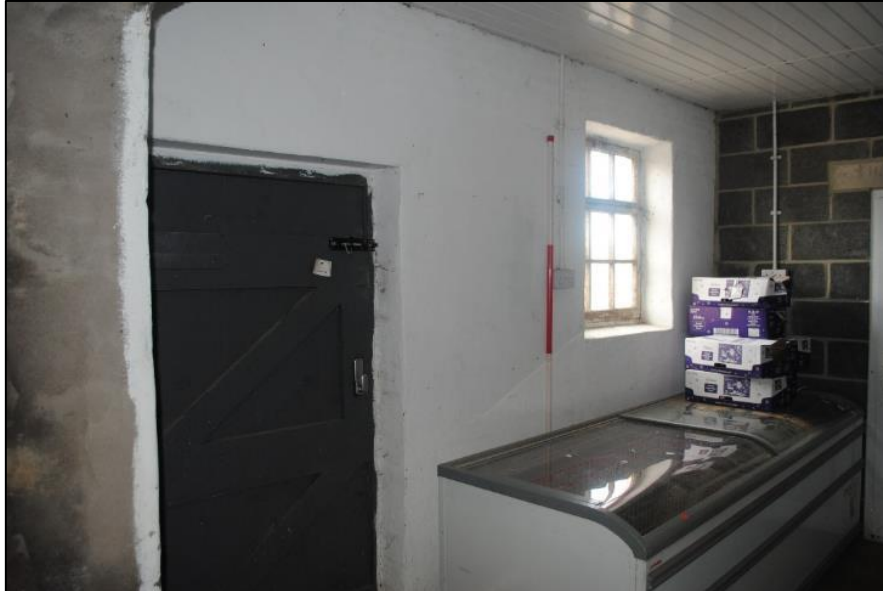
4.15.13 The northern section of the barn has been separated from the main room and can be accessed via a west facing doorway (Photo 81). The two small rooms at this end of the barn (Photo 87) function as part of the Cross Butts pub/hotel for the purposes of storing food.

Photo 87. Northern end of the barn; interior; view NE

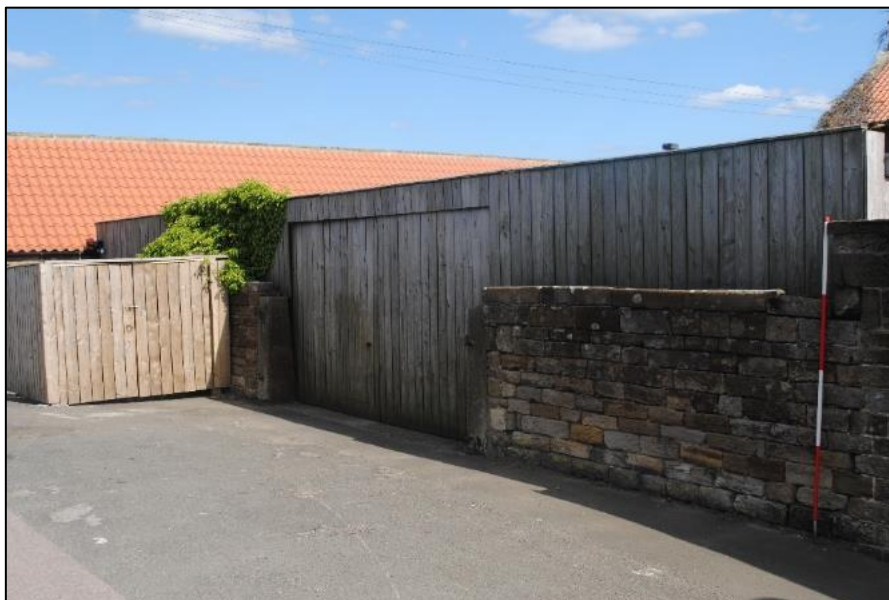
4.16.1 The former farmyard is obscured from views from Guisborough Road by a tall timber fence (Photo 88). Some of the containers are also shown on Photo 38 above.

Photo 88. Farmyard from the Guisborough Road, 2022; view SE

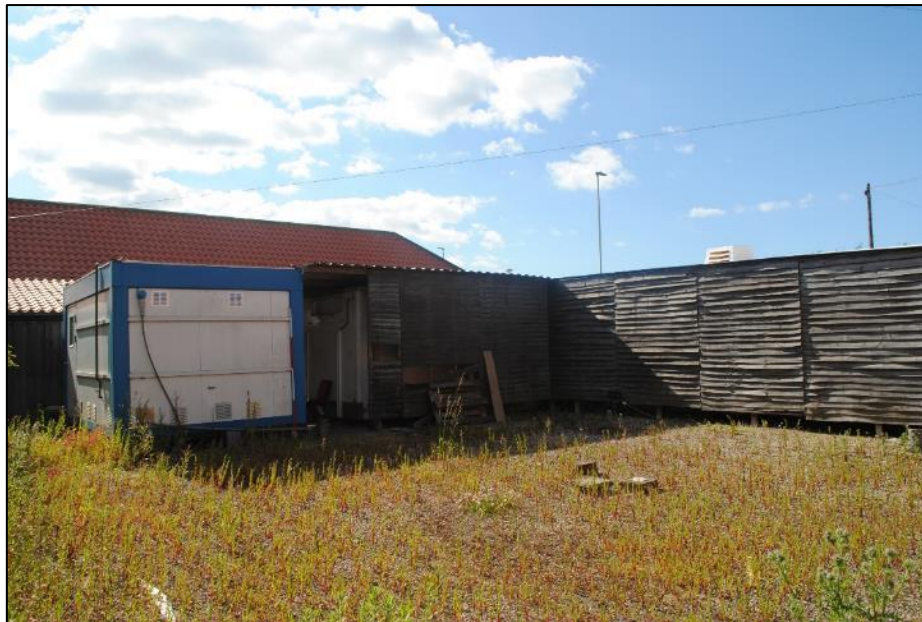
4.16.2 The ancillary structures associated with functioning of the hotel kitchen are in part housed behind a series of horizontal timber screens (Photo 89).

Photo 89. View of the ancillary structures within the farmyard; view NW

4.16.3 The current ancillary structures are of no visual or heritage merit and obscure the historical layout of this part of the site. The proposed works to the site seek to remove these structures, replacing them with a smaller and more considered design solution.
