# No. 65 High Street, West Malling, Kent Historic Building Recording

Client: DEBLANC STUDIOS AB Heritage Project No:10583 Date:10/07/2015

Client	Deblanc Studios
Project Number	10583
Prepared By	Kerry Kerr-Peterson
Illustrated By	Zoe Edwards
Approved By	Andy Buckley

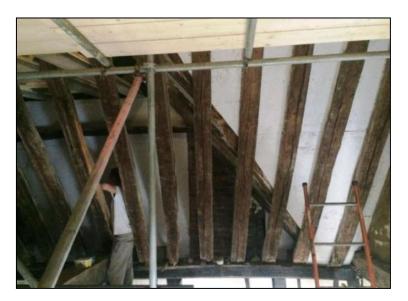
Photo 10: The plastered wooden lath stud walls and reed ceiling within the former attic space, taken during the early stages of the conservation works

- 3.6.7 Several modern timbers had been inserted beneath the crown plate and a number of the rafters, to provide additional support. (Photo 10). These modern timbers were removed during the refurbishment.
- 3.6.8 The attic space revealed the interior of the 19<sup>th</sup> Century stretcher bonded brick chimney stack on the south wall (Photo 11).
