High Farm, Normanby, Middlesbrough Heritage Report And Building Recording

Report Title: **High Farm, Normanby, Middlesbrough – Archaeological Desk
Based Assessment and Building Recording**

Revision: **Final**
Issue Date: **May 2011**
Report Ref: **2982**

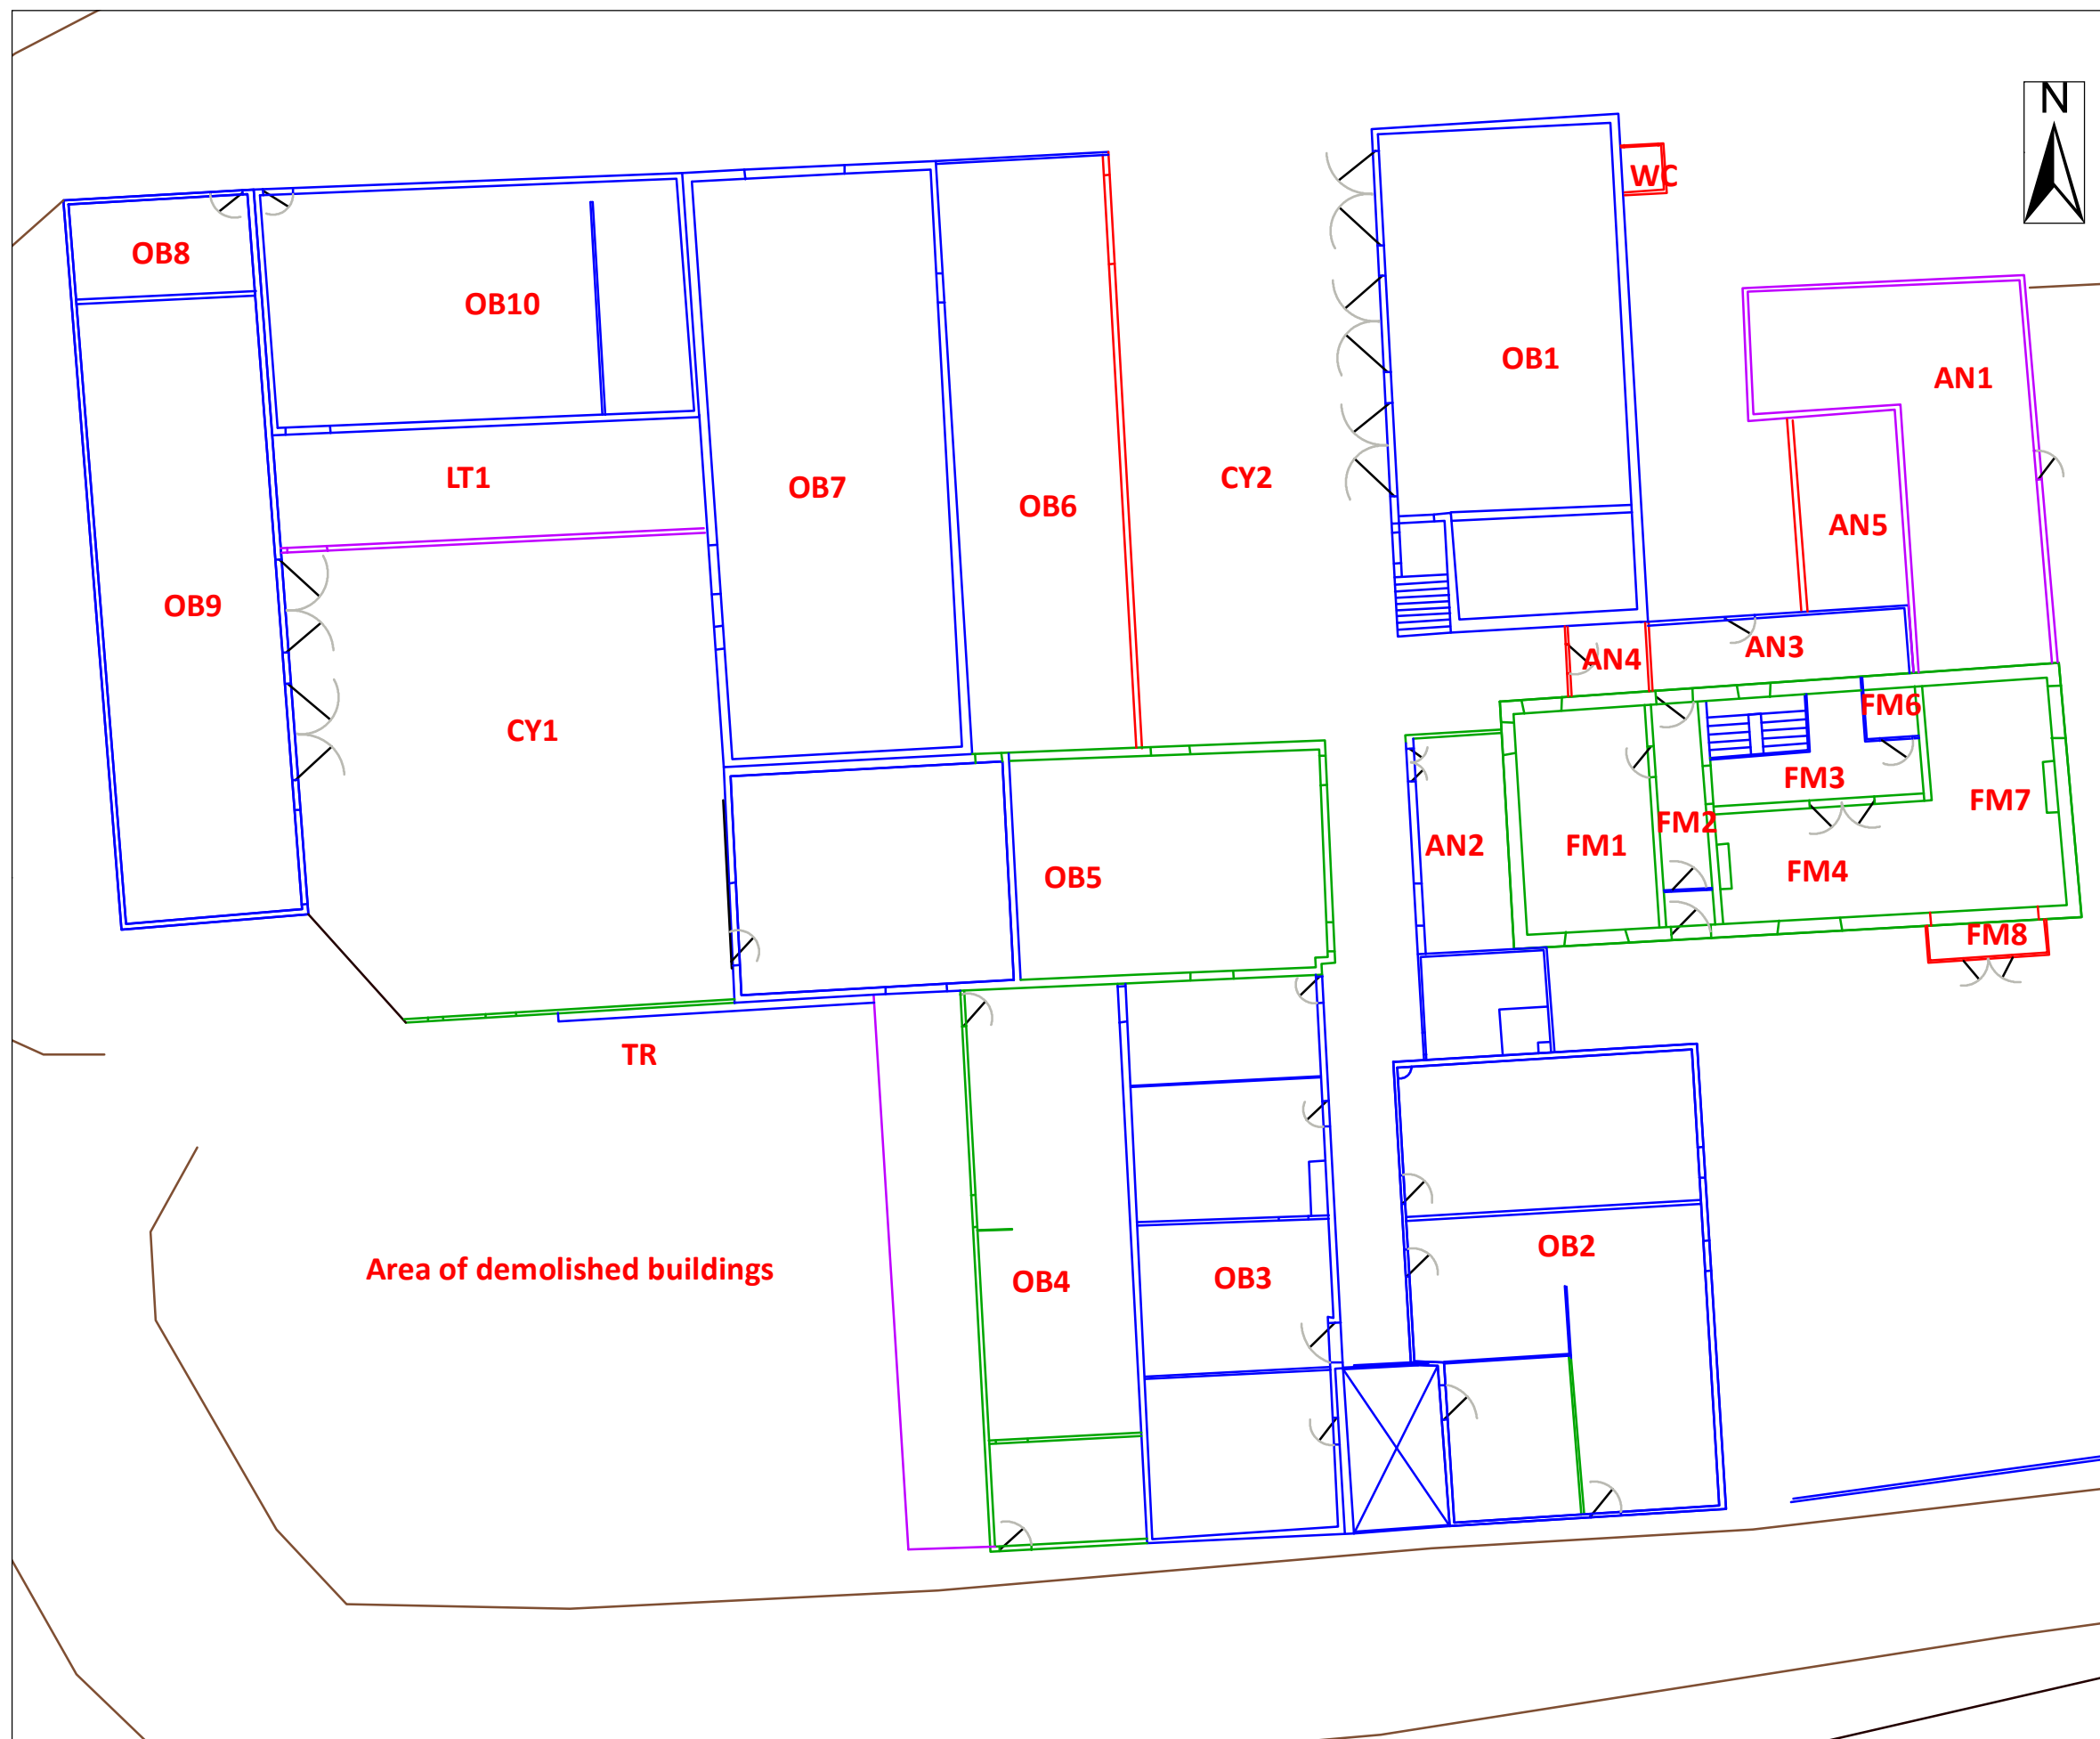
**Figure 10: Plan of
High Grange Farm**

The 20th century has seen the redevelopment of the outbuildings adjoining the north of the farm as well as the construction of the two modern barns to the north of the main complex of the farm. There is also evidence of significantly increased vandalism in recent times including the setting of several fires which have damaged parts of OB1 and significantly damage OB4 leading to partial collapse of the roof.

- 8.1.1 There is clearly some potential for further archaeological remains of 18th century farm buildings in the area of demolition marked on figure 10. However this would most likely on reveal a basic floor plan which can be obtained from a study of the historic mapping. The majority of the outbuildings are in a poor state of repair and many are partially collapsed already. As such it is not likely that any more can be gained by redeveloping them.
