**HISTORIC SCOTLAND PROPERTIES IN CARE
MINOR ARCHAEOLOGICAL WORKS 2011**

Fort Charlotte: West Bastion Wall Investigation, August 2011.

SITE: Fort Charlotte, Lerwick, Shetland Isles.

DESCRIPTION: Test trenching to establish the cause of structural cracks within the N and W walls of the W bastion.

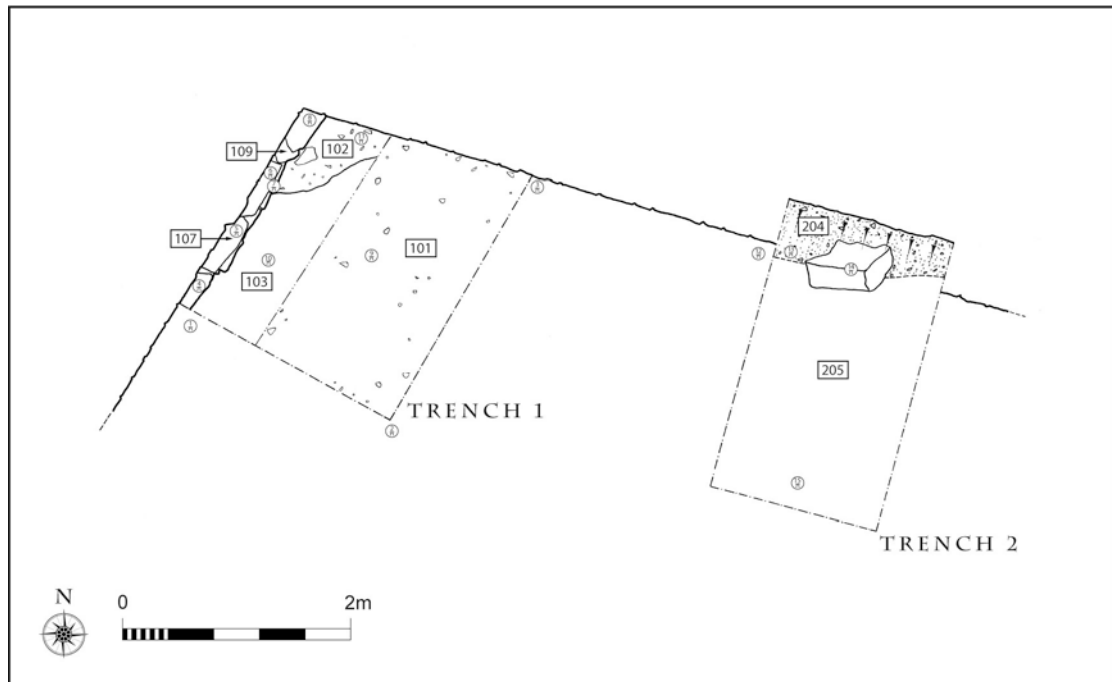
Figure 2: Initial plan of Trench 1 and Trench 2.

Trench 1 was located in the NW corner of the W bastion. This trench was intended to allow an examination of the junction between the N and W walls. In plan it measured 2.10m roughly E/W by 2.45m roughly N/S. The original design had a kink in the NE corner which, upon consultation with Historic Scotland, was straightened out, as it would require a less complicated shoring solution. The W wall consisted of a rough upper build **106** of angular pieces of different stone types, ranging from buff-coloured sandstone (sometimes containing pink or white quartz cobbles and rounded pebbles), grey angular granite/dolerite blocks, mid-brown conglomerate and a greenish-grey stone, possibly some form of breccia. The larger pieces of stone had smaller angular pinnars of similar rock types in between them. Several of the sandstone pieces carried a vertical drill scar on their faces c.2cm wide – this echoed similar scarring on the bedrock outcrop supporting the exterior W and SW corners of the bastion. The wall

was heavily re-pointed and carried a wide angled course of copes (1.70m wide) at its apex, slanting upwards from N to S. The wall stood around 2.08m high internally (at least 3.45m externally) and was affected by a structural crack, up to 5cm wide in places, running in a ragged course from N to S, 0.3m - 1m above the ground. Earlier attempts had been made to seal the crack with mortar, but it had simply opened up again. A quick probe showed that a further wall face lay in behind, at a distance of 0.65m - 0.70m. Build 106 was carried on a 0.20m wide, poorly-bonded, projecting masonry foundation 107, consisting of angular blocks of buff-coloured sandstone and greyish granite. This build had either become heavily voided, or partially re-built to the N, where a further projecting area of masonry 109 carried build 106 above. Context 109 was in a state of near-collapse, its masonry held together by a loose matrix of mortar-flecked silt (one large stone slipped out of the wall at an early stage, reinforcing the need for adequate shoring). Contexts 107 and 109 were carried on a further masonry build 108, consisting of large angular basal sandstone blocks bonded with lime mortar. This course was up to 0.40m thick, and was recessed back from 107 by 5cm.

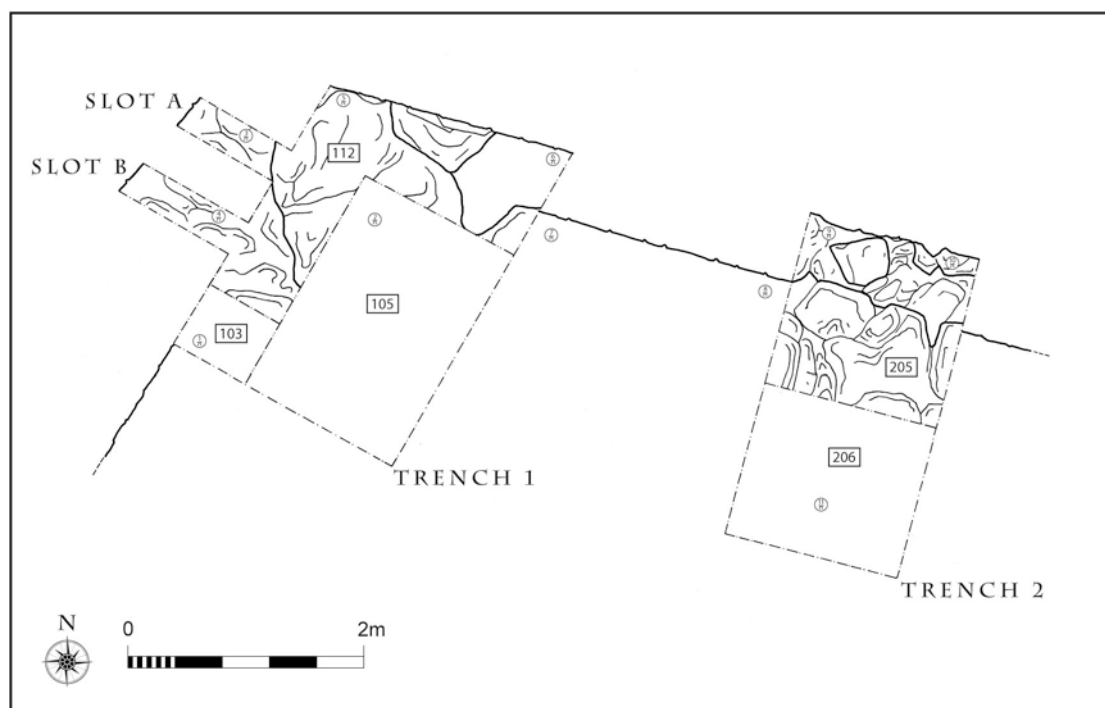
Figure 2: Final plan of Trench 1 and Trench 2.

The N wall again consisted of a rough upper build **113** composed of angular pieces of different stone types, ranging from buff-coloured sandstone (sometimes containing pink or white quartz cobbles and rounded pebbles), grey angular granite/dolerite blocks, mid-brown conglomerate and greenish-grey breccia. The larger pieces of stone had smaller angular pinnars of similar rock types in between them. Several of the sandstone pieces again showed signs of a vertical drill scar, c.2cm wide. The wall was heavily re-pointed and carried a wide angled course of copes (1.05m wide compared to 1.70m in the W wall) at its apex, slanting upwards from E to W. The wall stood approximately 2.10 - 2.15m high internally (at least 4.20m externally) and was affected by a structural crack, up to 3cm wide in places, running in a ragged course from E to W, approximately 0.20m - 0.30m above the ground.

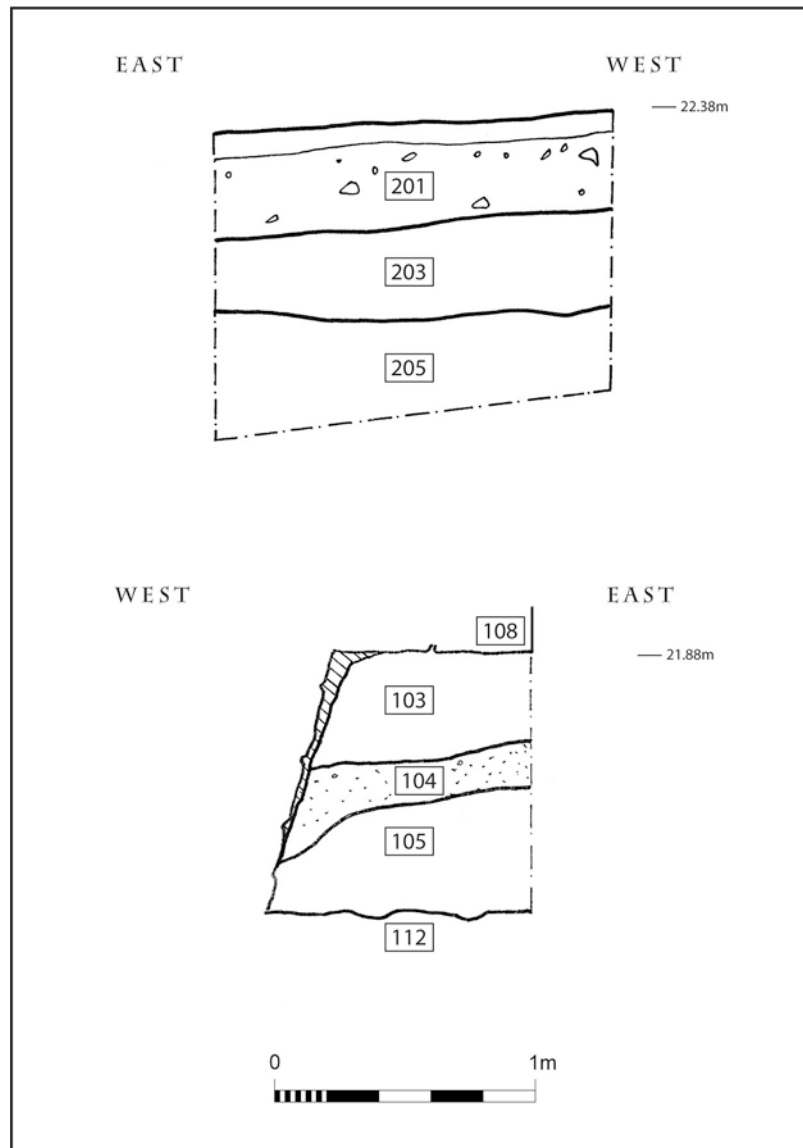
Figure 10: N-facing section in Trench 2 (top),
and S-facing section in Trench 1.

After the removal of the initial 1.2m of fill, the Historic Scotland engineer requested that the work concentrated on the exposure of the relationship between the wall and the bedrock. Thus the southern 1.3m of the trench were excavated to a depth of c.1.2m, while the northern end of the trench was 2.2m deep. The exposure of the angled N wall and the bedrock in Trenches 1 and 2 allowed the instability problem to be solved by building a brick wall directly on the bedrock to support the bastion wall.
