HISTORIC SCOTLAND PROPERTIES IN CARE
MINOR ARCHAEOLOGICAL WORKS 2011

St Mungo's Cathedral, Glasgow: Damage Inspection, July 2011.

SITE: St Mungo's Cathedral, Glasgow.

DESCRIPTION: Inspection of an area of flood damage on the N side of the Nave.

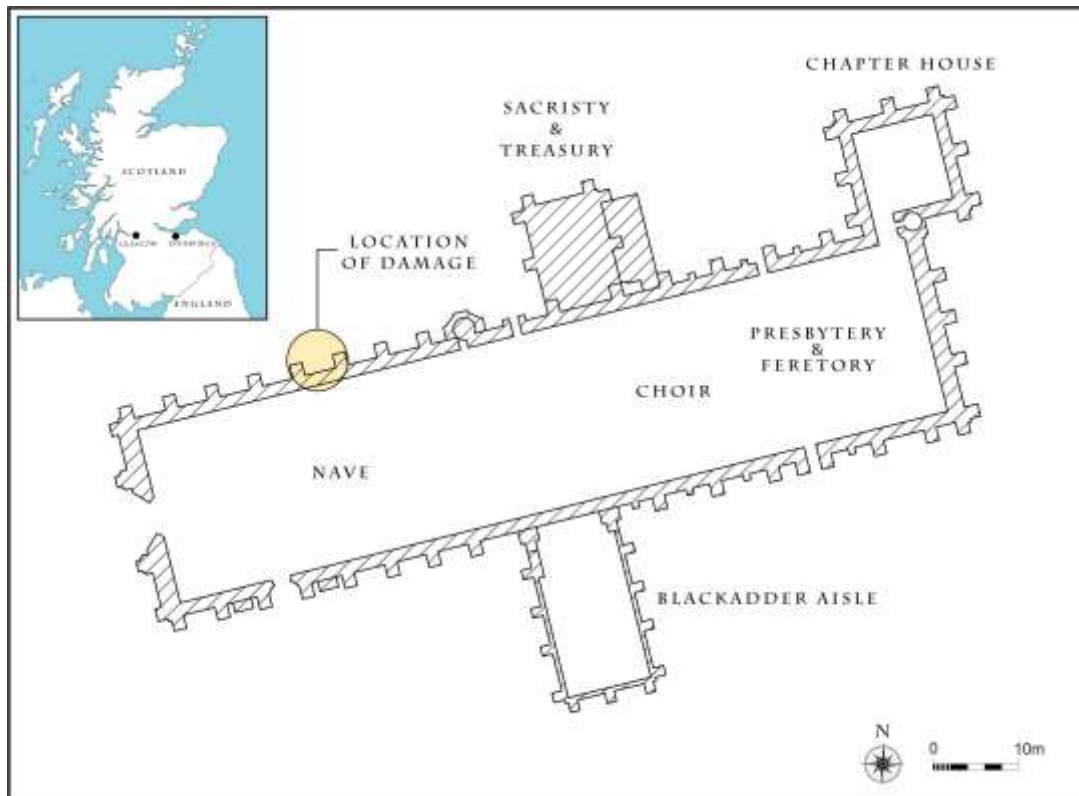
Figure 1: Location plan showing flood damaged area.

Under the terms of its Properties In Care (PIC) call-off contract with Historic Scotland, Kirkdale Archaeology was asked to undertake the inspection of an area of flood damage on the N side of the nave of St Mungo's Cathedral, Glasgow. Severe rain on Sunday 17th July 2011 caused the dislodging of a significant amount of material around two of the exterior window bays; the material comprised a mixture of small sub-rounded quartz pebbles (used as a decorative surface spread) as well as mixed backfill containing modern glass, iron nails, scaffolding bolts and a single disarticulated human bone. The work was carried out on 29th July 2011.
