Stirling Castle
James V's Palace
Fireplaces

Fireplace Cleaning / Recording

SCPP 2008-1

Stirling Castle Palace
Collapsed Sash Window in the
Queen's Presence Chamber

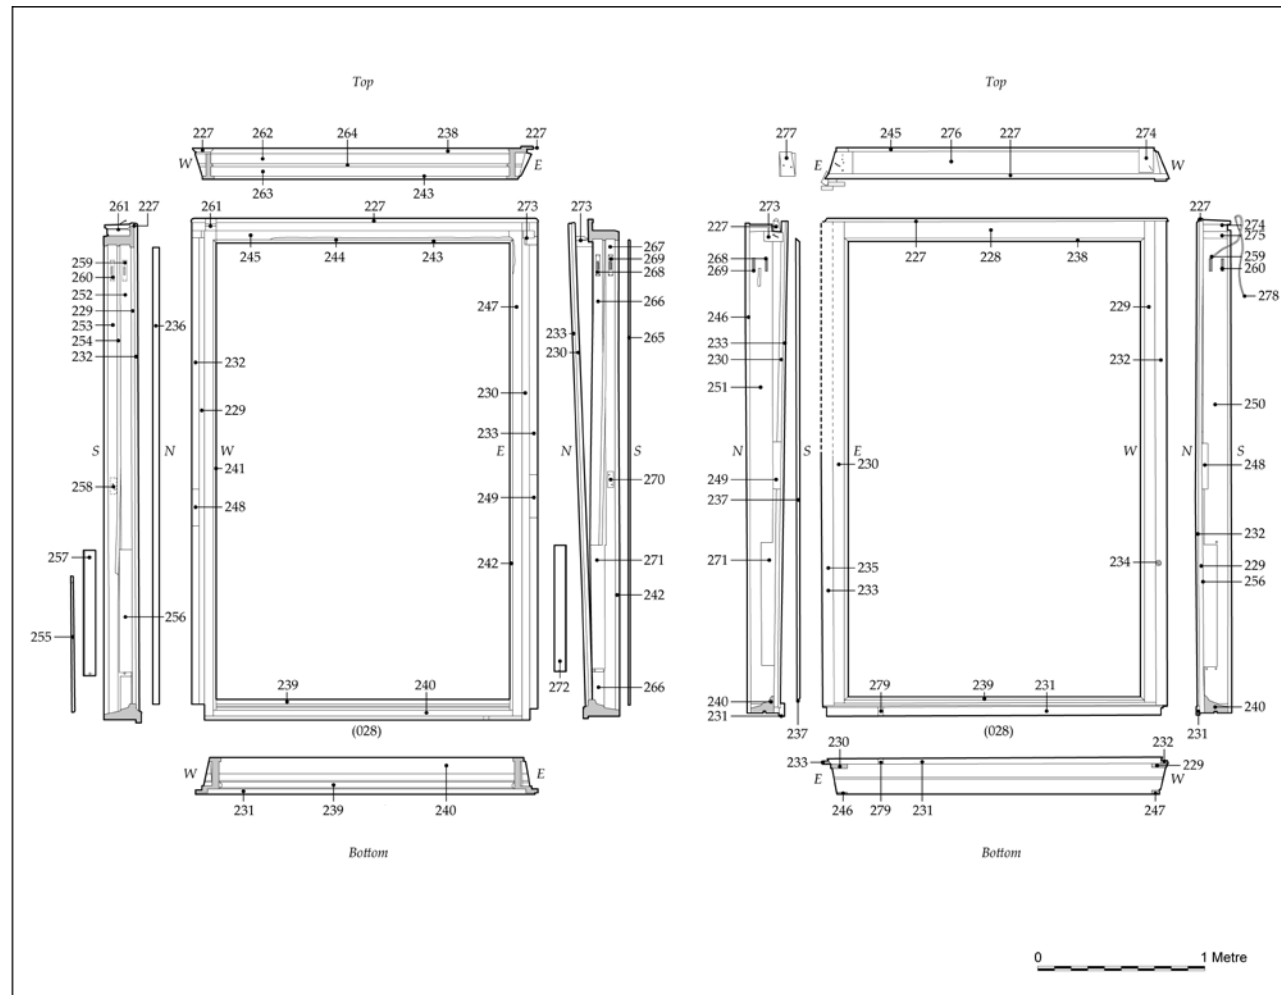
Figure 1: Drawings 1 to 10 (see Appendix 2 for descriptions of individual drawings)

The sashes and case are constructed of pine. The joints are not dovetailed together but are instead held together by lap joints (P09.3.229, Fig. 1 [Drawing 10]). These are called *Half Lap* or *Corner Lap* joints where two timbers are jointed together by means of overlapping recessed flat faces which are glued and nailed. This is again an indicator of a relatively late date for the window.

The sheer thickness and weight of these windows meant that in many cases the window backs had to be thickened out with courses of bricks to help support the weight. In order to secure the sash case into the aperture several elements were added to try to ensure that it stayed there. On the underside of the sash case a groove was cut so that the cement base would fill it and hold it (Fig. 1 [Drawing 10]). Chocking blocks (blocks of off-cut wood used to bridge the gap between the sash case and the aperture) were added to the sides of the weight boxes and at the top corners of the sash case (for an example see P09.3.274, Fig.1 [Drawing 9]). Putty (see P09.3.274, Fig. 1 [Drawing 1]) was also used to secure the sash case although this had become dried out and porous. The window was also secured to the aperture reveals by 2 iron brackets screwed to E and W weight box stiles – the scars of which are represented by P09.3.234 and P09.3.235 (Fig. 1 [Drawing 6]). These brackets were at a relatively low level on the window case.

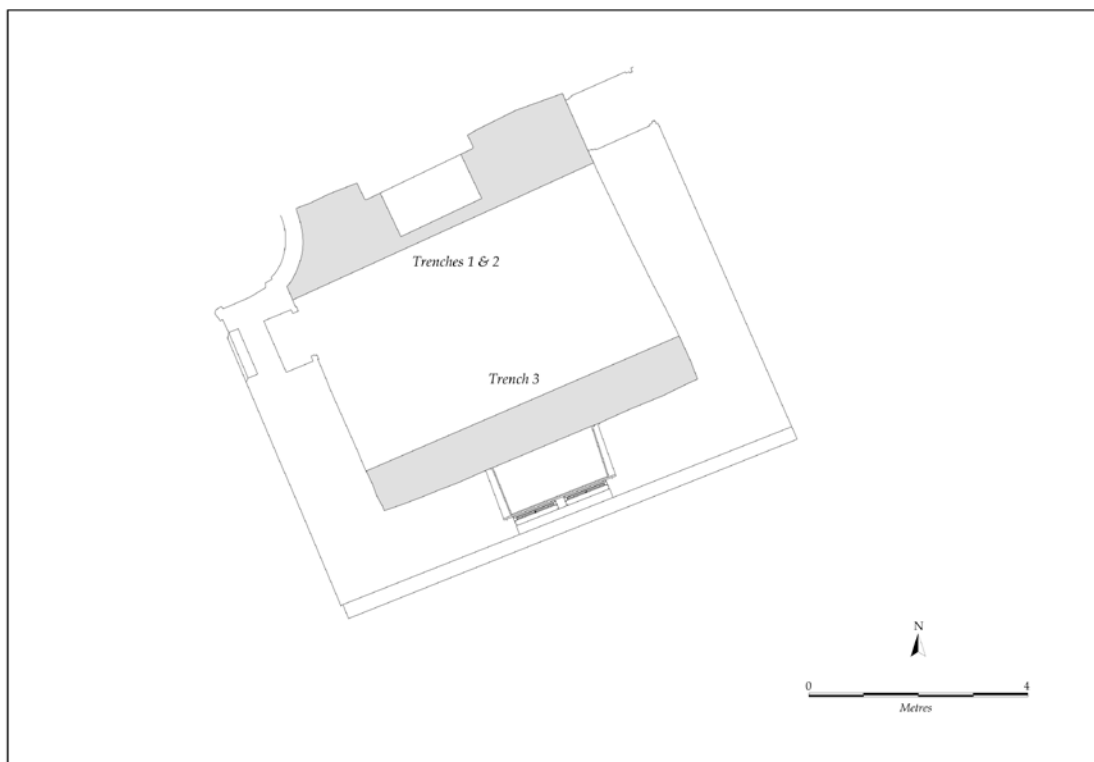
Figure 1: Location of Trenches

Three trenches were excavated, Trench 1 in the NE corner of the room, Trench 2 in the NW corner and Trench 3 along the S wall of the room. Trench 1 measured up to 1.60m E-W between the stairway in the NW corner of the room and the central fireplace in the NS wall, it extended 850mm S from the N wall and was excavated to a depth of up to 420mm. Trench 2 measured up to 1.90m E-W between the central fireplace in the NS wall and the entrance to the room in the NE corner, it extended 850mm S from the N wall and was excavated to a depth of up to 550mm. Trench 3 was excavated along the full length of the S wall and measured 6.10m E-W, 750mm N-S and up to 800mm in depth.
