**An Archaeological Standing Building Survey
Dowles Manor
Bewdley
Worcestershire
(NGR SO 77521 76419)**

ABRS Project No 2018-DMBW

**Worcestershire County Council
Historic Environment Record Event
No. WSM70433**

**An Archaeological Standing Building Survey of Dowles Manor, Dowles Lane, Bewdley,
Worcestershire (NGR SO 77521 76419).**

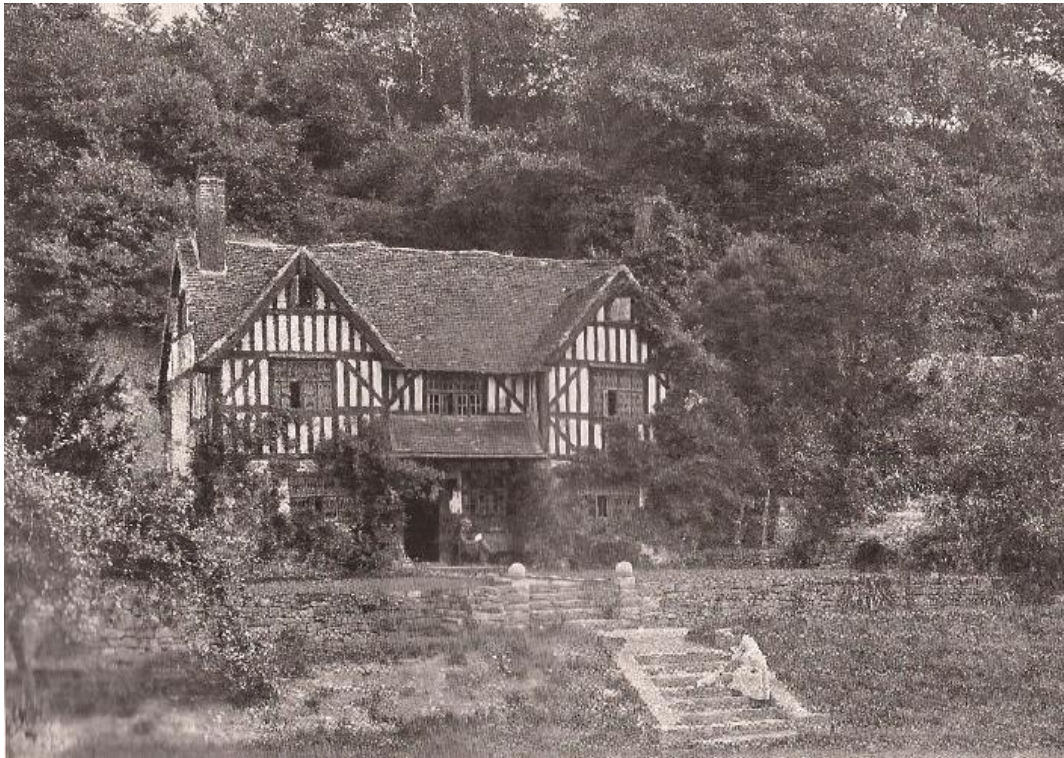
Figure 2
Early 20th Century Photograph of Dowles Manor.

Prior to its demolition the manor house was described as a “*small, but exceptionally complete Elizabethan Manor house*”. Early 20th century photographs (*Figure 2*) show a close studded timber frame atop sandstone sleeper walls. Internally, there were said to be remarkably well preserved wall paintings representing winged animals and human figures, half figures of Elizabethan ladies in ruffs, and other designs in grey and red. The building itself was a H-plan, two storied building with attics in gabled cross-wings under tiled roofs and a modern brick addition at the rear. The hall, entered directly from the main doorway, dated 1560, occupied the centre of the ground floor of the original part of the house, to the west was a room used as a drawing room, and on the east the present dining room and the original

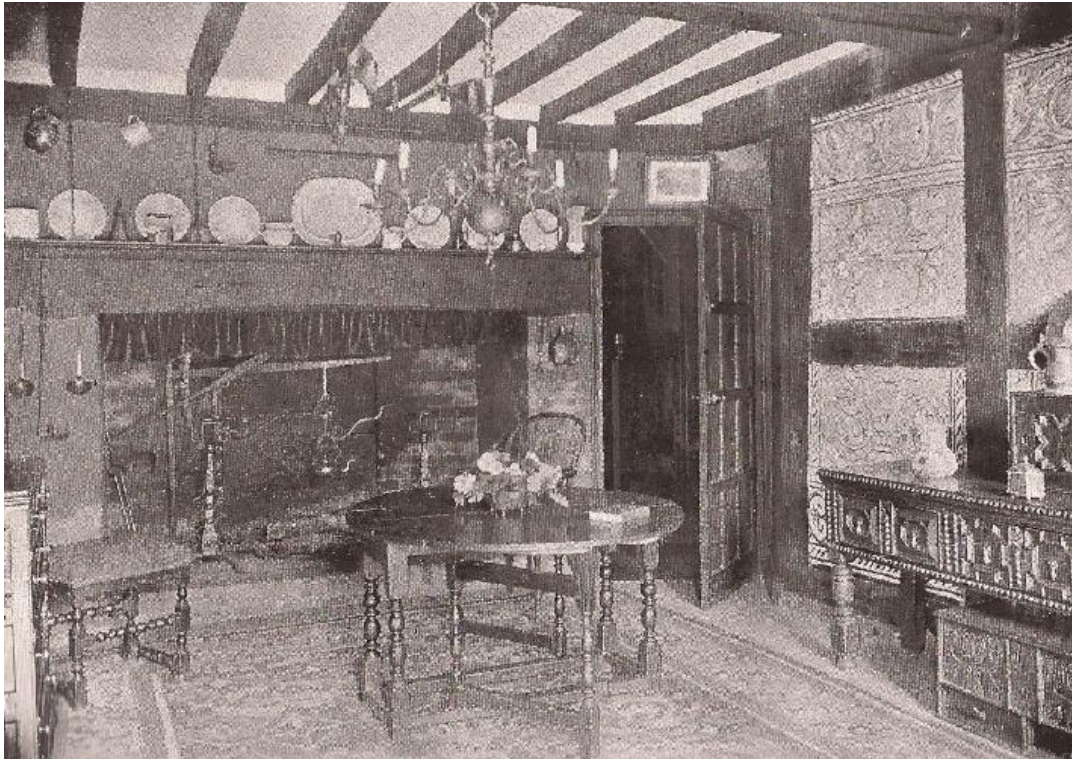
Figure 11
Early 20th Century Photograph of Fireplace.

The only remaining feature of the original Manor House is the partially re-built fireplace (*Figure 26*). Steele Elliott writing in 1916 describes it as “cavernous” (*Figure 11*). The fireplace was originally located opposite the front (south facing) door in what would have originally been the hall, or “Houseplace” as Steele Elliott describes it. The remaining fireplace consists only of the lower courses of bricks carrying a wide, oak bressumer, the bressumer is finished in a flattened arch with a scrolled stop (*Figure 27*), stylistically mid 17th century in date, confirming the potential date range for the original construction of the Manor House.

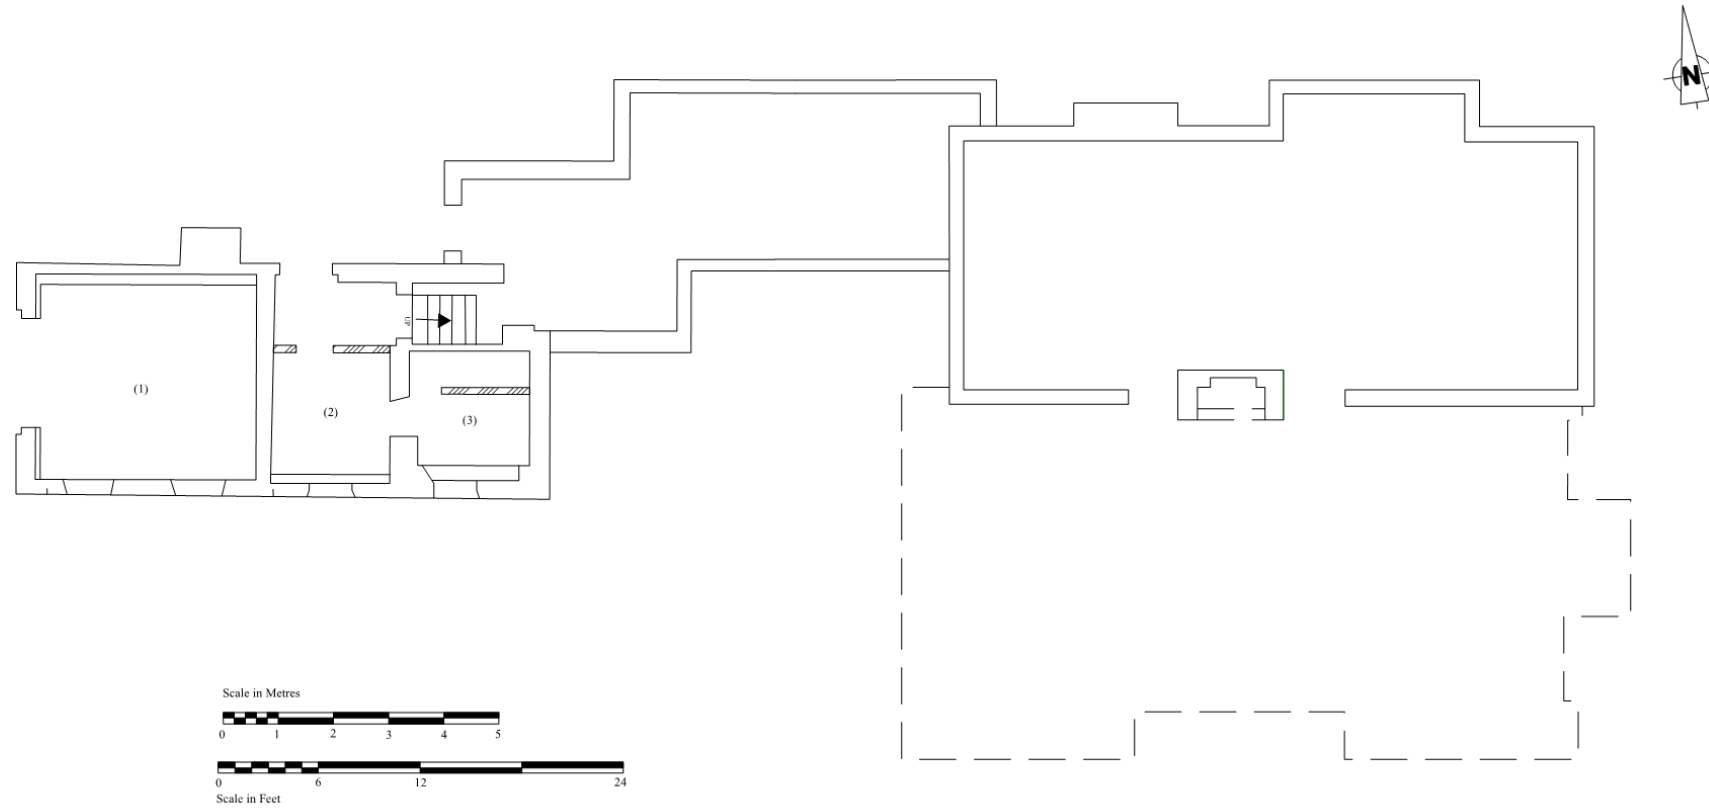
Figure 31
Original Fireplace.

The fireplace is the only structural element of the original Manor House to survive. The fireplace is brick-built with a substantial oak bressumer finished in a flattened arch with a scrolled stop.
