Fristling Hall, Stock, Essex. Description and analysis of the farm buildings
at Fristling Hall. Surveyed 09 11 and 06 12 2011. CBC 10/01780/FUL.

The buildings are recorded to discharge a planning condition monitored by Essex County Council on Chelmsford Borough Council application 10/01780/FUL.

The buildings under study to EH Level 3 are:

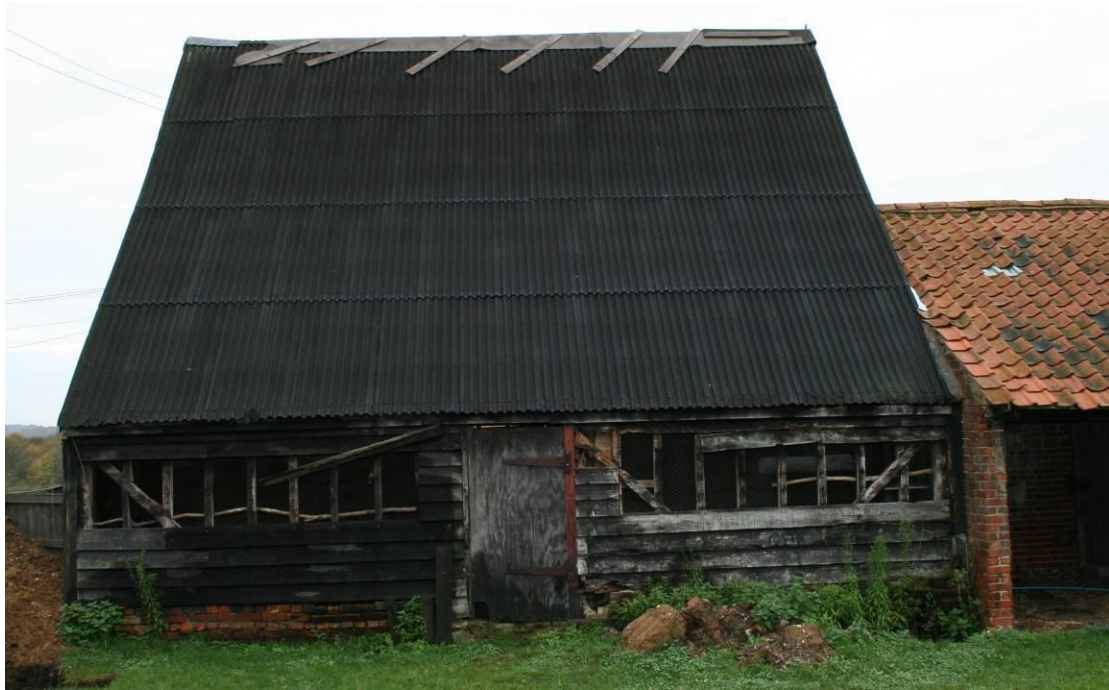
Catslide roof and outshut rooms used as bird rearing houses.

The cladding is bandsawn LC20th weather-boards and 3-4 runs have been deliberately removed to create light and ventilation. The frame has then been chicken wired on the inside to create bird cages for game birds such as pheasant. Unfortunately this has allowed the weather into the frame causing it to rot prematurely. The studs all appear to be oak.

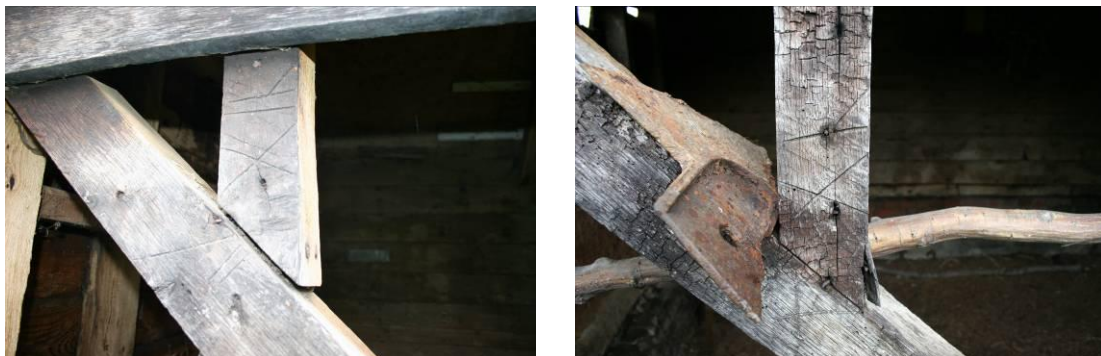
The southern elevation reveals the timber-frame of two outshuts separated by a narrow lobby into the rear of the Granary. The frames are of diagonally braced interrupted studwork fastened with chisel shanked wrought iron nails. The timbers are numbered throughout on the exterior with a race knife using a tagged number system. The numbers are identical to that used on the main frame and show the building was originally built with the outshuts.

Timbers numbered XXIItag and XXIItag adjacent in the same frame.

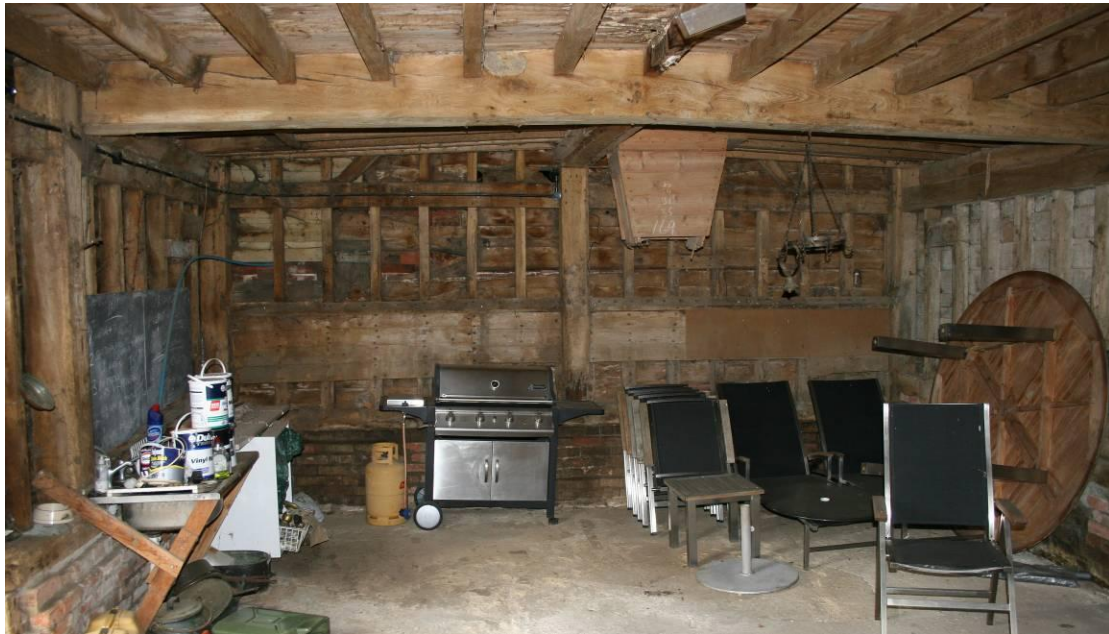
Looking E inside the Granary on the ground floor. Frame and floor is oak.

The Granary is composed of an oak timber frame with diagonally braced walls with nailed interrupted studwork. The braces are confined to the panels above the mid-rails and connect the storey posts to the mid-rails. The studs are cut on a module of 3x4in, set on edge and pegged into the horizontal members at 17in centres. The principal storey posts are 8x9in in section and chamfered with runout stops. The mid-rails are 7x5in. The front and rear doors have original 5x5in jambs with mortices for drop bars.

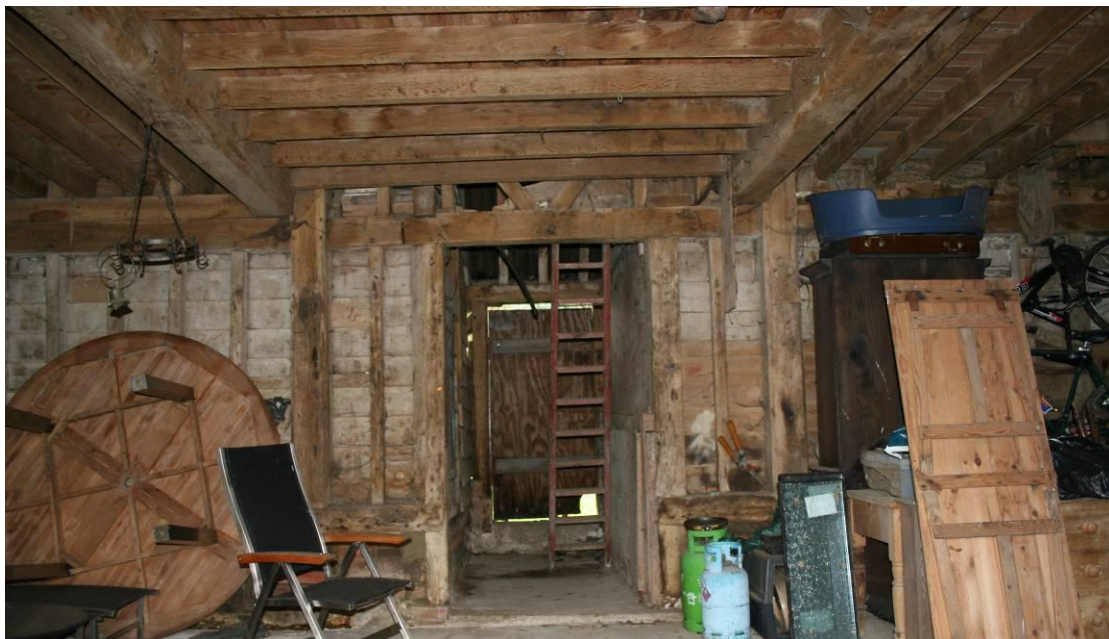
The central bay looking south at the rear door. Note added wall plates for the joists to sit on.

The floor is unusually framed by resting the two main transverse 10x13in deep joists on the mid-rails and dovetailing them sideways into the storey posts. This means the common joists which are 3x5in set at 17in centres cannot sit on the mid-rails. In the central bay the common joists are axial between the main joists. In the end bays there is a bridging joist tenoned into the central storey post and the common joists are transverse. A secondary plate has then been clout nailed to the interior of the studs for the common joists to sit on.

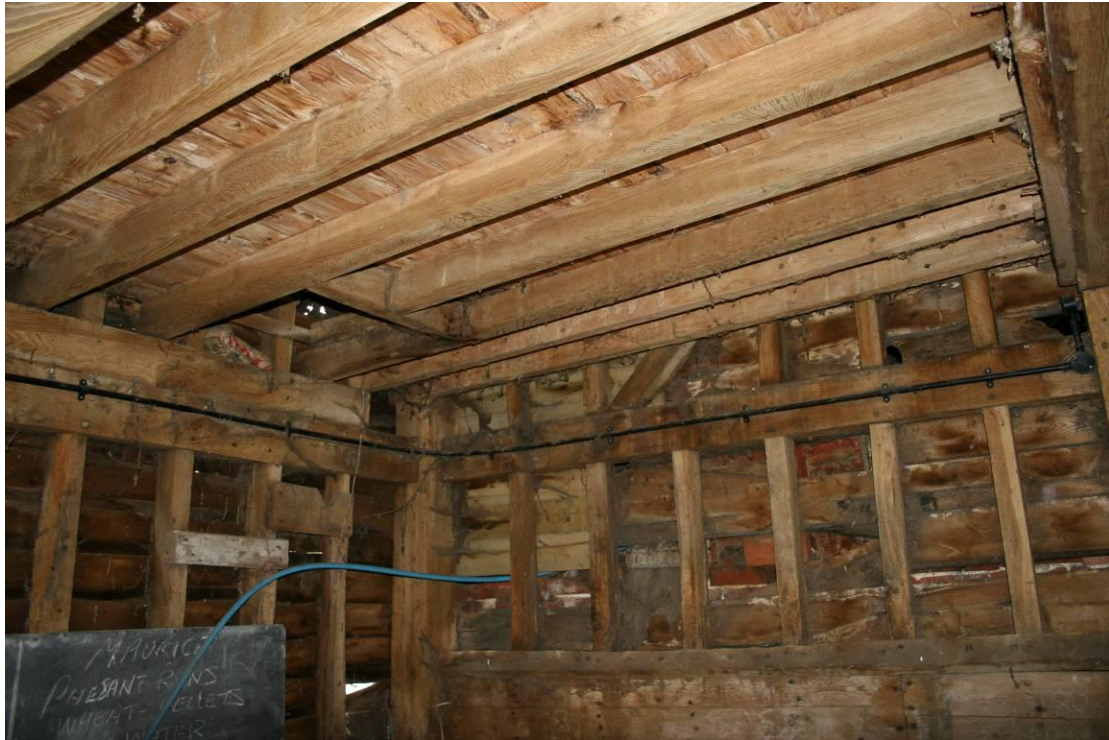
The NE corner with trimmer beam for a ladder hatch.

The main joists (and the tie-beams above them) are chamfered with cyma stops and have a pronounced camber which the boarded floor follows. This may be a considered design feature to allow the grain to fall to the outside of the floor when stored above. The floor has two properly framed ladder hatches in the NE and SW corners and the hand cleaved rungs of the ladders remain wrought iron nailed to the frame. One or two are modern replacements.

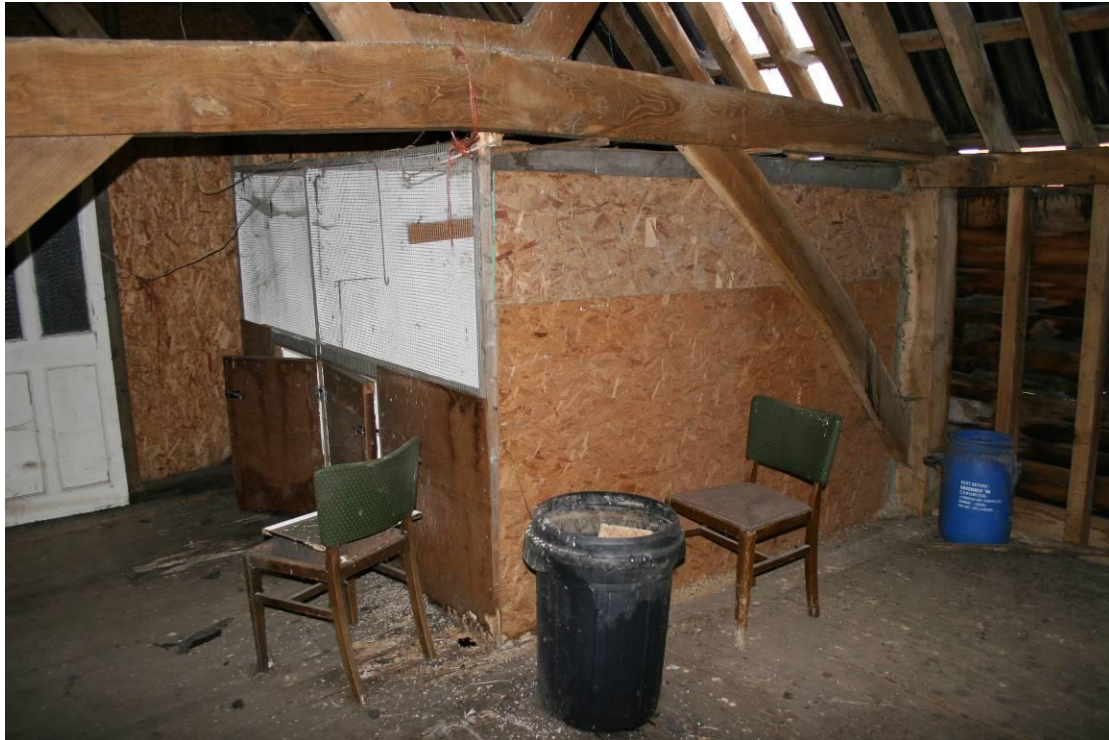
The upper floor has been divided into bird cages and an office. Looking NW.

The upper floor has tongue and grooved pine boards that are rotted in places where bird feeders and waterers have been positioned. The area is divided into three units. The westernmost bay is closed off and ceiled with OSB (Oriented Strand Board) into a windowless office with a C20th four panel half glazed door. The central bay has a large aviary built of OSB, bird wire and with ground level opening panels. OSB is a LC20th/C21st product. The rest of the floor is open.

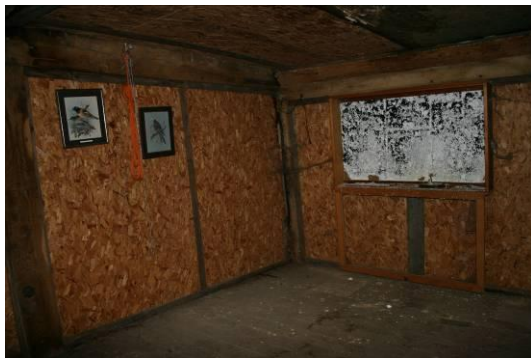
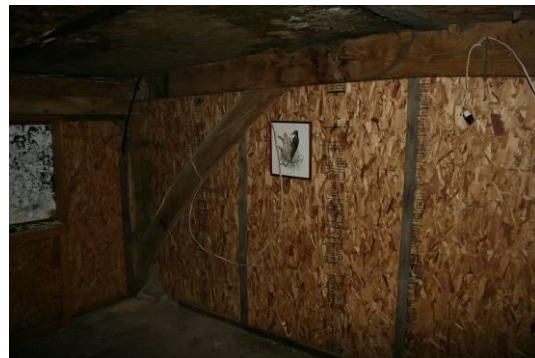
Interior of the office. Looking NW then NE.

The office has been boarded out entirely except for the north wall where there is a recess. This is however not a window but a modern cabinet with a drop front. Only the principal timbers are visible including a long curving spandrel to the cambered tie-beam on the north side. The southern one has been removed to insert the doorway. The room is considered as an office because it has a large desk in it and there are pictures on the wall. It could just as well have been an incubator room. There are abandoned electric cables for light and power. The OSB panels are printed with the date 06 MAY 1995.

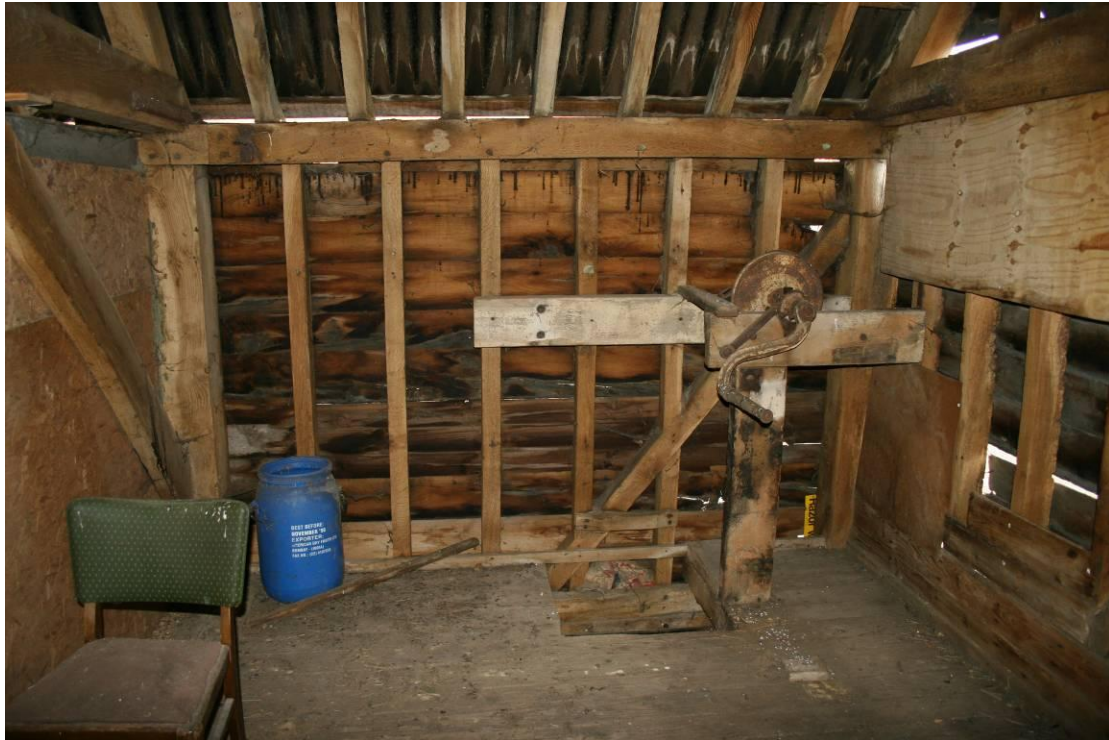
Grain hoist in the NW corner.

In the open area there is a cable hoist positioned in the NW corner over the ladder trap. Maldon Iron Works Co Ltd is cast into the housing. The support structure is cut from reused machined timbers and held together with carriage screws and French nails. Also the adjacent eastern wall has a few runs of applied pine boards wrought iron nailed to them to seal the interior. The other studs do not have any nail holes so it is likely the floor was divided into discrete grain bins when originally in use.

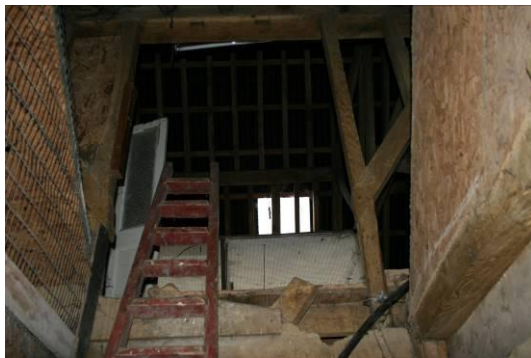
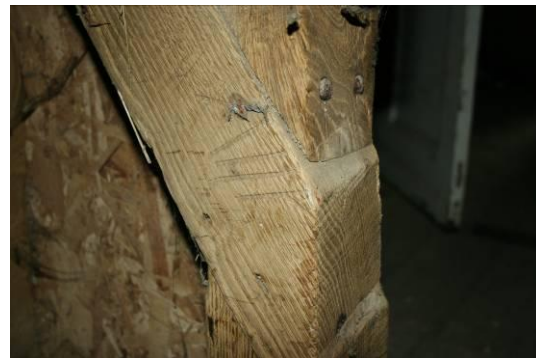
The frame has been sawn through to create a door revealing the carpenter's marks.

The upper floor is currently reached by a ladder to the rear of the building in the corridor. To create an opening the frame has been sawn through and two studs removed. The severed braces have oxidised to the same colour as the rest of the frame so it was probably done a long time ago. Revealed on the exterior of the frame is a series of carpenter's marks made with a race knife and tagged in the same way as those seen on the exterior of the outshuts. The exterior boards have fallen off and some lie in the roof void.

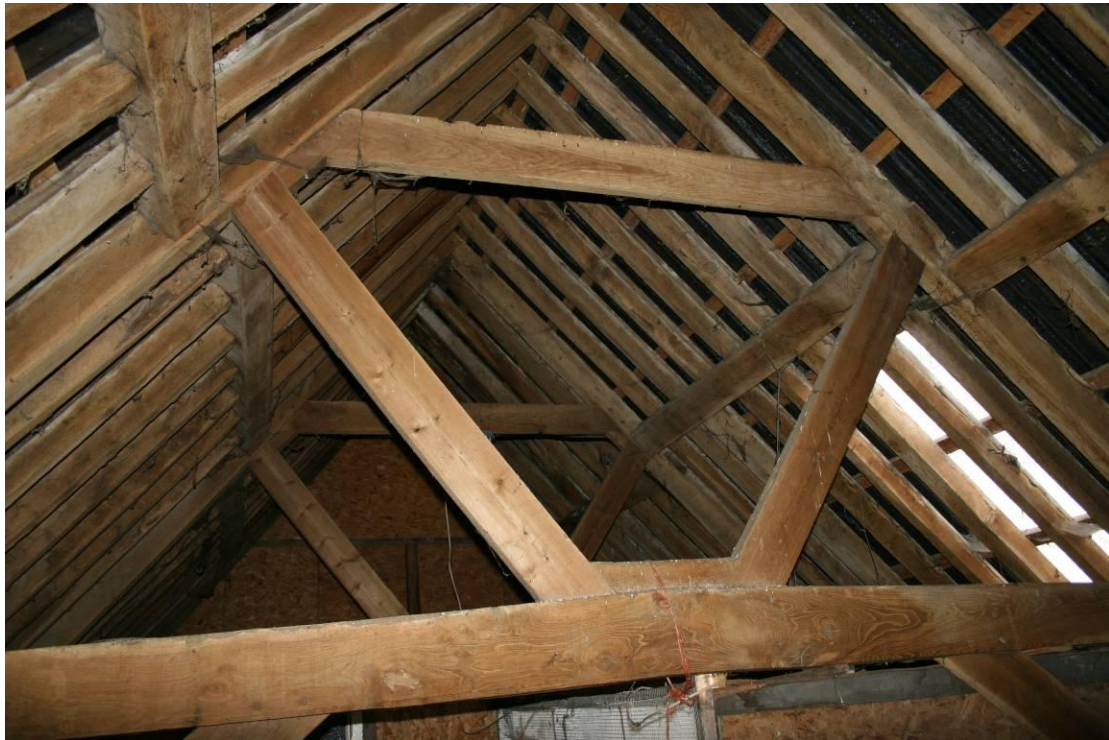
Offset butt purlin roof with original collar but added raking struts.

Further support has been added in the form of raking queen struts. These are 2.5inx8in softwood and are French nailed and not pegged in place. There are short retaining wedges holding them in-situ.

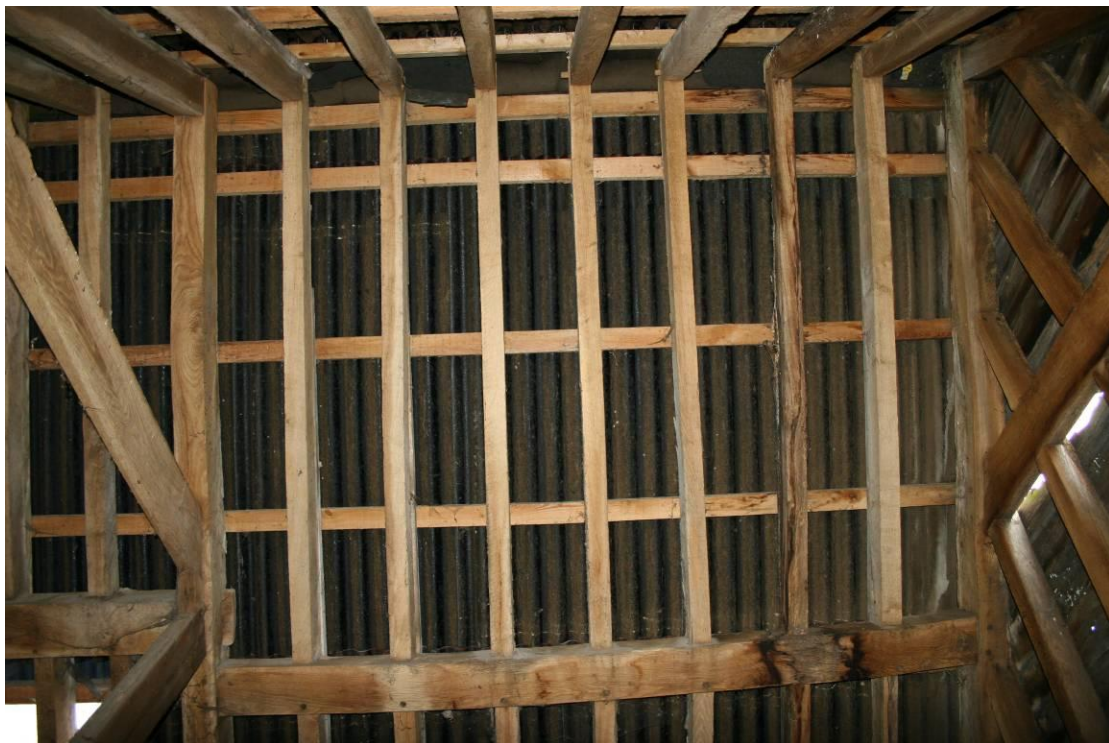
Looking upwards to the N in the easternmost bay at the butt purlin roof.

The roof is an offset butt purlin roof where the tenons pass right through the principal rafters. The 3x4in rafters are set on edge, birdsmouthed on the top-plates and pegged into the purlins at 13in centres. The upper rafters are all paired and pegged at the apex. The 5x6in principal rafters are pegged into the top of the 6x8in cambered tie-beams. The truss is braced with a collar double pegged into the principal rafters. The tie-beams are braced with long curving 3x8in spandrels. See photo page 10.

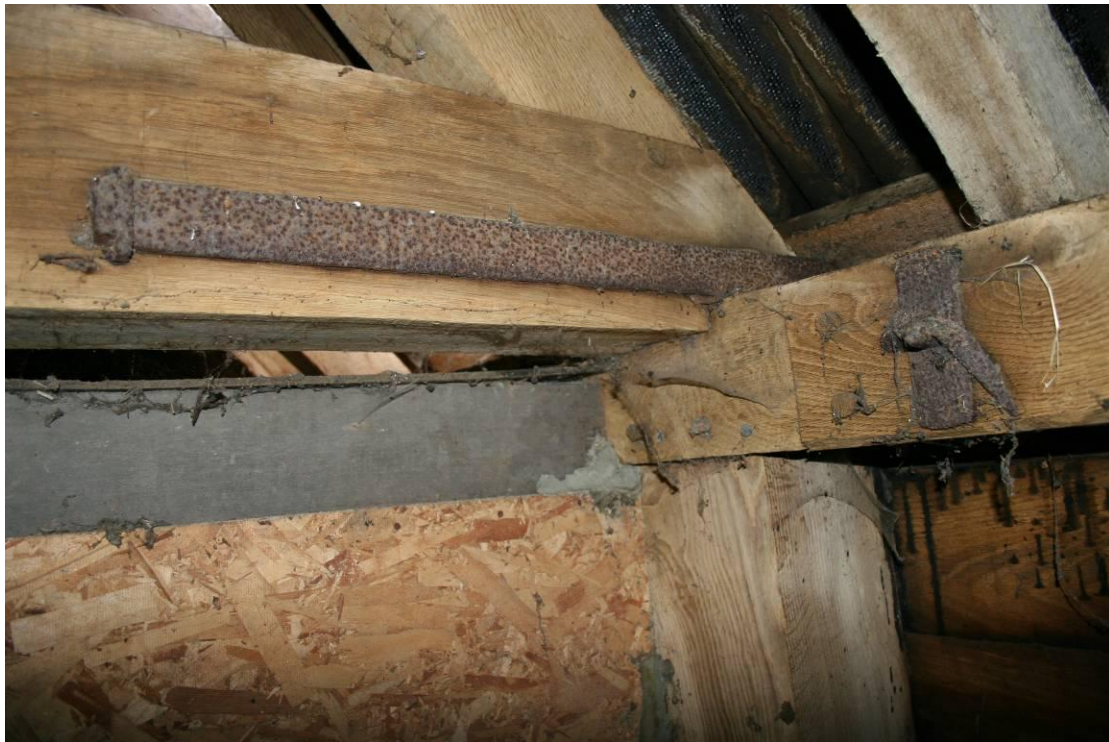
Forelock bolt through the scarf joint. Milled iron strap-work on the tie-beam. Looking NW.

The top-plate has a face halved and bladed scarf joint visible adjacent to the tie-beam II which is reinforced with a wrought iron forelock bolt with butterfly collar. All the tie-beams are secured with dovetails and a milled wrought iron strap with square staple and clout nails.

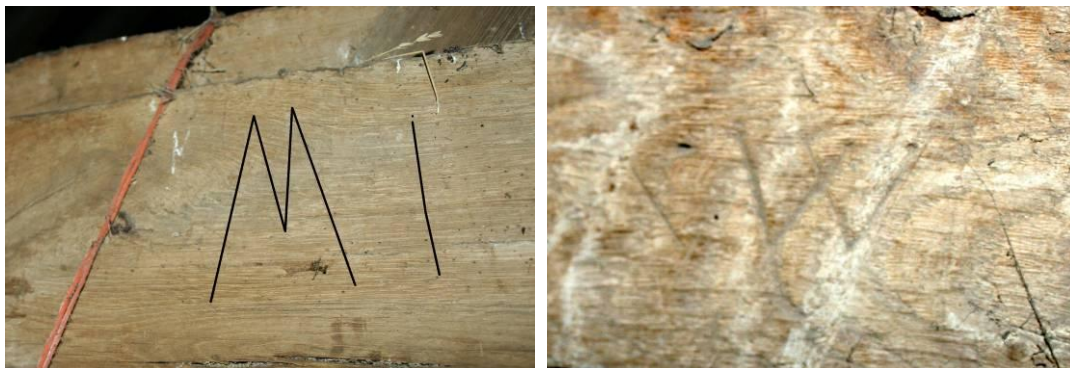
M scored on tie-beam II and W or VV scored on the boards in the rear lobby. Enhanced.

There were two possible apotropaic marks. The tie-beam II was marked with a very fine blade with the letter M and a few random vertical strokes. The centre of the beam was also marked with an upward facing arrow so lightly it was not possible to photograph. However this was a carpenter's mark.

Down in the rear lobby to the east side at head height was marked the letter W. It was scored however as two overlapping V's. Both these represent Marian marks invoking the protection of Mary or the Virgin of Virgins. The practice of marking buildings to keep out witches was commonplace until the C18th but it was also revived in the MC19th and many marks must date to then.

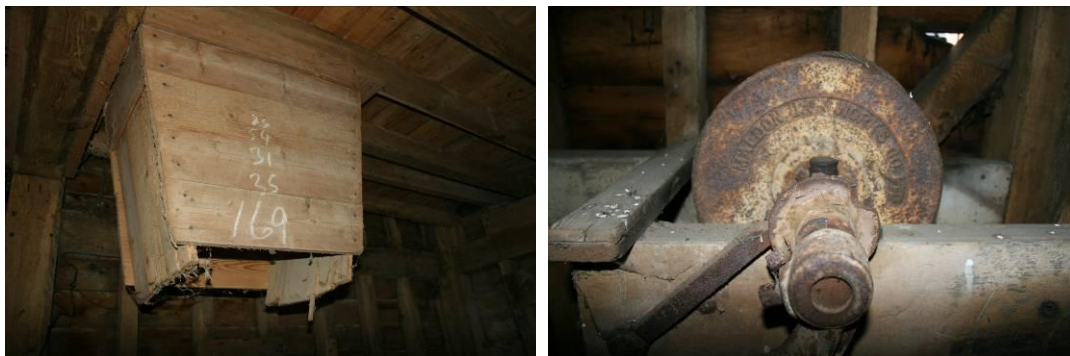
Grain chute marked with weights. Close up of the grain hoist.

The only fixtures left relating to the use as a granary are a timber grain chute still marked up in chalk with the sack weights and the grain hoist.

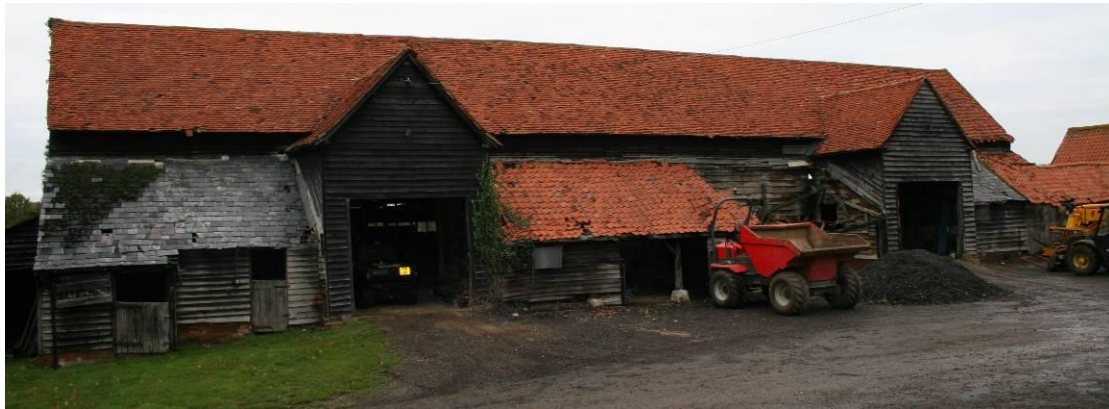
The southern elevation of the Double Essex Barn.

The Double Essex Barn as its name suggests has the appearance of two barns connected together with two midstreys porches with half height doors (which are now missing). The Barn has outshots flanking its entire length positioned either side and between the porches.

While the Barn is roofed in plain clay tiles these have grey slate and pantile roofs and are later additions. Presently they are all in parlous condition with one collapsed and the others unsound. Their last use was as stables to a large Livery.

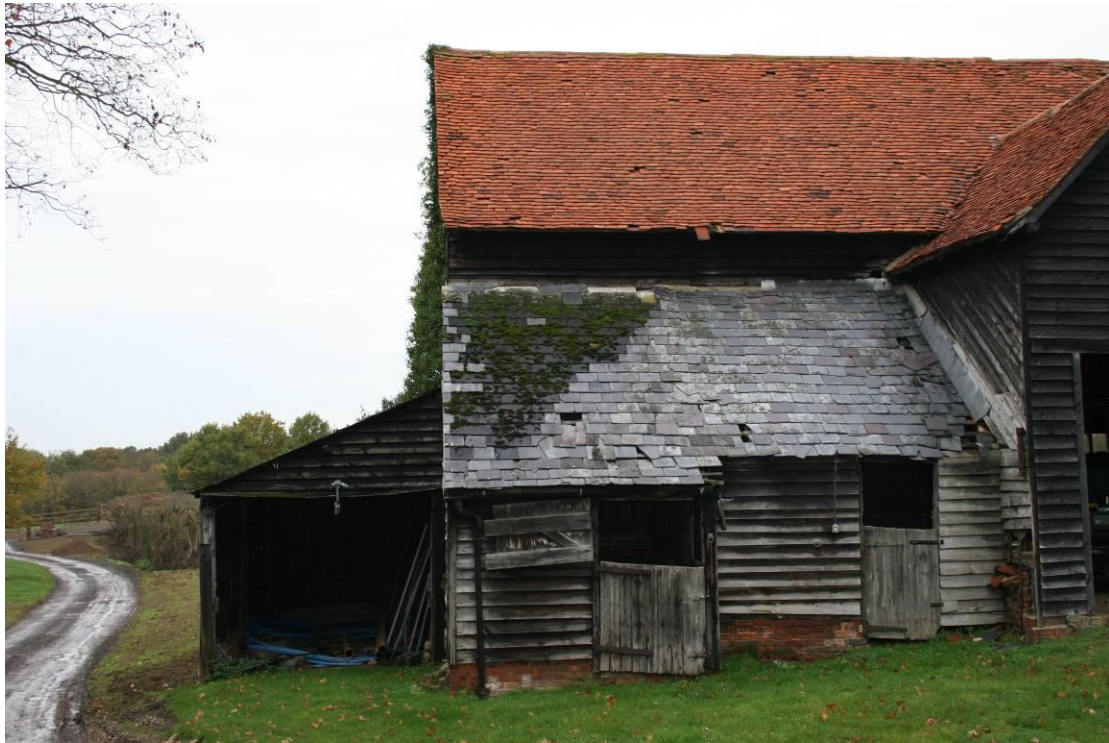
The southern outshot is built against the west side of the midstrey porch and can be accessed through a door in the side of the porch. The timber-frame is clad in C20th boards and sat on a brick plinth of the same bricks and form as the main barn. The outshot is divided into two stalls, each with a C20th split stable doors with mild steel pintle and T-strap hinges.

The plan is staggered so that the westernmost stall projects further south than the other and is a later addition. The floor levels are stepped to follow the fall of the ground. The common roof is of 12x24in grey slates and only the western half has a painted metal gutter and cast iron downpipe. Photo follows.

The westernmost outshut divided into two horse stalls.

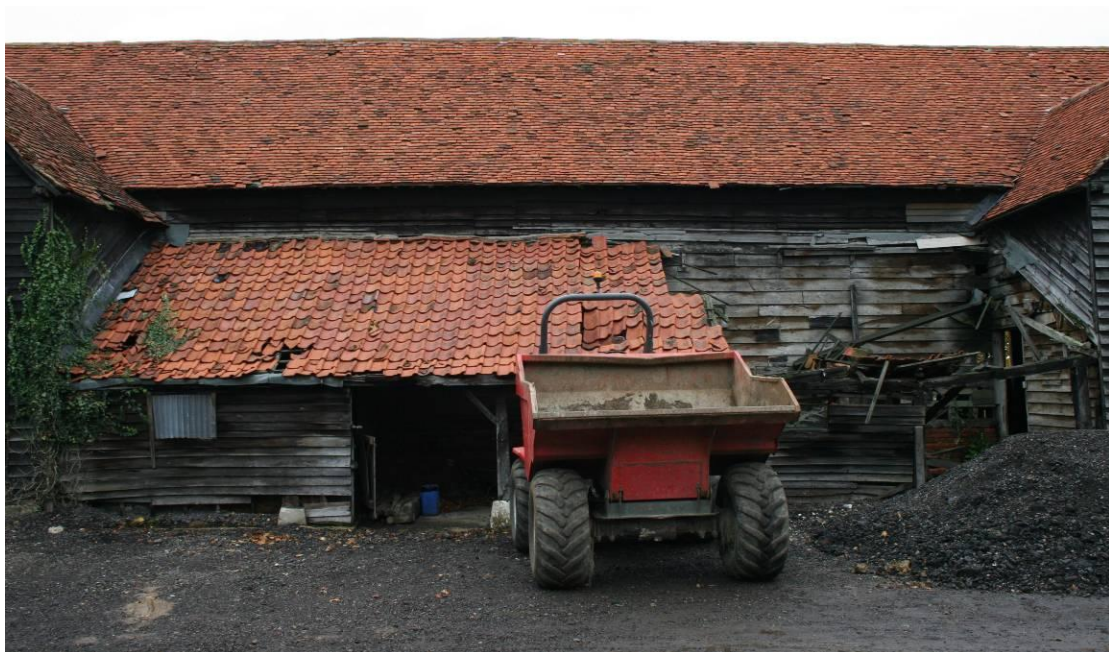
The central outshut is in a parlous state and half has collapsed.

The central outshut is a timber-framed shelter that was originally open its full length, divided into 6 bays by braced posts. The first two bays from the west have been framed and boarded in the LC20 to form a stall. The two central bays remain open-sided as a useful shelter and the remaining bays have collapsed. The weather-boarding is LC20th. The roof is clad with C19th pan-tiles. The scantling roof is possibly elm but certainly not oak.

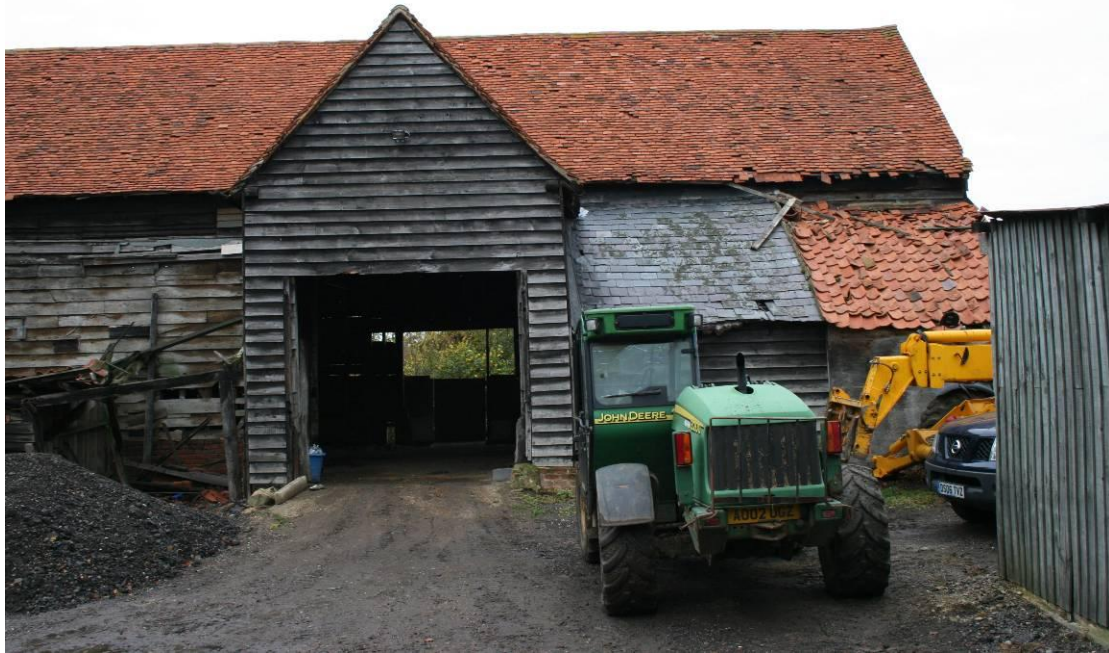
The northern outshut obscured by the John Deere tractor.

The northern outshut is nestled between the midstrete porch and the first bay of the Barn Stables. It can only be entered from inside the midstrete porch. The roof is clad in 12x24in grey slates and the walls have LC20th weather-boards. There is a small central C20th window. The interior of the room is lined with horizontal tongue and grooved kick-boards showing this was also a stable. Therefore the window represents an earlier door opening.

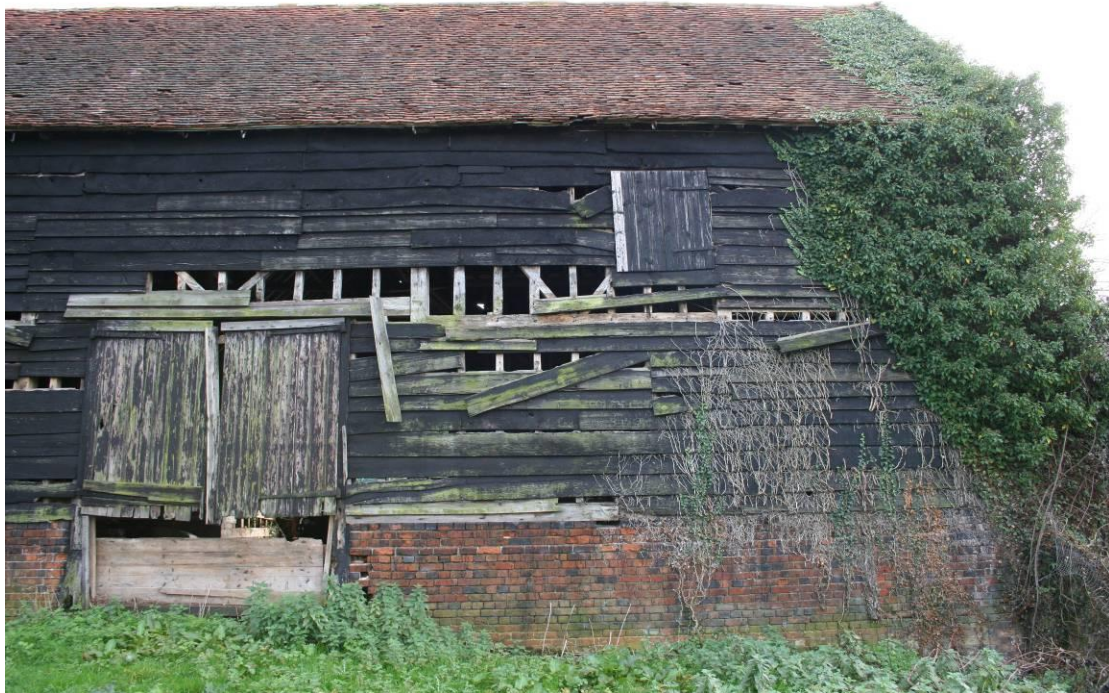
The western end of the northern elevation.

The midstrete door retains the upper leaves of a pair of C19th vertically boarded, edge-moulded, tongue and grooved, gate and ledger doors. They are hung on wrought iron pintles and constructed with clenched wrought iron nails. There is a similar hatch door high up in Bay 1 (from the W). Below, the threshold has a C20th boarded leap laid across it.

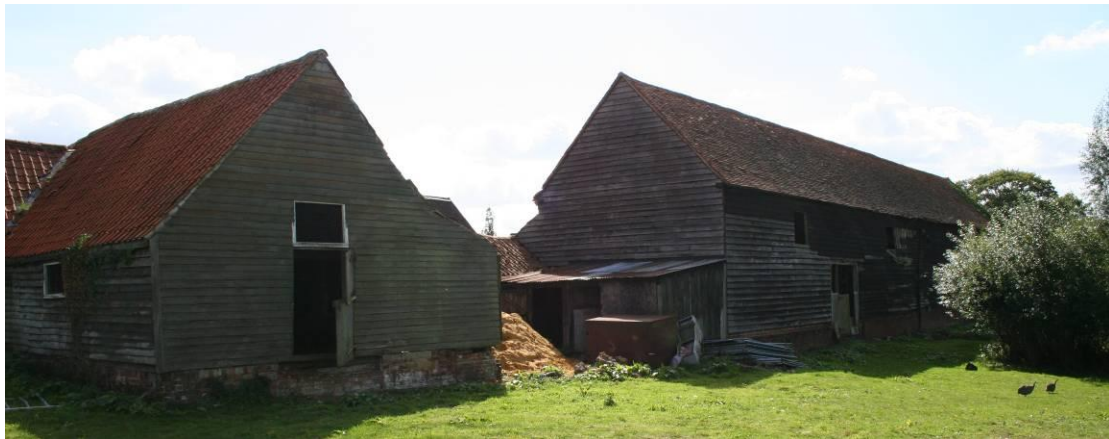
The last two bays to the east have been clad in LC20th softwood and the doorway infilled with a marine ply construction to reduce it to a pedestrian door with side lights. This has mostly failed.

The Double Barn seen adjacent to the Dairy (left).

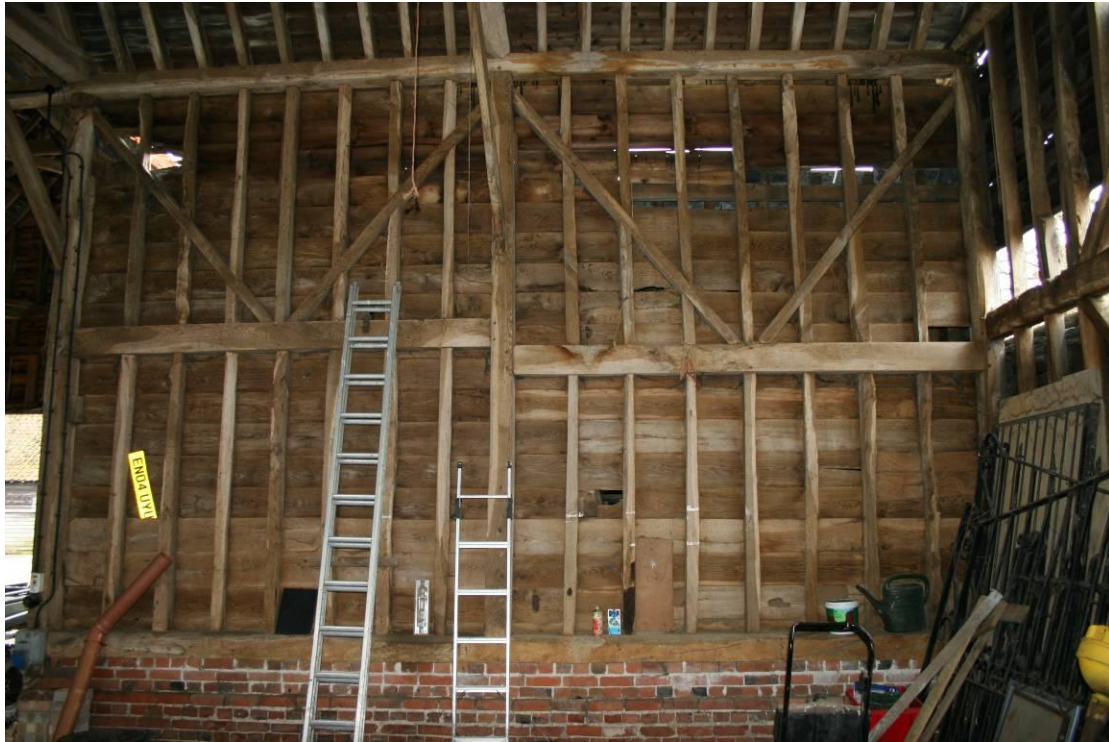
The framing of Bays 1 and 2 on the south side. V braces above the offset midrail only.

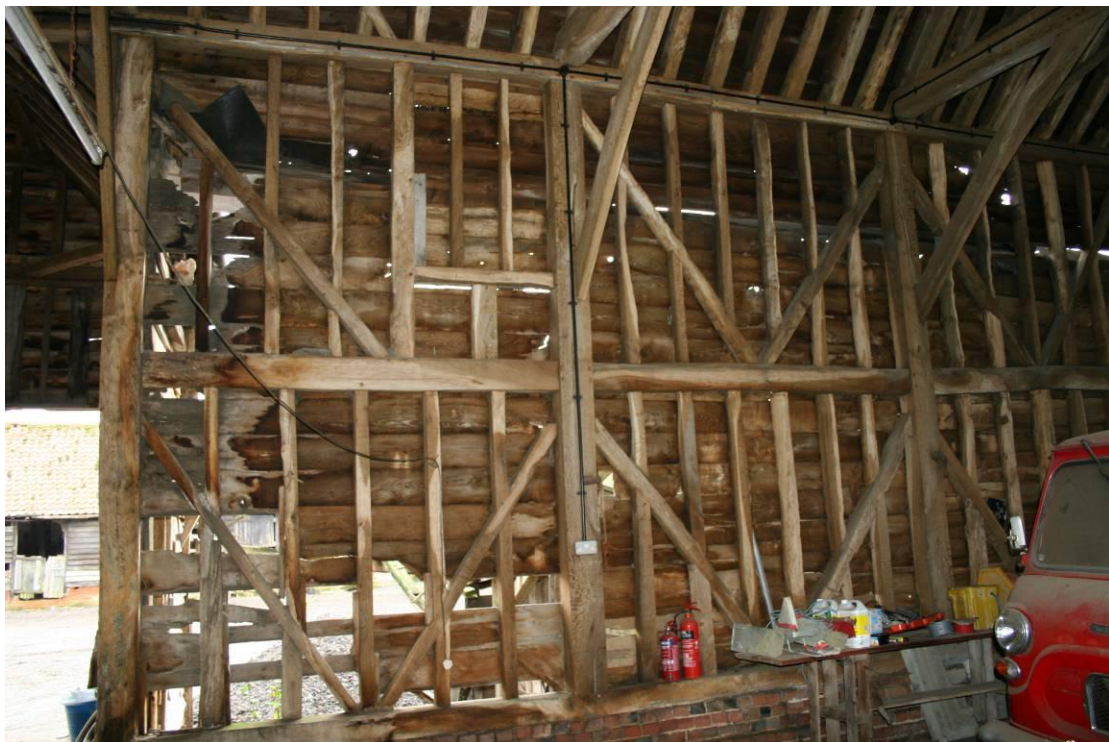
Bays 6, 7 and 8 on the south side. V braces above and below the in-line midrails.

Bays 6, 7 and 8 have V braces above and below the mid-rail which is in-line along the frame. This section also has many more $\frac{1}{4}$ poles than the rest. Bay 8 also has trimmer beam for an opening which has been boarded over with the old 12in boards. Bays 10 and 11 have only V-braces above in-line mid-rails. The eastern gable end also follows this pattern.

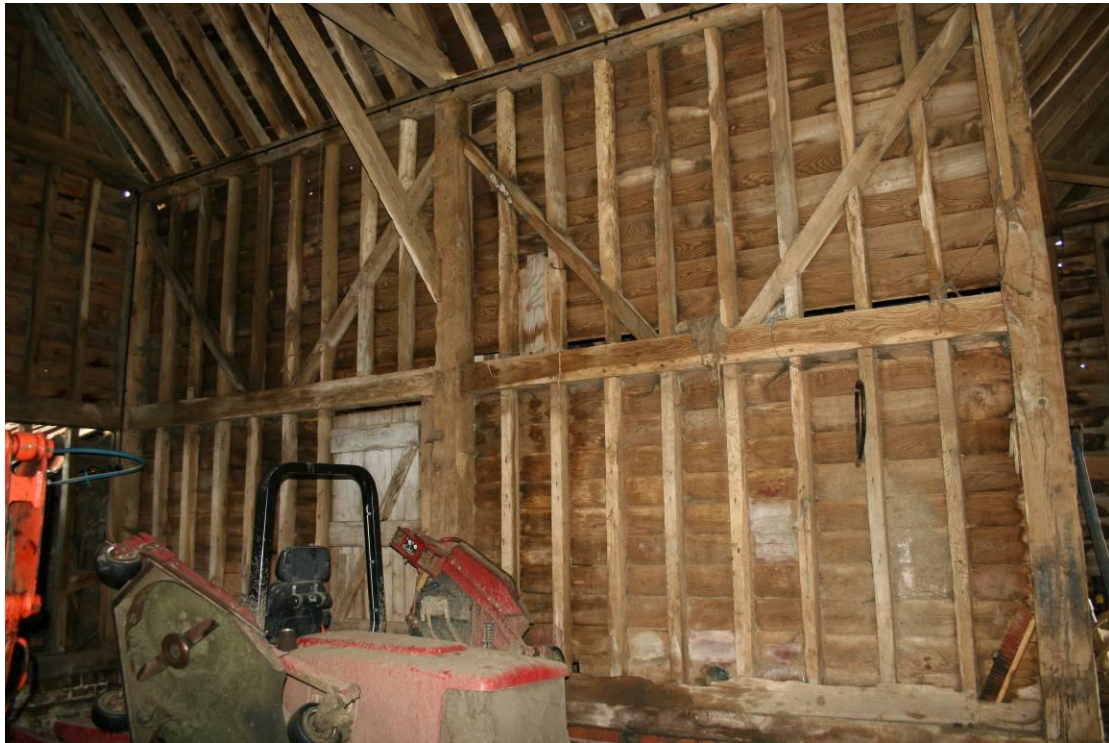
Bays 10 and 11 on the south side. Diagonal braces above the in-line mid-rail.

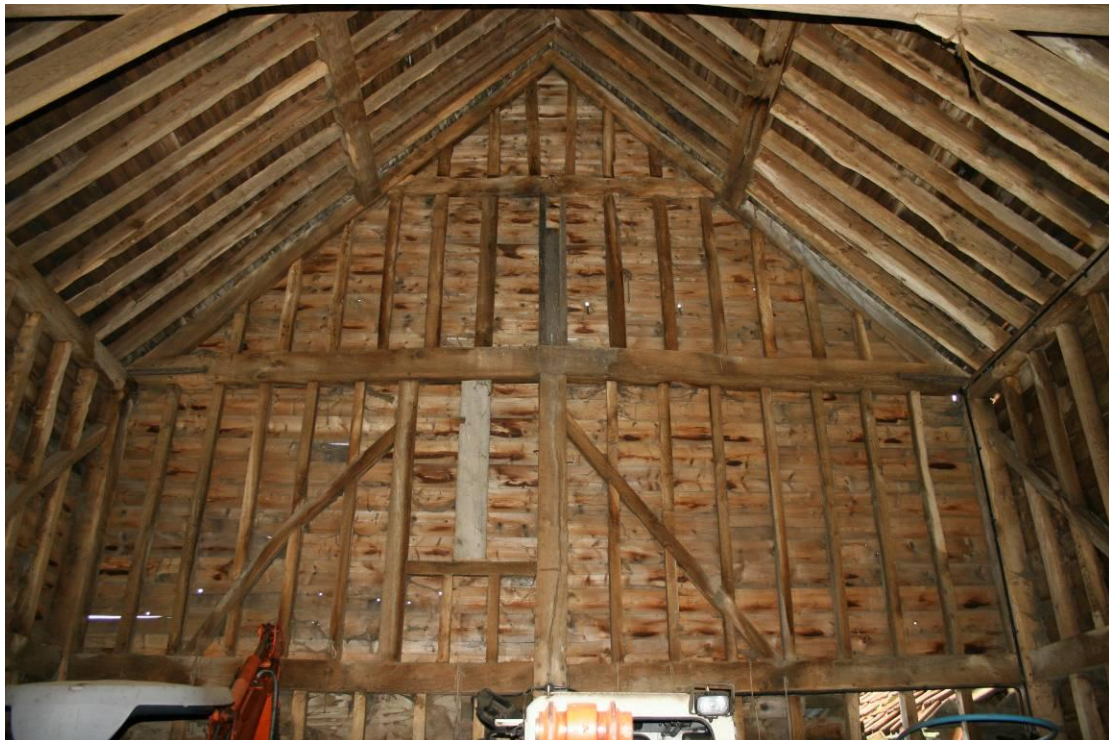
The eastern gable end has only two braces and a hatch opening only recently blocked.

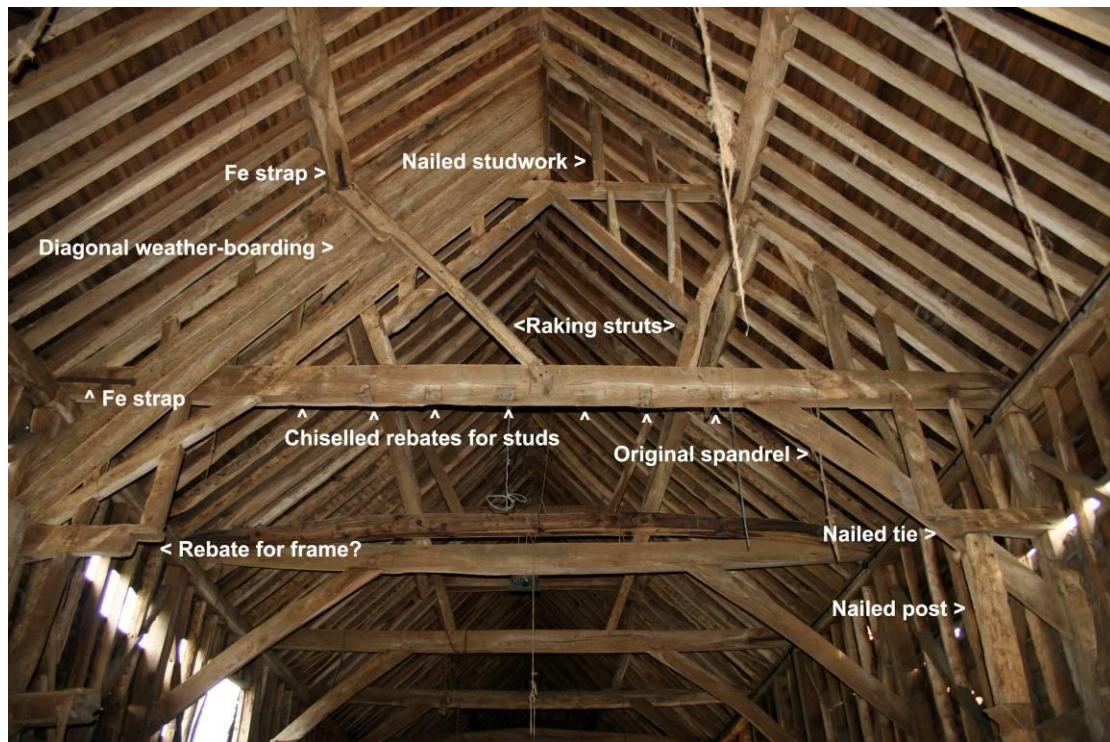
The timber partition above the plinth. Looking E.

The barn is divided by a brick plinth which is butted against the continuous plinth to the timber-frame. Made of very similar bricks and mortar it is probably contemporary with the other plinth. The framing above is quite complicated and it is suggested it represents the end wall of one of the original cells. There are a number of reasons why this is not so.

The tie-beam retains its original spandrel on the south side, the northern one being a nailed in replacement. There are no mortices in the underside of the tie-beam but rather a series of chiselled rebates to nail studwork to. The upper section (above the tie-beam) bears no resemblance to the fully framed gabled ends but rather is a construction to allow weather-boards to be nailed diagonally across the apex.

The extra weight of the structure has required reinforcement from two mismatched raking struts and the addition of strapwork to the butt purlins. Most obvious of all is that the top-plates which are fully pegged into the unjowled principal posts pass right across them.

The lower structure is reinforced with a second inner post nailed to the spandrel on the south side and one now lost on the north side. There are short horizontal struts dovetailed into the principal posts but nailed to the spandrels. These have cut-outs that suggest door or hatch frames.

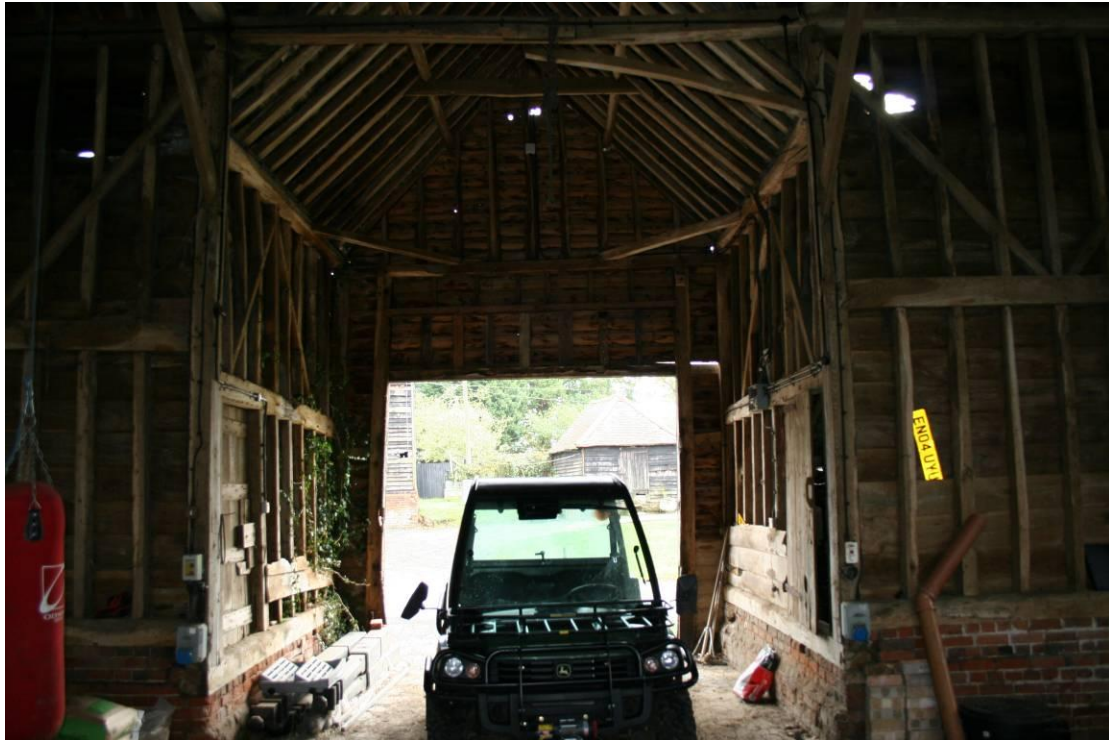
The western midstrey looking south. The original doorway has been reduced with studwork.

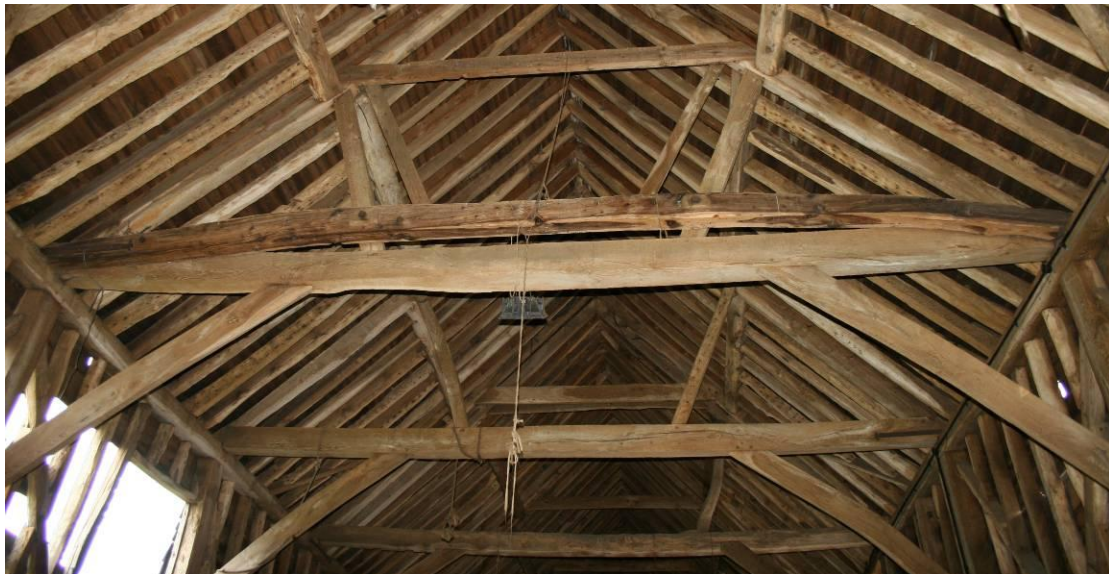
Truss 6 has an additional tie-beam bolted on. Looking E.

Trusses 5, 6 and 7 have pegged and nailed raking queen struts to support the sagging principal rafters. These are of either straight machined timbers or waney scantling. Truss 6 has an additional softwood tie-beam with a pronounced upward curve. This is bolted across the earlier raking struts and tied in with iron L-ties.
