Fristling Hall, Stock, Essex. Description and analysis of the farm buildings
at Fristling Hall. Surveyed 09 11 and 06 12 2011. CBC 10/01780/FUL.

The buildings are recorded to discharge a planning condition monitored by Essex County Council on Chelmsford Borough Council application 10/01780/FUL.

The buildings under study to EH Level 3 are:

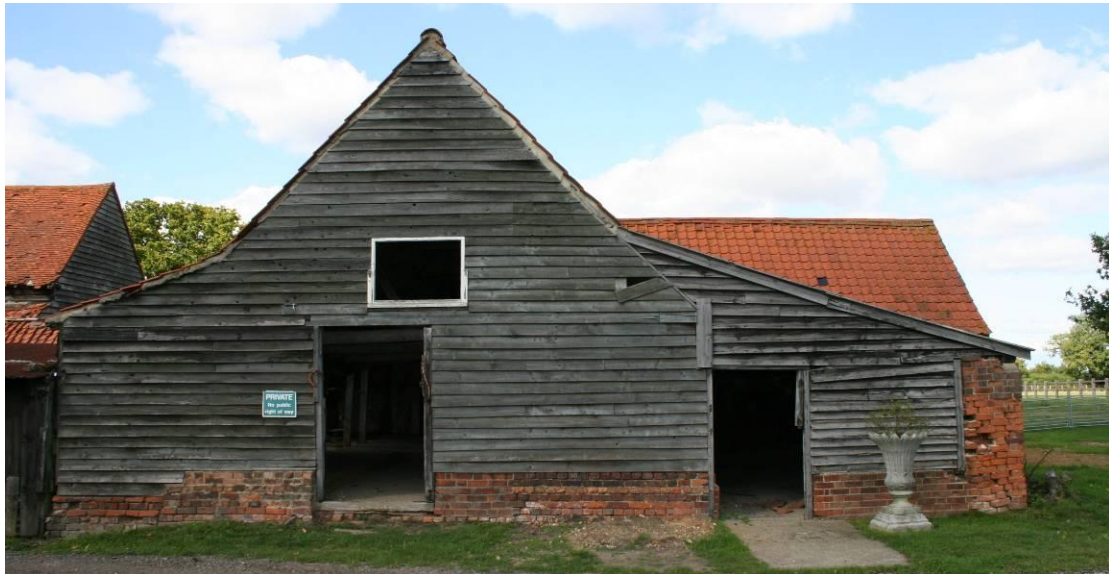
The front (south) facade of the Dairy. The building has been widened to the west and a lean-to added to the east springing off an older wall.

The extended portions have plinths of larger 70x110x225-30mm orange and purple bricks with creased faces and sharp arrises. There are a number of repairs in grey cement. The plinth indicates that the now off-centre doorway was originally central to the gable and below the C20th casement. There are queen closers to show the extent of the original build to the east but the rest has been disrupted by rebuilds.

Apart from the very top two boards at the apex all the 7in weather-boarding is LC20th fastened with French nails and long ago treated with cold brushing tar. The main roof and extension are clad with C20th style roman tiles and has a cement rendered dry verge. The extension is of corrugated asbestos with timber barge boards.

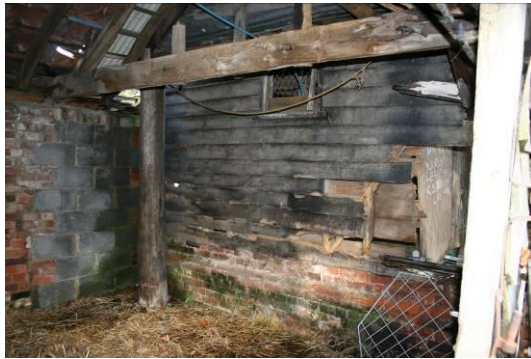
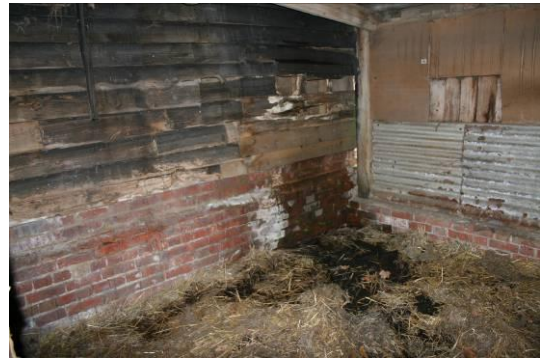
The western wall of the Dairy inside the Barn Stable (left) and the Modern Stable.

The wider tarred boards can be seen in the horse stalls inside the Barn Stable and the Modern Stable which form the Livery courtyard. The timber is in poor condition having suffered from water ingress and being chewed by bored horses. The section exposed has failed very badly and is blocked off with a variety of old gates and corrugated metal sheets. The roof of the extension is badly bowed allowing in rainwater and rotting the frame. The pitch of the roof is near flat which is very unsuitable for roman style tiles.

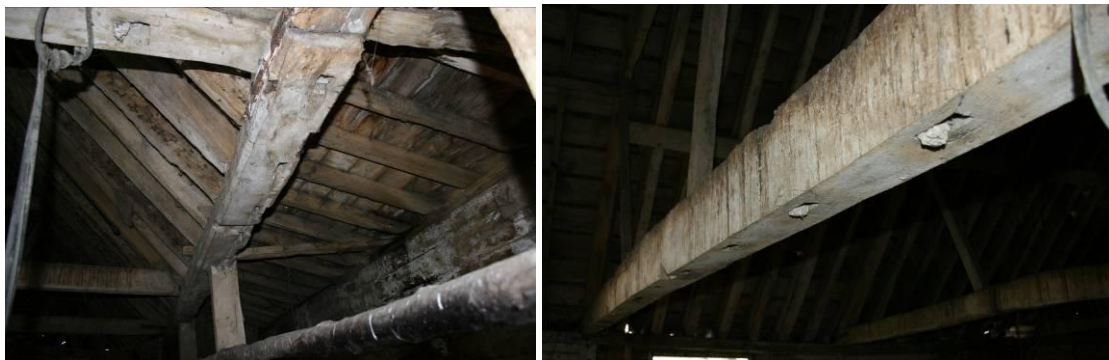
The undersides of the western plate (left) and the northern most tie-beam.

At the same time as the western wall was dismantled so was the original northern one and an extra bay added. The northernmost truss has the remains of torn out studs in its soffit matching those in the plate. There is also a wider central mortices with double pegs. The wrought ironwork securing the new bay is of the same form as the rest and so it can be concluded it was all done as one remodelling episode.

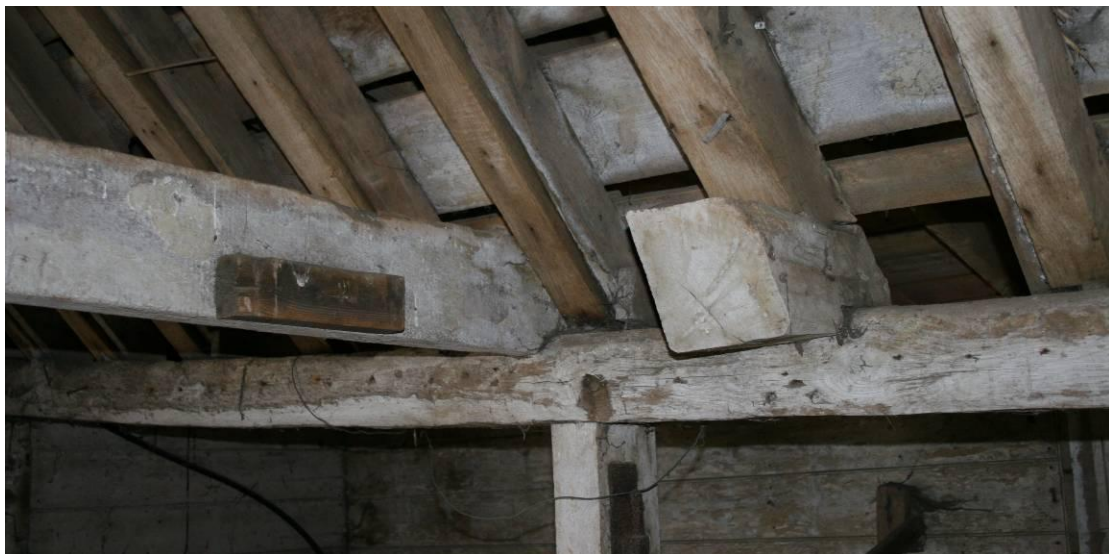
The southernmost sawn off tie-beam retains the principal rafter.

The five original tie-beams (not including the sawn off stumps) are numbered I to V (S to N) and tagged on the west side. The stumps were retained because the principal rafters are pegged into the top of them. Birds-mouthed struts have been added to support the sagging purlins.

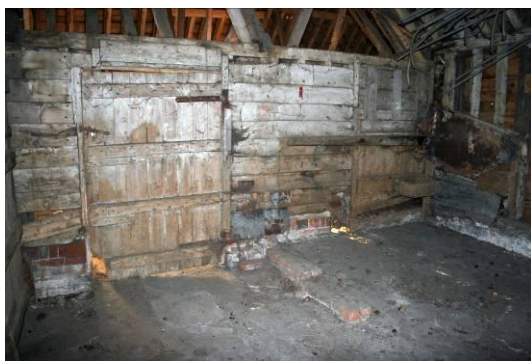
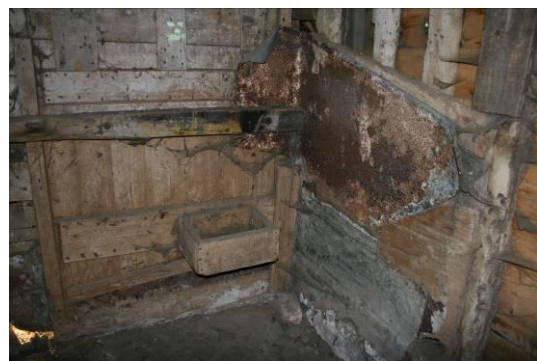
The western wall panelled as a stall with a wooden feed box in the corner.

There are sections of C20th brickwork set in cement used as noggin in the south wall and in general the interior is damaged in line with the use as a stable. There is a wooden feed box in the NW corner and the walls are patched and boarded to form a stall. There is also the base of a brick wall in the floor which corresponds with the shadows in the timberwork.

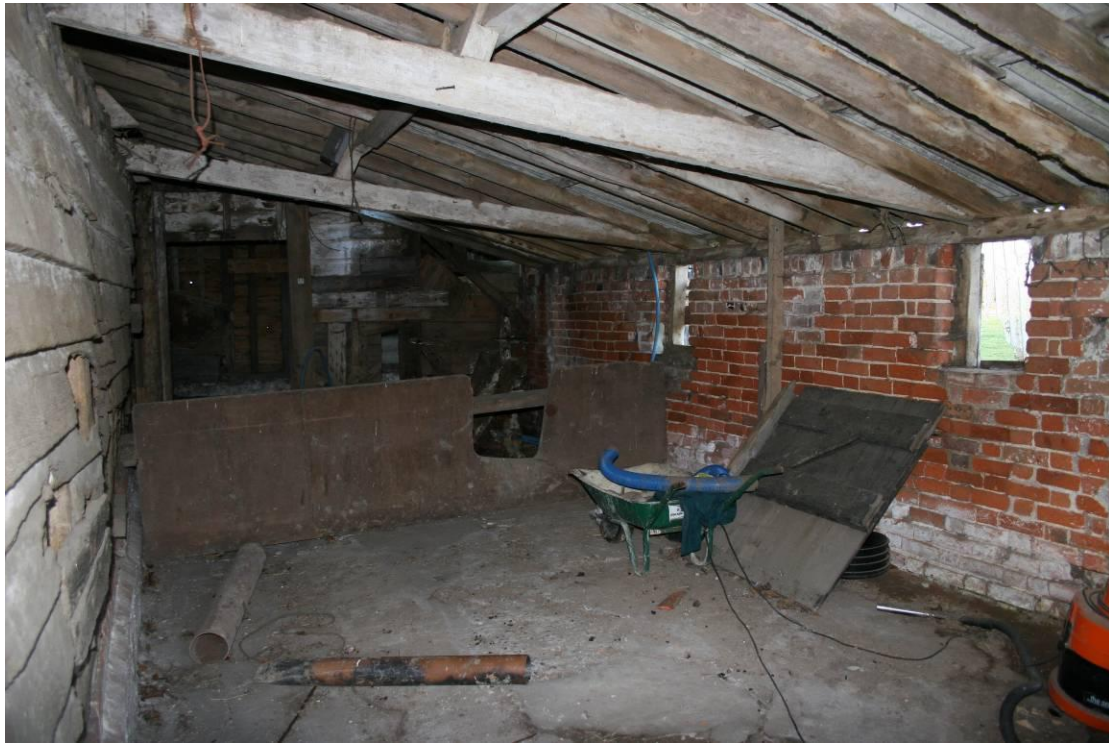
Looking N into the Dairy Outshot. Modern partition. Elm roof.

The interior has a concrete floor and very modern makeshift partitions. The west wall is clad with heavy boards and the weight of everything indicates the bulkier animals were kept here. There is a modern timber partition with a curious cut -out which is probably for entrapping sheep for treatment.

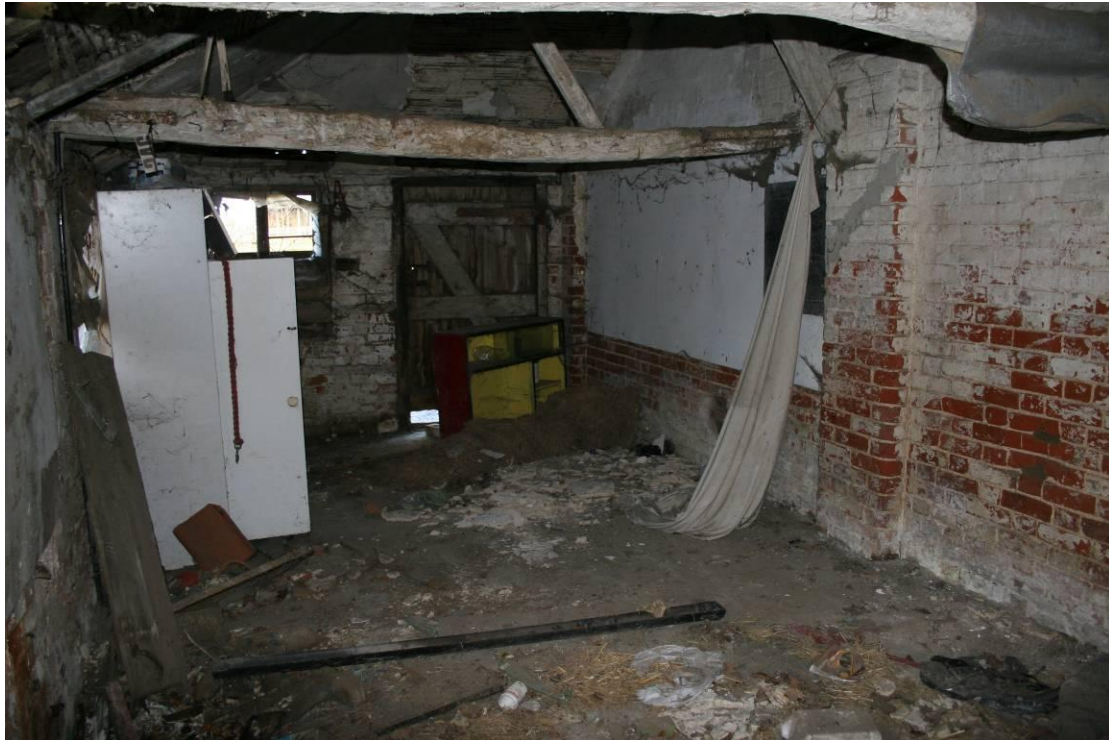
Inside the Tack Room looking E.

The interior of the Tack Room is rather derelict. The ceiling was finished with riven lath and plaster of which much has failed and the roof has badly bowed. The two elm tie-beams have raking struts to support the central purlin. There are fittings to show a horse called Jonjo was recently kept here. The LC20th cupboard and bookcase indicate this was a tack room.

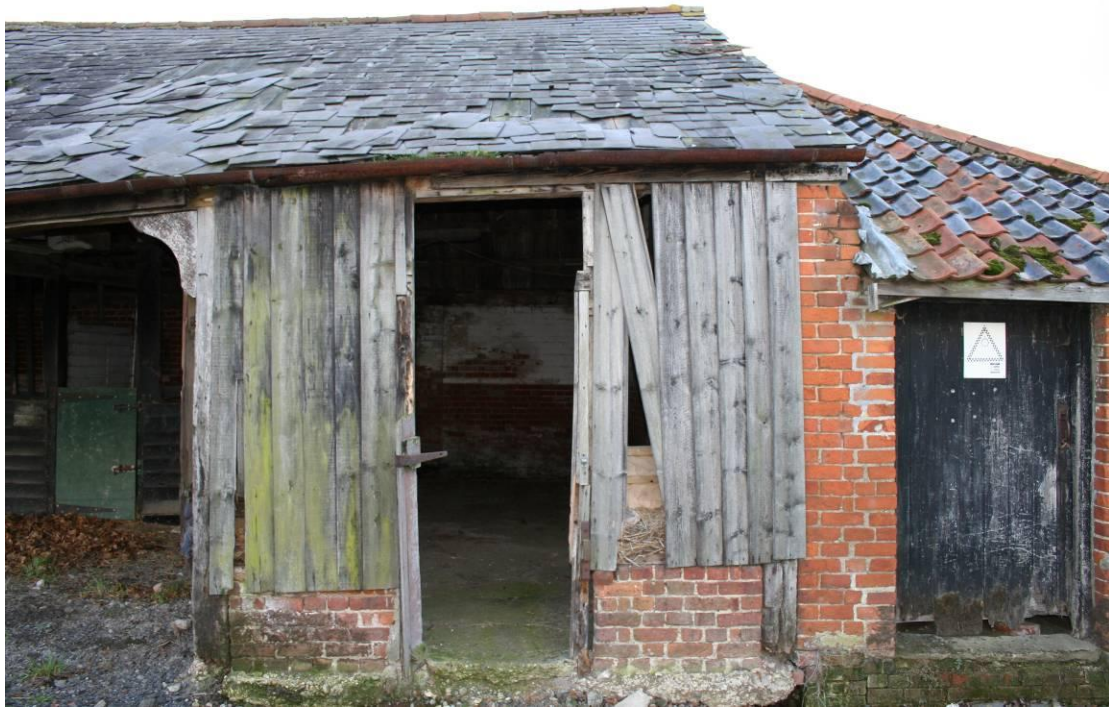
The northern bay of the Shelter is divided off with LC20th vertical boards and studwork.

The Shelter is a very large structure with three enclosing brick walls and open to the east. There are no openings in the brick wall which is built of red 65x110x225mm bricks in white mortar in Flemish bond. The interior has been divided up in the LC20th into loose boxes and the northernmost bay (of 3 bays) has been closed off with LC20th studwork and vertical boarding.

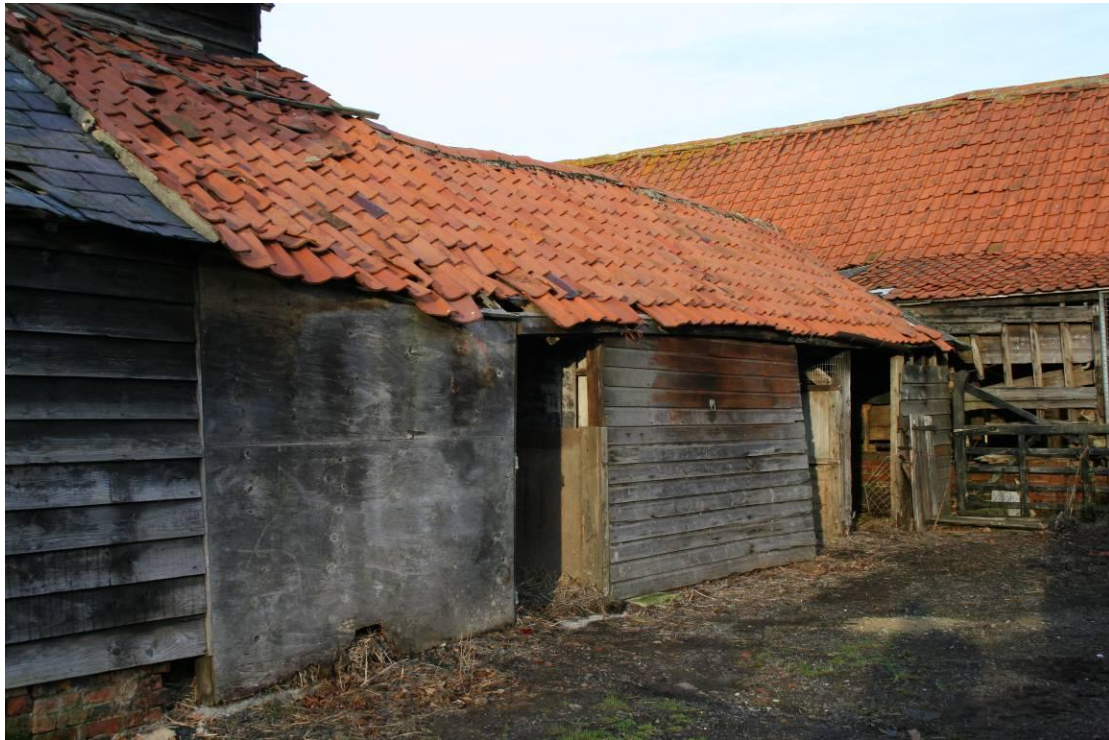
The Barn Stables was open-sided until turned into stable in the LC20th. Looking NE.

The Barn Stables is a 3 bay building with a northern wall composed of red 70x110x220-30mm bricks set in beige sandy mortar. As built it was open-sided to the south and served as a cow byre. The bays have been panelled in with a variety of LC20th salvaged materials including marine ply and tongue and grooved boards to form three horse stalls. The work is of the poorest quality.

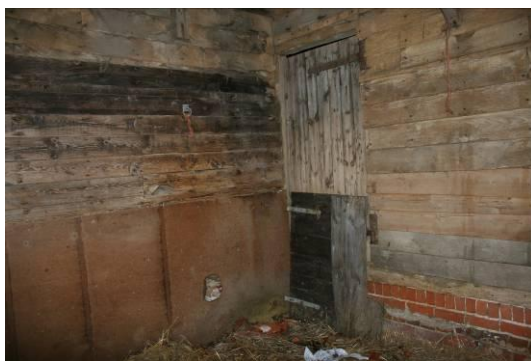
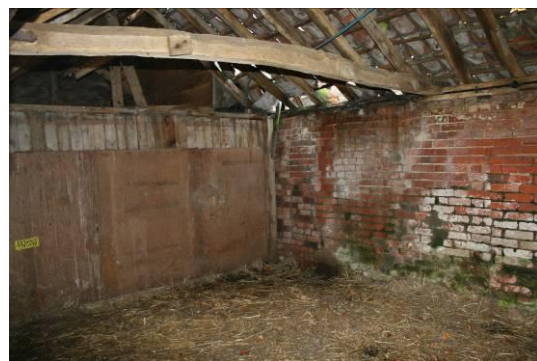
The western and central stalls. The LC20th door leads into the Double Barn. Looking NW.

The westernmost stall is formed in the crook of the Double Barn and there is a LC20th vertically boarded door into Bay 10 of the Barn. There are no other remaining doors and all the details are LC20th. The roof rests on the buttressed wall and on capitalised posts on the open side. The rafters are riven and nailed onto a ridgepiece. Unusually there are no purlins, collars or original struts. The battens are C20th but reused. The nibbed pantiles are also reused. Photo follows.

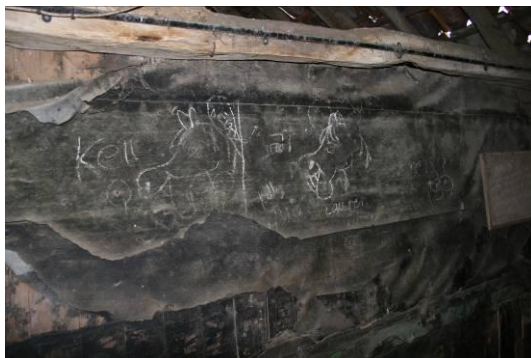
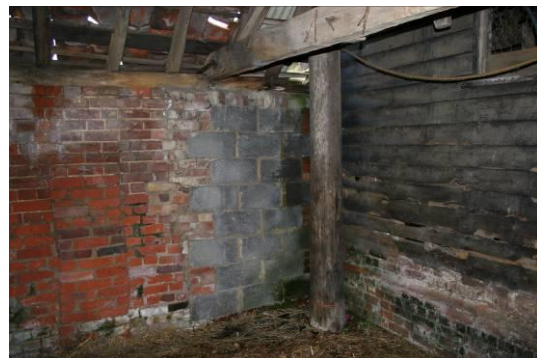
Horse graffiti in the style of Thelwell. Blocked off doorway. Both in the easternmost stall.

There is a blocked doorway in the NE corner of the easternmost stall that has been closed off with medium density blockwork and Flettons. It is likely there was a cross-walk here as the tie-beam is placed rather unnaturally away from the wall as though to form a corridor. Apart from modern galvanised tethering rings and an aluminium hoop for a feed net there are no fixtures.

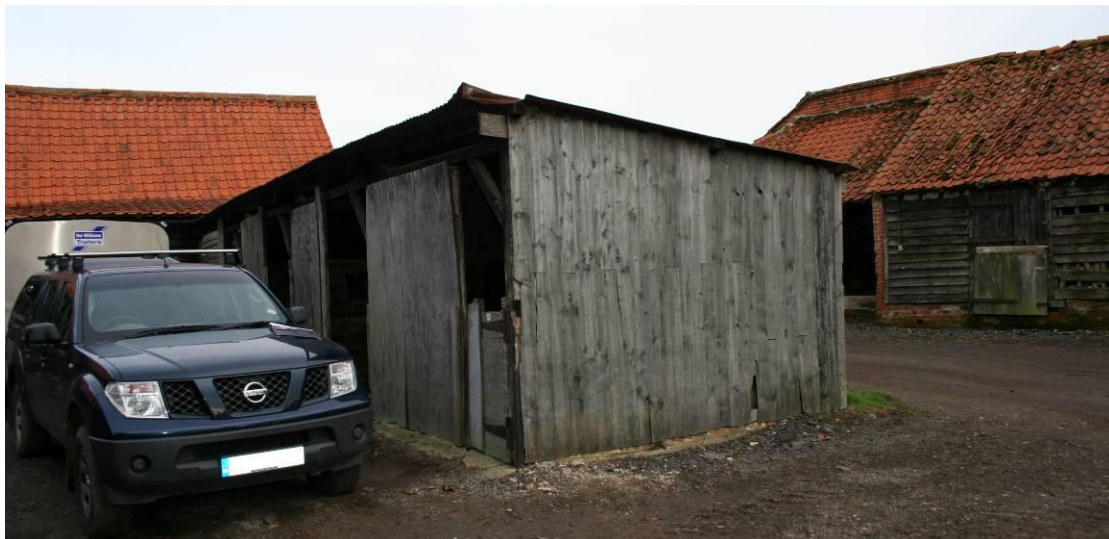
The modern stable has four stalls. Looking E.

The modern stable is a simple bolted together timber-framed building sitting a plinth of red/orange 70x110x225mm bricks set in grey cement. The exterior is clad with vertical weather-boards fixed with French nails. The roof has a slight pitch down to the south and the over-sailing corrugated iron has no gutters. The north side is clad with marine ply and the one remaining leaf of a split stable door is also of marine ply.

The stall are devoid of features and have long been out of use. There are small notices warning against tethering the horses to the building - presumably they may tear it down. The westernmost stall is still in use as a tack room but it is not a secure room as the upper door is missing.
