Havering Grove Farm, Hutton nr Brentwood, Essex.  
Description and analysis of the farmyard buildings.  
Surveyed 19 07 2011.

This report deals with the farmyard buildings that were formerly part of Ellis's Farm and are now under conversion to residential use. Planning app. no: Brentwood Borough Council - BRW/0265/09 and BRW/0278/11. The buildings were recorded to report at RCHME Level 2.

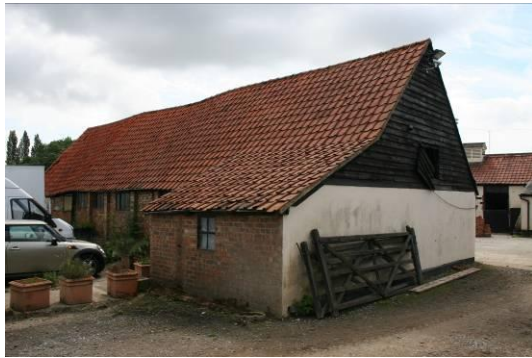
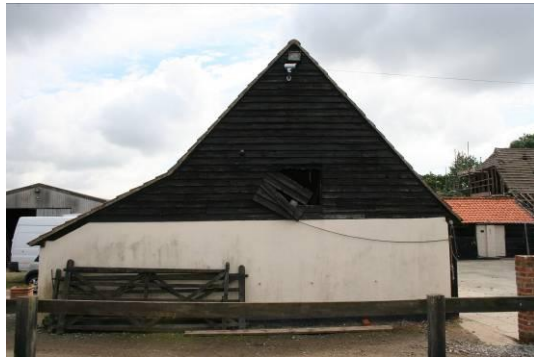
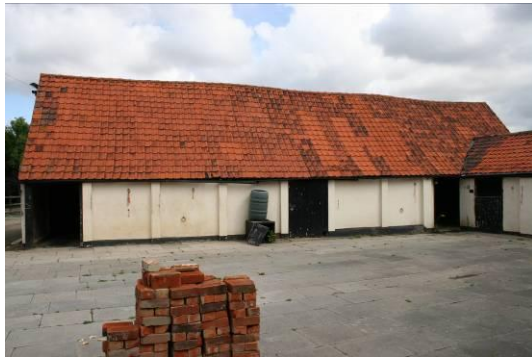
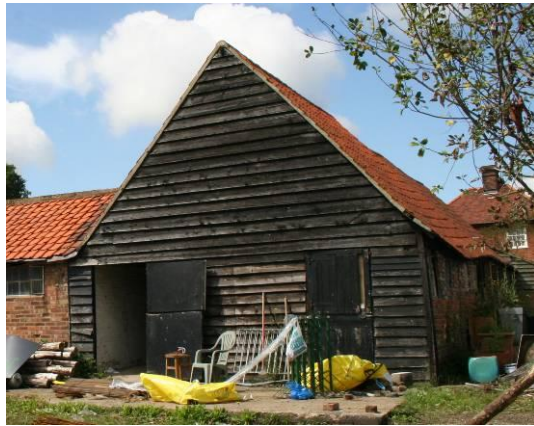
The N, W, S and E elevations of the North Stables.

The North Stables consists of a 6 bay E-W oriented range with a small brick outshut on the NW corner all roofed with C20th single roman clay tiles. Originally the building was open on the north and south sides but the walls have been under-built in flettons and textured engineering bricks set in grey cement. The east and west gabled ends are clad in C20th weather-boards over scantling studwork frames and the lower part of the western elevation is built in flettons on a low plinth of soft red bricks.

The west and south elevations have been rendered in hard cement and painted. The metal plastering beads can be seen on the corners and this would have been done in the 1975 refit.

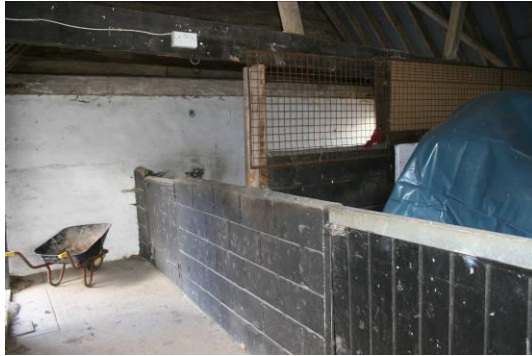
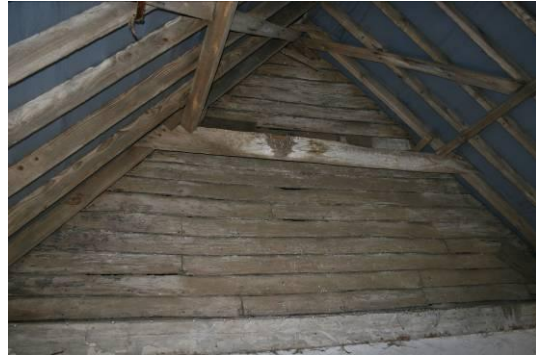
The eastern bay showing the stalls and the weather-boards on the partition. Looking NW.

The easternmost bays have been divided with medium density blockwork and modern timber and wire grille partitions into two large stalls. There are two entrances from the east and another from the south. This allows the horses to be walked through the building from the yard into the eastern field.

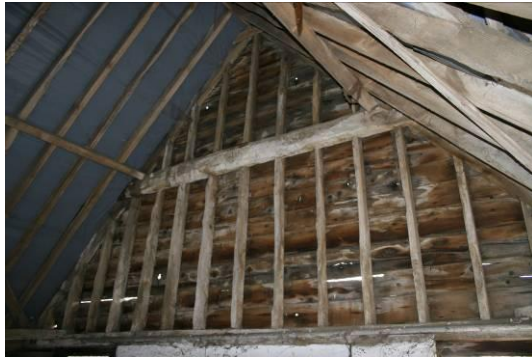
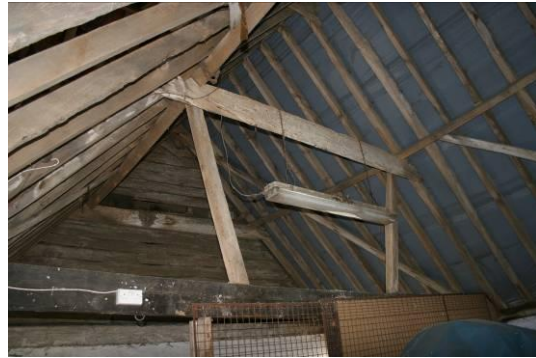
The eastern gable and the roof structure above the stalls. Looking NE and NW.

The eastern wall is composed of sawn quarter poles clad in C20th weather-boards and the lower section is reinforced with blockwork. The western wall is clad with C19th weatherboards above the tie-beam and modern blockwork below.

The roof is a simple clasped side purlin design with raking queen struts off the tie-beam to the purlins. The roof has been recently reroofed and a blue plastic membrane inserted as well as a number of modern sawn softwood timbers. Most of the rafters are machine sawn but there are a few quarter poles. The roughly sawn collars are lapped and heavily nailed.

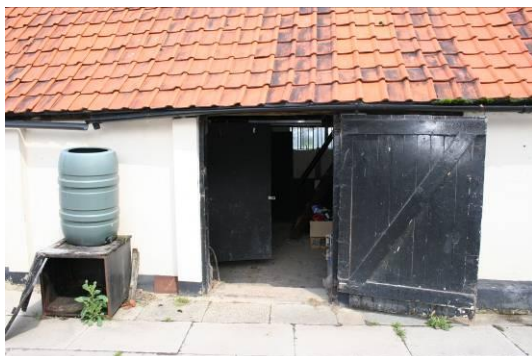
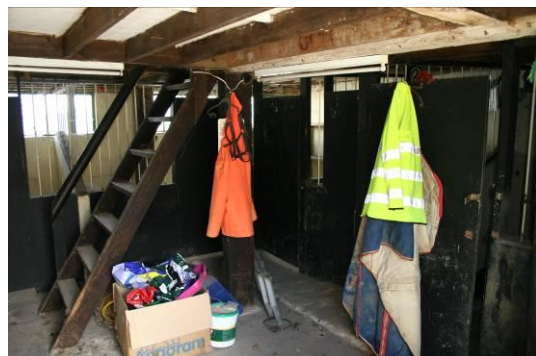
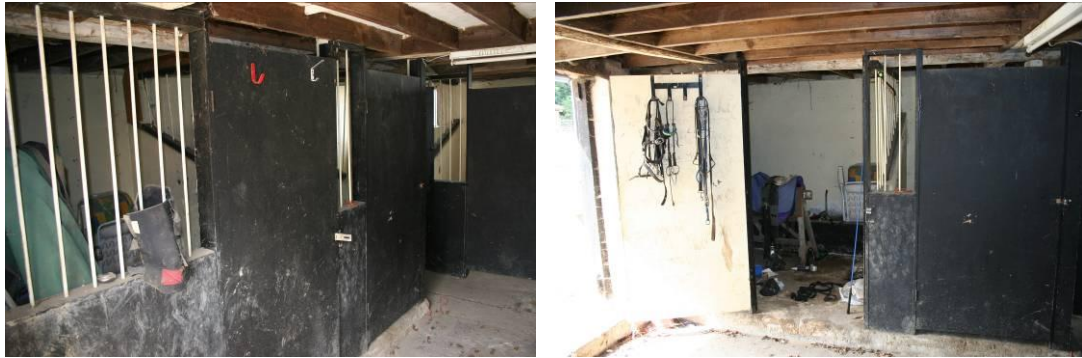
The central bay has been converted into a secure store with loft above. Looking NW and W.

The two central bays have been converted from pig pens to discrete lockable stores for riders to stow their harness and gear safely. The pens are divided by brick partitions and each has a low-level poured concrete trough and a sliding tether rail close to the ground. Each pen has then been made secure with mild steel bars and marine ply doors.

On the wall of each pen is a saddle tree and a set of harness hooks. In the SE corner pen is a tall steel cabinet and some fixed shelving. The room is not currently in use and it is obvious from the damp and spiders webs that much of the tack and clothing has been abandoned. It is understood that only two very old horses belonging to the owner's family are kept on site at present.

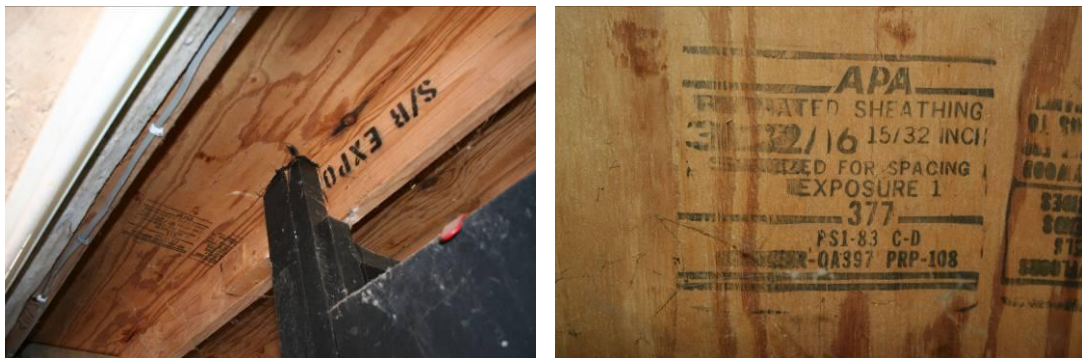
The present loft is LC20th made of recycled packing and breathable sheathing.

There is an inserted loft floor made of treated softwood joists and batch marked ply board stamped 'APA Perforated Sheathing 15/36'. The joists appear to be recycled from large packing crates.

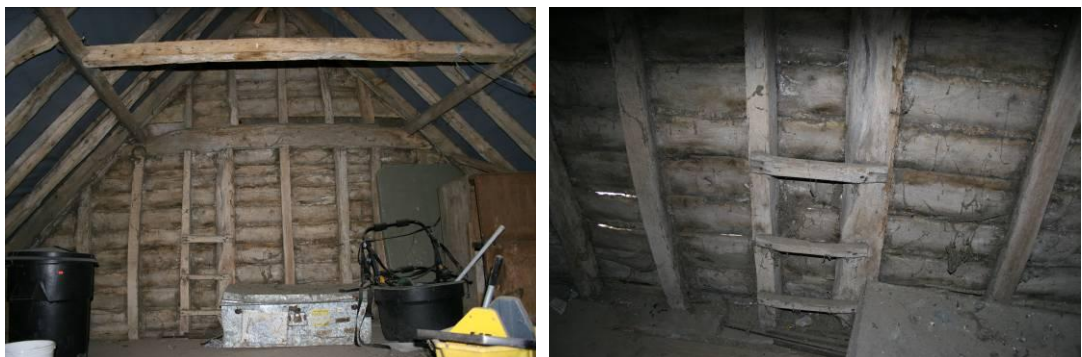
Timber framed eastern wall and C19th batten loft ladder.

Although the loft is obviously modern it replaces an older one whose presence is marked by a nailed batten loft ladder on the eastern wall frame (common with the Eastern Bay). In the opposite wall is a small hatch hung on wrought iron T-strap hinges with spoon terminals.

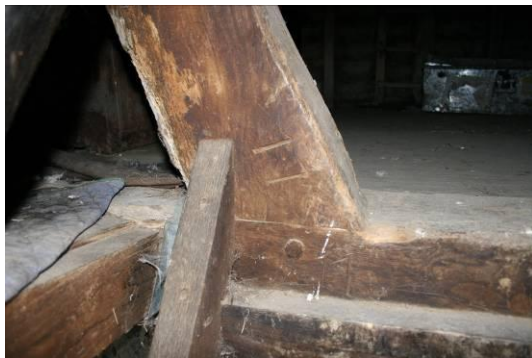
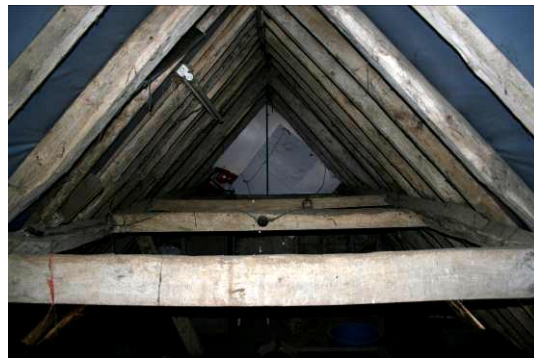
Carpenter's mark on the raking strut. Birds-mouthed struts reinforce the roof structure.

The roof is similar to that on the eastern Bay with raking queen posts supporting the clasped side purlins. The central tie-beam appears reused and the northern raking strut is heavier and squarer than all the other timbers and is marked II with a bolster to match a mark on the tie-beam. The collars are tenoned in and the weight further taken up by inserted birds-mouthed struts to prevent the roof from sagging. The rafters are pit sawn scantling with a principal rafter constituting a true truss. There is also a blue membrane under the battens.

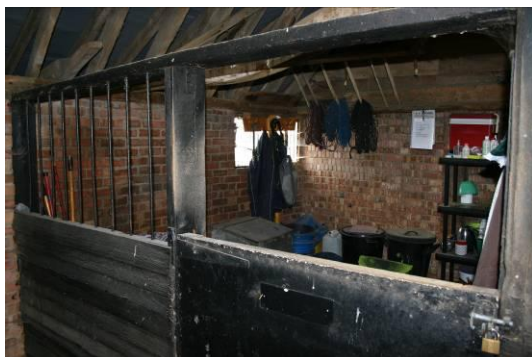
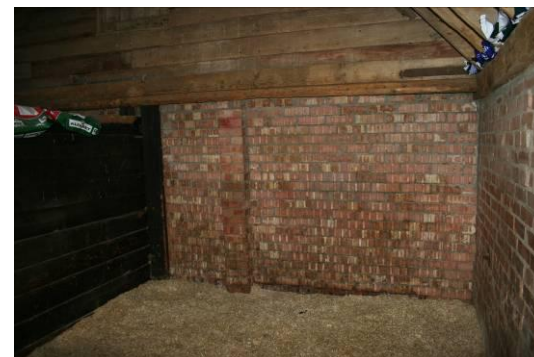
Modern partitions form two stables north and south.

The western room is also two bays and is divided axially using heavy beams to form two stalls. Inside the flettons and engineering bricks are clearly visible. There is a remnant of a timber hay rack in the NE corner above which the partition is clad with aged weather boards.

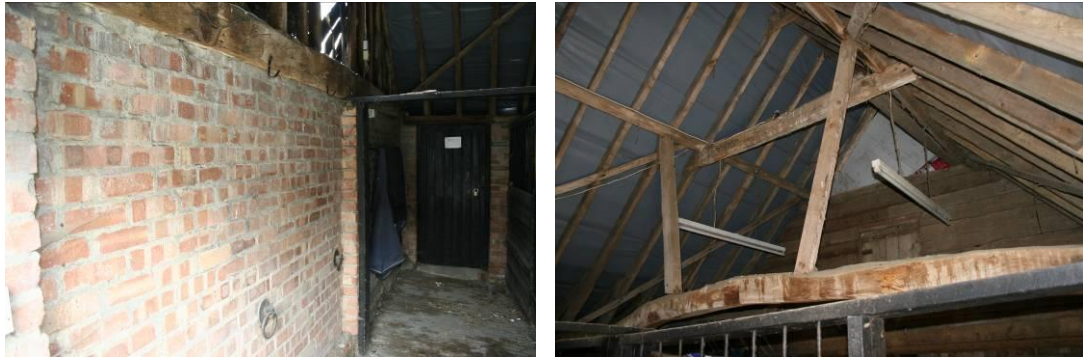
Corridor leads to northern outshut. Side purlin roof similar to the eastern bays.

The partitions and steel grille match those in the central bays and are from the 1975 refit. A corridor has been created leading to the northern outshut which is used as a secure store for the harness and tack belonging to 'Star' the horse who is currently stabled here. All the floors are concrete except for a small section of 55-50x110x230mm yellow paviors in the corridor which have been repaired at the threshold with larger much worn bricks.

The roof structure is similar to that in the east bay with side purlins clasped in lapped and nailed collars. There are two raking struts from the tie-beam to the purlins and no principal rafters. The tie-beams are secured with wrought iron ties although those on the central tie-beam are heavily rusted and may be mild steel.

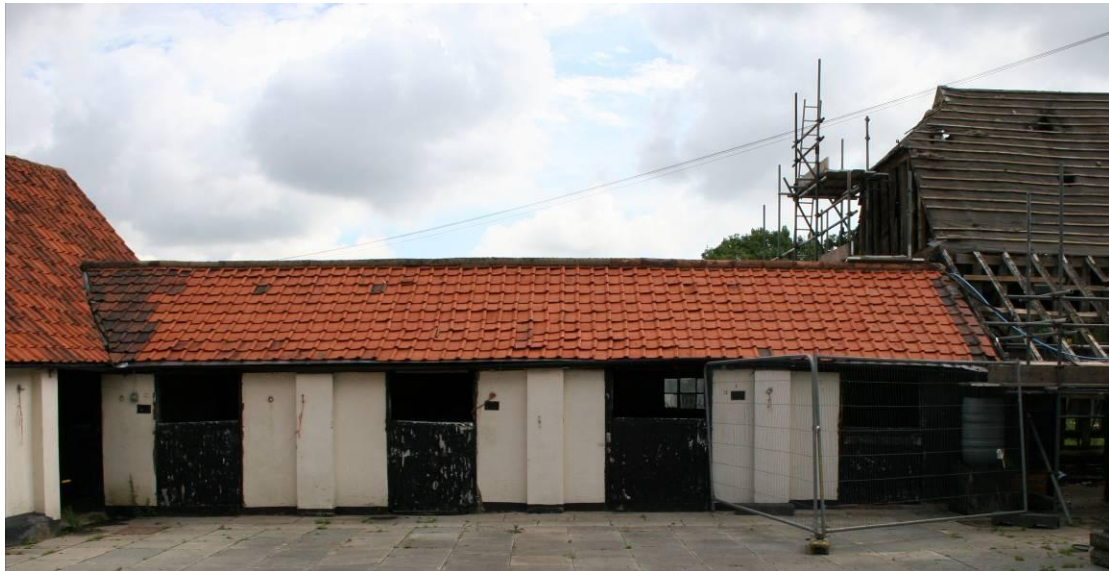
West elevation facing into the yard.

The East Stables is position N-S linking the North Stables to Barn and its western outshot. It is very similar to the north Stables being a previously open timber framed building that has been underbuilt in flettons and textured engineering bricks. The roof is clad in single roman clay tiles. The western elevation has been rebuilt in rendered brickwork to create four stables divided by blockwork. The doors are all LC20th softwood pattern split doors hung on reversible hinges.

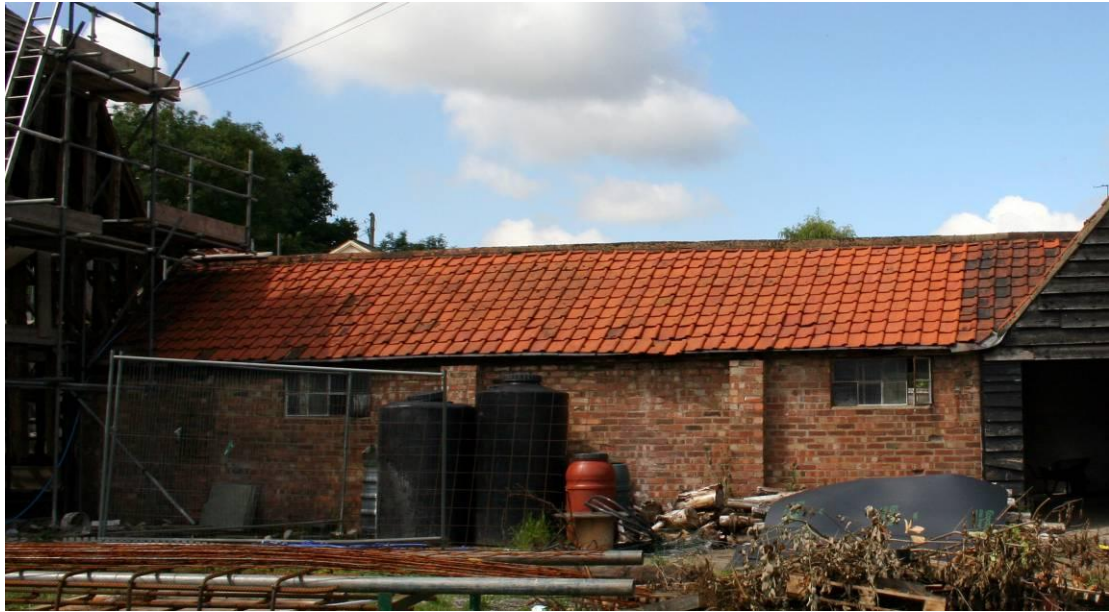
Eastern elevation of the east Stables.

The eastern elevation has been left unrendered and is made of textured engineering bricks. Each elevation has full height buttress reinforcing the single skin walls. There are two rolled steel casement windows each with 8 lights.

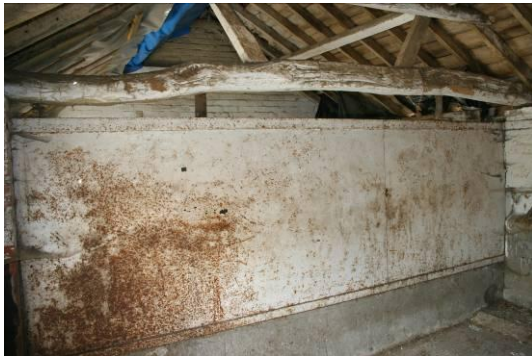
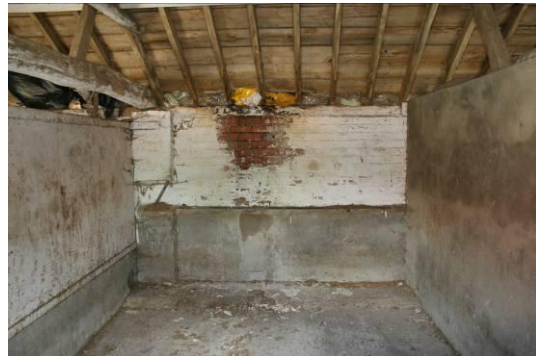
Stalls 1 and 2 (from the N) are separated with a steel sheet.

The inside is divided into four featureless stalls divided by textured celcon block except for between the 1<sup>st</sup> and 2<sup>nd</sup> from the north. These are divided by two large steel sheets painted white. Possibly an exceptional fractious horse was kept in the first stall. The partitions are positioned partially across the windows so that they are lit except Stall 3. There is a bricked up doorway in Stall 4 that original went into the Barn.

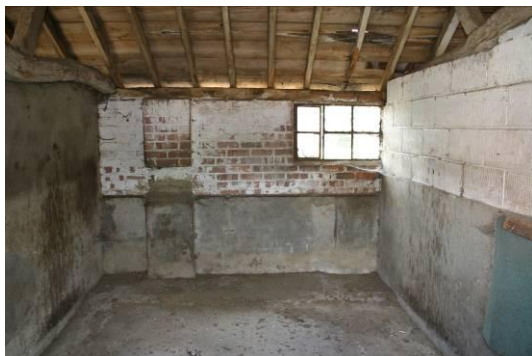
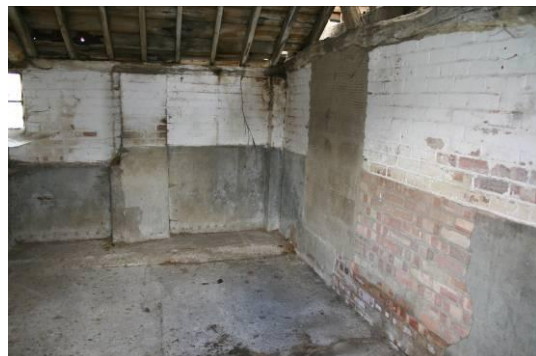
Stall 3 is typical of the internal space. Stall 4 has a blocked door into the Barn.

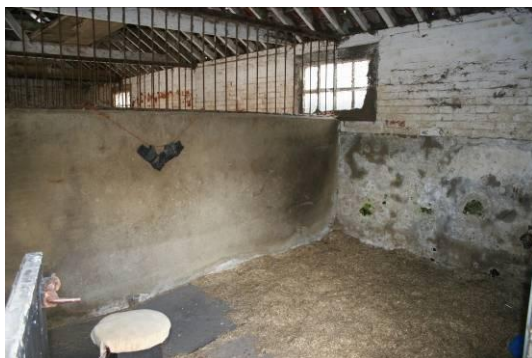
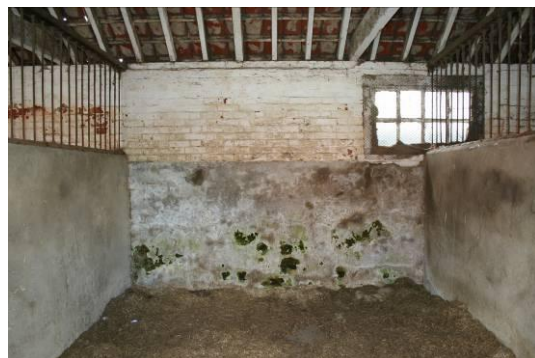
Stalls 1 and 2 (from the west) have blockwork partitions.

Four stalls have been created by inserting blockwork partitions with mild steel grilles above to separate the horses but provide light through the windows. The blockwork and lower parts of the external brickwork were rendered with hard cement.

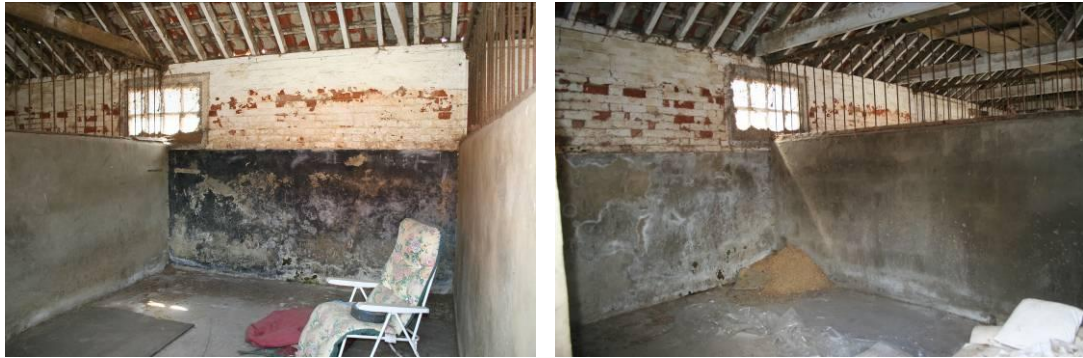
Stalls 3 and 4. All the stalls are featureless without fixings.

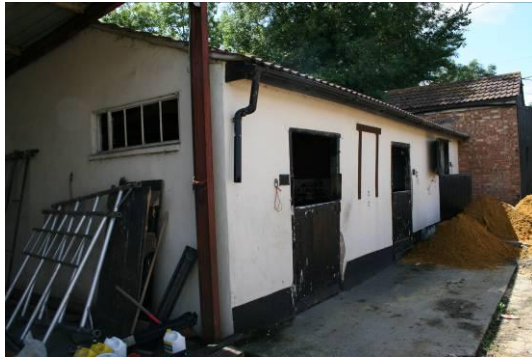
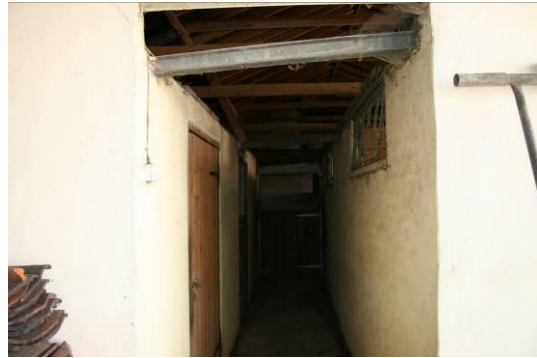
East elevation obscured at time of survey. Passageway between former buildings.

In the eastern elevation there is a passageway allowing entrance to a store and another stable at the rear and it is here that it can be seen that there were originally three C20th buildings. Part of the asbestos roof remains embedded in the top of the SE stall. There are a rolled steel 5 pane casements that define the earlier larger building set in the rear and flanks of the stalls and it is apparent that the gap between this and the garage was only recently filled in.

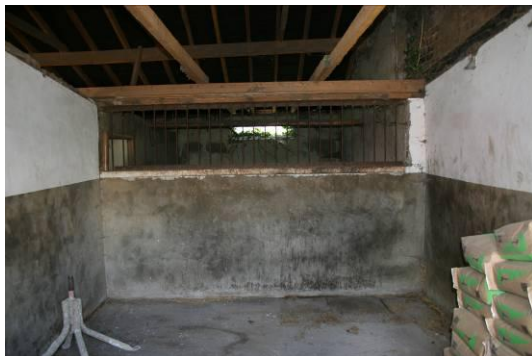
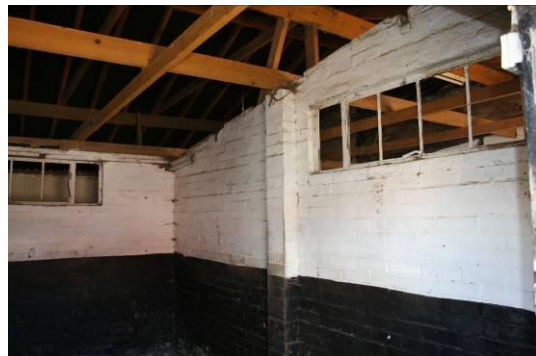
Stalls 1 and 2 (from the west). Windows in Stall 2 define an earlier mono-pitched building.

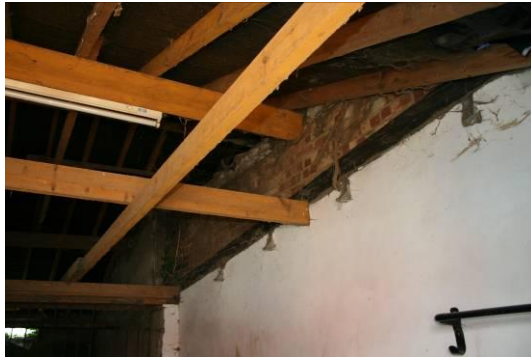
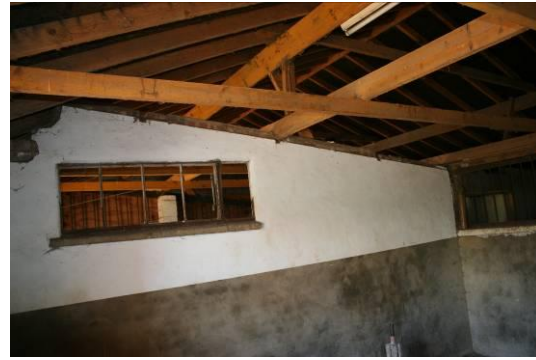
The modern roof is housed in the garage wall. Earlier roof held on steel joist hangers. Stall 1.

In the side of the garage are modern steel joist hangers for the previous mono-pitch roof between the Garage and Stall 2 showing it was also a LC20th addition.

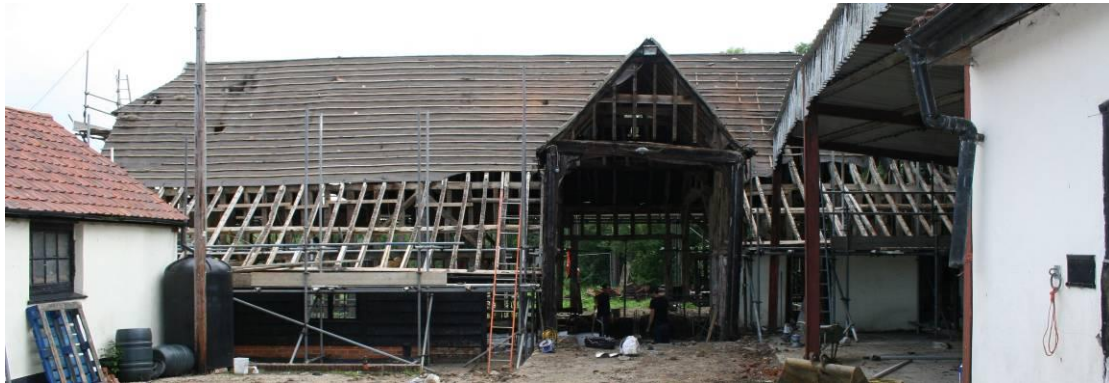
Western elevation.

At the time of the survey the Barn had been stripped of its weather-boarding and roof tiles and shored with a scaffolding armature to prevent further collapse of the frame. Historic photographs (see later section) showed that the frame has been previously sheathed with internal boards to try to arrest its collapse. The floor had also been excavated out and a suspended concrete 'Clayformer' floor was being constructed on piles.

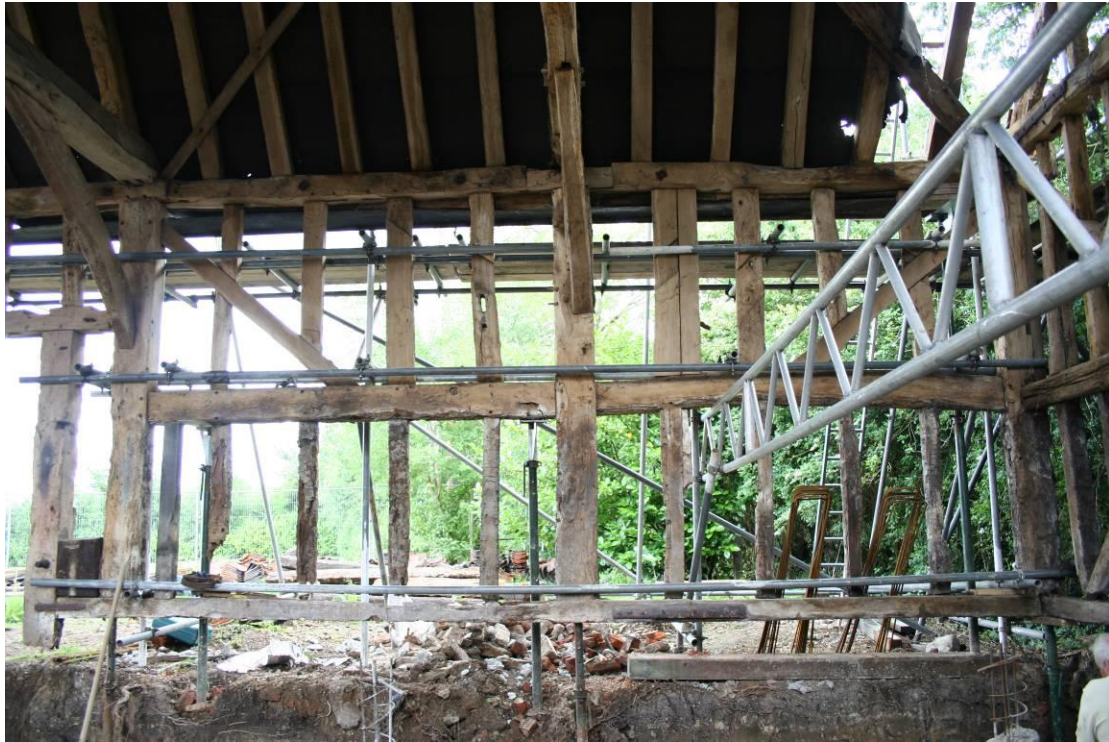
Bays 6 and 7 looking east.

The barn was stripped of its cladding and windows, roof tiles and battens prior to its conversion. This may seem premature but the historic photographs clearly demonstrate that all this was part of a LC20th conversion and that any original cladding material was lost then. The frame is in remarkable sound condition except for some of the sole plates and rotted off studwork on the south and west sides and most can be retained. New oak can replace the reused oak now lost from the frame.

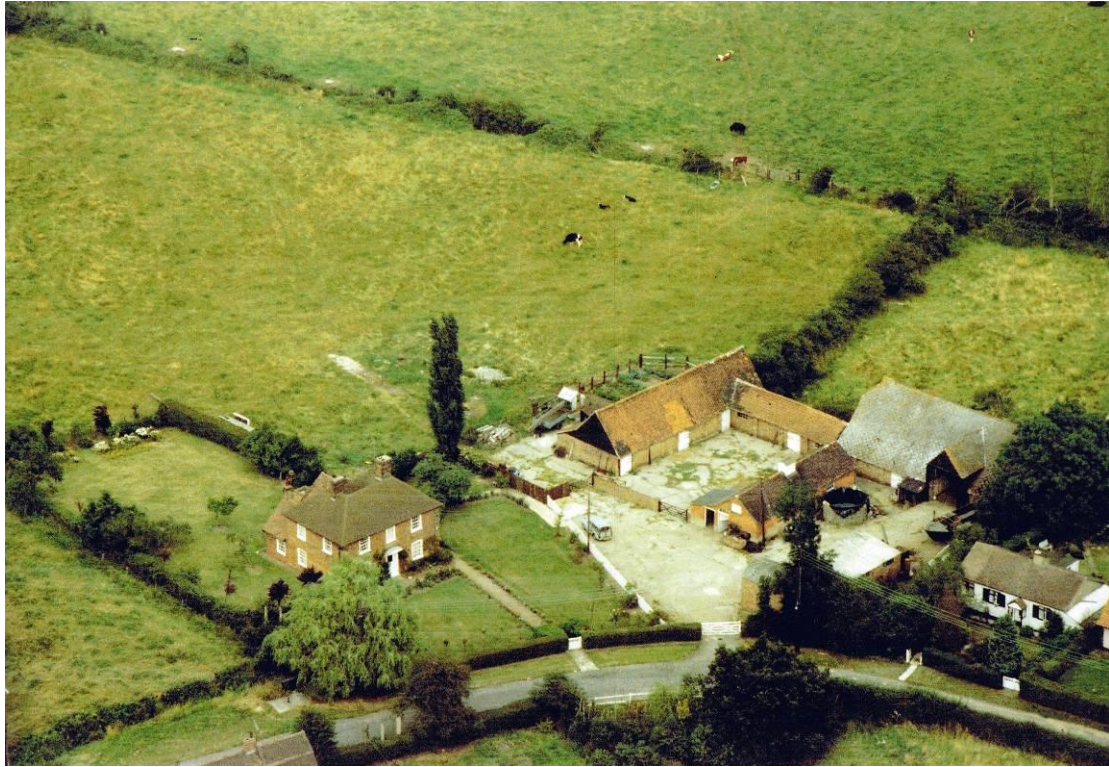
**Late 1960's. Post 1967. From the SW.**

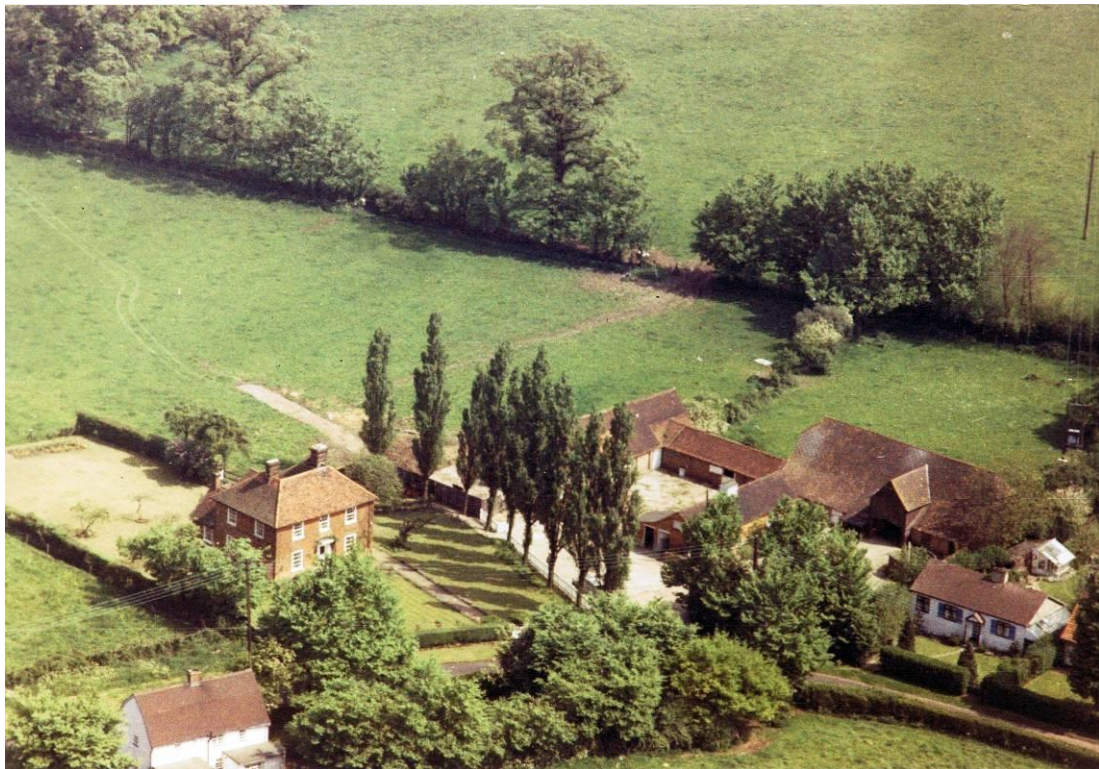
**C.1980. From the SW. Note the much larger trees.**

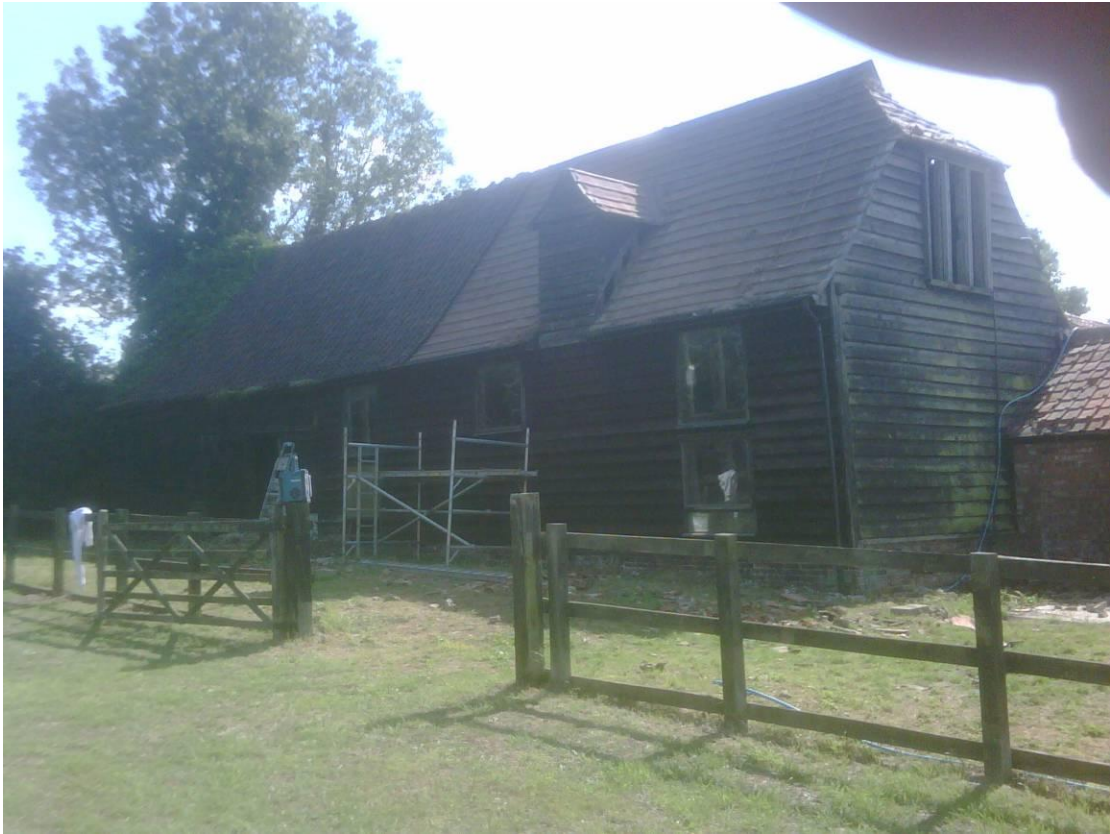
**The east side of the Barn in 2011.**

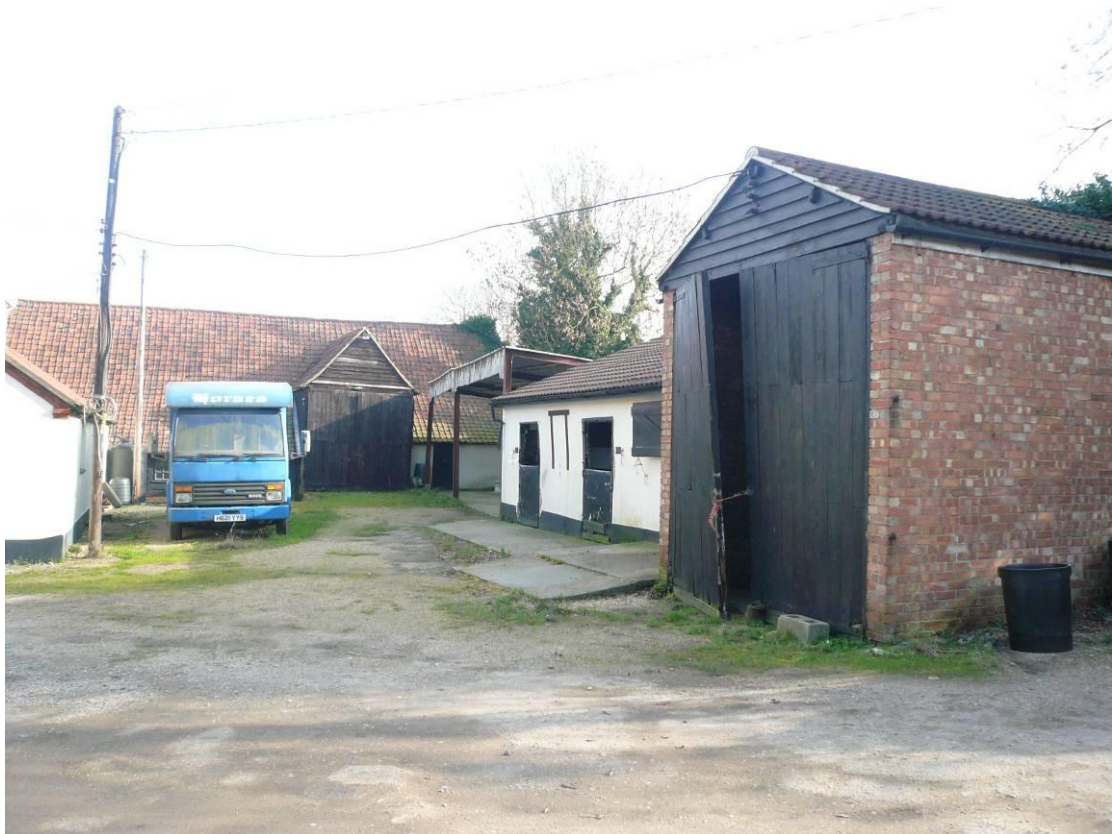
**The west side of the Barn in 2011.**

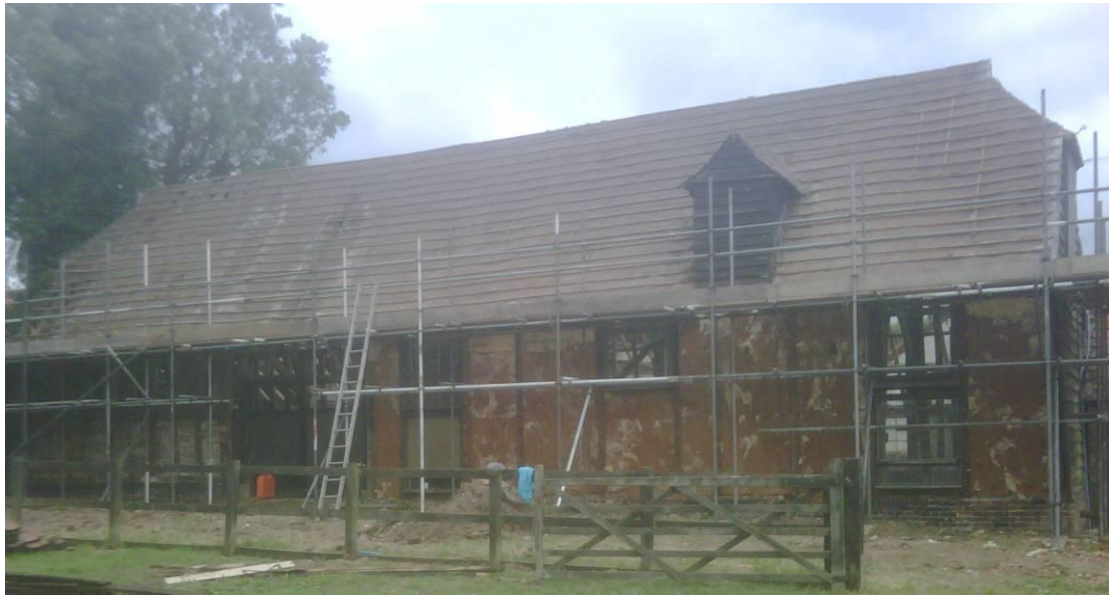
**East side of the Barn in 2011 showing previous LC20th sheathing.**

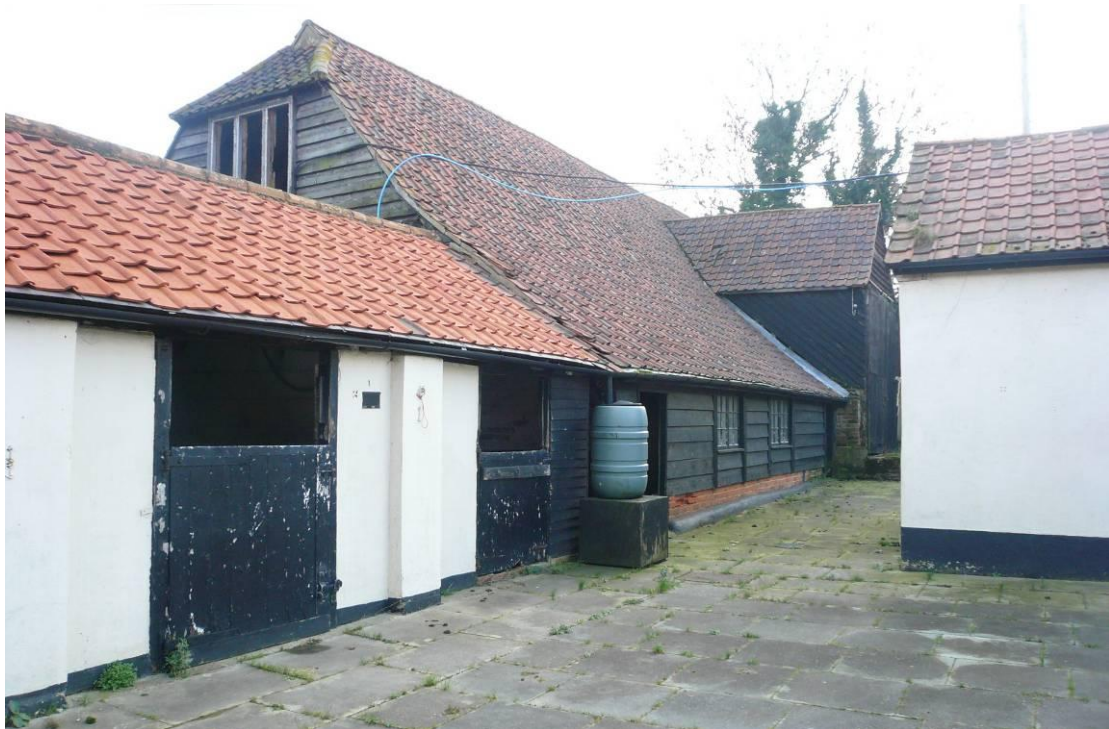
**West side of the Barn with outshots. 2011.**
