Ken Browns Garage, 42-44 Potter Street, Harlow, Essex.
Description and analysis of the timber-frame contained within the
Maintenance Workshop. Surveyed 06 10 2011.

| Type of Work: Historic Building Recording | Site Director/Team: Barry Hillman-Crouch |

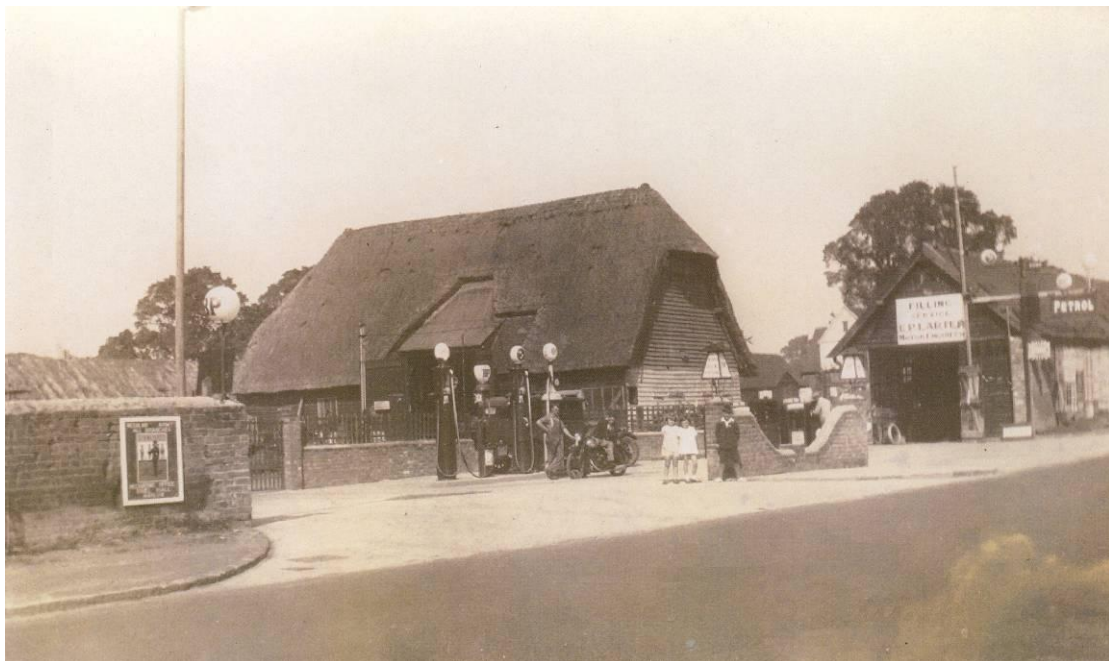
The barn in the EC20th. The electric lights, pumps and motorcycles suggest the 1920's - 30's.

The Maintenance Garage was previously a thatched aisled barn and is clearly shown in a photograph kindly provided by Mick Taylor, a Senior Technician who has worked at the garage for over 40 years. The photograph, although undated can be attributed to the 1920's or 30's by the style of the fuel pumps, the typography of the signs and the presence of electric lights. At that time the garage was run by E.P. Larter.

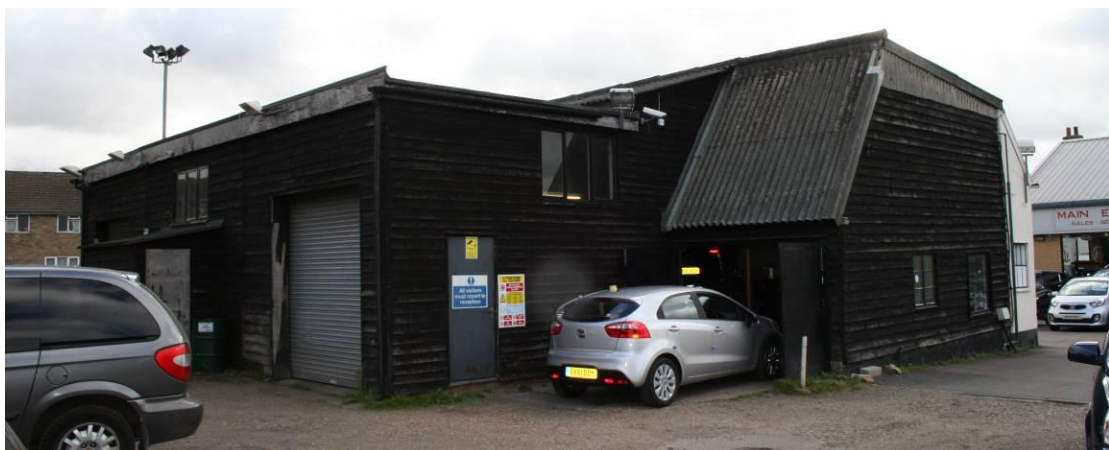
Oblique view of the rear of the building.

There are three extended bays to the rear of the building. It is known the central one was built first and the other two added later (Mick Taylor - pers comm.). They are all LC20th however and constructed from Celcon blocks.

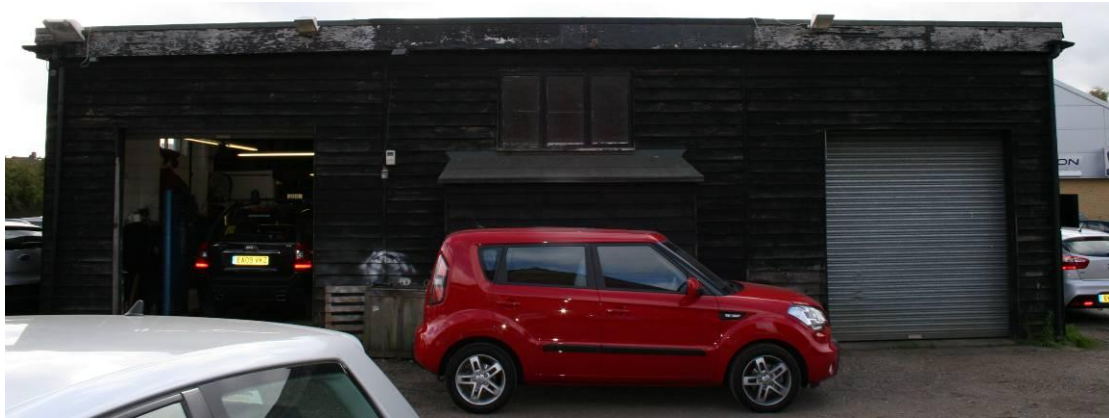
Northern Elevation

The rear of the building has three maintenance bays.

The northern elevation has the three extended bays. The central one has a small secured outshut with a L20th light weight hollow door in parlous condition on the western side. This bay is accessed from inside the building.

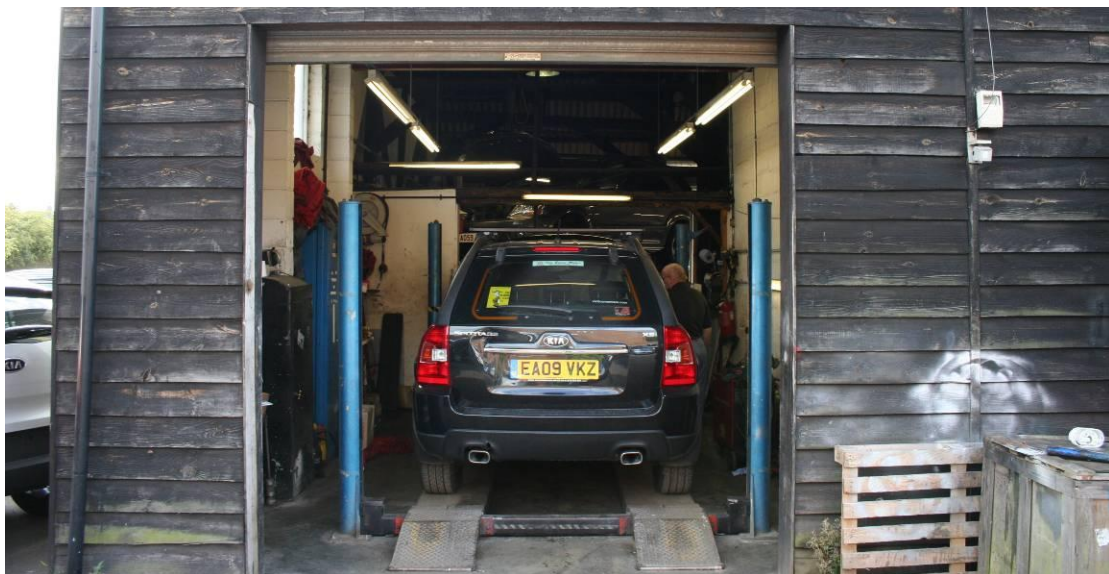
All the bays contain hydraulic lifts. Easternmost bay looking S.

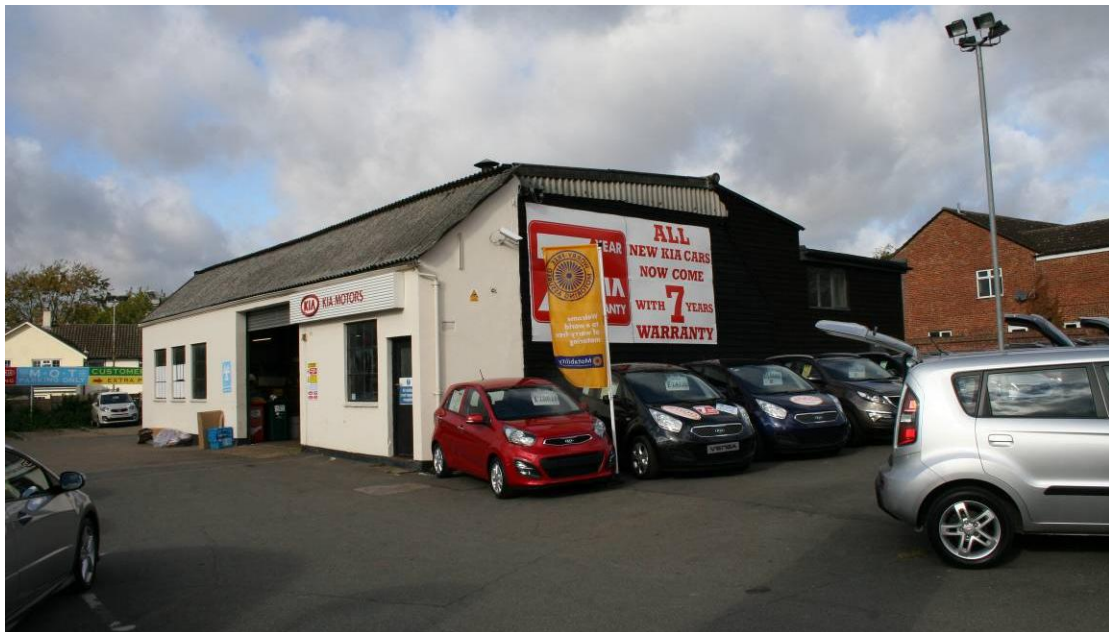
The Maintenance Workshop as it appears from the road. Compare with the historic photograph on page 2.

There is a C20th workshop door hidden beneath the modern cladding which was used up until the LC20th. Originally it linked the workshop with a roadside building.

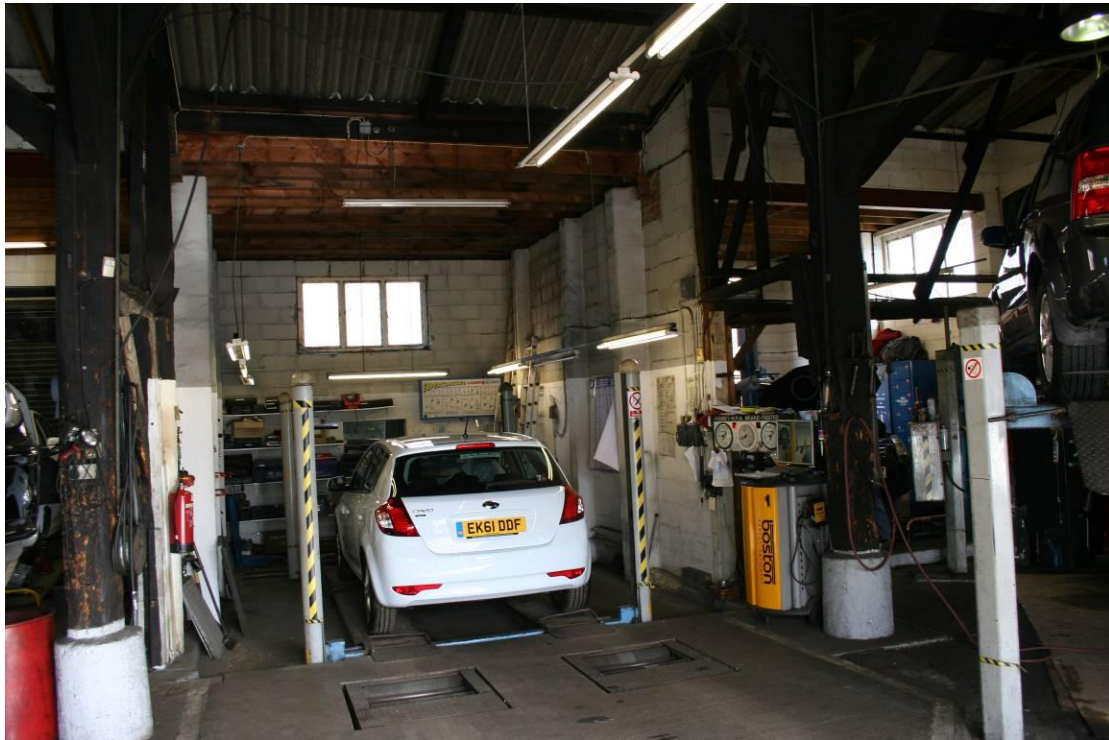
The interior is divided into six areas with hydraulic lifts.

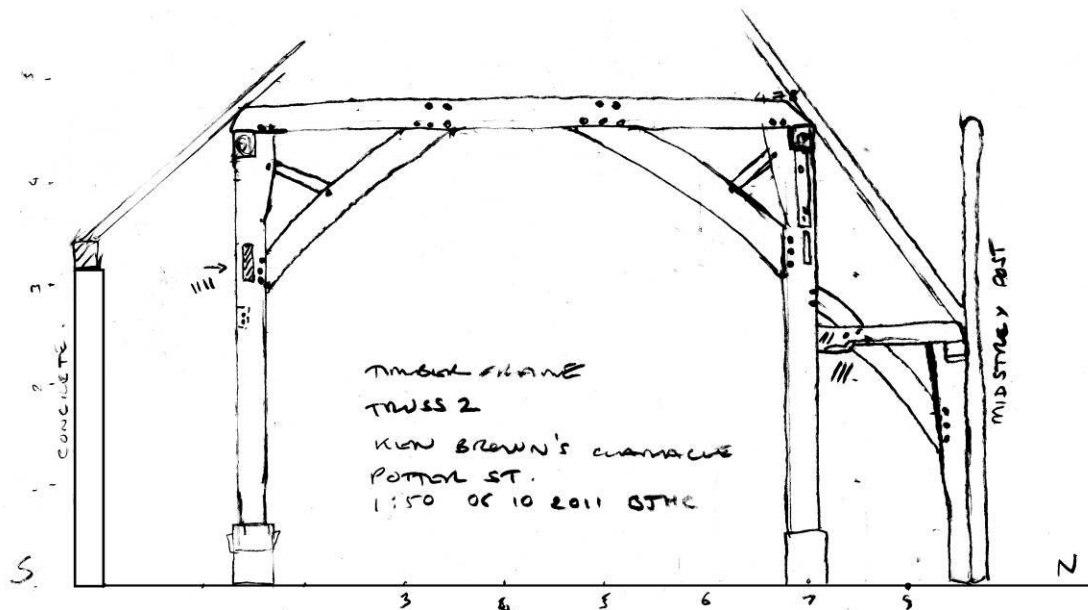
Measured site drawing excluding the modern roof structure.

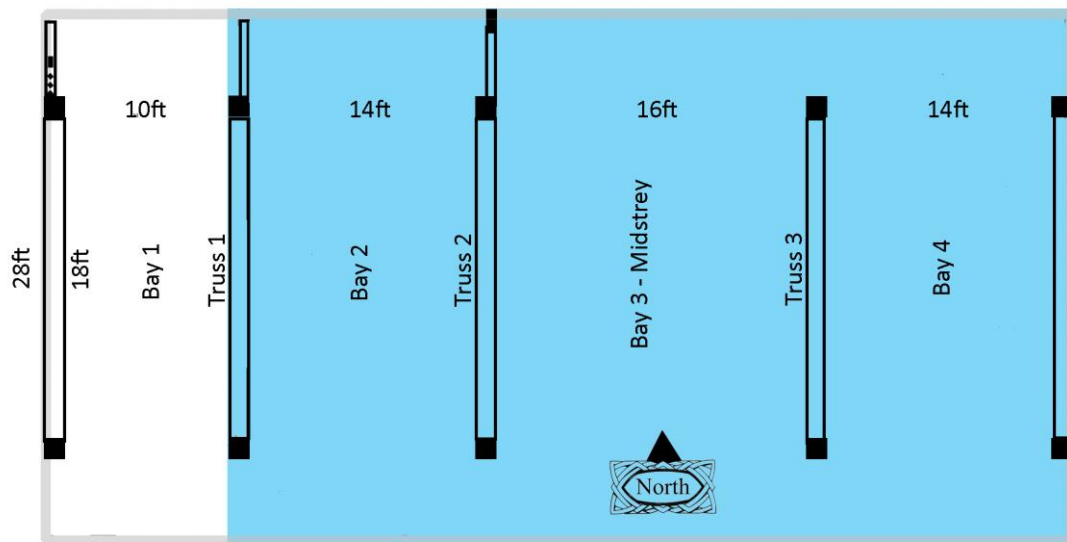
Plan of the historic frame ignoring the C20th additions.

40ft long - all measurements centre to centre of posts.

Phase 1 - The original aisled barn. LC15th.

The original barn was framed with three bays designed harmoniously in feet and inches. The width (centre to centre) between the wall posts is 28ft and the two end bays are 14ft across. The midstrey is wider at 16ft and it is probable that the height of the tie-beams was also 16ft. The floor has been brought up since the frame was erected. There is no evidence for an original midstrey porch and the sawn through top-plate indicates a pair of low doors before the tall, Georgian style doors were inserted (visible in the historic photographs).

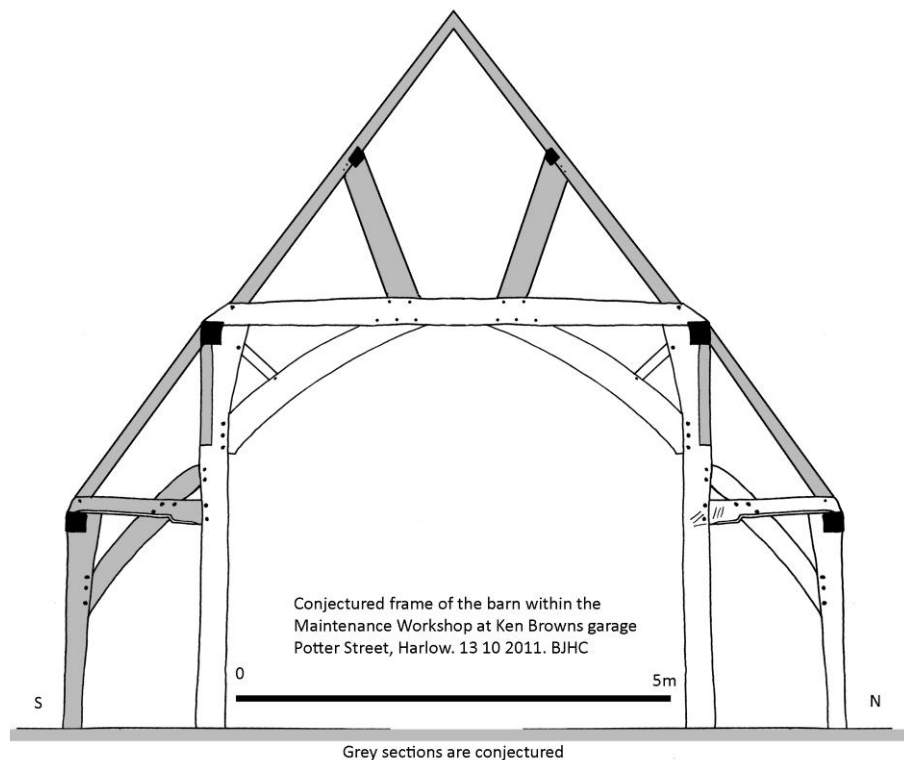
Conjectured section through Truss 2.

Originally the trusses would have been symmetrical with matching curving braces to the tie-beams and short braces into the backs of the arcade posts (often called 'shores'). The aisles were strengthened with heavy bladed braces into the narrow but deeply jowled wall posts.

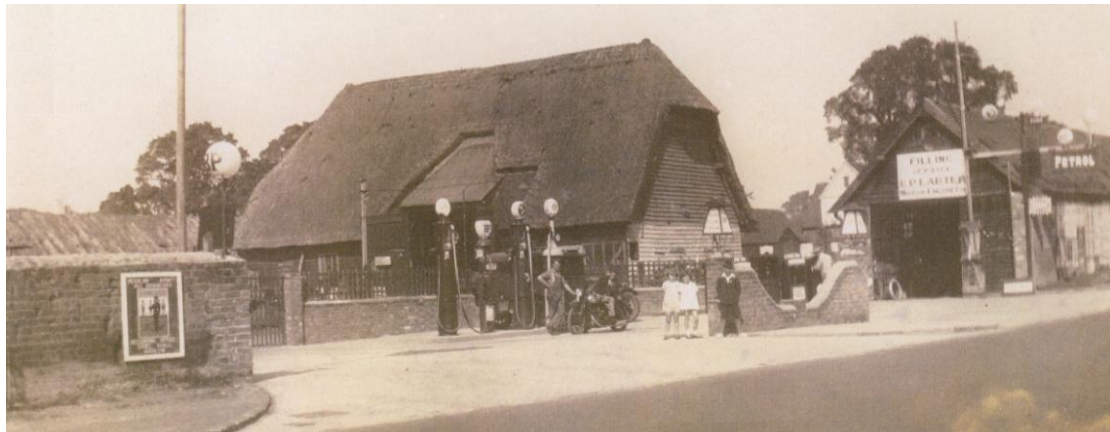
The barn in the 1920's or 30's. With additional bay and full height doors.

The extension should be dated to the turn of the C19th - a time when there was a revolution in farming driven by the grain embargoes of the Napoleonic Wars. There is also a trend for asymmetrical barns at this time. There remains a post for a full height rear porch and photographs show a raised roof section for a full height door on the southern side. The doors are typically C19th.

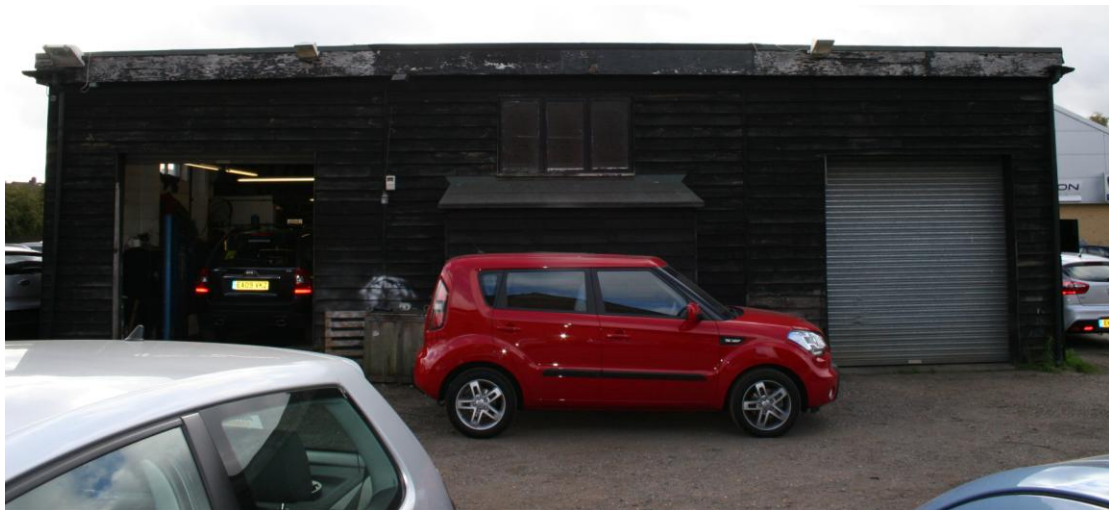
LC20th extensions to house the maintenance bays.
