Cordwainers, (Cordwinders), 89 High Street, Lavenham, Suffolk.
EH Level 1 description and analysis of the house. Surveyed 03 09 2012. Revised.
Also - Impact analysis of the proposed scheme of alterations.

Scope of this Report.

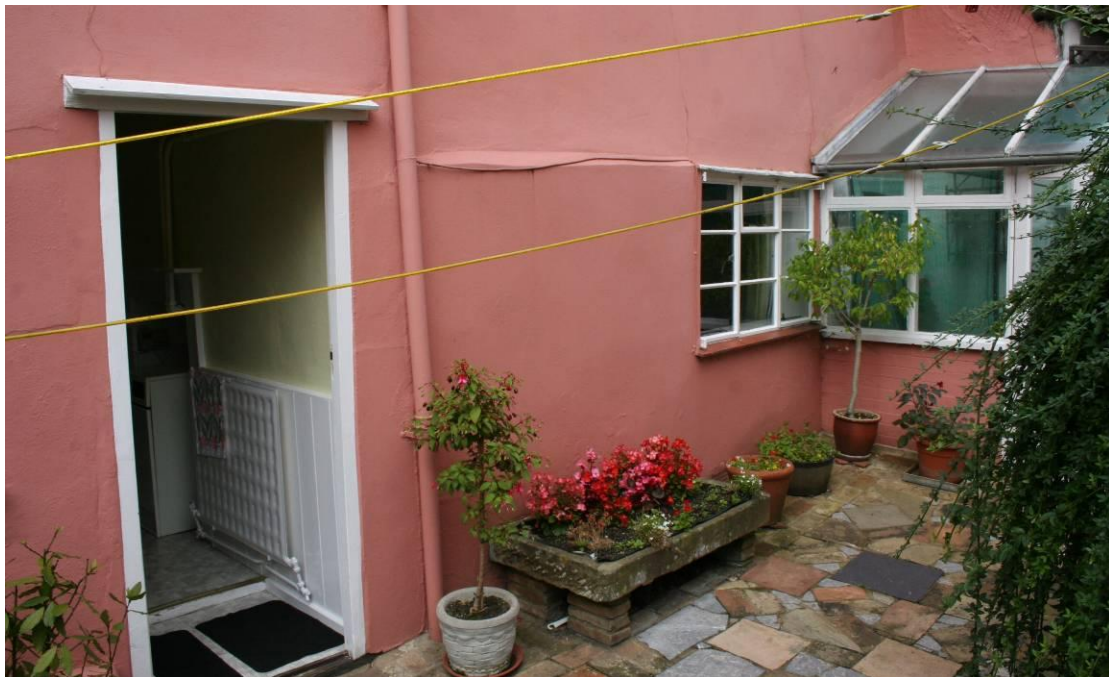
The eastern elevation is completely rendered in lime mortar. The windows are EC20th and all different in style. The upper central 9 light window is a Crittall style rolled steel casement and there is another to match it lighting the main lounge. From here it can be seen the chimney has two shafts both of EC20th Flettons with red brick banding.

The rear of the building from the garden. Looking NW.

It would be to the long term benefit of the building to replace the steel casements with timber ones. The visual impact on the building would be negligible as only the upper window is visible from the street. As there is no cohesiveness in the window types on the rear elevation, changing two of them will not create an unbalance in the facade.

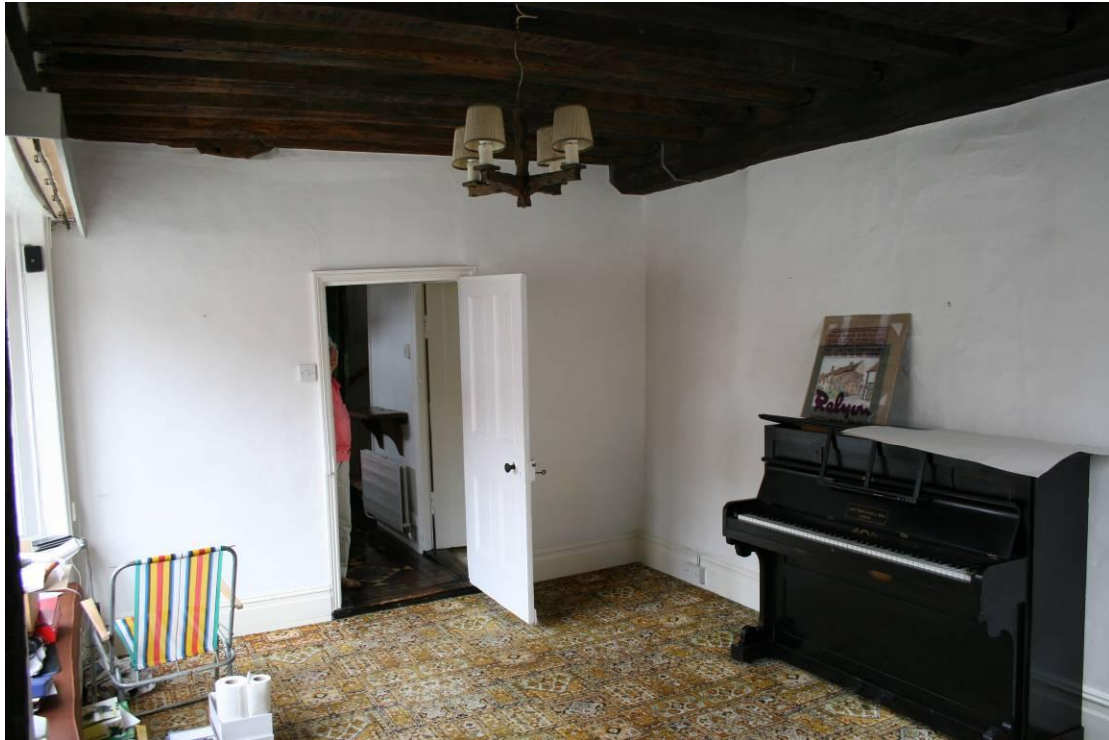
The Front Room looking NE. The wall beside the piano is disrupted for a modern chimney.

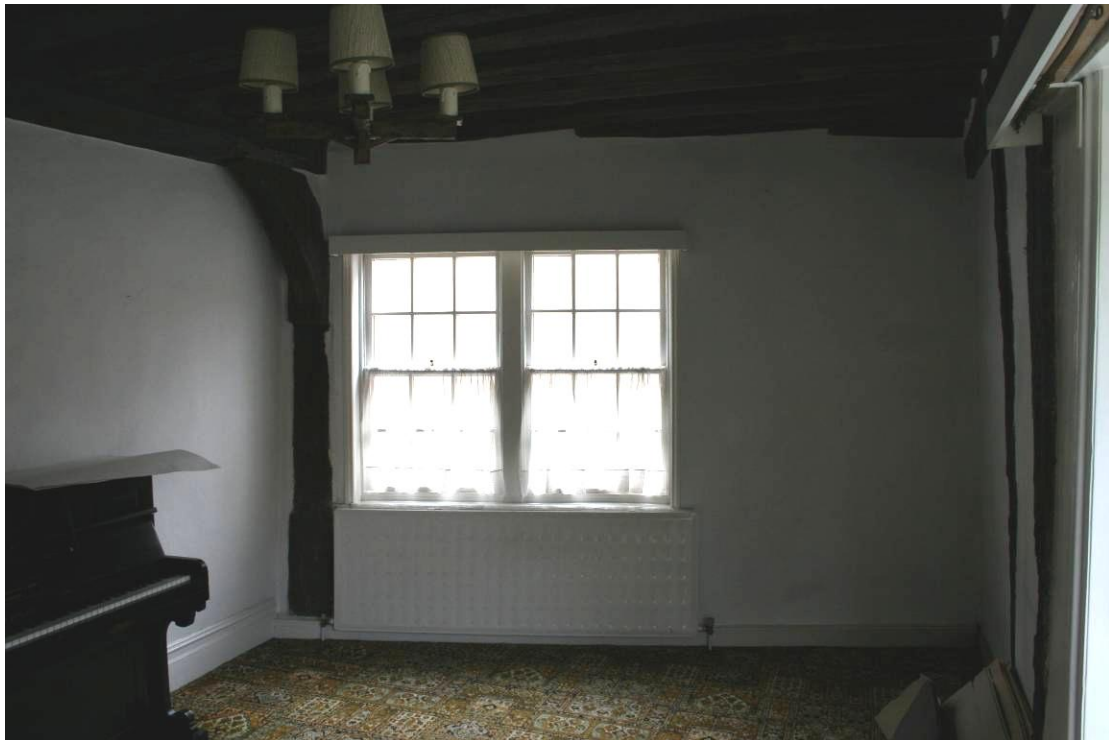
The Front Room looking S. The blank wall beside the piano is modern brickwork.

The eastern wall has been rebuilt to install a C20th Fletton brick chimney in the Kitchen and a brick built partition wall. It is this wall that the present owners would like to remove. It can be assumed the chimney had a fireplace on both sides and there a large patch of disturbance in the plaster where it should be in the Front Room. The ceiling joist has no pegs to indicate and original partition indicating the ground floor was open here.

2a. Examination of the timber-frame shows that originally there was no partition wall in this position. The present wall houses a circa 1930 'catalogue' fireplace and a chimney made from Flettons which has been subsequently blocked. To the LHS (north) is a section of scantling studwork which has EC20th lath and plaster and wattle and daub. The properties of the wattle and daub are not authentic but an uniformed recipe with too much mortar and too much fresh straw. It is proposed to remove the plaster which is failing to reveal the structure of this section. If it proves to be older than the C20th then it will be retained.

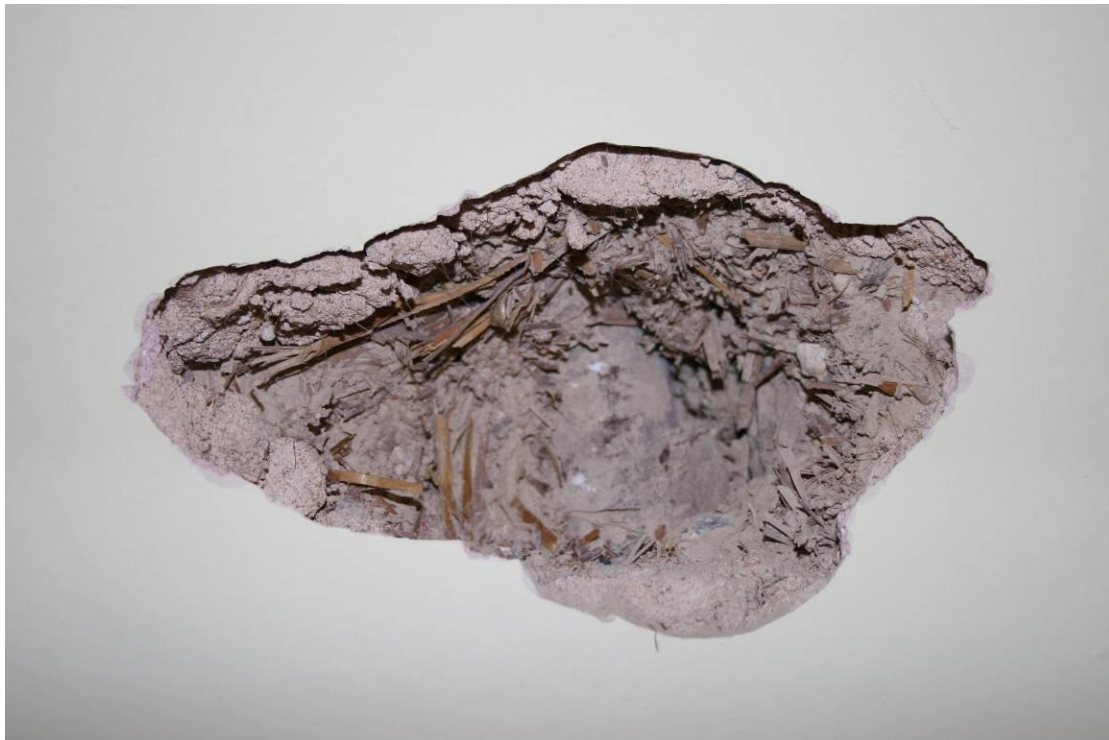
Wattle and daub revealed in the kitchen wall.

Opening up in December revealed the bricks in the chimney stack to be an older larger type than the Flettons elsewhere. However, the mortar used is identical and therefore they are reused. A small inspection hole in the Kitchen wall revealed a hazel rod wattle and daub panel beneath. However, this is not an old panel. The straw is very fresh and there is too much of it, there is very little binding soil and too much mortar. It is probably EC20th.

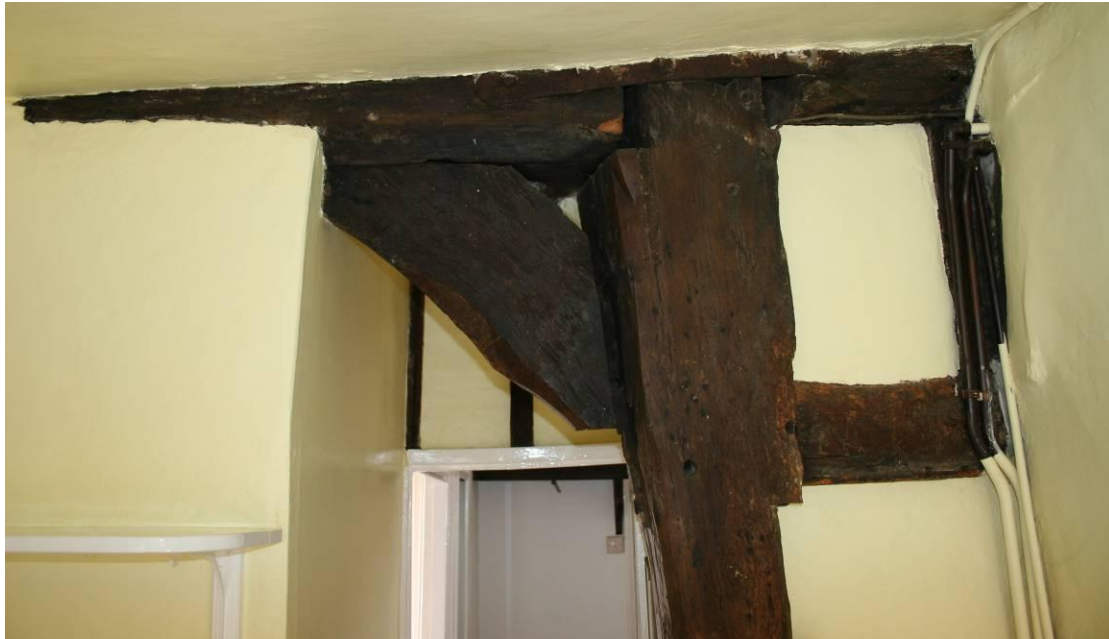
The frame visible in the Kitchen looking west into the Hall.

There is an exposed section of frame in the Kitchen beside the stairs that contains a storey post bracketed to two axial main joists that allows the common joists to span the room. This is braced with another large bracket. The underside of the bracket has been hacked back to insert a door frame and another doorway is present on the other side of the post. This retains its lintel which has been repeatedly scored with a thin bladed knife. These are apotropaic marks put there to ward off evil and bless anyone who walks through the now blocked doorway.

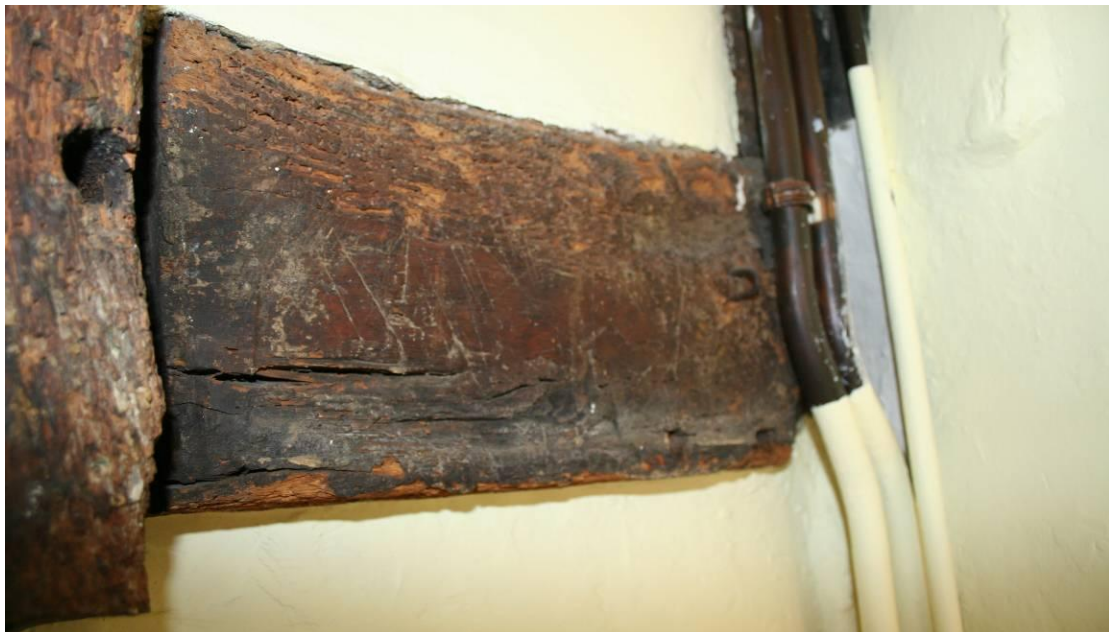
Fine scratches put in to bless the doorway.

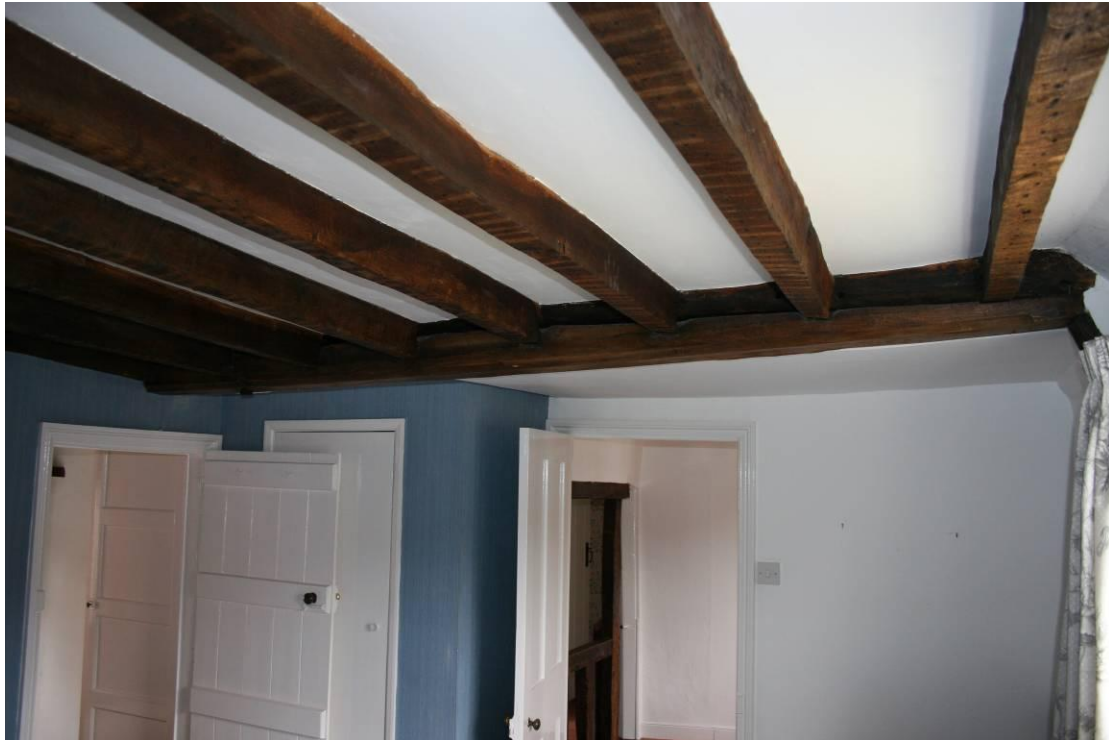
The ceiling in Bedroom 3 showing the tie-beam.

The frame in Bedrooms 1 and 3 has been heavily contorted because the braces have been cut off and the effect redressed in the Georgian era. Rather than try to straighten the frame the builder has inserted a plate that he has bolted onto the underside of the original tie-beam. The plate has then been morticed through and the ceiling joists levelled by cutting the tenons in different positions to suit the level. The ceiling is thus Georgian and the scantling joists are only 3in wide set on edge.

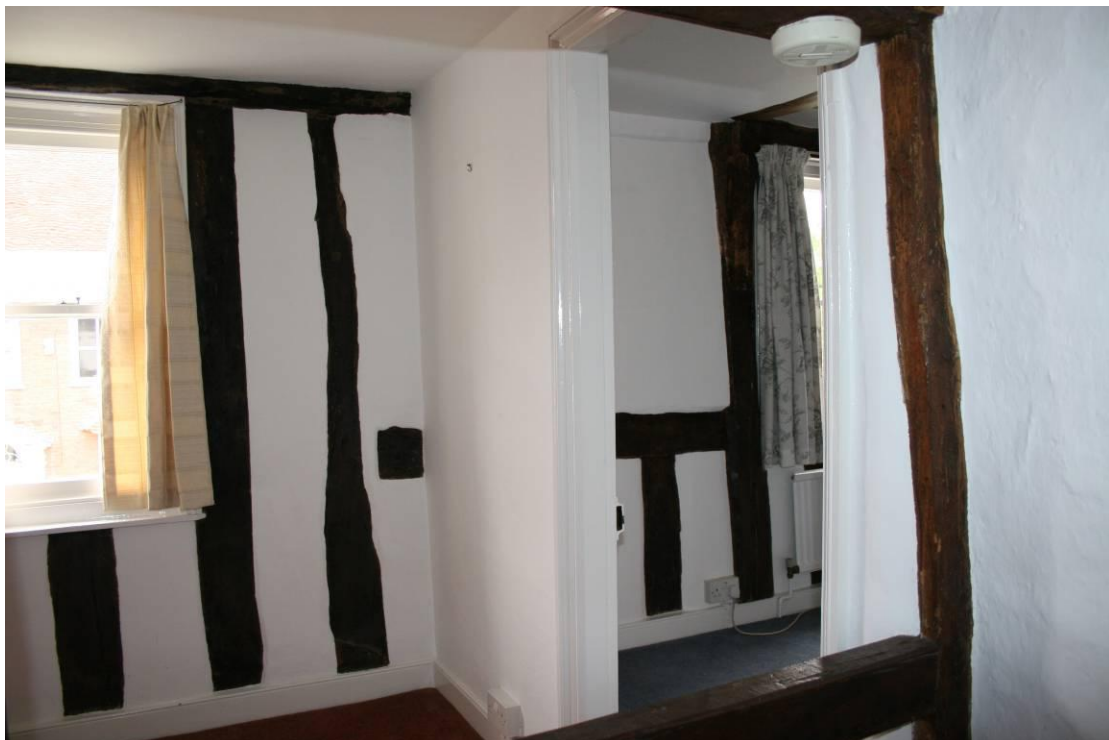
The original window is now divided by a modern wall. Looking NW from the stairs.

In Bedroom 3 there is an original window opening that has now been truncated by stud wall to form a large landing big enough to be another bedroom. The frame here has several 1.25in fixture holes at eye level.

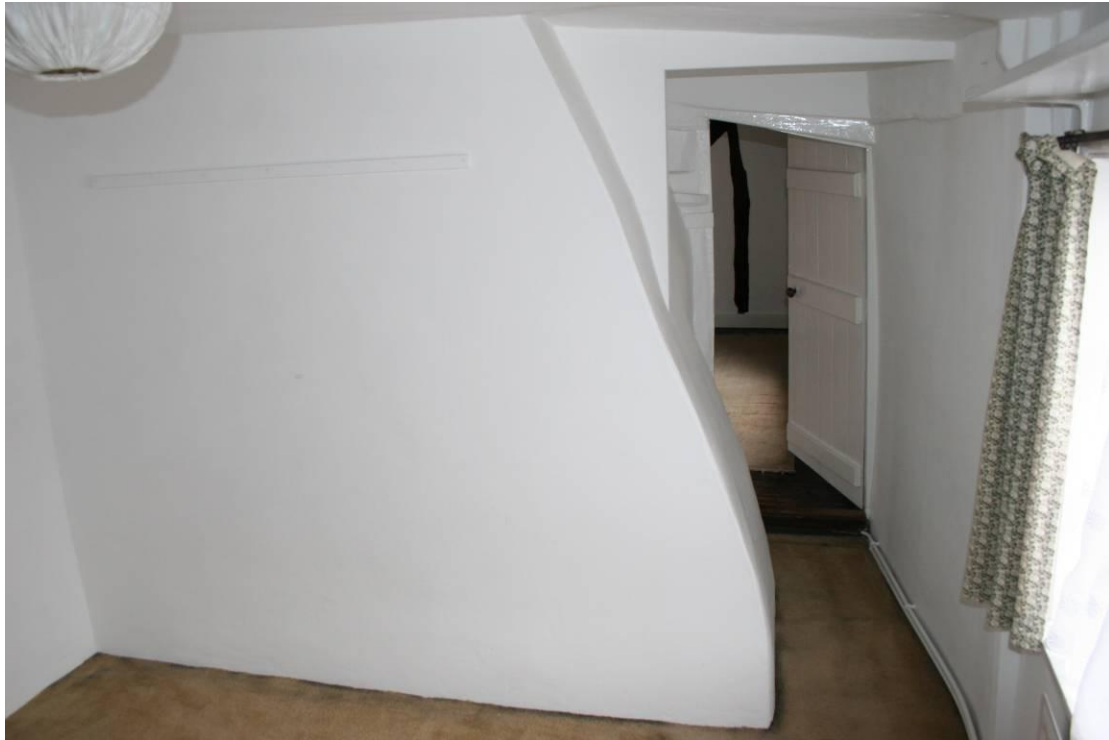
The firestack in Bedroom 2. Looking N.

Bedroom 2 is now little more than a corridor that contains a very considerable firestack that coincides with the fireplace in the Main Lounge. It has been completely plastered over but the upper section is visible in the roofspace where it is composed of Georgian style bricks set in a bright white mortar. There is also a secondary flue that has been completely plastered over.

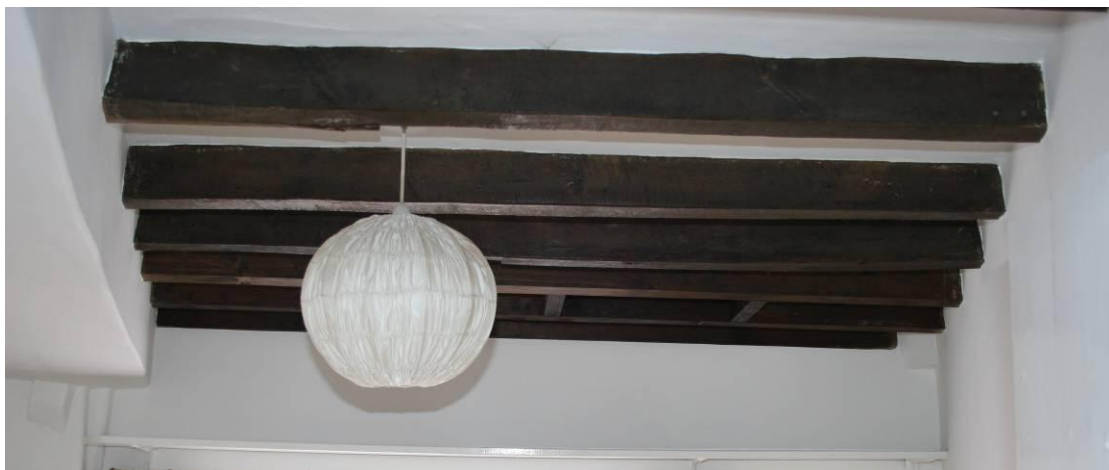
Georgian ceiling joists in Bedroom 2.

Like Bedrooms 1 and 3 the ceiling is composed of narrow ceiling joists as part of a Georgian refurbishment. There are also at least two modern 2x4in machined joists with noggins added in.

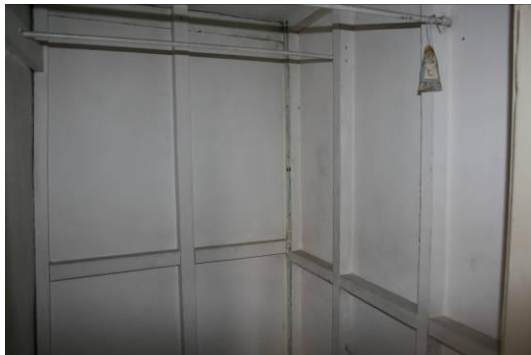
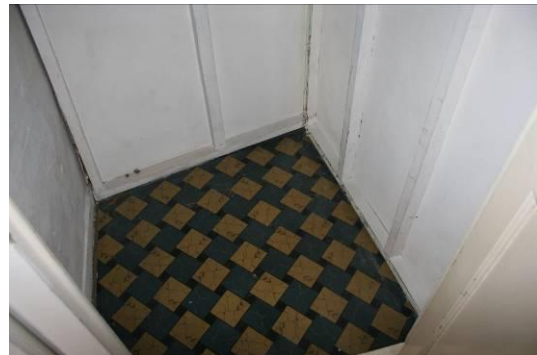
Inside the closet which is made of hardboard.

There is a C20th closet made from square battens and hardboard with a lino floor which would have been put in during the 1930's. The door to the closet is the only one of its type in the house and is a Georgian two panel servant's door.

3a. It is proposed to remove the hardboard closets and partitions to make better use of the space and remove the somewhat tired and fire hazardous materials. These have no historic value and are temporary screens rather than proper walls.

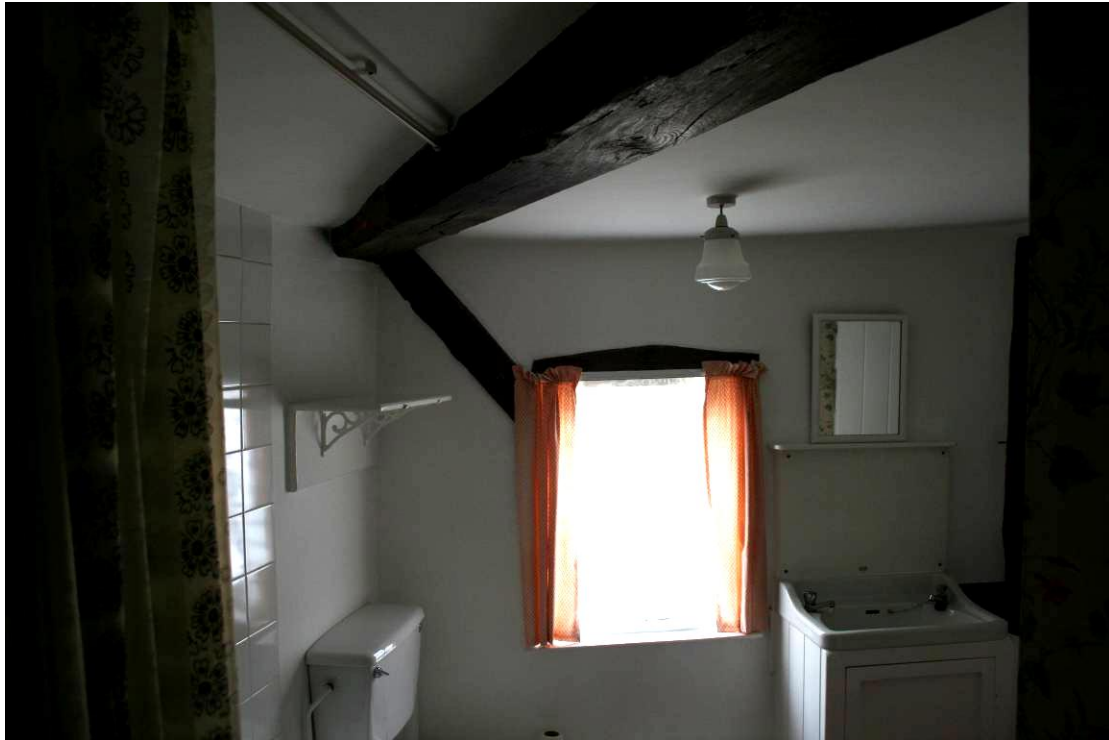
The en-suite closet is built into the neighbouring room which houses the bathroom and the airing cupboard. The tie-beam passes right through the wall and indicates the room partition is not original to the frame.

The bathroom looking E. Note the tie-beam coming from Bedroom 4.

3b. It is proposed to remove the studwork wall between the Bathroom and the Bedroom. This is a C20 partition made from machined studwork and lath and plaster. It has no connection with the original form of the house. It proposed replacement will follow the line of the bridging joist to create two more equal rooms. The small chimney stack is made of LBC Phorpres bricks and is therefore C20th. It is a redundant structure that can be removed.

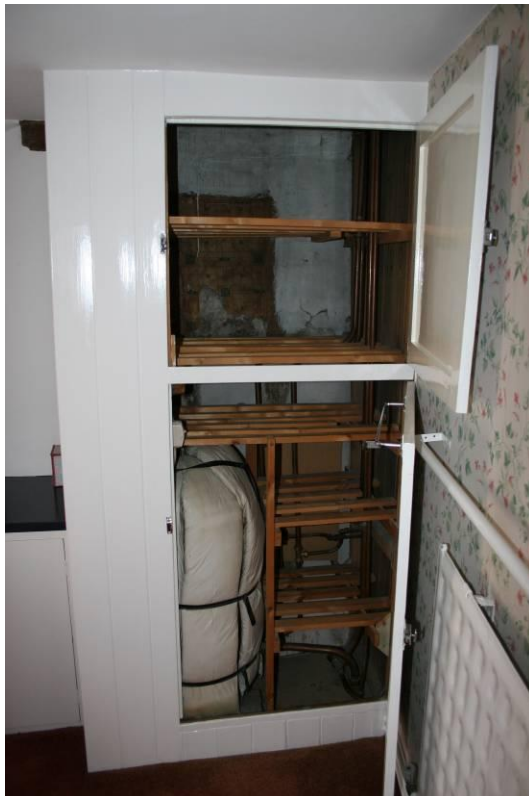
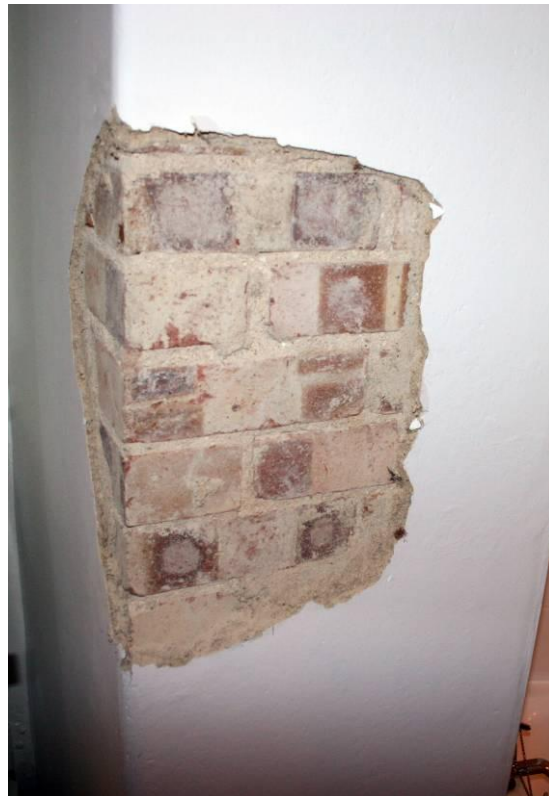
The bathroom retains some of its 1930's fixtures. Chimney is made of Flettons.

The Bathroom is unremarkable and contains some fittings from the 1930's including the airing cupboard. Opening up revealed the chimney stack serving the fireplace in the Front Room is made of Flettons. These are visible in the marked roofspace as LBC Phorpres bricks.

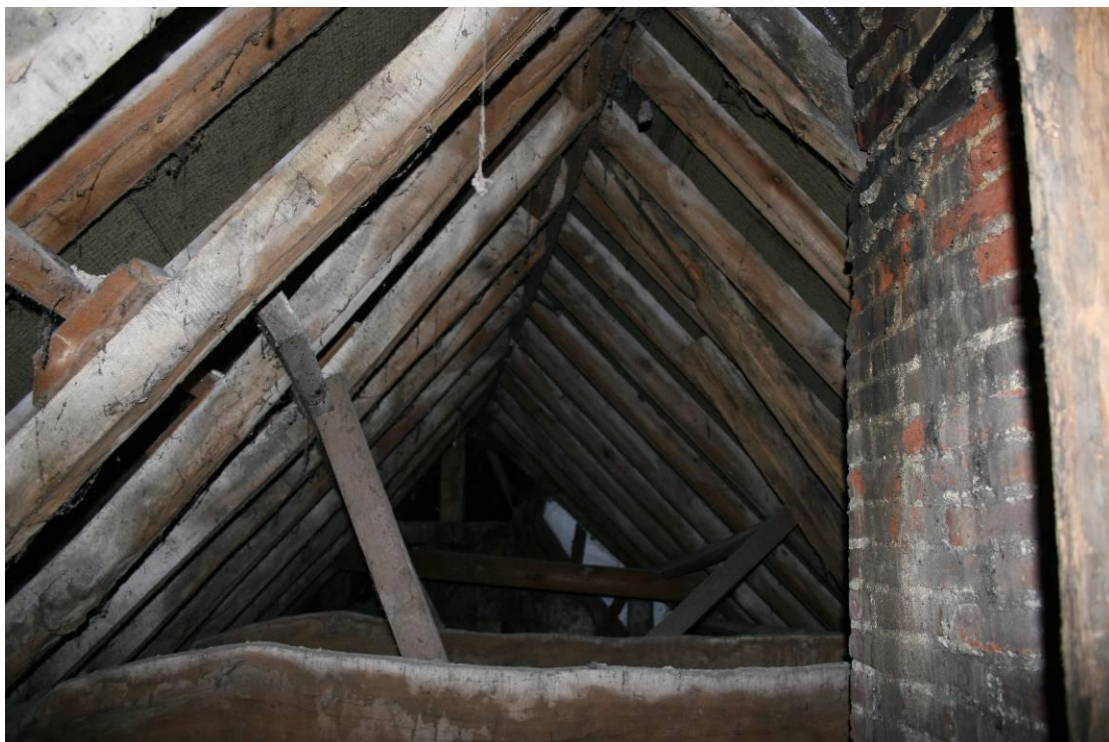
Looking N into the roof space.

The roof was re-tiled in 1973 and there is a black asphalt membrane under the battens. The scantling rafters are set on edge and are now paired onto a ridgepiece. The roof is a clasped side purlin roof with side lapped and nailed collars. The purlins and collars are of the 1973 rebuild.

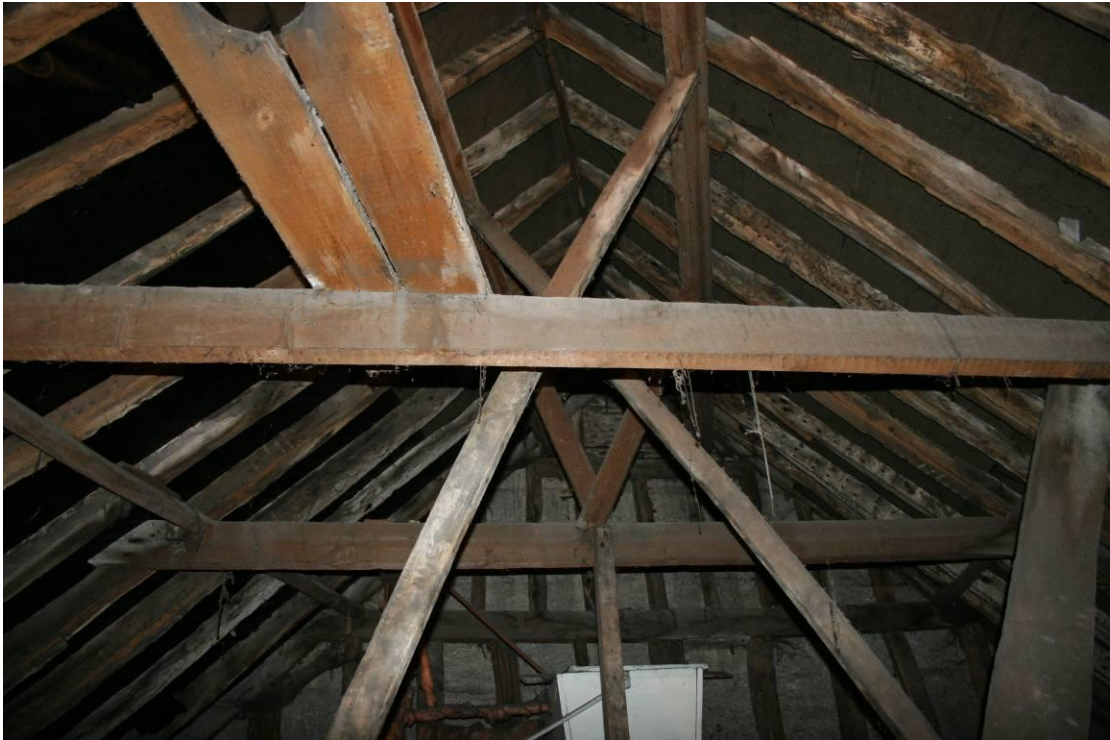
Looking south in the roofspace. The yoke is for a chimney flue.

The roof space is unsafe as it is covered in insulation and many of the ceilings are simply hardboard. It was possible to see the top of the Kitchen chimney stack where it had been dismantled and see that it was made of LBC Phorpres bricks. Above is a yoke presumably for a steel chimney flue since removed.

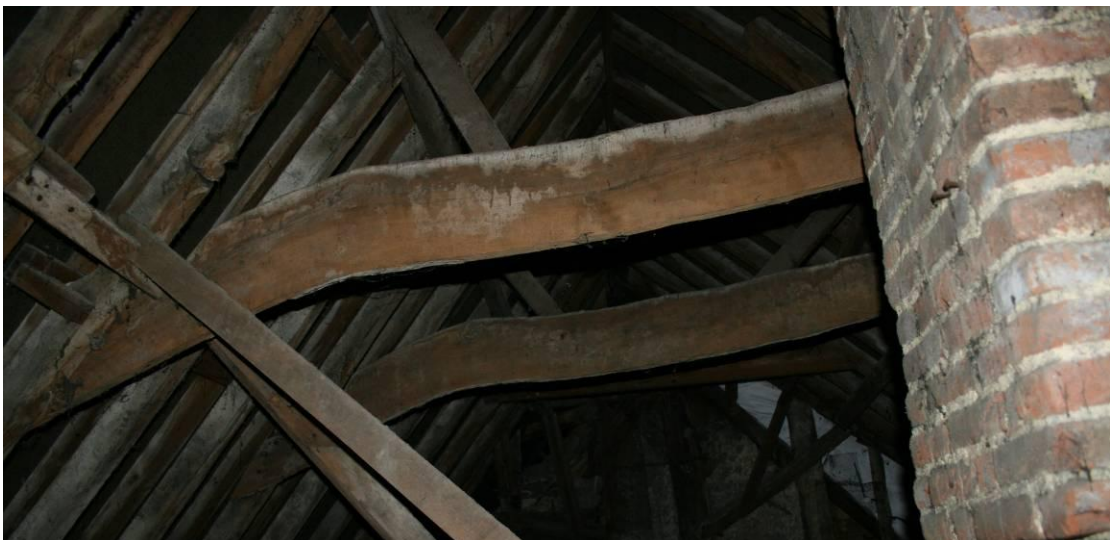
Earlier waney collars reused in the roof.

Looking north there is a pair of earlier waney collars but these have been French nailed to the replaced rafters.

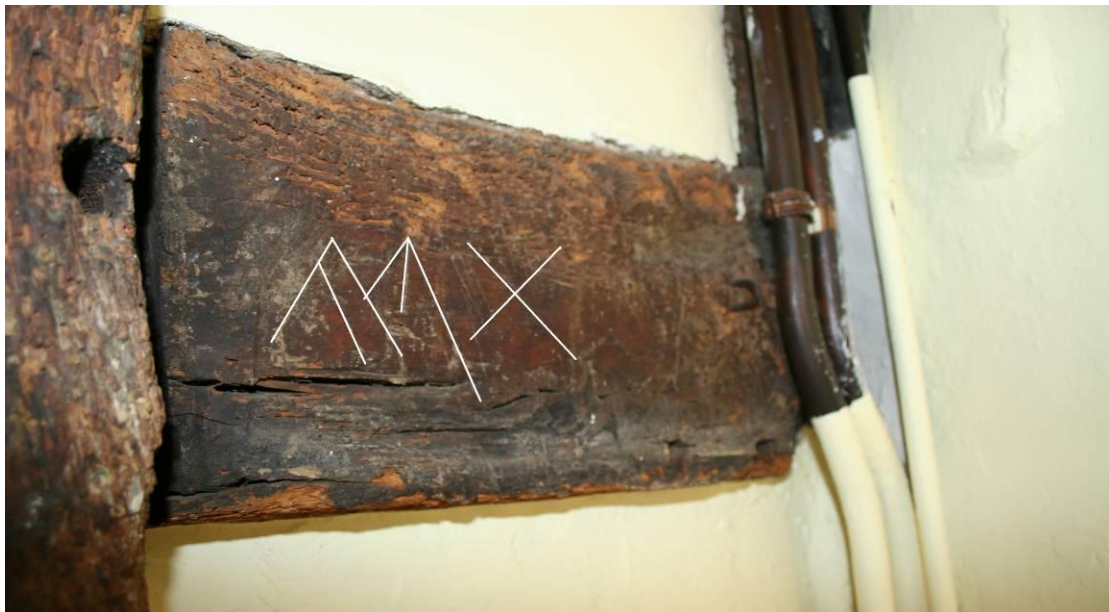
Apotropaic marks over an old doorway into the Kitchen.

The only apotropaic marks found were over the blocked doorway beside the stair in the Kitchen. There were many frenetic marks but it is possible to delineate the heavier more deliberate marks. This shows an M for Mary and an X for Christ. These marks are the most common found in old buildings and can date from the C16th or C17th but also from the MC19th when they were revived.

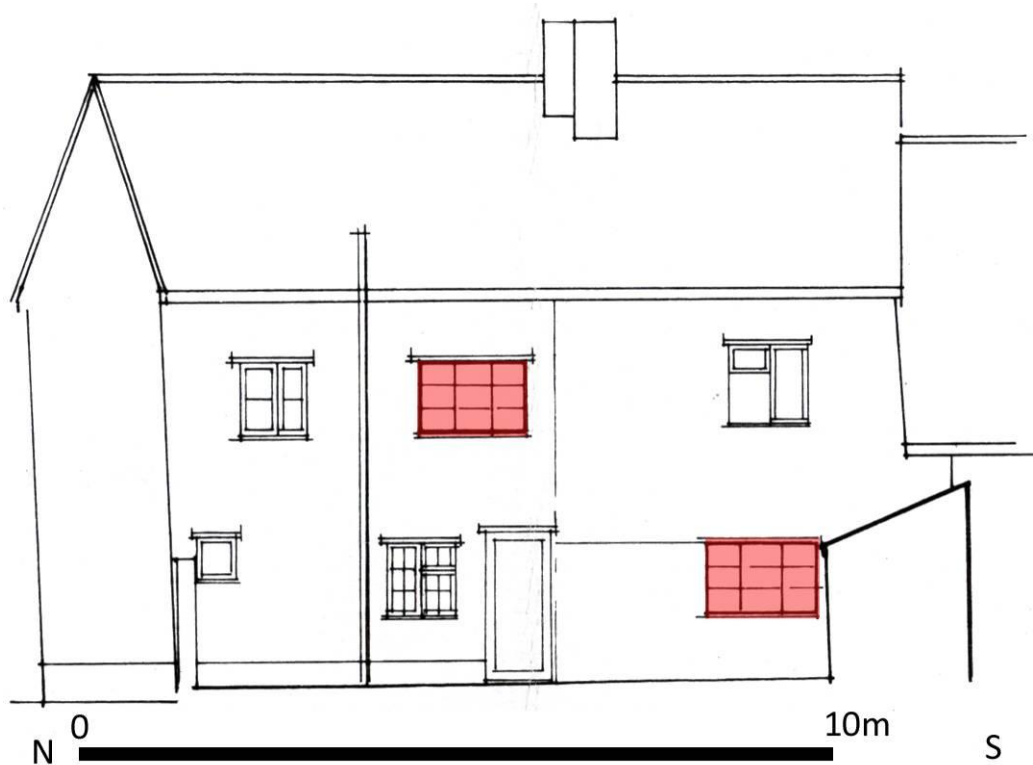
Eastern (rear) elevation of Cordwainers.

1a. They are very rigid being made from strip rolled steel and do not flex with the building leading to cracking of the render and stress of the frames.

1. It is proposed to replace the Crittall windows with timber windows.
