Thorley Houses Farm, Thorley Lane West, Thorley, Hertfordshire CM23 4BN.
Recording and analysis of the thatched barn. Surveyed 05 07 2017.

SUMMARY SHEET

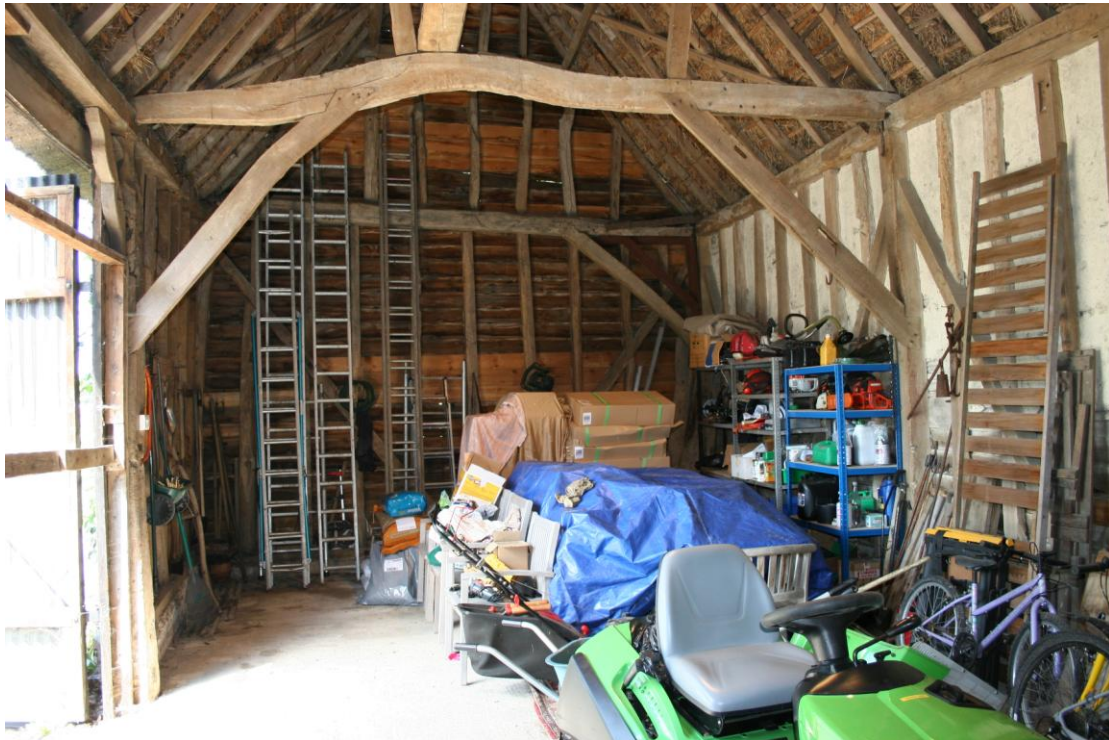
Looking W inside the Barn.

The Barn has three bays composed of primary braced nailed interrupted studwork, pitsawn from elm with some reused oak and elm timbers. The tie-beams are halved waney trees.

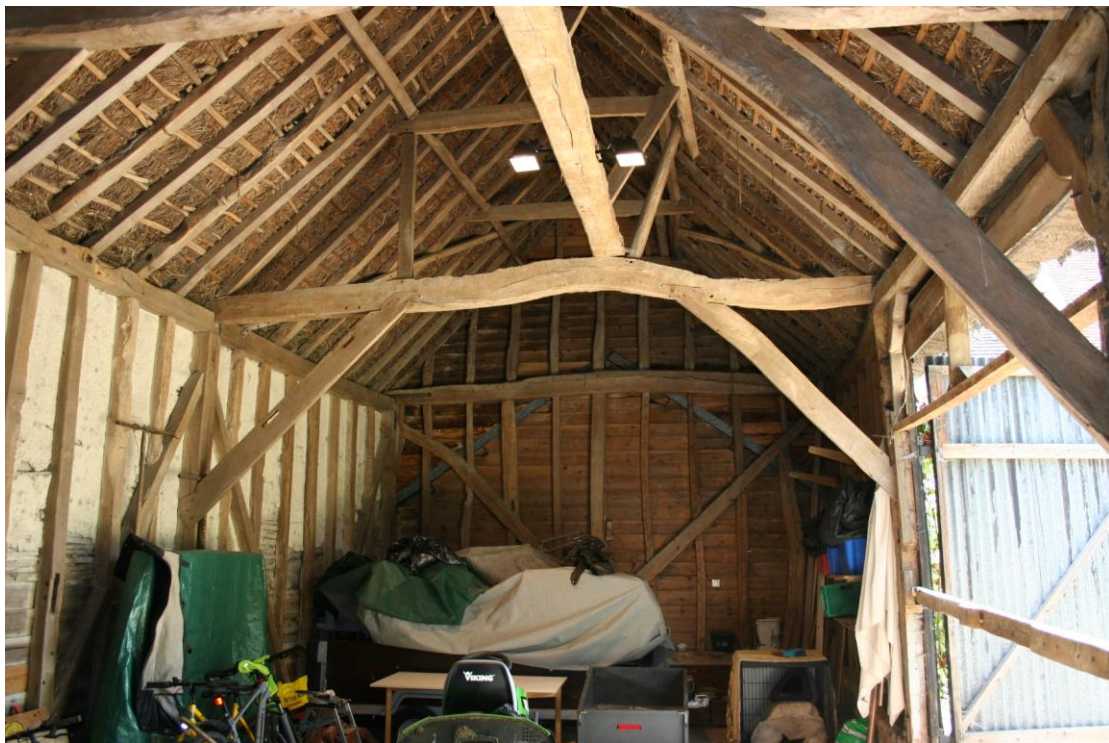
Looking E inside the Barn.

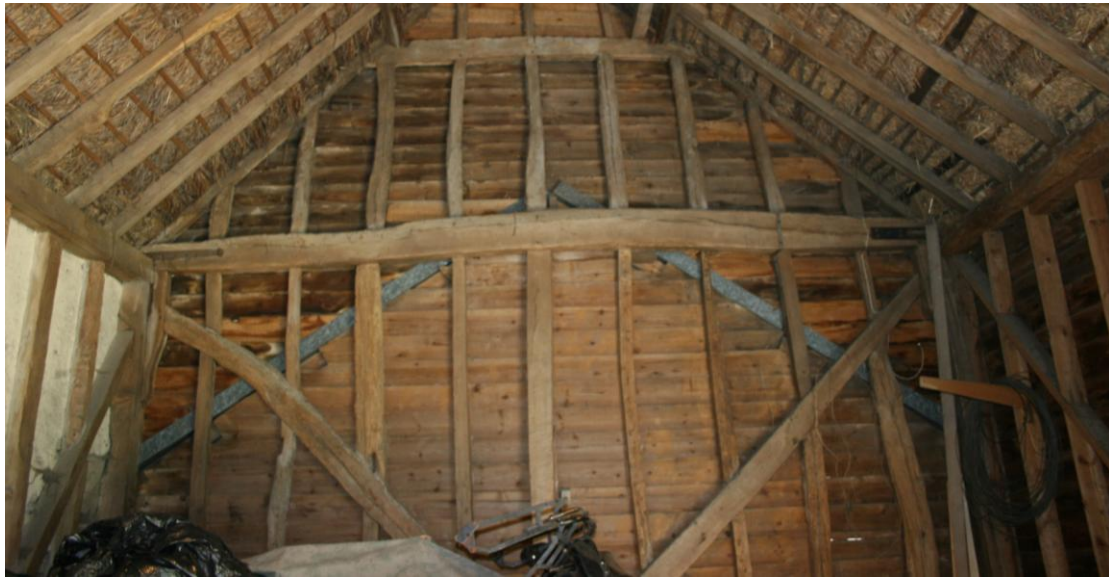
Detail of the eastern wall.

The primary braces are cut very straight except for one in the eastern wall which is supported by an added jowl piece at the post head. Most of principal posts have no jowls and the joints are held with LC18th style wrought iron ties. The SW corner post is a reused post with swept jowl.

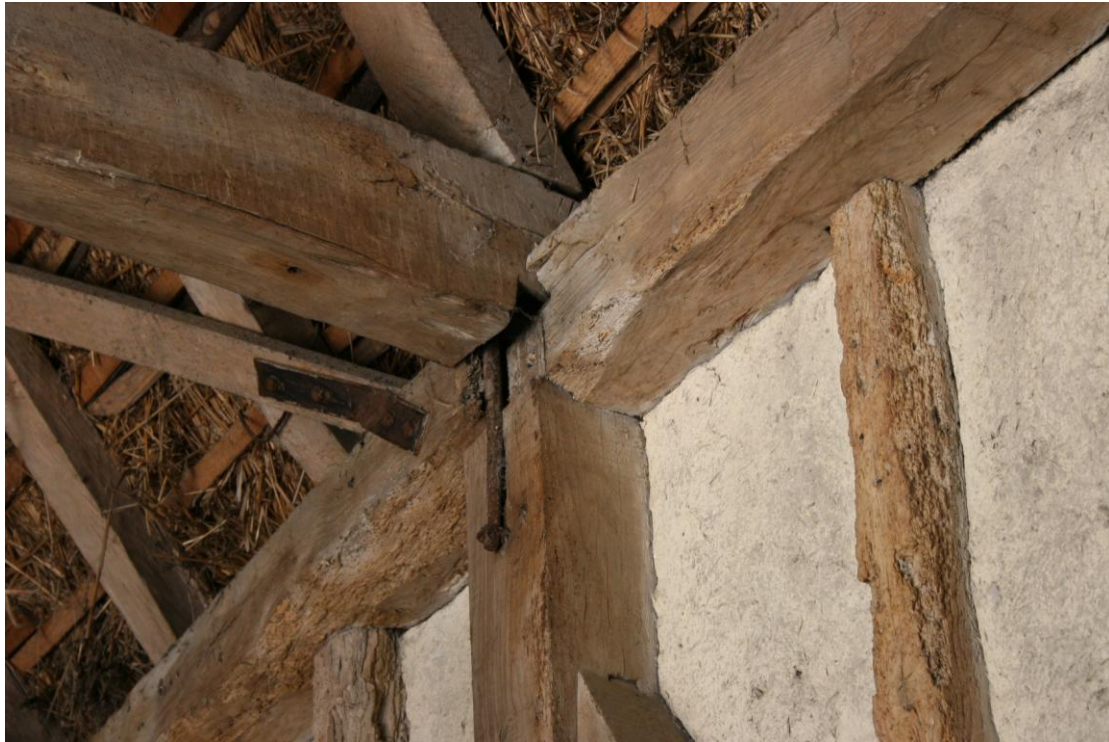
Detail of the principal post in Truss 2 (from W).

The principal posts are of variable sections, 8x7in, 5.5x6.5in, 6x6.6in and 6x6in. The studs vary more so but are cut on a 3in module. The face halved and bladed scarves are secured with forelock bolts which are original (not repairs) dating the joints to the LC18th.

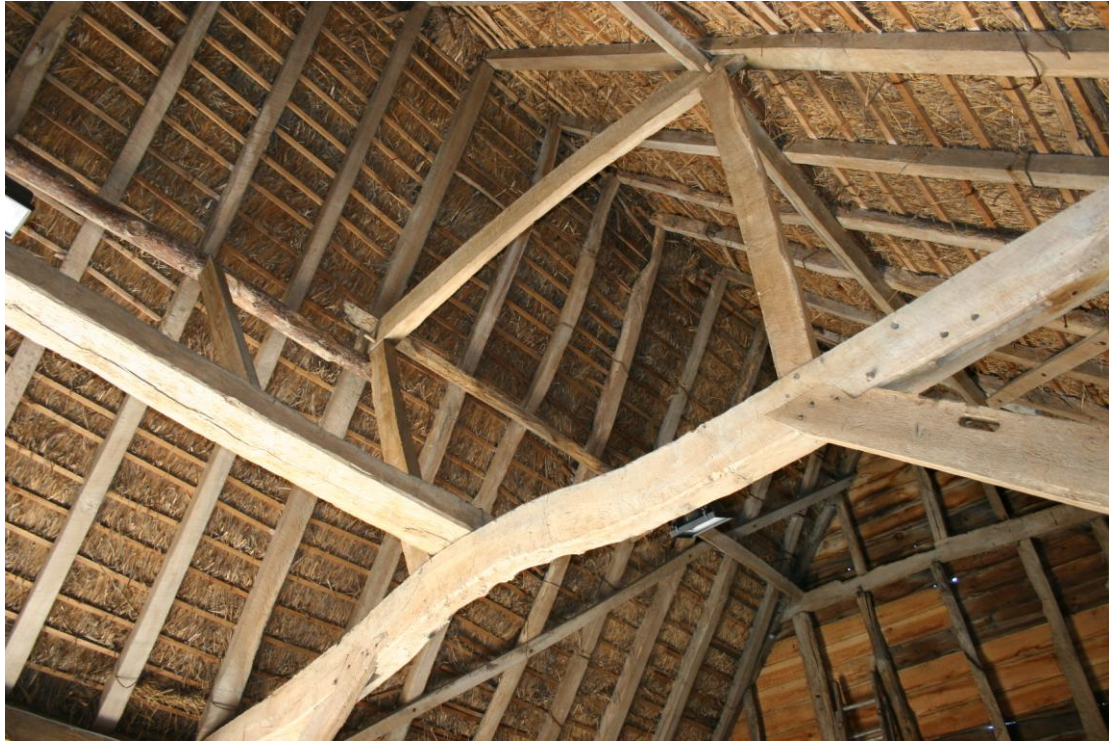
Looking upwards to the SW at the queen post roof.

The roof is a queen post roof with paired elm rafters of near square section of varying size. Some are obviously quarter sawn and retain the bark. The roof is supported on two waney elm tie-beams that appear cut from the same tree. They are morticed for spandrels that have been removed and side nailed braces put in their place. The side purlins are supported by collars with queen posts pegged into the tie-beams. The assembly remains complete in Truss 1 (from W) but has been altered in Truss 2 in the 1990 works. Here the pole purlin has been dropped and supported on raking struts birdsmouthed onto the purlin. These are supported on an axial beam rested on the tie-beams.

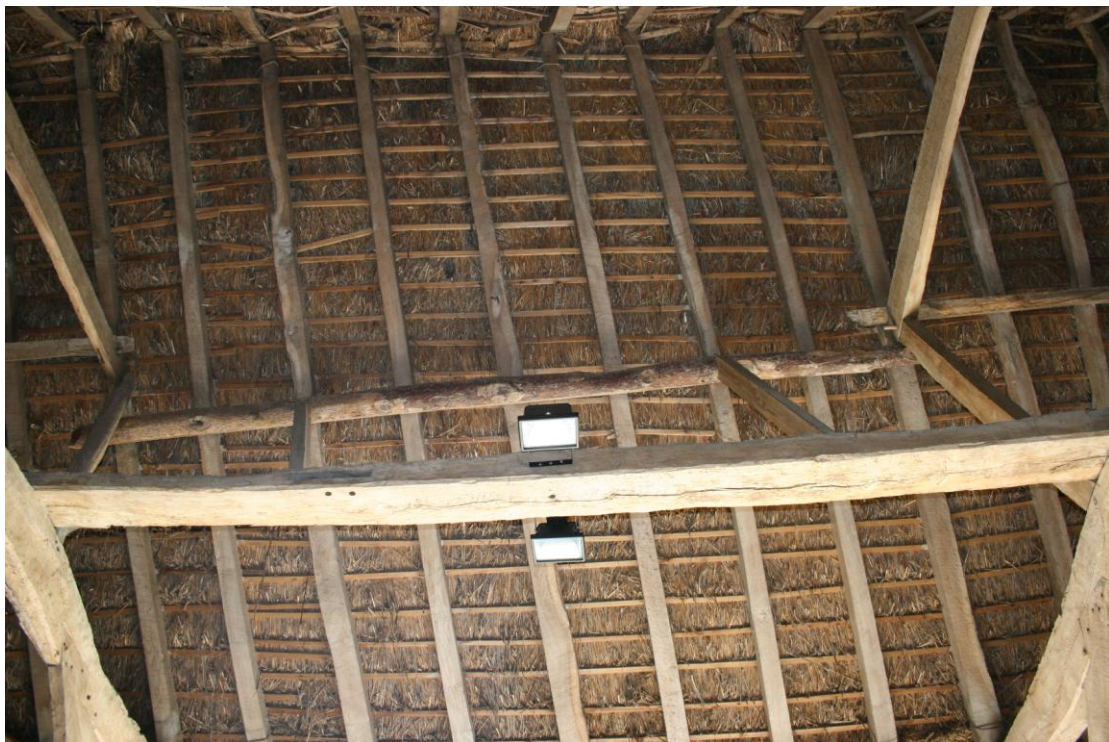
Detail of the thatch over the central bay/ Looking S.

The thatching is LC20th and was largely done in 1990. However the laths are of different qualities, some being machined softwood and some being riven laths and rods, pointing to an incremental approach to repairs. In particular the central bay has a different character to the end bays where the thatch is darker and so presumably older but not by many years. The split rods and riven laths are still fresh.

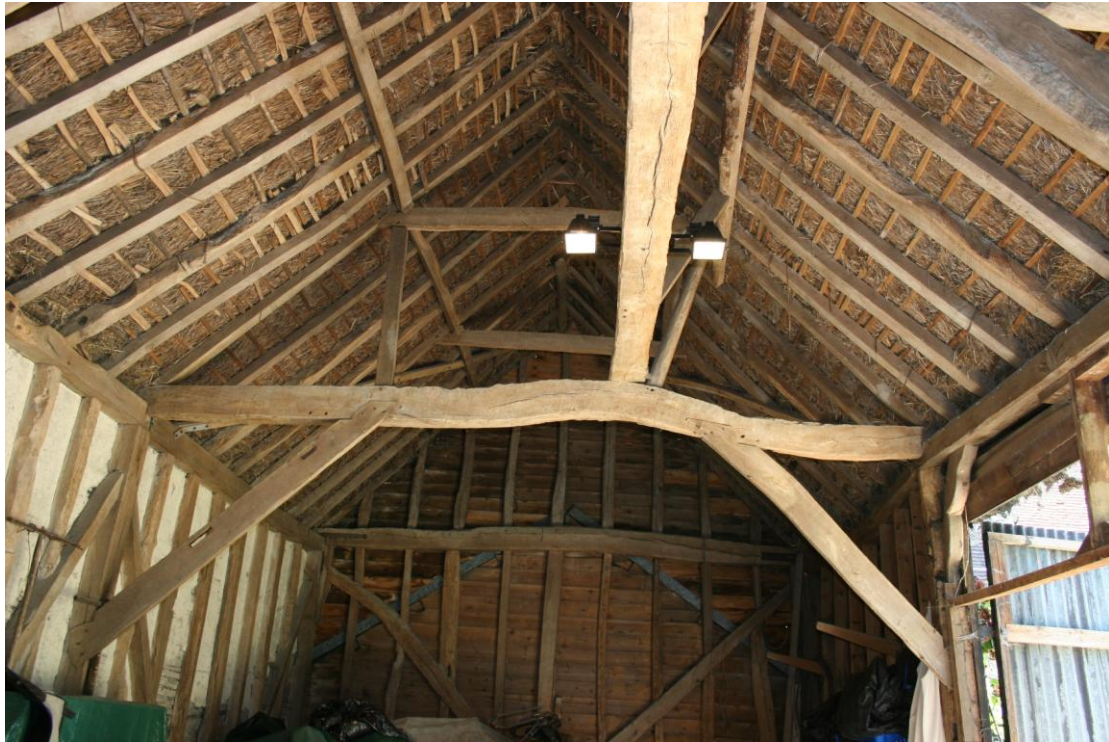
The tie beam in Truss 2 (from W).

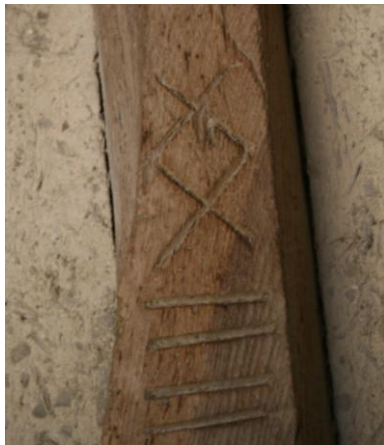
Carpenter's mark denoting 34.

It is most likely the frame is marked throughout on the outside under the boards. A single stud displays a carpenter's mark XXVIII made with a race knife and must be a reused timber. Truss 2 is marked III but the tie-beam is marked N (9) suggesting reuse. Apotropaic marks representing M (Mary) and VV (Virgins of Virgins) are scratched on the principal post guarding the doorway. These are very common and were revived in the MC19th despite the scientific enlightenment of the age and were being reported in the 1840's as a device by which the 'Cunning Men' made money for blessing the buildings.

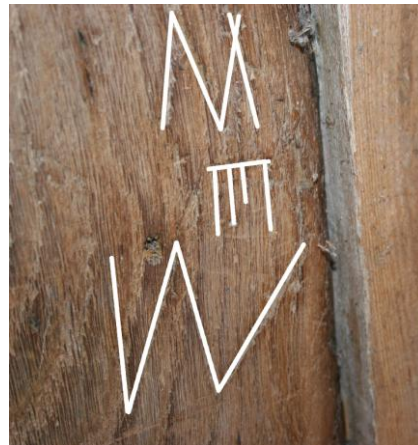
Apotropaic marks on the principal post of Truss 2.
