Street Farmhouse, Main Street, Shudy Camps, Cambridgeshire CB1 6RA.
Recording and analysis of the house. Surveyed 19 09 2016/04 06 2017

Scope of this Report

This report describes and analyses the farmhouse from records made during visits before (19 09 2016) and during its refurbishment (04 06 2017).

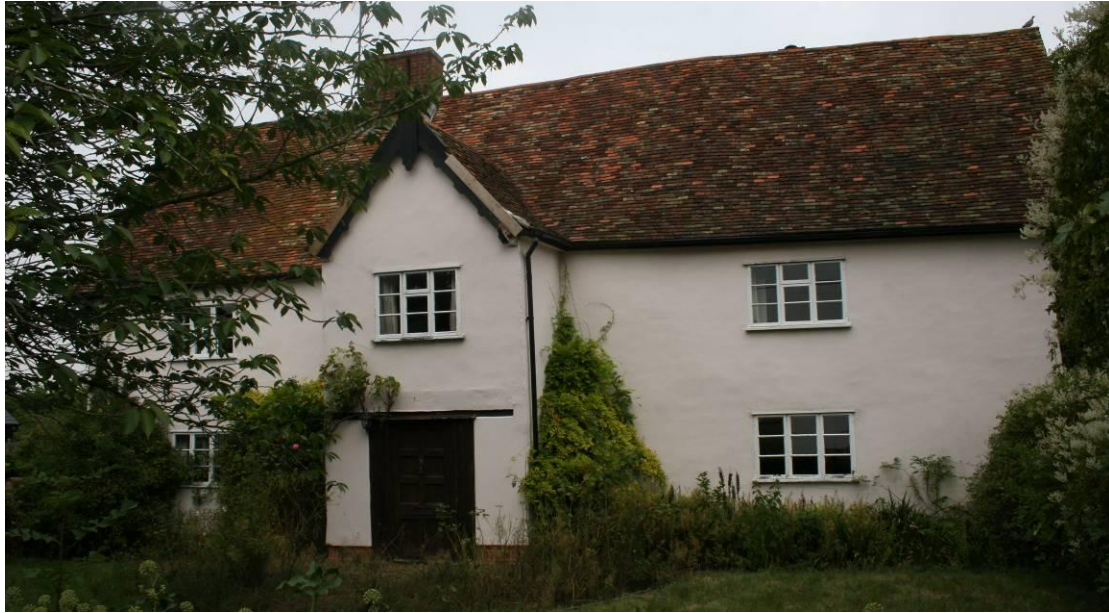
South elevation. 2016.

The former farmhouse is a timber framed building clad with lath and plaster and fitted with 1930's casements with landscape panes in three lights. There is a centrally placed two storey porch with a C20th front door. The roof is clad with plain clay tiles and was last retiled in the LC20th between 1965 and the 1980's as evidenced by an asphalt membrane.

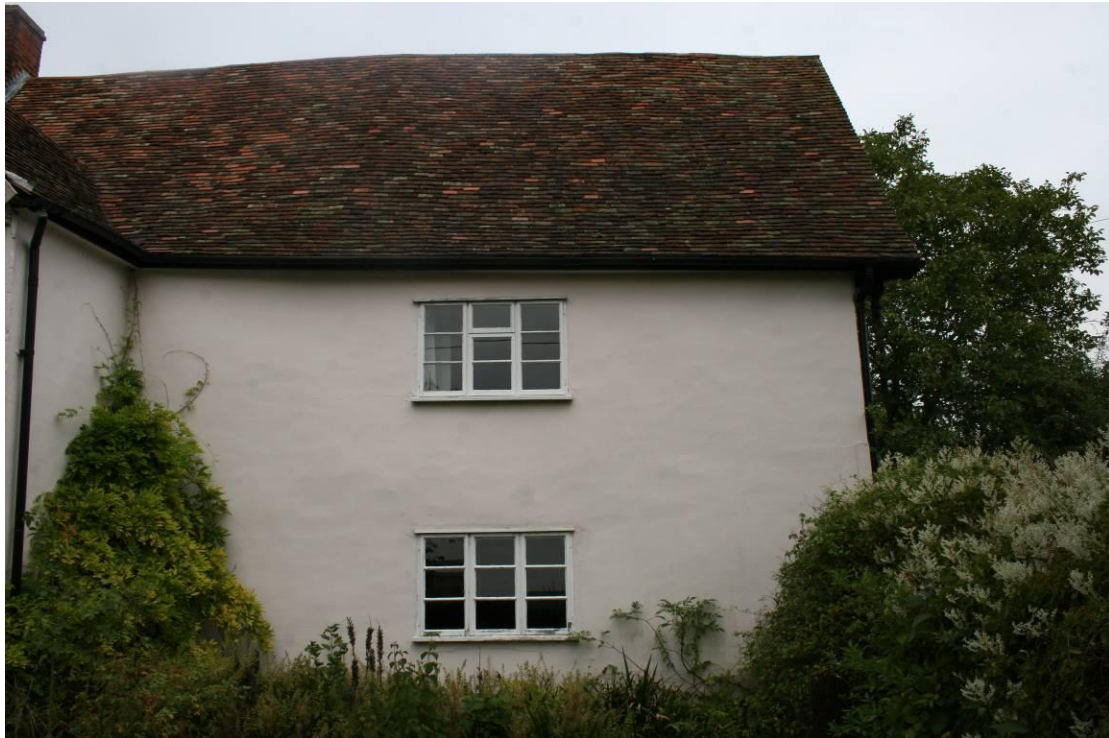
Detail of the 1930's style casements.

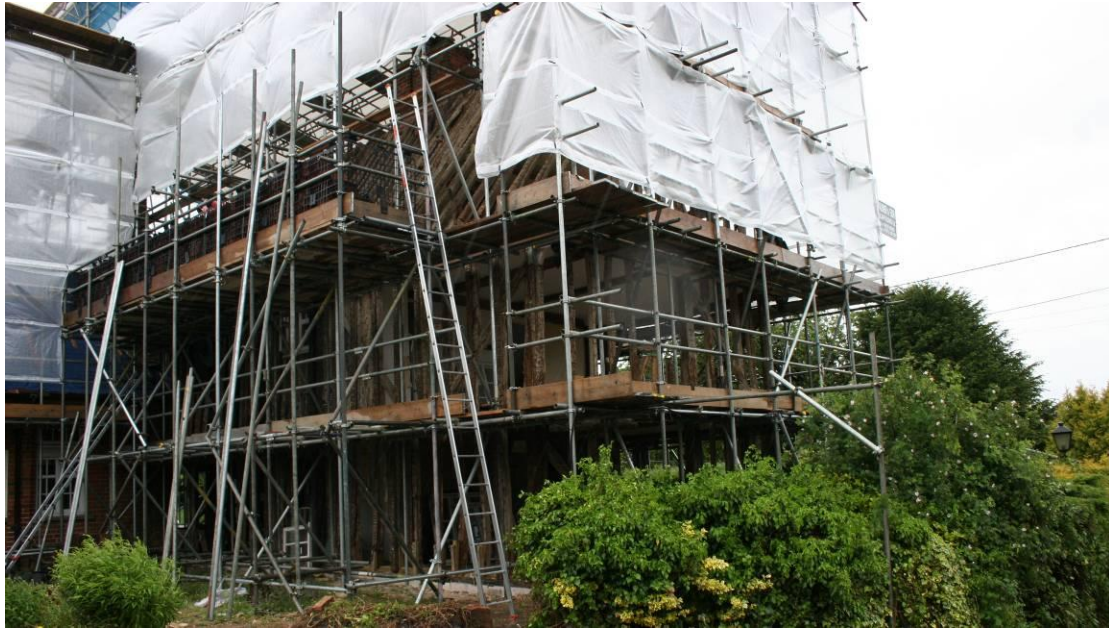
During the strip out the building was clad with protective sheeting. Looking SE.

The strip out revealed a highly altered frame with C16th origins but remodelled in the C18th to its present form. The south wall had been particularly dismembered and redesigned and it can be presumed it was fitted with sash windows which were replaced in the MC20th with Crittall style windows.

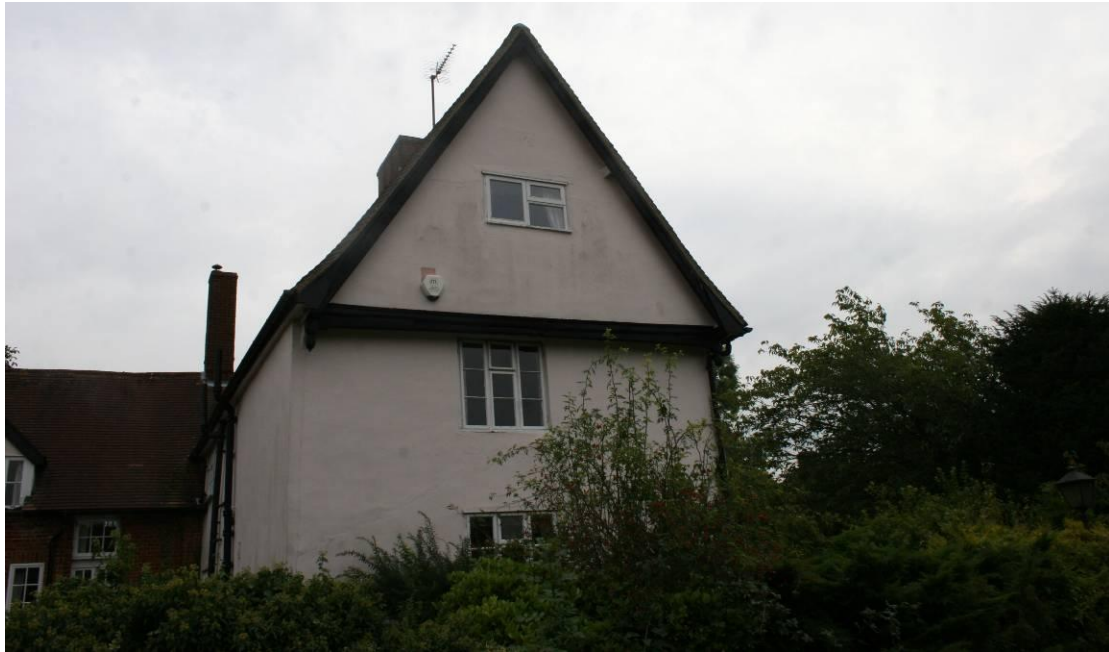
The western elevation of the timber-framed house.

The western elevation has a jettied gable with an attic room over a two storey timber-frame. There are two centrally placed Crittall style windows serving the ground and first floor and a LC20th simple casement for the attic room. The strip out revealed a nailed interrupted studwork primary braced frame made from reused timber almost certainly from the earlier frame.

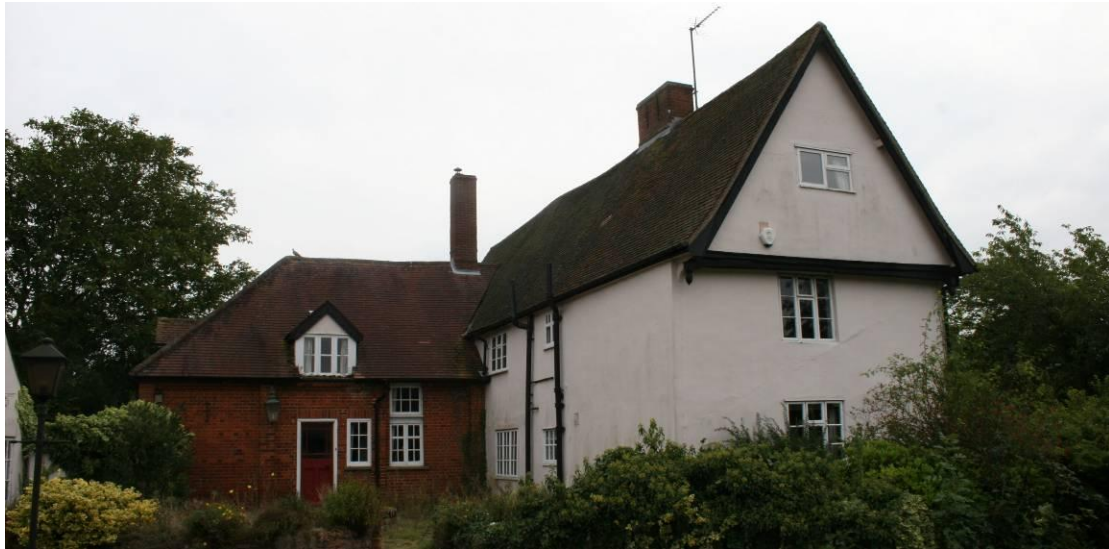
The western elevation showing the rear wing.

The house has been extended in red brickwork under a fully hipped roof clad with C20th plain tiles. The one and a half storey chalet style extension houses the Kitchen with bedrooms and bathroom above and is LC19th in character. The brickwork has pilasters giving three equal panels and there is a corbelled architrave beneath the eaves. The windows are mismatched and indicate an alteration in the LC20th, most likely to insert the staircase which has required an upper window. The brickwork indicates that the door was originally where the staircase windows are as the queen closer bricks are full height on one side. The doors and side window are inserted under soldier course lintels and have no closer bricks. The door itself is a peculiar mix of a Victorian style four panel door with over sized margin glazing. The brickwork is marked KK 1885.

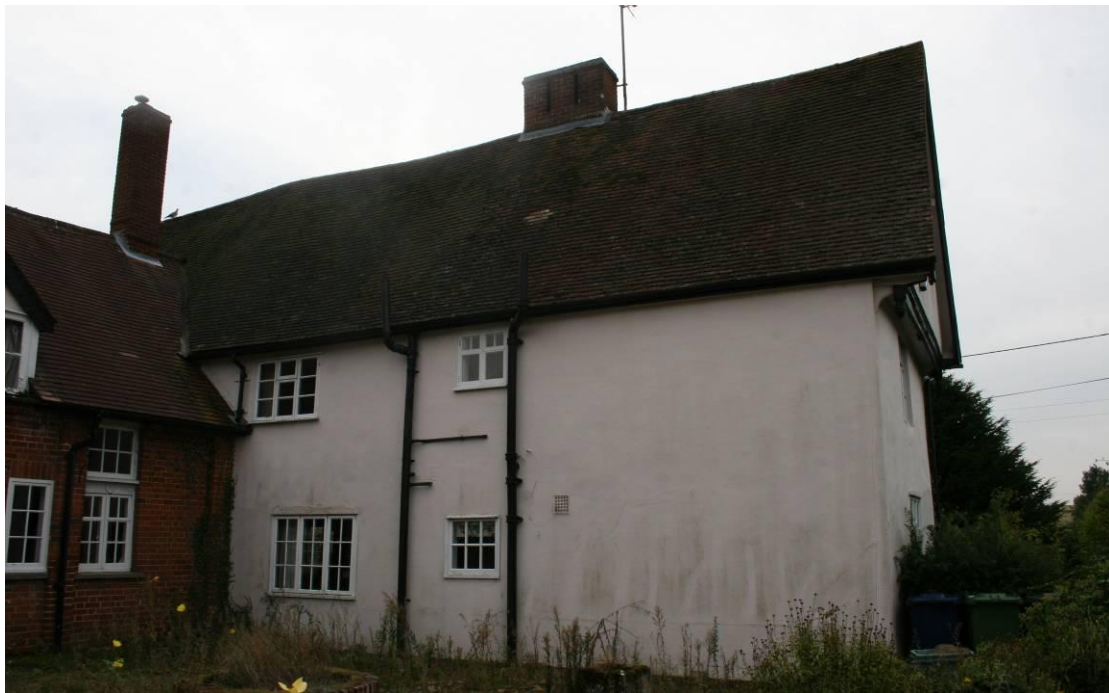
The northern elevation of the main house.

The northern elevation has seeming a randomly placed selection of windows from the 1930's to the LC20th and these respect the positions of the primary braces which are pegged and side nailed in position.

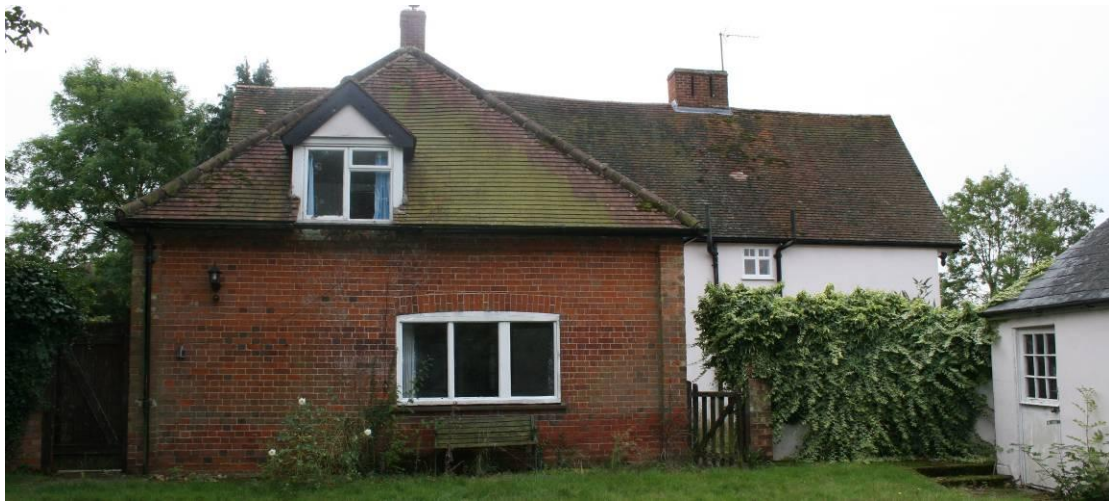
The northern elevation of the Rear Range.

The Rear Range has a LC20th 3 pane casement placed in an original opening that is correctly finished with closer bricks and a segmental curved lintel. Above and off centre is a dormer with LC20th casement window and deep barge boards with circular holes that matches the other on the western side as part of a LC20th conversion.

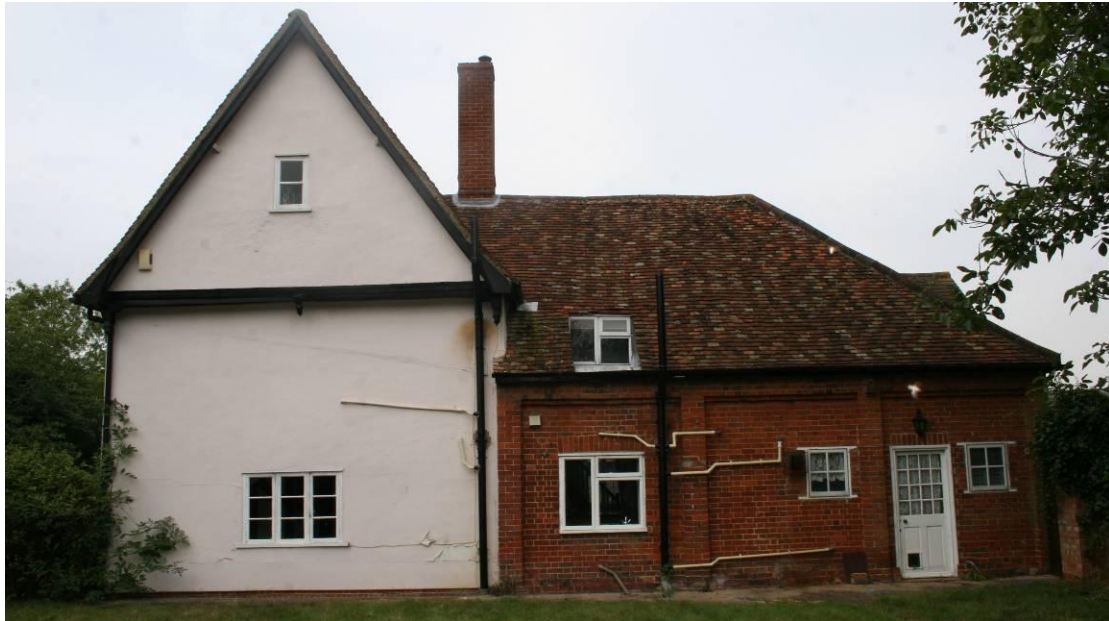
The eastern elevation of the House and Rear Range.

The eastern elevation of the Brick Range has three recessed panels defined by pilasters and a corbelled plat band. A LC20th casement has been let into the roof for the bathroom which is betrayed by an ungainly set of white plastic waste pipes. One large LC20th casement is set in an original window opening under a segmental arch. The MC20th half glazed door is inserted and under a soldier course lintel. The two top hung four pane casements are crudely inserted and pointed with grey cement.

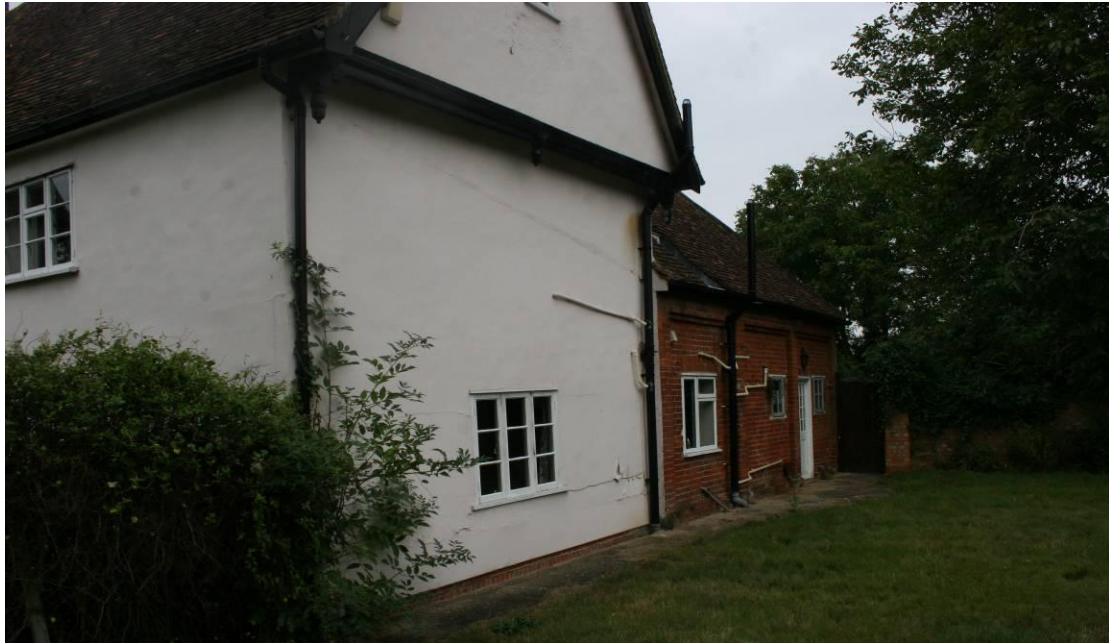
The jettied gable for the attic rooms. The exposed frame is shown below.

When the frame was stripped it became more apparent that the entire western half of the House was a new building from c.1800 (+or- 20 years). The wall frames are composed of deep section nailed interrupted studwork with primary braces. Many of the studs are skew nailed at the midrail. There are no full height storey posts instead the frame are spilt above and below the midrail.

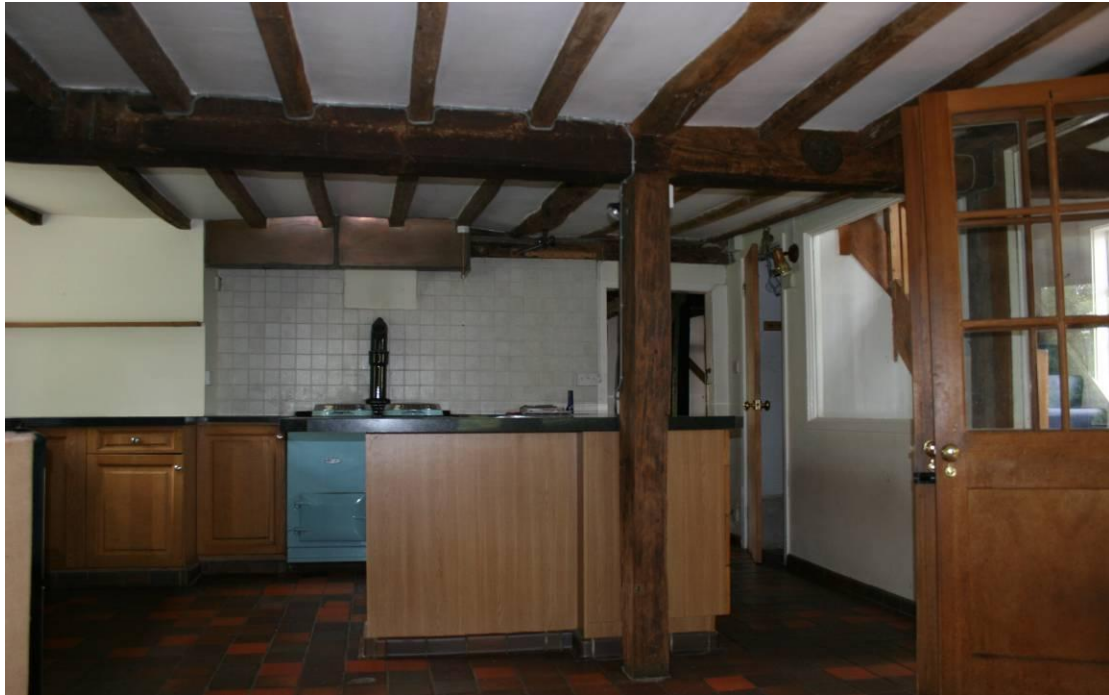
Looking S in the Rear Range at the Kitchen.

The Rear Range contains the modern Kitchen and Dining Room. The ceiling has an exposed timber frame with large transverse joists supported on timber props. There are no mortices for partition walls but the span is too wide for the joists not to sag. Instead there are shadows and nail holes for side nailed studs which would indicate a reuse of the frame in the LC18th or EC19th. Originally there were three rooms with doorways near the middle.

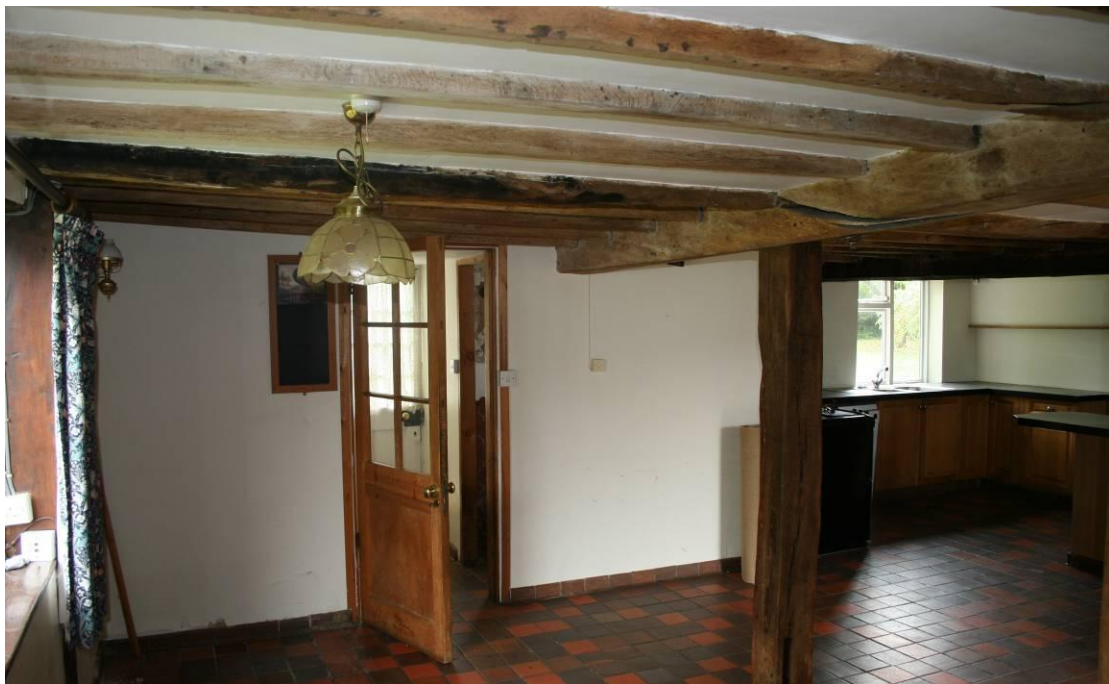
Looking E in the Rear Range.

The exposed frame has been cleaned in various episodes and a large number of LC20th repairs and insertions carried out. The area over the Kitchen is most convincing as it still retains the sooting expected from being over a fireplace. The northernmost transverse main joist has a massive split that has been arrested with C.1800 style wrought iron bolts and is also likely to be original. The common plain joists are of varying sections and some are much less convincing than others. The originals have soffit tenons.

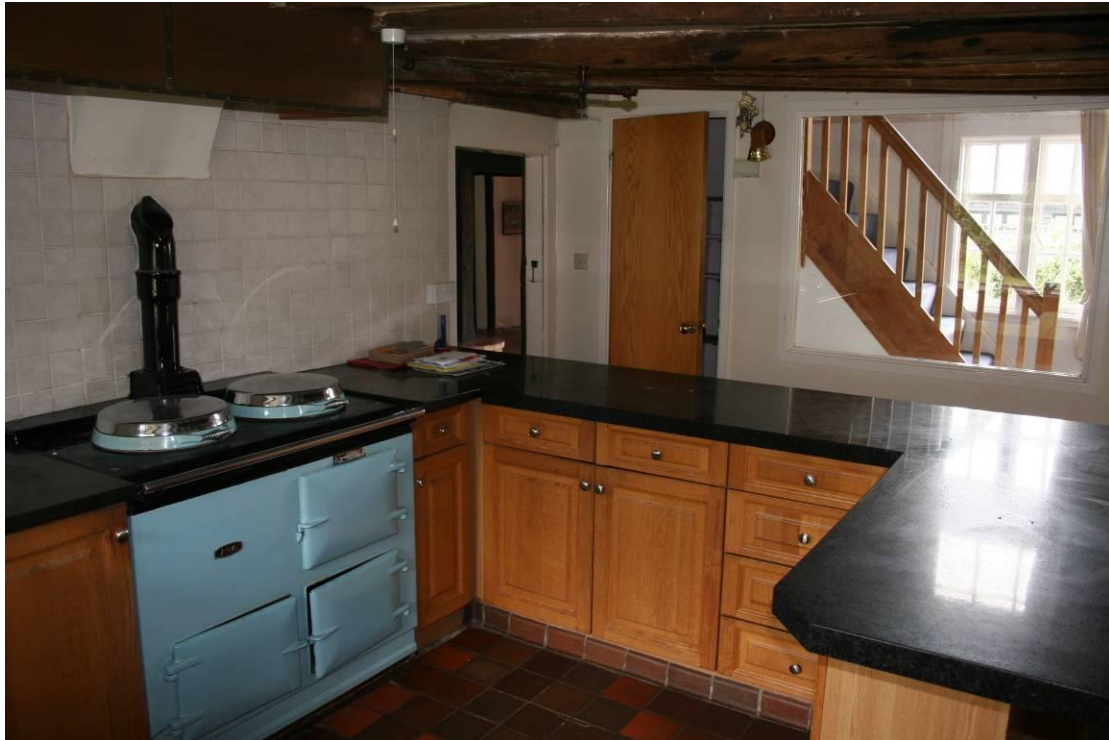
Modern kitchen with Aga. The inserted staircase is also recent.

There is a LC20th inserted staircase which has been enclosed in a glass booth presumably to conserve heat and prevent cooking smells going upstairs.

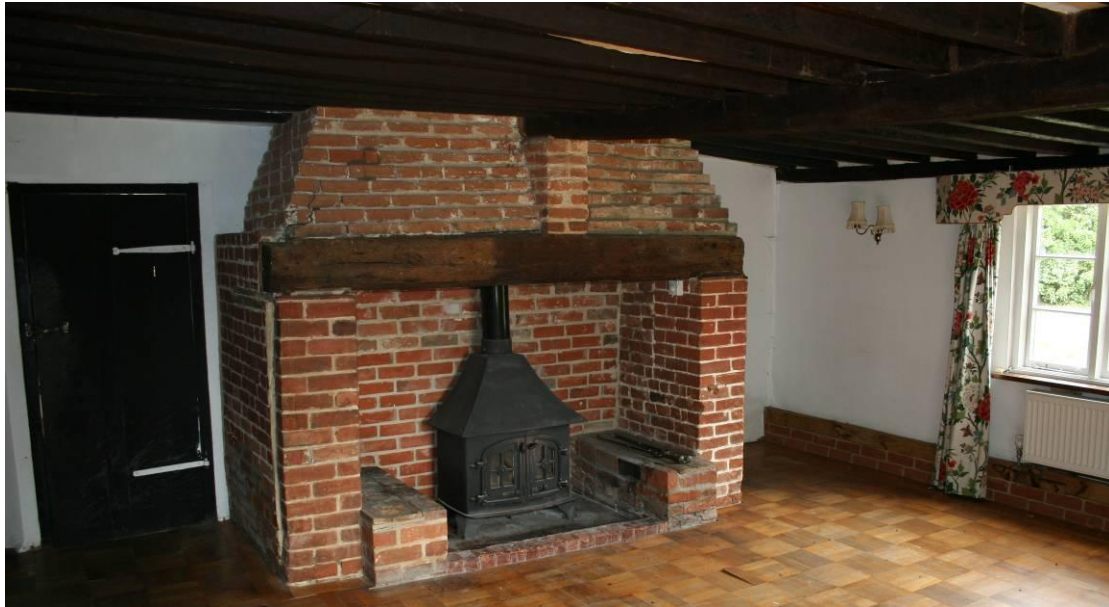
The fireplace in the Sitting Room. Looking NE.

The Sitting Room has a large red brick firestack that has been almost completely rebuilt below the bressummer in the LC20th and the upper section which has 2in Tudor style bricks pointed in grey cement. The bressummer itself is a reused timber from elsewhere as the soffit chamfer continues right through into the brickwork repairs instead of being correctly stopped. There is some EC19th style brickwork in the outer flanks with very white lime mortar and timber stakes to apply panelling to.

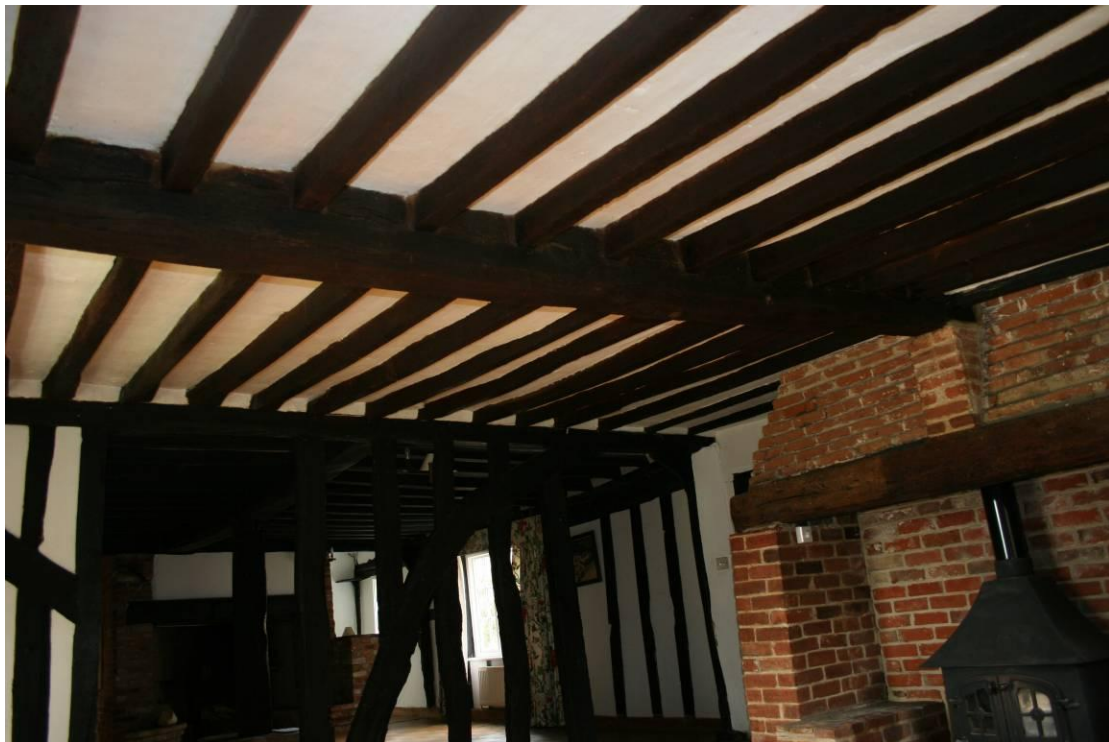
The exposed beams over the Sitting Room.

The heavy main joist has a deep chamfer. The common joists are plain and set on edge. They have soffit tenons with refined entry mortices. A central pillar has been built in to support the failing end of the main floor joist. Originally the fireplace would have been plastered over and ruled to look like stone. Its present appearance is a LC20th interpretation common to that era.

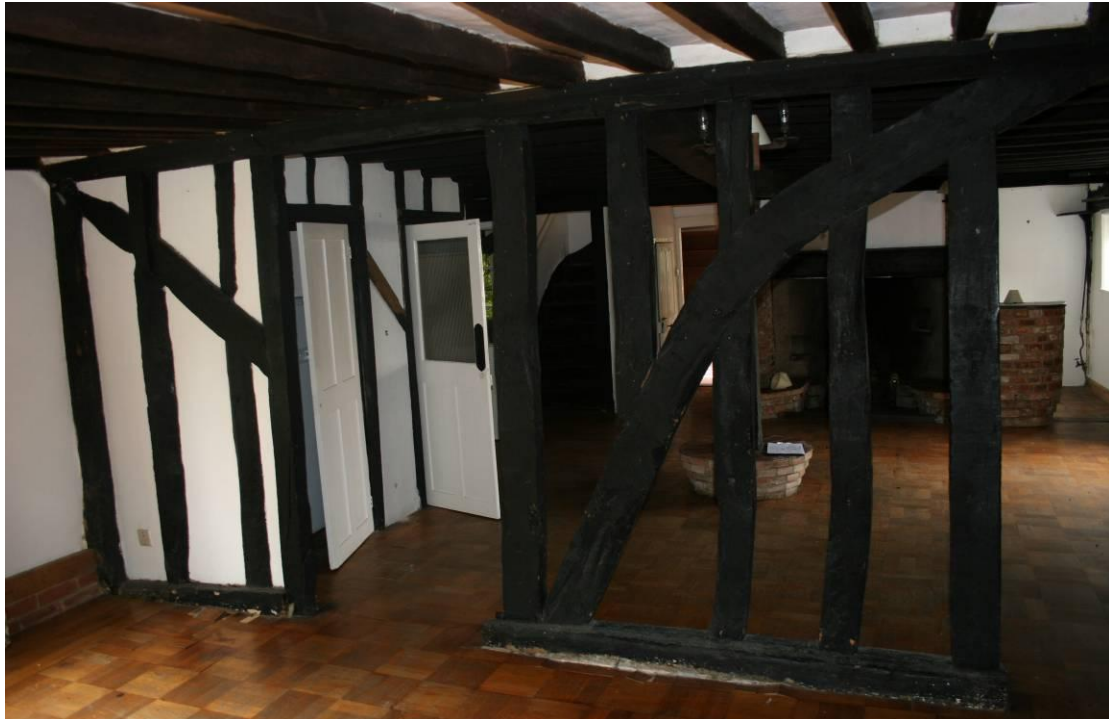
The frame of the wall common with the Living Room.

The wall frame between the Sitting Room and Living Room represents a boundary between the older, remodelled frame of the Living Room and Lounge and later c.1800 frame which continues up to a later roof structure. The visible frame is however a modern caprice and does not reflect the design of the rest of the house. Originally there was a very large central post taking the weight of the wall and this has been replaced by a very short interrupted stud nailed on the highly curved brace. All of the joints are nailed and none of the wattling darts and mortices line up. There is a similar structure near the porch door.

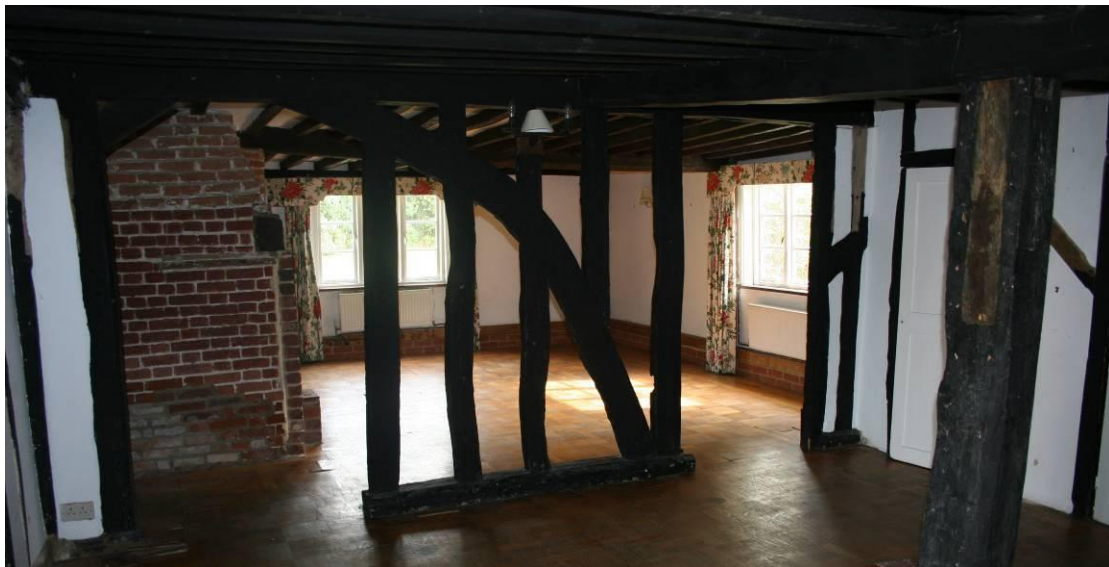
Looking E in the Living Room.

The framed floor above has a heavy axial main joist with chamfers and stepped cyma (lamb's tongue) stops. The common joists are plain, nearly square and set on edge indicating a C17th design. The main joist has sagged and is supported on a post cut from another main joist of which the other half has been used as the bressummer for the inglenook fireplace which has been entirely rebuilt in the 1970's.

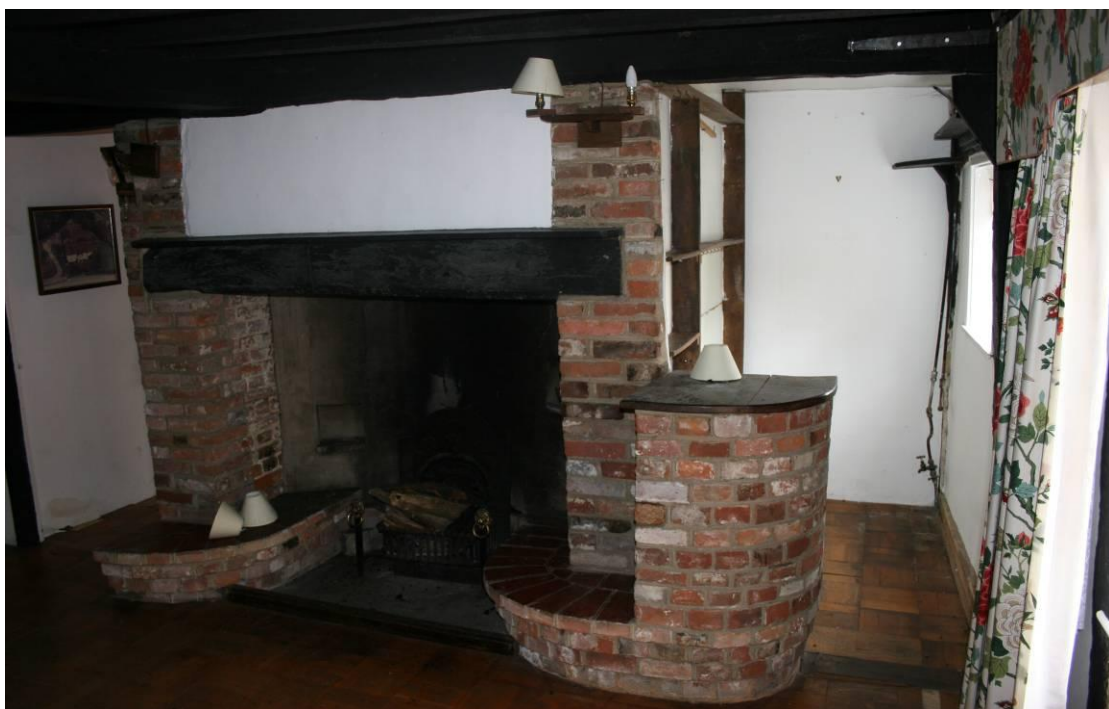
The 1970's style fireplace come drinks bar.

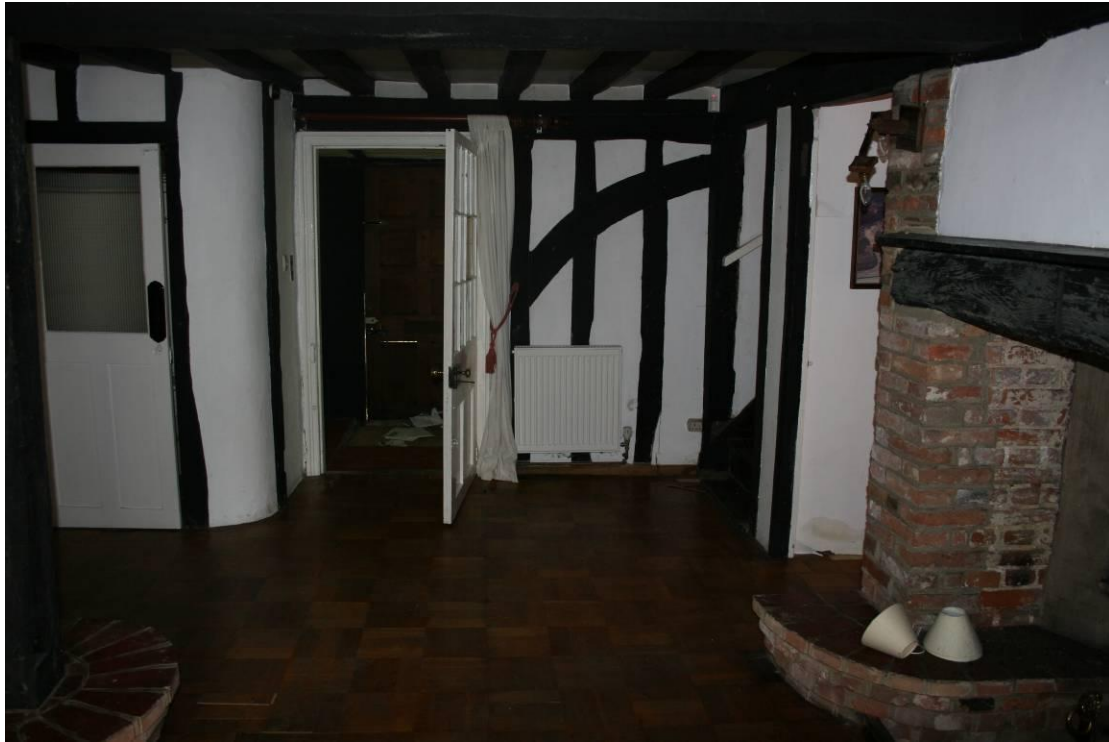
Looking S towards the Porch.

Two LC20th timber framed closets have been inserted into the Living Room for a coat cupboard and utility room. The wall framing into the porch is not convincing and again LC20th. The glazed door is unusual and has been made from a 6 panel Georgian style door. The staircase in MC20th and the soffit can be examined under the stairs where the Cellar steps descend.

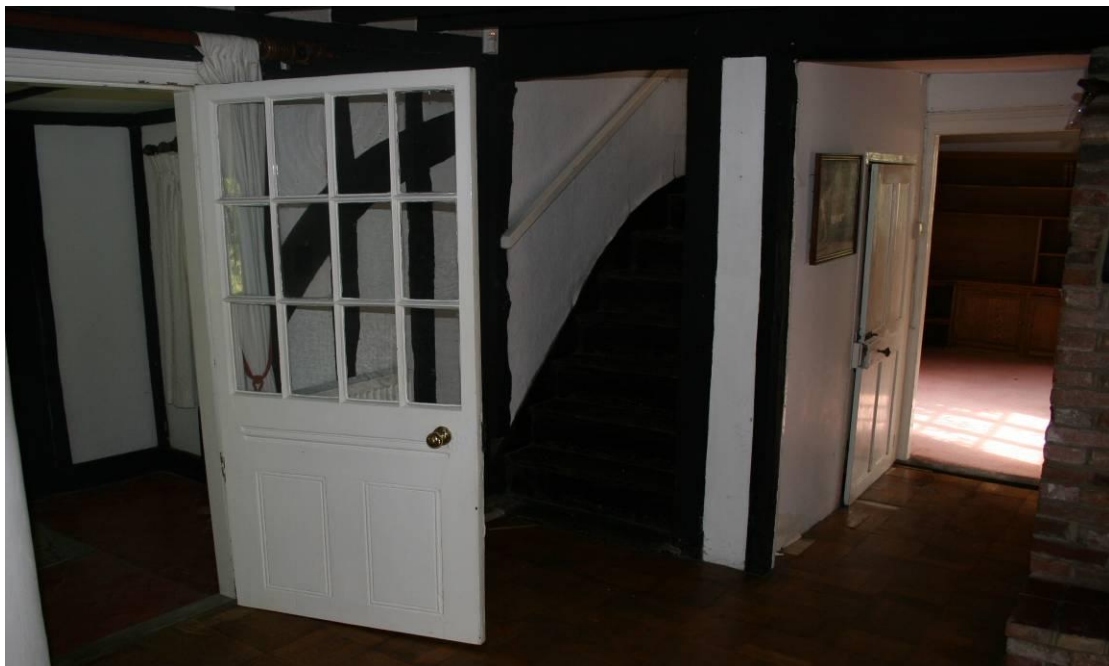
Looking SW towards the stairs and doorway down to the Cellar.

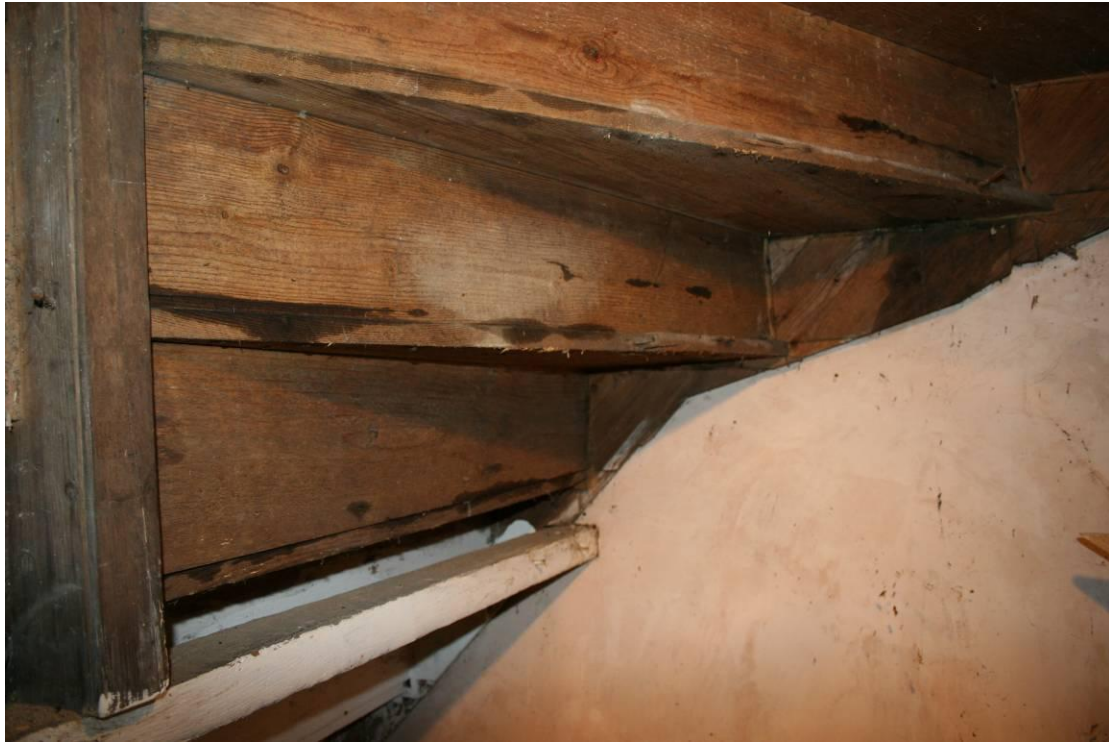
The soffit of the stairs in the Living Room.

The staircase is made of rough pine floorboards nailed together. Joints for the larger treads have been made with loose tongues (splines) requiring the grooves to be machine routed. There is a brick staircase down into the Cellar of EC19th white paviors and a section of the floor is also finished in similar bricks. Modern repairs are evident.

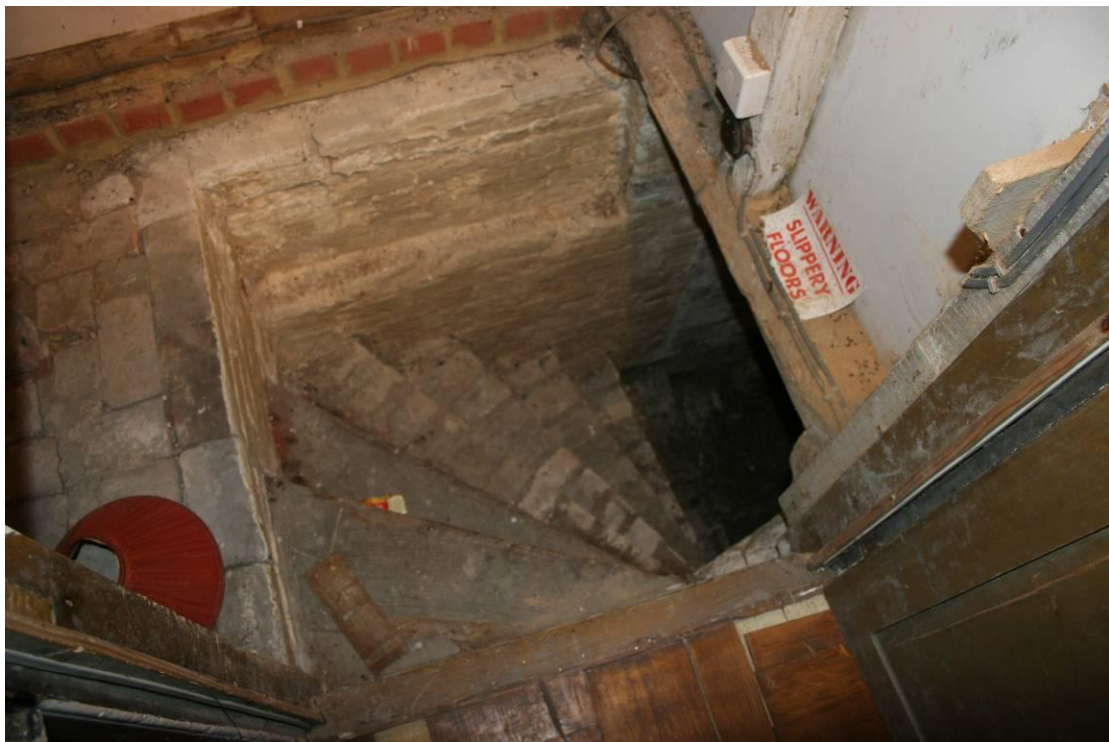
The brick steps down to the Cellar.

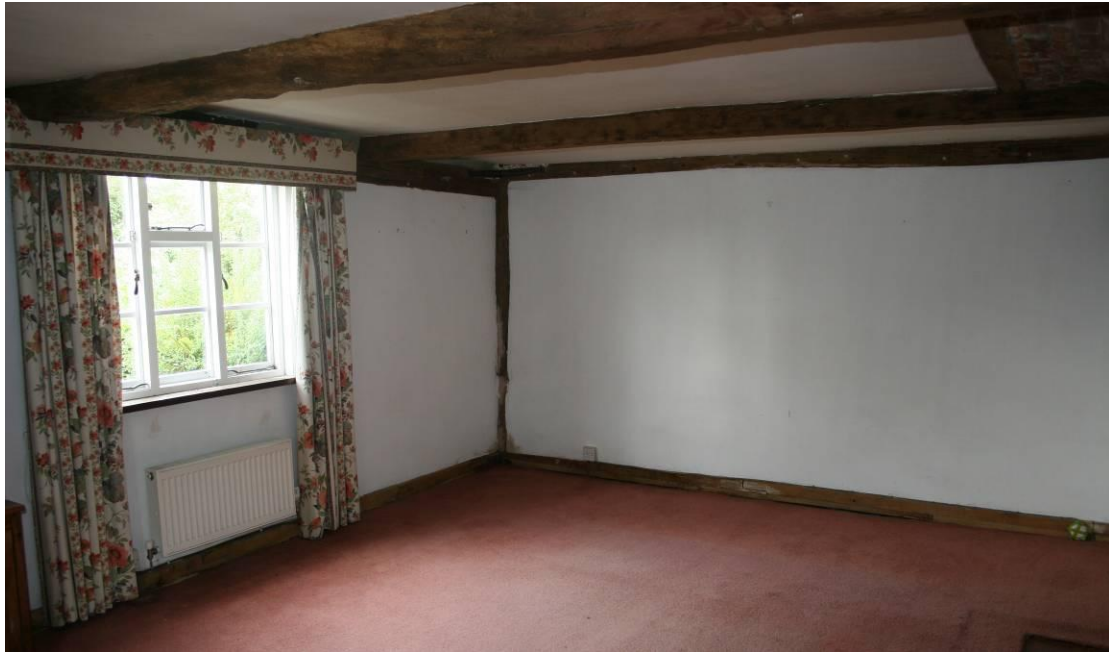
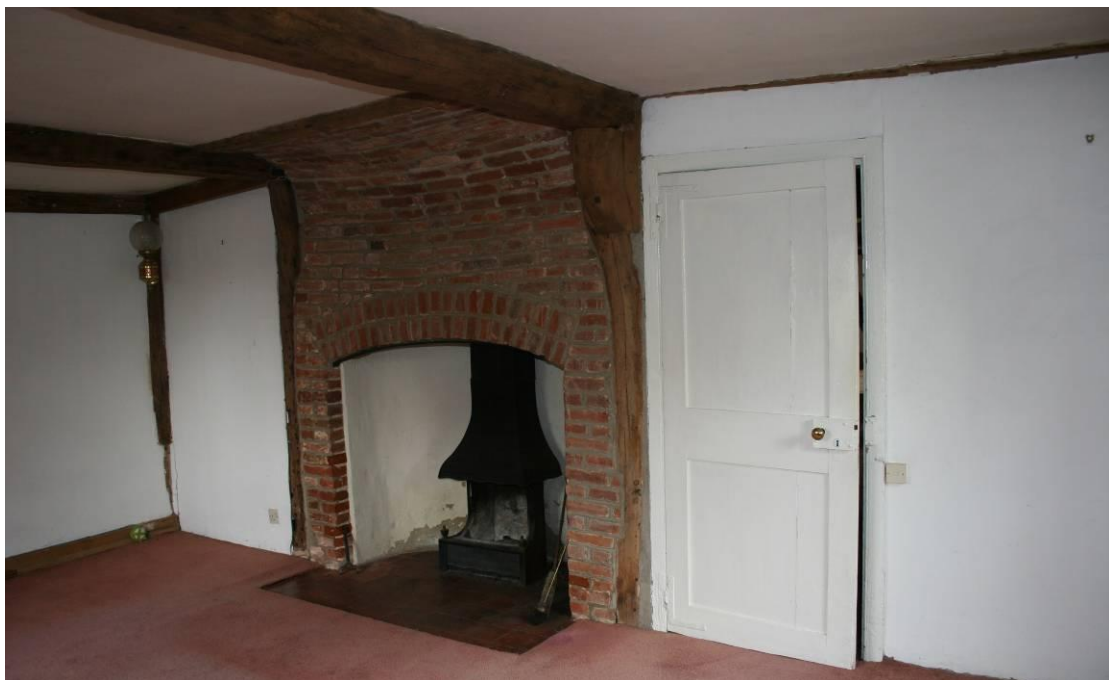
Looking NW in the Lounge.

Looking NE in the Lounge.

Two large deep chamfered axial joists are visible in the floor frame and are supported on jowled posts that turn into the frame rather than in the plane of the joists. An additional support has been clout nailed on. This would suggest a remodelling of the frame to incorporate the brick fireplace which is of EC19th design.

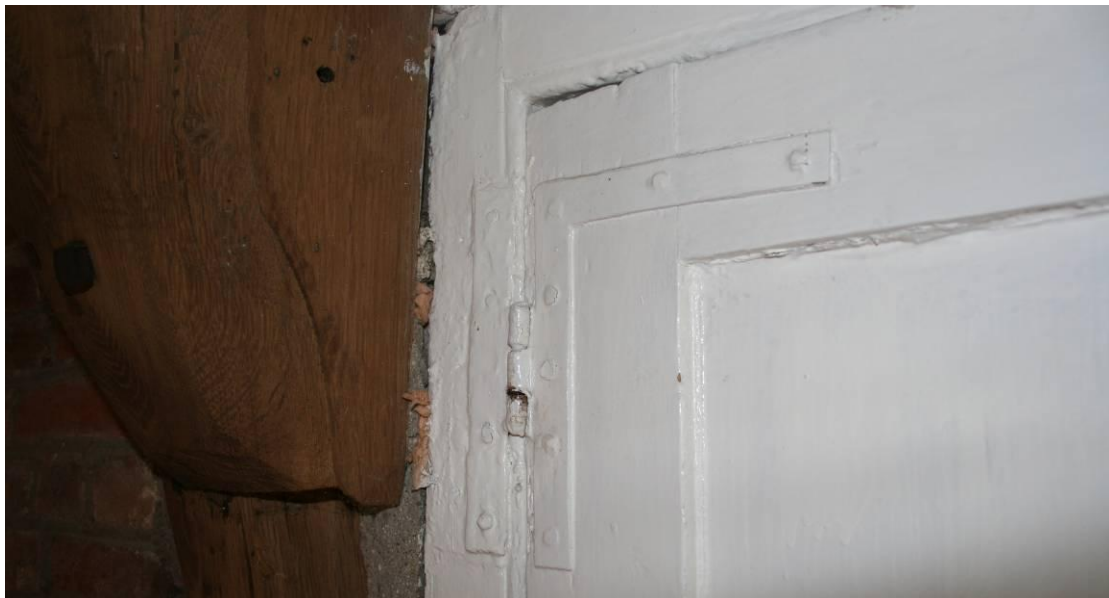
Detail of the door hinge.

The door into the Lounge is an original EC19th two panel Georgian style door hung on IL hinges which crucially are nailed to the moulded door frame indicating it was fitted in the first 20 years of the C19th when these doors were briefly popular for the main rooms.

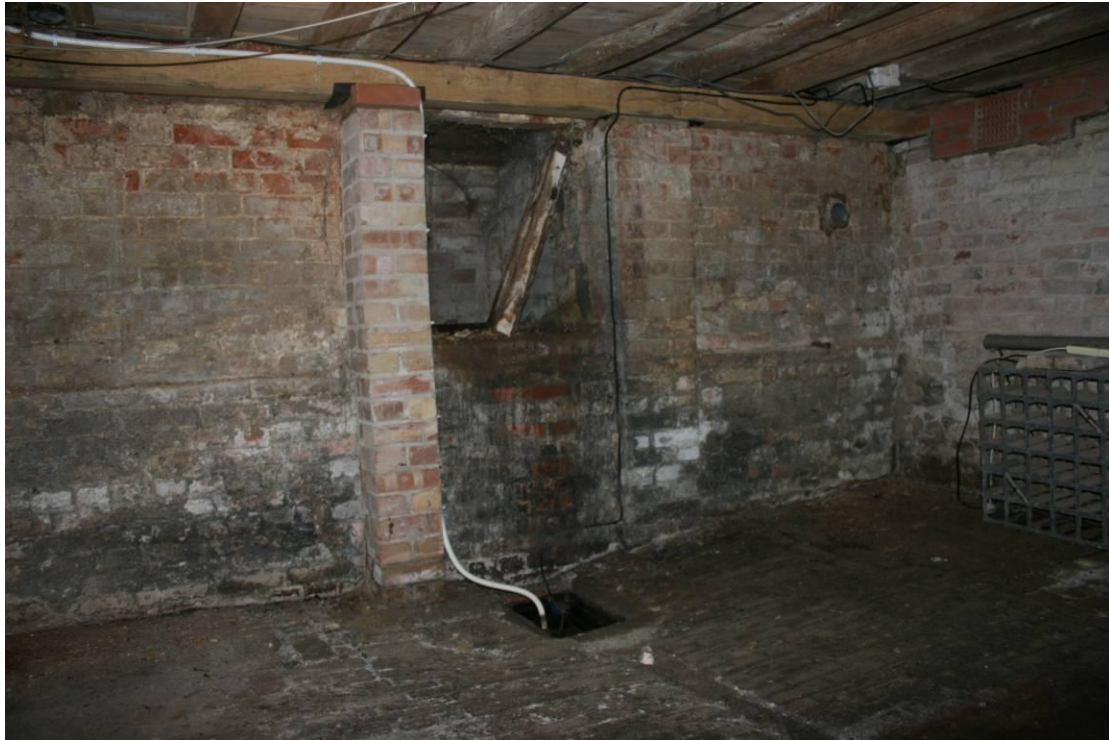
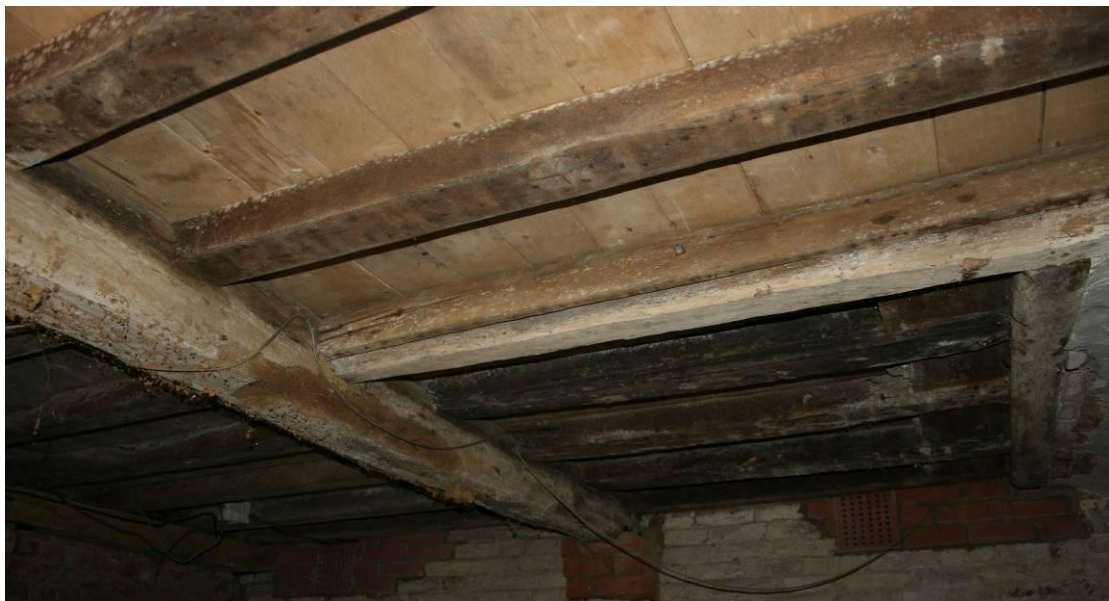
Looking NW in the Cellar.

Looking N at the floor of the Lounge.

The Cellar is built of C.1800 red bricks set in sandy lime mortar laid in Flemish bond. The framing for the floor is made from a reused C16th or C17th frame that was quite worn when repurposed. The ends of the common joists have been cut to follow the contours of the eroded main joist.
