Street Farmhouse, Main Street, Shudy Camps, Cambridgeshire CB1 6RA.
Recording and analysis of the house. Surveyed 19 09 2016/04 06 2017

Scope of this Report

This report describes and analyses the farmhouse from records made during visits before (19 09 2016) and during its refurbishment (04 06 2017).

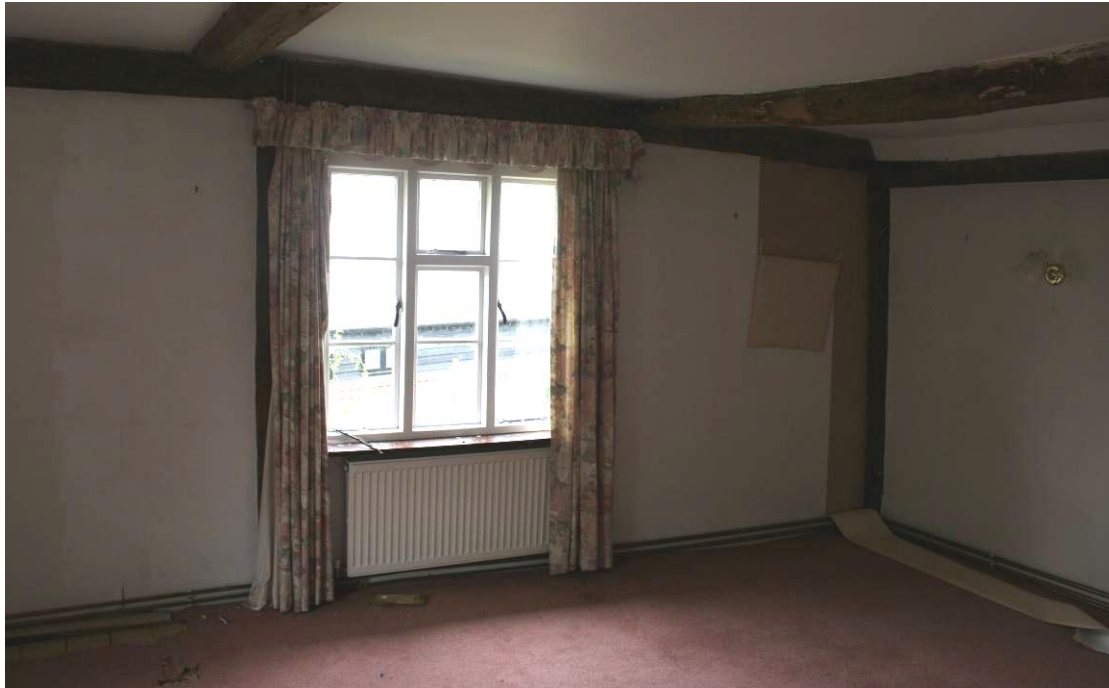
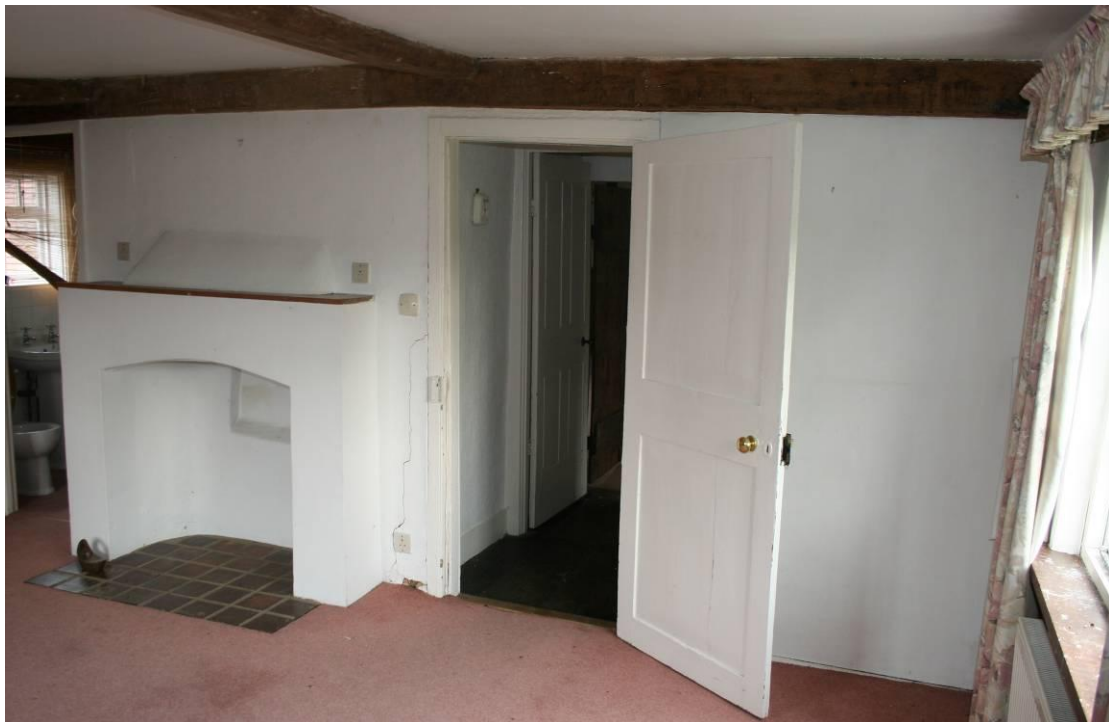
Looking W in Bedroom 1.

Looking E in Bedroom 1.

Bedroom 1 has an EC19th two panel door with IL hinges nailed to the door but screwed to the frame. There is a simple brick fireplace of EC19th form added to the main stack with a LC20th tiled hearth. The top plates and central axial main joist is exposed.

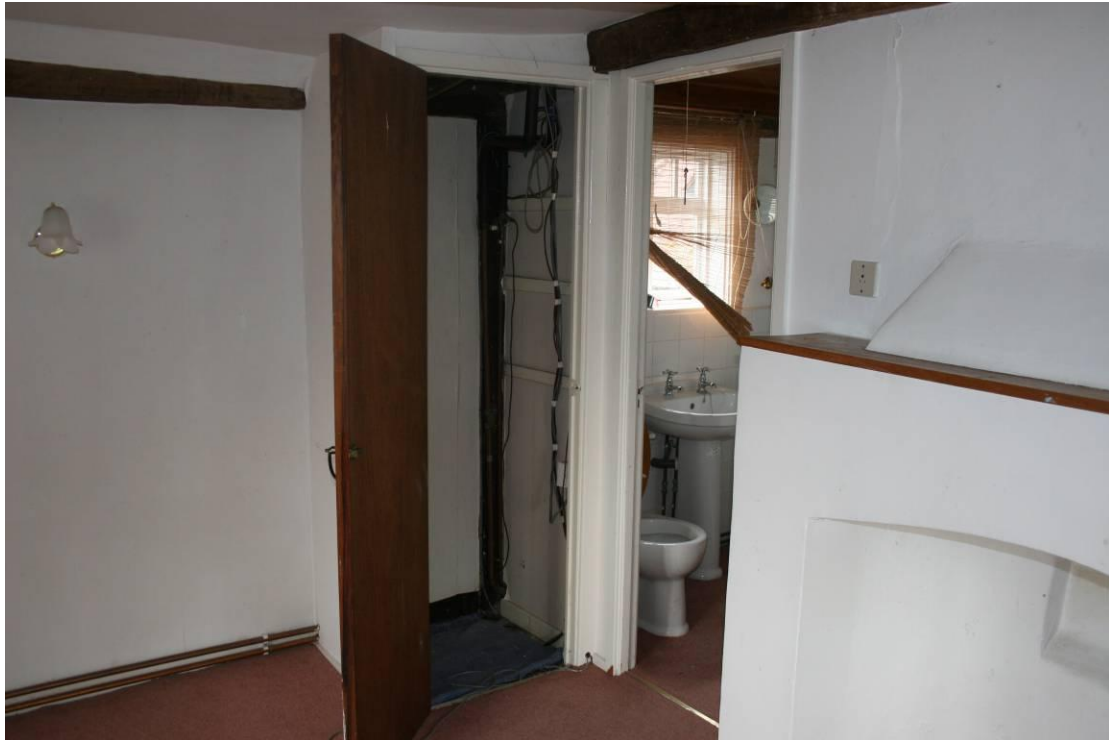
Airing cupboard in Bedroom 1.

An airing cupboard of the 1950's remained in Bedroom 1 and could be dated by newspaper stuffed into the cracks in the walls from the Radio Times of December 6 1957. The stripped frame revealed an earlier oak frame with full height studs that had been cut up to insert primary braces and nailed interrupted studwork. One primary brace was later cut through to insert a larger window in the western wall.

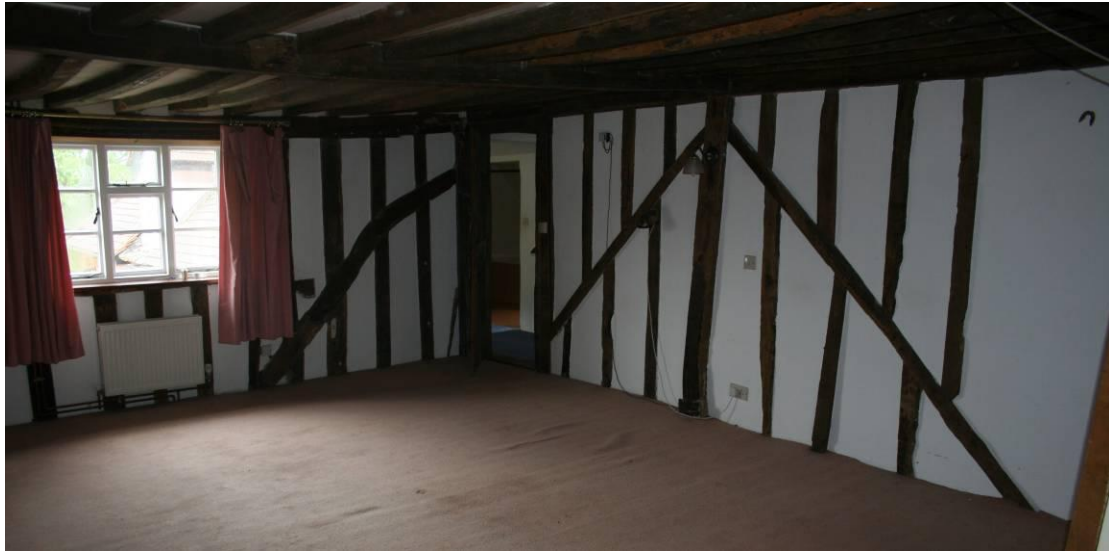
Master bedroom looking NE.

The stripped frame revealed that a second axial joist has been placed above the first and secured with wrought iron straps and a large centrally placed forelock bolt. Forelock bolts are the pre-cursors of threaded bolts (which do not become common until c.1800) and indicate a repair in the C17th or C18th. The timber itself is a pitsawn elm tree trunk cut in half.

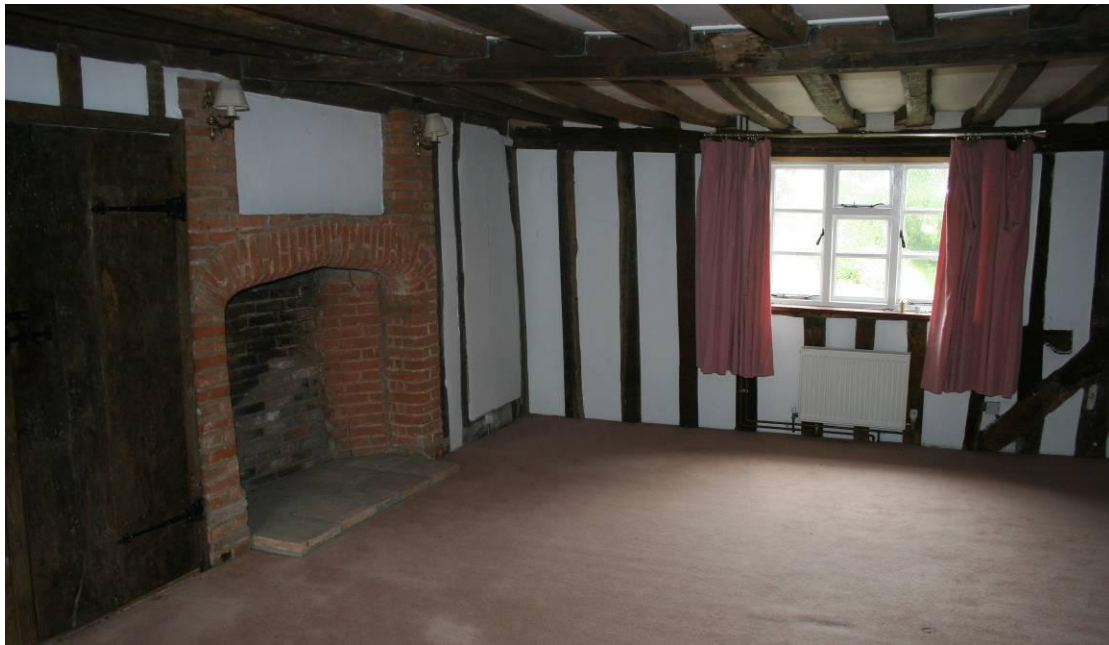
Master bedroom looking NNW.

The Master Bedroom has a fully exposed frame of which the north wall only is of the original design. Here there are full height studs and a cranked brace with is trenched across the inside of the studs. It seems likely this has been used as the pattern for the LC20th fake work on the ground floor. The eastern wall has primary bracing with nailed interrupted studwork made of reclaimed timbers of different sections.

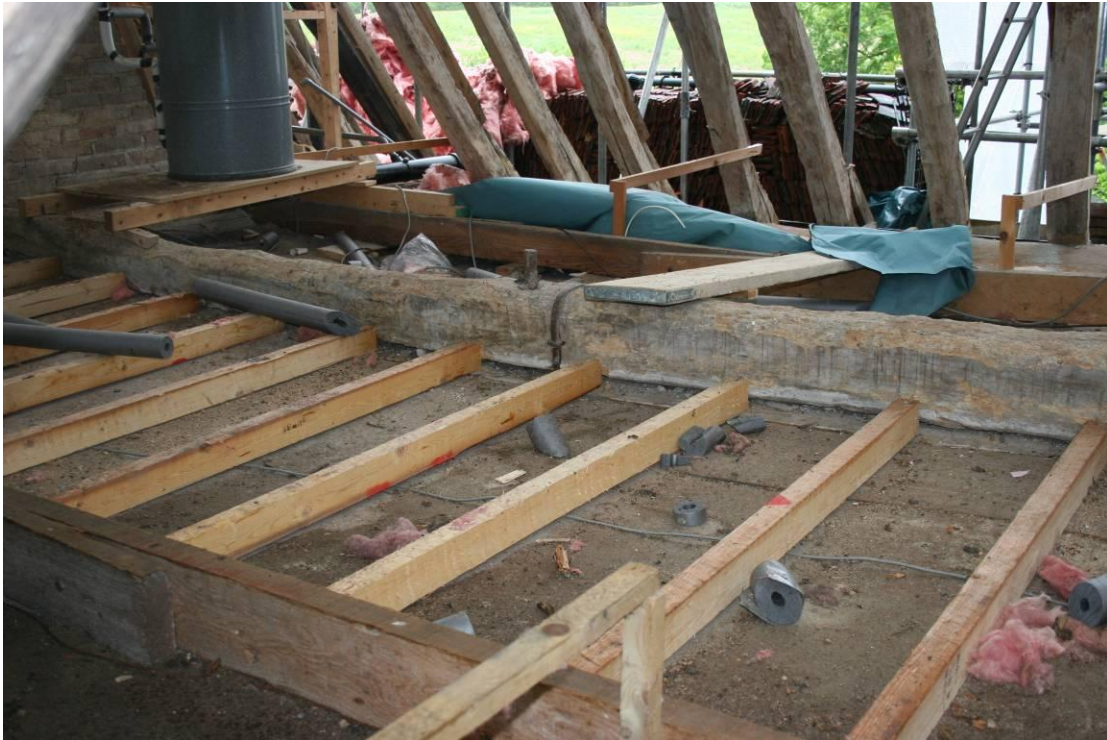
The ceiling frame above the Master Bedroom. Looking NW.

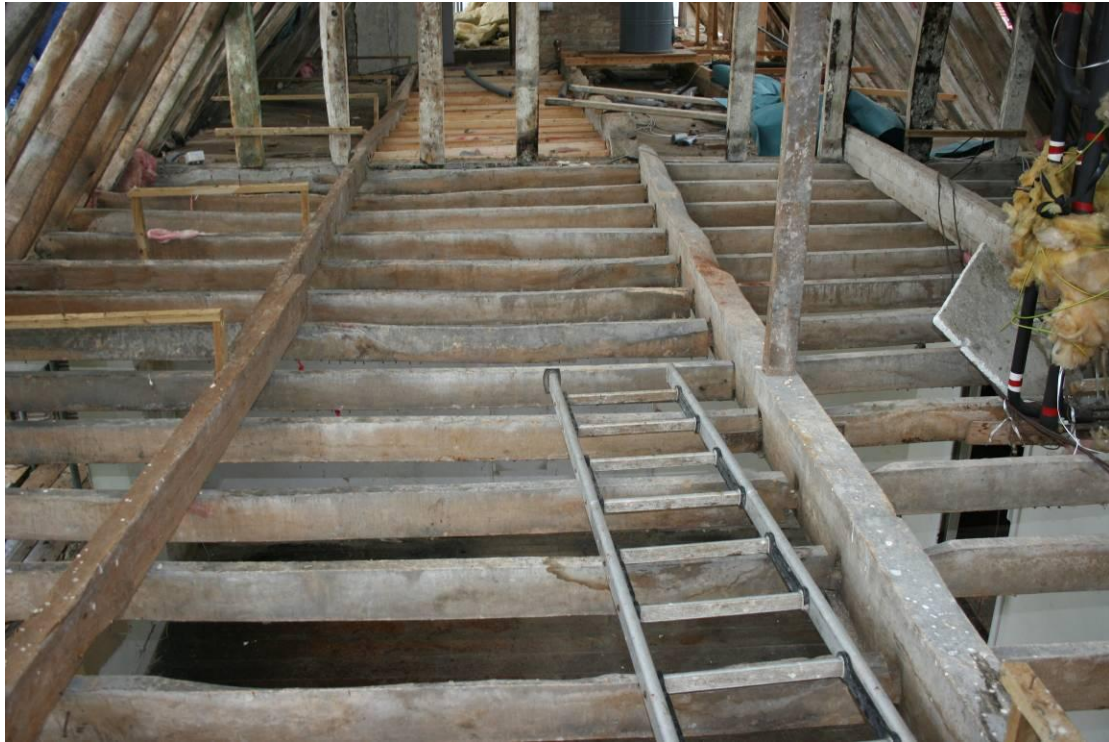
The frame over Bedroom 2. Looking W

The frame above Bedroom 2 is of c.1800 design and fabric with elm joists set on edge with centre tenons with refined entries. Ironwork straps are inserted to prevent spreading. The mass of the joists indicates an attic room was put in above.

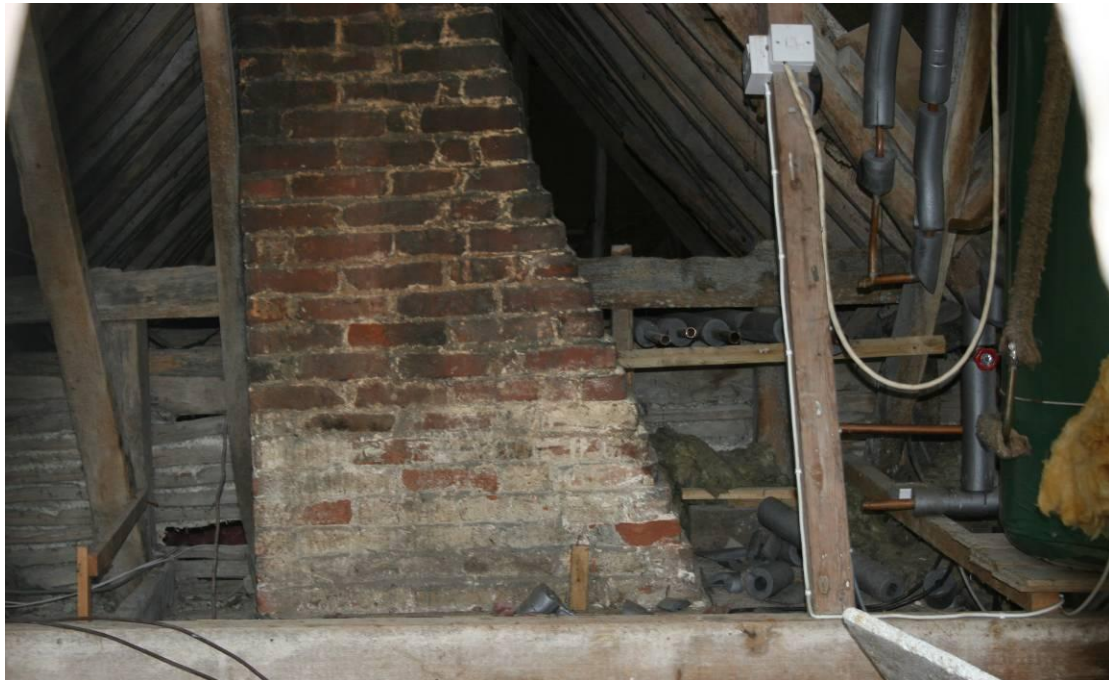
The chimney stack over Bedroom 2. Looking S.

Bedroom 2 lies within a later development of the house than Bedroom 1 and the Master Bedroom. The walls and floors as well as the roof structure above are of Georgian design. The chimney although made of Tudor bricks has been remodelled using sandy lime mortar of Georgian characteristics.

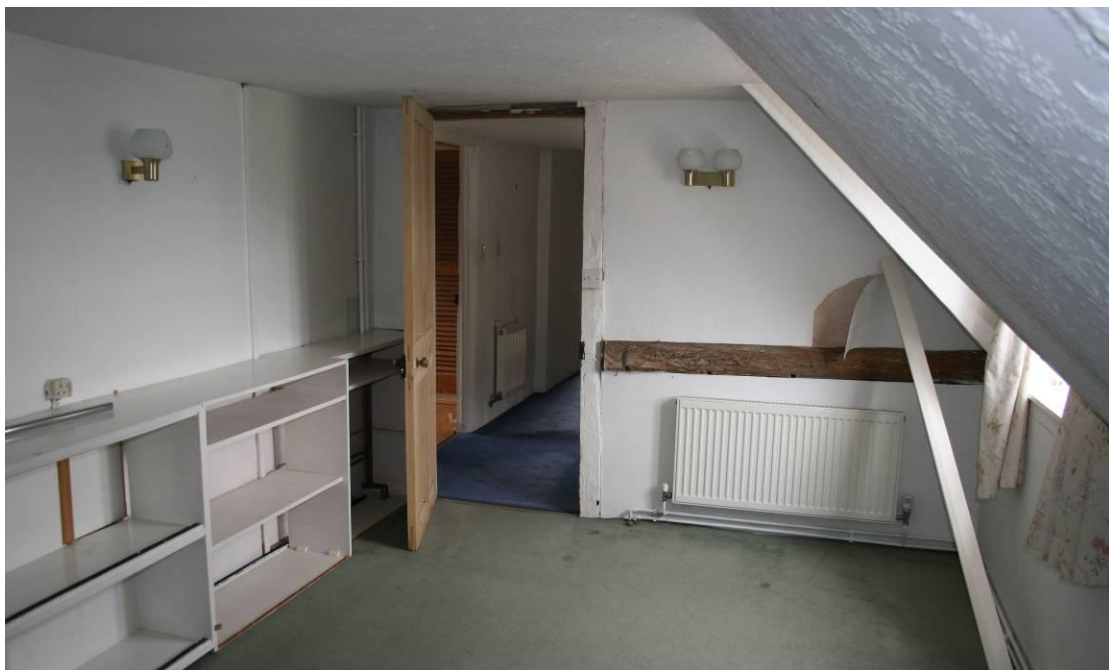
Looking S in Bedroom 3.

Bedroom 3 is an L shaped room wrapped around the very large Bathroom. The lightweight partition walls are LC20th and most probably from the 1970's. The tie-beam has been cut through to insert a Victorian style four panel door in its original frame. The Bathroom has an early partition wall and the doorframe is fitted with a pintle hinge and wrought iron hasp.

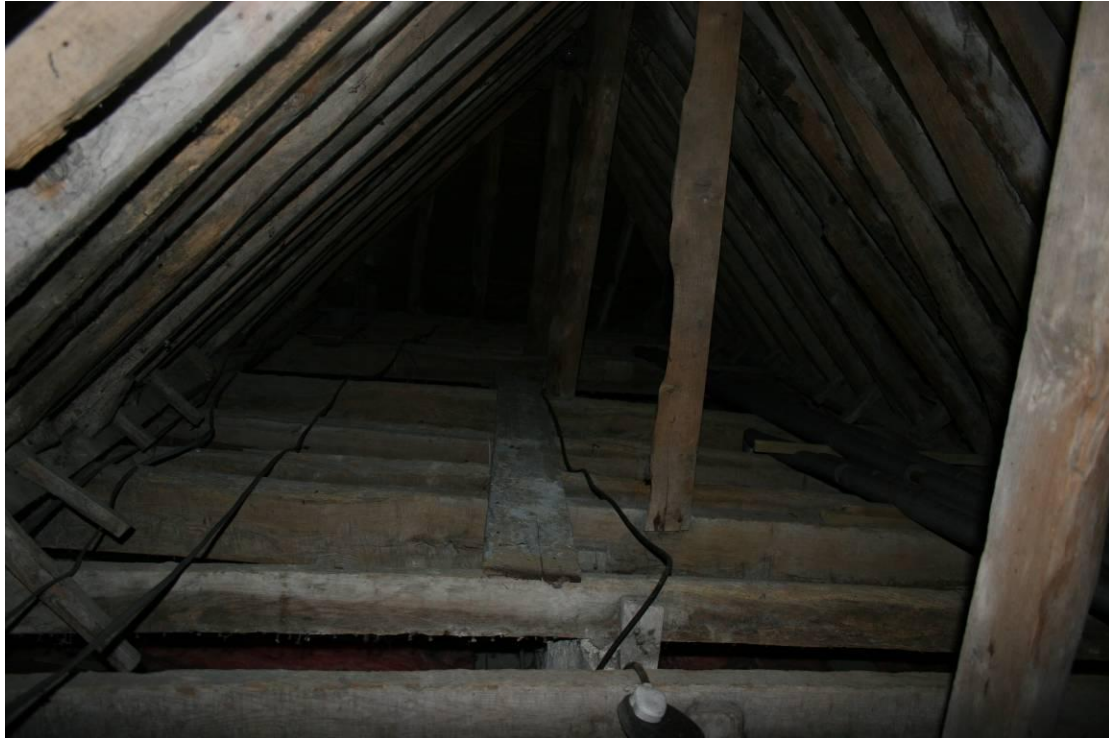
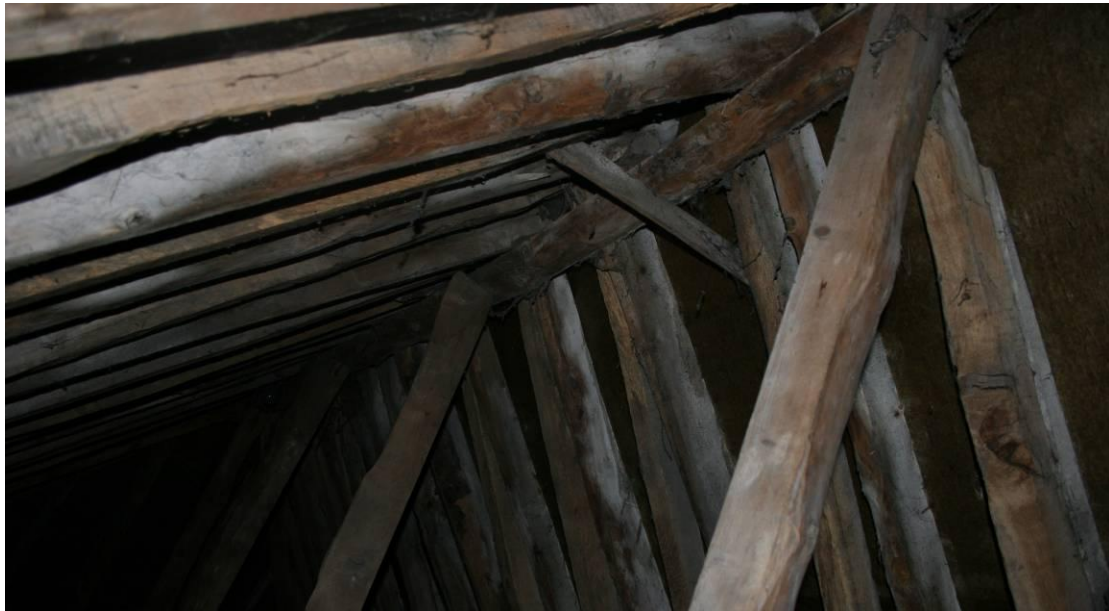
The roof structure over the Rear Range looking N.

The apex of the rafters over the Rear Range looking N.

The roof over the rear range is made of paired rafters each with their own collar supported on a ridge piece that is supported by nailed on struts. The partition wall below (with the Bathroom door) is side nailed onto the collars. Many of the timbers are sliced poles and may be knotty pine. The roof has been retilled in the LC20th between about 1965 and the 1980's inserting an asphalt membrane.

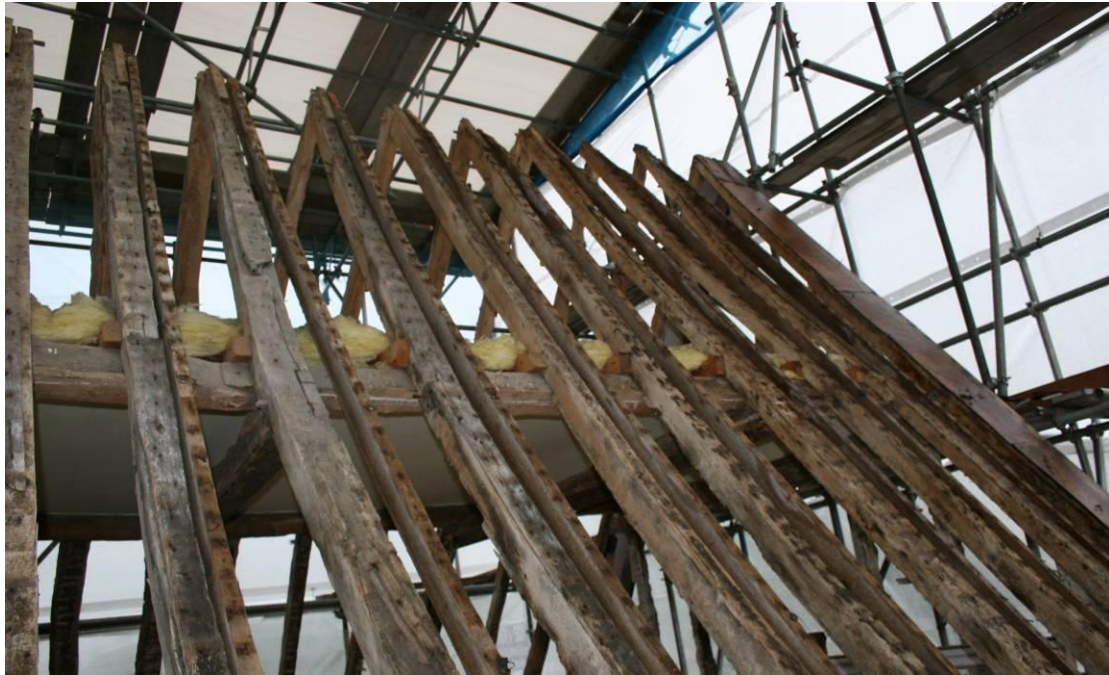
When the frame was stripped it could be seen that the whole roof had been reworked in the M-LC20th with the addition of many softwood furrings and intermediate 2x4in rafters. The roof over the western side had also been reworked to remove the curved windbraces which are evident over the centre of the building.

The roof over the Western Attic Room. Bedroom 4.

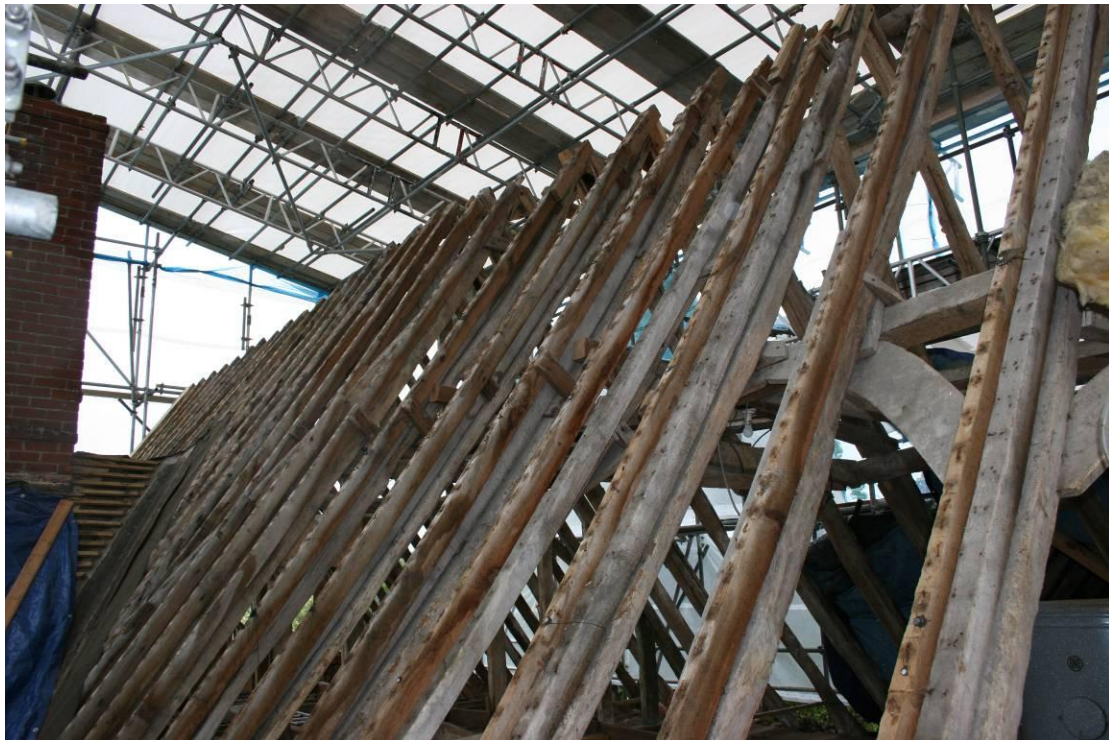
The roof over the Master Bedroom. Looking SE.

The central roof has curved windbraces that connect the principal rafters to the purlins. The collars are centre tenoned into the principal rafters and additional birdsmouthed struts added to prevent sagging. The flat, tapered rafters are paired and pegged in the same fashion.
