Shemmings Farm Buildings, Hardys Green, Birch, Essex. CO2 0NY.
Recording and analysis of the farm buildings. Surveyed 08 05 2017.

Scope of this Report

This report describes and analyses the buildings with a view to mitigating for and informing future development.

The report adheres to Historic England Level 2 as outlined in Historic England. Understanding Historic Buildings – A guide to good recording practice. 2016. Page 22.

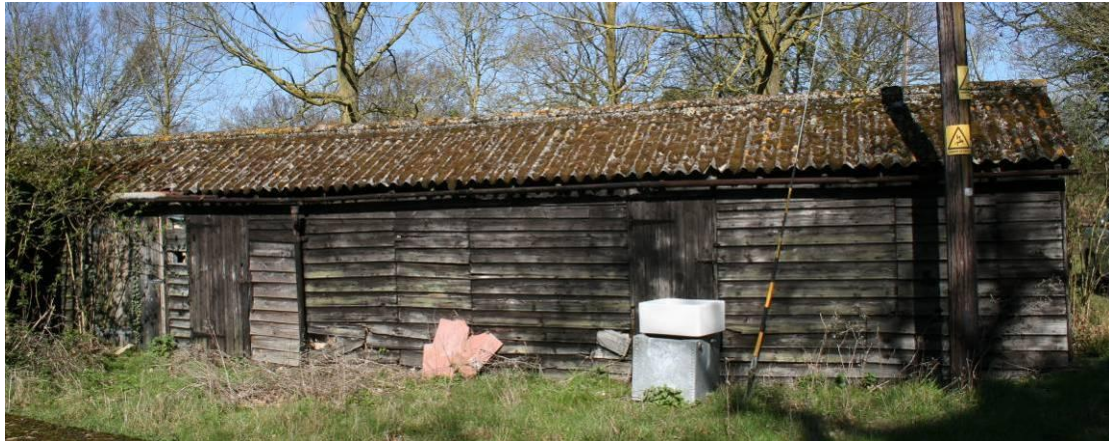
Southern elevation of the Sheds.

The Sheds are three conjoined timber-framed buildings that have been highly altered in the LC20th. The primary braced interrupted studwork frames are clad with MC20th weatherboards, some hot tarred and some cold brushed, fixed with wrought iron and French nails. The southern, farmyard side, is equipped with narrow, stable like door openings that have often been blocked and others inserted.

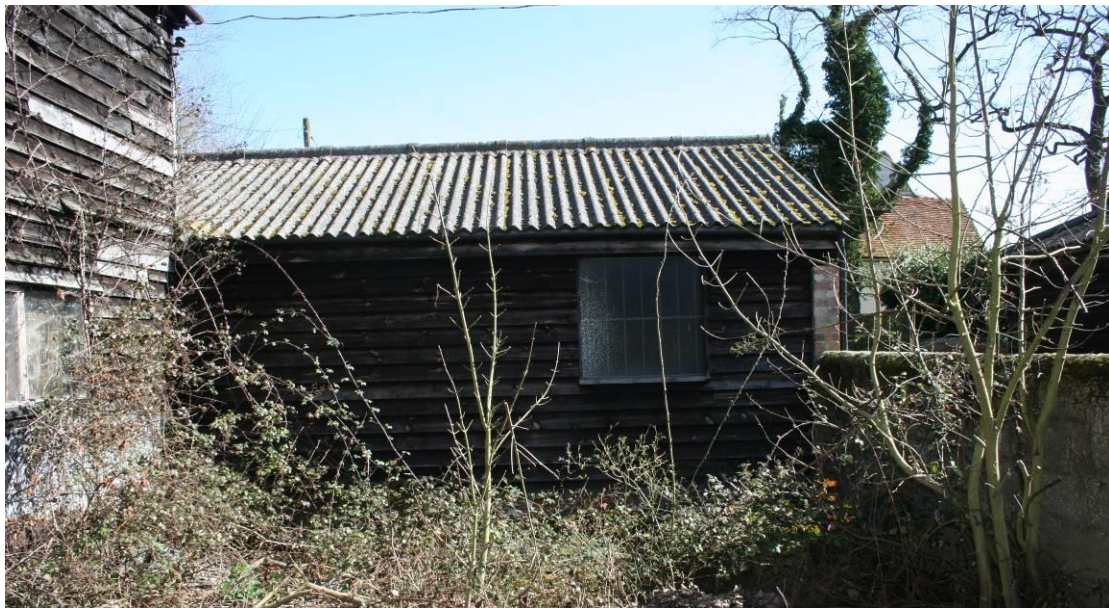
Western elevation of the Garage.

The Garage has a timber-frame clad with M-LC20th weather-boards and a southern wall built of LBC Flettons. The roof is clad with corrugated asbestos. There is a pair of garage doors and to the rear a large pane window armoured with bars on the inside. The concrete ramp up to the doors suggests vehicle access for a small tractor or car.

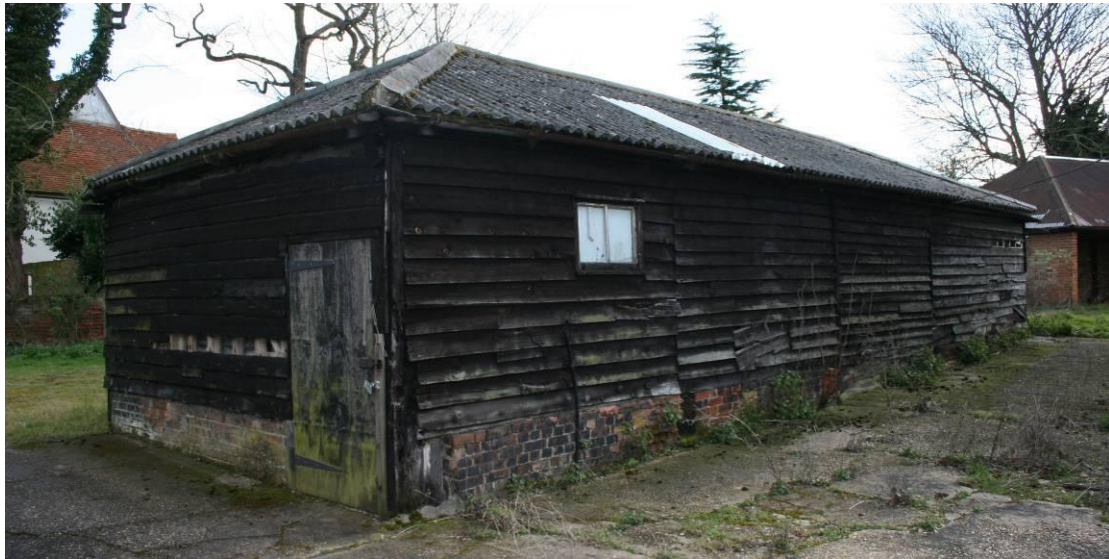
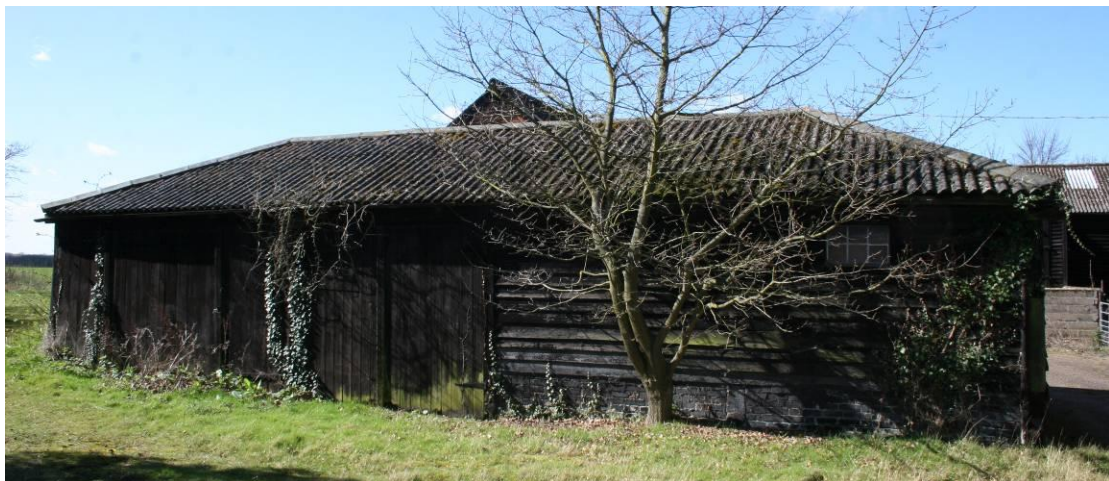
The Stables from inside the farmyard.

The Stables from the west.

The Stables is a timber-framed building with nailed interrupted studwork on a brick plinth of EC19th bricks with large modern infill sections. The low pitched fully hipped roof would have been clad with grey slates but now has MC20th corrugated asbestos. The building has been altered into garages and the inward facing doorways closed off.

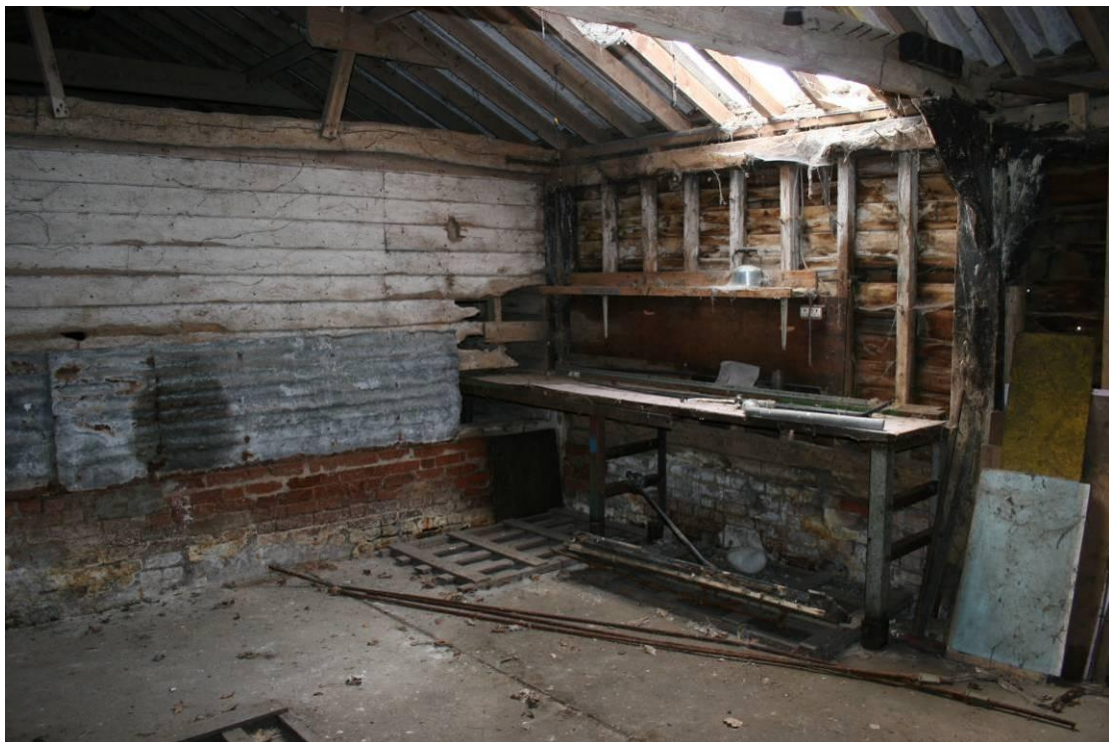
Looking SW in the northern room of the Stables.

The interior of the Stables has been outfitted with elm kick boards of which only those on the partition wall remain. The walls have also been lined with corrugated iron which indicates they were used as pig sties in the M-LC20th.

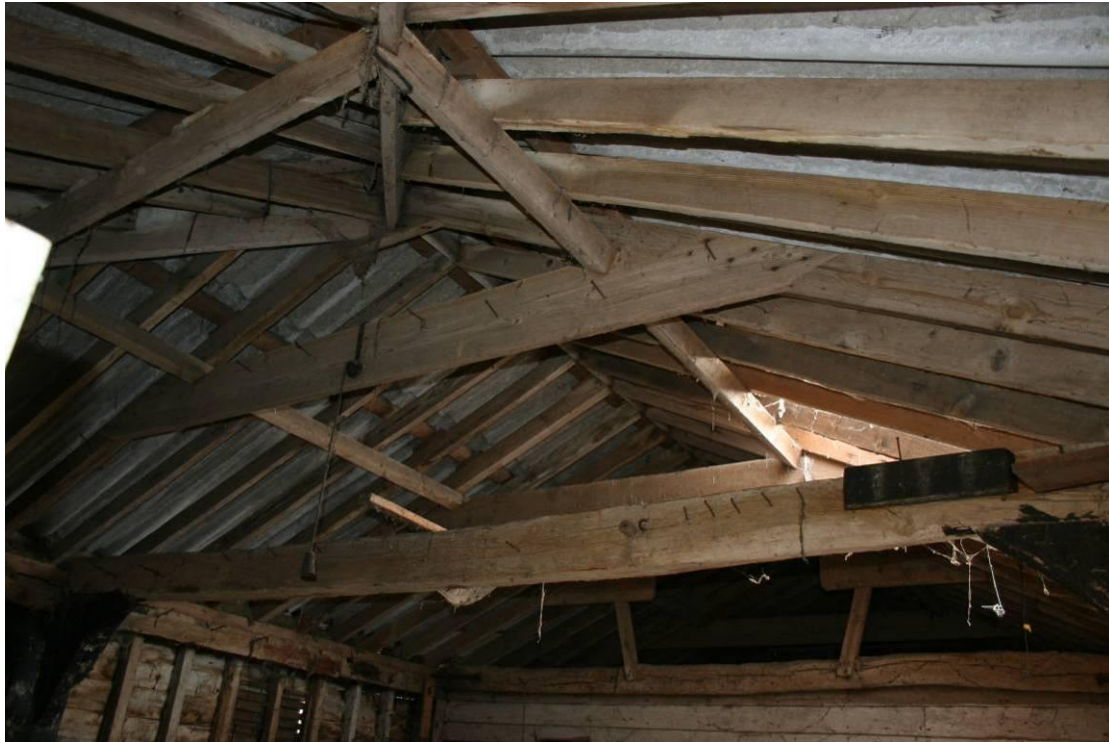
Detail of the roof structure.

The roof is made of machined pine rafters and plank collars, one of which has been sawn through to install a piece of machinery or water tank.

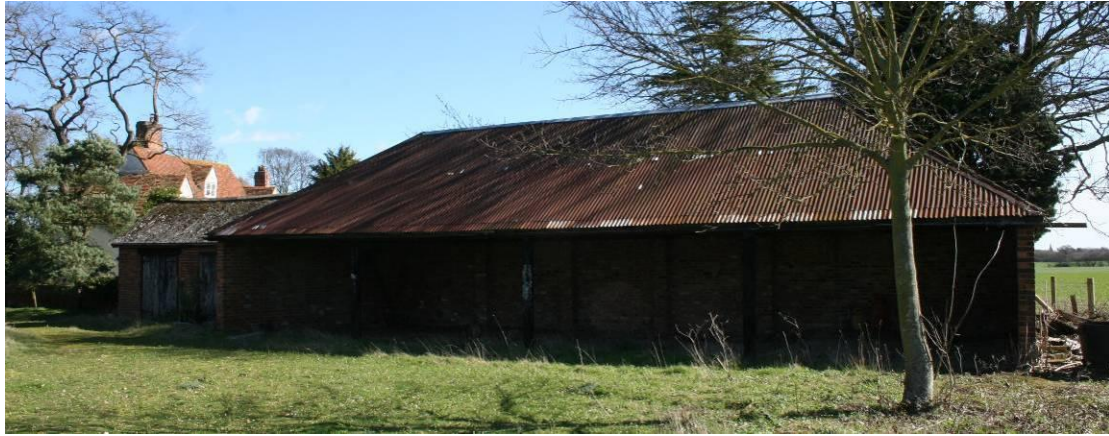
The Tractor Shed looking E.

A building corresponding to the Tractor Shed is shown on the 1896 Ordnance Survey map as a closed building but the present structure was built in the MC20th. The walls are built of reclaimed bricks set in very buttered cement pointing with added buttresses to support the machined pine plank roof. The roof is clad with corrugated iron sheeting in very poor condition

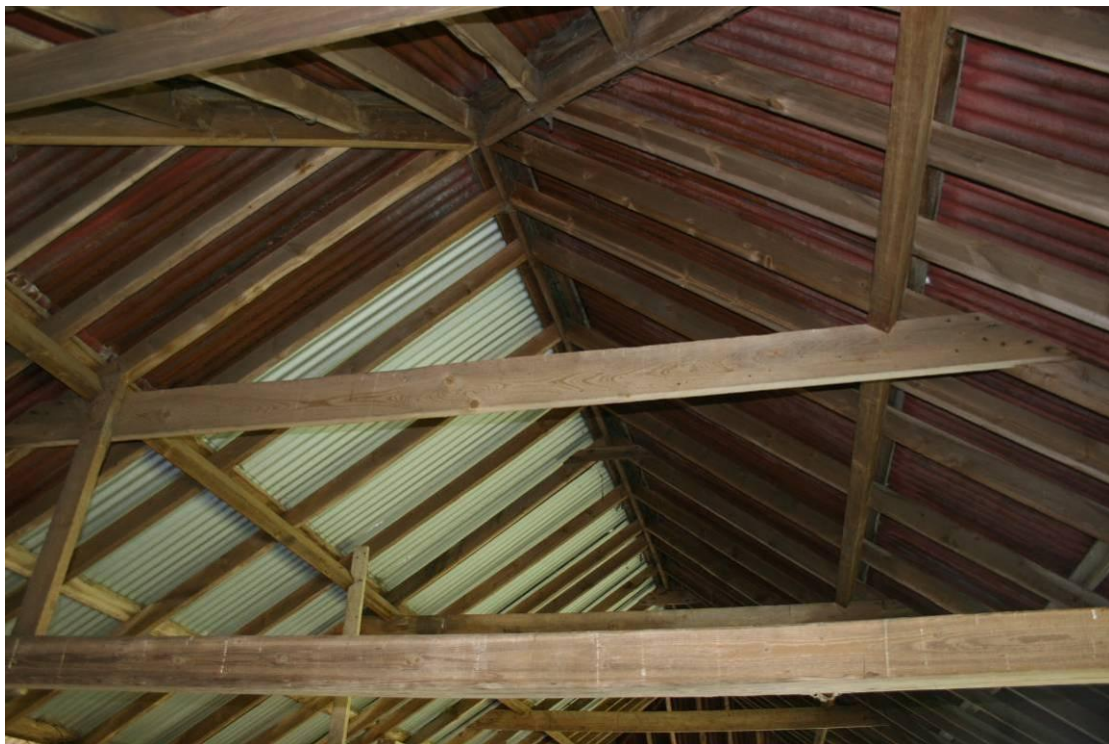
Roof structure of the Tractor Shed looking S.

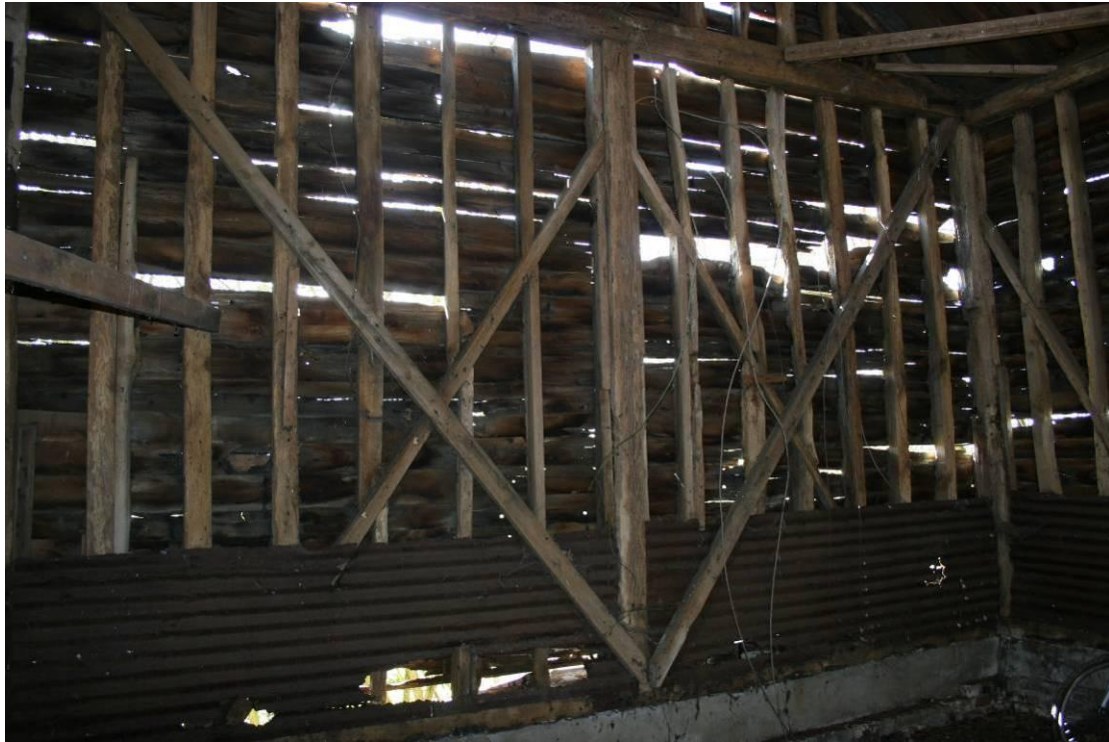
The barn has some C20th repairs adding in contra braces on the northern wall. The walls are lined with corrugated metal and this usually indicates the space was used for keeping pigs in the MC20th.

Detail of the north wall.

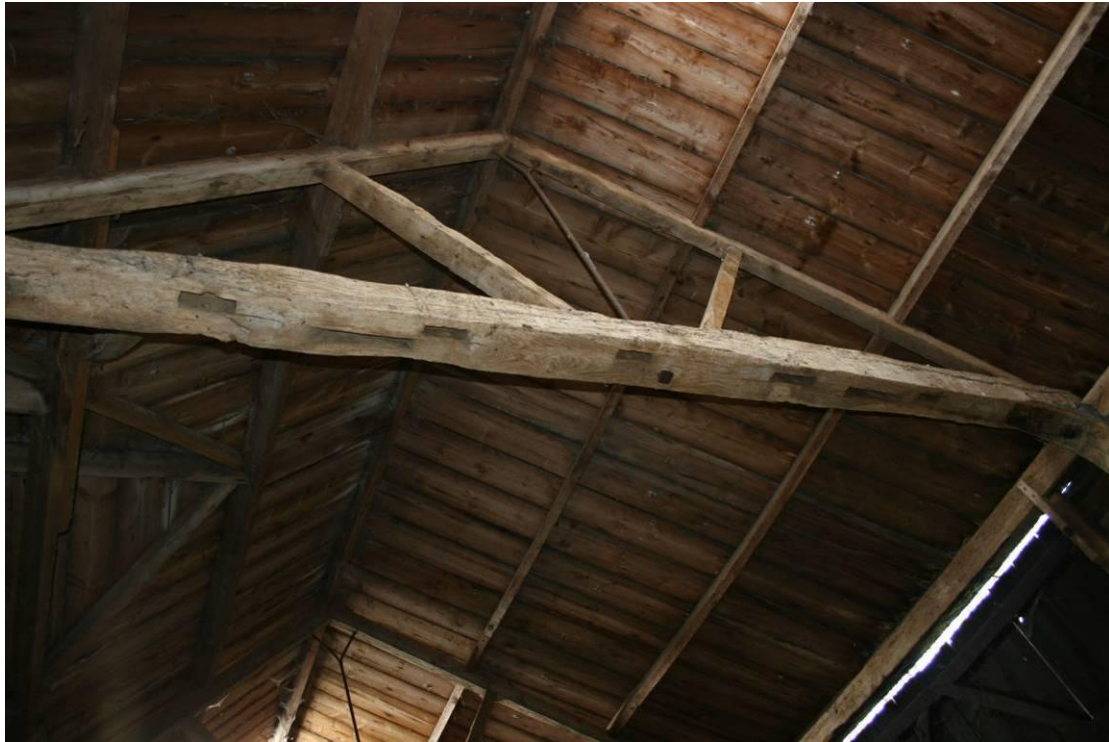
The roof of the porch and of the barn is composed of king bolt trusses. These have a single wrought iron bolt that connects the tie beam to the apex and tensions the two raking struts to create a stiff support for the roof. The porch has a crudely built LC20th box made of old doors to act as a dovecot for which there are three holes over the main doors.

Detail of a king bolt truss. Note the reused timbers.

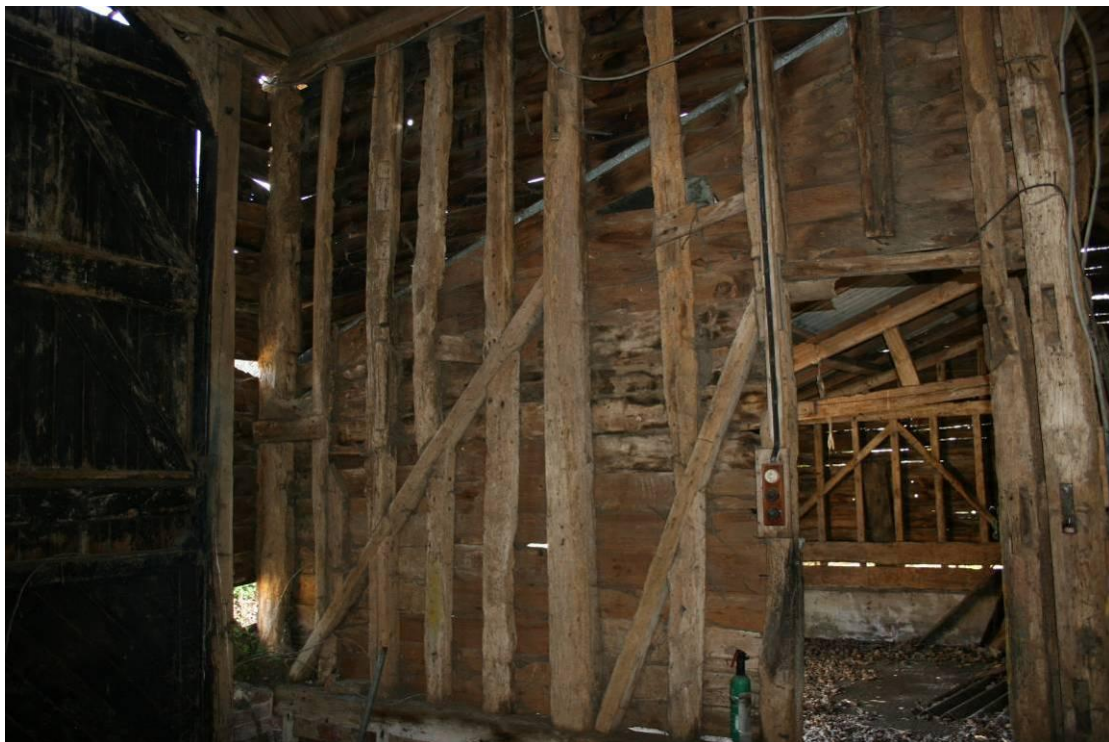
The southern side of the porch. The braces have been designed to accommodate the doorway.

The porch originally has pedestrian doors on both sides but the northern one has been boarded over in the C20th.

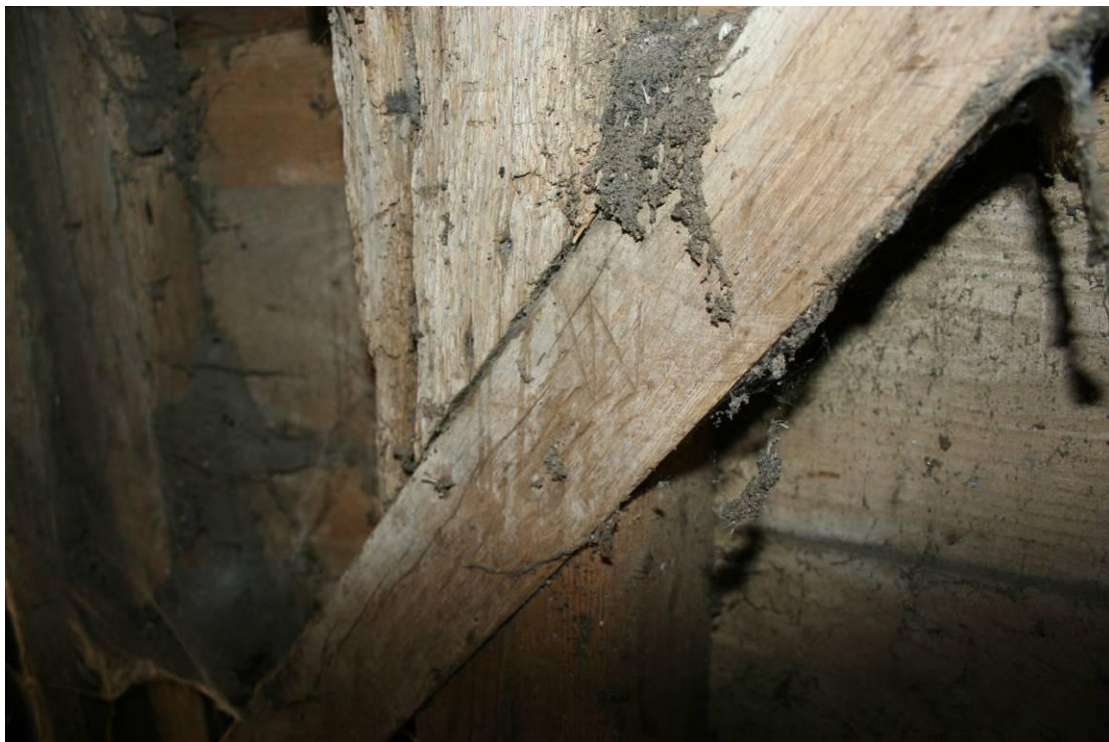
Possible apotropaic mark on the porch primary brace.

Some of the timbers bear merchant's marks made to identify the timber when being shipped in the C19th. The letter W has also been carved in the porch. This is very likely to be an apotropaic Marian mark for the Virgin of Virgins - calling for the protection of Mary. These marks resurged in the MC19th as a result of the practices of the 'Cunning Men'.

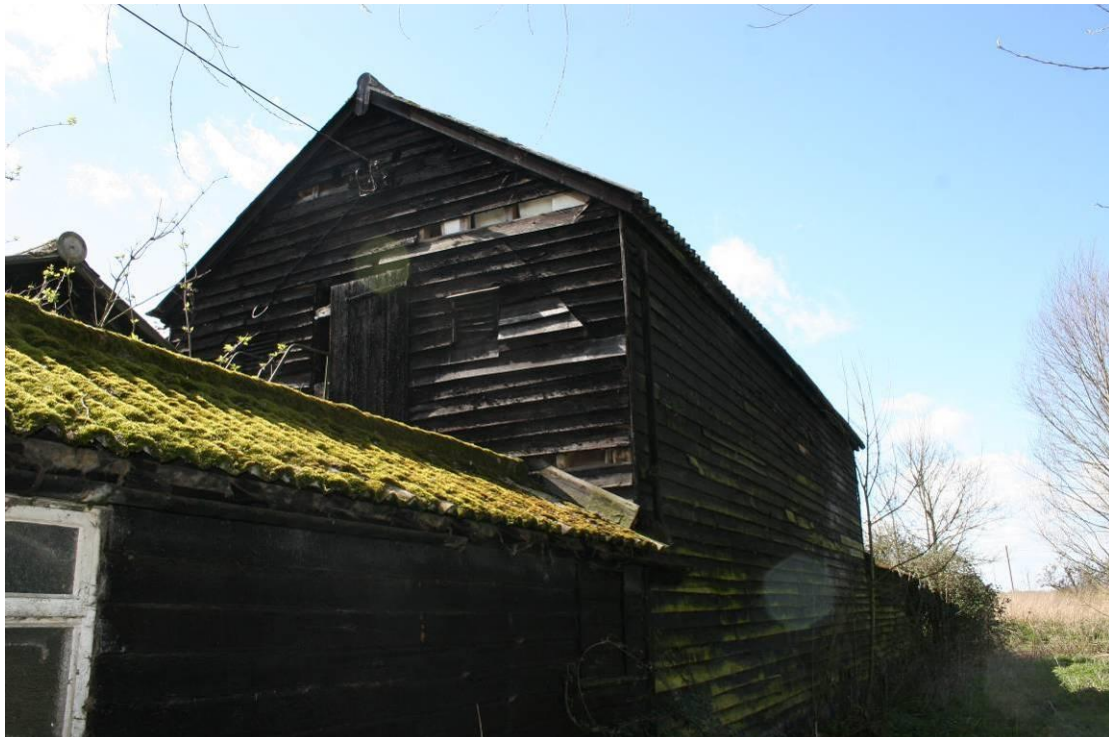
The northern end eastern elevations of the Granary.

The Granary is a purpose built timber-framed with a heavy duty grain floor. Like the other buildings it has been recalled with weather-boards and an asbestos roof in the MC20th. An office has been installed in the upper floor in the LC20th, most likely the 1970's and the building used as a store.

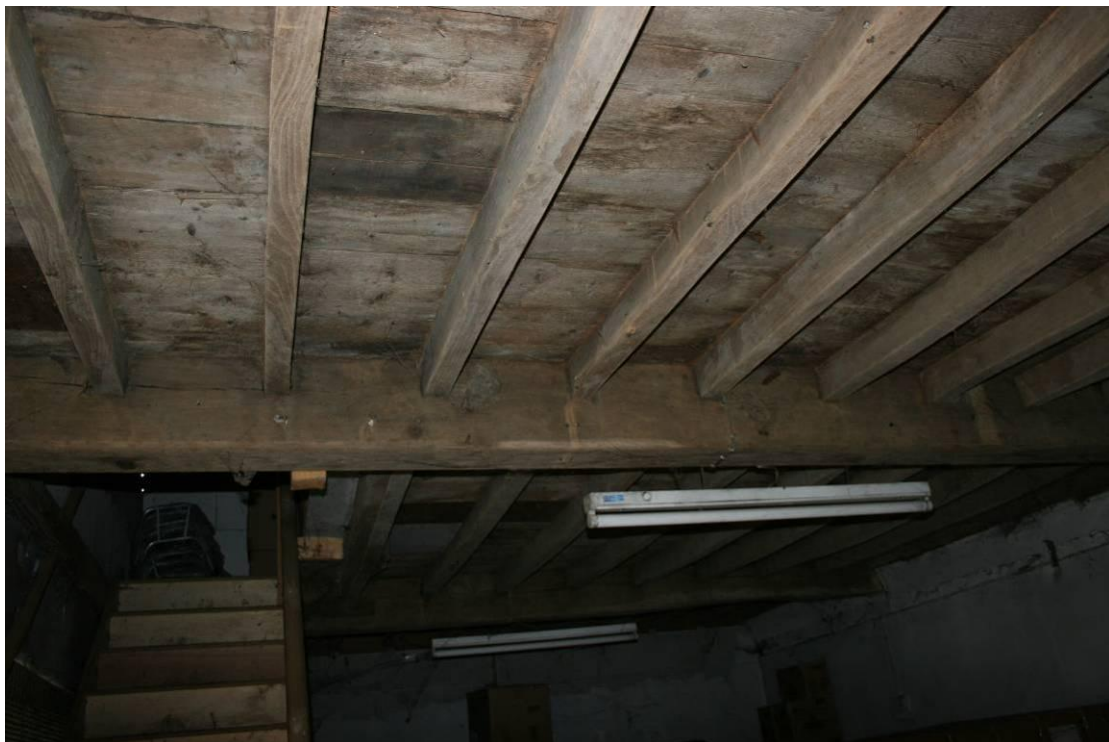
The framing of the Granary floor. Looking W.

The timber frame of the Granary walls has been hidden by modern finishes but the grain floor joists are exposed. These appear to be steam sawn elm joists laid on edge with massive transverse joists to take the weight of the grain that would have been stored above. A building of this size might store 30-60 tonnes of grain when full.

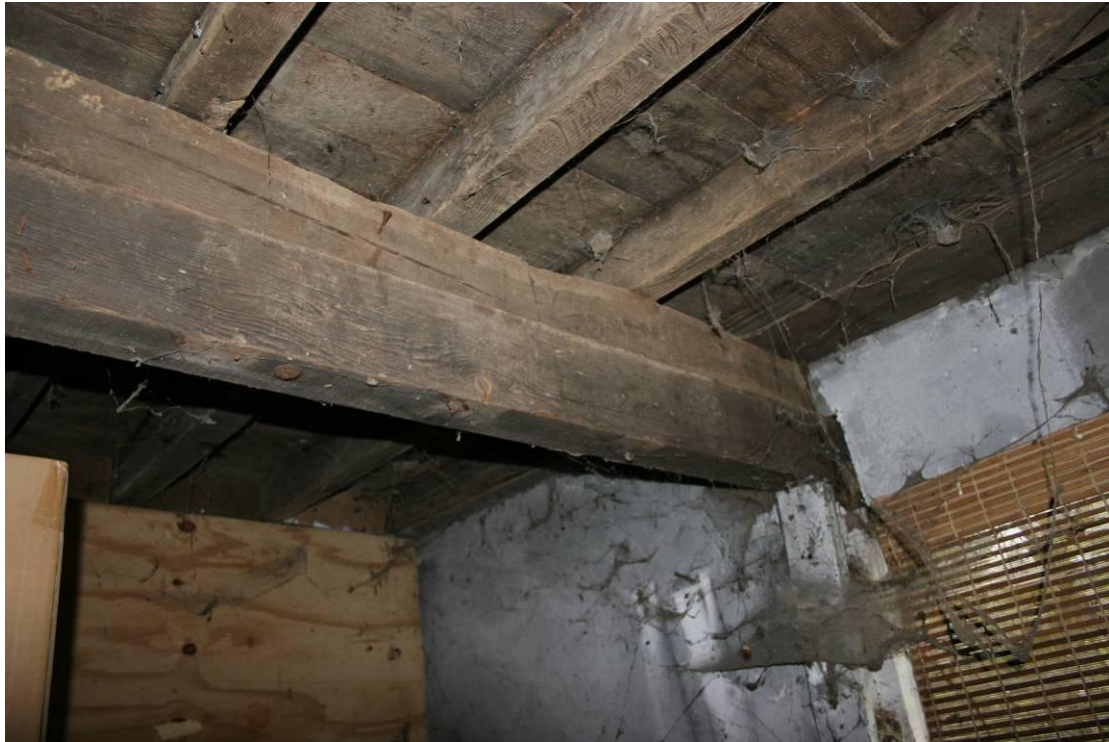
Additional support for the main joists.

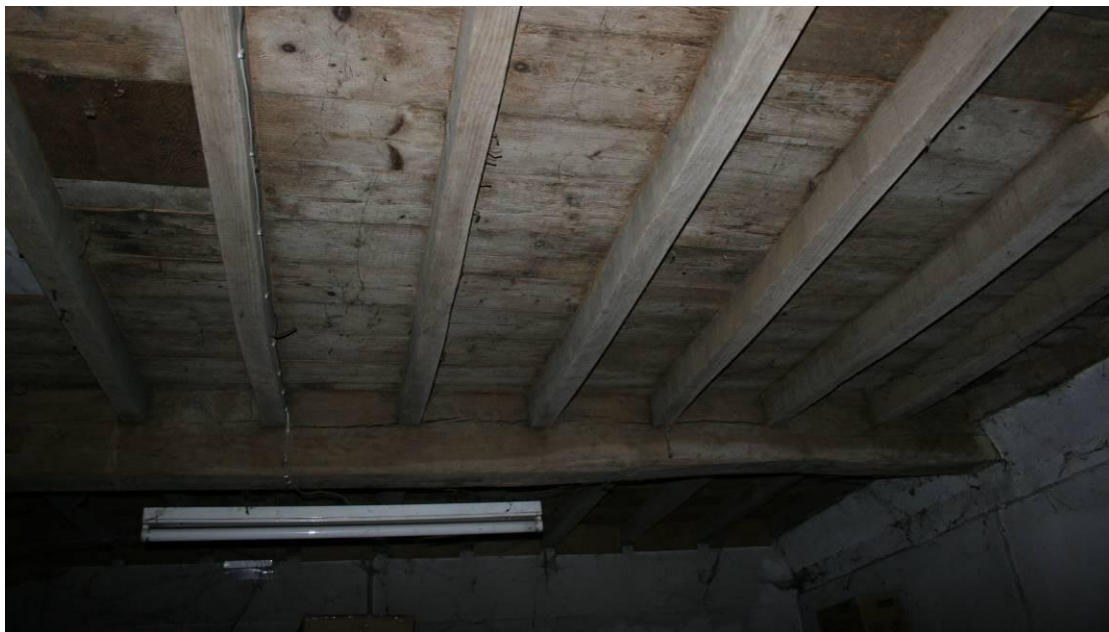
Hatches in the floor allowed the grain to descend into grinding or cleaning machines.

The grain floor had some small hatches to allow the grain to be funnelled down into machines on the ground floor. Particularly after WW2 farmers were actively encouraged to glean their own grain on site to maximise its value and electrically driven seed gleaners like those made by Boby would be installed. The floor has additional MC20th softwood joists with marks showing that partitions were skew nailed in place creating smaller rooms and giving extra strength to the floor above.

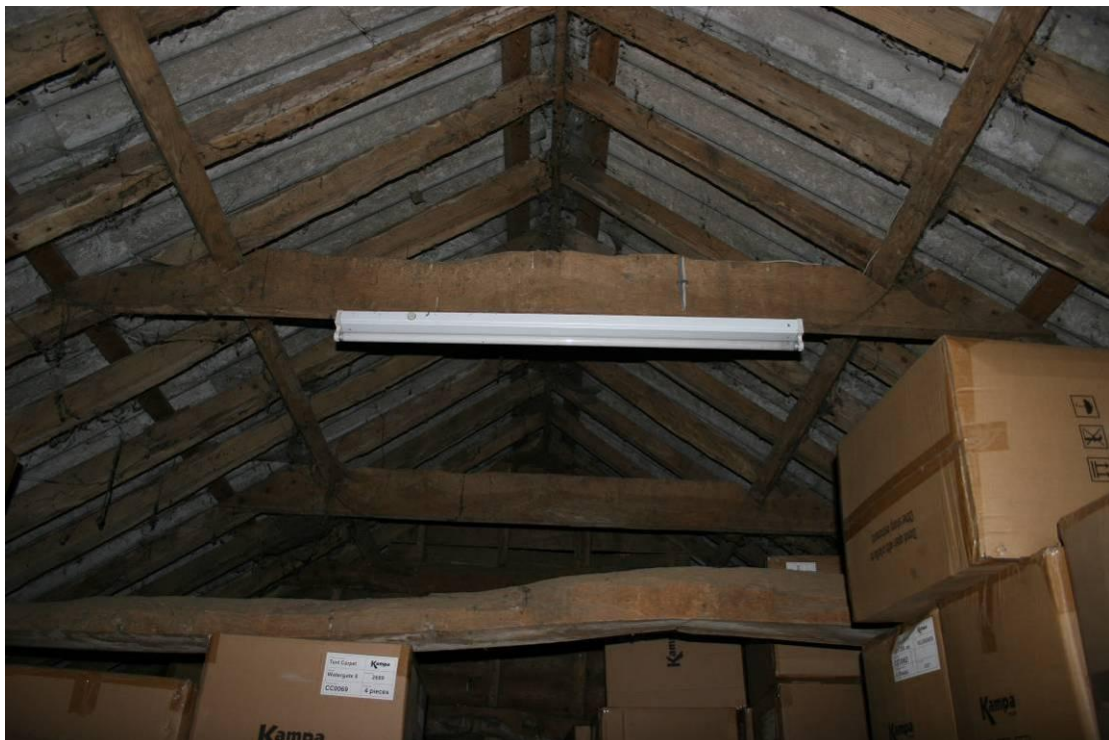
Looking E at the roof structure.

The Granary has a trussless roof with waney tie-beams and plank collars clasp the machined side purlins. The original rafters have been used to support the asbestos roof but most of the rafters were already second-hand when the building was put up.

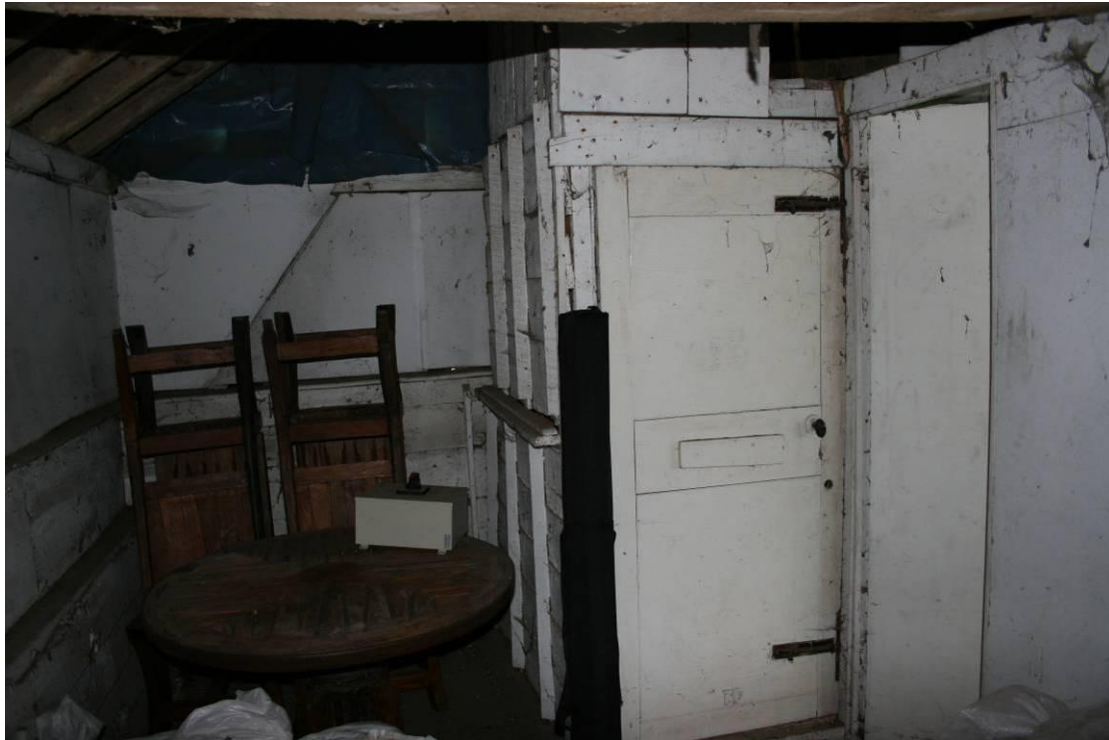
Storage area in the eastern end of the Granary.

A small office and workspace has been built in the eastern end of the upper floor and the details are all LC20th, most likely the 1980's. The work is of poor quality, cobbled together reusing old doors and cheap windows with aluminium fittings.

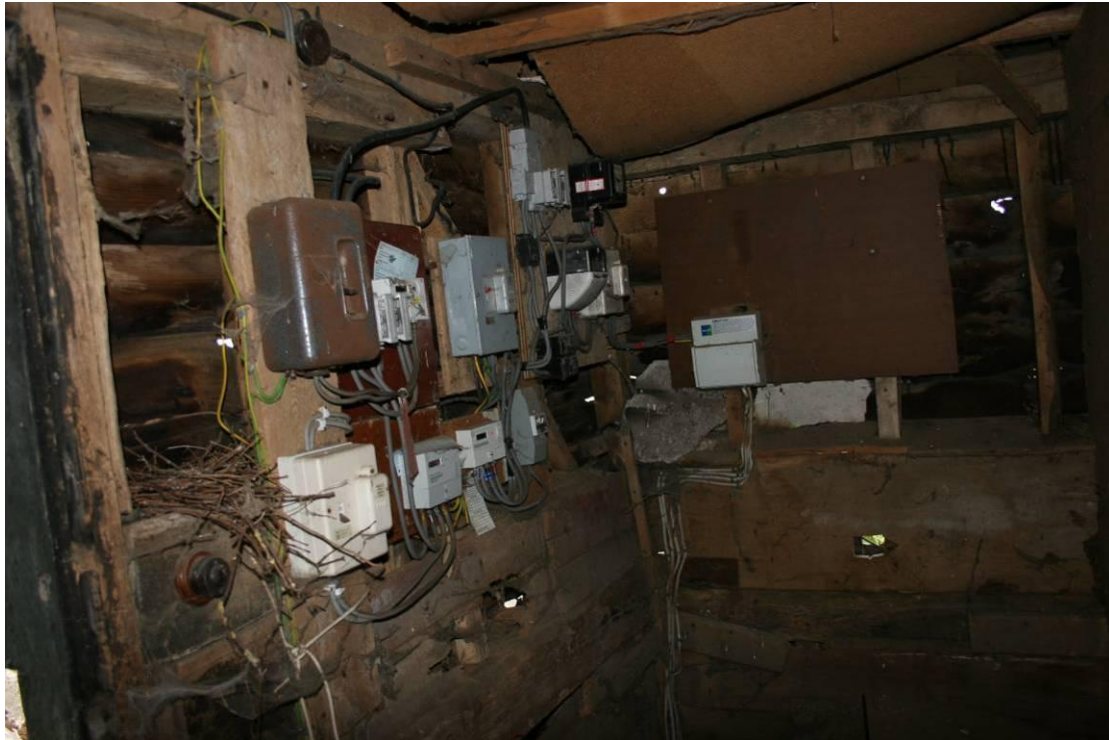
Power supply and meters are fixed to the original frame.

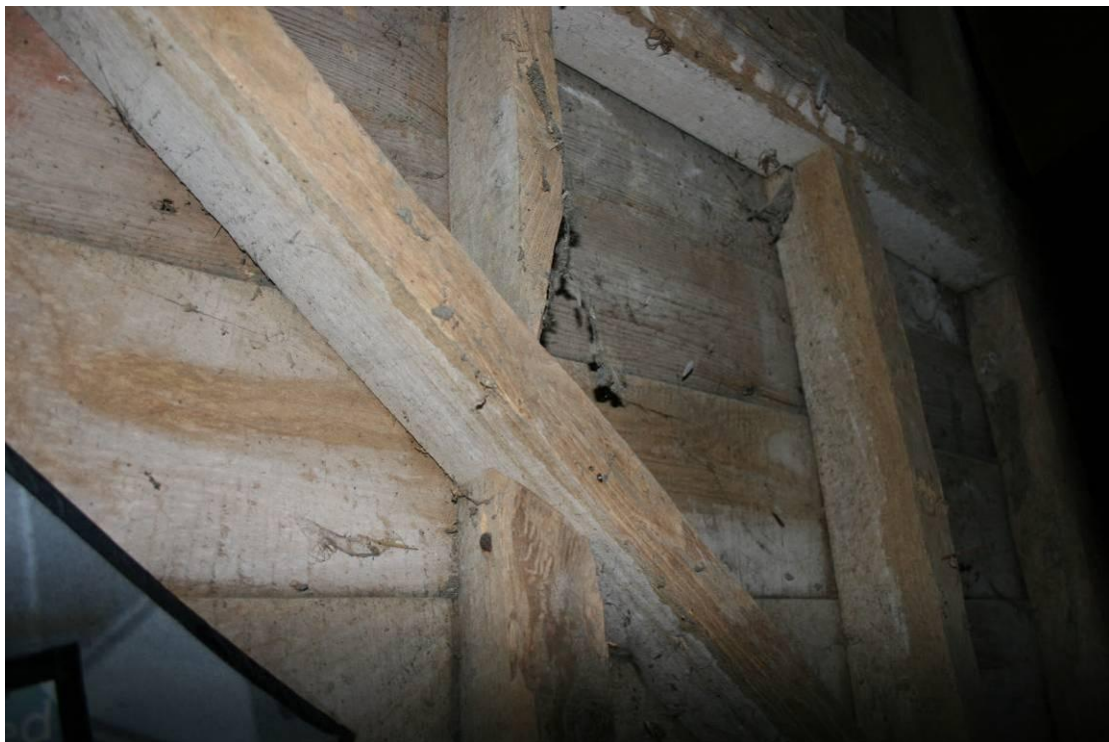
Nailed interrupted studwork in the partition wall.

Where the frame is visible it is very similar to that of the Barn and Granary and it must be assumed that all the buildings went up at the same time to form an early version of a Victorian High Farm. These three buildings are all shown in the same disposition on the 1841 Tithe Award Map for Birch.
