**Longstowe Hall, Longstowe, Cambridgeshire CB3 7UT.**  
Description and analysis of the Coach House, Squash Court and Kennels. Surveyed 24 03 2015.

This report describes and analyses the Coach House at Longstowe Hall to mitigate for conversion to a wedding venue. There are further descriptions for the Squash Court and Kennels with a view to future development.

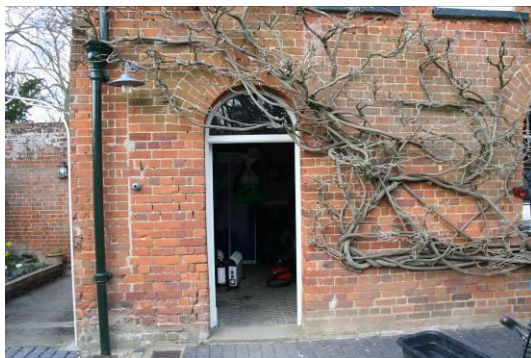
The queen closers near the corner.

The Cottage is finished with orange 70x105x230mm handmade bricks with smooth faces, crisp arrises, horizontal pressure made and laid in English bond. The door and ground floor window are under gauged segmental brick arches. The doorway has been reduced in width and the queen closers for the former opening can be seen near the SE corner. The arch headed window is also inserted as the brickwork is butt jointed to an earlier column of brickwork now behind the downpipe. It can be assumed there were originally two larger openings for carts or coaches.

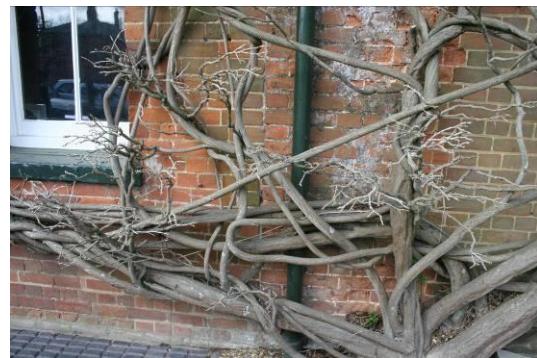
Butt joints in the brickwork by the window.

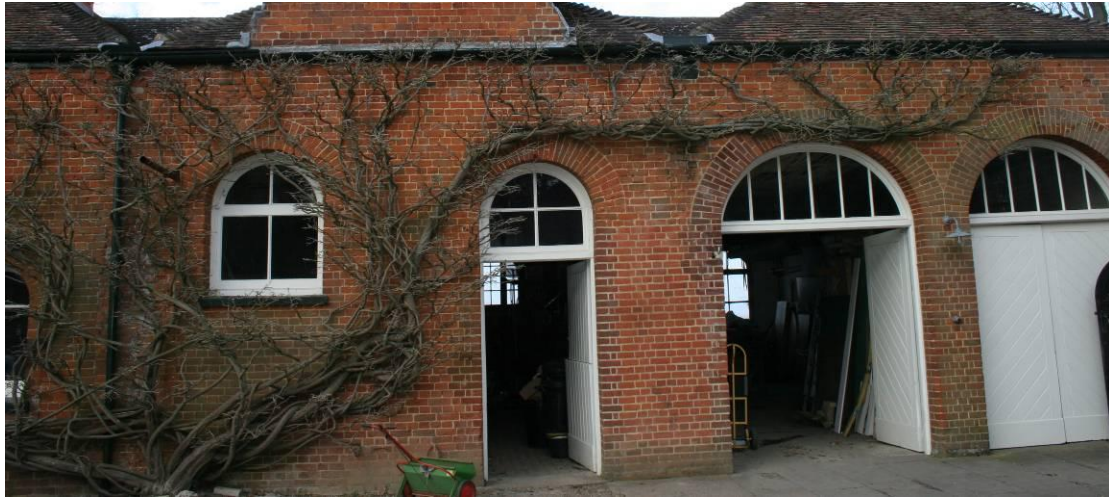
Elevation of the central cell containing the Stables.

The central cell contains a fully equipped LC19th Stables. A former doorway was bricked up and a window inserted to match the others. The 65x105x220-225mm bricks are more Victorian in size and character with much less eroded faces which have been discoloured by the large vine (presumably wisteria).

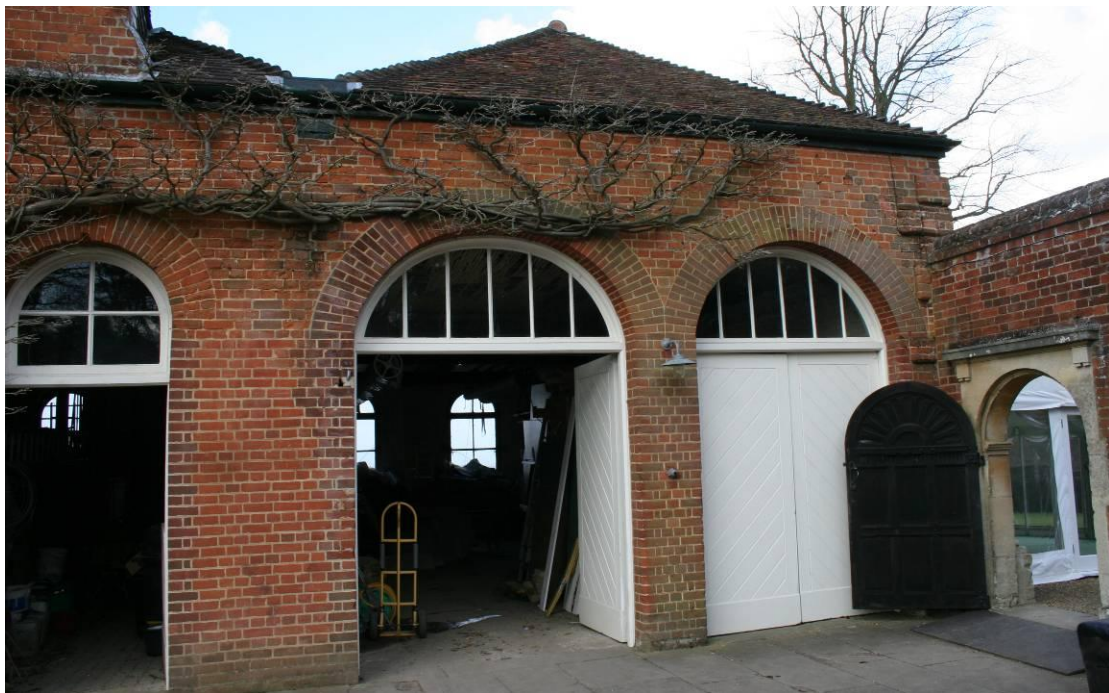
The garage doors are EC20th.

The garage doors and lights above are EC20th in design and fabric with mild steel furniture. The arches have been rebuilt with 65x100-105x210 orange bricks with purple dressings set in a sandy cement. Unlike the other openings whose edges have been chipped and softened by years of passage the quoins are sharp. The garden wall mentioned in the Listing is connected to the elevation with a butt joint passing over brick rustications. The doorway is likewise largely unworn only having been chipped by the passing of wheelbarrows.

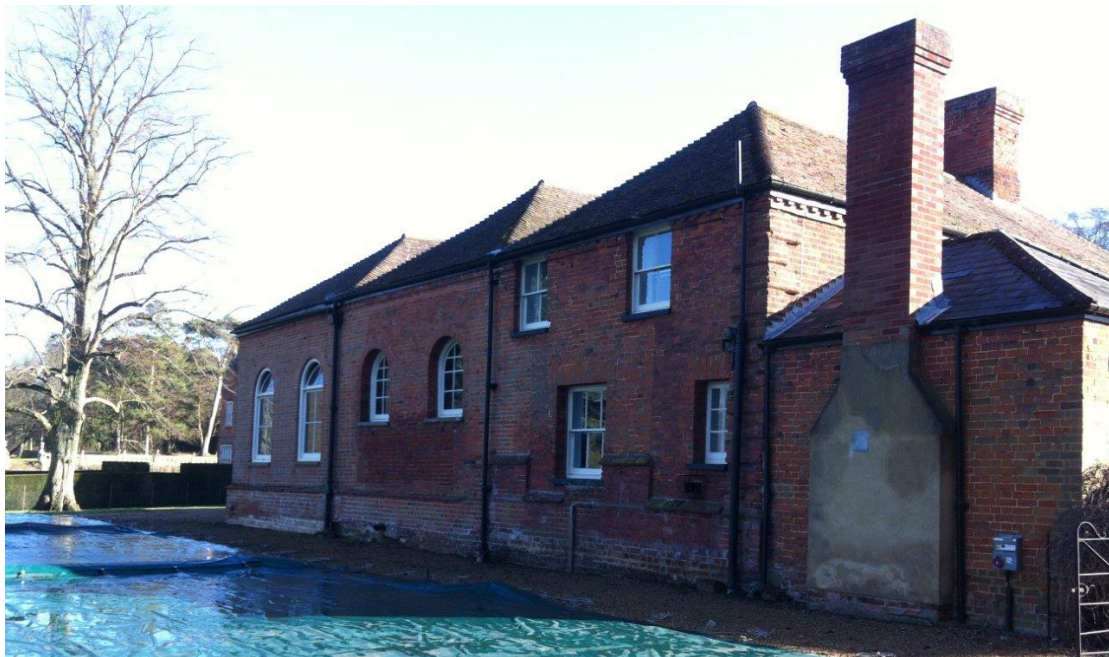
The NW elevation has suffered several rebuilds which may have been prompted by subsidence which is still evident in places. The SW corner has a straight joint in the brickwork that runs awkwardly under a window and must represent part of the C19th remodelling. The cottage windows have gauged flat arched and stone window cills but no closing bricks. The SW corner is rusticated with brick quoins.

Looking NE along the length of the NW elevation. Photo by Colin Walker.

It can be seen that the northernmost section of the wall corresponding to the first cell has been completely replaced with C20th brickwork. The other two cells have been remodelled with C19th brickwork and windows.

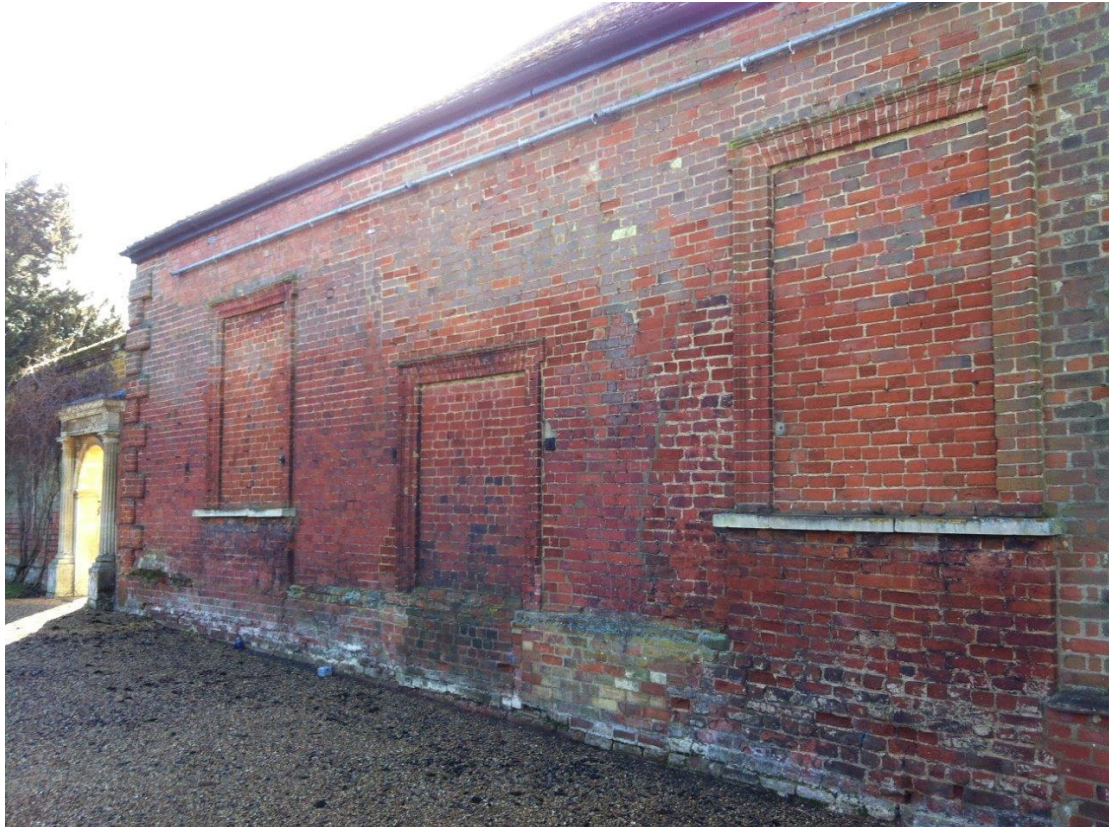
The NE elevation. Looking E. Photo by Colin Walker.

It is very likely they were all bricked up around the same time using different batches of bricks and different bricklayers. Above the two tall window heads the walls has been rebuilt with bricks covered in kiss marks like those in the SW wall. There are large vertical cracks where the brickwork has evidently descended historically and this may be why the openings were filled in. There are four bolts with square nuts and large square washers set at regular intervals along the brickwork. As one passes through the blocking of a window they must be later than this alteration. Inside they can be seen to be tethering rings with lion's head decoration.

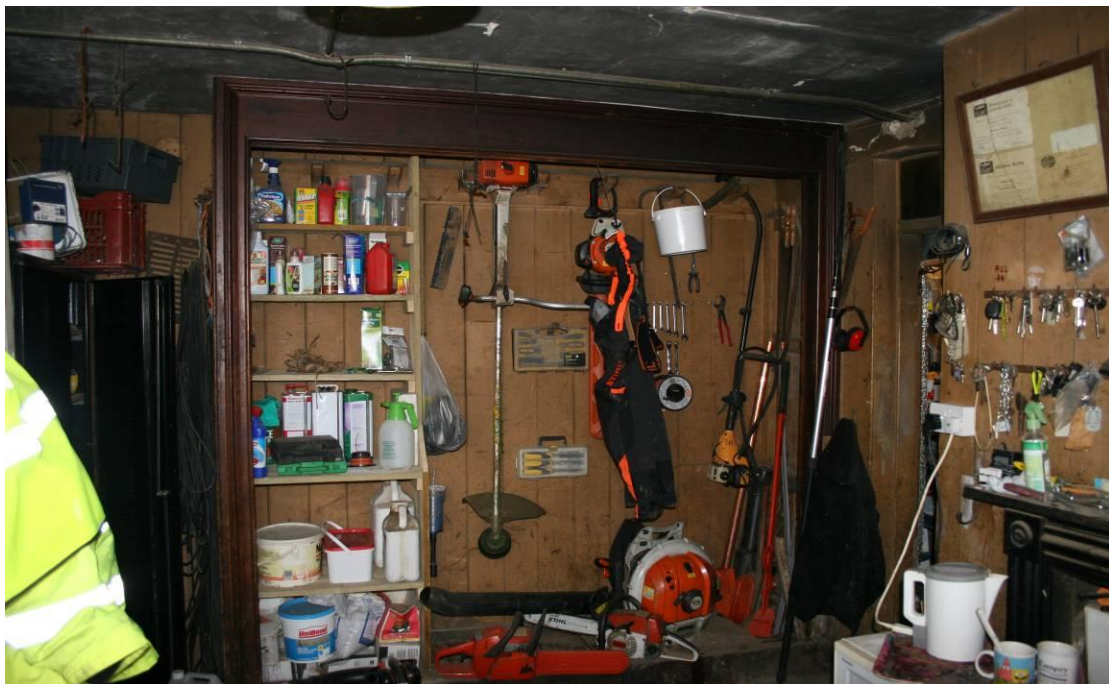
Looking N in the Store Room. The cabinet frame had sliding doors.

Originally there was a large doorway under a curved arch connecting the Tack Room to the Store Room at the rear (descriptive names, not historical). The doorway has been halved in size apparently to build in large cabinet that had sliding doors. The harness trees have been retained inside it so perhaps the highest quality tack was kept here.

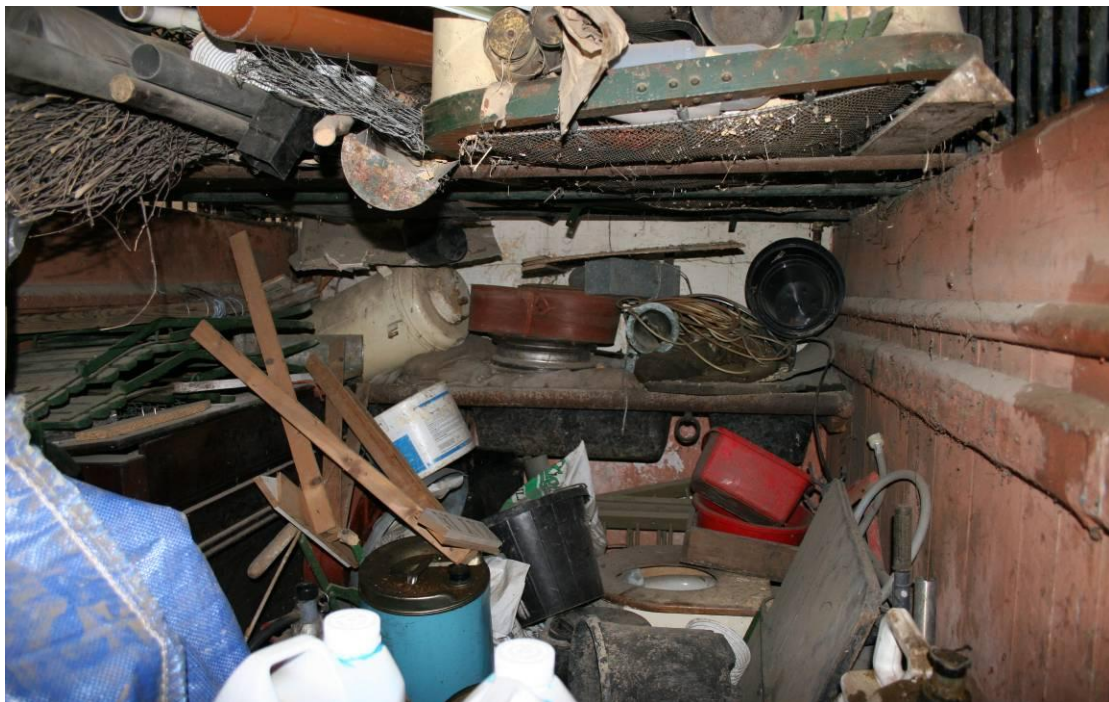
The central Stable has been fully equipped with timber partitions with iron grilles late in the C19th. Currently it is used as the workmen's store. There are four stalls against the SW wall and two loose boxes against the NW wall. Each stall was equipped with cast iron feed and water troughs of which three remain buried under the stored materials.

Looking SW in Stall 3 at the cast iron feed and water trough with tethering ring.

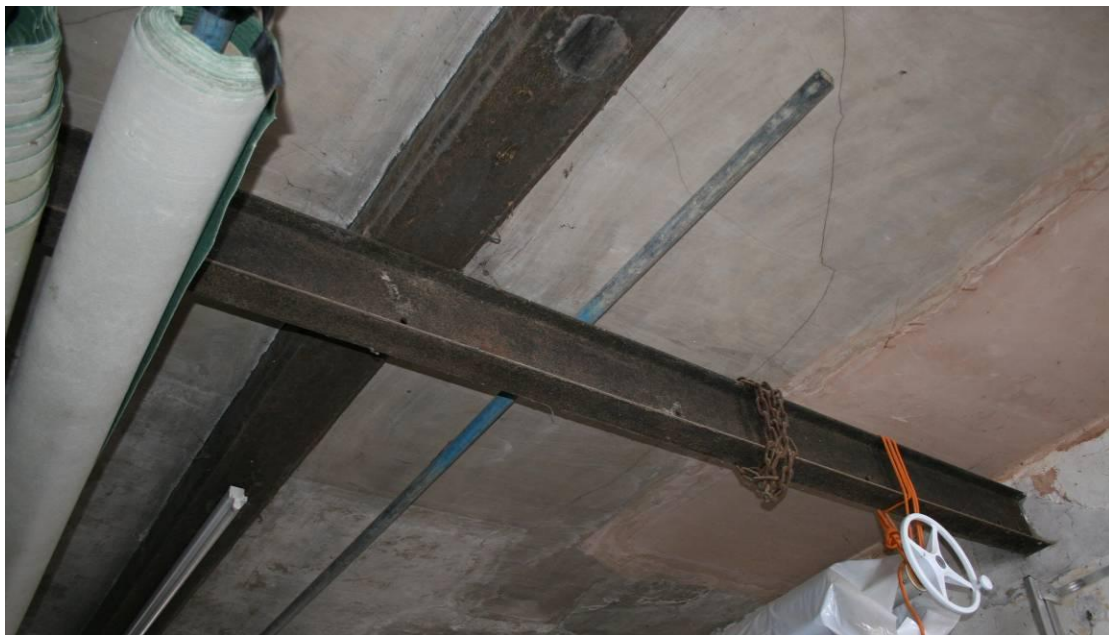
Detail of the steel beams.

The Garage is a single open space where the roof has been reinforced with steel beams. It seems likely that the room was originally outfitted in the same way as the Stable and when the central columns were removed the beams were needed. Circles in the paintwork show where they would have been. The RSJ's (Rolled Steel Joists) may have contributed to the cracking of the brickwork. The lath and plaster ceiling has cracked and there are large patches of pink skim repair. The area near the main doors is completely denuded.

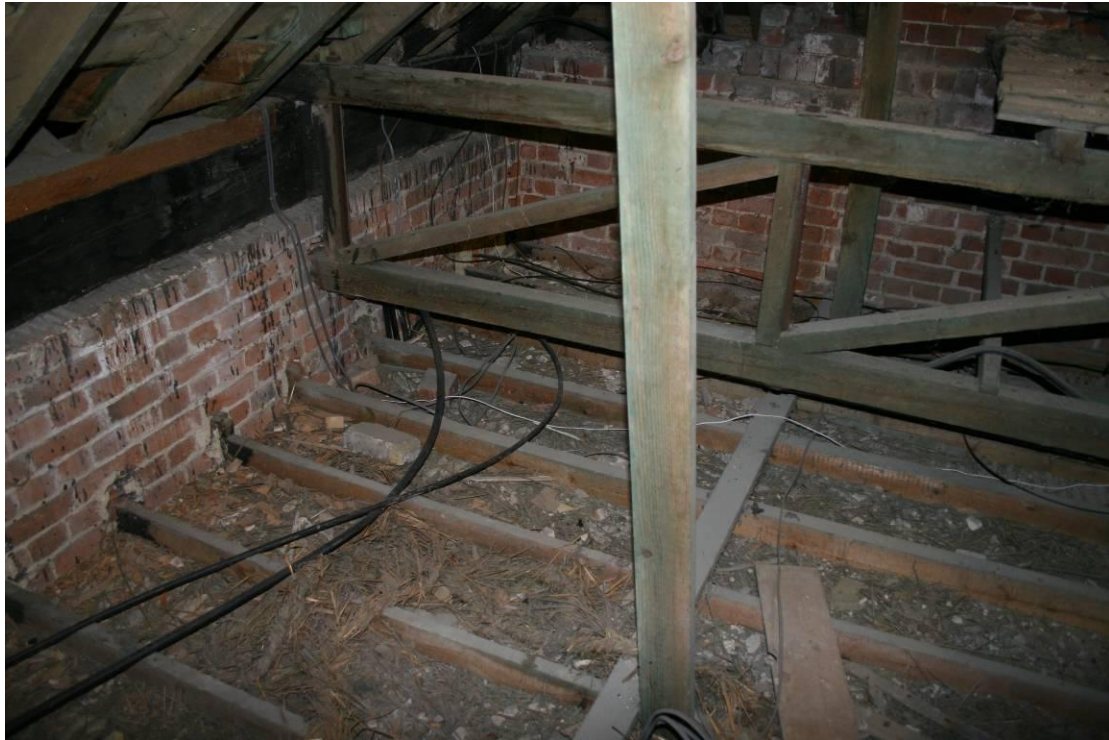
The machined timber supports for the gantry.

The clock platform itself is supported on a machined softwood truss reinforced with steel bolts with square headed nuts. Below this the lath and plastered ceilings over the Stable have joists made from bandsawn softwood that looks quite fresh despite the detritus upon them and must be M-LC20th.

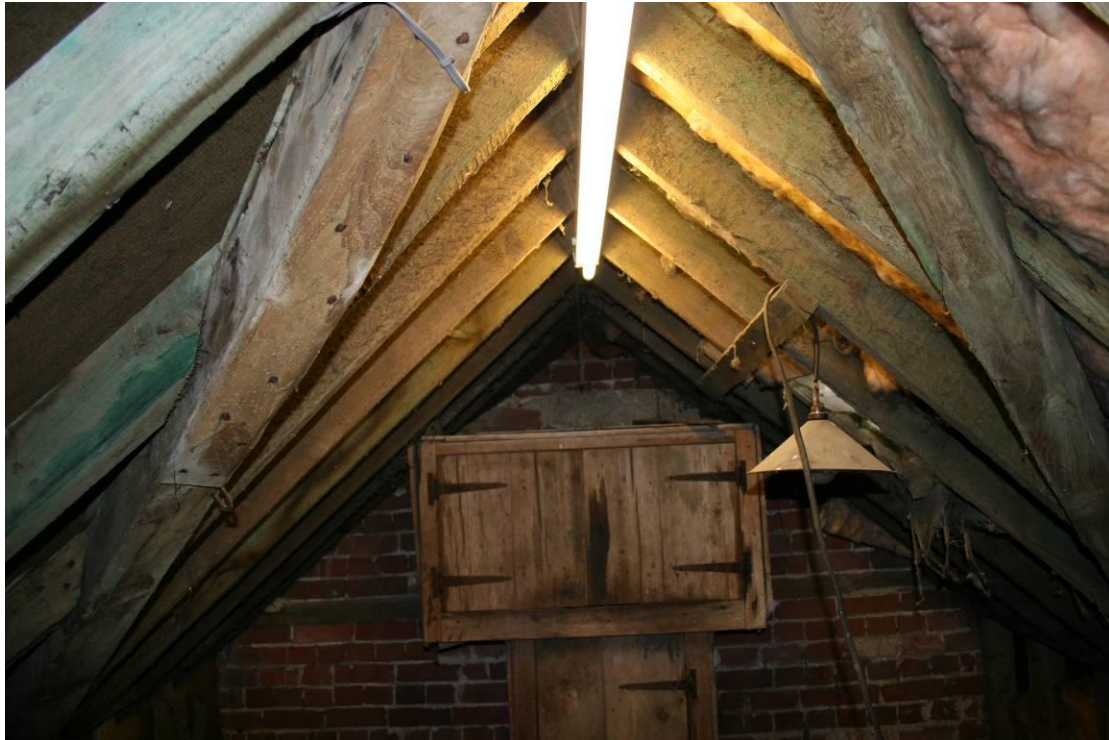
Looking SE at the clock gable roof structure.

The roof of the clock gable has been rebuilt in the last 20 years or so with fresh tanalised machine sawn softwood fixed with French nails. However the jack rafters appear to be elm and there are some older common rafters still nailed in with wrought iron nails.

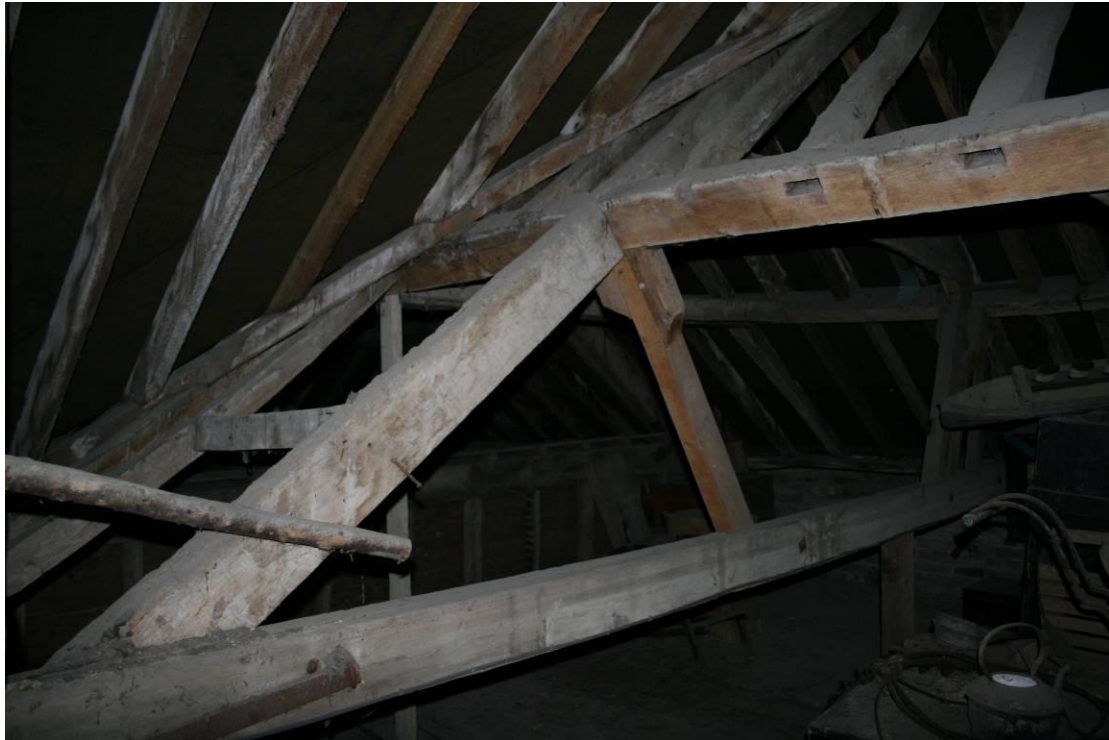
The roof structure over the Stables.

The roof structure is quite difficult to envisage until it is realised that originally there were three separate pyramidal roofs with valleys in-between. These are in-line butt purlin roofs with full hips where the common rafters are tenoned into the purlins. The purlins are tenoned into the principal rafters and each joint has been later reinforced with a milled strip wrought iron tie fastened with square staples. The principal timbers are pit-sawn oak and elm.

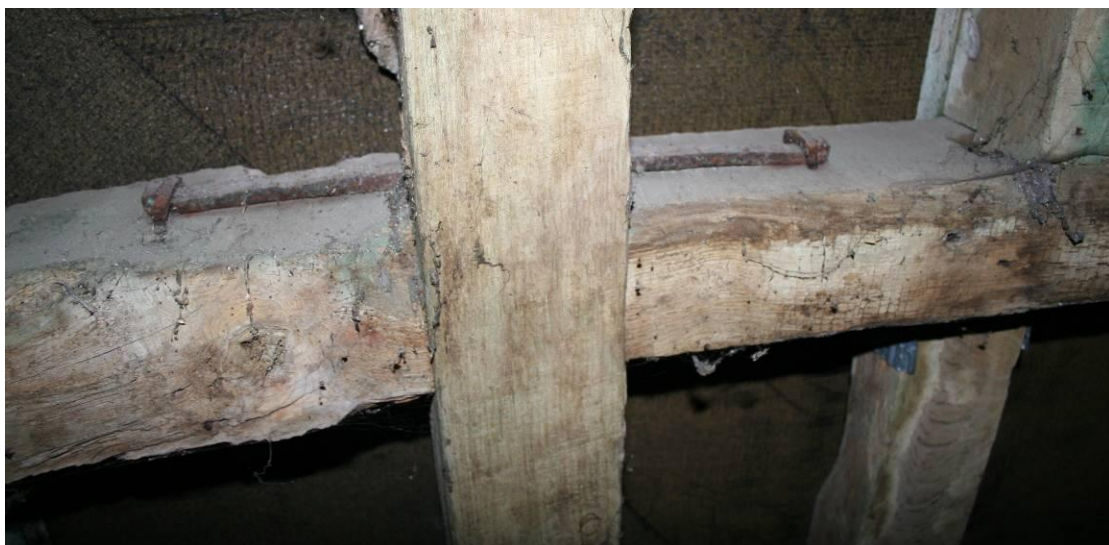
Wrought iron tie reinforcing the butt purlins as they meet at the principal rafter.

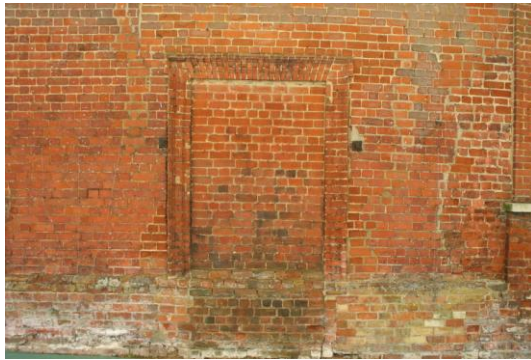
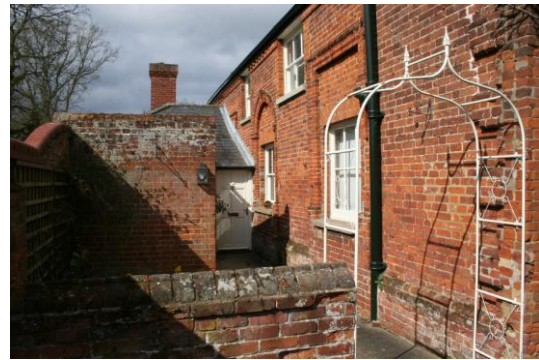
The bricked up openings in the NE and SW elevations.

The blocking of the three large openings in the NE wall facing the garden were likely done in two episodes as the SE window and the door have 65x105x210mm bricks set in a flinty mortar in English bond (in contrast to the Flemish bond of the wall). The NW opening has been blocked using random coursing with 65x110x205-215mm bricks.

The blocking of the door and windows in the SW wall are easier to date bracket as they have Georgian style gauged flat arches over the inserted windows. The SW wall of the Cottage has 65x105x230-250mm bricks in a penny struck mortar course laid in Flemish bond while the SE wall has 70x105x230mm bricks with horizontal pressure marks (denoting mass production for a kiln) laid in English bond like the blocking panels.

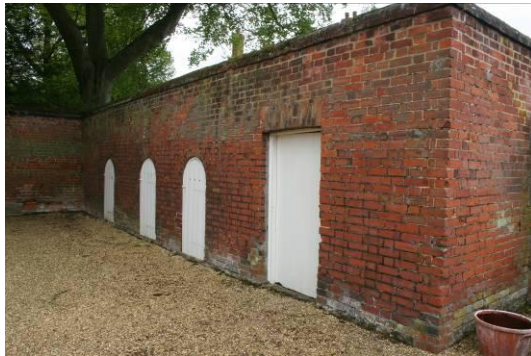
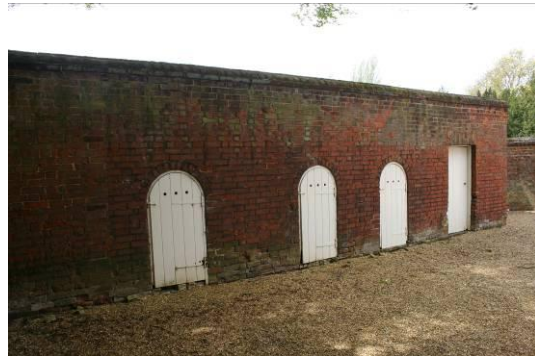
The NE elevation of the Kennels within the yard.

From the yard the Kennels appears as a rectangular facade of red /orange 70x105x220mm bricks with smooth faces, sharp arrises and horizontal pressure marks. They are laid in Flemish bond and set in a hard white lime mortar that has been repointed in black mortar. The perimeter wall is built in the same way. The top of the Kennel wall has a simple brick plat band and is in fact a raised parapet.

There are three segmental arch headed doorways with EC20th doors and one larger pedestrian doorway under a segmental rough gauged arch. All the openings and the quoins are finished with queen closing bricks except for the SW side of the pedestrian door which shows it has been enlarged. The extant closers show the previous opening was taller than the others but not full height.

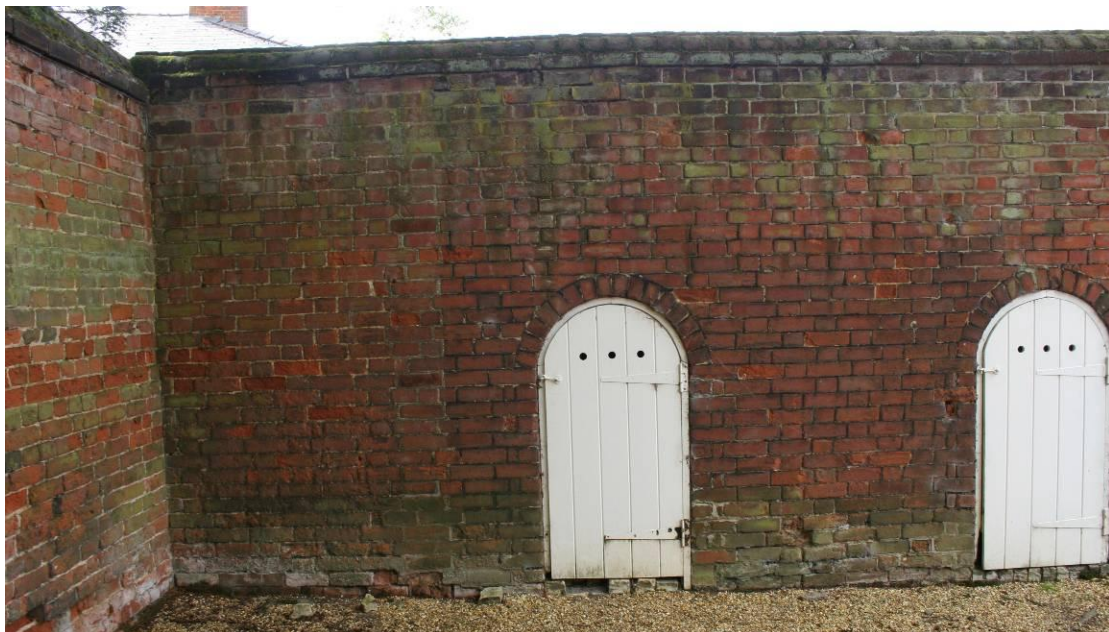
There was small building in the corner with single pent roof.

At the junction of the Kennels with the perimeter wall there was a small building with a single pent roof that has marked the perimeter wall. The black pointing ends in vertical line.

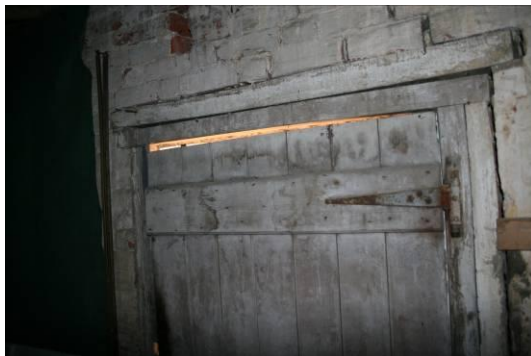
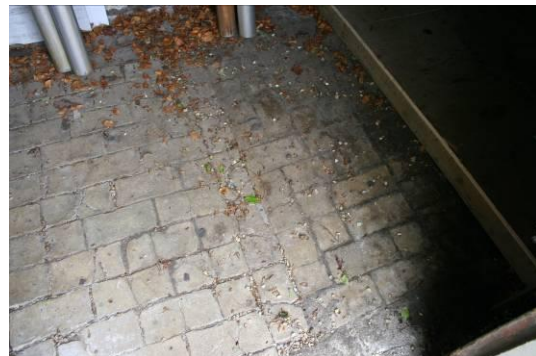
C20th door and brick paved floor.

The door is EC20th. It is a vertically boarded, tongue and grooved door with horizontal ledgers fixed with French nails. The T-strap hinges are of mild steel fastened with slot head screws. The frame has been reduced in size indicating there was originally a larger C19th door under the inserted lintel.

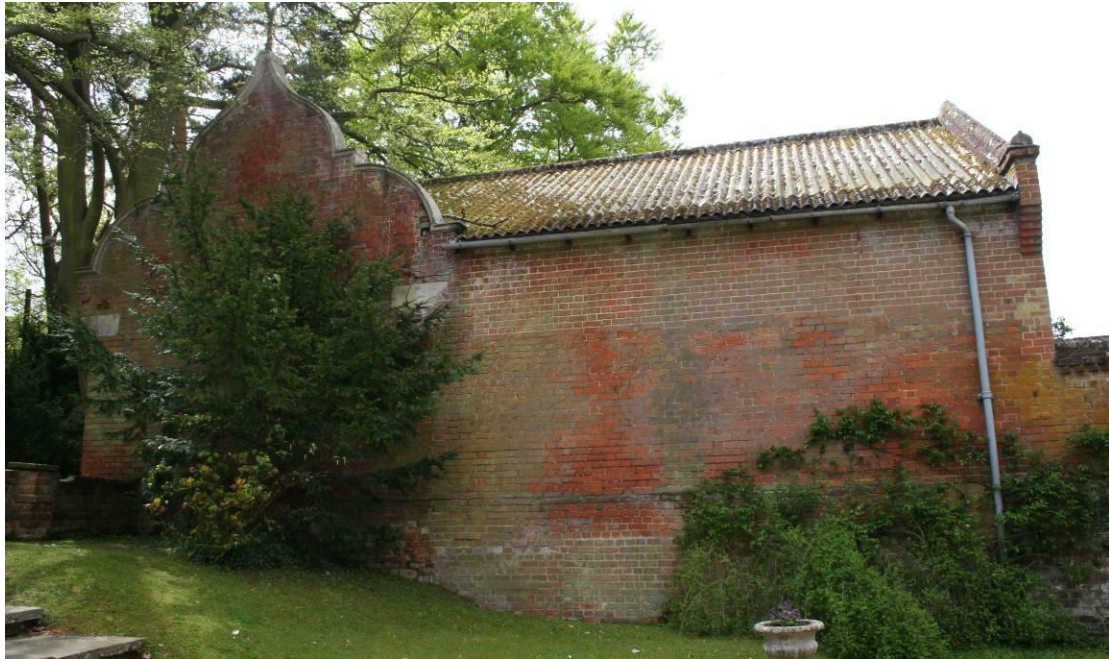
The NE elevation comprises three brick builds.

The NE elevation has at least three definite brick builds. The ogee gable end matches the SE wall with red/orange 68x105x220-225mm red/orange bricks with creased faces, soft arrises and horizontal pressure marks. Butted to this is the perimeter wall of 70x105-110x 220-225mm red/orange bricks. The wall has then been raised with 65x105x225mm bricks to form the Squash Court.

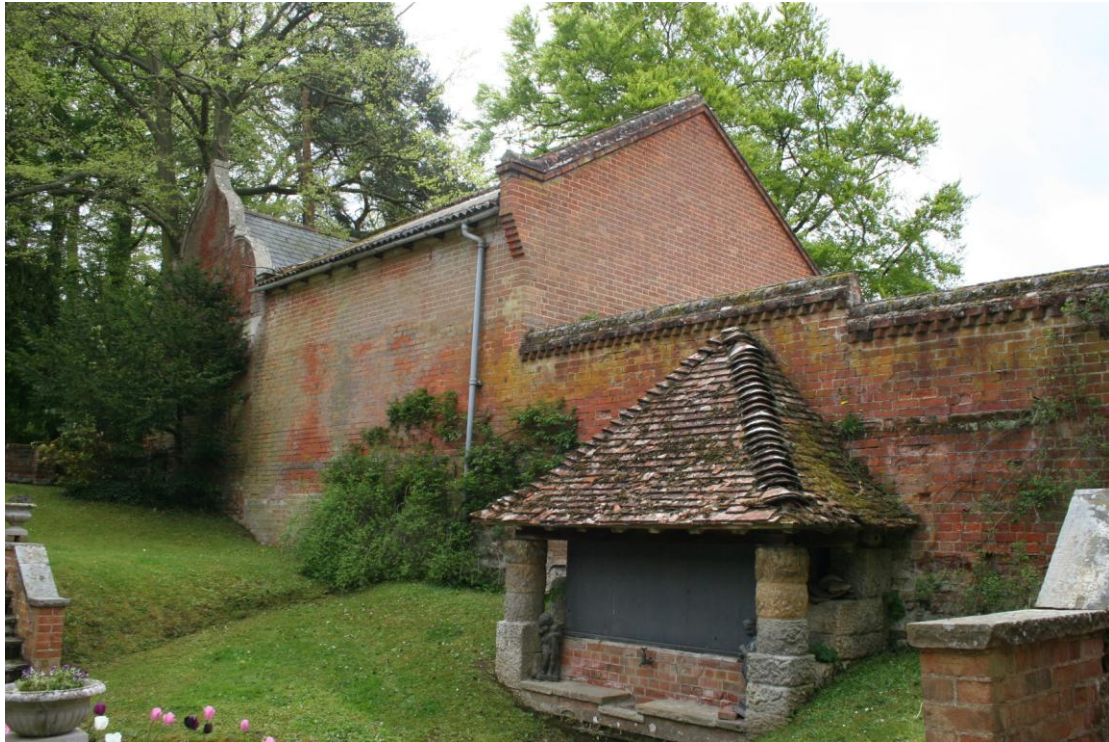
The perimeter wall continues along the sunken garden.

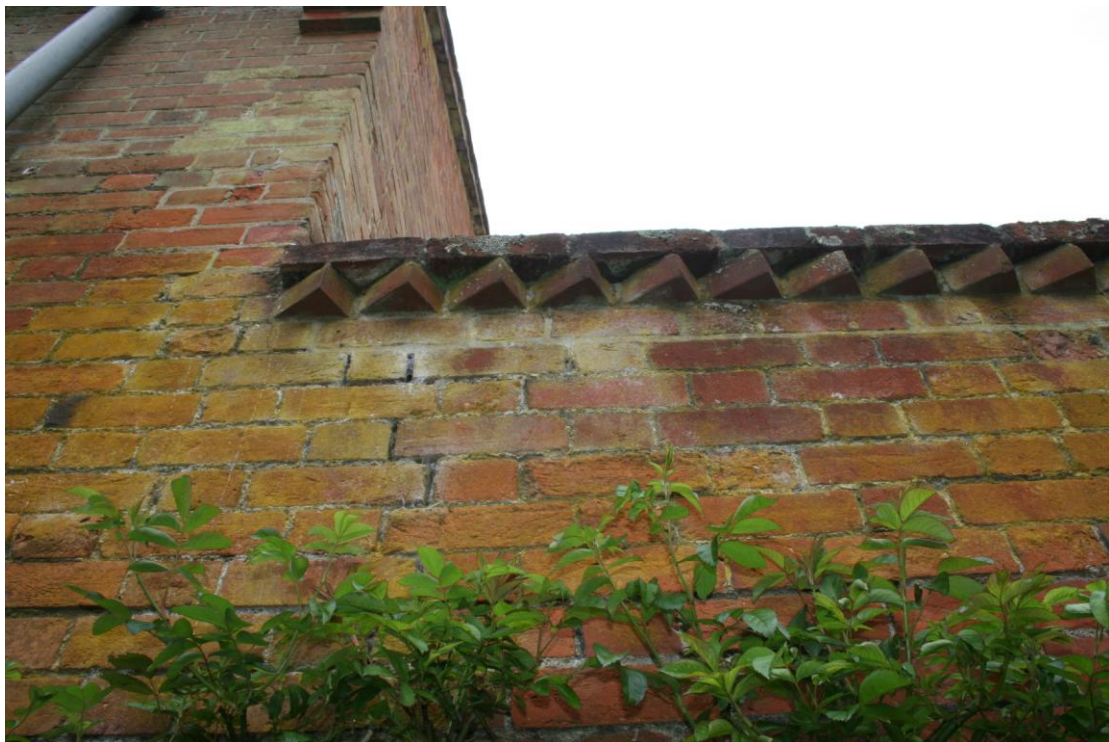
Detail of the of the herringbone dentillation.

The perimeter wall continues along the edge of the sunken garden where it has brick saddleback copings and a herringbone dentillated course. This form of decoration is a nod to the LC16th or EC17th.

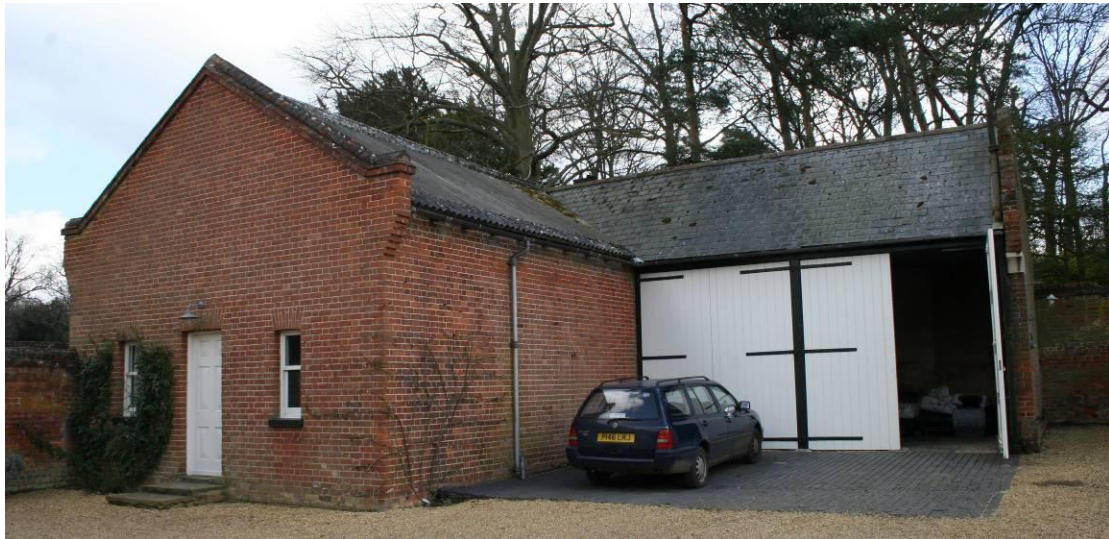
The NW elevation of the Squash Court.

The Squash Court has been created by building a forward wing off the perimeter wall with 65x105x225mm red orange bricks. The NW brick corbelled shoulders that mimic those of the SE gable of the earlier building. There is a centrally placed C20th door and two small C20th windows, all under rough gauged brick arches. There is a long vertical crack above the front door.

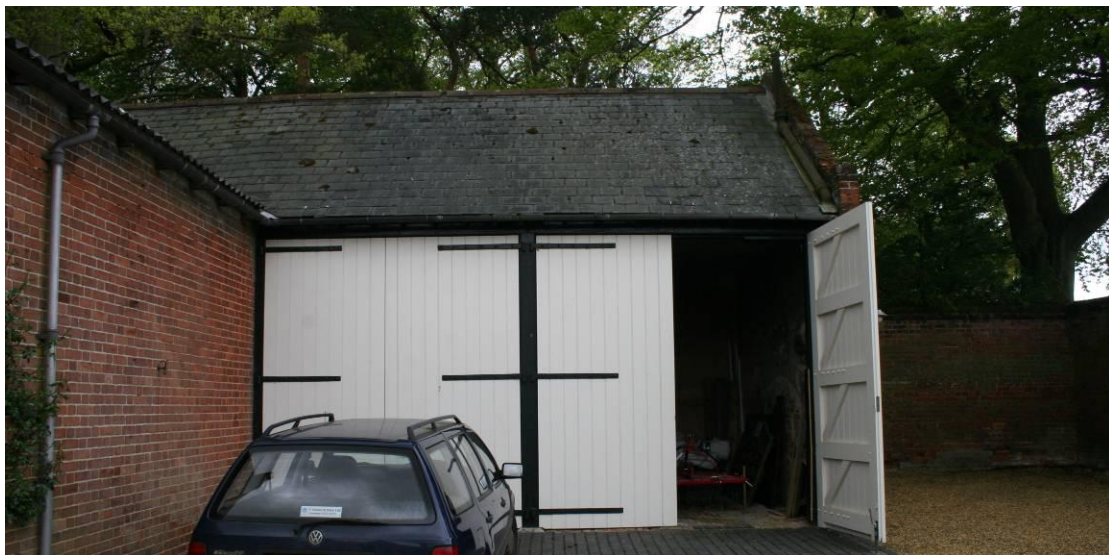
The former coach house has modern full height doors.

The SW arm of the building is equipped with two full height pairs of timber gate and ledger doors which are very recent. Although labelled as a car port it is in use as a store.

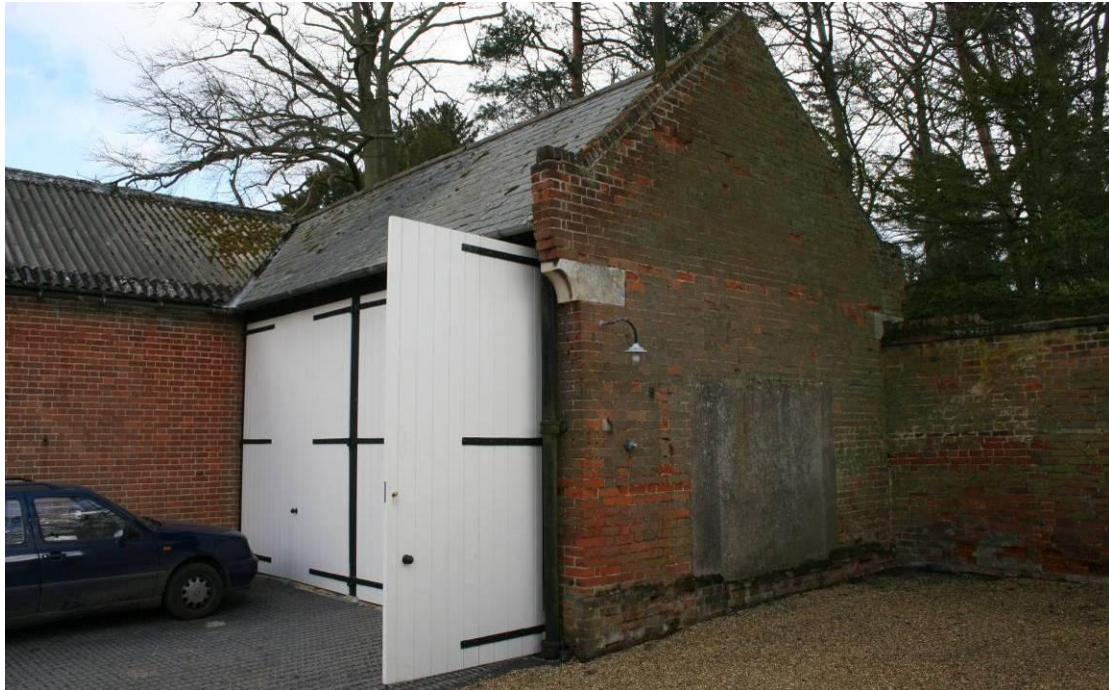
The SW elevation of the Car Port Squash.

The SW elevation of the Squash Court itself is void of features. The roof appears to be translucent corrugated glass reinforced plastic. This means that it could not have been in place before the 1950's when GRP became available.

The gable end of the Car Port has the same stone corbels as the other gable but the wall is built of 65x105x220mm brickwork and has shouldered brick gables with simple brick cappings. A large square section of the wall has been rendered with grey cement.

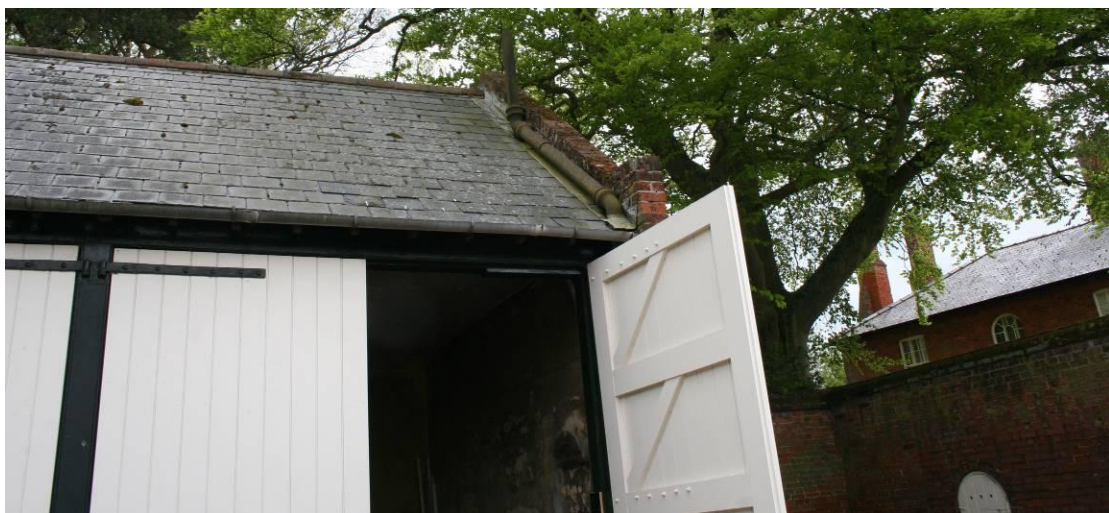
A stink pipe is laid on the roof.

Laid against the raised gable is a stink pipe and this feature combined with the extensive drains indicates that the yard toilets were adjacent to here.

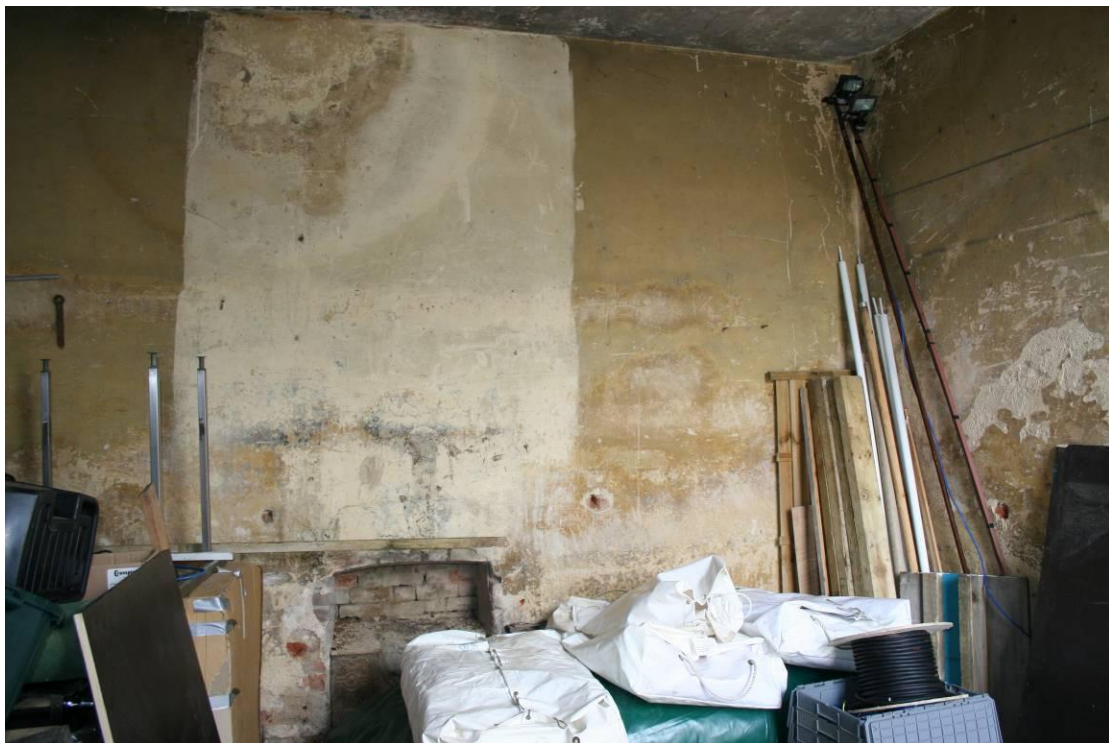
Looking E at the fireplace in the wall of the Car Port

The Car Port part of the Squash Court is a single large room with rendered walls and lath and plastered ceiling. There is a hob-grate fireplace against the SE wall.

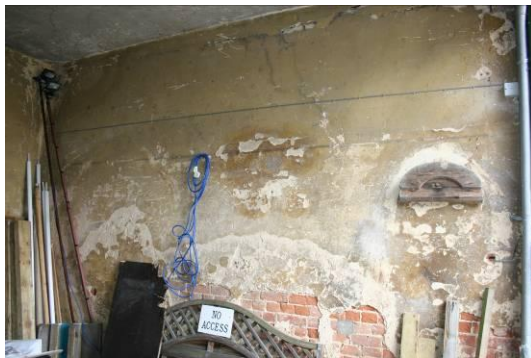
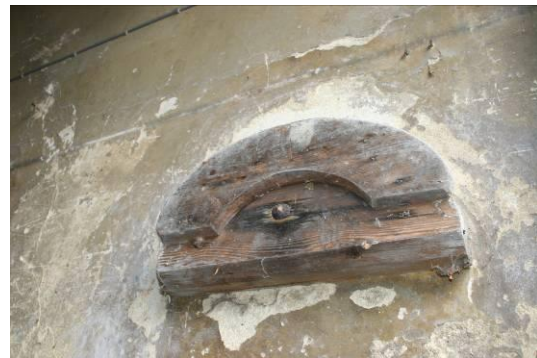
The SW wall with a fire hose reel holder.

Detail of the reel holder.

There are only two remaining fittings in the room. There is a circular steel eye in the ceiling for lifting gear and on the SW wall is a wooden holder that looks like a harness tree but is more likely a fire hose reel holder. Homemade from pine and nailed together with wrought iron nails it is fastened to the wall with a carriage bolt with a square nut and large square washer cut from a metal strip. The wall is marked in an oval where the hose used to rest.

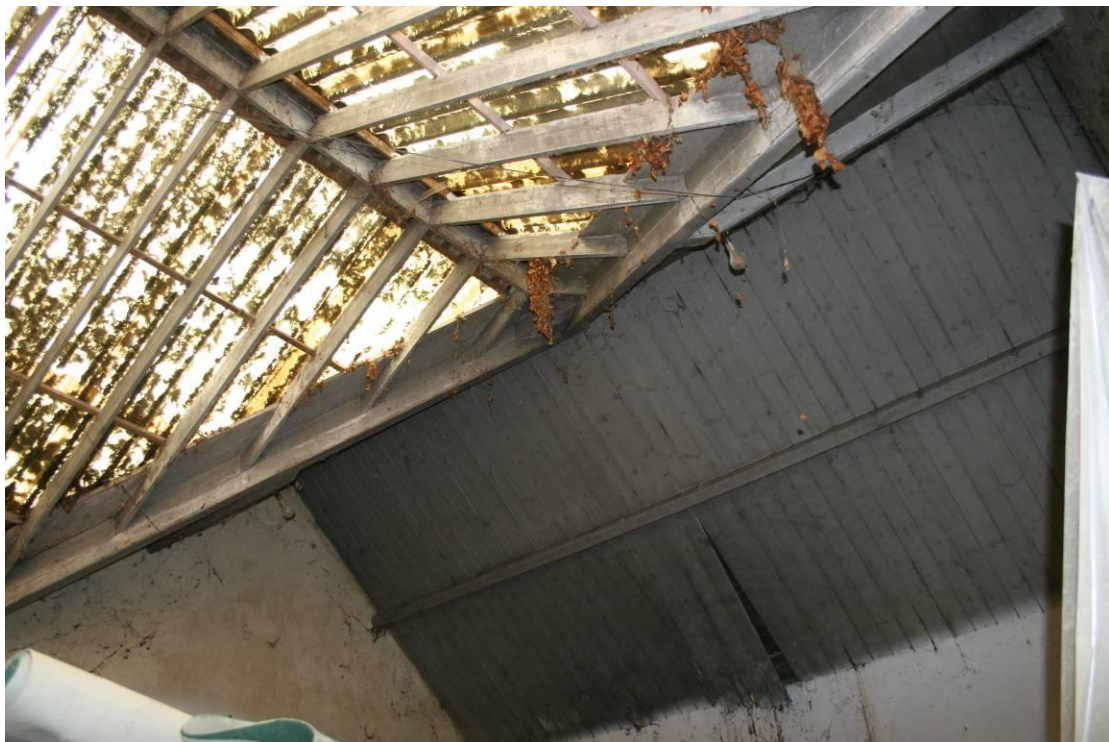
Looking NE upwards at the back of the Squash Court.

The Squash Court has a translucent GRP roof except at the back where it is clad with tongue and grooved boards beneath the slated roof. Many of the visible softwood rafters are recent replacements. The walls are finished in a hard cement render and the concrete floor is still marked out for the squash court.

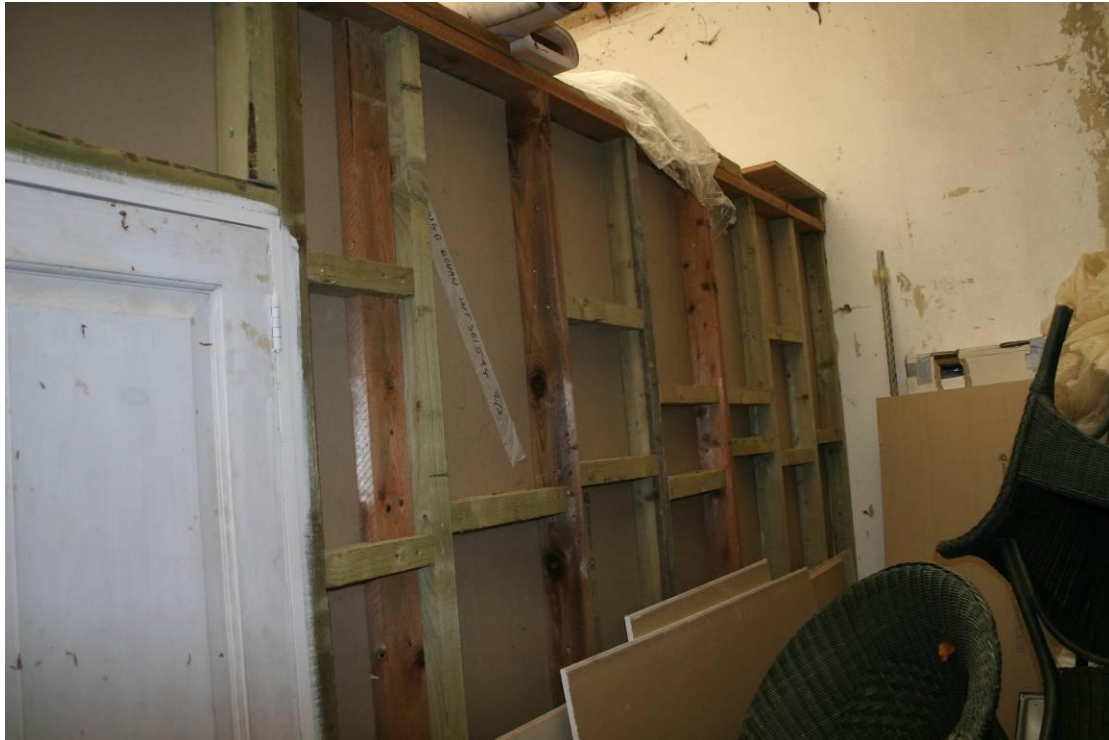
Modern studwork for the wedding reception rooms.

About half the volume of the Squash Court has been taken up by a very recent fabrication to form two reception rooms. The rest has been given over to storage for personal items. The lightweight structure is formed from tanalised timber and plasterboard. The two rooms conform to contemporary taste and were built to accommodate a dressing room for the wedding band and the bride.
