Maypole Farm, Top Road, Wimbish, Essex CB10 2XJ.
Description and analysis of the Barn and Outshots. Surveyed 24 02 2015.

This report describes and analyses the conjoined buildings that form the Barn at Maypole Farm, Wimbish. The main building is formed from two large timber-framed barns containing old frames but extensively remodelled circa 1800. The outshots house the Workshop, Drier Motor, Sack Drier and the former Pre-Dresser Room. Most of the machinery has been removed but half of the C20th silos are still in-situ. A full length open-sided Shelter has been erected against the southern side.

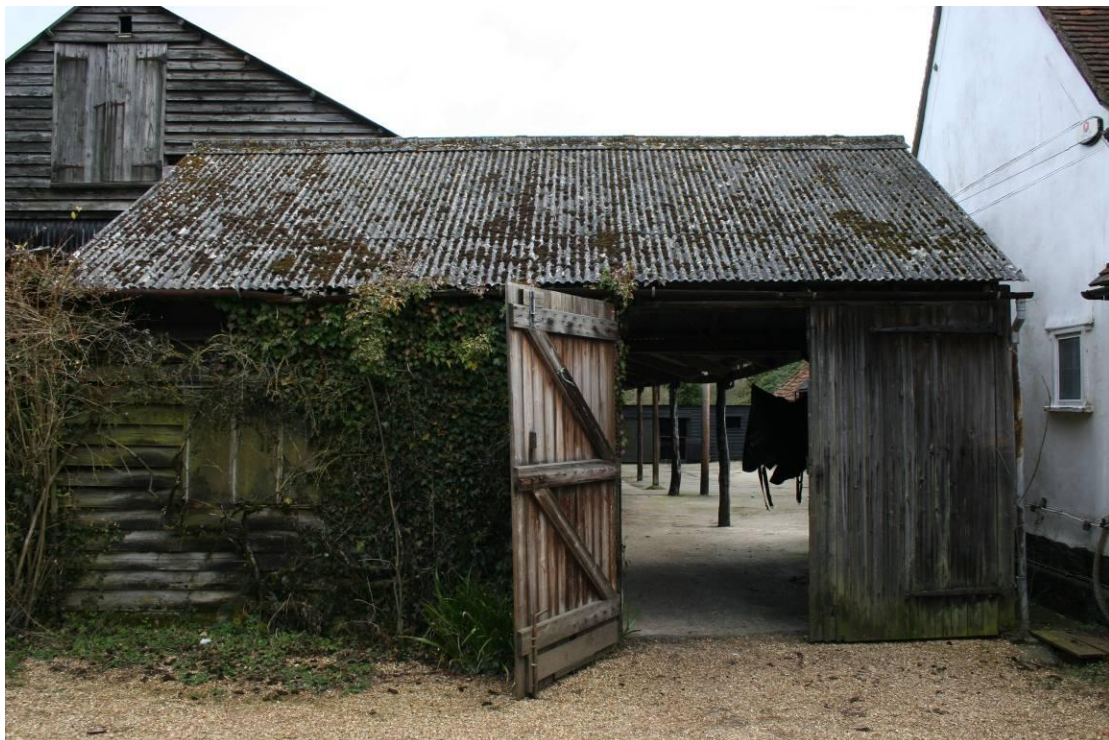
Detail of the garage workshop.

The garage workshop can only be entered by pedestrian doors at either end so it can be imagined that the mechanic worked under cover of the carriage arch using the machine shop tools and benches inside the workshop.

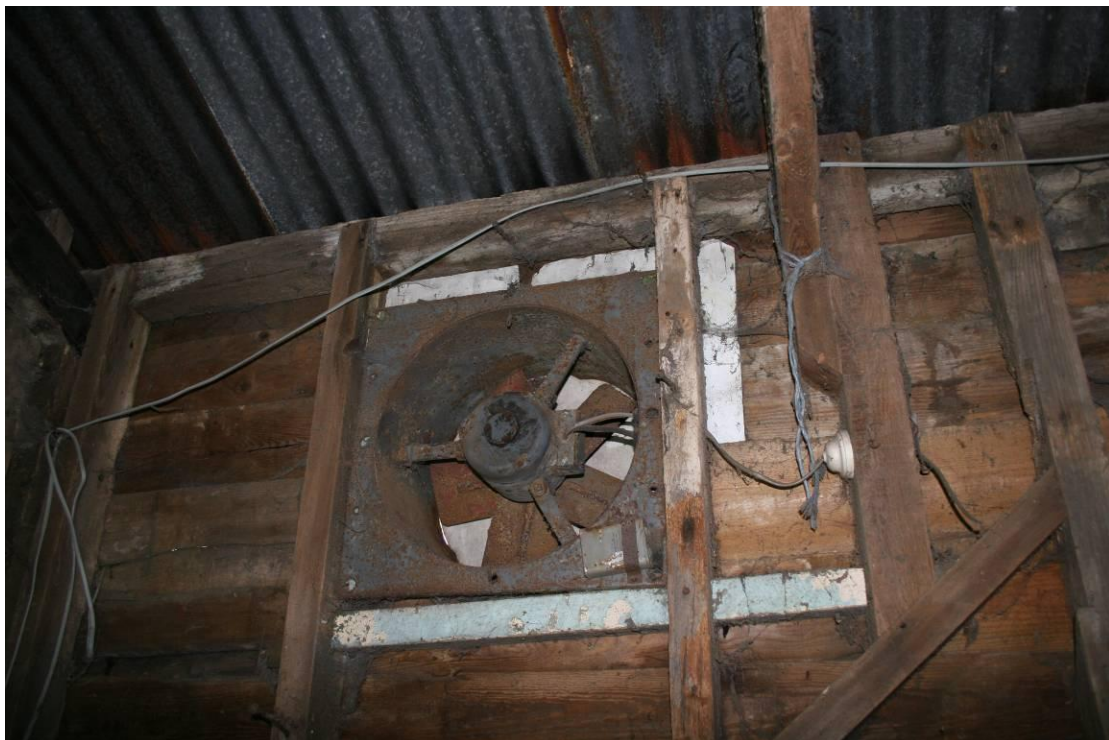
Detail of the extractor fan.

The Pre-dresser was fitted with electric extractor fans of which only one remains. Its construction and detail suggests it was fitted in the 1950's or 1960's.

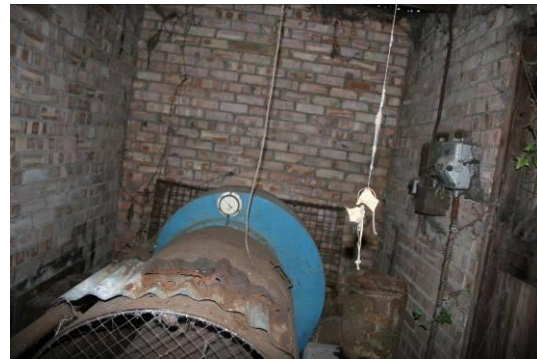
The electrically powered drier motor.

The large drier motor and its switchgear all appear to date from the 1950's or 60's. A quick scan of the internet shows that sack drying was introduced after the 2nd World War in Britain and used on farms with relatively low yields as it is very labour intensive. As the yields increased, column drying (i.e pre-dressing) became dominant. See Appendix 1.

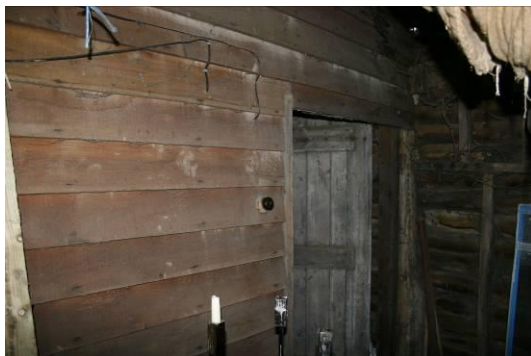
The entrance door from the Barn.

The oldest thing in the Sack Drier is the entrance door which is an EC19th vertically boarded, tongue and grooved timber door with horizontal ledgers. It is hung on hand wrought iron pintle strap hinges. The frame of the Barn has been reboarded in the LC20th.

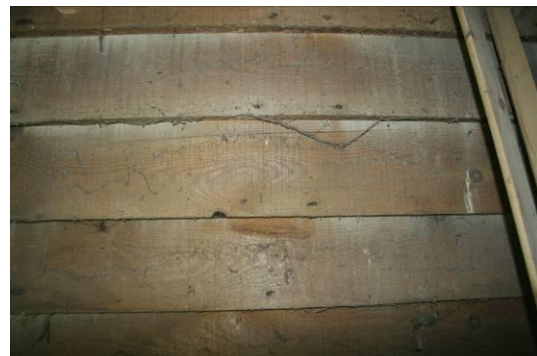
Detail of the LC20th weather-boarding.

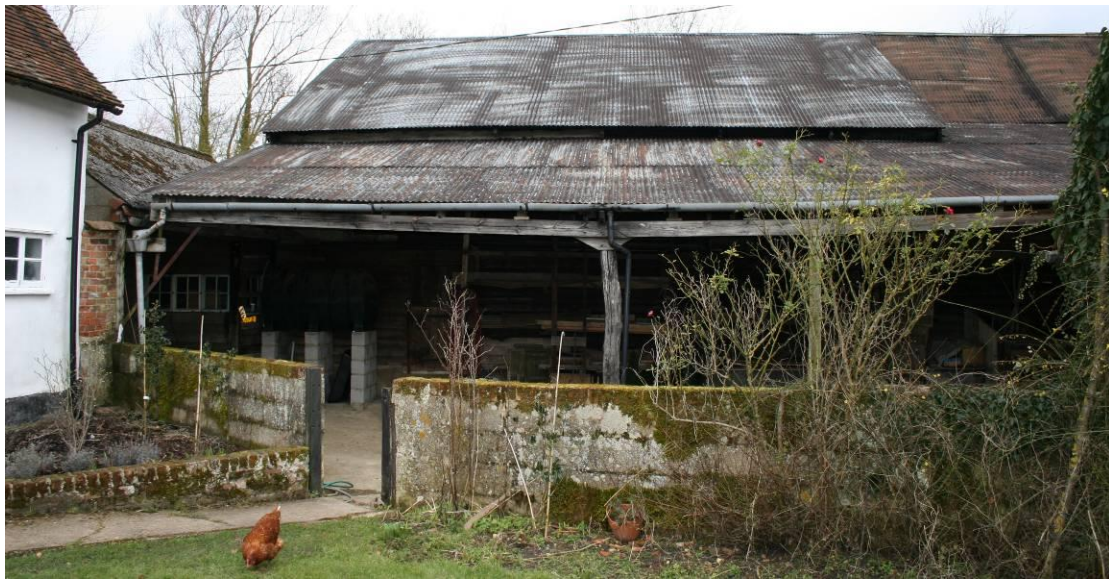
The more recent roof of the West Frame above the Open Shelter.

The entire roof of the Barn has been removed and replaced with a lightweight structure clad with corrugated iron. The section over the West Frame looks more recent but still over 20 years old.

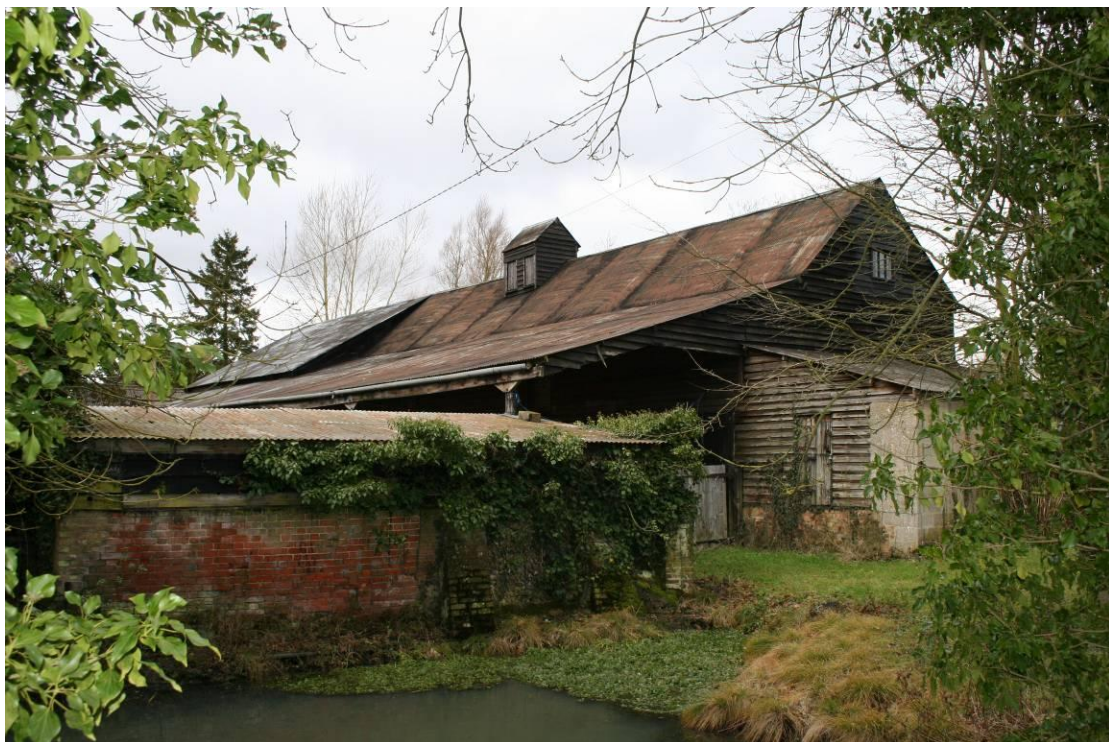
The corrugated iron roof of the East Frame.

The two frames have very similar LC20th roof structures of lightweight timbers skinned with corrugated iron. That over the West Frame is obviously more recent as it lacks the patina and corrosion of the other. Also it has been painted black on the outside – a common addition in the 1990's when it was a conservation issue to dampen down the bright steel.

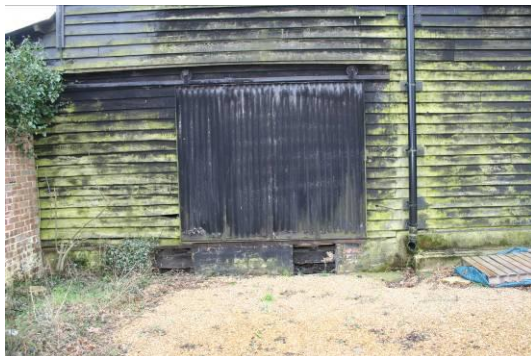
The sliding steel door to Bay 5..

Bay 5 of the East Frame has been fitted with a M-LC20th sliding steel door giving access to a suspended timber drying floor that is ventilated on both sides of the Barn. The floor is stood on brick plinths and laid with sawn tree trunks fastened with wrought iron clout nails. The detail inside suggests it was put in place in the LC19th or EC20th. Raised timber floors were quite commonplace in C20th grain barns to prevent the bagged up goods from overheating and germinating before being shipped.

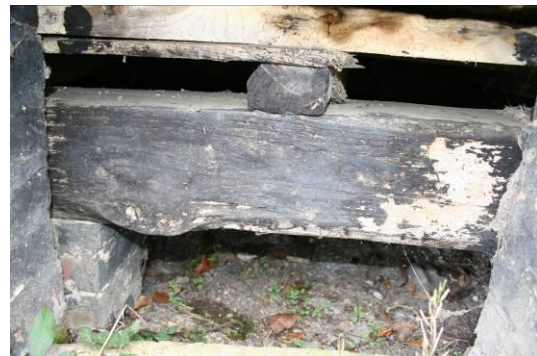
Detail of the suspended timber floor.

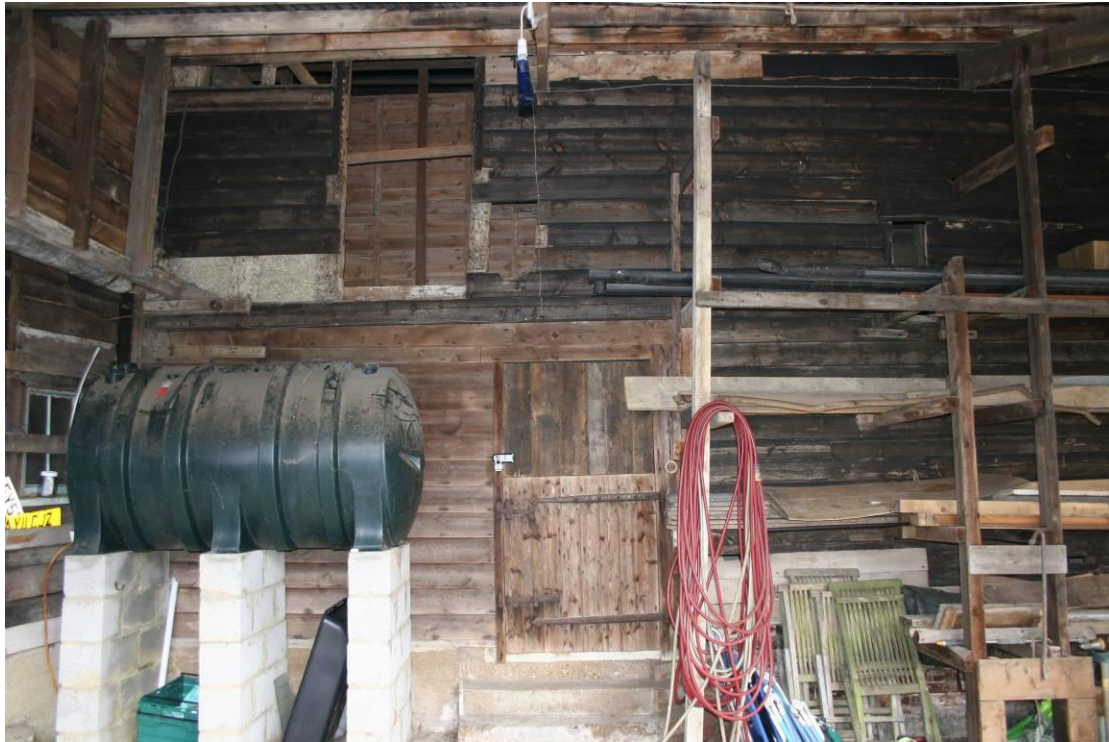
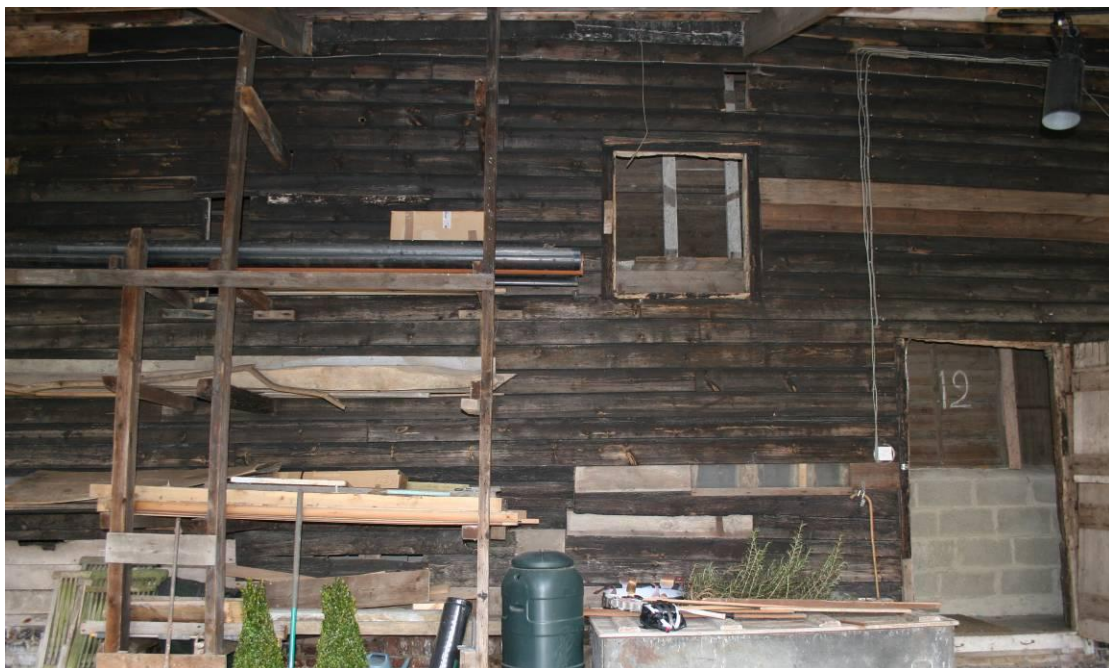
The southern elevation of Bay W1 in the West Frame.

The southern elevation of Bays W2 and W3 in the West Frame.

The external cladding of the West Frame is nearly all LC20th. Only a very few boards appear to be remnants of the older cladding. There are three doorways and a hatchway, all of which are C20th as they serve the layout of the internal silos and gantries. The main split stable door is MC20th fixed with French nails and hung on a variety of reused C19th pintle hinges.

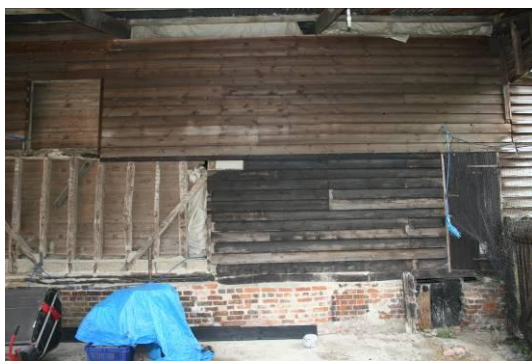
Bay E5 has an EC19th door.

There is an EC19th boarded door hung on wrought iron pintle hinges with spooned terminals. It appears to be of the same type as that leading into the Sack Drier. Below it is a ventilation duct for the boarded floor that has been raggedly broken through the plinth. It has been blocked with split down logs to prevent the animals getting under there.

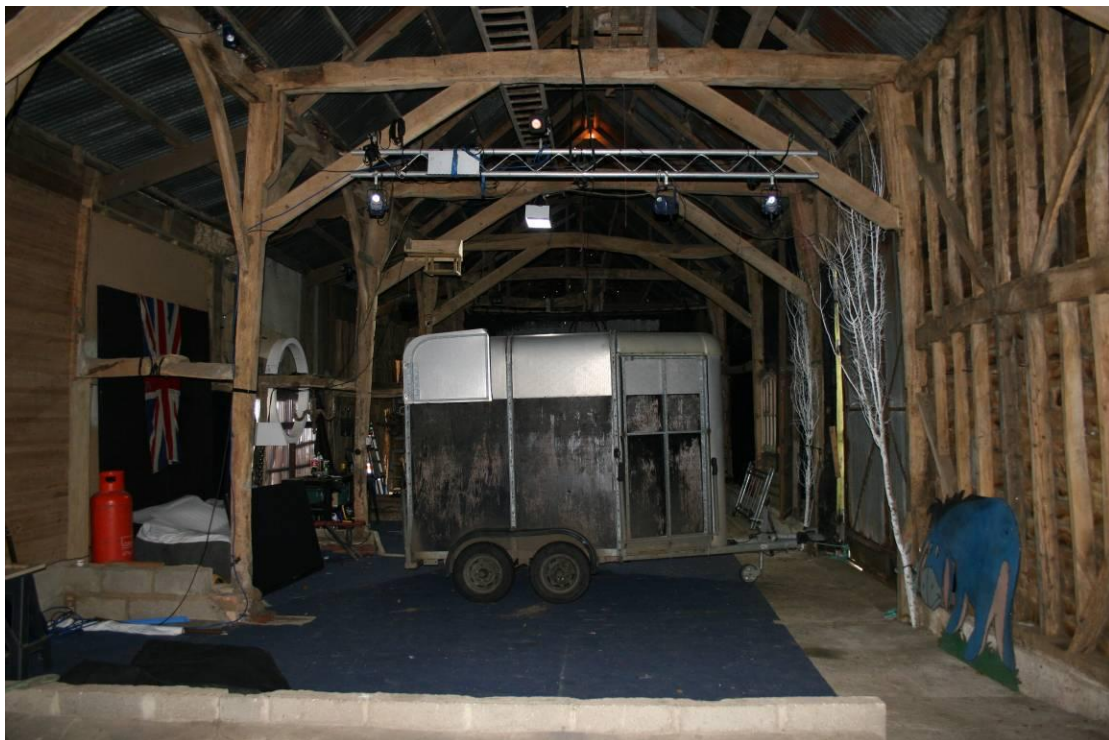
Looking W inside the East Frame.

While the East Frame contains elements of a C16th or EC17th barn it is evident that the frame has been re-erected with many new timbers and interrupted stud walls c.1800.

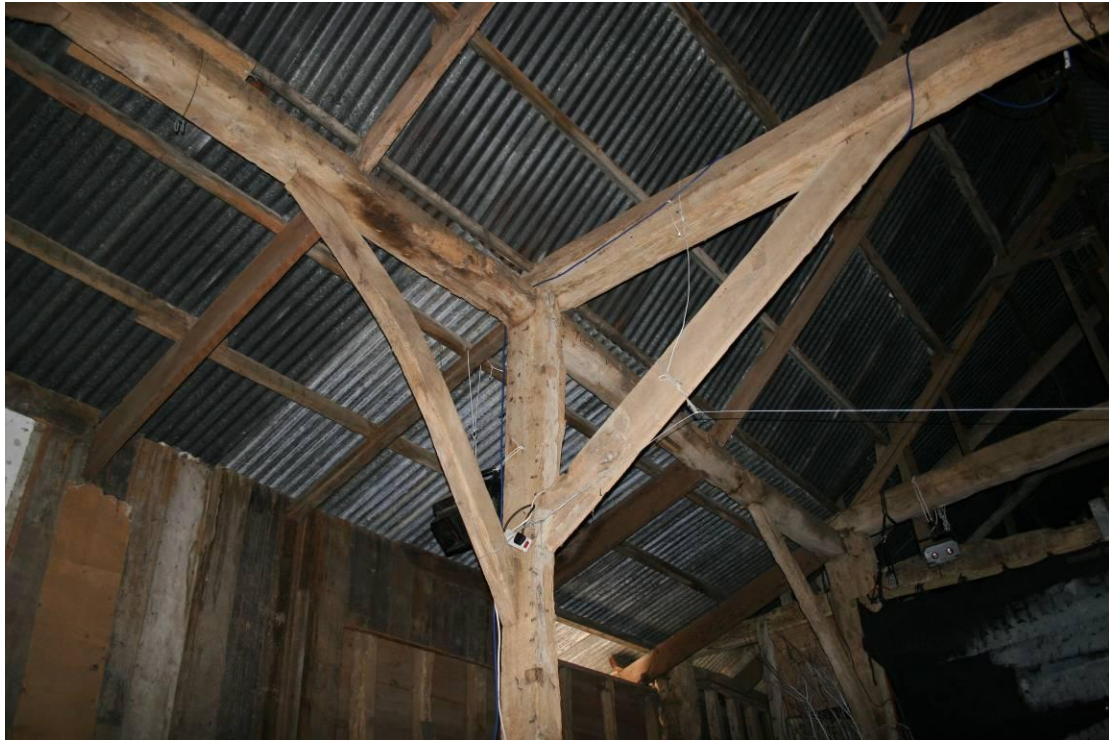
Detail of the arcade post in Truss 2, south side. Curved and straight spandrels.

There are other indications that the frame has been re-erected. The posts are not consistent in section or form. They vary between 5x6in, 6x6in and 7x7in at the base and the jowls are of different styles, some with very abrupt transitions while others are swept. The spandrels also vary considerably. Some are long, slender and curved while the later ones are straight and heavy and have the red-grey hue of elm. These are pit-sawn and poorly chamfered, conforming to the style of c1800.

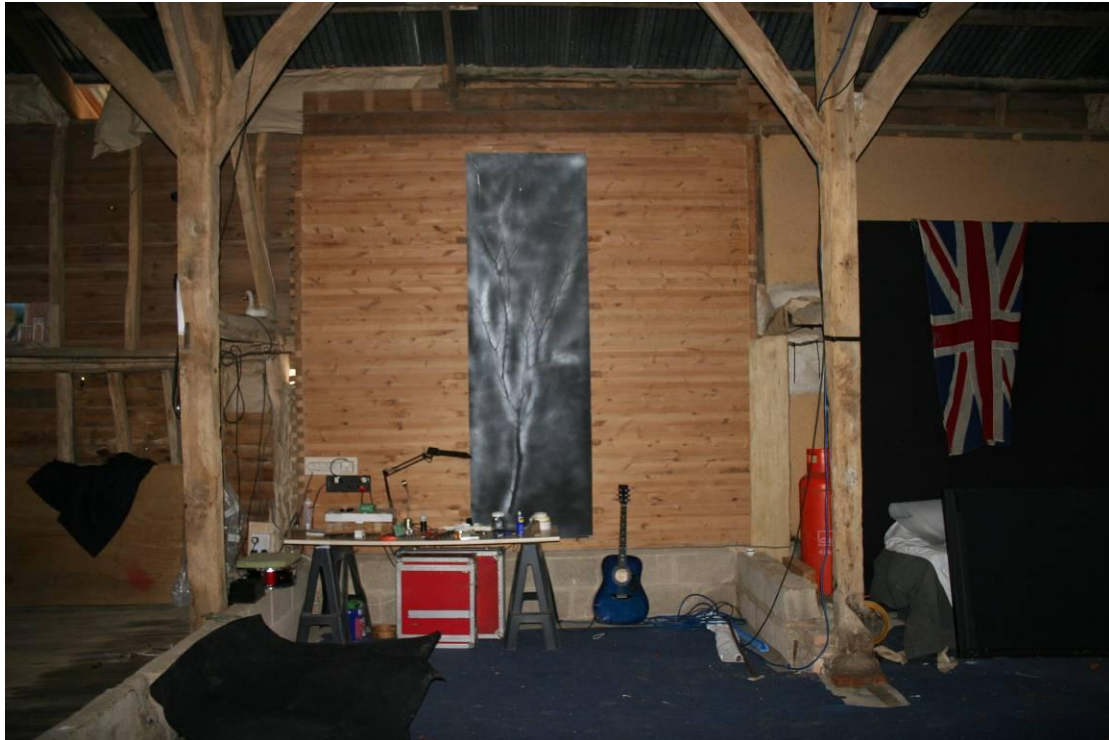
Bay 3 on the south side retains one side of a wooden silo.

Large sections of the frame have been removed in the LC20th. The wall common to the Pre-dresser has had all its studs removed and the current panels are made up of theatrical flats and a prop door and window from a stage set.

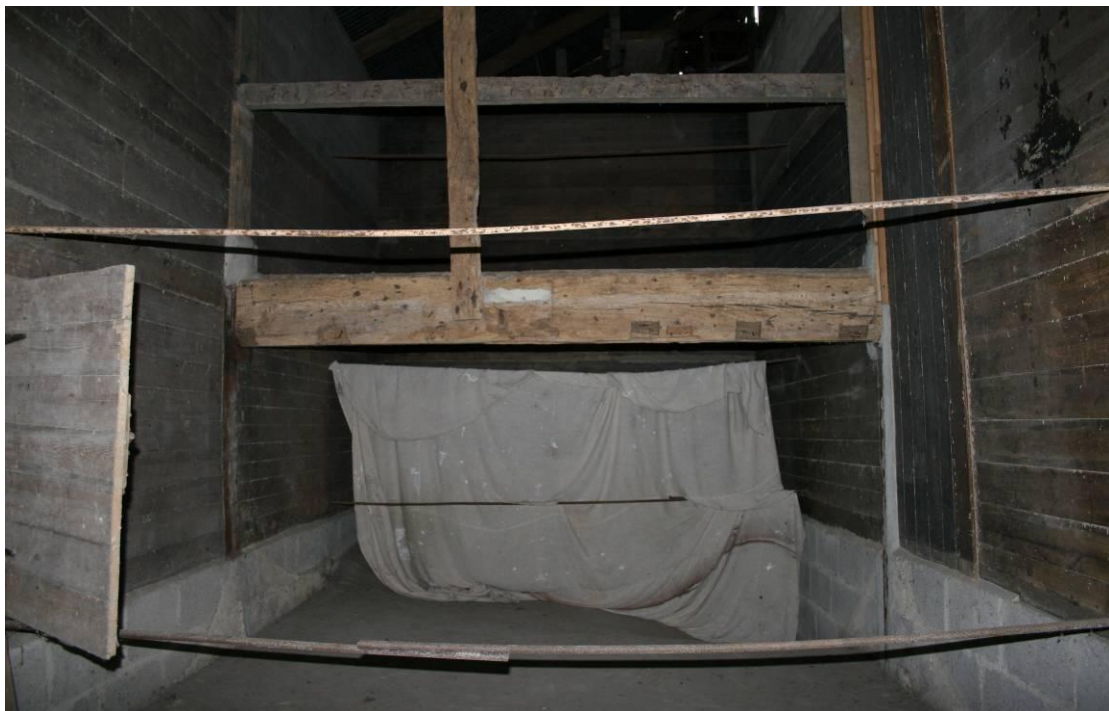
Looking W into the eastern silo. Note the main joist that originally supported a floor.

In the eastern silo is a main joist that supported a former granary floor that ran the whole length of the West Frame. It is morticed for large axial joists. The structure remains above the western silo where it has been repeatedly repaired and propped. The 6in flat joists are axe hewn from oak and clad with elm and pine boards (overboarded above).

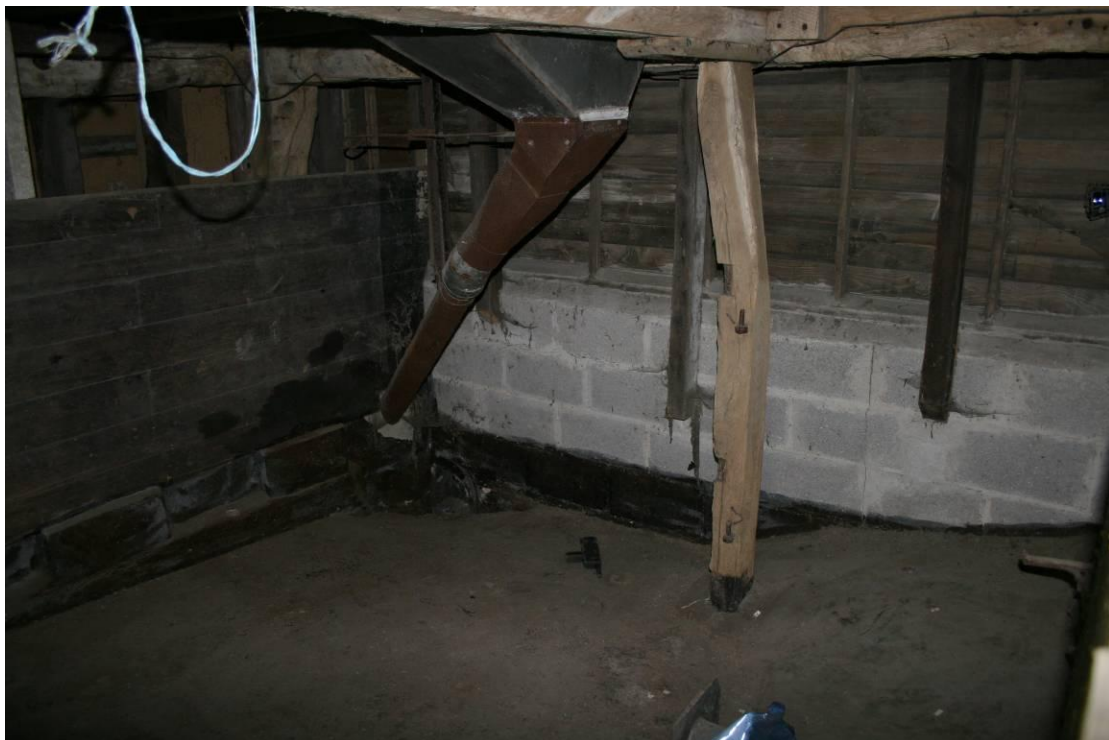
Looking NE into the western silo beneath the granary floor.

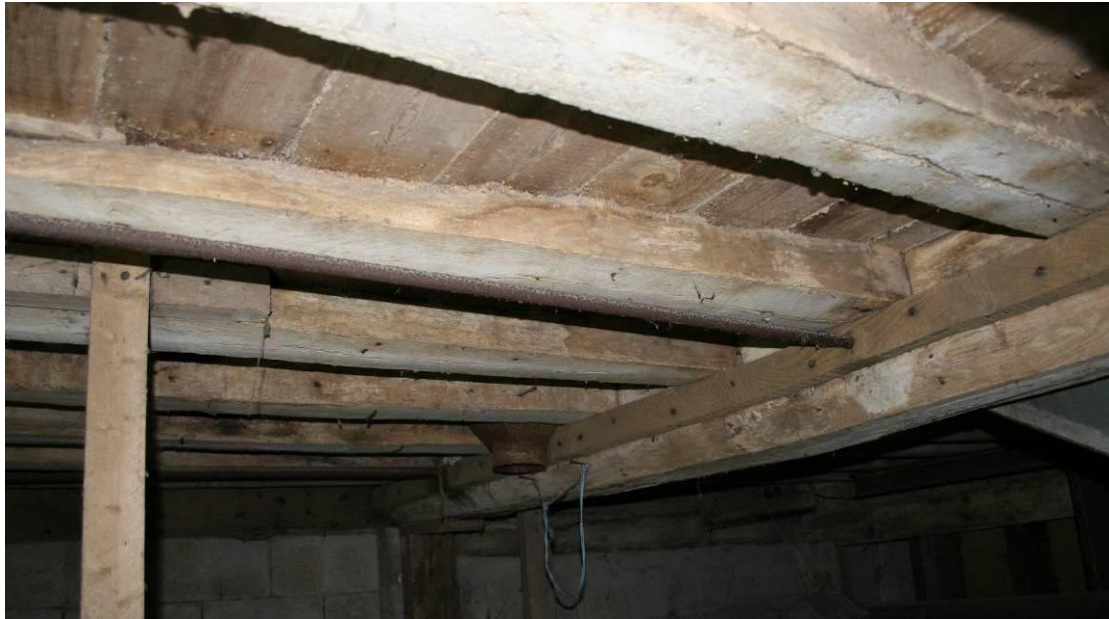
The granary floor has flat joists and wide elm and pine boards.

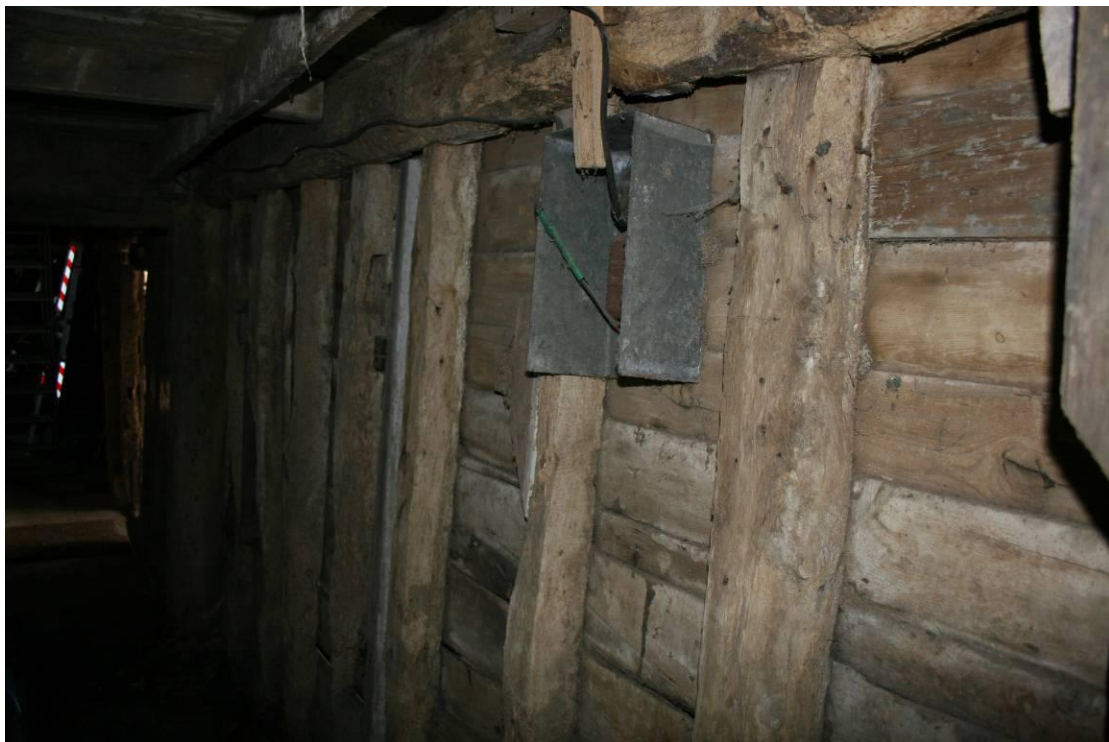
Detail of the southern wall of the West Frame.

Most of the original studs have been removed from the West Frame but a few remain on the southern side that look original. The 5-6in oak axe hewn studs are at 14in centres. Each bay is 12ft across and is defined by an 11x8-9in section storey post with heavy jowl connected to a chamfered and cyma stopped tie-beam. The frame has a very unusual detail in that the mortices have not been cut square but left round ended. This is normally associated with LC18th or EC19th work but the holes have been cut with spoon bits and so must be earlier.

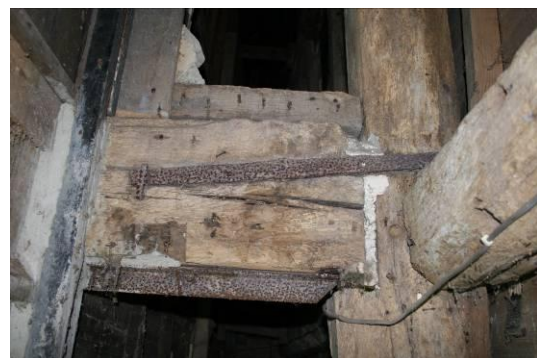
C.1800 iron tie reinforcing the floor joist.

The soffits of the mid-rails and top-plates have wattle grooves for wattle and daub panels and the flanks of some of the studs have darts for ledgers. The major joints are reinforced with wrought iron ties that are c.1800 in design. C20th RSJ's have also been added.

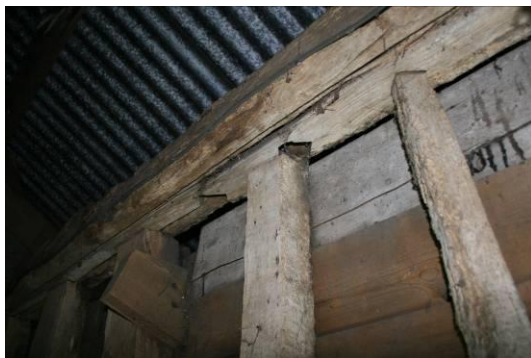
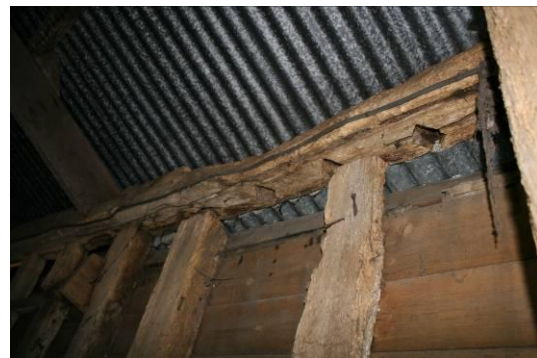
There is evidence for two mullioned windows in the southern wall.

The upper section of the southern wall can be examined from the gantry. The studwork is trenched for internal curved braces to the SE storey post. There is also evidence for two diamond mullioned windows set against the storey posts. These have been subsequently over-boarded with c.1800 style studwork. One original mullion remains.

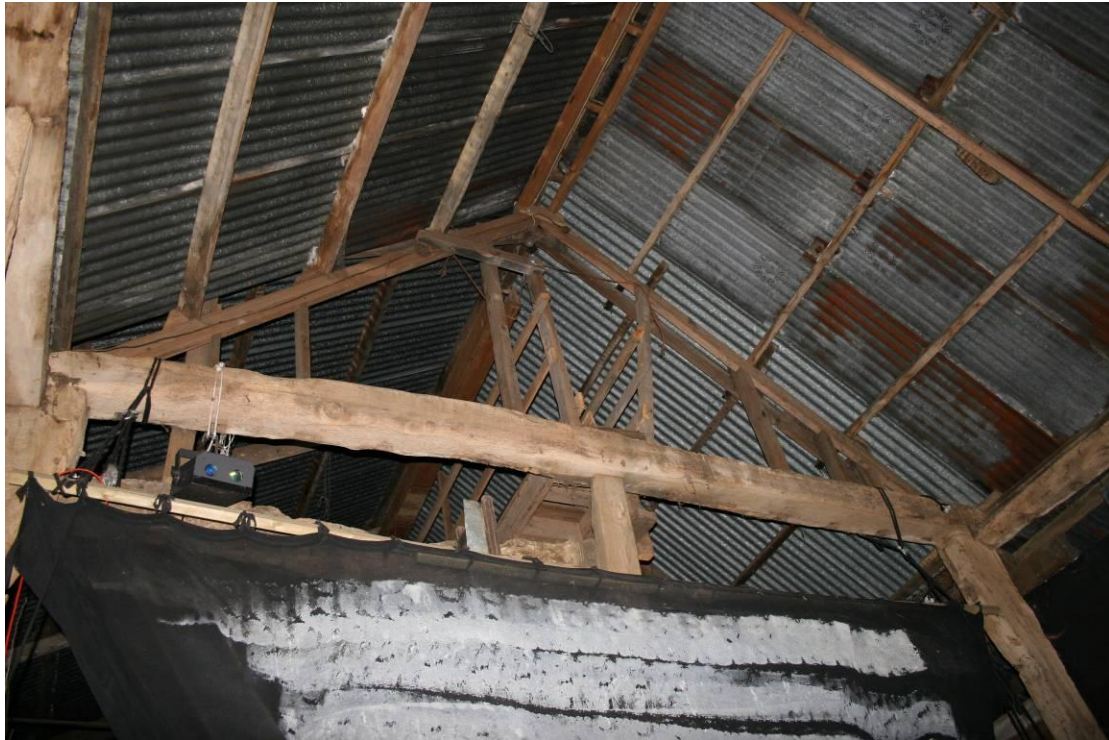
The roof structure over the West Frame. Looking W.

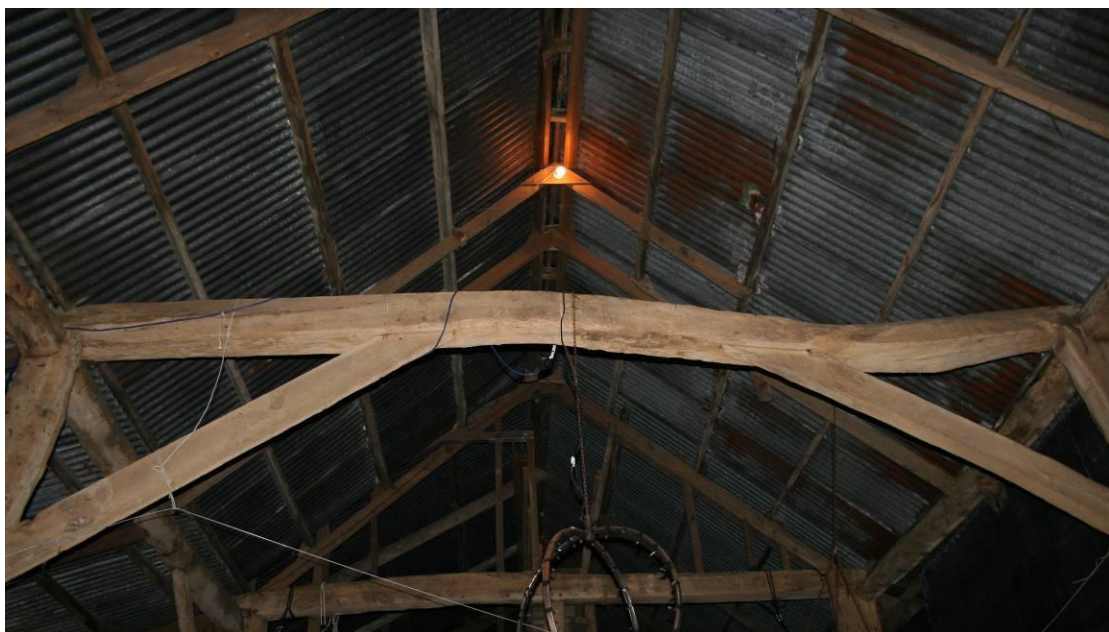
The roof structure over the East Barn looking W.

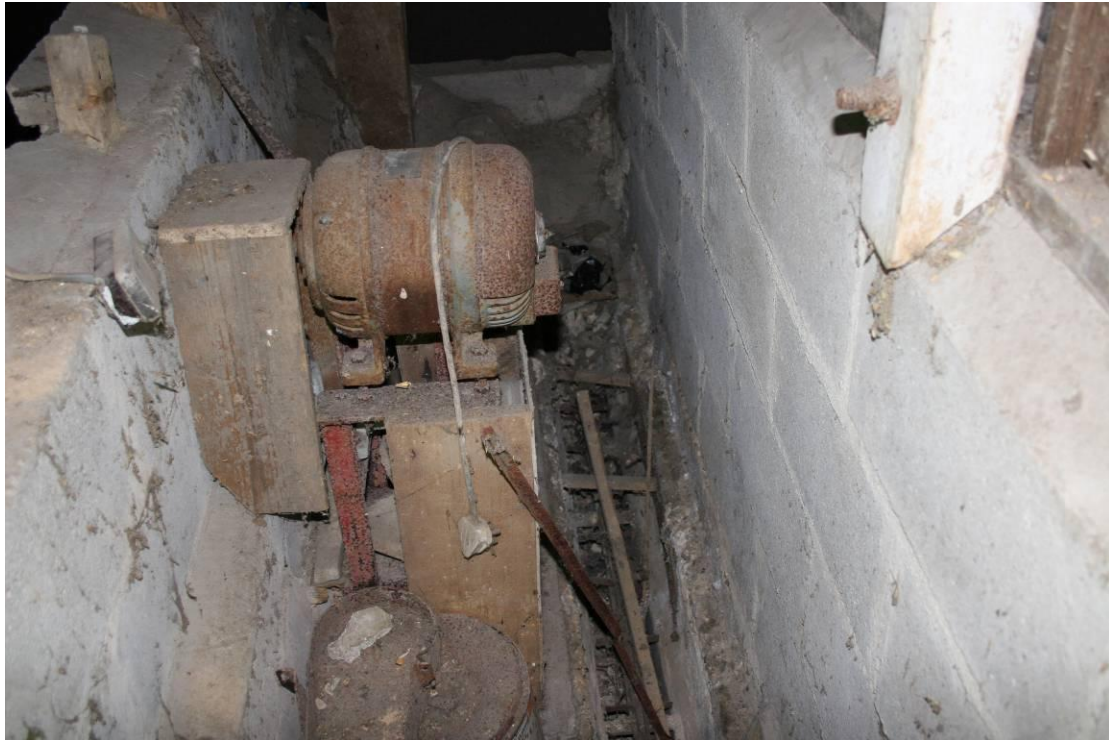
Electric motor to run the chain drive in the floor.

The electric floor motor has a manufacturers plate for the Lancashire (Dynamo &) Crypto Motor Company and describes it as a 'single phase – repulsion start induction motor'. The company was in business under that name between 1951 and was closed down in 1967 (See Appendix 2).
