Wilderness, Drakes Lane, Little Waltham, Essex CM3 3NA. Description and analysis of an outbuilding. Surveyed 31 10 2016.

Type of Work: Historic Building Recording

Barry J Hillman-Crouch MStPA DipFA BSc HND.

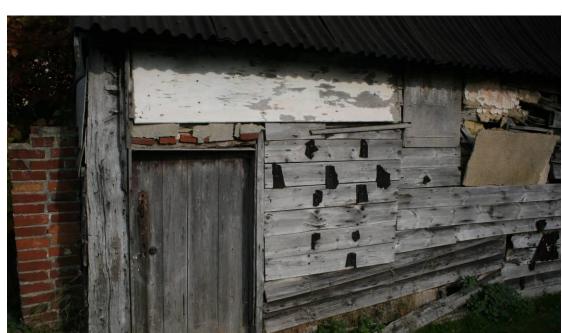
The southern elevation presents a single storey chalet building with a small dormer in the LC20th/C21st corrugated bitumen based roof product known as Onduline - Onduline is an extremely tough, lightweight, corrugated roofing and wall cladding material manufactured utilising a base board produced from recycled cellulose fibres which is saturated with bitumen under intense pressure and heat. The interrupted studwork frame is clad with LC20th weatherboards fixed with French nails, some EML and lath and daub panels.

Detail of the doorway and boarded over window.

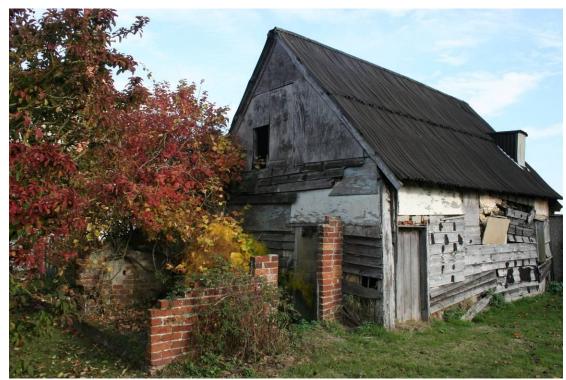
The western elevation.

The gable of the western elevation has been clad with marine ply leaving a window opening. The ground floor has a C20th door with glass light and a four pane casement that has been boarded over. The rest is clad with C20th sheets and weatherboards. A pig sty has been built against the end of the building reusing old red frogged bricks set in hard grey cement.

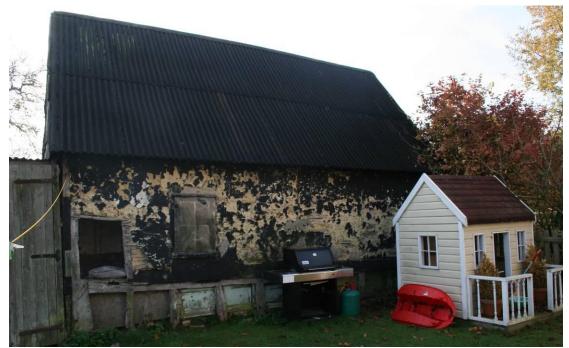
The northern elevation.

The northern elevation retains large sections of MC19th lath and daub finished with black bituminous paint. The exposed frame displays a reused rail to which the lower, short studs are lapped and nailed or skew nailed. A few are pegged. The lower section was weather-boarded but is now shut off with old panels and wardrobe doors on the inside.

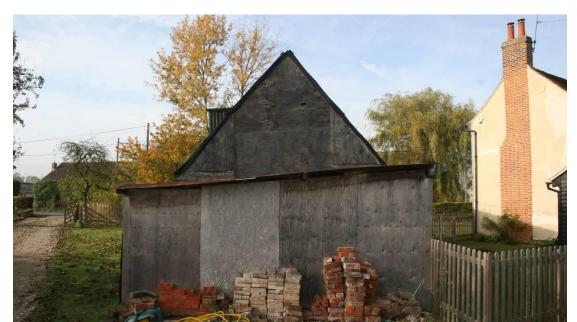
The eastern elevation.

The eastern elevation of the outbuilding is preserved within the makeshift garage which is constructed of machined timbers, marine ply and OSB (Oriented Strand Board) print dated to 2007. The present owners removed an adjacent similar shelter in 2010. The outbuilding retains a run of lath and daub above a section of 9in deep EC19th weather boards fixed with wrought iron nails. There is an opening into the outbuilding but this is not an original doorway. The upper section has been clad in marine ply as part of the reroofing of the building.

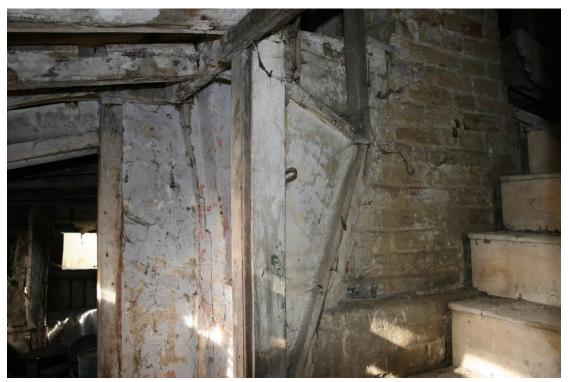
The eastern side of the firestack.

There is a small lobby that gives access to the staircase and then the Living Room. The fall of the frame is very noticeable in this area. The frame has little remaining top plate. Instead ledgers or clamps are nailed in sections all the way round to support the joists. The scantling nailed interrupted stud frame has fallen out and the joists are hanging in the air supported only by the floorboard nails in places. The rest is supported on wooden props and very rusty Acroprops. The joists above the lobby are also supported by a nailed on C20th bed leg.

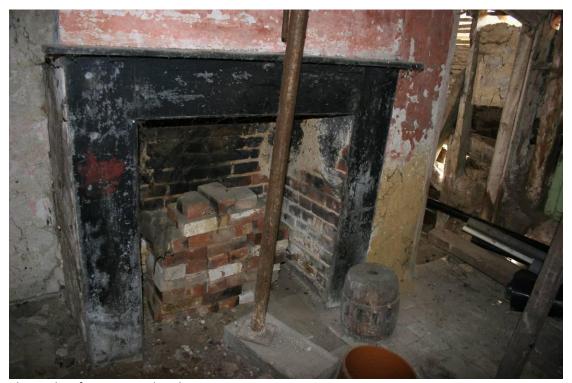
The timber fire surround in the Living Room.

The Living Room is equipped with a fireplace with a Victorian style plain timber fire surround with small mantel shelf. The opening is 39x43in high and the bricks are 65x110x225mm reds set in lime mortar and the chimney is built as one unit. The firebreast has been lath and plastered and extended to the south with a lath and daub screen which has been clawed on both sides by an animal. The walls have been limewashed with a red tint.

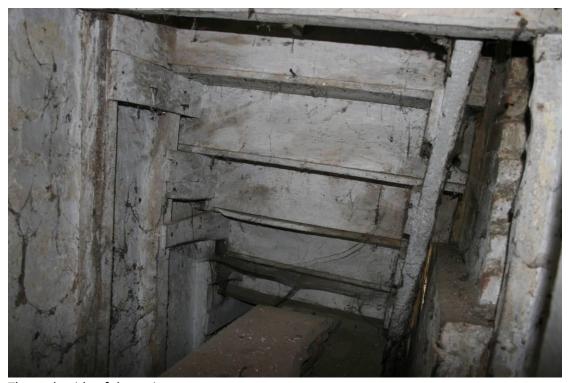
The underside of the staircase.

The Pantry is an L-shaped room making use of the space under the stairs which can be seen to be MC19th is design and fabric with machine cut treads, risers and strings and nailed on hand hewn supports. The small room is boarded in the inside to waist level using modern bandsawn boards and doors to protect the friable walls.

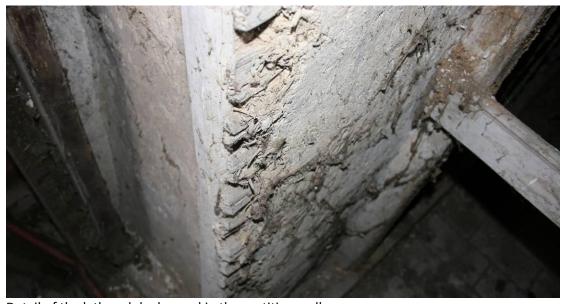
Detail of the lath and daub panel in the partition wall.

The Pantry is equipped for shelves and there are two wooden supports for a single shelf and there is a slot cut right around the room for a continuous shelf at chest height. There is a small tethering ring high up which is most likely to hang a lantern on. The partition wall is made of thick riven rods nailed to scantling poles and daubed on both sides and then whitewashed to improve the light given by the small four pane window. A large hole has been cut through the wall so junk can be put in from the garden side.

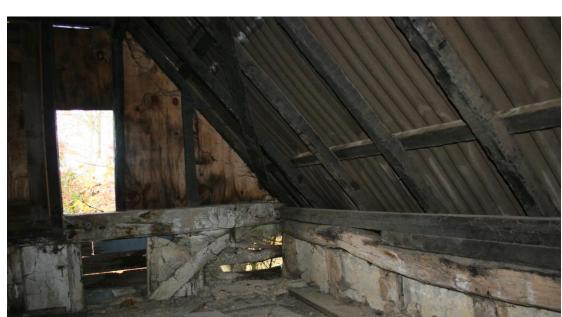
Looking W in the Upper Rooms.

Marks on the brickwork of the chimney stack show there were two upper rooms before the roof was replaced. It is very likely there was a small landing and two partition walls. The eastern gable is still in place and shows the framing and lath and daub construction. The waney tie-beam is not jointed to the top-plate but is secured with a very rusty iron tie. The tie beam at the other end of the building is a large reused timber correctly dovetailed in.
