# Whitehall Hotel, (Church Hall), Broxted, Essex, CM6 2BU.

Heritage Statement for the hotel buildings. Surveyed 24 08 2016.

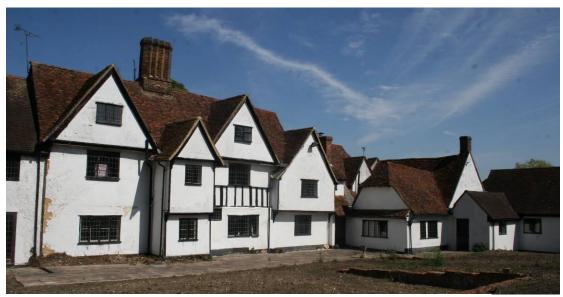
Southern elevation of Whitehall Hotel and the Brewhouse to the RHS. BJHC 2016. Images of England shows the wrong building.

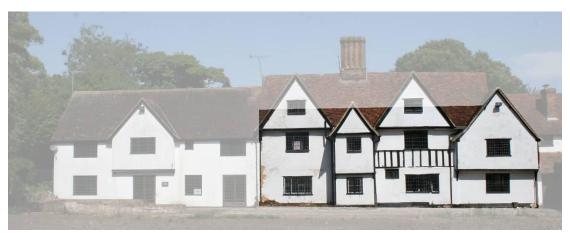
Originally built as a hall house in the LC15th the fixture holes for the high end can be seen in the westernmost wall of the timber-frame. The hall was subsequently floored over and the roof height raised above that of the cross-wing and the massive chimney stack installed. This would have been done most likely in the MC16th when it became fashionable.

Approximate volume of original house.

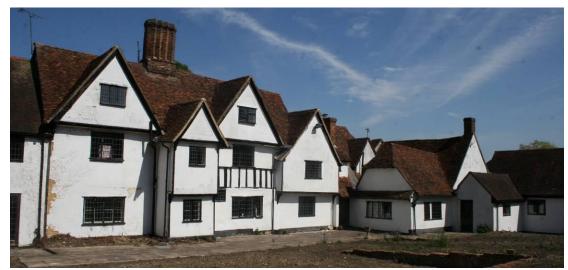
The Brew House in context with the House. Looking NE.

To the SE of the House is the Brew House. This is a timber-framed structure with some unusual features and a large firestack. Internally it resembles a C16th or C17th Kitchen but its actual age may prove contentious. The building is not shown on the 1839 Tithe Award while all the other buildings are. It appears on the 1876 Ordnance Survey in its present plan and so is likely a Victorian addition reusing an old building.

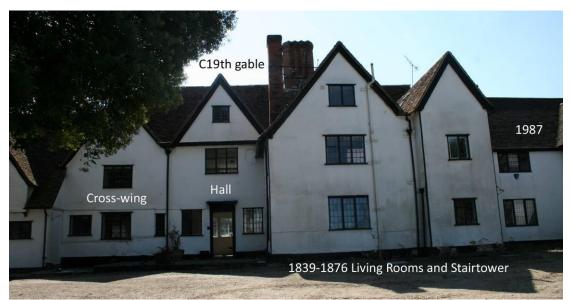
The northern elevation.

The northern elevation became the front of the House between 1839 and 1876 by which time there was turning circle and established rear gardens. There are two extensions, the larger containing a living room, bedroom and attic room and the narrower containing the staircase which is early Victorian in design and fabric. A further gabled dormer was added to the roof and decorative chequerwork barge boards added to the new builds. Notably the original cross-wing does not have this feature.

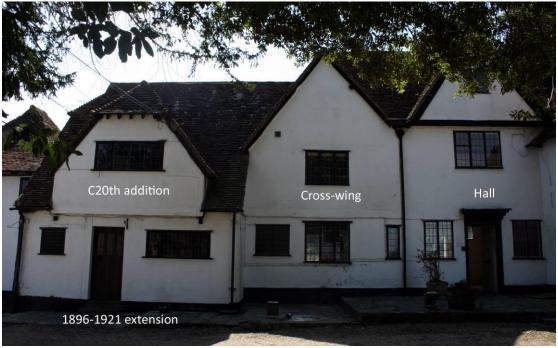
EC20th extension to the west of the cross-wing.

The utility building containing the boiler house was put up between 1896 and 1921.

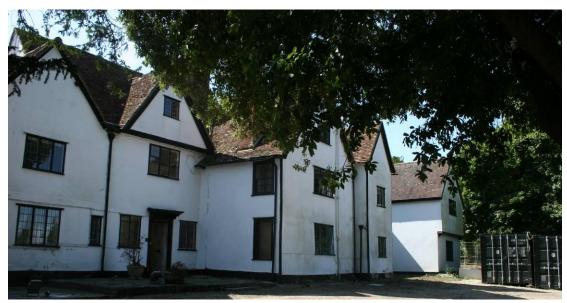
Looking SW along the northern elevation towards the Lord Butler wing.

The 1987 Lord Butler Wing is actually quite sympathetic to the form of the older house, even adding a jettied wing to echo that on the other side.

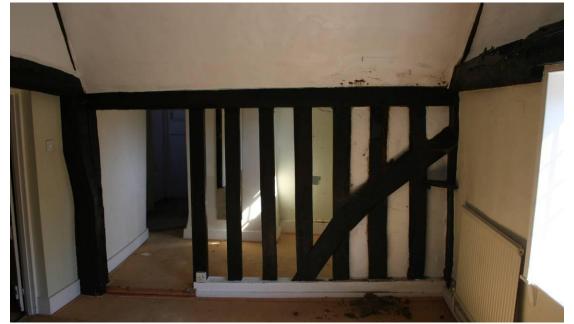
The cross-wing frame seen the upstairs bedroom

The cross-wing has close studding and internally trenched curved braces in the walls. The roof is a clasped side purlin structure with cranked wind braces suggesting a C15th origin. The storey posts have heavy jowls with deep chamfers. Much of the wall frame has been removed to insert a bathroom and a connection to the EC20th link.

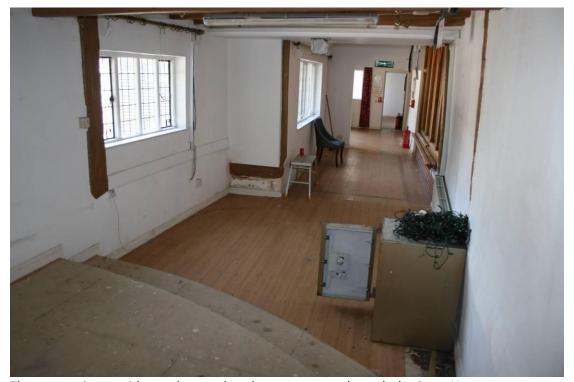
The connecting corridor to the new hotel rooms passes through the Brew House.

The rooms inserted in the northern end of the Brew House are most likely C20th. There is an exposed frame but it is not convincing, being made of too many different types of timbers all painted to disguise them.

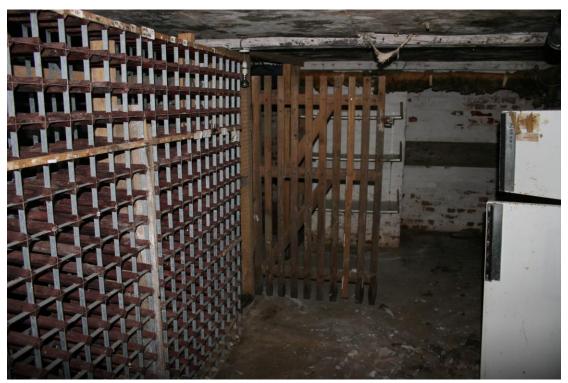
Extensive cellars under the Entrance Hall

The house has extensive cellars under the cross-wing and Entrance Hall build of EC19th red bricks with vaulted brick ceilings supported with wrought iron rails. There is a brick staircase with wooden tread plates. There are alcoves for bottles with rough gauged brick arches and brick platforms for barrels.

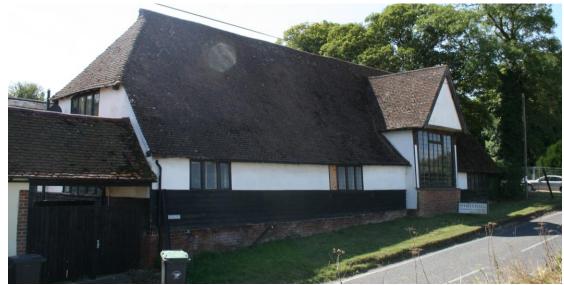
The northern elevation of the Barn. Looking SW.

The Barn was converted into a house by the time of the 1979 OS Map. The building was made part of the hotel in AD2000 so it can be assumed that much of its exterior appearance dates to the LC20th. The roof is clad with concrete tiles and the walls are rendered and have LC20th weather-boards over the timber frame. The off-centre midstrey porch is very shallow and the opening has been bricked in with leaded light glazing above.

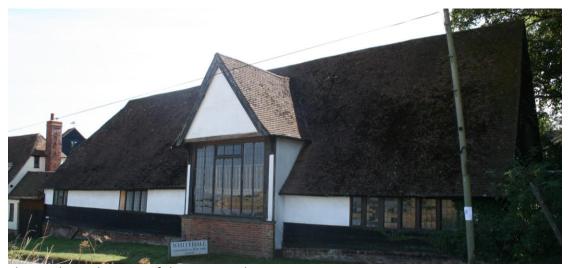
The northern elevation of the Barn. Looking SE.

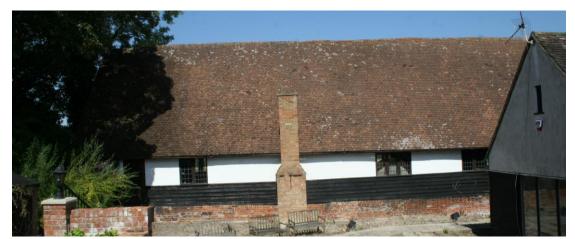
The southern elevation.

The southern elevation has no opening for the midstrey. Instead there is a LC20th firestack with plain square chimney. The plinth brickwork is EC19th is character except where infilled. The Barn is joined to the rest of the hotel with a link designed in 1999. (UTT/1083/99/LB). The design drawings show that the connected buildings were built in 1991.

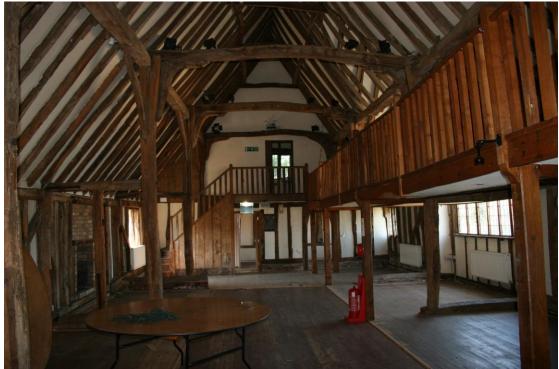
Looking W from the entrance.

The Barn has an oak timber-frame of 7 bays, with the midstrey porch in the third from the west. The Barn has been reassembled from another barn and reformatted as an aisled barn. All the original spandrels have been removed and replaced with bolted hanging knees in the style of c.1800. There are principal rafters connected to high collars clasping the side purlin.

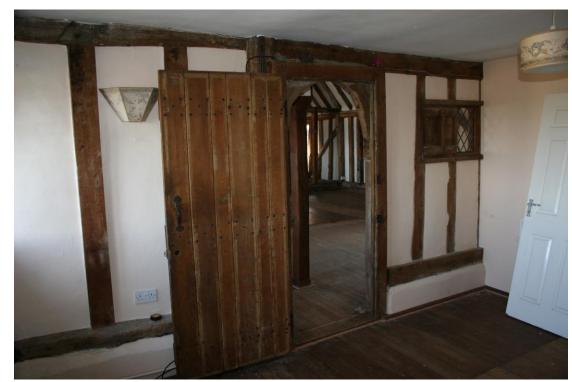
Detail of the inserted partition wall at the western end.

The end bays of the buildings have inserted partitions to form living rooms, WC's, a kitchen and offices. These are all LC20th and are most likely part of the conversion to a house rather than the later addition to the hotel. The damaged kitchen ceiling reveals patinated machined timbers. UTT/1087/81/LB requests internal alterations for a bedroom, bathroom, living room etc in October 1981.

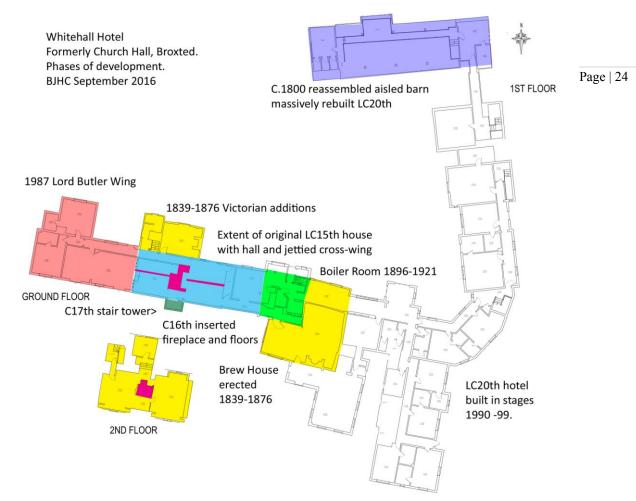
#### 2016. Phasing diagram of the fabric of Whitehall Hotel.

The Whitehall Hotel began as Church Hall, Broxted, ideally situated some 50m east of the church. The original house was a hall house with jettied cross-wing containing carpentry with LC15th elements. The high end was located at the western wall. In the C16th the central firestack was added to support new floors and the entire hall roof was raised to create new upper rooms.
