**Old Bakery Walden Road, Littlebury, Essex, CB11 4TA**  
Description and analysis of the house. Surveyed 15 06 2016.

This report describes and analyses the fabric of the building recorded during a visit on 15 06 2016 to English Heritage Level 3 as outlined in English Heritage. Understanding Historic Buildings – A guide to good recording practice. 2006. Page 14.

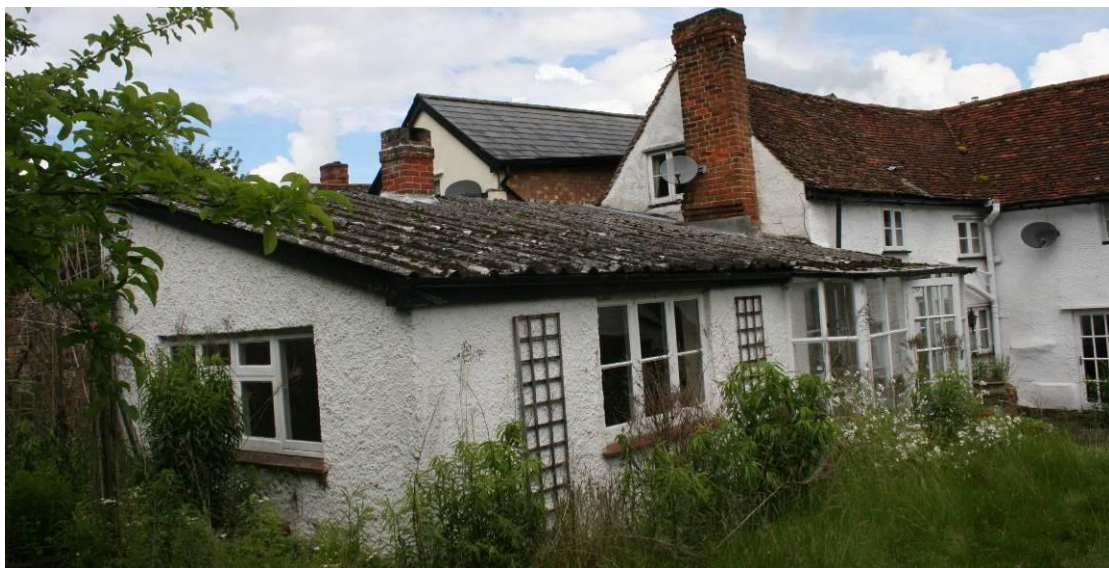
The eastern elevation is rendered in pebbledash without openings. The exposed chimney of the eastern side has been cut back and rebuilt with Flettons. The upper part is also C20th with grey cement pointing. There is no fireplace inside. The rear extension under a corrugated asbestos roof is of brick and blockwork. The red tiled window sills were popular in the MC20th as were the plain timber casements.

The eastern elevation of the house with rear extension.

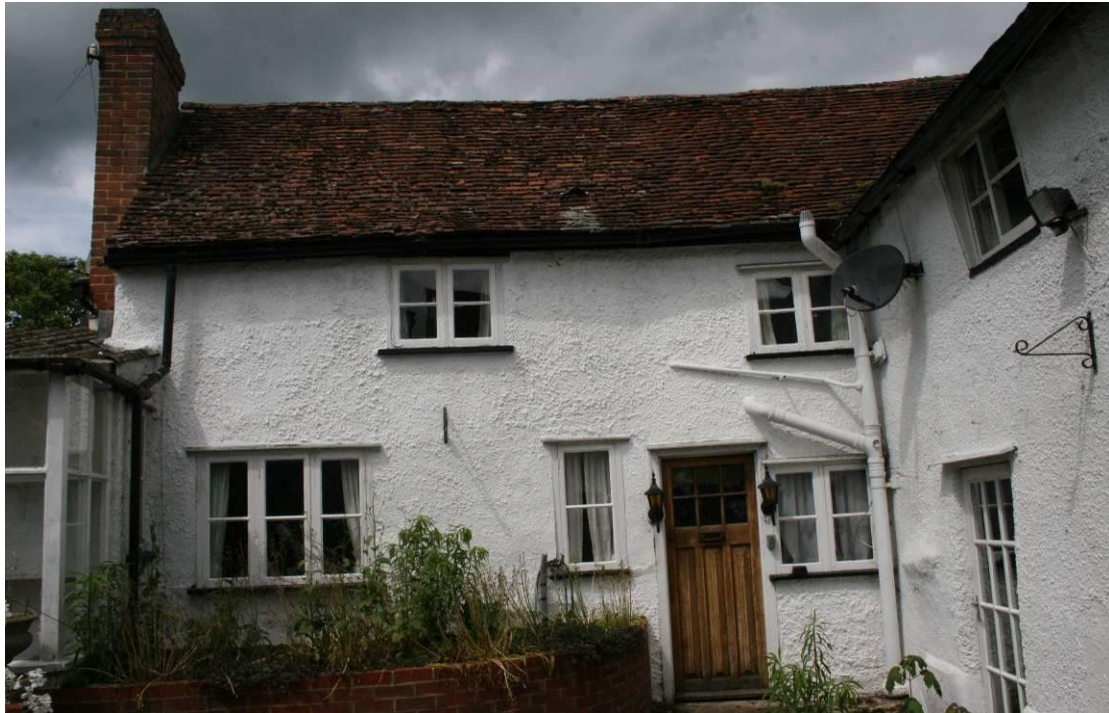
The eastern elevation of the rear range.

The building has a rear timber-framed range that map evidence shows has been joined to the main house in the LC20th. The exterior has been pebble rendered. The windows are a set of LC20th casements under timber drips with timber window sills. The door, equipped with a letter box is LC20th. The rainwater goods and foul water goods are all plastic. The roof tiles and details are consistent with the rest of the house implying it has all been reroofed. Looking in the roof void upstairs it can be seen that the back of the house was last retiled in the MC20th and the front retiled and an asphalt membrane added in the later part of the C20th before the 1990's when breathable membranes were introduced.

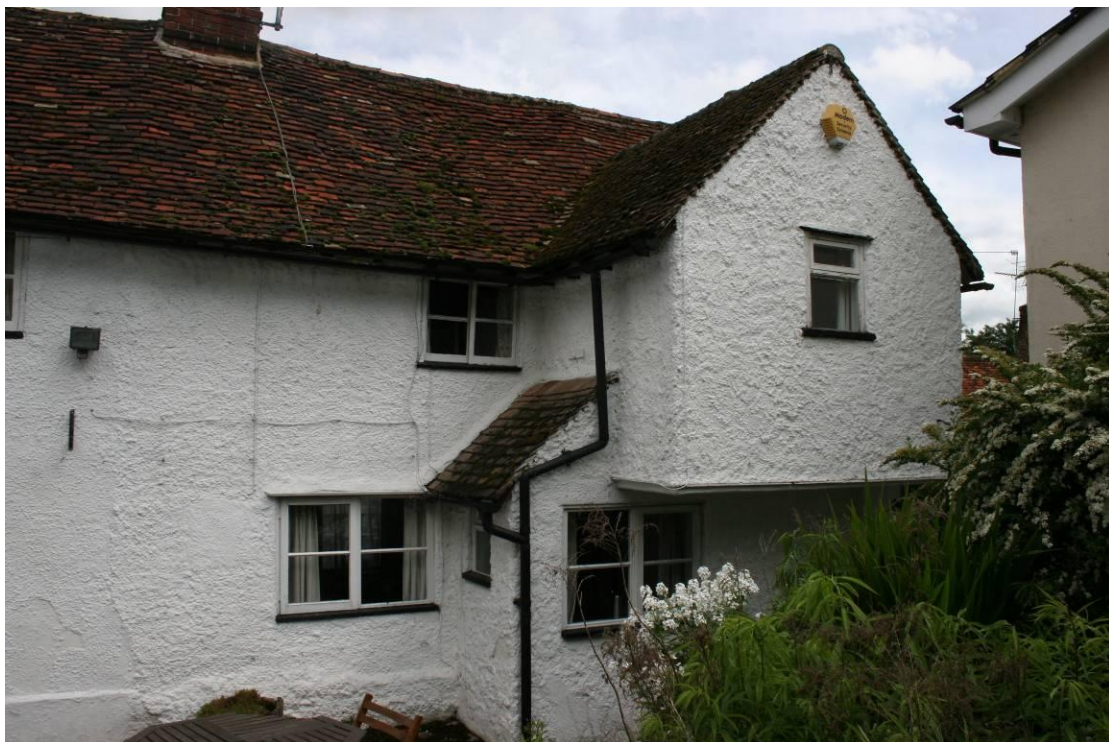
The eastern end of the southern elevation.

The rear of the building shows a piecemeal series of MC20th alterations including the addition of a C20th 'cross-wing' to house the bathrooms. Beneath it is a small extension under a single pitched roof that now serves as a window seat in the Living Room and the downstairs bathroom.

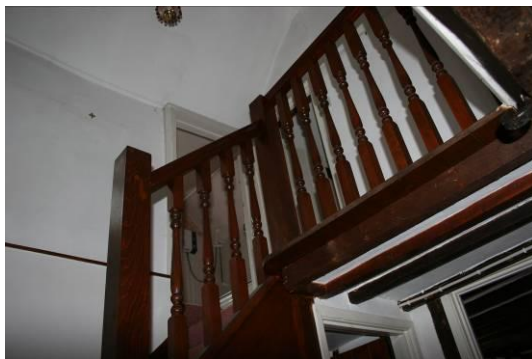
The LC20th staircase in the Entrance Hall.

The building has four bays forming two cottages. The easternmost bay has the front door and Entrance Hall. Half of the original ceiling has been removed to insert a MC20th but Victorian style staircase. An original axial joist is visible jointed into the scantling frame of the western partition. The eastern wall, which should have a fireplace, is blank.

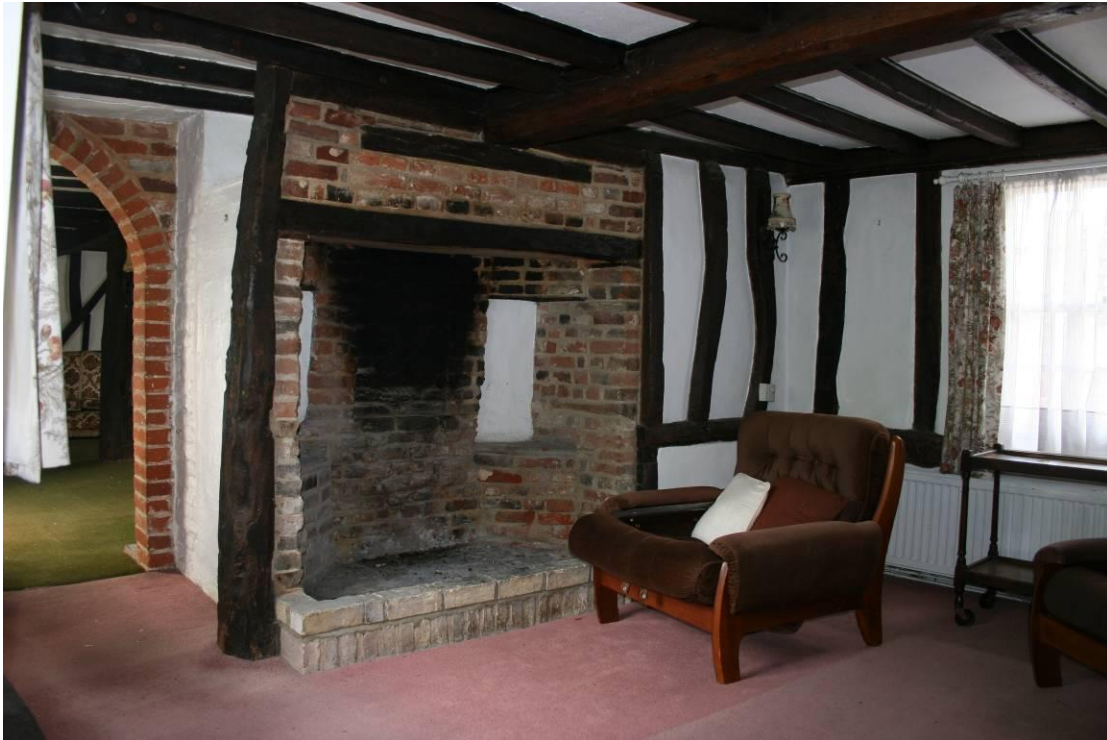
The eastern Living Room.

In the Living Room the exposed frame and fireplace are of C18th character. The poor quality scantling studwork and narrow ceiling joists were originally lath and plastered and were never meant to be seen. The fireplace is designed for a range or hobgrate but has added timber seats. The 2in thick Tudor style bricks are mostly bats and reused. The bressummer is only 3in deep. A brick arch beside the fireplace although very modern looking is bedded with lime mortar and has wooden dowels for a frame and so is likely Victorian.

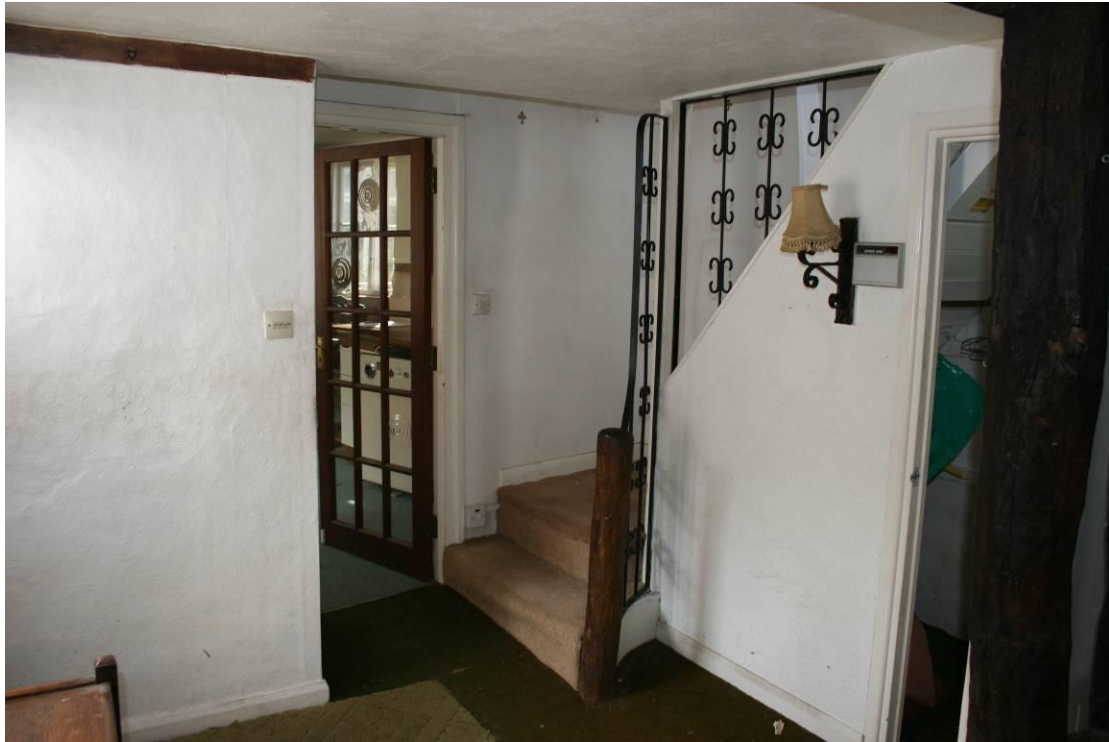
The Lobby is a MC20th infill.

The rear lobby has a 1960's style staircase and a front door implying that the property was extended as two properties in the C20th. The Kitchen denotes the limit of the C18th style frame. Historic mapping shows this was a separate building until the MC20th (pre 1970) and the Lobby was built to join it to the main house. Beyond that is a LC20th extension of no historic value.

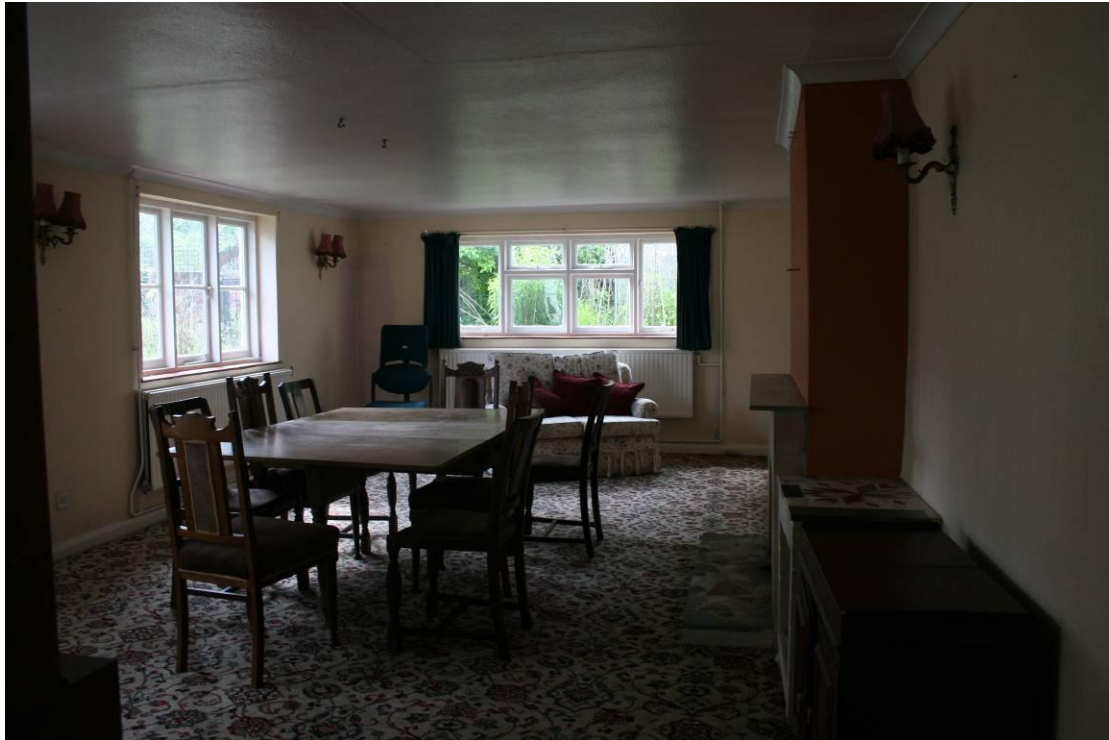
Looking S in the Rear Extension.

The fabric of the Rear Extension can be seen in the roof void as being LC20th blockwork with a machine cut softwood frame. The asphalt membrane would date it to between 1965 and 1995.

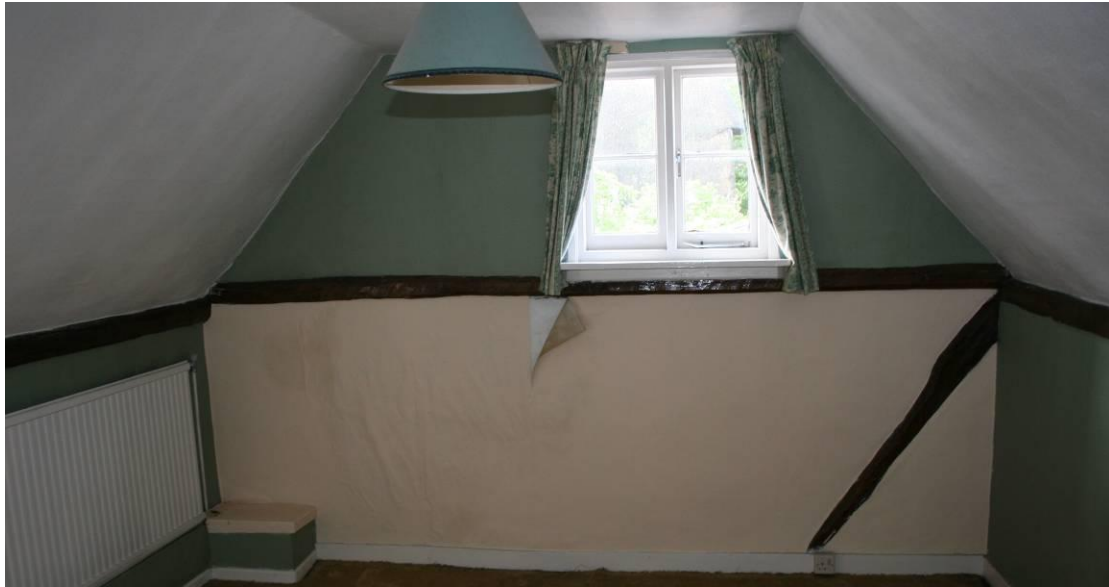
Bedroom 1 above the Kitchen displays parts of an historic frame.

Bedroom 1 displays parts of an historic timber frame. The top-plate is visible in three walls and a diagonal brace is visible in the southern wall. The ceiling appears lath and plastered. Built into the northern end of the room is a wardrobe with shelves and a suite of closets containing the hot water cylinder, header tank and laundry shelves. These all appear LC20th. The heating system is likely C21st.

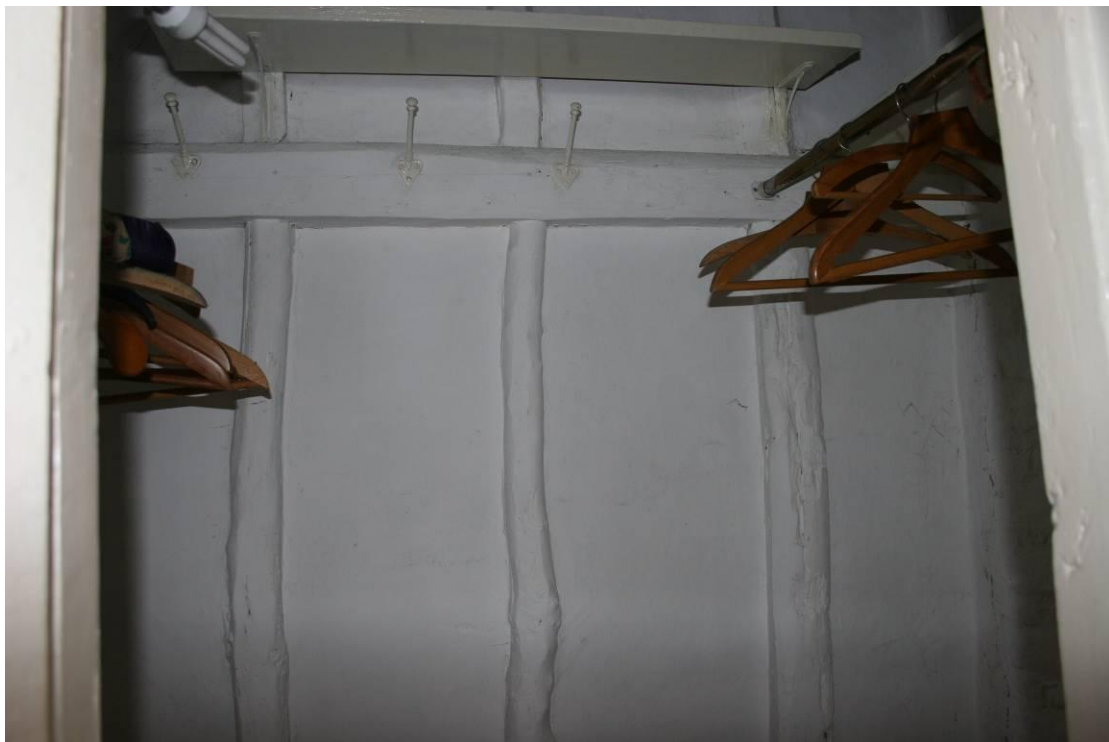
Pole construction in the closet.

The partitions in the closet besides the firestack have frames cut from poles and lath and plastered over. There is also a rail with Victorian or Edwardian style hat pegs and a shelf with EC20th pressed steel brackets. Although rustic this type of work was quite common up to c.1840.

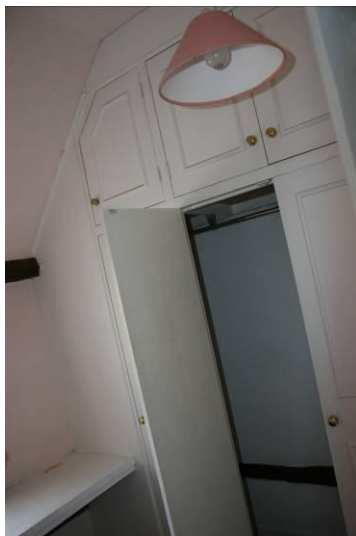
The Dressing Room.

It is not possible to pass across the house upstairs. Instead there are two staircases. To the east the staircase leads to a landing connecting to the C20th Bathroom and the tiny Dressing Room. Of interest in the Dressing Room is a timber clamp fastened with a wrought iron square headed bolt and another with a rectangular headed bolt. These are characteristic of the EC19th and represent a repair to a failing top-plate.
