Phillips Farm, Edney Common, Chelmsford, Essex.
Description and analysis of a timber-framed barn and outbuildings at
Phillips Farm. Surveyed 05 10 2010.

This report considers the historic buildings to the east of the site. These are the timber-framed Barn and its outshot Stables and Piggery. These are recorded to EH Level 3. Also recorded to Level 1 are the C20th Piggery and the Offices converted some 12 years ago.

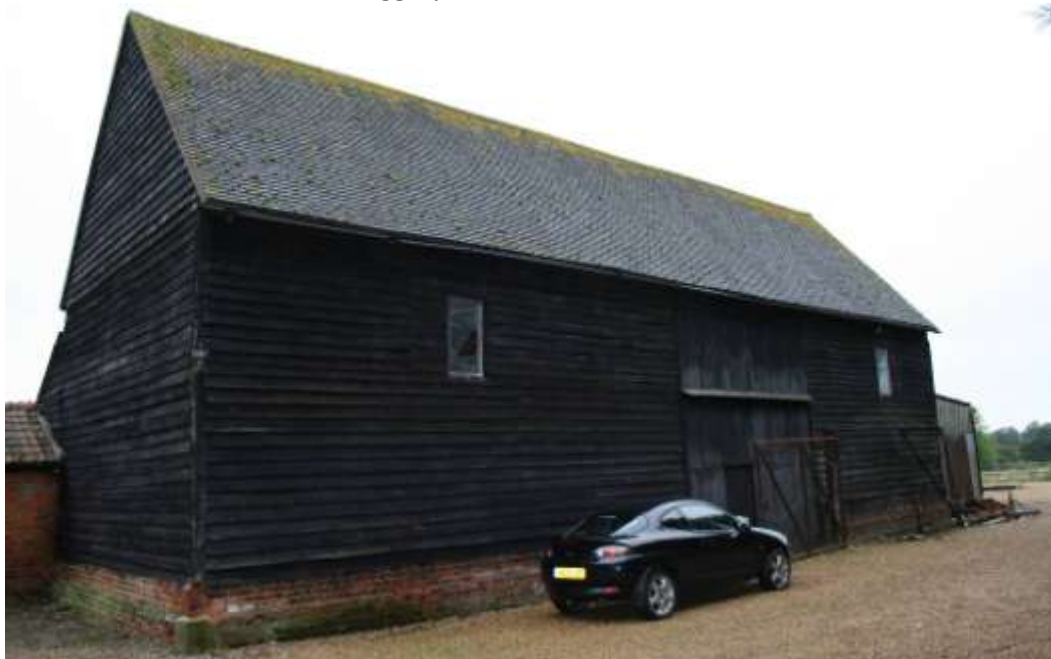
The eastern elevation has modern windows and an inserted panel with pedestrian door.

The eastern elevation has an inserted panel to replace the original barn doors. This is a LC20th softwood frame clad with corrugated iron sheets. There is a pentice board 2/3rds of the way up and a single pedestrian door. This is a LC20th tongue and grooved, gate and ledger door with mild steel strap hinges and bolt all screwed on. It has an aluminium handle and a small maker's plate 'Edward Green Doors- Ingatestone'.

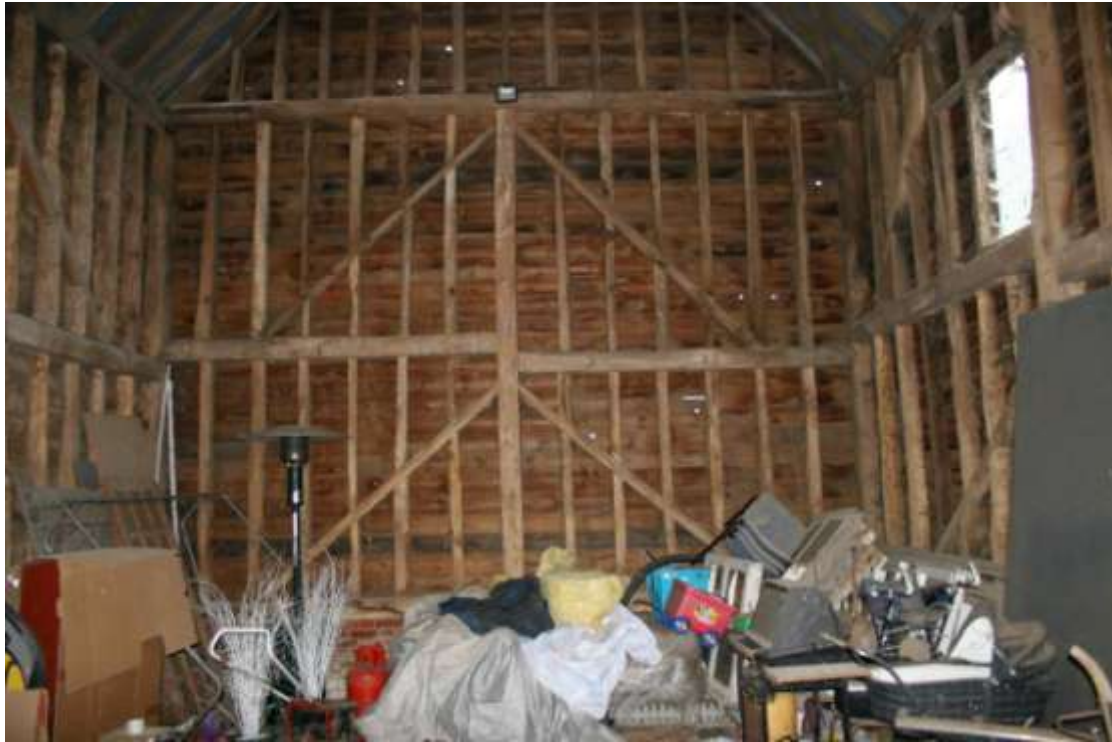
Northern wall. Note offset mid-rail.

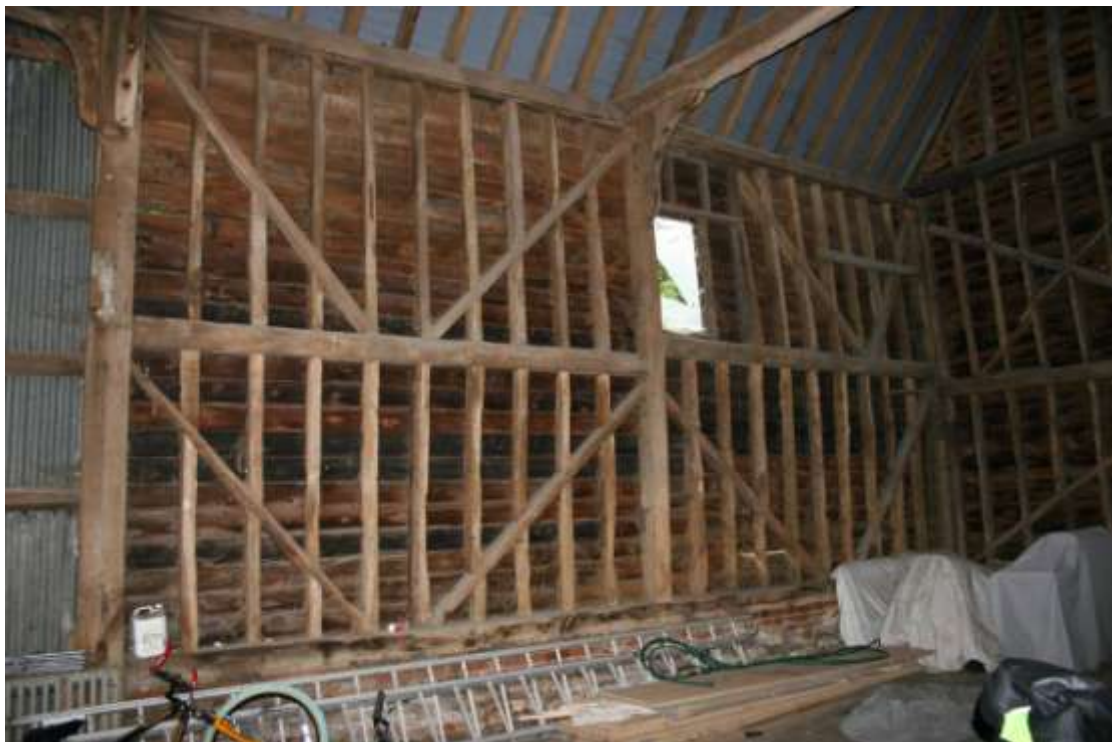
Bays 4 and 5 looking SE. The bays are wider in the southern half of the Barn.

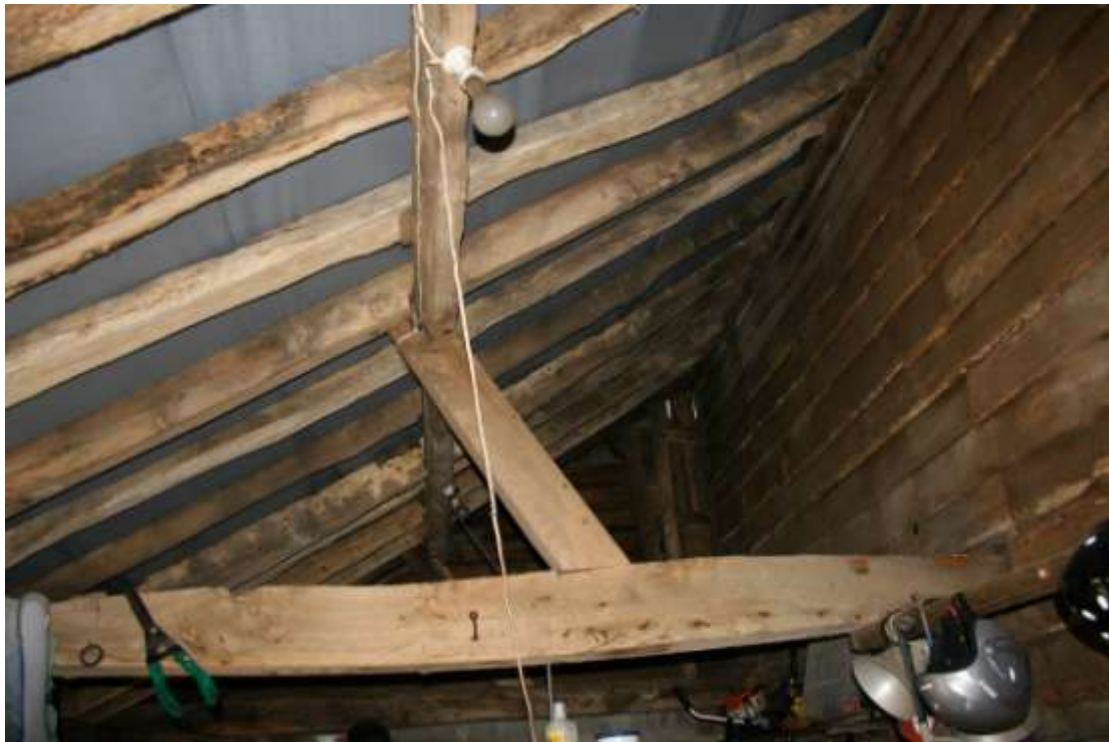
Simple lean-to roof with single raking strut. Looking N.

The roof structure is a simple lean-to with the rafters supported on a central purlin held in place with single raking struts off the tie-beams which are all in elm. The tie-beams sit on the front plate but are clamped with iron ties to the storey posts of the Barn. The rafters are reused with some on the flat and some quarter sawn. There is a blue reinforced membrane.

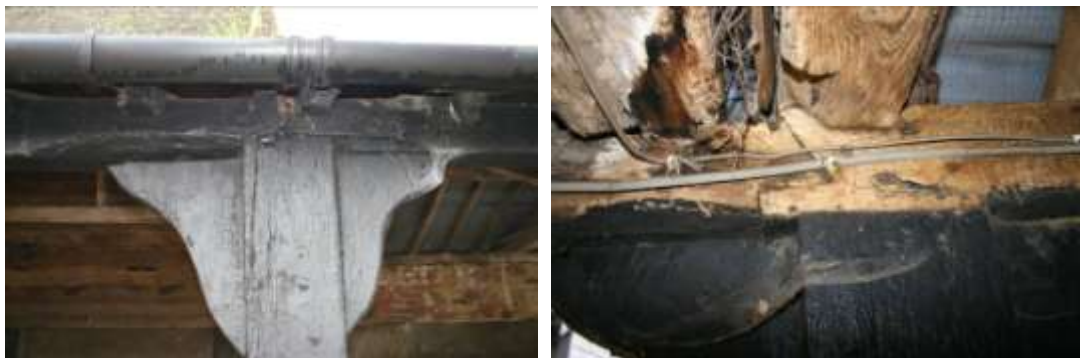
Post head with nailed brackets and strapwork. Reverse (left) shows scarf joint over post.

Each bay is defined by a strong post supporting the front-plate and stiffened with brackets clout nailed in place. The joints are further reinforced with wrought iron L-ties to the tie-beams and short straps nailed and stapled in place.

The front-plate is scarfed using a variant of a scarf described by Hewitt as 'a straight bridling of three quarter depth with squinted abutments and over lipped face, edge pegged'

(Hewett. C, P270, F274). Although it is upside down according to his reasoning of being lipped to prevent water ingress. This is actually a common scarf in C19th buildings and is placed over the post to prevent deflection and secured with a short strap to prevent it pulling out.

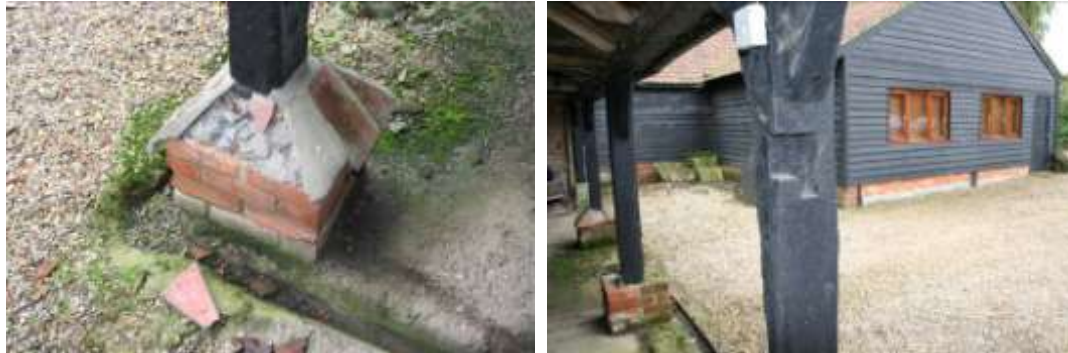
Detail of C20th brick pedestal and (left) slot for drop bar in Bay 2.

Each post is stood on a brick pedestal composed of C20th bricks a set in grey cement and sheathed in plain roof tiles stamped FRANCE on the undersides. Post 2 (from the north) has a mortice for a drop bar. The southern door jamb for the barn doors has a second set of pintles to support a door that would have closed across Bay 1. Post 3 has a mortice in its outer face, probably for a fence.

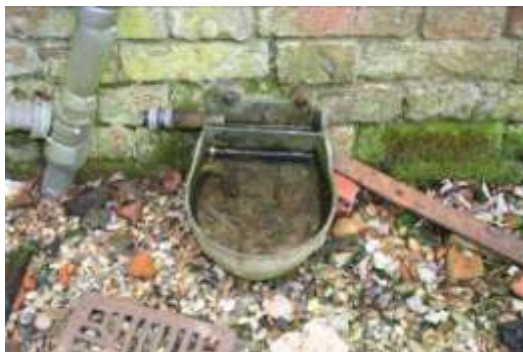
Low level water dispenser.

Near the ground besides the opening is a low-level water dispenser of the type used to serve pigs. The plumbing fittings suggest it was in use until recently although more likely for the farm dogs.

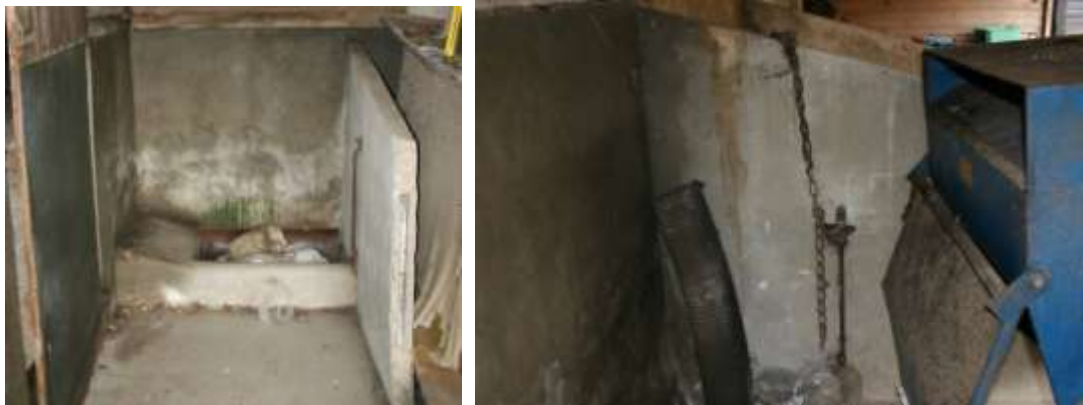
Stall in Bay 1 showing steel tubing in partition. Right - pig restraint chain on slide bar.

The rear wall of the open section is outfitted for feeding pigs. There is a low cement trough lined with a ceramic half pipe. This is divided by thin concrete partitions fixed on a frame made of steel piping (visible in Bay 1). Where the partitions have been broken out the EML (Expanded Metal Lath) can be seen in the cement render on the Barn wall. The floor is poured concrete and there were concrete retaining walls between the posts shown by scars on the ground.

Each partition has a slide bar for a tether and one piece of restraint chain remains. Above there are hanging brackets for pipework. Bay 1 has been caged with wire netting and heavy duty galvanised grid to form a dog compound and there is a makeshift wooden kennel - no longer in use.

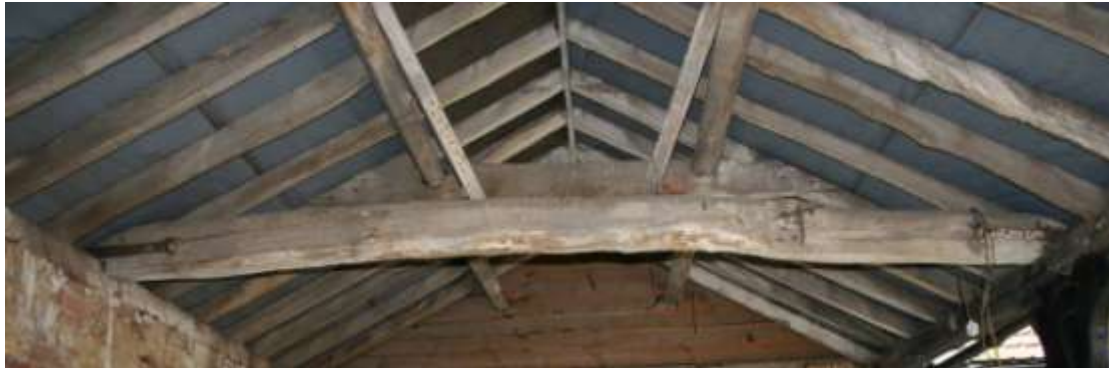
The roof structure in the southern section of the Piggery. Looking S.

The southern section incorporating the stable/ office is a newer construction with a clasped side purlin roof entirely in elm. The deep collars are halved and nailed to the rafters which are paired onto a ridge piece. The tie-beams are independent of the rafters of which most are quarter sawn.

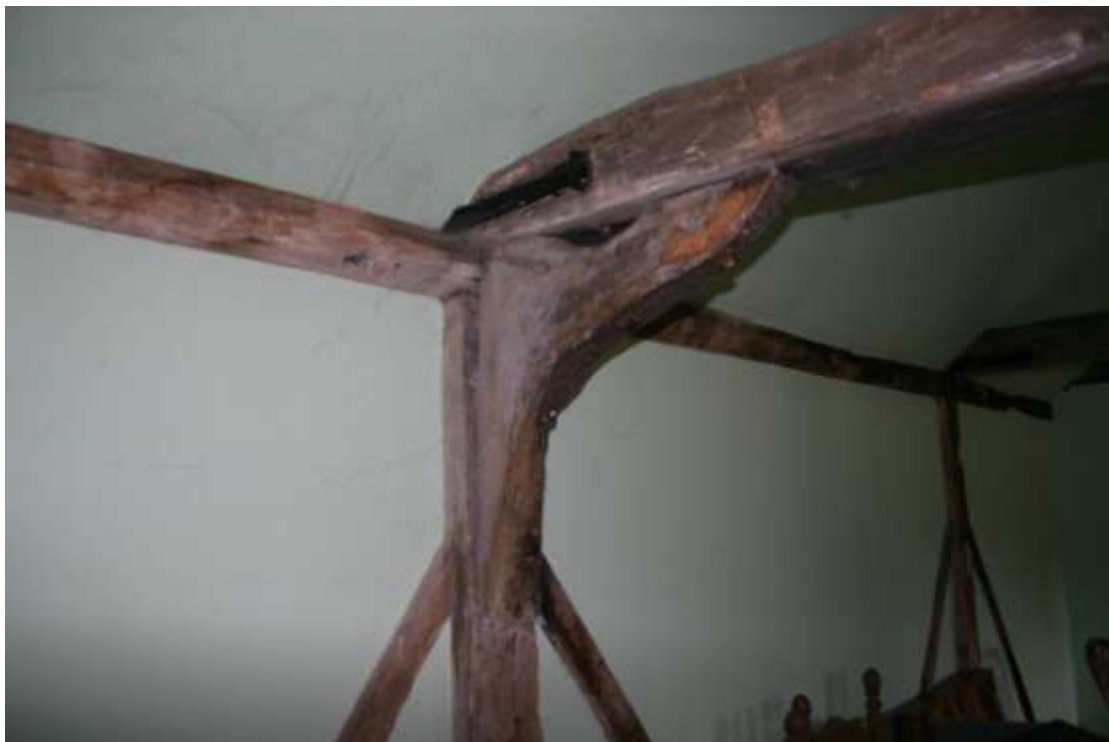
Hanging knee construction on the tie-beam. Wrought iron bolts and L-tie.

The tie-beams are secured with wrought iron L-ties and strengthened with pit sawn and adzed hanging knees held with four square headed bolts. The vernacular quality of the knees is typical of low caste Essex farm buildings. Each tie-beam has a pegged mortice for a central post and there was an open gutter the length of the floor before renovation. (Owner -pers comm.)

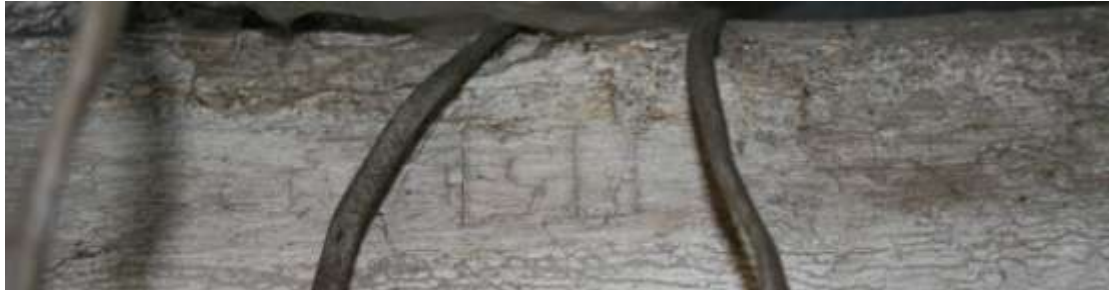
Modern mark on tie-beam 5 of the Piggery.

The fifth tie-beam of the Piggery is marked with the numeral 5 between two lines presumably to aid reassembly when the building was reroofed. It is upside down.

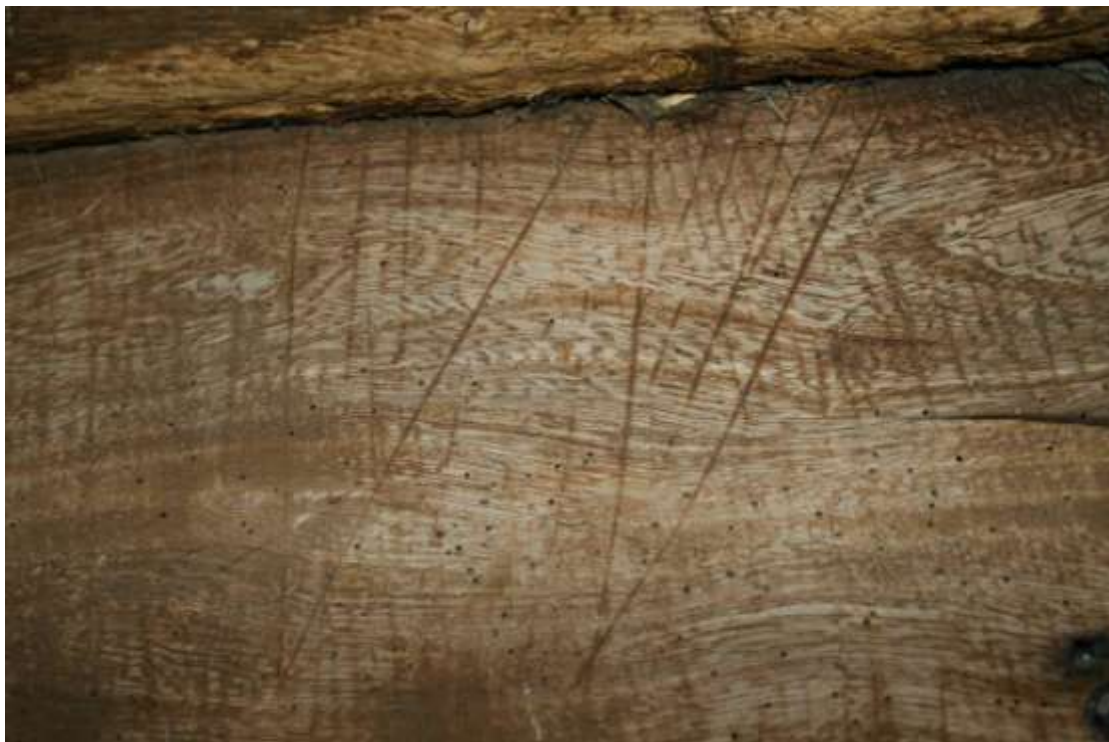
There is a well defined apotropaic mark in the form of VV on the outside of the cladding within the outshot Piggery and this must relate to the function of the outshot as an animal shelter. The well defined letters have also been hatched in with further lines.
