## Historic Building Recording

The Norman King Public House

Church Street

Dunstable

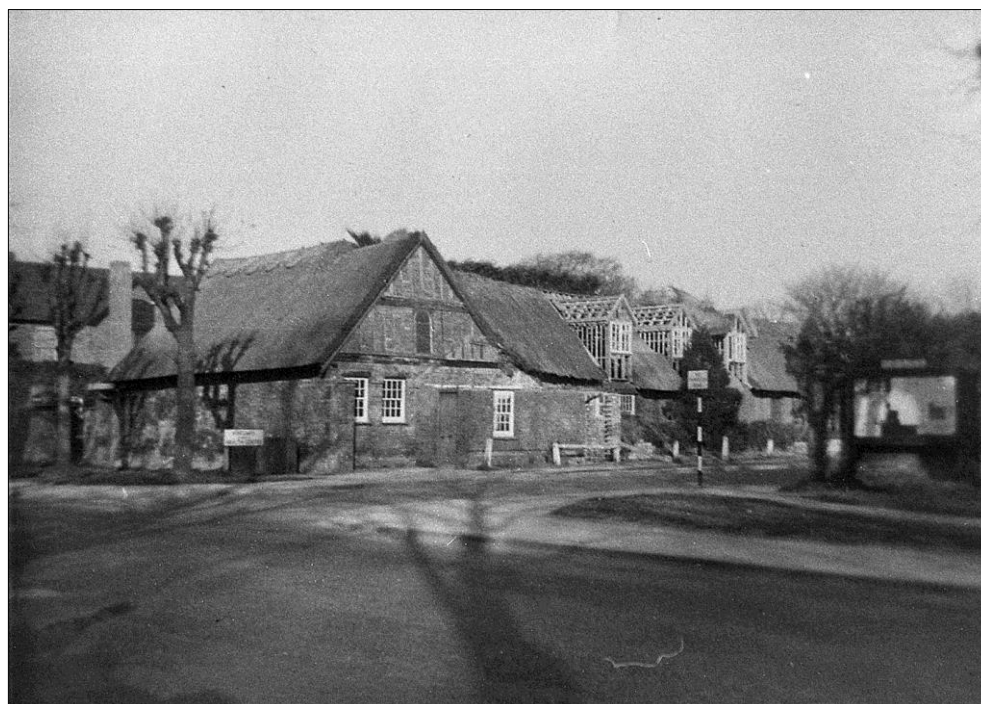
Figure 13: The conversion to the Norman King c. 1961  
(Courtesy of Dunstable History Society)

Although photographic evidence attests to an upper floor, this has not survived the fire and subsequent degradation. Dormer windows were added in the 1960s conversion programme (Figs 13- 14)

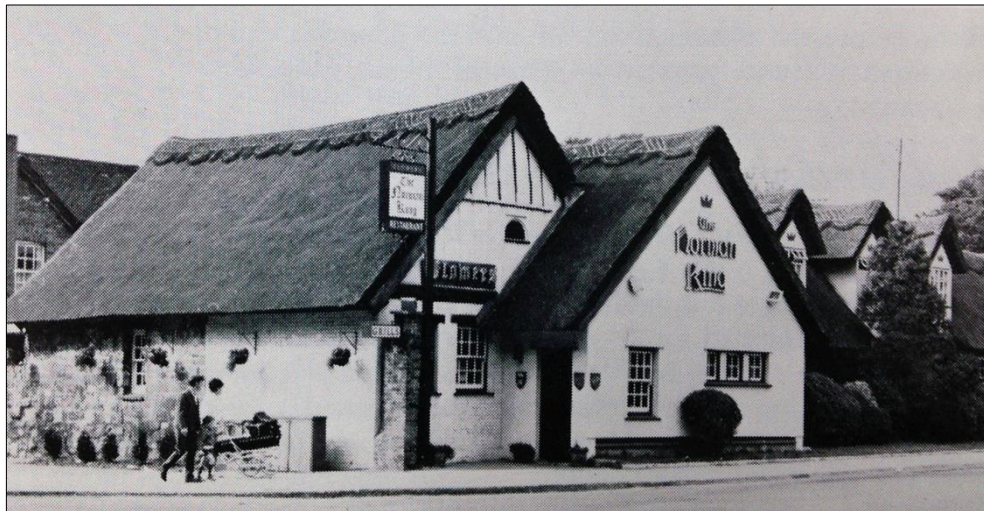
**Figure 14:** The Norman King in 1966  
(from Bedfordshire Magazine No. 11)

The southern end of the east range is brick built and has a small extension to the east housing the former main entrance (Fig. 14). Recent photographs show this, as well as the south range,

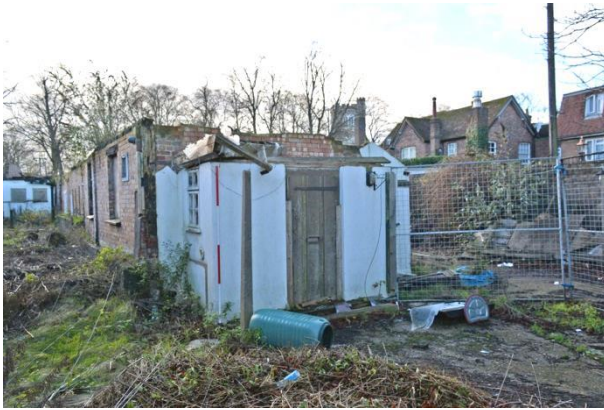
**Plate 1:** North & east elevations of East Range

At the northern end of the range is a modern extension with a reproduction plank and batten door (Plate 1).

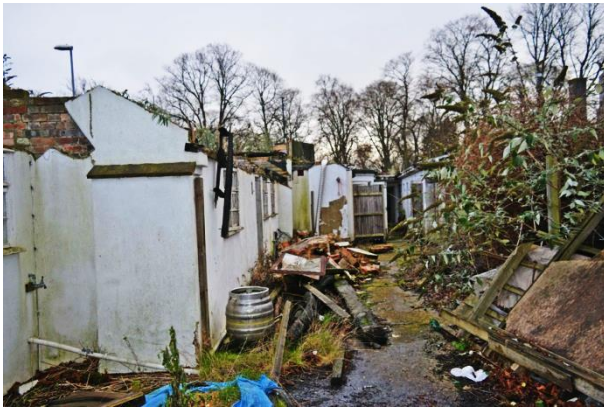
**Plate 3:** West elevation of East Range from the NW

as having been thatched (Fig. 12). The west elevation is brick built, plastered and painted white and has modern timber windows and doors (Plates 3-5). The east elevation of the east range has 5 bays, which for the purposes of this report are numbered from south to north. It is built of timber and brick on a substantial plinth of indeterminate material some 40cm high (Plates 14-19). The bricks are machine made but intended to appear old with spanish, inclusions formerly added to improve the firing process, and horizontal skintlings, which were formed when the bricks were stacked for drying before firing. The wall is built in a Flemish bond with lime mortar and is clearly early 20<sup>th</sup> century.

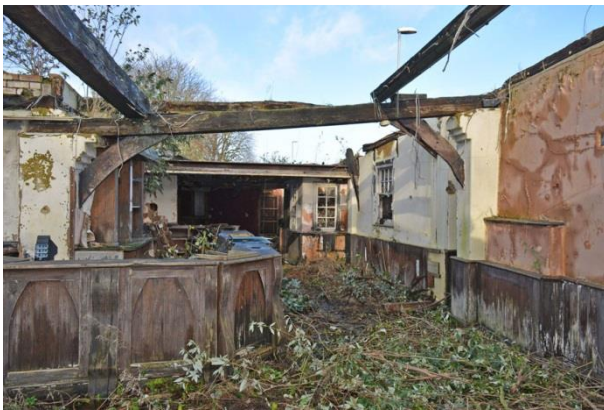
**Plate 13:** View northwards from G4

Internally little of the historic building fabric survives other than two north-south aligned binding beams and the wall plates (Plates 8-12). The eastern beam is supported by brick built pillars at either end, as is the east-west aligned beam above the bar (Plates 11-13). The present north wall has late 20<sup>th</sup> century Fletton brickwork above the wallplate (Plate 12) and either early 20<sup>th</sup> or possibly 19<sup>th</sup> century brickwork below. However, only a small area of the latter was exposed during the survey making identification difficult. A post medieval iron tie was observed at the western end of the northern wallplate.

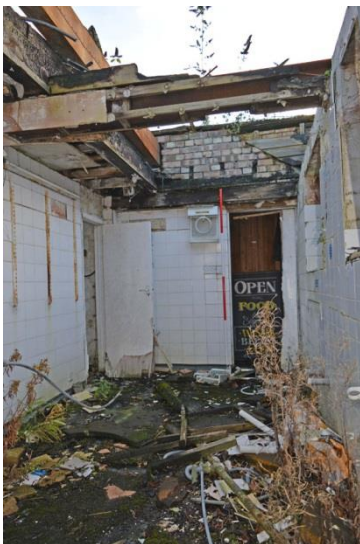
**Plate 33:** View southwards in G8

The west range is entirely mid-late 20<sup>th</sup> century. The west elevation is brownish-red brick, partially plastered, and the interior walls are of Fletton bricks. Doors and windows are all of timber. There are no architectural details of interest (Plates 33-36).

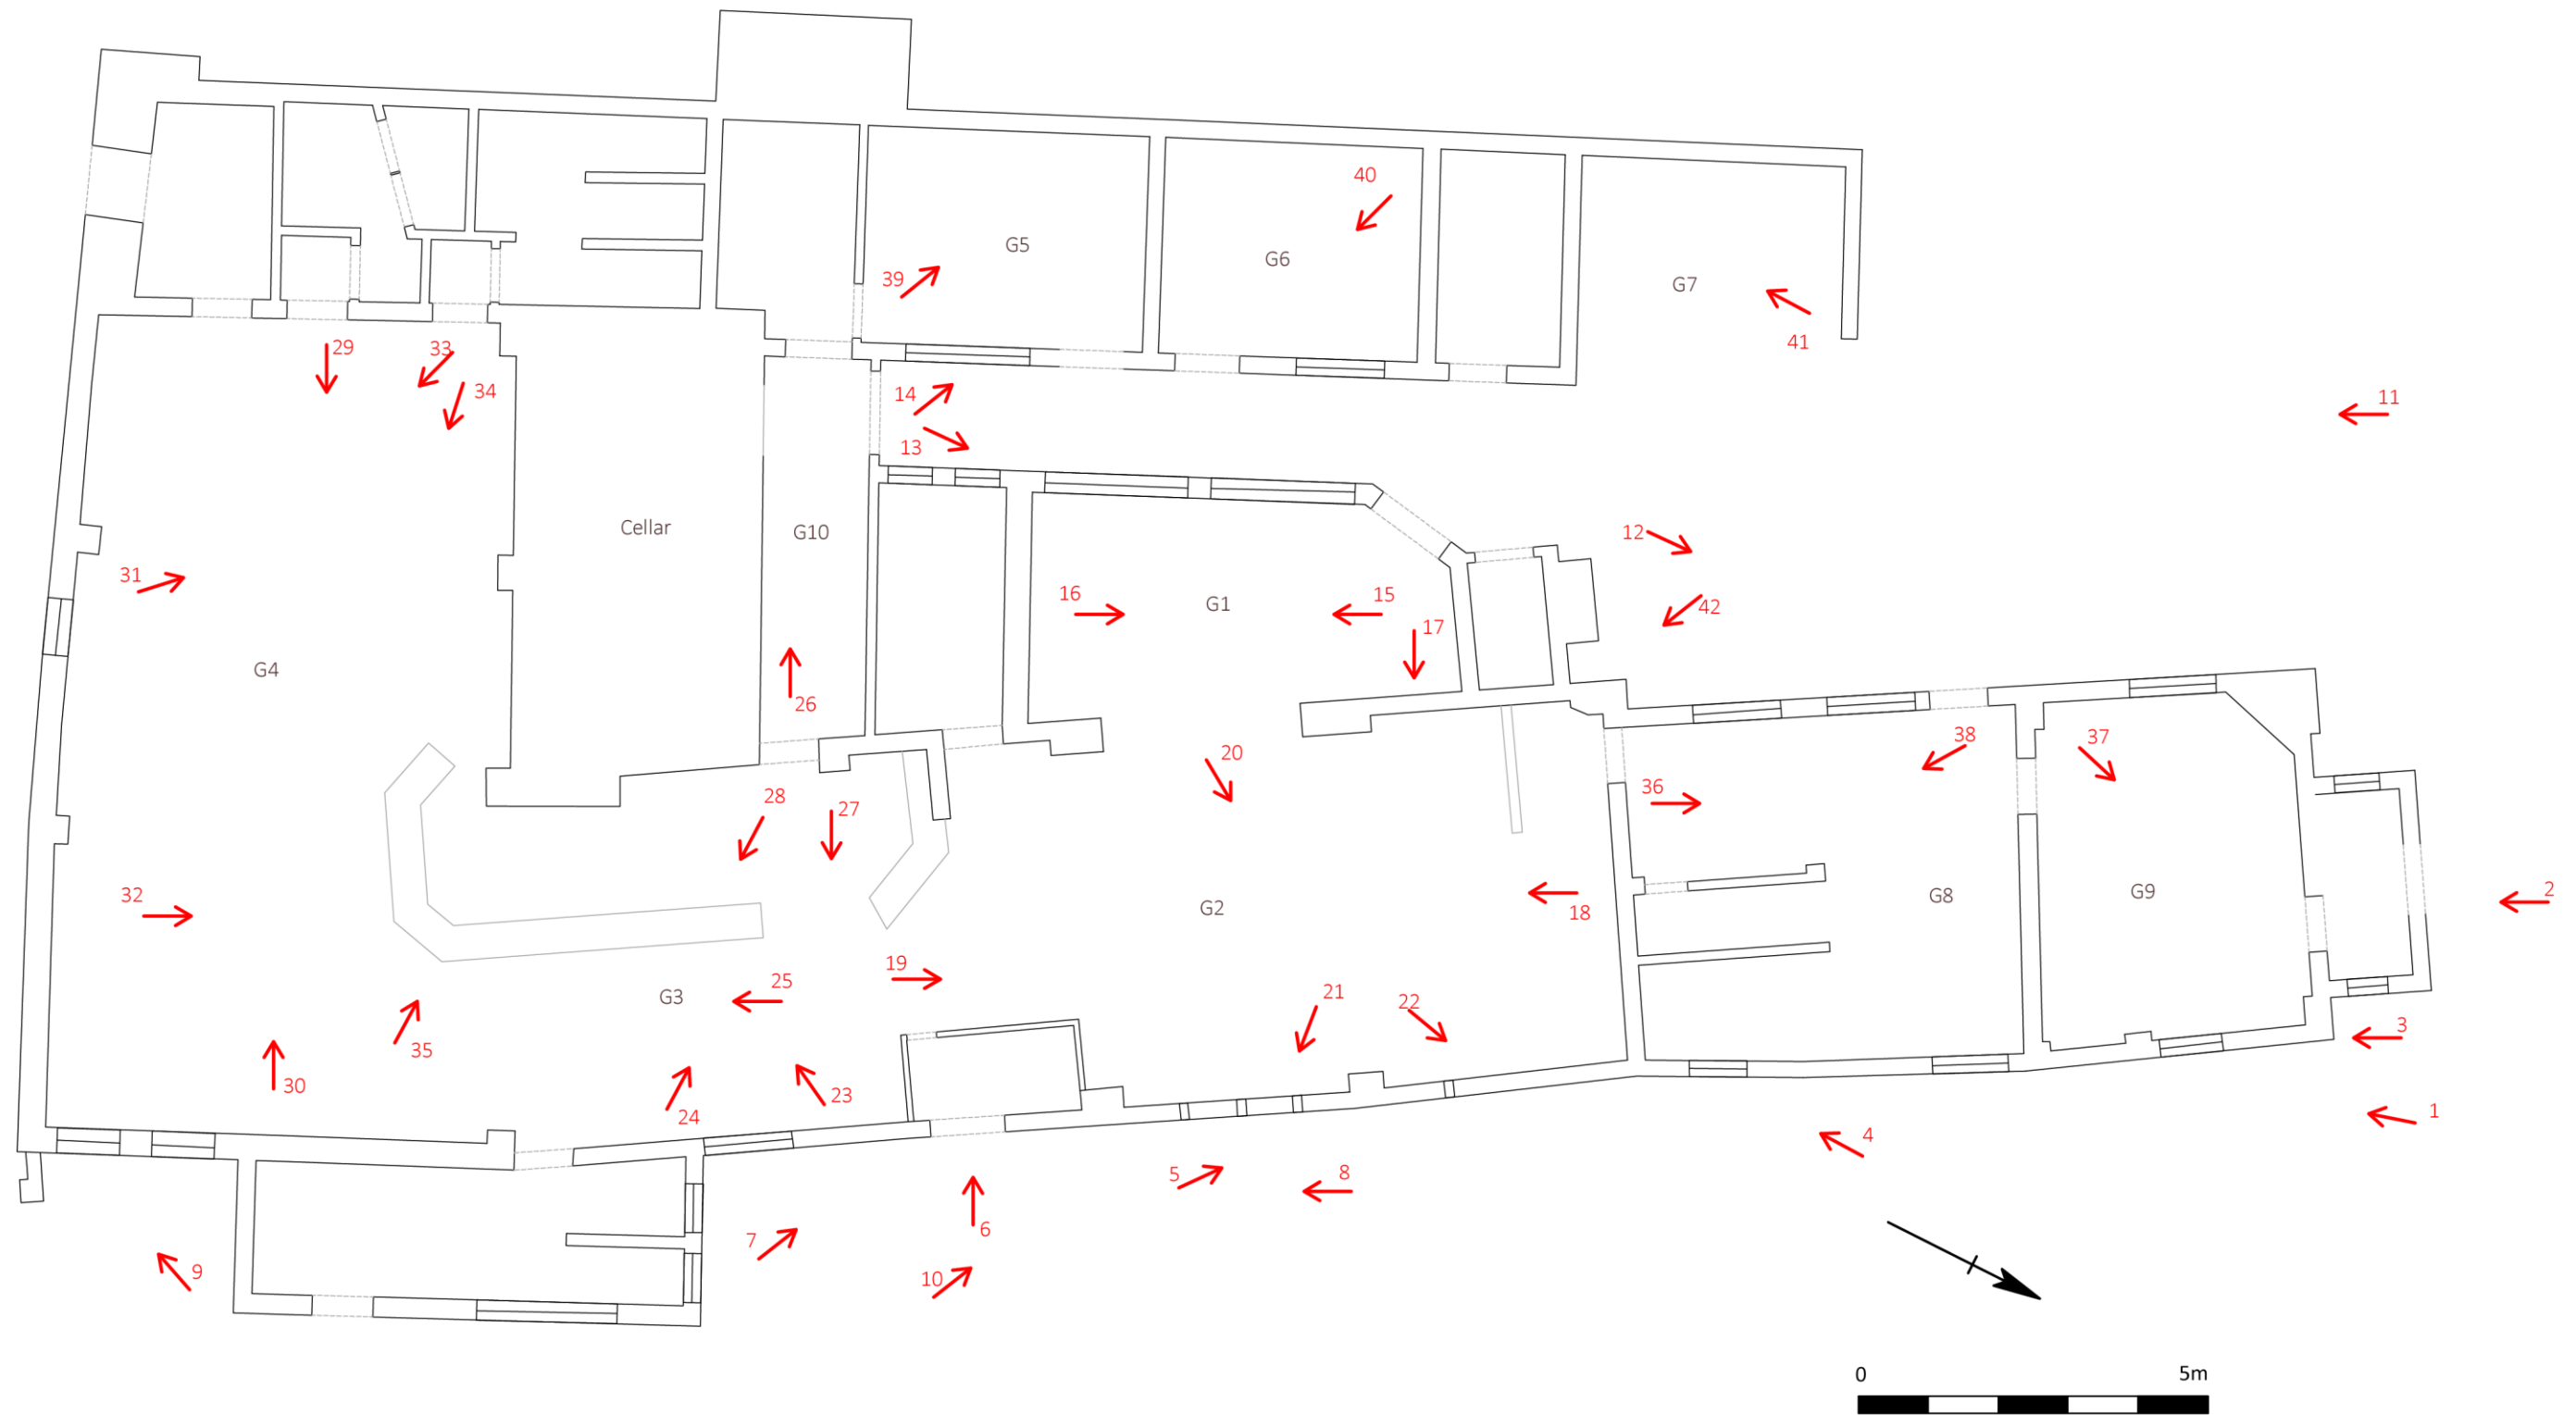
Figure 23: Floor plan showing photo views (scale 1:100)

The former Norman King PH comprises an east-west aligned building on the street frontage with a north-south aligned range to either side separated by a gangway only wide enough for barrels to be brought up to the cellar from the rear yard (Fig. 23). The historic core of the building is the former barn on the street frontage, the south elevation of which is largely built of Totternhoe Stone. The side facing the street was obscured by hoarding during the survey and the description below is largely informed by what was visible internally and recent external photographic and laser recording. This part of the building is flanked by the ranges on either side, the western one of which is also behind a stone wall. The eastern range is brick built and provided the main entrance to the pub from Kingsway.
