Heritage Asset Appraisal

The Dolphin Inn
Leighton Road
Stoke Hammond
Buckinghamshire

December 2017

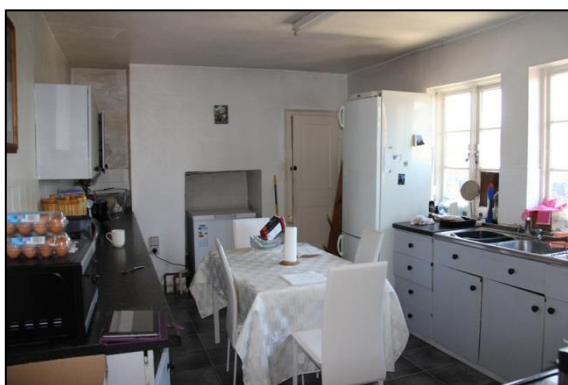
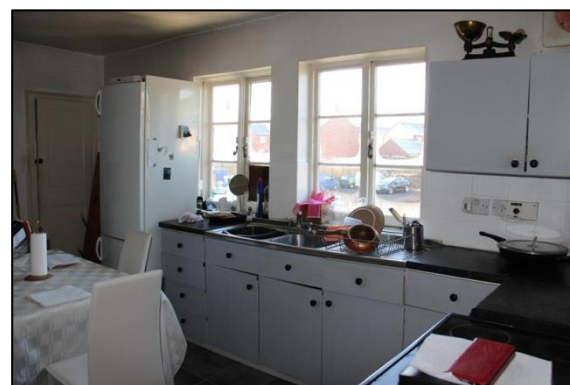
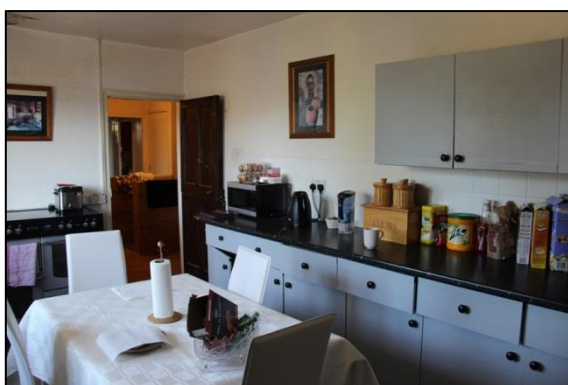
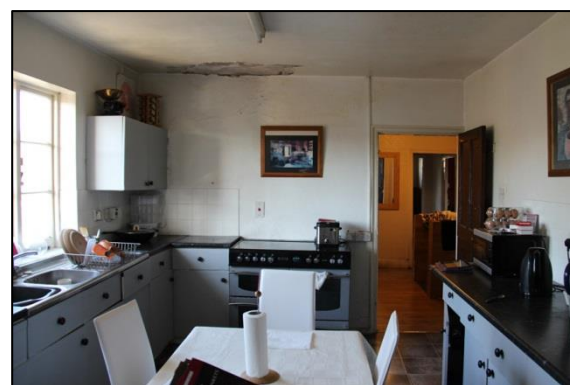
Project No: 337/SHD	Project: The Dolphin Inn, Stoke Hammond	Room no: F2
Location: First floor		Function: Kitchen
Wall form & decor: Painted plaster with tiles to the east and west. Plain skirting		
Ceiling / roof structure: Artex		
Windows: Two 2 light casements to the west		
Doors: A 4 panelled door to the north has been modified to create stable door. 2 panelled door to cupboard in the southwest corner of the room		
Floor: Vinyl tile effect		
Fireplace: In south wall. Recess but fireplace removed		
Staircase: None		
Other architectural details: Small cupboard to south. Mould to the north. Serious damage to plaster to the south		
Recorder: KK		Survey Date: 17.11.17
