KDK ARCHAEOLOGY LTD

Historic Building Watching Brief

St Michael and All Angels' Church
High Street
Shefford
Bedfordshire

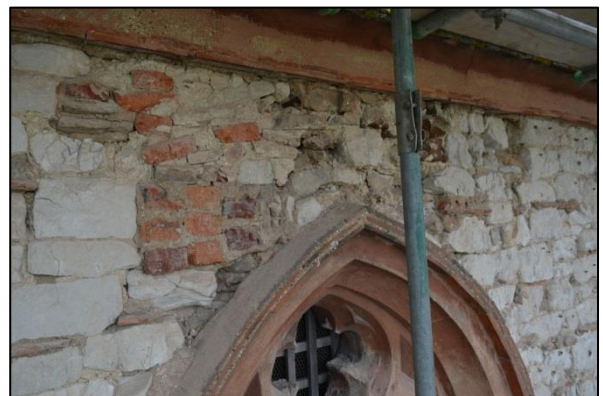
Shot 46: East elevation Stage 4, ironstone repair
