KDK ARCHAEOLOGY LTD

Historic Building Recording

Wheathampstead Place
Station Road
Wheathampstead
Hertfordshire

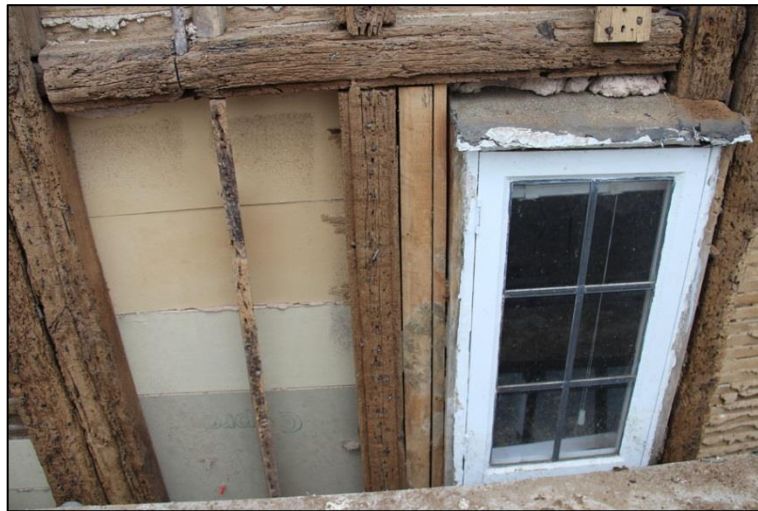
Plate 11: Lower section of mullioned window incorporating later casement

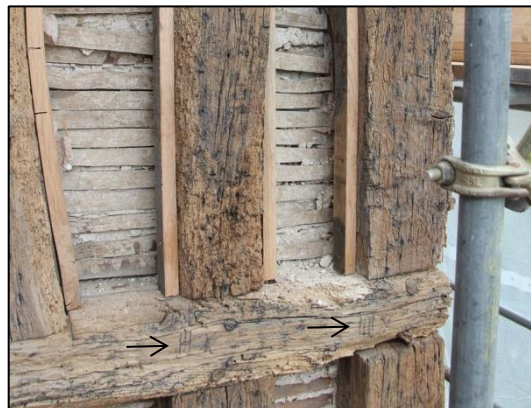
Amongst the most interesting features of the cross wing is the series of carpenter's marks on the north elevation. These are incised into the original wallplate and the studs above. Not all survive as many of the timbers have decayed, but nonetheless, it is possible to see the figure 13 -15 in Roman numerals to the south of which are the numbers 20 -24 (Plates 17-21).

Plate 17-18: Carpenter's marks on the north elevation

Plate 19-20: Carpenter's marks on the north elevation

Plate 21: Carpenter's marks on the north elevation

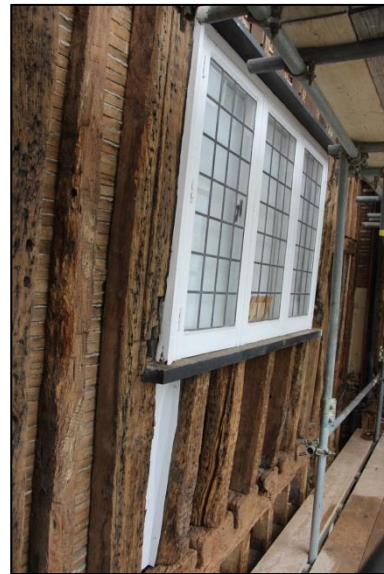
Plate 41: First floor window

The fenestration has inevitable been altered over the centuries to accommodate the latest styles. The mortices in the principal posts to either side of the ground floor window (Plate 36) and the mortices in the beam above (Plate 41) suggest there was a large oriel window at the southern end of the range. Three mullions from a timber mullioned window now support the existing ground floor window. It is possible that the reconfiguration of the studs above the southern first floor window may have been associated with the installation of a sash window that has since been replaced.

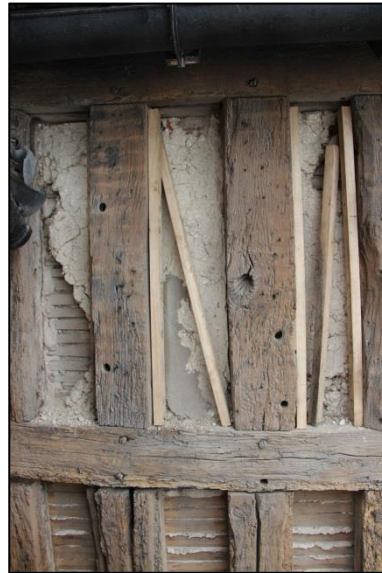
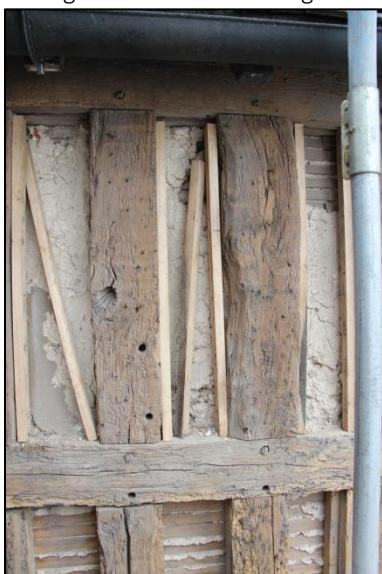
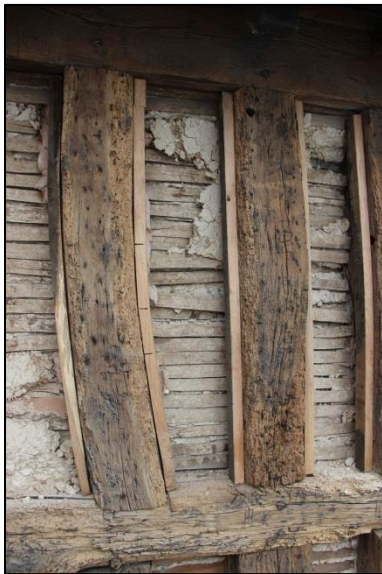
The cross wing has seen several episodes of rebuilding. It was clearly heightened, as is evident in the addition of an entire series of studs above the original wall plate in the north elevation (Plates 6 & 7). Further evidence can be seen in the south elevation where the tops of the jowlposts have been cut and reinstated above the original wallplate (Plates 8 & 9). The northern jowlpost in the west elevation remains unaltered, but its counterpart to the south has been replaced by a straight corner post. Indeed, the posts adjacent to this in the south elevation, like the corner post, extend as far as the heightened roof and must all have been inserted when the roof was raised. Within this section of timberwork at the western end of the south elevation, is a timber mullioned window that houses a more recent single light casement window at its eastern end (Plates 10 & 11). The central mullion is square section and the iron rod to the north of it survives. The principal posts to either side of this mullioned window have mortices which appear to have been for a large window, which could either suggest that the mullioned window is a later insertion or that the posts have been reused, as is the case with a post to the east of the southern chimney stack.

Plate 47: Stage 1: later studs to heighten the wing

Plate 48: Stage 1: heightening studs ii

Plate 49: Stage 1: heightening studs iii

Plate 50: Stage 1: heightening studs iv

Plate 51: Stage 1: heightening studs v

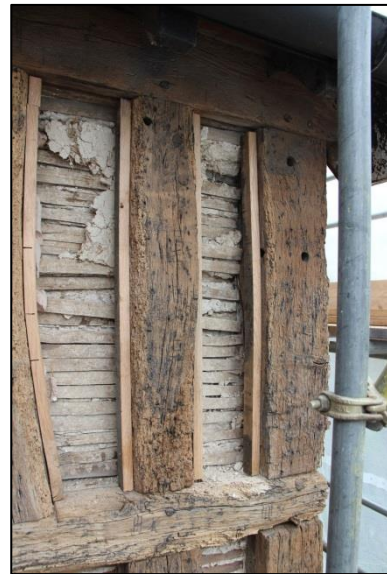
Plate 52: Stage 1: heightening studs ii

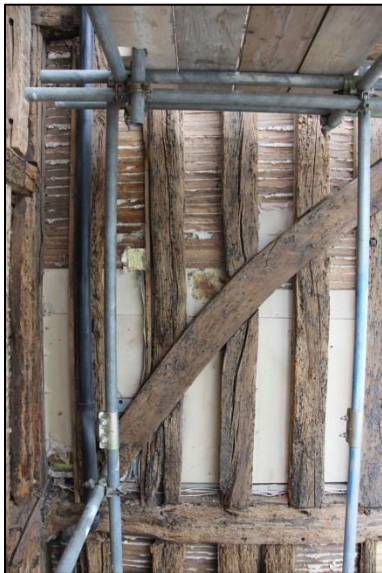
Plate 53: First floor: brace

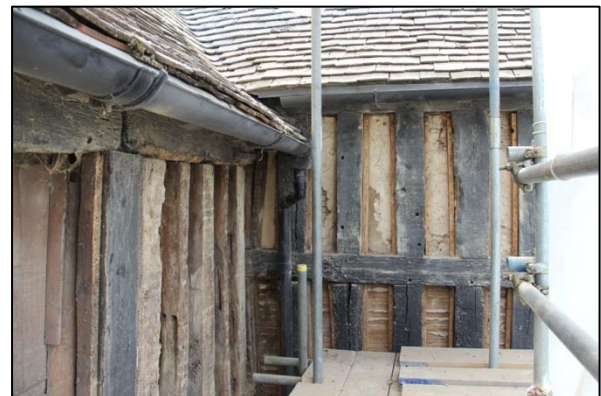
Plate 56: Upper level of timberwork before cleaning

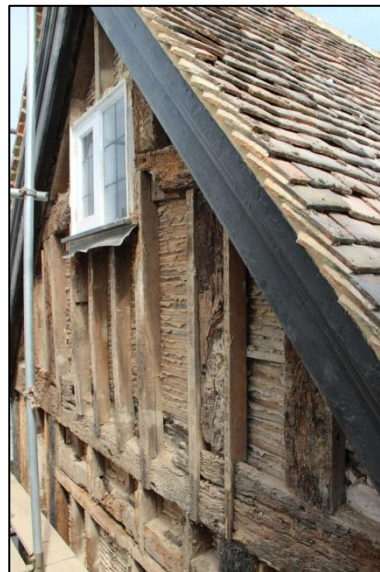
Plate 59: Upper window from the south

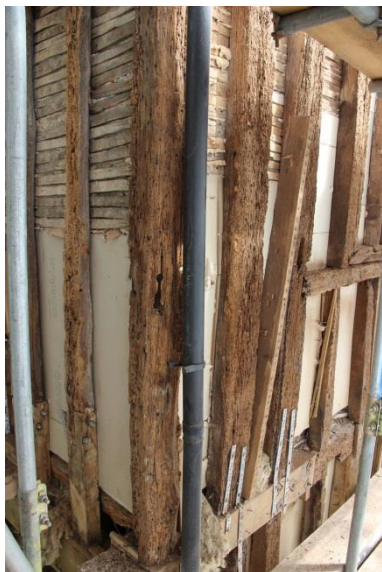
Plate 73: Ground floor with the modern brick plinth

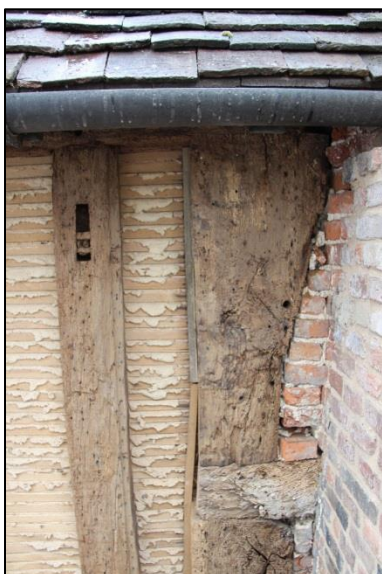
Plate 79: Top stage: truncated and reinstated jowlpost

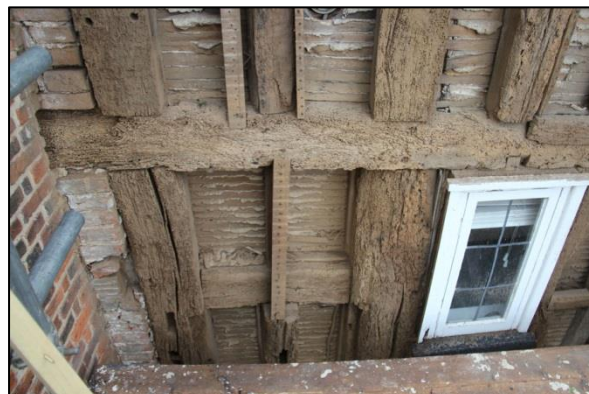
Plate 93: Top stage: western end detail

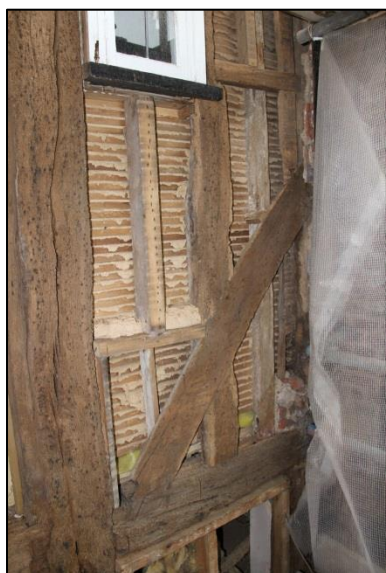
Plate 100: First floor: eastern end

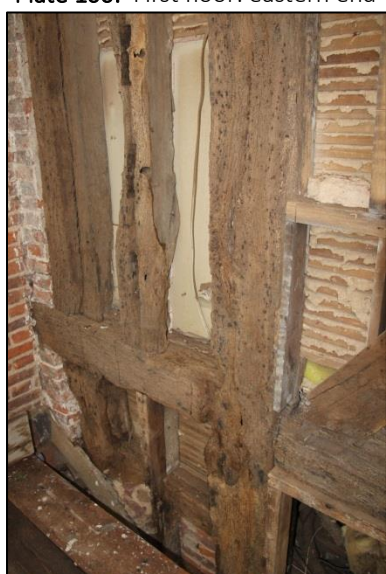
Plate 102: First floor: eastern end detail

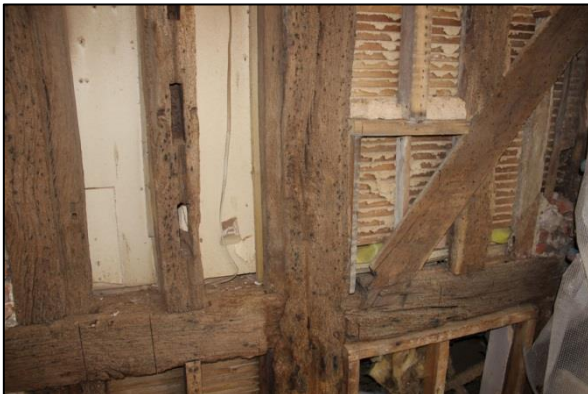
Plate 104: First floor timber detail

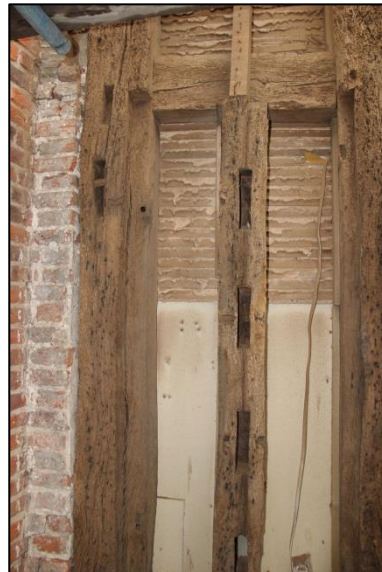
Plate 105: First floor timber detail
