Historic Building Watching Brief

The Hayloft
Chiltern Way Academy
Church Lane
Wendover
Buckinghamshire

<i>Author</i>	Karin Kaye MA MCIfA and Chris Martin-Taylor BSc	<i>Version</i>	445/WCL/2.1	<i>Date</i>	20.07.2020
---------------	--	----------------	-------------	-------------	------------

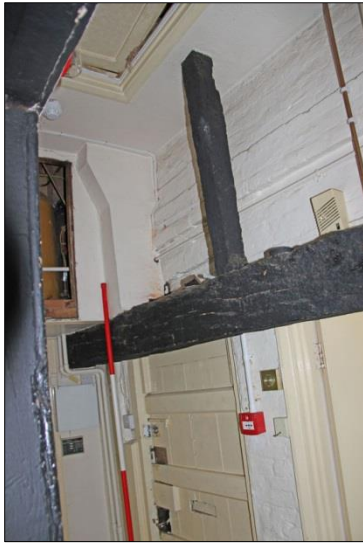
Plate 7: Truss 1, facing southwest (1)

Truss 1, which is located immediately inside the west wall of the Hayloft, has a king post on a tie beam that is 24cm high x 21cm deep and a 10cm² post (Plates 7 – 8). There is a large mortice at the northern end measuring 31 x 7cm, and two large mortices for posts in the soffit measuring 30 x 7cm to the north and 23 x 6cm to the south (Plate 9).

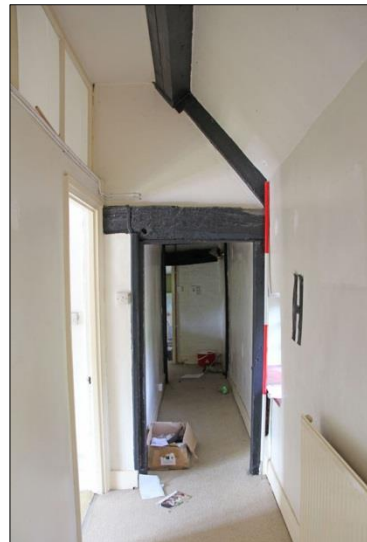
Plate 10: Truss 2, facing west (5)

Truss 2 is located at the partition of the kitchen (F2) and the office (F3). The doorway at the northern end has a 10 x 11cm post to the north and a stave hole in the tie beam above (Plate 10).

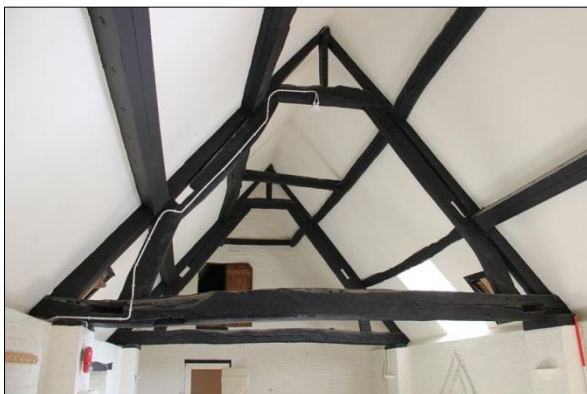
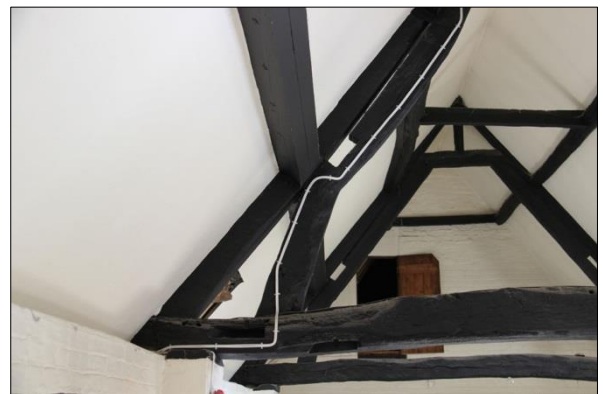
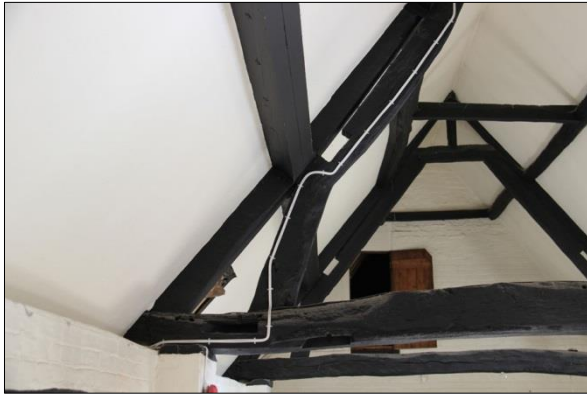
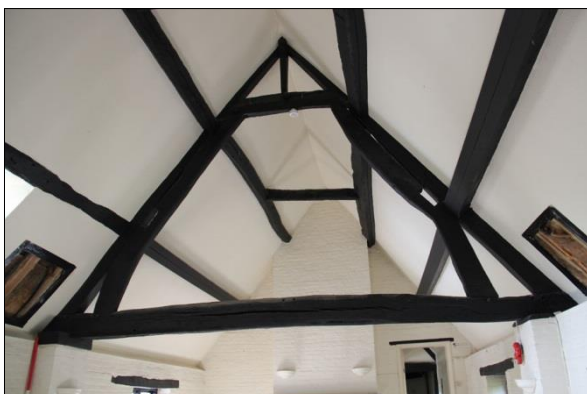
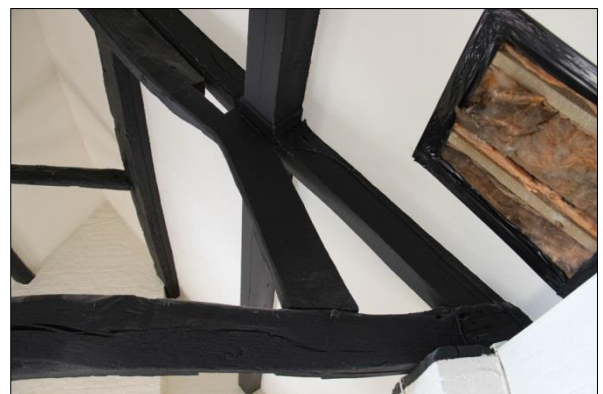
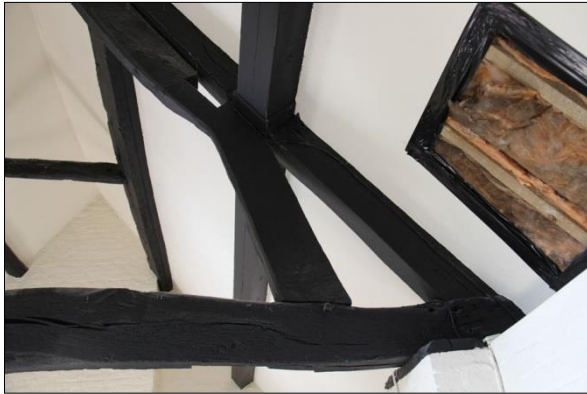
Truss 3, which is located at the western end of Room F4, is fully exposed, as is Truss 4 to the east. These are both of a relatively local form and have cranked inner principals and a short king post above the collar beam. These have clearly been re-used as the original cranked inner rafters that supported trenched purlins are now set within a butt purlin roof. Whereas the original trusses were clearly adzed, the newer timbers were machine cut. The mortices on the western face of the tie beam suggest that the truss came from a larger building and was cut down to fit and the mortices in the soffit suggest that the original building was fully timber framed. Peg holes indicate the presence of a former King Post in Truss 3. Of interest are the carpenter's assembly marks which showed tagged Roman numerals on the principal joints of the truss, including the newer rafters (Plates 11 – 23).

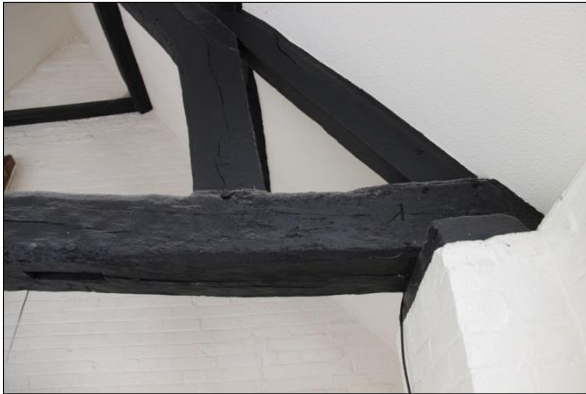
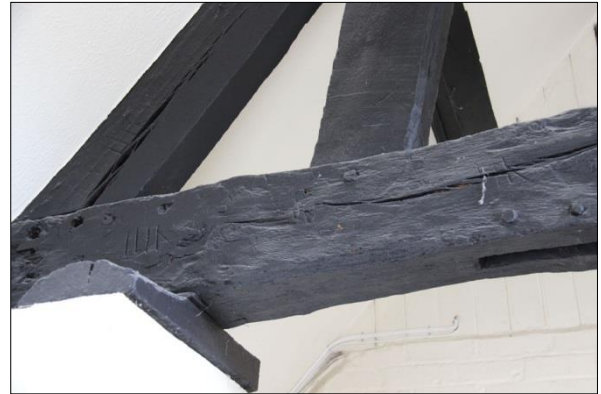
Truss 4 has no mortices in the fascia, but does have two in the soffit measuring 23 x 5cm (Plates 24 – 26). Figure 4 shows Truss 4 but its structure is representative of Trusses 3, 4 and 5.

Plate 25: Truss 4 carpenter's marks, facing west (25)

Plate 26: Truss 4 carpenter's marks, facing west (26)

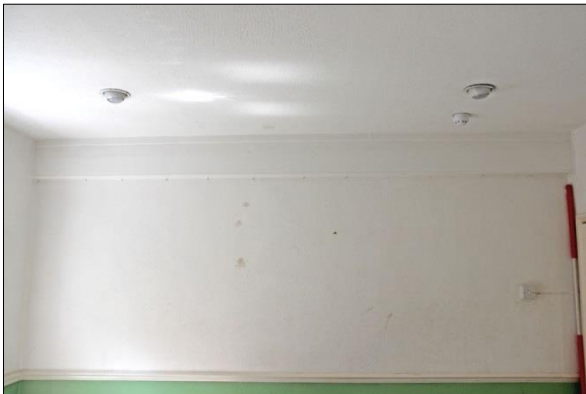
Truss 5 is located within the wall between Rooms F4 and F5. All that can be seen from the first floor is part of the tie beam, however the braces and collar beam can be seen in the loft, where the truss has been filled in with brick to create a partition (Plates 27 – 28).

Plate 27: Truss 5 location in F6, facing west (27)

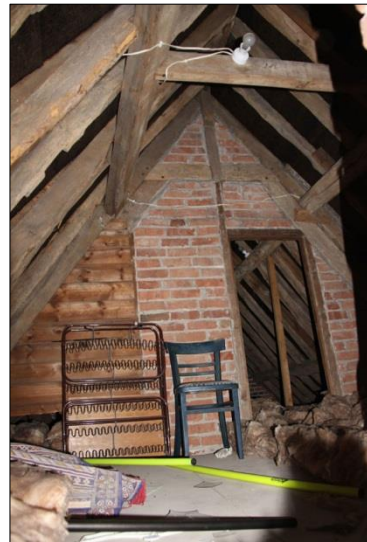
Plate 28: Truss 5 in the roof space above F5, facing east (41)

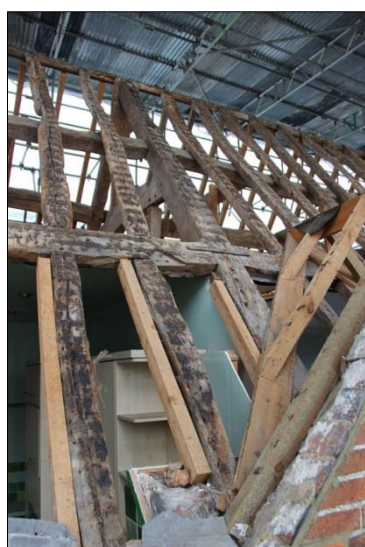
Some timbers are modern machine-cut replacements, notably all the rafters in Bay 3 have been replaced, as well as some sporadically replaced rafters in Bays 1 and 2. The replacement rafters are of a far lesser scantling and are no more than 5cm (2 inches) in thickness. A board was placed over the lower purlin in Bay 3, obscuring the original timber, the purpose likely to provide a level base with which to secure the new rafters (Plates 47 – 48). Some historic repairs are evident in Bay 5 with additional rafters measuring 10 – 12 cm added (Plates 53 – 55). The purlins to either side of Trusses 2, 4 and 5 are braced with iron straps (Plates 41, 52 and 56).

Plate 41: South roof, Truss 2 (92)

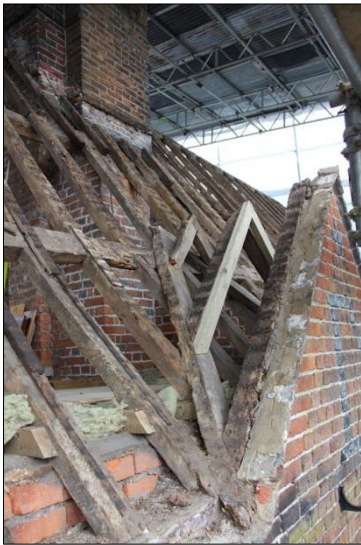
Three projecting gablets are present on the south side of the roof, which were added in the 18th century, the largest of the three is centrally located. The original timbers survive behind this and the eastern gablet (Plates 61 – 62). There is a scarf joint in the lower purlin in Bay 7, beneath the main chimney stack (Plate 64). Carpenter's marks are present on the lower purlins in Bays 1, 5, 6 and 7 (Plate 70), as well as on some of the adjacent rafters in Bay 5. Those in the south face of Bay 1 are sequential, but this is not the case elsewhere. Both purlins in Bay 7 have clearly been re-used, and despite the similarity between this part of the roof and the bays to the west, the overall impression was that this is a slightly later or different build. (Plates 65 – 72).

Plate 61: South roof, main chimney (115)

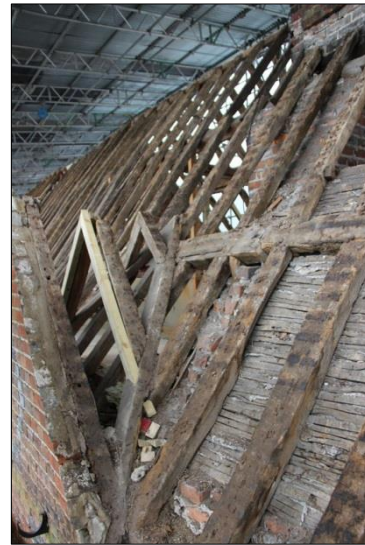
Plate 62: South roof, main chimney (116)

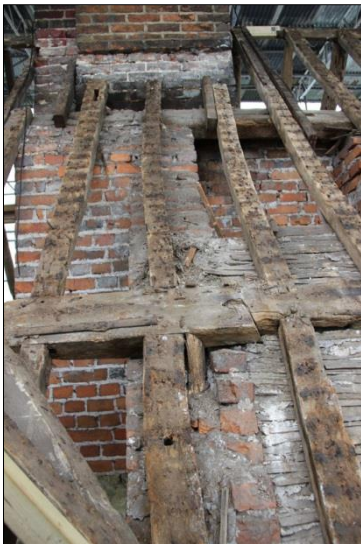
Plate 63: South roof, main chimney (117)

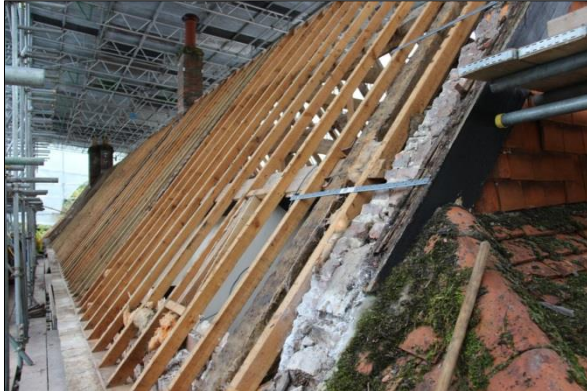
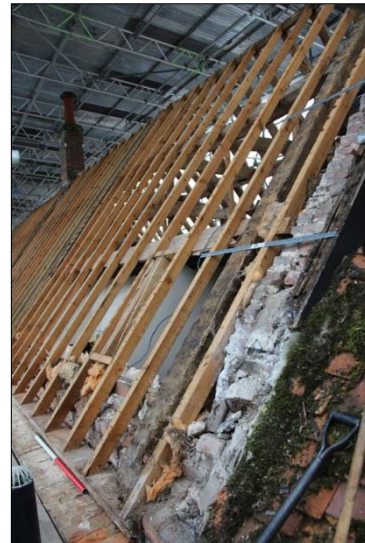
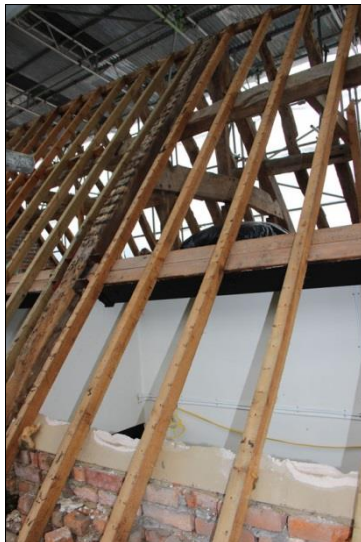
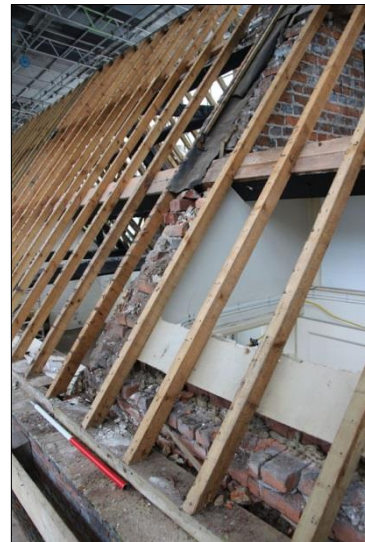
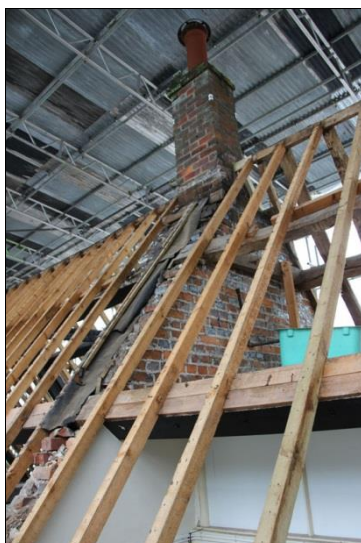
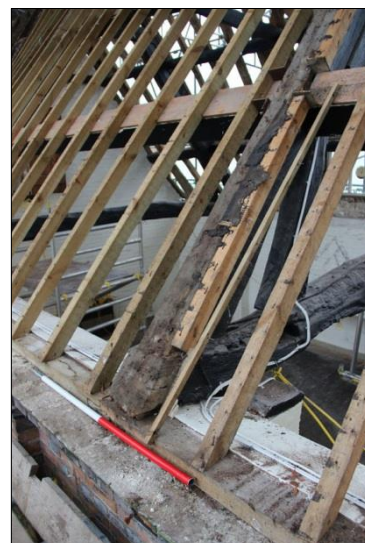
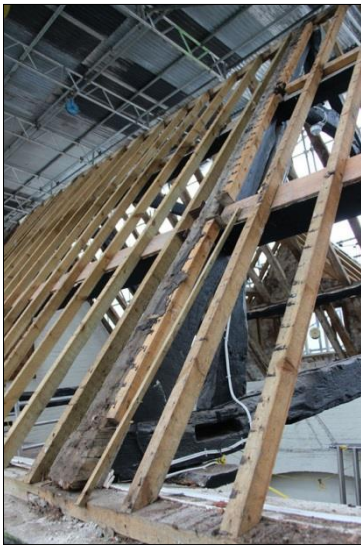
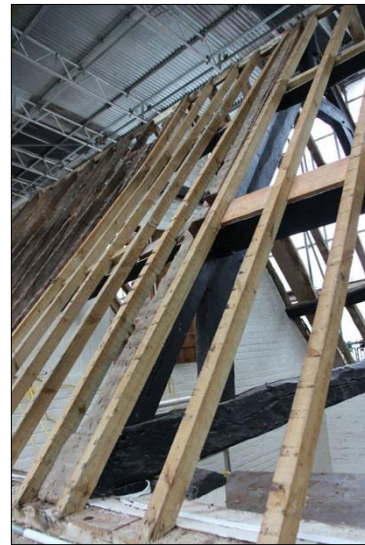
The majority of the rafters on the north side of the roof are modern replacements of the same type found to the south, particularly at the west end (Plates 73 – 80). The exception is most of the rafters in Bay 5 and all of those in Bays 6 and 7, which are still hand cut (Plates 81 – 100). The principal rafters remain unchanged however. The lower purlins were also replaced in Bays 1, 2, 3 and 4 but the upper purlins are still original. More carpenter's marks are present on the original lower purlins on the north side. The marks in Bay 5, though still Roman numerals, are of a distinctly different type than those on the other side of Truss 5 in Bays 6 and 7. Those in Bay 5 are considerably larger, covering the entire width of the purlin, this may represent a different craftsman (Plates 83, 85 and 95). Truss 5 has another iron strap brace (Plates 86 – 87). A modern catslide roof is present at the east end, with modern 5cm (2 inch) rafters that attach to the original hand cut rafters in Bay 7, overlapping them at a shallower angle (Plates 97 – 100). They are placed 32cm (1 foot) apart.

Large portions of the rafters have been entirely replaced with modern machine cut timbers, particularly on the north side, where Bays 1 – 4 have been almost entirely reworked. Some earlier stages of repair are evident, such as the addition of supportive hand cut rafters in the south side of Bay 5.
