KDK ARCHAEOLOGY LTD

Historic Building Recording

New Farm
2 St Mary's Road
East Claydon
Buckinghamshire

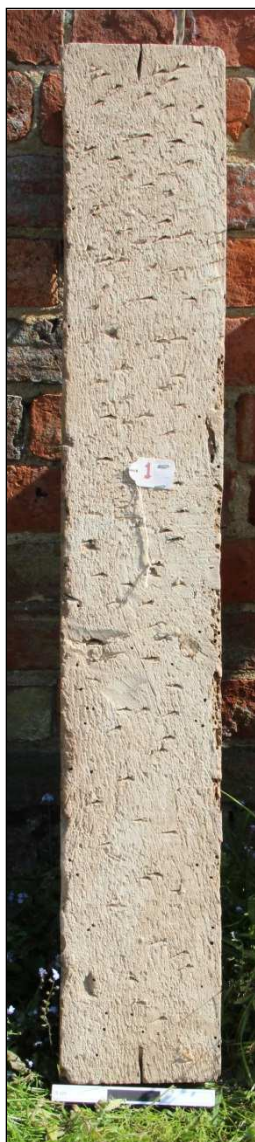
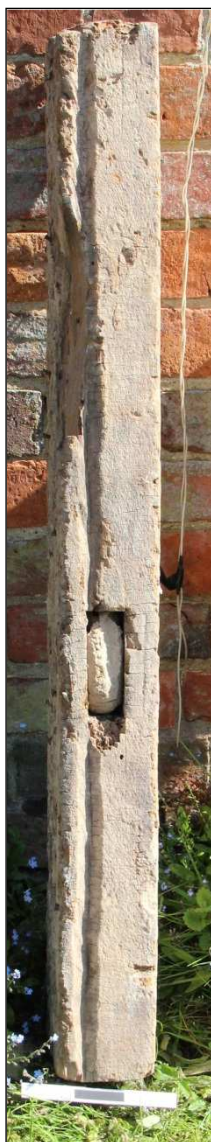
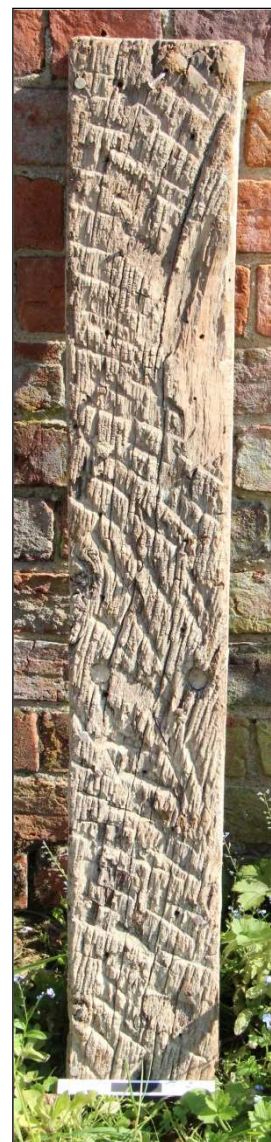
Project: New Farm, East Claydon, Bucks.		Project Code: 451/ECS	Timber No. 1
Dimensions (cm):	Length:100	Width:16	Depth:10
Timber type: Oak			
Date: 16 th century			
Function: Rail, south elevation			
Description: V grooves on both sides as well as a through mortice. Small nails on outer face which has incisions from either render application or removal			
Recorder: KK		Survey date: 24 th May 2019

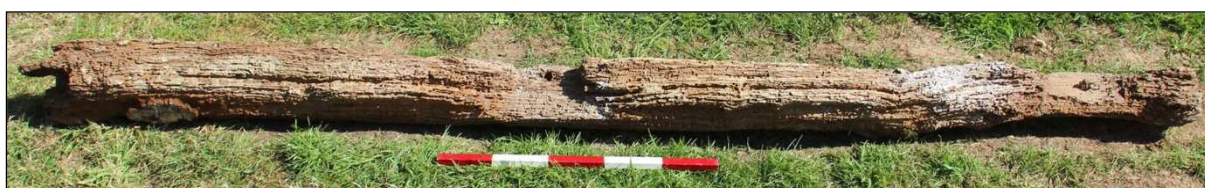
Project: New Farm, East Claydon, Bucks.		Project Code: 451/ECS	Timber No. 5
Dimensions (cm):	Length: c.227	Width: 16	Depth: 10
Timber type: Oak			
Date: 16 th century			
Function: Rail, north elevation			
Description: Very decayed timber with two seatings for vertical posts, one with a surviving peg and the other with just a peg hole.			
Recorder: KK		Survey date: 24 th May 2019

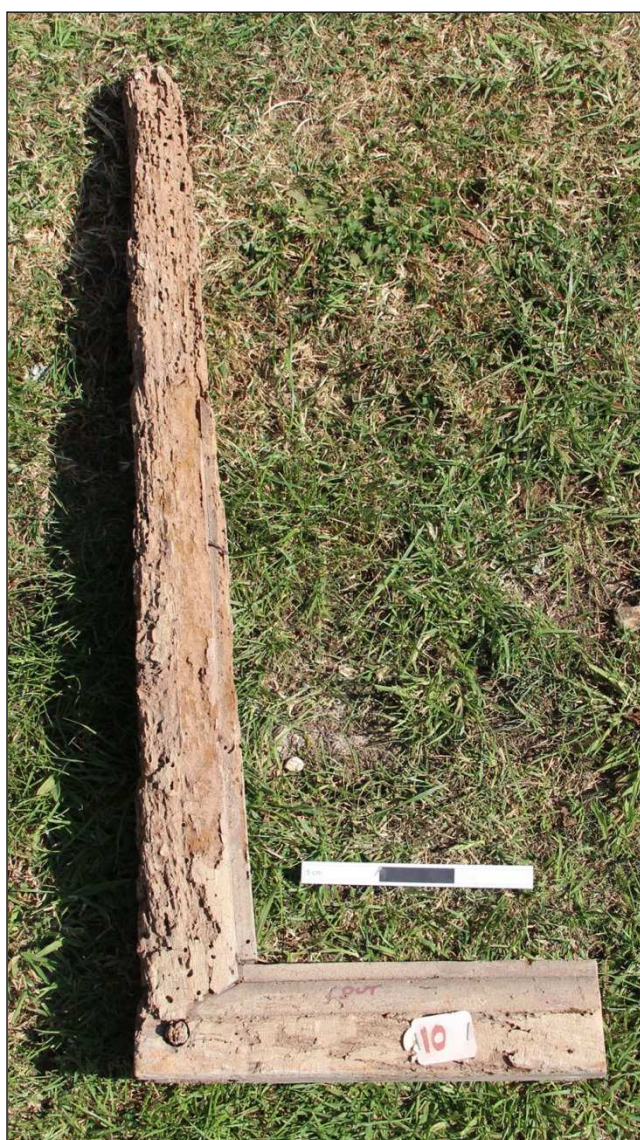
Project: New Farm, East Claydon, Bucks.		Project Code: 451/ECS	Timber No. 10
Dimensions (cm):	Length: 29/76	Width: 8.5/8	Depth: 7/7
Timber type: Oak			
Date: 16 th century			
Function: Section of the top and left side of the window frame, eastern end of the north elevation.			
Description: Corner section of a mullioned window. Tenoned with surviving in situ peg and diamond mortices . The moulding differs on the inside from the outside (see photos)			
Recorder: KK		Survey date: 24 th May 2019

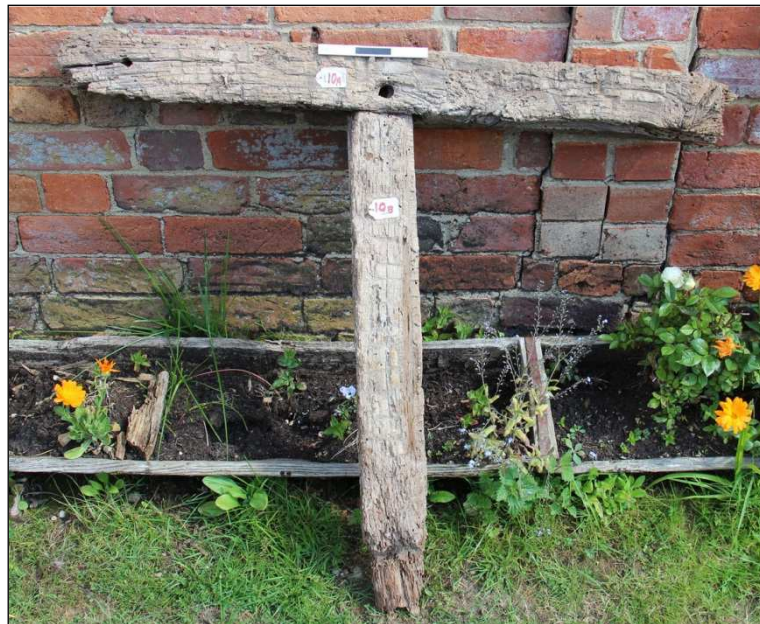
Project: New Farm, East Claydon, Bucks.		Project Code: 451/ECS	Timber No. 10a
Dimensions (cm):	Length: 99	Width: 9	Depth: 8
Timber type: Oak			
Date: 16 th century			
Function: Rail, south elevation			
Description: Joined with 10b. Very worn with no evidence for tool marks or V-groove			
Recorder: KK		Survey date: 24 th May 2019

Project: New Farm, East Claydon, Bucks.		Project Code: 451/ECS	Timber No. 10b
Dimensions (cm):	Length: 74	Width: 9	Depth: 7
Timber type: Oak			
Date: 16 th century			
Function: Stud, south elevation			
Description: Upright for 10a. V-grooves on both sides and tenon on one end			
Recorder: KK		Survey date: 24 th May 2019

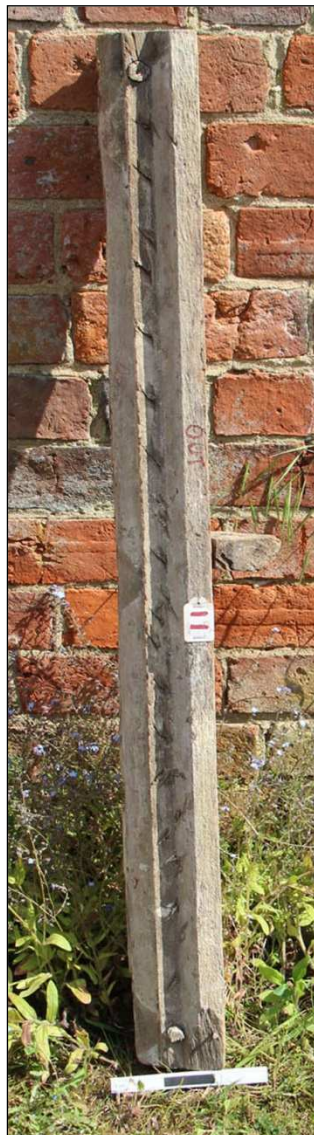
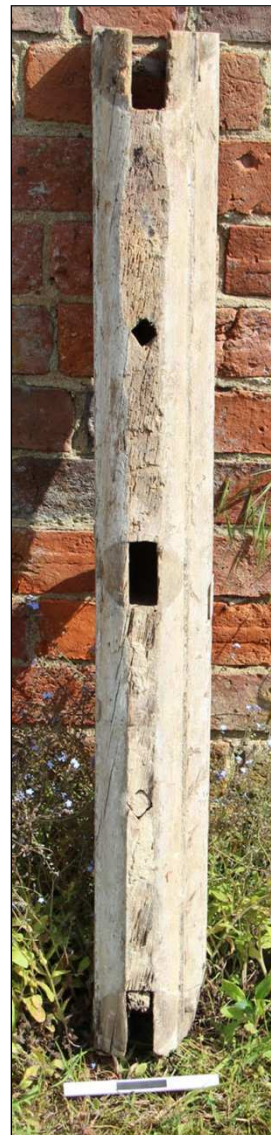
Project: New Farm, East Claydon, Bucks.		Project Code: 451/ECS	Timber No. 11
Dimensions (cm):	Length: 99	Width: 12	Depth: 10
Timber type: Oak			
Date: 16 th century			
Function: Upper or lower part of window frame, north elevation			
Description: Asymmetrical timber with the inner face wider than the outer. Two diamond mortices between 3 rectangular mortices. One of the diamond mortices retains a section of the mullion.. Small piece of wood attached to the back.			
Recorder: KK		Survey date: 24 th May 2019

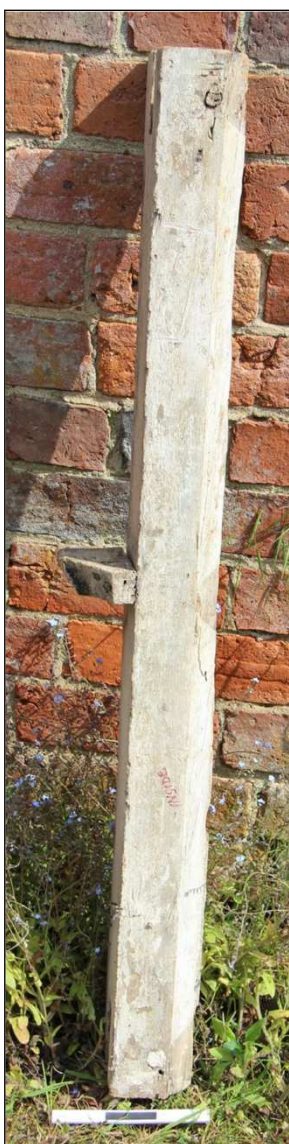
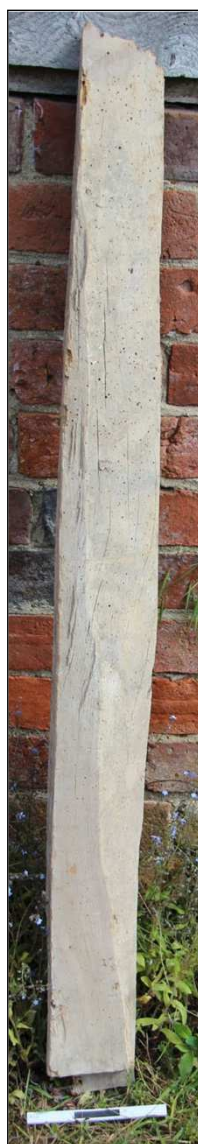
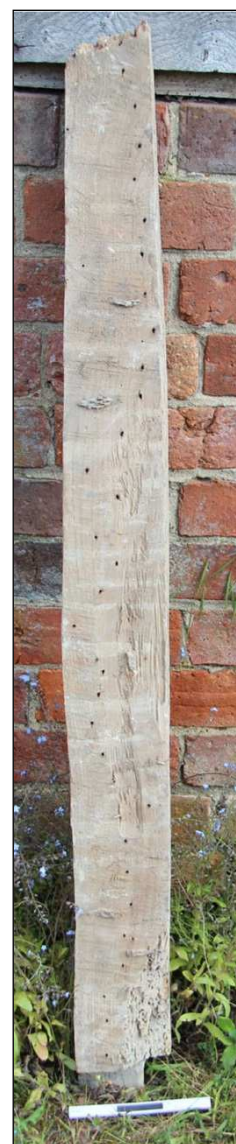
Project: New Farm, East Claydon, Bucks.		Project Code: 451/ECS	Timber No. 12
Dimensions (cm):	Length: 112	Width: 11	Depth: 8
Timber type: Softwood			
Date: ?19 th century			
Function: Rail, north elevation			
Description: Waney edged timber with sawmarks, and marks for lath and plaster on one side.			
Recorder: KK		Survey date: 24 th May 2019

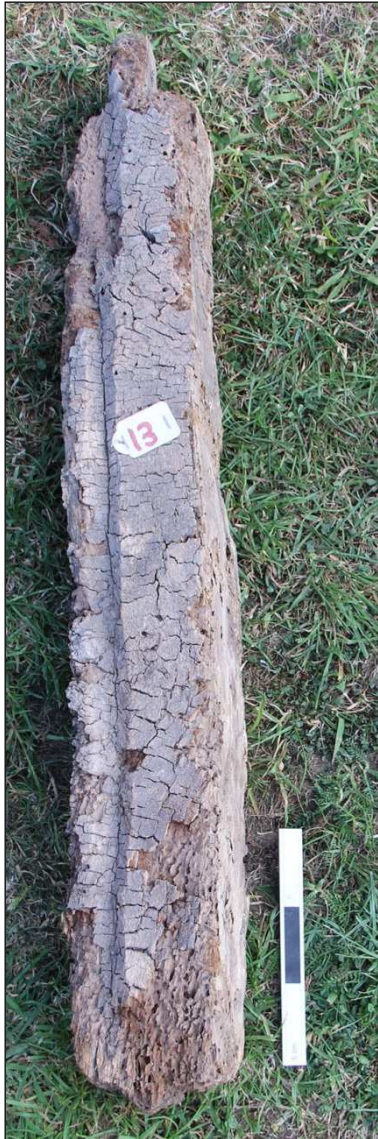
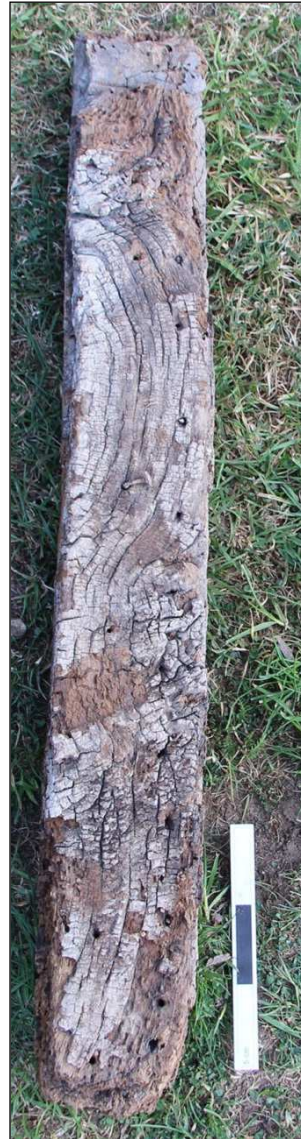
Project: New Farm, East Claydon, Bucks.		Project Code: 451/ECS	Timber No. 13
Dimensions (cm):	Length: 73	Width: 10	Depth: 9
Timber type: Oak			
Date: 16 th century			
Function: Stud, south elevation			
Description: V-grooves on both sides and tenon at one end. Line of nails along edge (?to the back of the timber) without a groove.			
Recorder: KK		Survey date: 24 th May 2019

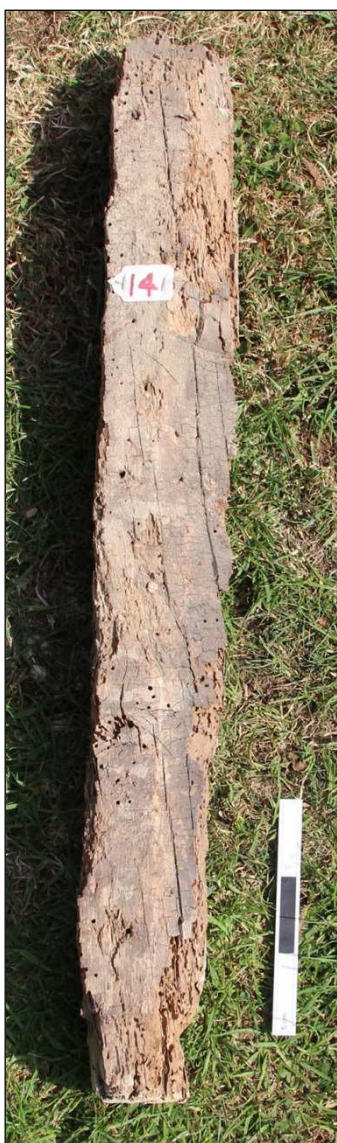
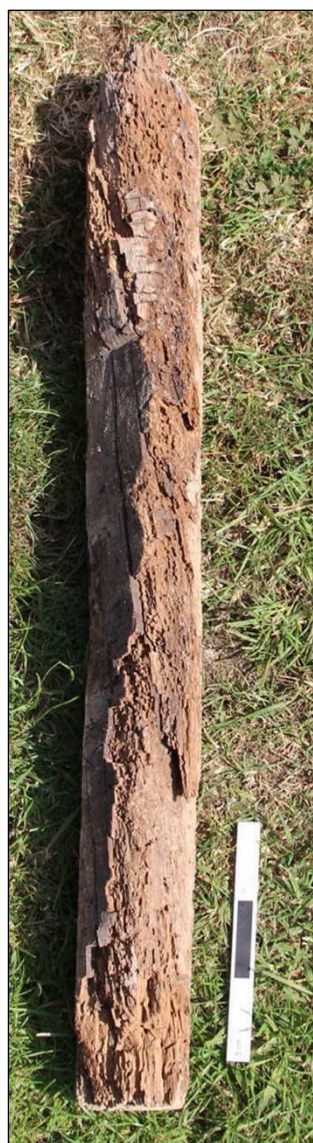
Project: New Farm, East Claydon, Bucks.		Project Code: 451/ECS	Timber No. 14
Dimensions (cm):	Length: 77	Width: 9	Depth: 7
Timber type: Oak			
Date: 16 th century			
Function: Stud, south elevation			
Description: Very worn with shallow notch and tenon at one end			
Recorder: KK		Survey date: 24 th May 2019
