KDK ARCHAEOLOGY LTD

**Historic Building Recording,
Historic Building Watching Brief &
Archaeological Watching Brief**

Abdale House/Northside
32-34 Warrengate Road
North Mymms
Hertfordshire

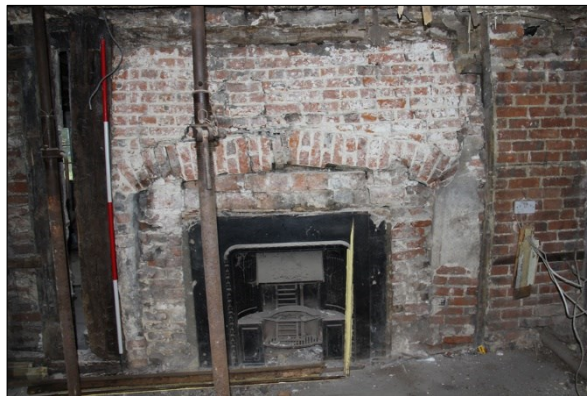
Photo G60: G8: west wall

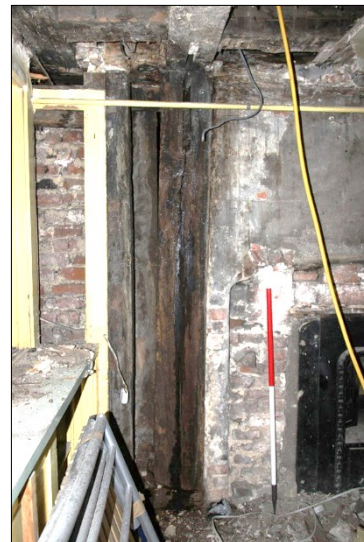
Photo G61: G8: detail of fireplace, west wall

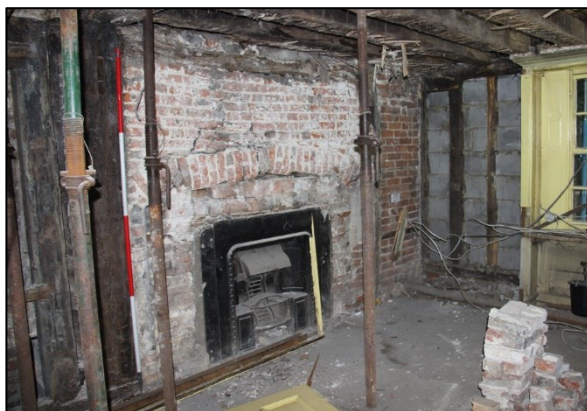
Photo G62: G8: detail of timberwork south of fireplace

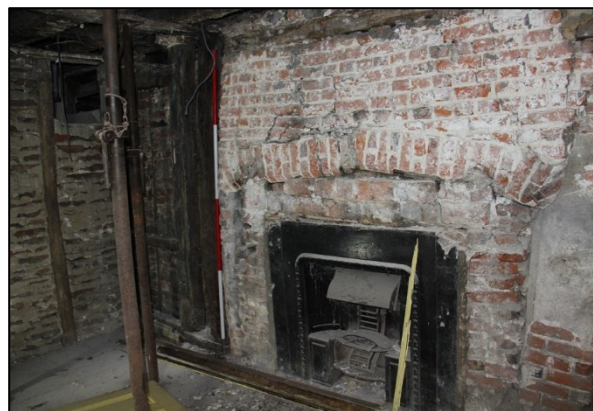
Photo G63: G8: northwest corner

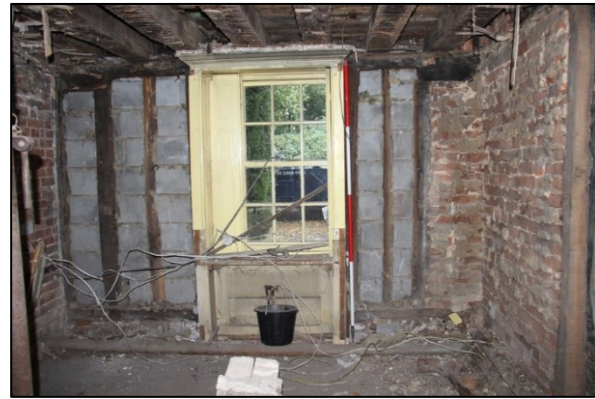
Photo G65: G8: south wall

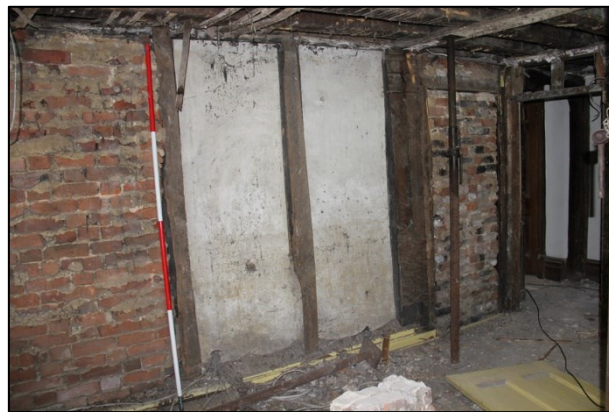
Photo G66: G8: north wall stripped

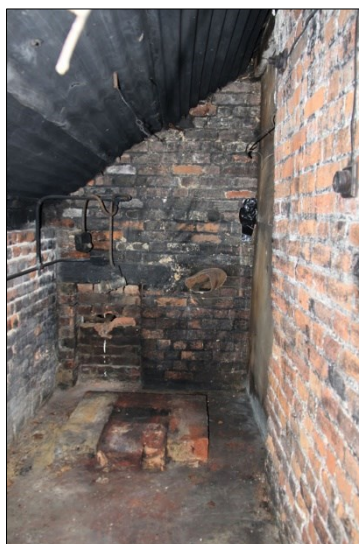
Project code: 482/NMW	Project: Abdale House, North Mymms		Room no: G9
Location: West side		Function: Store	
Dimensions (m):	Length:	Width:	Height:
Wall form & decor: Brick			
Ceiling / roof structure: Pitched to north, timber planks			
Windows: None			
Doors: Exterior door on west, plank and batten door to G10 on south.			
Floor: Brick with platform for boiler?			
Fireplace: None			
Staircase:			
Other architectural details:			
Recorder: KK & ES		Survey Date: 16.08.2019

Photo G68: G9: Facing east

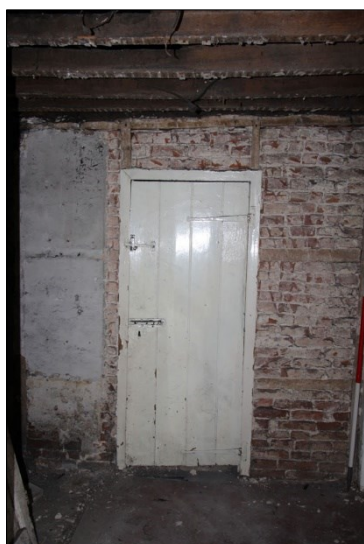
Project code: 482/NMW	Project: Abdale House, North Mymms		Room no: G10
Location: West side		Function: Lobby	
Dimensions (m):	Length: 2.00	Width: 2.23	Height: 2.27
Wall form & decor: South and east wall has some timber framing, west and east walls are later, probably 18 th century. North wall does not bond to west wall.			
Ceiling / roof structure: Exposed floor joists.			
Windows: Possible former window to south of door in west wall.			
Doors: Half glazed exterior door to west. Plank and batten door to east. Two panel door with H hinges to north. Six panel door to south, removed but leaning against wall.			
Floor: Brick covered with modern rubberized surface.			
Fireplace: None			
Staircase: Step down to G11 on south.			
Other architectural details:			
Recorder: KK & ES		Survey Date: 16.08.2019

Photo G69: G10: east wall

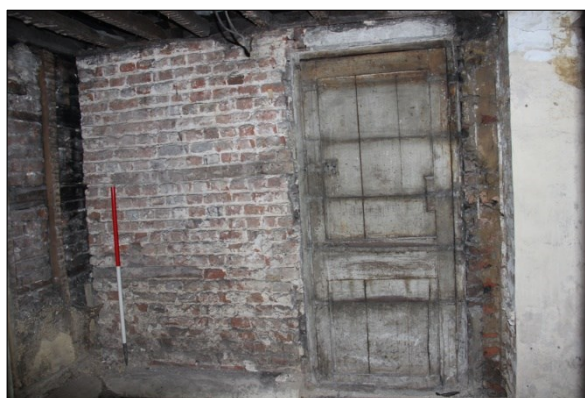
Photo G71: G10: north wall

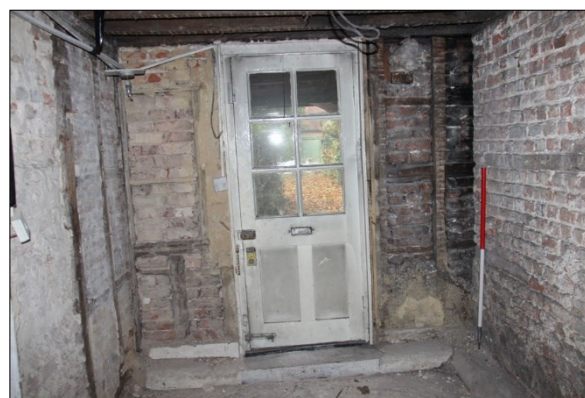
Photo G72: G10: west wall

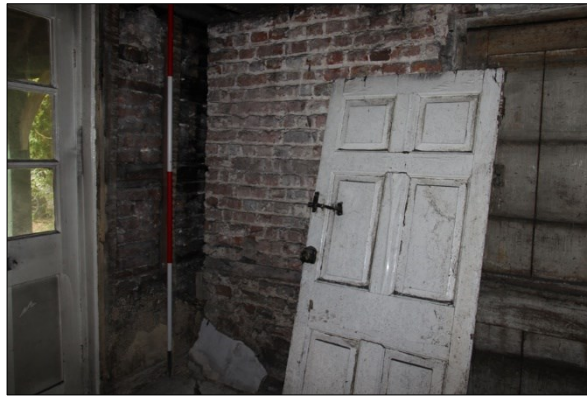
Photo G73: G10: northwest corner

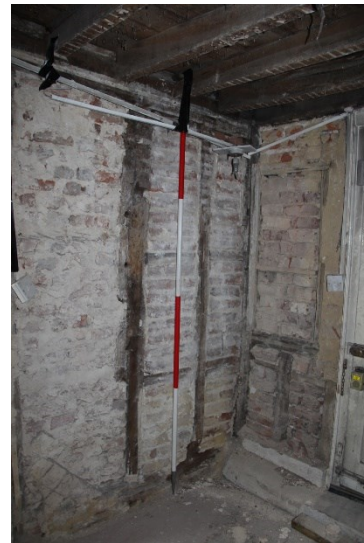
Photo G74: G10: northeast corner

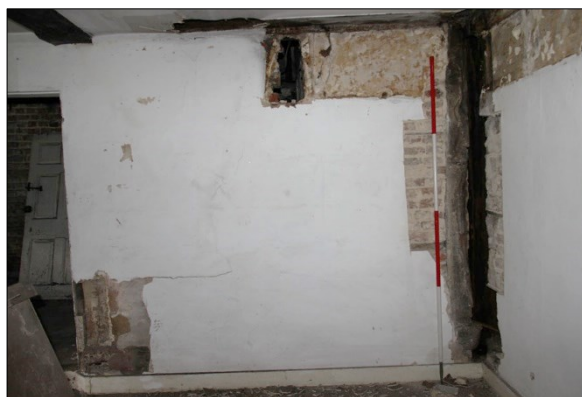
Additional notes: The timber work in the north and east walls have been partially exposed. Both have brick infill. The bricks are variably sized with some at c.5cm thick and some 19th century examples at 7cm. The studs in the north wall are 13cm wide and fairly irregularly spaced. An infilled door is located to the east of the present door. This and the neighbouring section to the east have narrow bonding timbers. The east wall also has bonding timbers in the brick infill. Although the floorboards above this room are wide, the joists are not all ancient. Those to the east of the spinal beam have been largely replaced. But those to the west are 10-12cm on 40-50cm centres.			
Recorder: KK & ES		Survey Date: 16.08.2019

Photo G75: G11: north wall

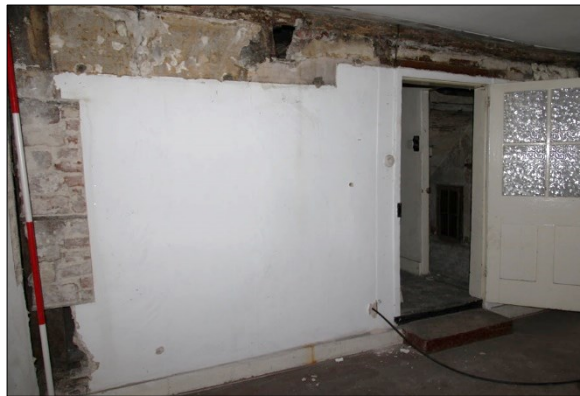
Photo G77: G11: east wall, facing southeast

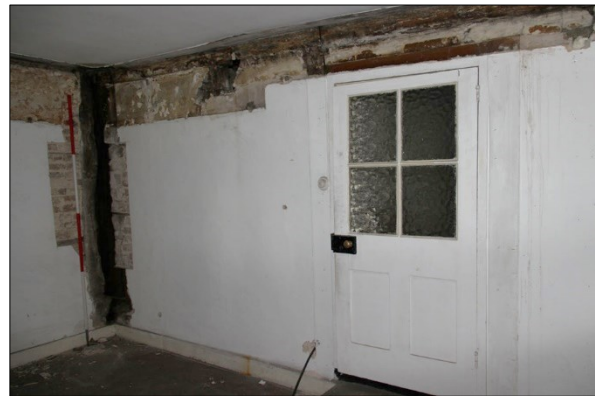
Photo G78: G11: east wall, facing northeast

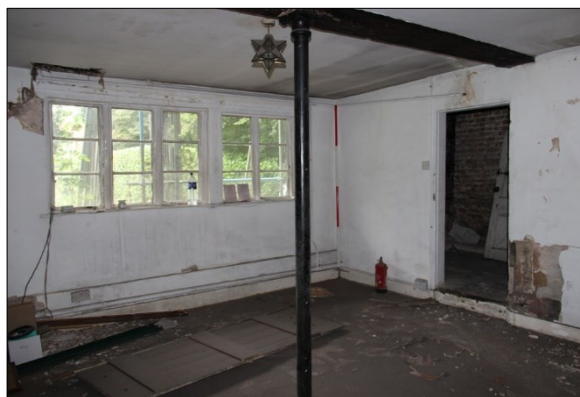
Photo G79: G11: west and north walls, door to G10

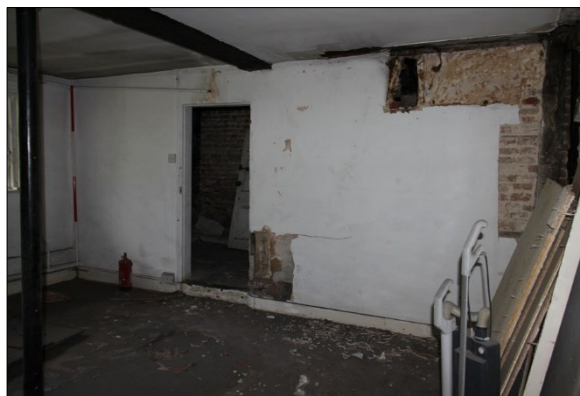
Photo G81: G11: north wall

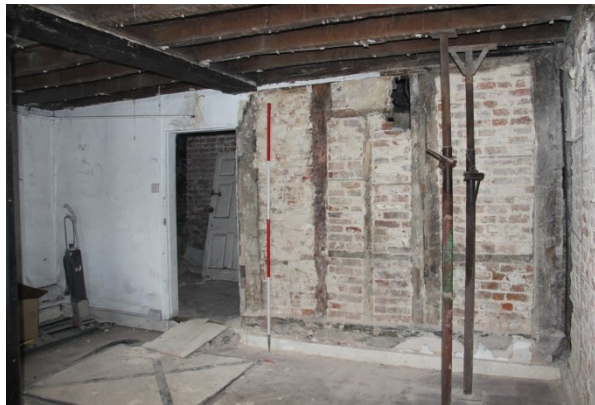
Photo G82: G11: north wall partially stripped

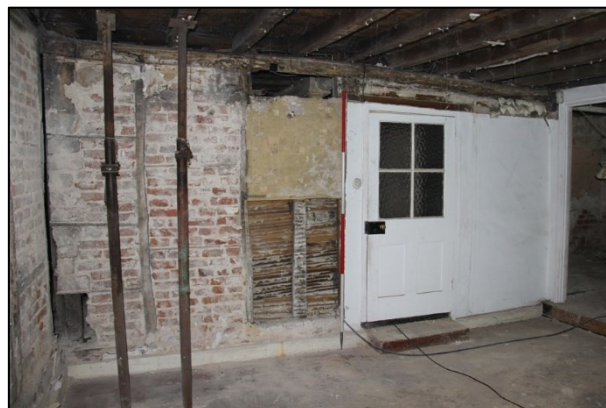
Photo G83: G11: east wall stripped

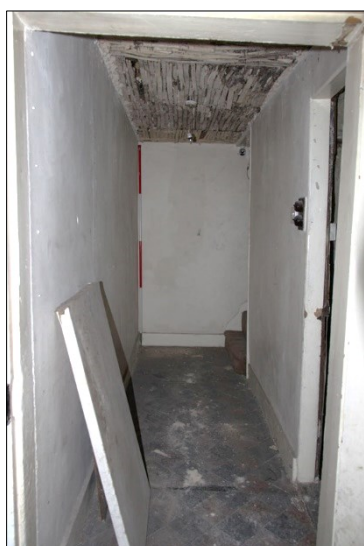
Photo G84: G12: facing east, basement stairs on near right, stairs to first floor on right at far end

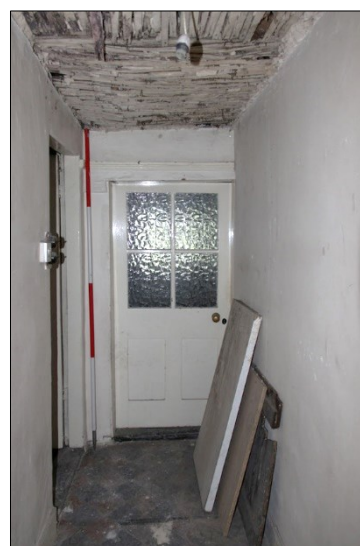
Photo G85: G12: facing west, basement stairs on left, door to G11

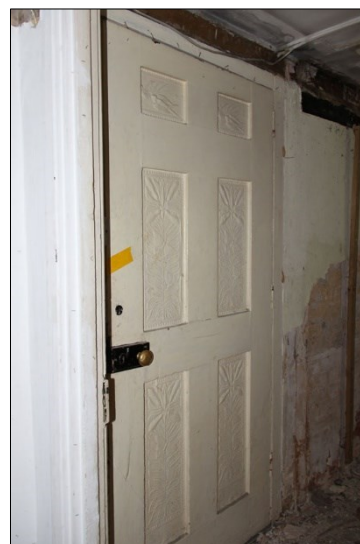
Photo G87: G13: detail of door into G14a, facing southeast

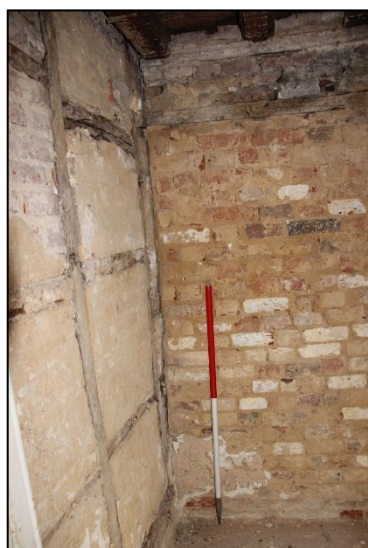
Project code: 482/NMW	Project: Abdale House, North Mymms		Room no: G14
Location: South		Function: Store	
Dimensions (m):	Length: 2.35	Width: 1.24	Height: 2.12
Wall form & decor: West and north: timber framing with brick infill, south: 18 th century brick, east: 19 th century brick.			
Ceiling / roof structure: Painted lath and plaster			
Windows: Single light with lozenge and diamond panels in south wall			
Doors: Six panel door on west to G14			
Floor: Red and black quarry tile			
Fireplace: None			
Staircase: None			
Other architectural details:			
Recorder: KK & ES		Survey Date: 16.08.2019

Photo G88: G14: northeast corner

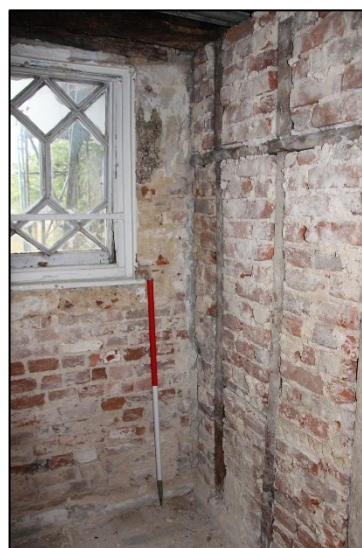
Photo G89: G14: southwest corner

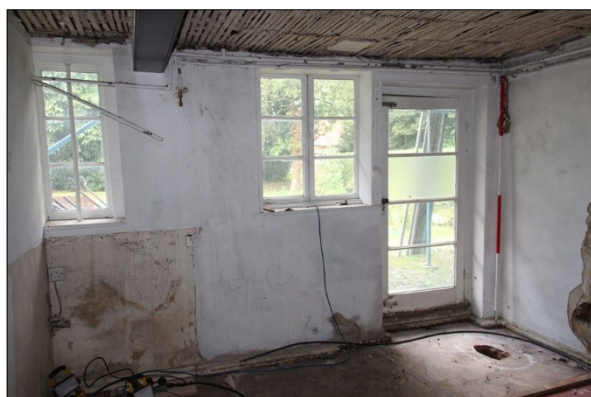
Photo G90: G15: west wall

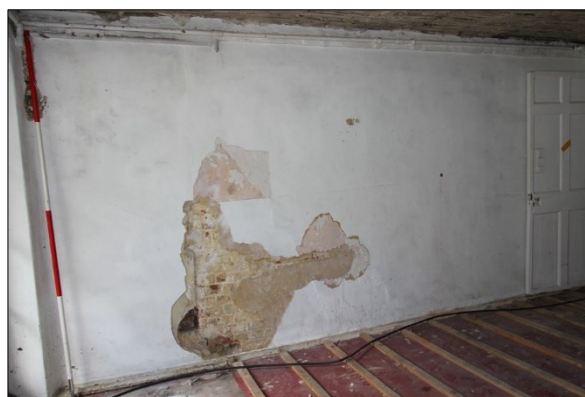
Photo G91: G15: north wall

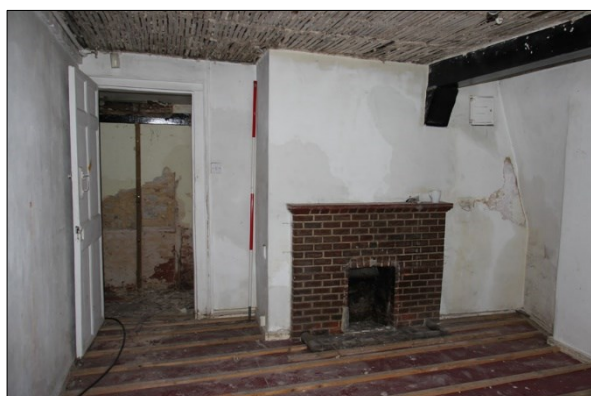
Photo G92: G15: east wall

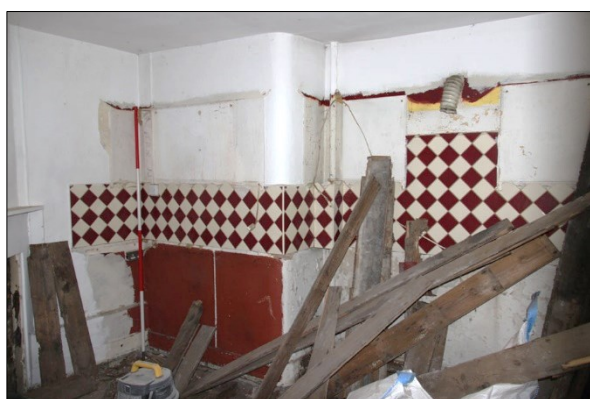
Photo G94: G16: south wall, facing southeast

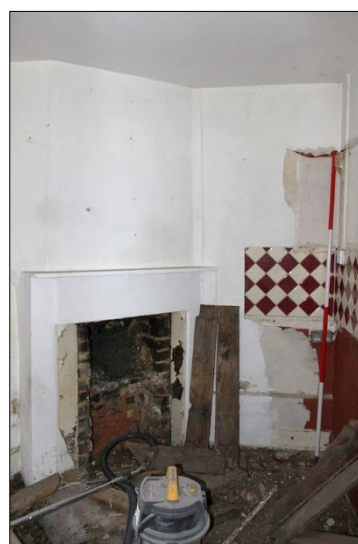
Photo G95: G16: east wall with corner fireplace

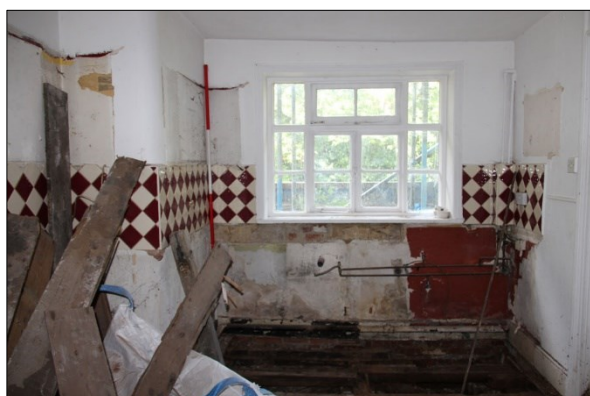
Photo G96: G16: west wall

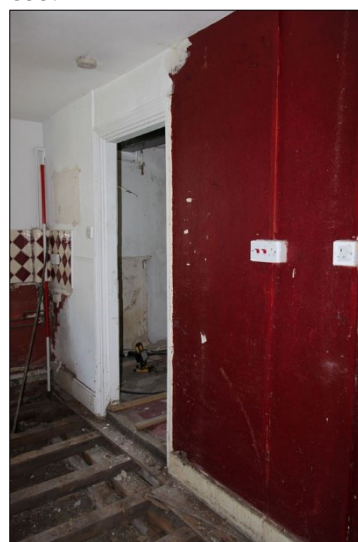
Photo G97: G16: north wall, facing northwest

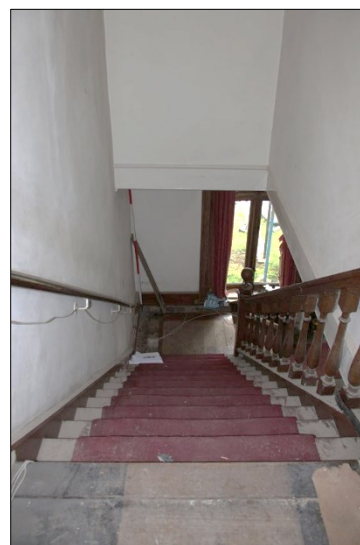
Photo F2: F1: view down staircase, facing north

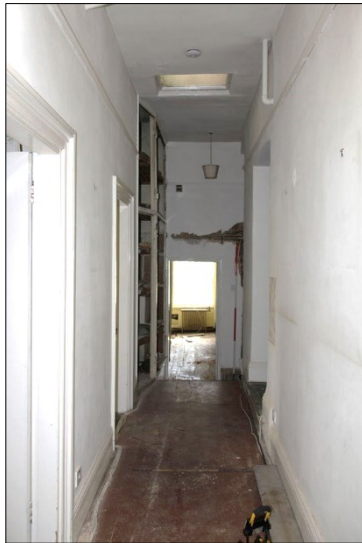
Photo F3: F1: view to east

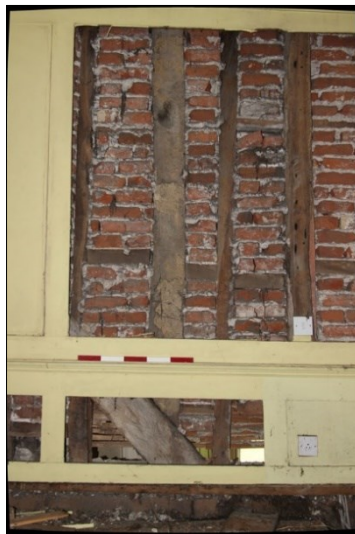
Additional notes: Room F4 was fully exposed and also visible from the room below (G2). The walls have curved tension braces 17-22cm wide. The studs in the east wall are closely set at 40cm centres but the studs are alternately 16 and 7cm wide. The bricks in between are 23x10x5cm. The mortar is actually hard render. The same can be seen in the south wall where render has replaced the mortar. The studs here are mostly later replacements and binding timbers are prevalent. This appears to be late 18th century reworking of the wall. The north wall is largely obscured by debris. Only the braces and the central part to the left of the window before the brace are original. Earlier replacements are 13cm wide on 40cm centres. Modern studs are more prevalent to the right of the window. The west wall has been largely rebuilt, probably in the 19th century when the fireplace was installed. The bricks in between the studs also appear to be 19th century. The ceiling joists are also later replacements although the floor boards above are wide.

Photo F29: F4: detail of timberwork, east wall

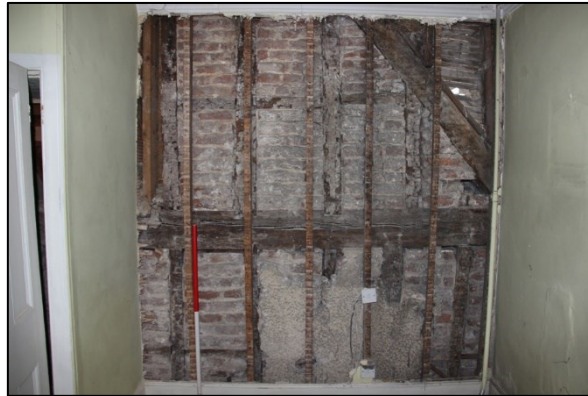
Photo F39: F5: north wall stripped exposing timber frame from east cross wing

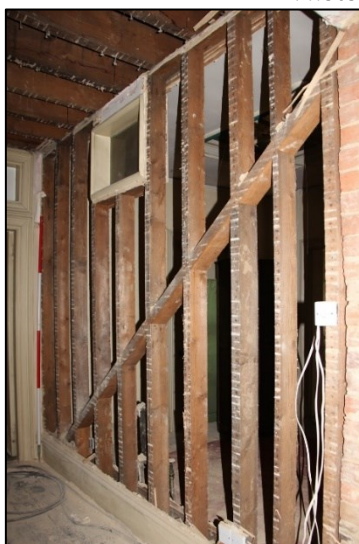
Photo F52: F8: east wall stripped

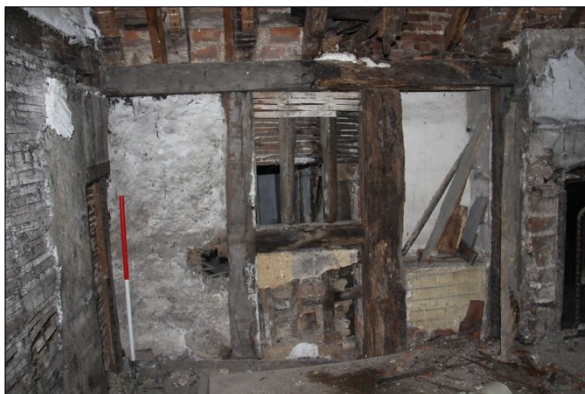
Staircase: None.			
Other architectural details: Recessed niche in northwest corner on west wall.			
Additional notes: The mullioned window and wattle and daub to the south of it are to the south of a 25cm wide post with a mortice some 30cm long at the top. The opposing post has a similar mortice with the tenon still present. There are only three surviving posts in the west wall, measuring 13-15 cm wide. The brickwork in the same wall is 19th century. The studs above the window in the north wall are likely to be original, with one later replacement to the east. This alongside the window are partially replaced. The wall here has lath and plaster as does the outside of the mullioned window. The entire south wall is lath and plaster. Rafters are between 11 and 14cm wide, probably oak. The arched brace in the NW and NE corner is 20cm wide. The rafters are pegged and without a ridge post or beam. Each rafter couple is braced. It has butt purlins on both sides. It is abutted by a short roof to the west that joins the chimney stack. This has been partially rebuilt; the base is made of Tudor bricks that have been rendered in cement mortar.

Photo F64: F11: exposed mullion window, wattle and daub on left below window

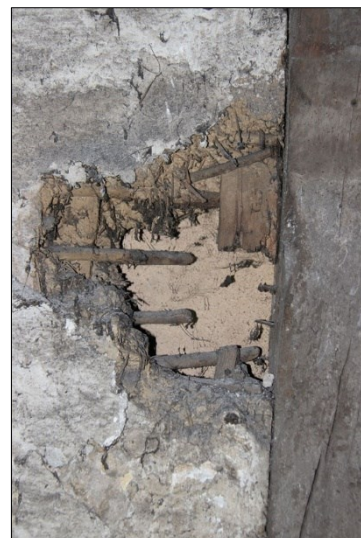
Photo F65: F11: wattle and daub below window

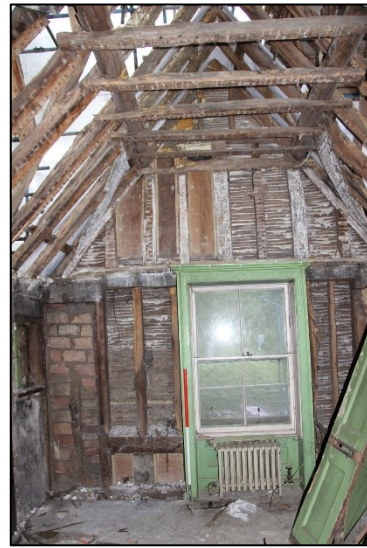
Photo F67: F11: north wall stripped

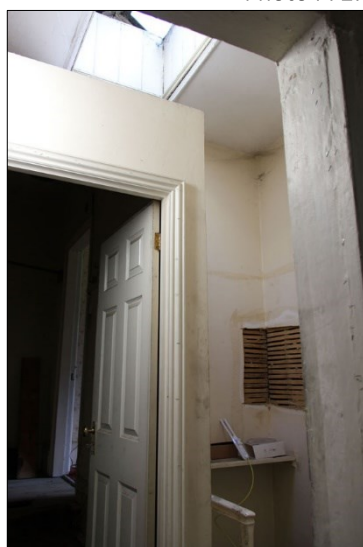
Photo F73: F12: partition wall dividing Northside and Abdale House, facing southeast

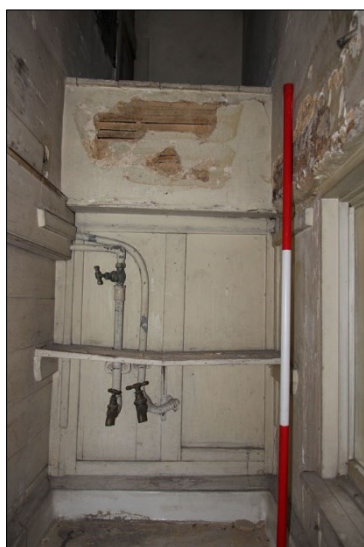
Photo F77: F14: top of east wall with sink at bottom, showing high ceilings

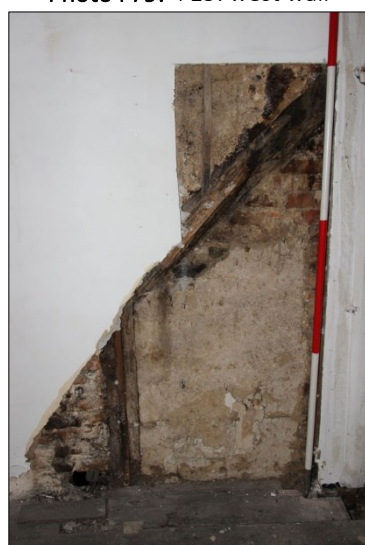
Photo F81: F15: detail of timber framing in north wall

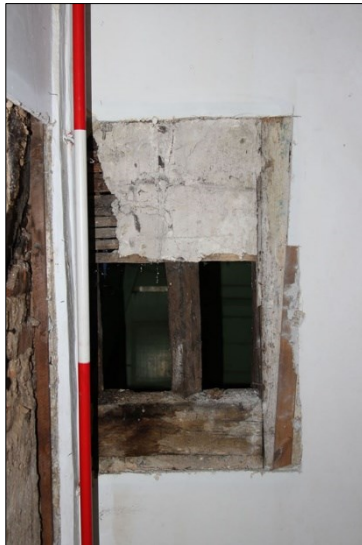
Photo F83: F15: detail of timber work in east wall, mullion window from F11

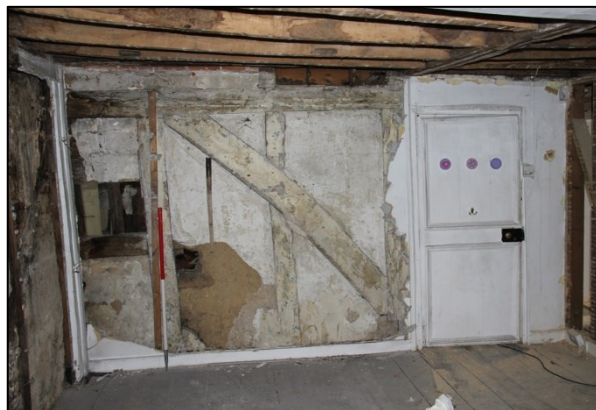
Photo F86: F15: east wall stripped

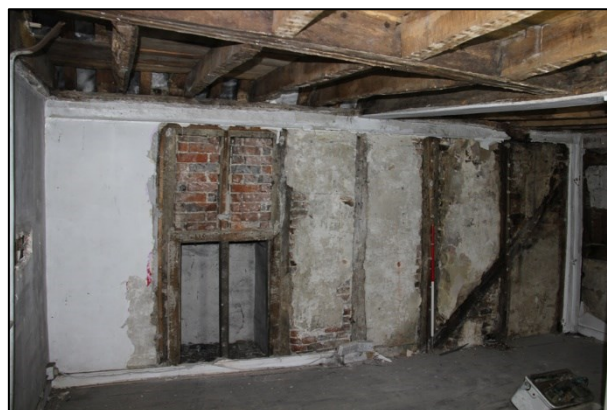
Photo F87: F15: south wall stripped

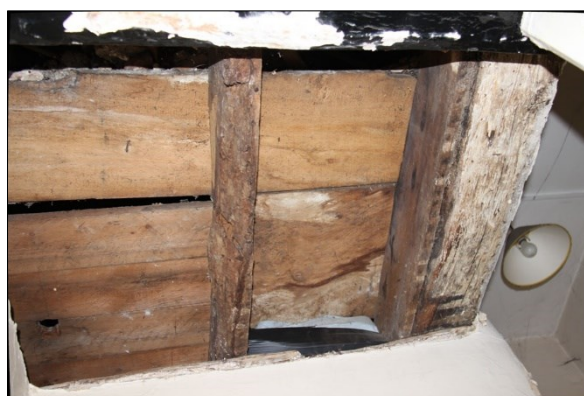
Project code: 482/NMW	Project:Abdale House, North Mymms		Room no: F17
Location: Outside F16		Function: Hall	
Dimensions (m):	Length: 3.30	Width: 0.95	Height: 3.20
Wall form & decor: Painted plaster, stud work on east, north and west and probably brick on south. Simple skirting.			
Ceiling / roof structure: Painted lath and plaster, beam running east and west, 0.83m from north wall			
Windows: Single light casement with three horizontal panes in south wall.			
Doors: 4 panel on west to F16			
Floor: Timber, 16cm wide aligned east to west.			
Fireplace: None			
Staircase: Step up to F16, step down to hall outside bathroom (F12).			
Other architectural details: Exposed floor joists in the ceiling at north show bark on surface.			
Recorder: KK & ES		Survey Date: 16.08.2019

Photo F95: F17: detail of ceiling at north end of F17

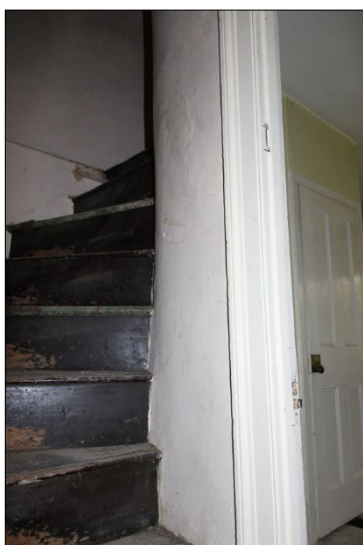
Photo S1: S1: bottom of stair to second floor (S01)

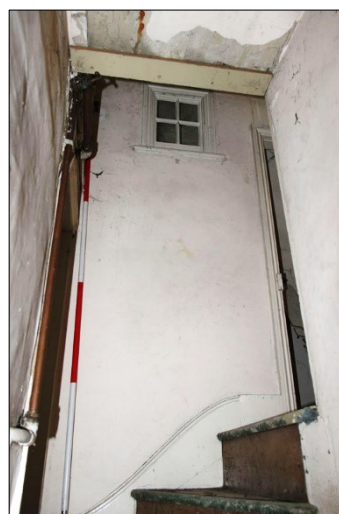
Photo S2: S1: top of stair in S01, leading to S01a, facing east

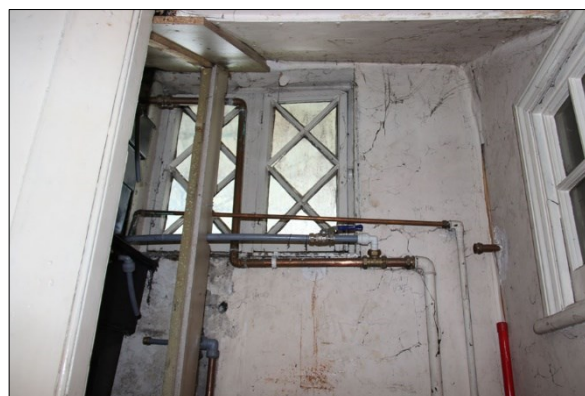
Photo S4: S1: windows above stairs, facing north

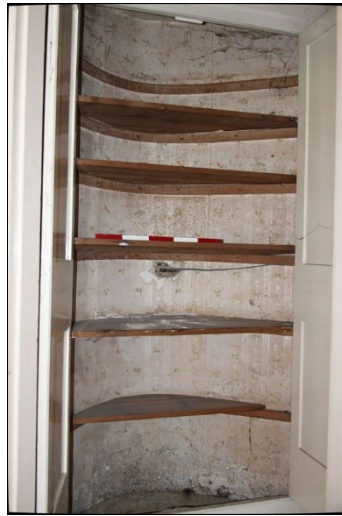
Photo S5: S1: curved-back cupboard outside S5, facing northwest

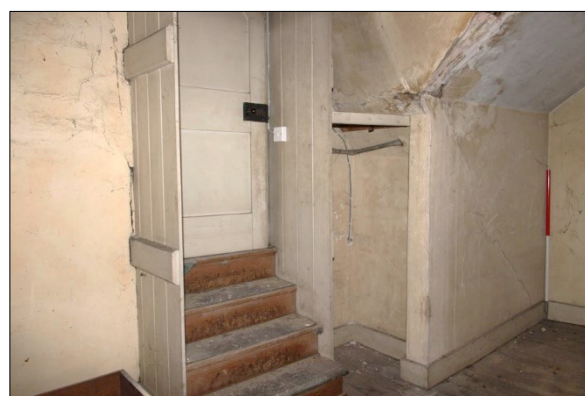
Photo S7: S2: south wall with steps to S01

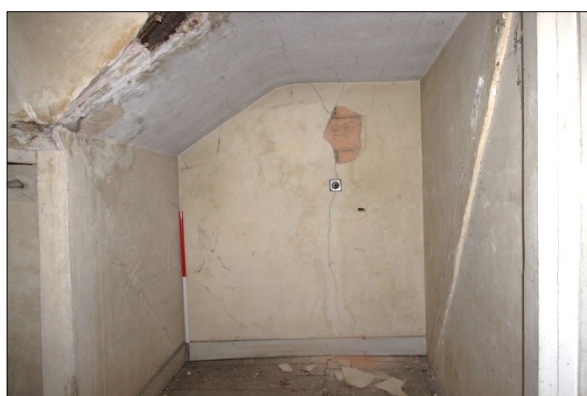
Photo S8: S2: west wall

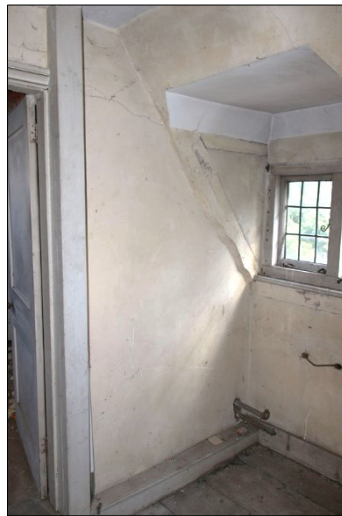
Photo S10: S2: northeast corner of room, facing northeast

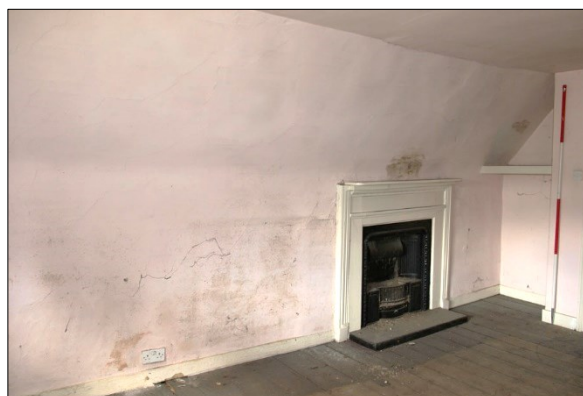
Photo S14: S5: west wall

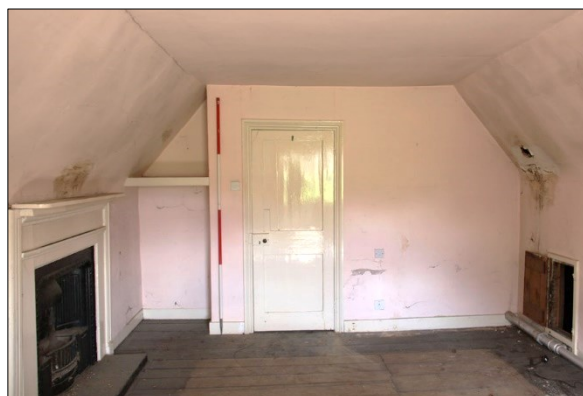
Photo S16: S5: north wall

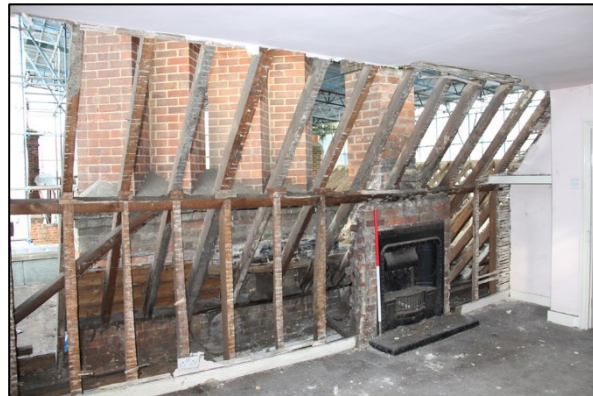
Photo S18: S5: west wall stripped

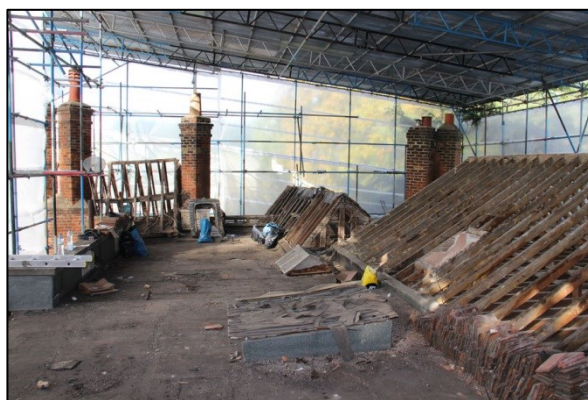
Project code: 482/NMW	Project: Abdale House, North Mymms	Location: Roof
<p>Roof 1-sawn and machine cut roof timbers (20 wide 35cm apart)', ridge board, purlin on southern side only. Square 4 stack chimney set into roof at the eastern end, red brick and cement with evidence of later repairs. Clay pots.</p> <p>Roof 2- sawn and hand hewn timbers (15 wide 40cm apart), pegged at ridge (Roof 1 ends inline with ridge), evidence of later repairs at northern end. Brace towards southern end purlins on either side with braces running across and the full length of the roof. Double chimney attached with evidence of modern repair, appears cement pointed with clay pots, over lapped partially but roof 3.</p> <p>Roof 3- Tiled on northern face still with hand made clay peg tiles, sawn timbers with evidence of reuse (with wooden pegs still in previous joints)'and later repairs, carpenters marks visible on most main timbers. Eastern end has been completely replaced with later timbers. Pegged joints along ridge visible.</p> <p>Roof 4- machine cut timbers (15 wide 34cm apart), nailed to ridge board, laths attached to inside.</p> <p>Roof 5- sawn and machine cut timbers (17 wide 40cm apart) nailed to a ridge board, purlins on either side where many timbers have joints which have failed over time (containing iron nails) and have either been replaced or other timbers added to support. Central brace shows evidence of reuse or that supports have been removed. Internal bracing runs along supporting the failed timbers. Double chimney at north end, red bricks (22x11x6cm) evidence of later repairs with cement repointing but with area of lime mortar still visible. Clay pipe protruding from the west stacks north side (appears to be a later addition). Double chimney stack on west side identical in construction to north stacks with more cement repointing visible and with modern clay pots.</p> <p>Roof 6- machine cut timbers (15 wide 40 cm apart), nailed to ridge board, evidence of later repairs to the north and south with braces at southern end and braces running along length of roof. Evidence on some reuse/previous joints visible. Floating chimney set into east side of roof, made of red brick (22x11x7cm) with lime mortar visible with later cement repairs, stack appears to have been repaired/replaced more recently, including whole brick replaced with cement. Clay pot. Large 4 stack chimney just attached to eastern side of roof appears that all four stacks have recently been replaced, red brick (23x10x7cm) and cement pointed. The base has evidence of a repair to the south of red bricks (22x10x7cm) and lime mortared while northern half is a mix of yellow (22x10x7cm) and red bricks with cement.</p> <p>Roof 7- sawn timbers (15 cmwide 40cm apart) with large central purlin with timbers joined in, even fence of later repair to the north, wooden pegged at ridge. Later dormer added with machine cut timber roof, cutting through purlin and surrounding timbers.</p>

Photo 235: R1: Roofs 1, 3 - 5, facing west

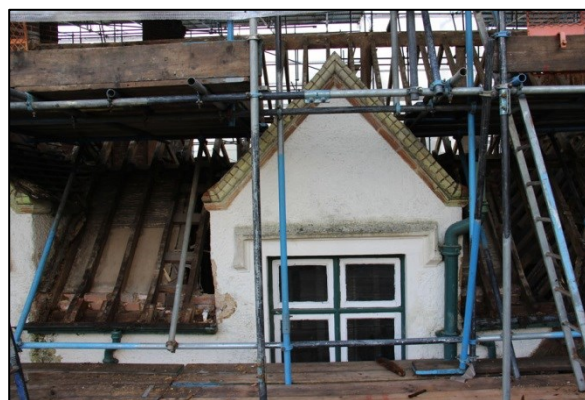
Photo 236: R2: Roof 1, facing southwest

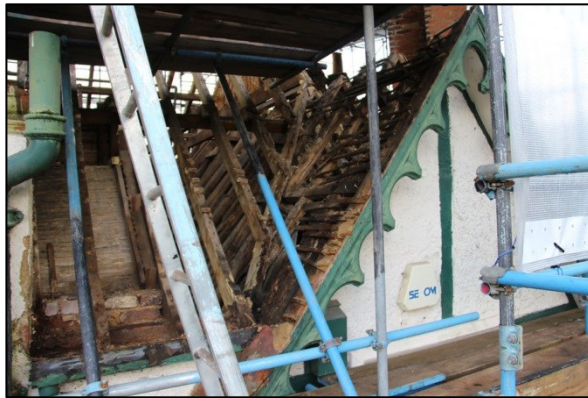
Photo 237: R3: Roof 1, facing southwest

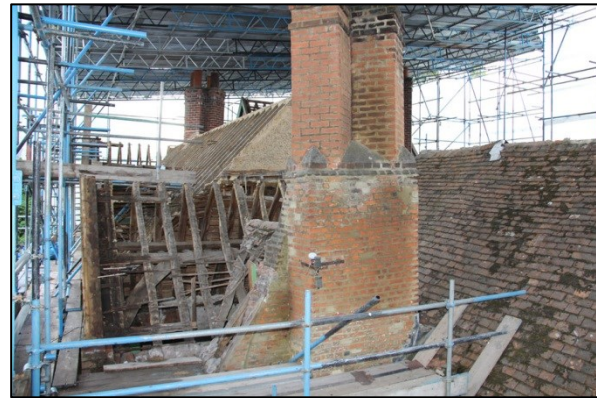
Photo 238: R4: Roof 2, facing east

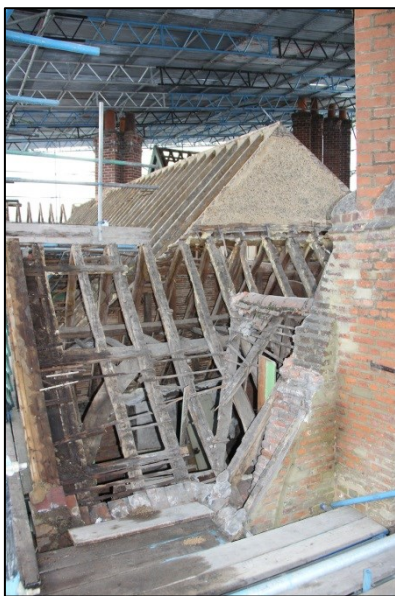
Photo 239: R5: Roof 2, facing southeast

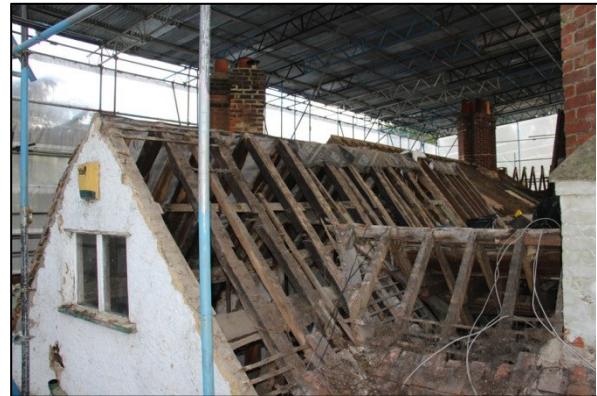
Photo 240: R6: Roof 3, facing northeast

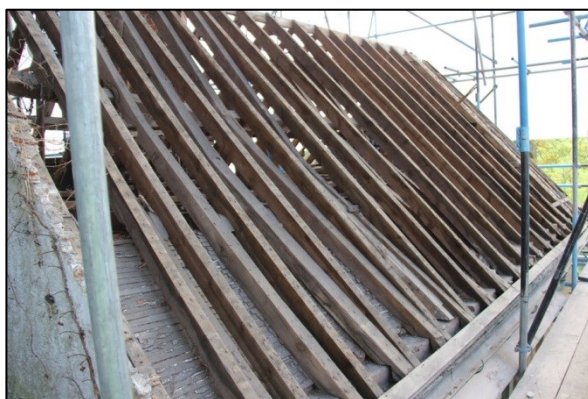
Photo 241: R7: Roof 5, facing southeast

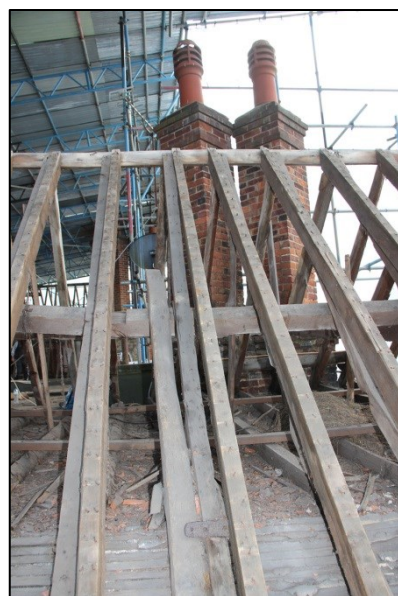
Photo 242: R8: Roof 5, facing east

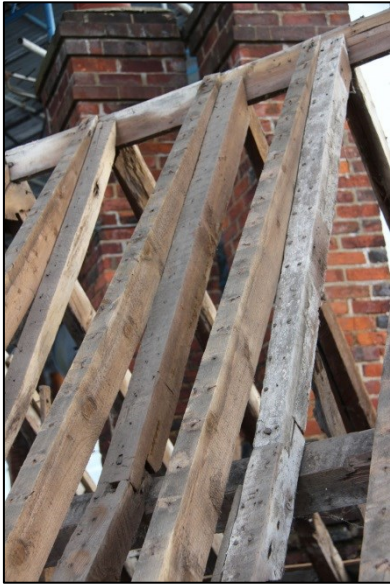
Photo 243: R9: Roof 5, facing east

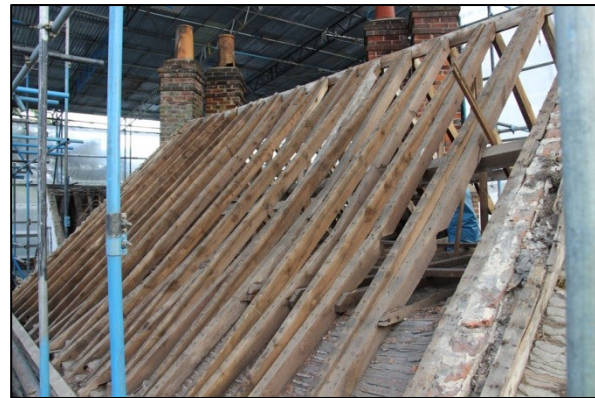
Photo 244: R10: Roof 5, facing northeast

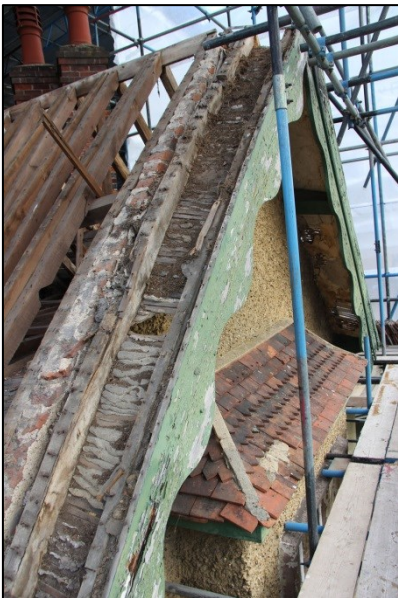
Photo 245: R11: Roof 5, facing northeast

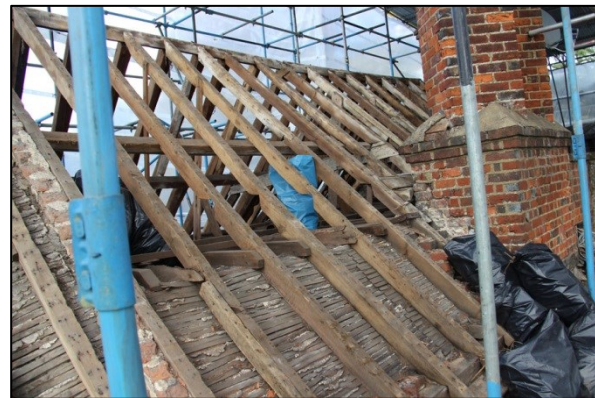
Photo 246: R12: Roof 5, facing northwest

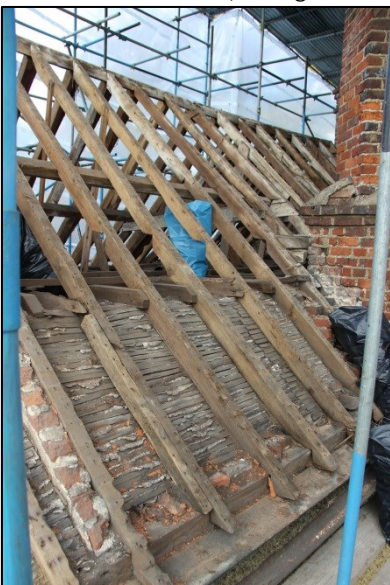
Photo 247: R13: Roof 5, facing northwest

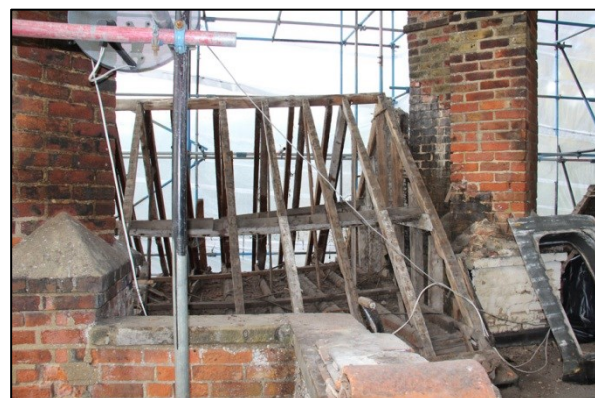
Photo 248: R14: Roof 5, facing west

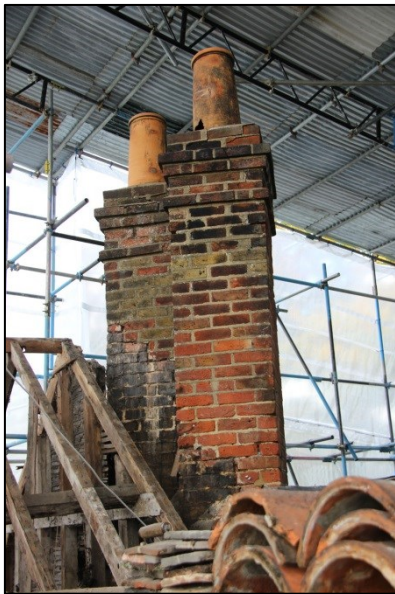
Photo 249: R15: Roof 5, facing northwest
