KDK ARCHAEOLOGY LTD

Historic Building Recording

Minsden Chapel

Scheduled Monument 1003543

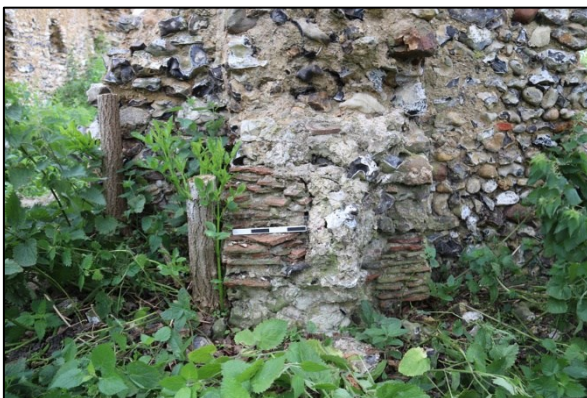
Roof tiles have also been used as walling material, to line some of the putlog holes and at the top of the window arch in the south wall between the voussoirs. These are largely isolated pieces, but the base of the buttress to the east of the south window has several courses of tiles. The base of the neighbouring buttress to the east is of floor tiles measuring 13 x 11 x 5cm and 10 x 10 x 5cm. Some roof tile is also present at the back of the buttress and also on the buttress at the east end of the nave. Whereas the tile within the walling is likely to have been spolia, that within the buttress is clearly later repair.

Plate 21: Tiles used in a southern buttress (31)

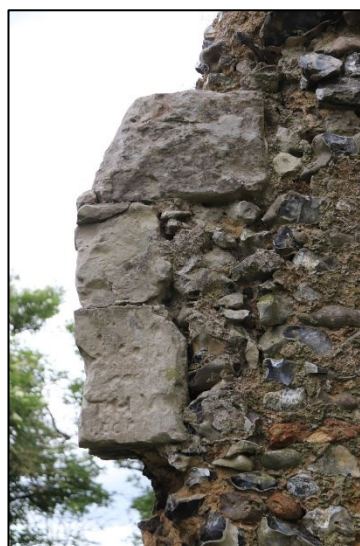
Shot 30: Southeast diagonal buttress detail

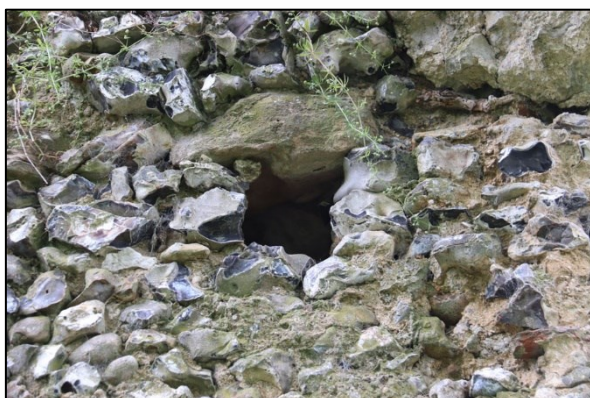
Shot 33: Putlog hole in south wall

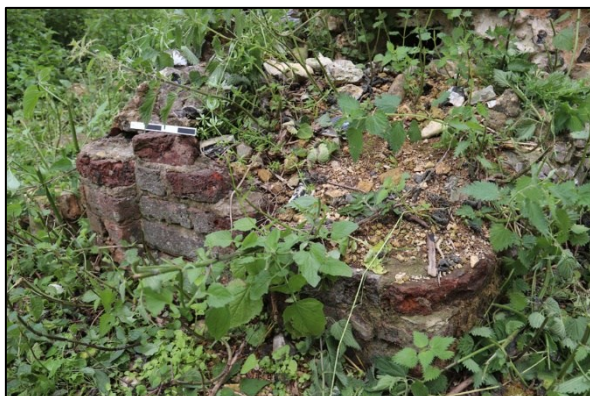
Brick has also been used within the structure; as a repair to the door opening in the north wall, and to construct a belfry in the southeast corner of the nave. The bricks within the door opening are c.13 x 10 x 6cm although some are only 5cm high and others are bullnosed. They are poorly puddled reds, with a few stone inclusions but no spanish and appear to be 18th century. The mortar is hard and cement based, which would suggest that the bricks have been re-used. The bricks used for the belfry could only be studied in detail through the camera lens and photograph. They are also handmade reds, with no apparent inclusions and appear to be c.5cm high. There is a narrow arched opening 4 courses high and roughly 29cm wide more clearly evident from within the church. The bricks are handmade reds and the return wall to the left of the opening is bullnosed. Bricks have also been used in later repairs to the south wall.

Shot 48: Brick base to door opening

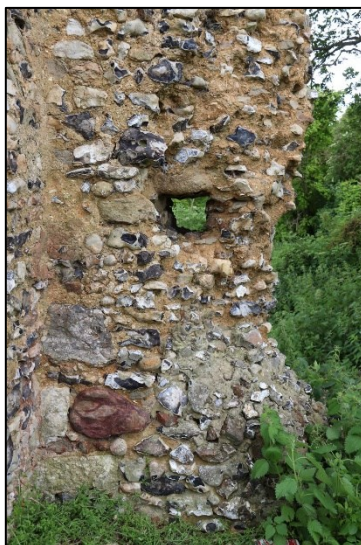
Plate 26: Brick repair work on south wall (66)

| Shot | Date | View | Subject |
|---|---|---|--|
| 66 | 22.06.21 | S | Brick repairs at the top of the freestanding section of south wall |

Shot 66: Brick repairs at the top of the freestanding section of south wall

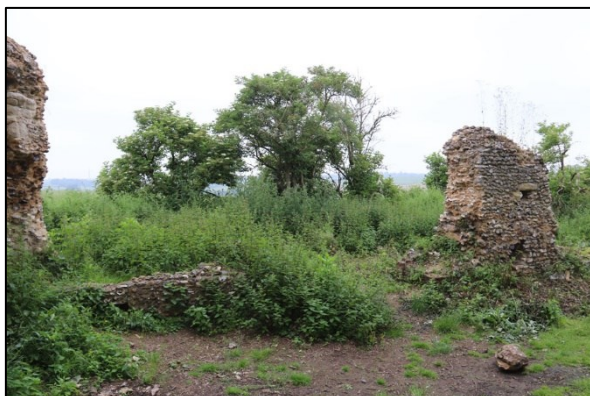
Shot 12: North wall of nave & remains of chancel arch

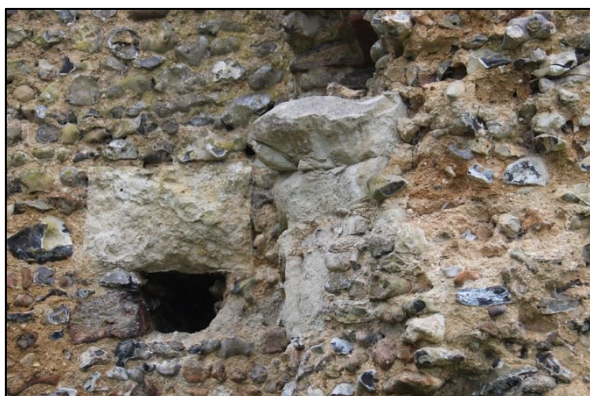
Shot 17: Remains of window tracery in north wall & putlog hole in west wall
