## Historic Building Watching Brief

Minsden Chapel

Langley

Scheduled Monument 1003543

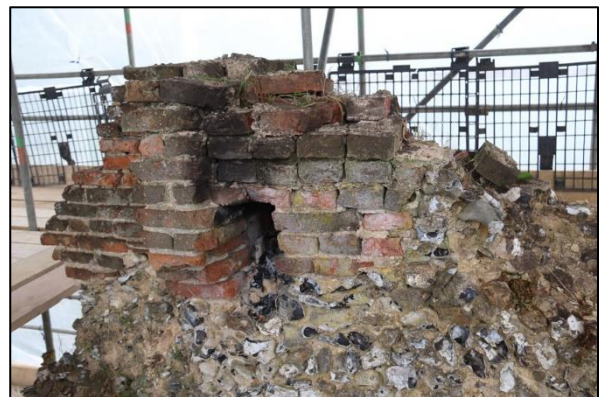
**Plate 2:** Bellcote from the northeast

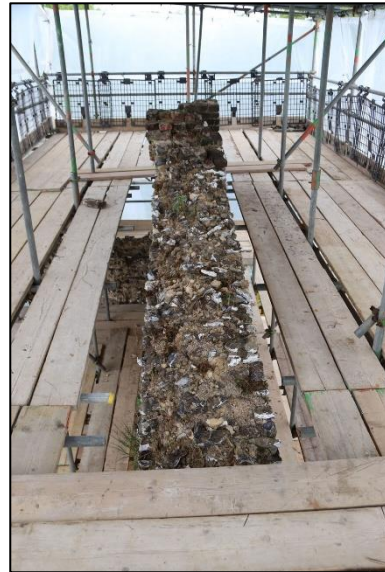
**Plate 4:** Wall and bellcote from the north

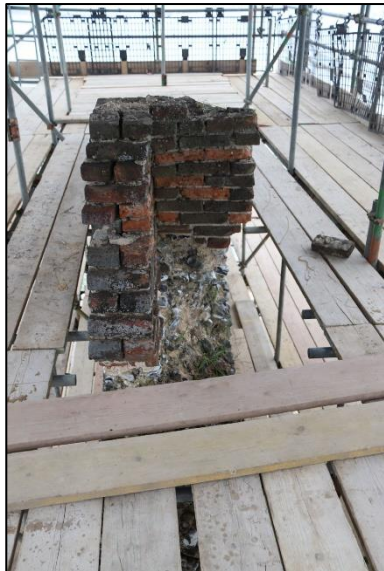
**Plate 5:** Bellcote from the south

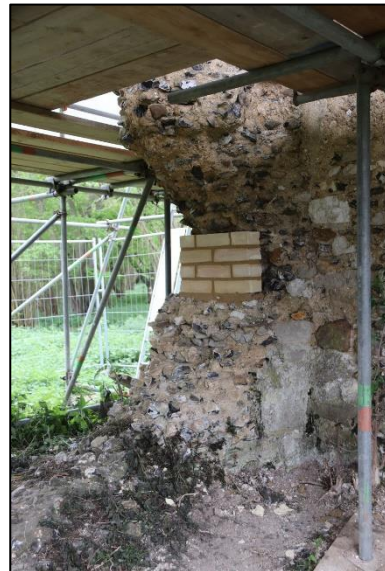
**Plate 12:** West side of south nave wall opening with sample brickwork from the northeast

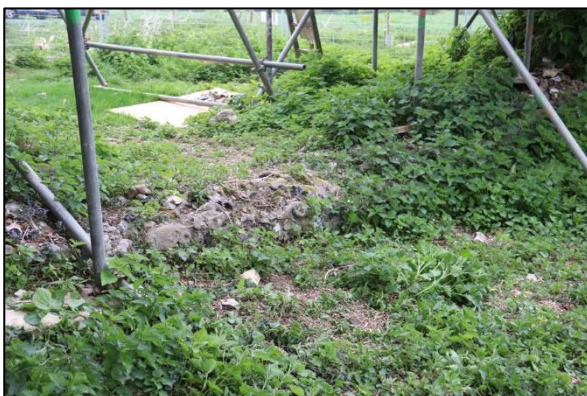
**Plate 13:** South chancel wall from the southwest

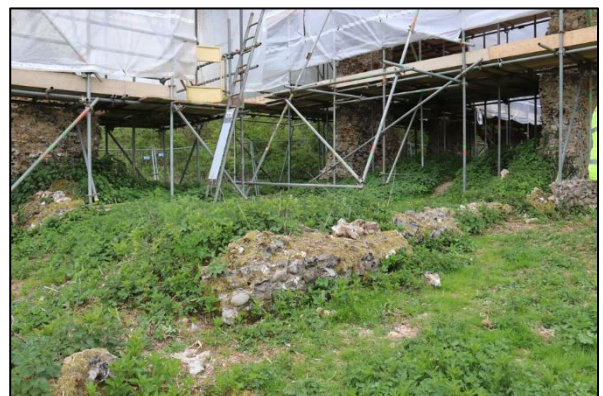
**Plate 14:** North chancel wall from the northeast

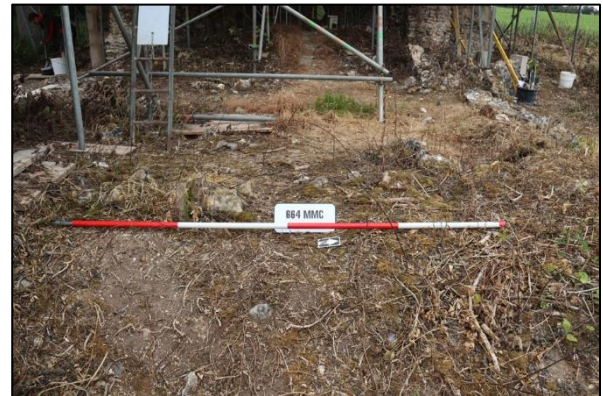
**Plate 4:** East wall from the east

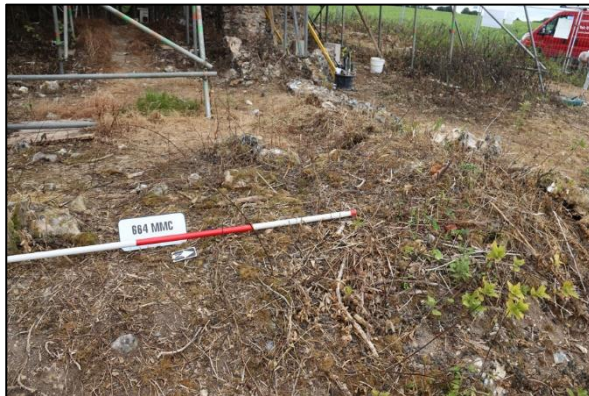
**Plate 5:** North and east walls from the southeast

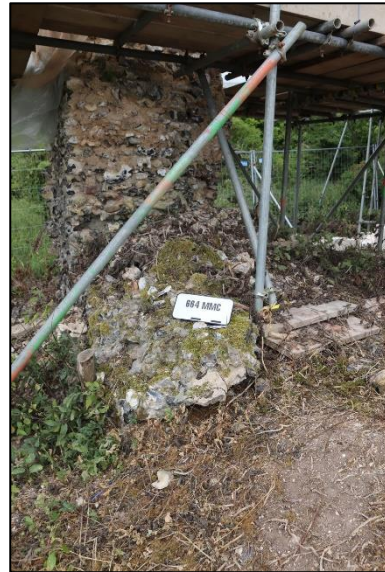
**Plate 6:** Southeast chancel buttress from the northwest

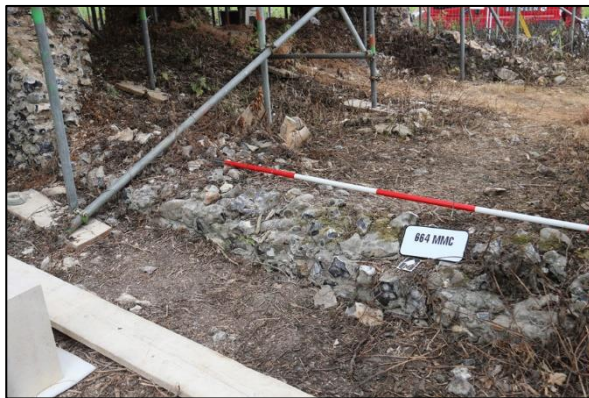
**Plate 7:** South chancel wall from the southeast

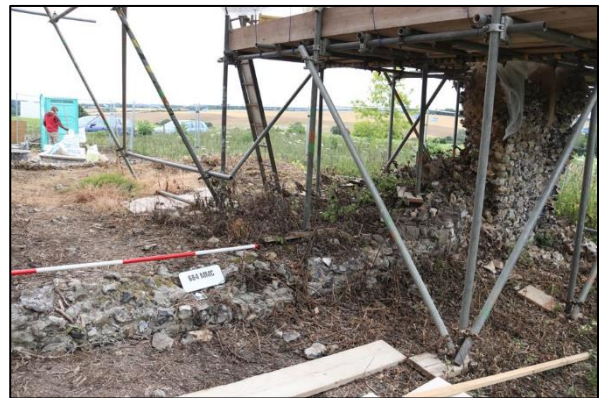
**Plate 8:** South chancel wall from the southwest

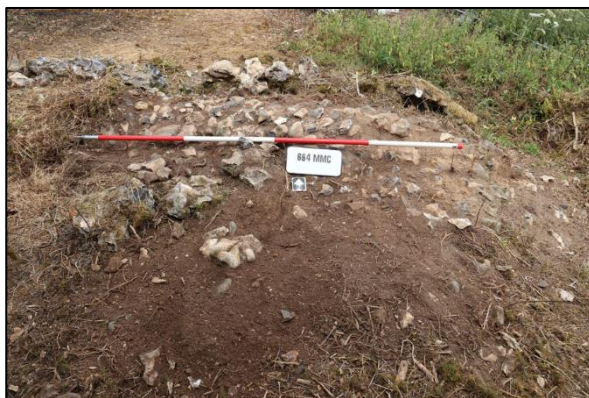
**Plate 9:** East end of north chancel wall from the south

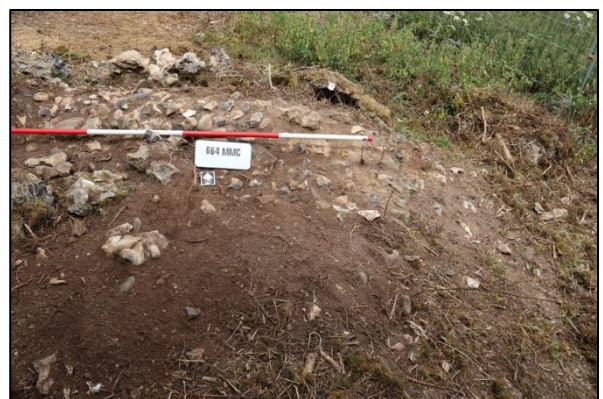
**Plate 10:** East end of north chancel wall from the south

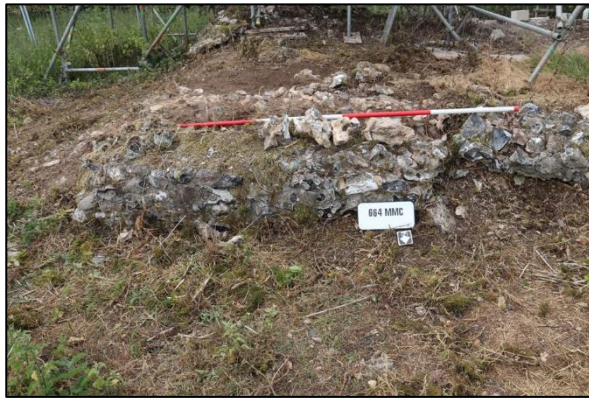
**Plate 11:** East end of north chancel wall from the north

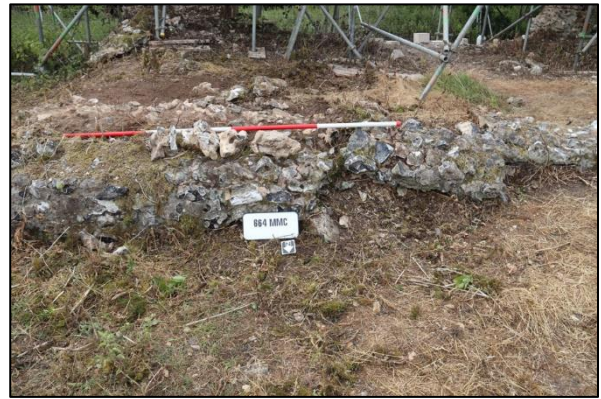
**Plate 12:** East end of north chancel wall from the north

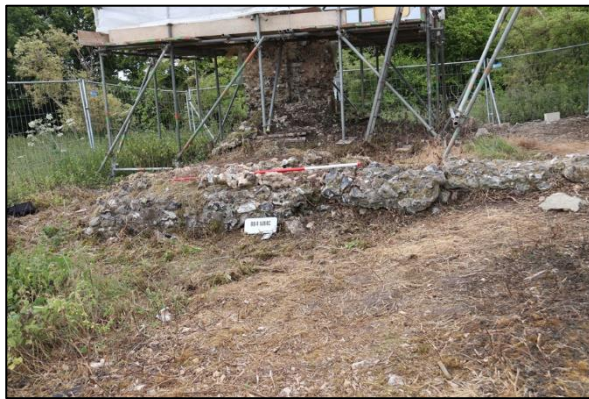
**Plate 13:** East end of north chancel wall from the north

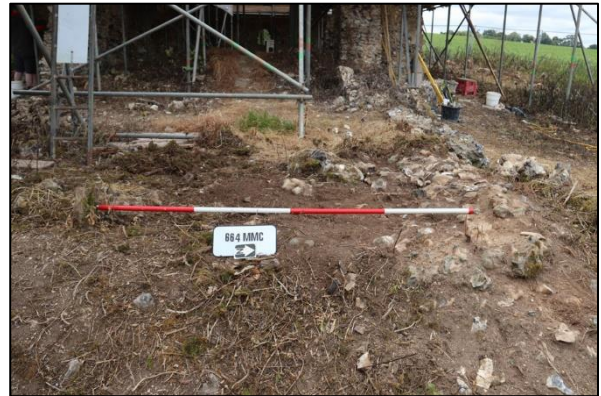
**Plate 14:** East end of north chancel wall from the east

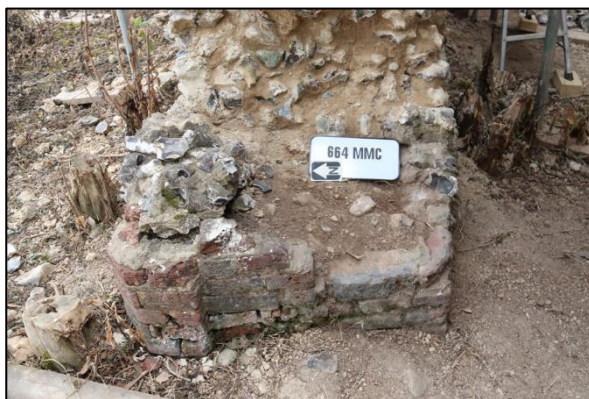
**Plate 15:** Opening in north nave wall from the west

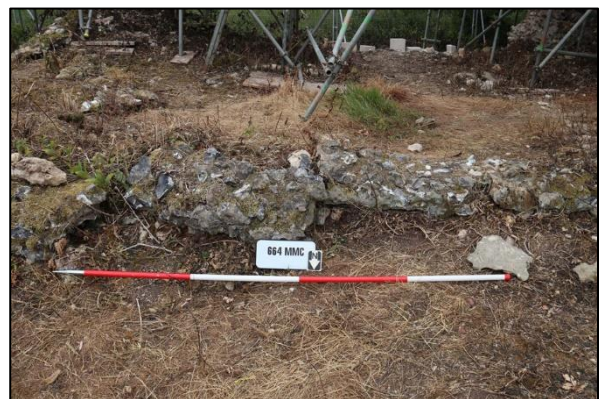
**Plate 16:** East end of north chancel wall from the north following preliminary weed clearing

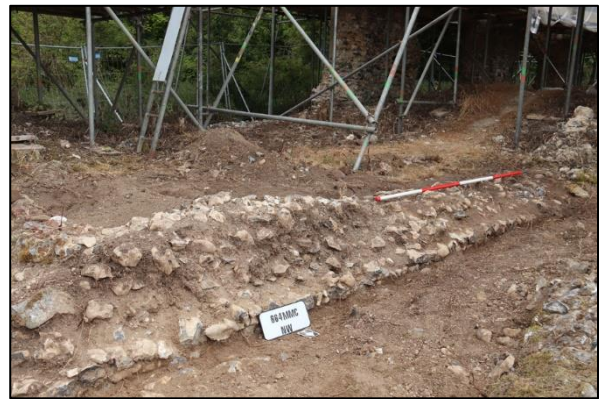
**Plate 2:** North chancel wall from the northeast

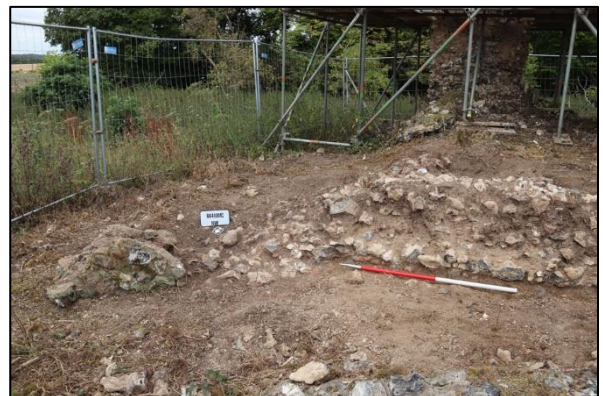
**Plate 4:** North chancel wall and buttress from the northeast

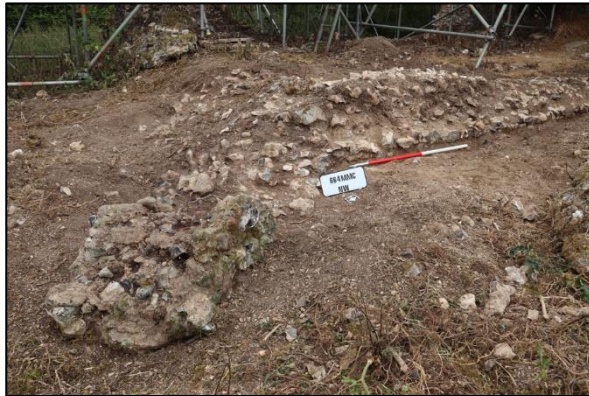
**Plate 5:** North chancel wall and buttress from the northeast

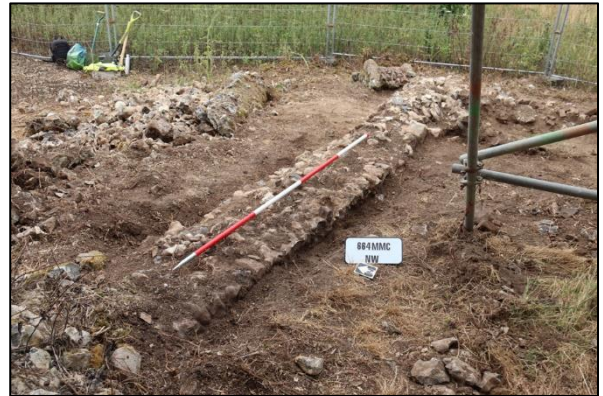
**Plate 6:** North chancel wall from the southwest

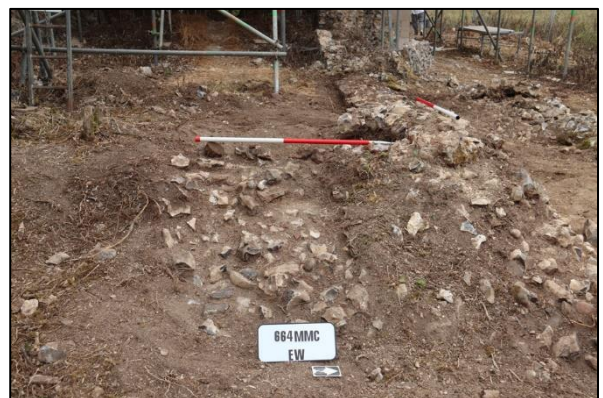
**Plate 9:** North and east chancel walls from the west

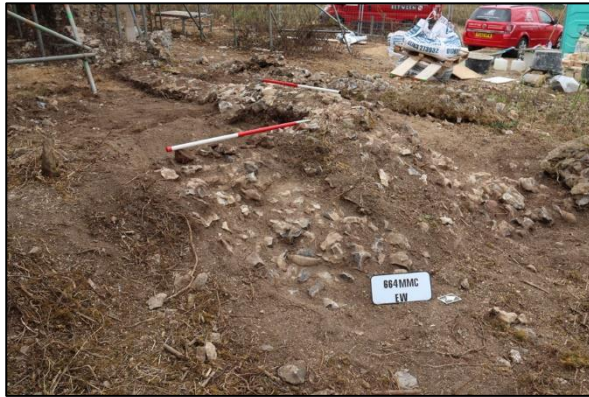
**Plate 10:** North and east chancel walls from the east

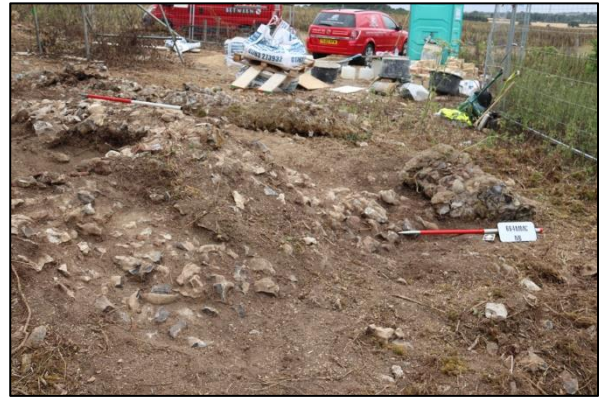
**Plate 11:** North and east chancel walls from the southeast

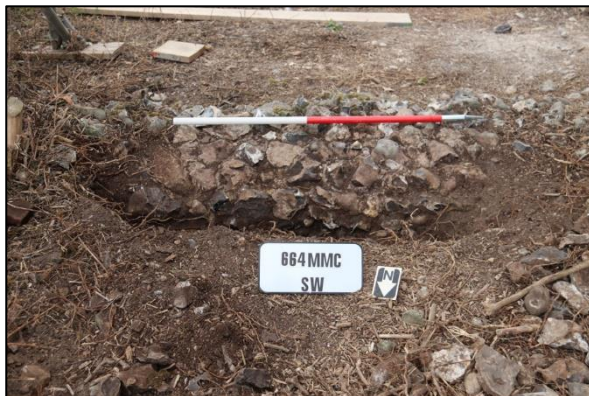
**Plate 14:** Northeast chancel buttress and adjacent chancel walls from the northeast

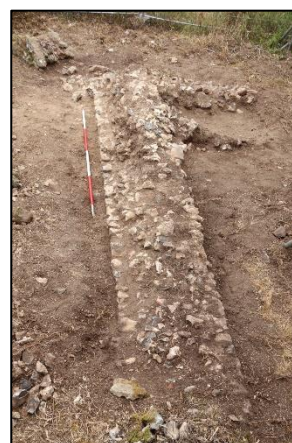
**Plate 17:** South chancel wall from the south

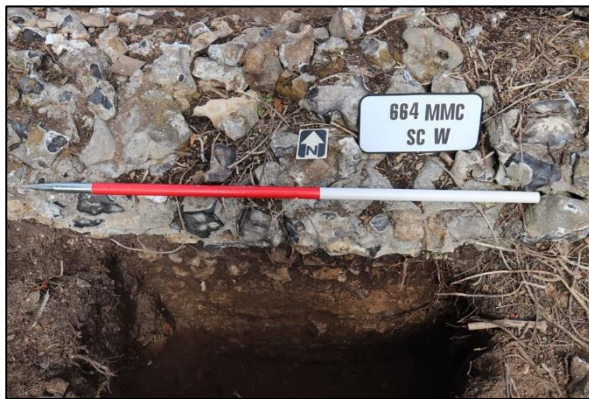
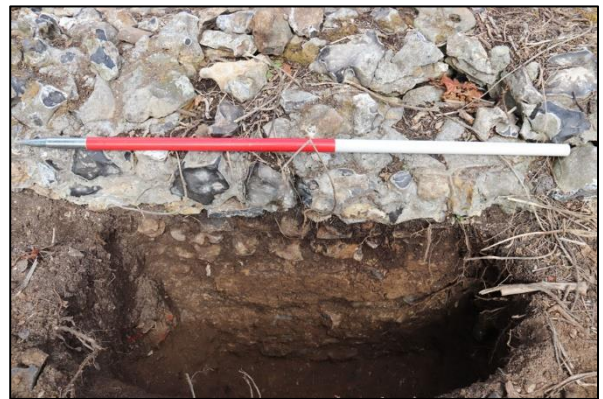
A slot measuring 0.90m x 0.40m was excavated to a depth of 0.80m from the top of the wall along the outside of the chancel wall to ascertain the depth of the foundations (Fig. 5; Plates 19-20). The fill was made up of building debris consisting of flint, roof tiles and brick fragments. The foundations consisted of the same mix of building materials as elsewhere, including some fragments of rendered stone approximately 0.30 from the base of the pit. The rendered area was 20cm high and covered only the stones, which were c. 0.50m long, which could suggest that these have been re-used. However, it is also possible that this indicates the original ground level.

**Plate 19:** Test pit along chancel wall from the south

**Plate 20:** Test pit along chancel wall from the south

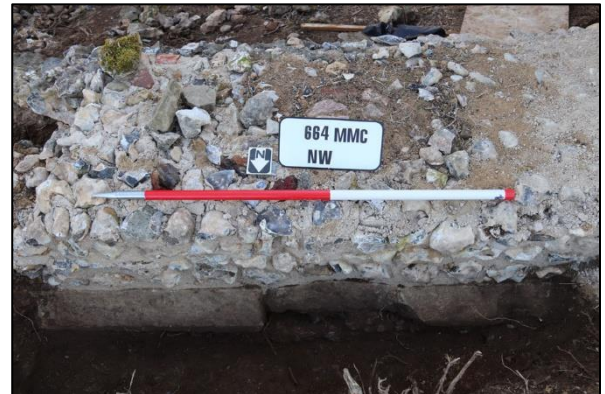
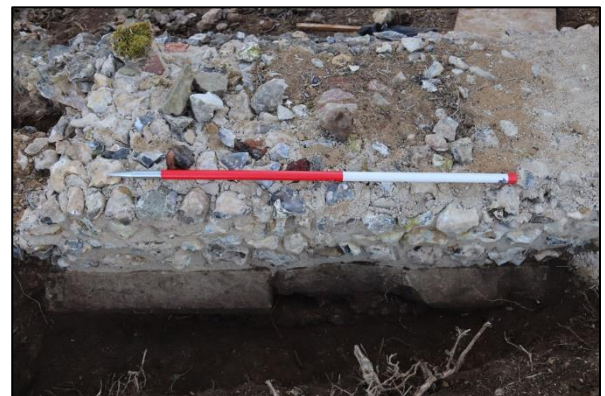
Three large moulded stone pieces were revealed to the west of the opening and c.0.30m below the top of the wall. On further investigation they were found to be of Totternhoe Stone and appeared to form part of a drip ledge. The stones were 0.74m, 0.43m and 0.55m (min) long and 0.20m deep (Fig. 4). Other worked pieces of stone were also present in the north nave wall between the gable end and the door opening, although none of the others were moulded. The varied building materials exposed in this part of the chapel included 4 courses of tiles immediately above the basal course of ashlar stone in the return wall immediately adjacent to the moulded stones (Plate 25).

Plate 24: Moulded stones in the north nave wall

Plate 25: North nave wall and moulded stones from the northwest

Plate 26: Detail of moulded stones from the north in the north nave wall

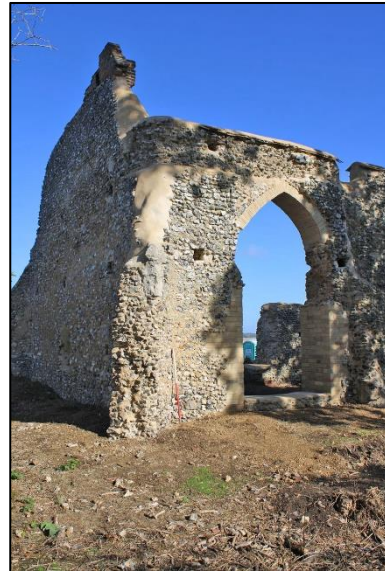
**Plate 1:** Chapel from the northeast

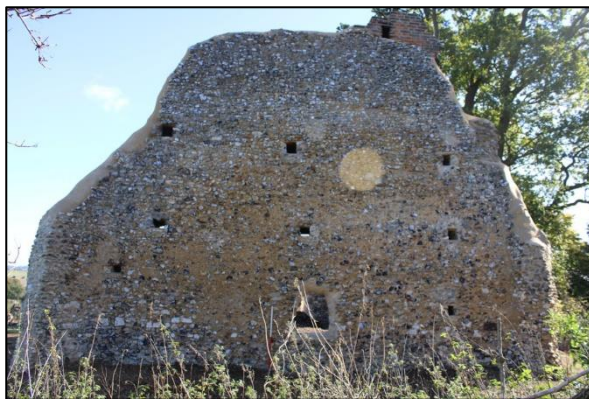
**Plate 2:** Southwest corner of the nave

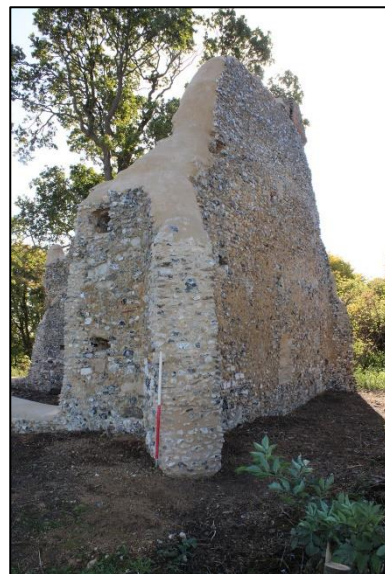
**Plate 3:** External face of the west wall

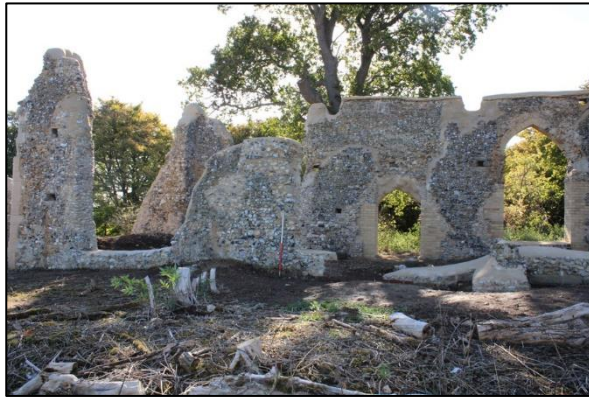
**Plate 4:** Northwest corner of the nave

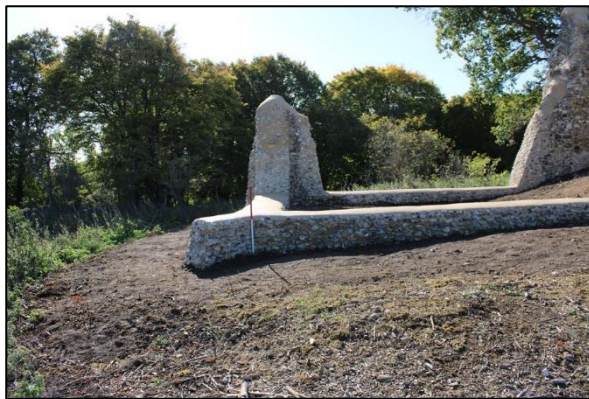
**Plate 6:** View of the nave from the northeast

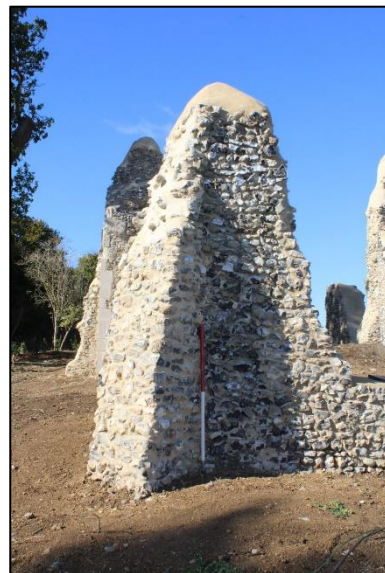
**Plate 7:** Chancel from the north

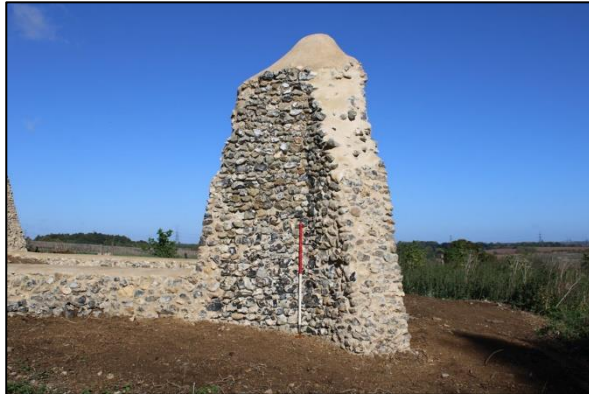
**Plate 8:** Southeast chancel buttress from the east

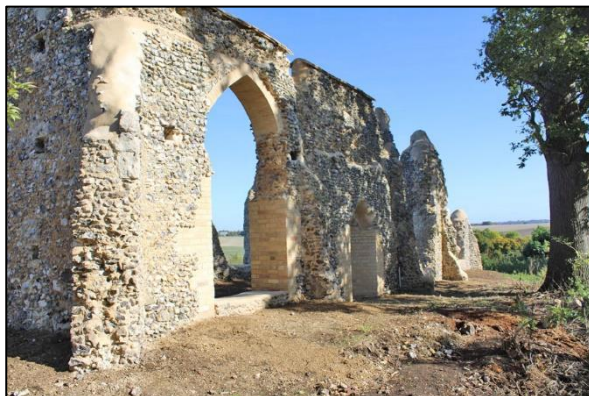
**Plate 12:** South nave wall and southwestern buttress

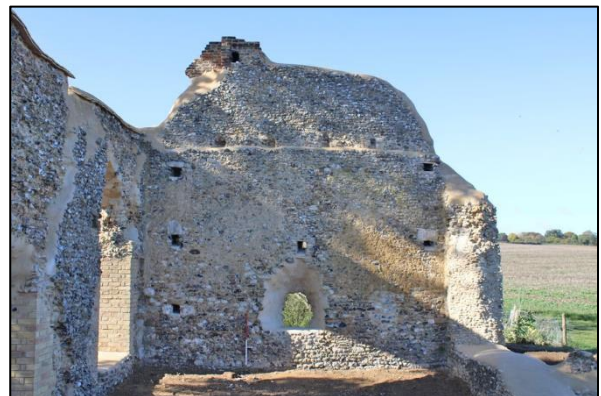
**Plate 13:** South wall from the southwest

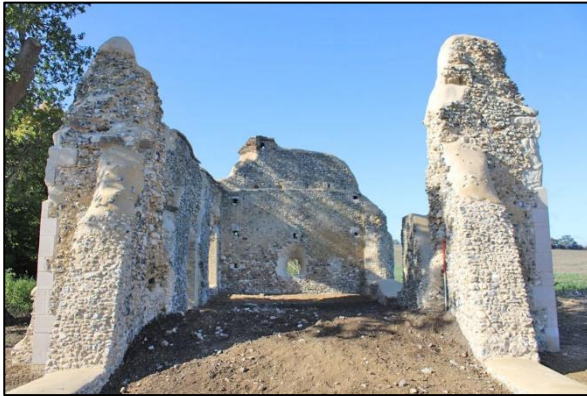
**Plate 14:** West wall from the east

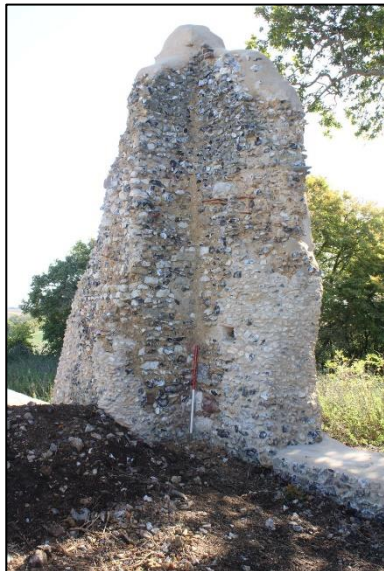
**Plate 16:** South wall at the nave/chancel interface from the north

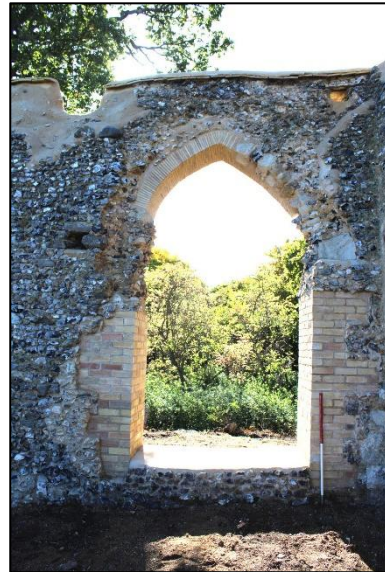
**Plate 19:** South nave wall from the northeast

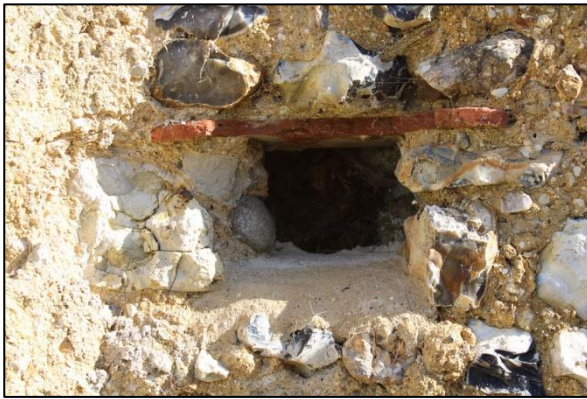
**Plate 24:** Detail of putlog hole in the west wall from the west

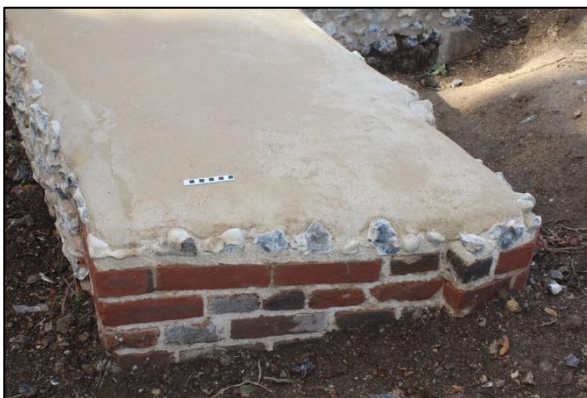
**Plate 28:** Detail of east side of the north nave wall opening from the southwest

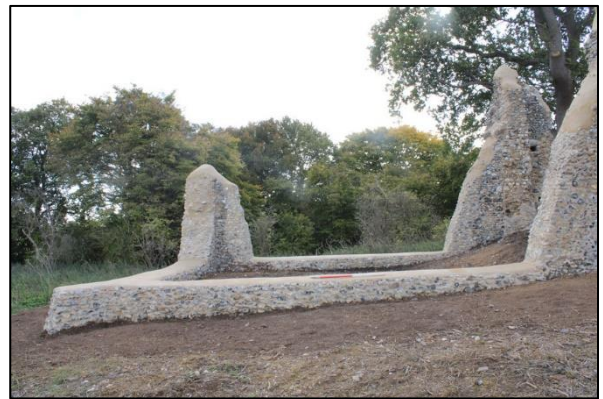
**Plate 39:** North nave wall from the northwest

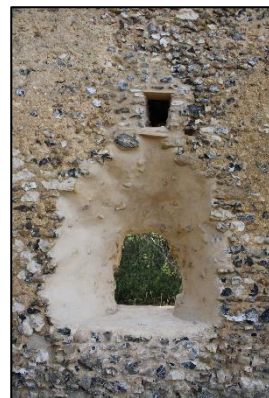
**Plate 41:** Chapel from the east

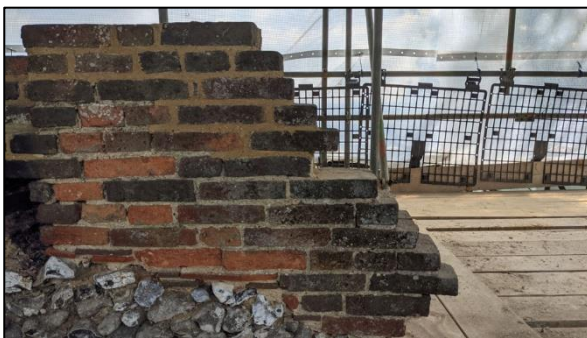
**Plate 3:** Detail of southern side of west wall of the bellcote

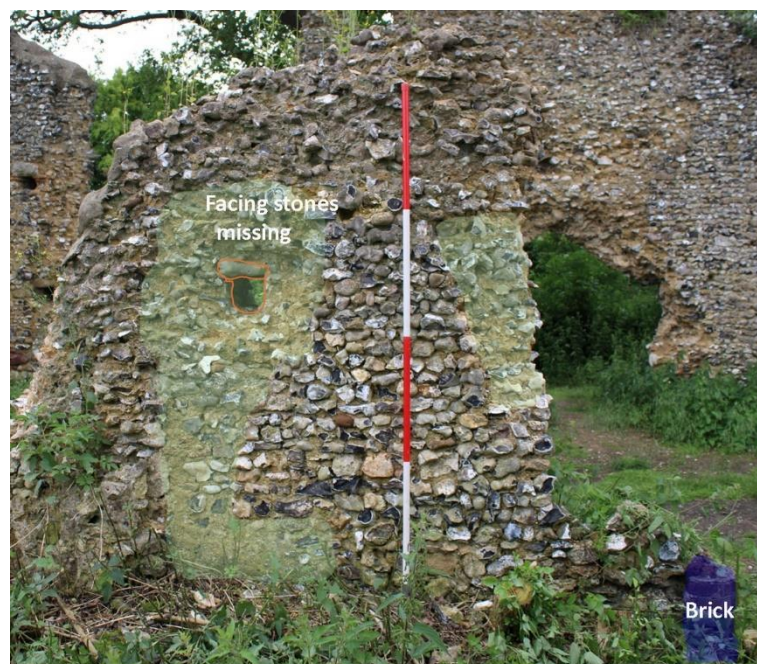
**Figure 35:** North nave wall exterior, centre (before)

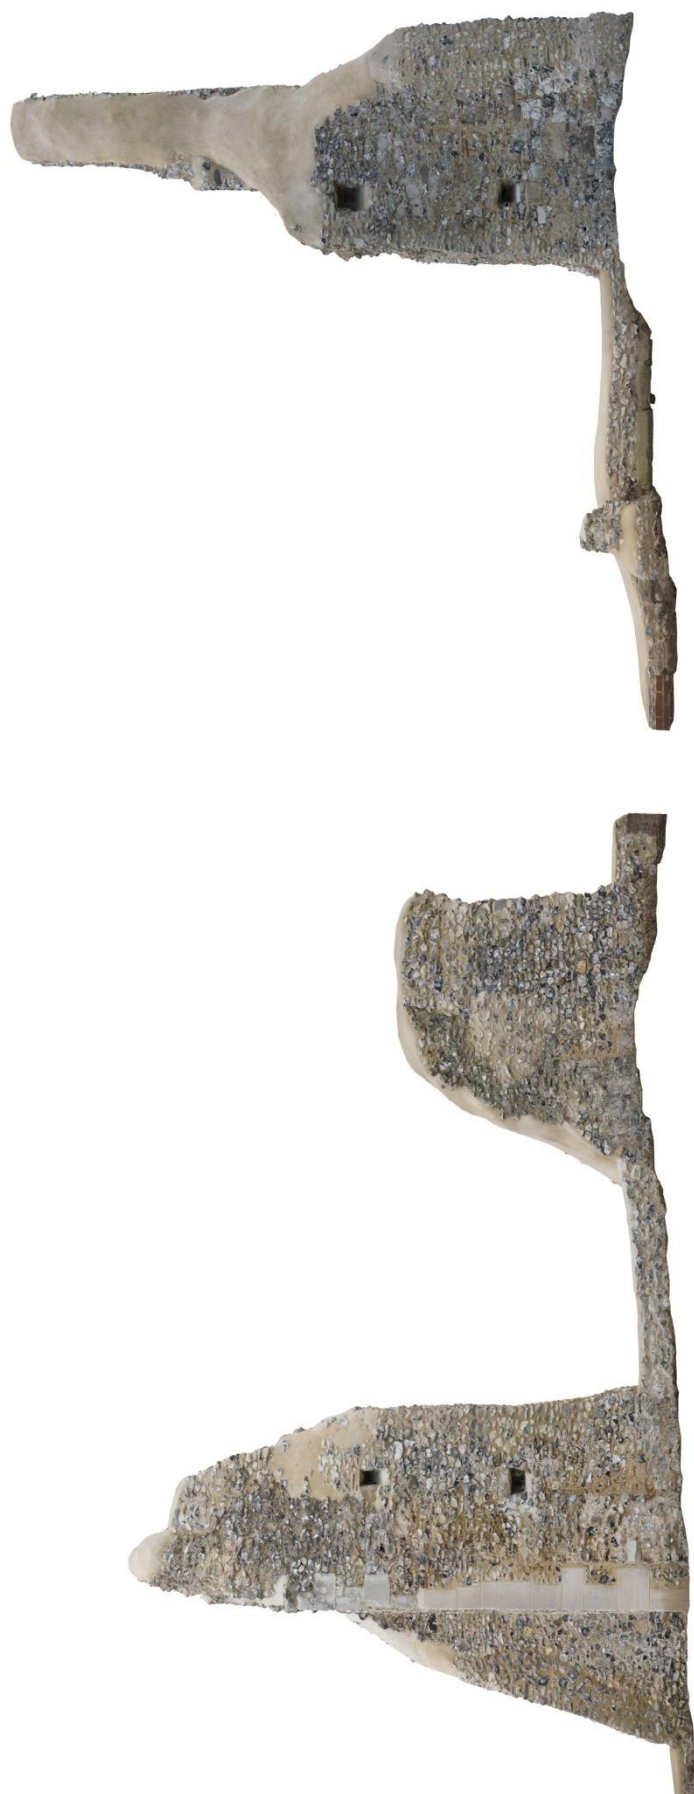
**Figure 36:** North nave wall exterior (after)

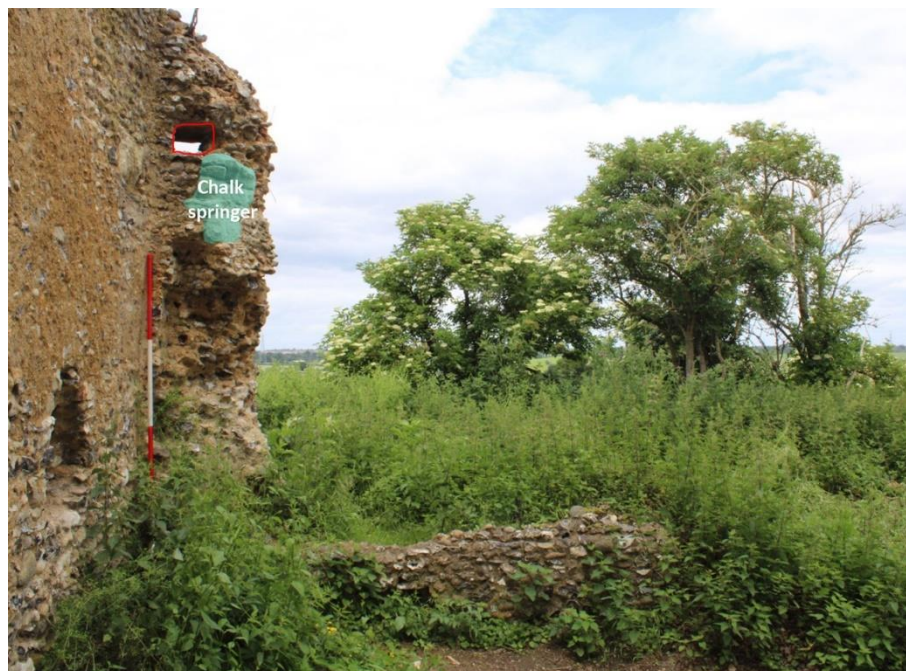
Figure 37: North nave wall interior, west (before)

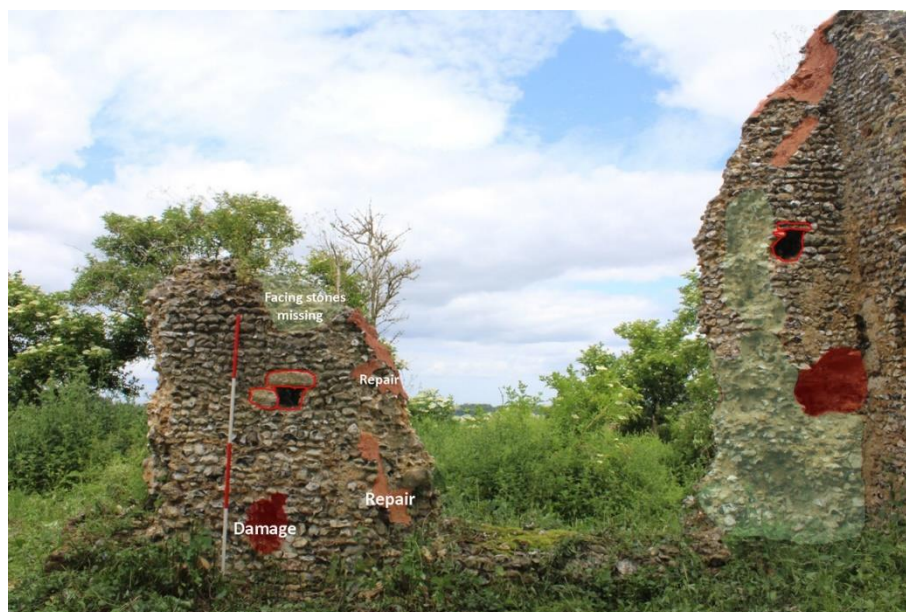
Figure 38: North nave wall interior, east (before)

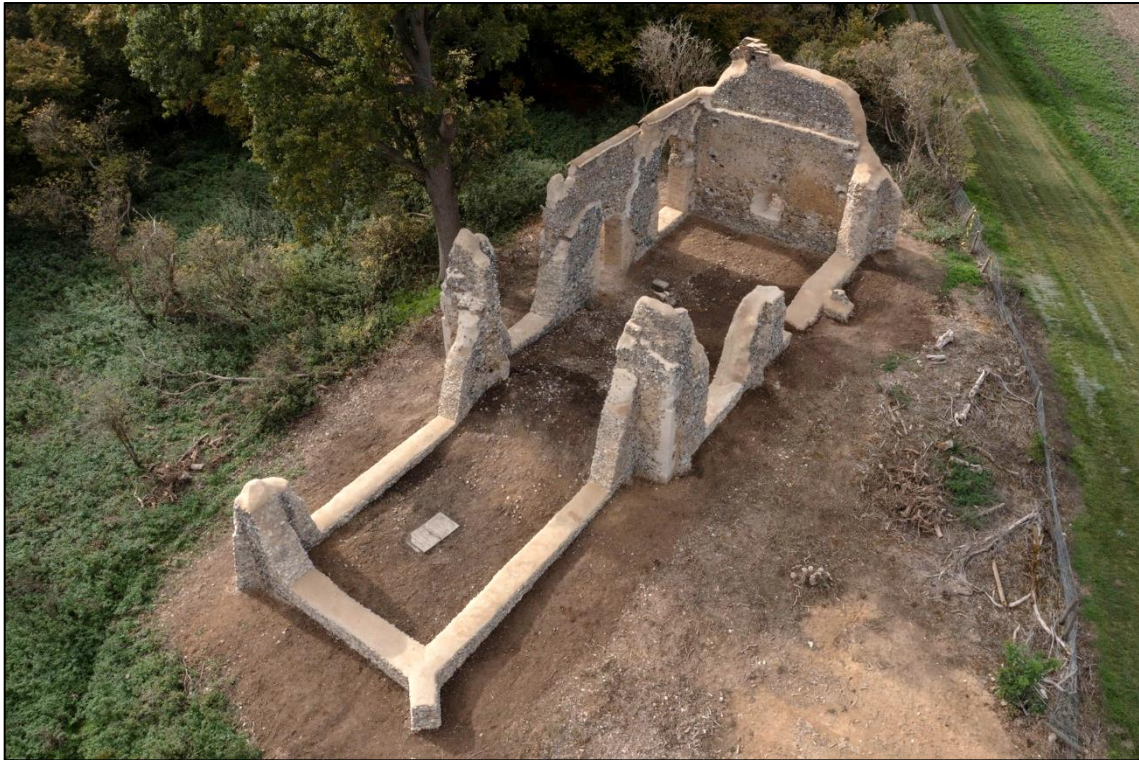
**Figure 41:** Minsden Chapel, the completed works  
*(Courtesy of AerialCam)*
