**Historic building recording
at an outbuilding at The Old Vicarage
Husborne Crawley, Bedfordshire
Level 2
February 2022**

Report No. 22/021

THE OLD VICARAGE, HUSBORNE CRAWLEY

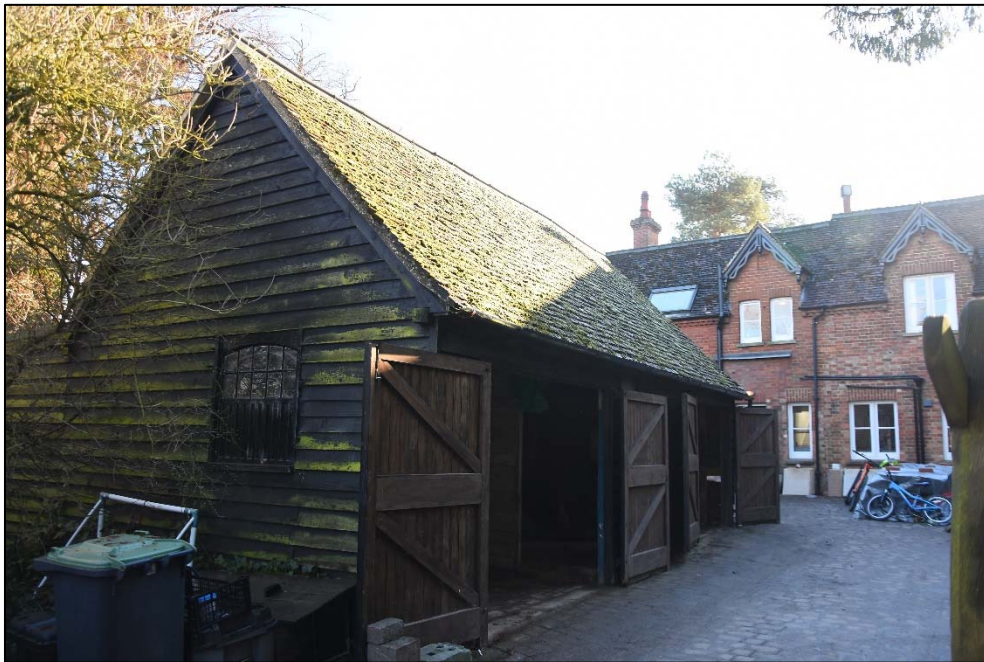
The building is timber-framed with weather-boarding to the exterior and a clay peg-tile roof (Fig 3). The historic ranges are L-shaped in plan with a pitched roof extending east-west and a return to the east end, which extends northwards. This has then extended with a flat-roof range to the north-west infilling the return and creating a rectangular form.

The outbuilding upon entering the site with the Vicarage behind, looking east Fig 3

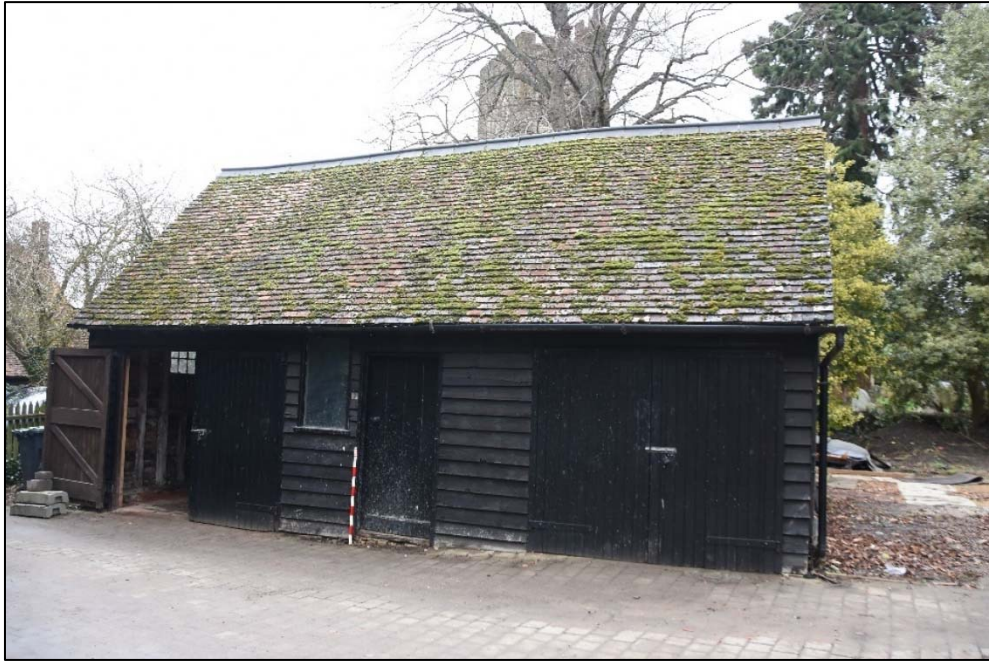
This elevation faces the driveway to the west of the main house and comprises the principal elevation of the building. There are two large double doors flanking a central single door with a window to the west (Fig 4). The weather-boarding, where measured along this face, were between 12.75cm and 17cm wide and comprised softwood. Above the peg-tile roof rises with much moss to blue ridge tiles.

The single central door is boarded with a simple moulded frame, though heavily painted, and retains a Bakelite-style doorknob and keyhole. The threshold timber is much weathered and below bricks are exposed. The window to the west has a heavily painted timber frame with simple sill and comprises modern safety of a single fixed light. Both double doors are timber, boarded with modern ironwork. Both examples sit on pintles with long strap hinges, but their pintle brackets differ.

South elevation of the outbuilding, looking north Fig 4

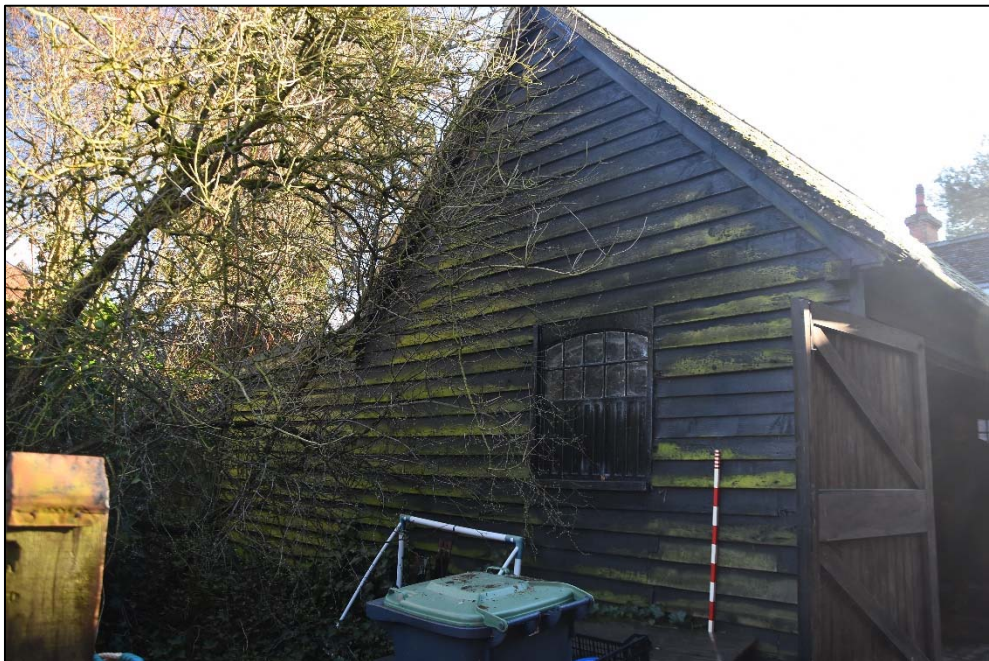
This end is all weather-boarded with a straight joint to the north where the front range and flat-roof extension meet (Fig 5). There are bricks exposed to the base which are of poor red/orange fabric with a buff mortar. There is a single window to the front range, of timber with a surround and sill. It has upper multi-light glazing below a cambered arch and a lower timber sliding grille. There is a matching example to the east gable end which has been previously called a Duke of Bedford window.

West elevation of the outbuilding, looking east Fig 5

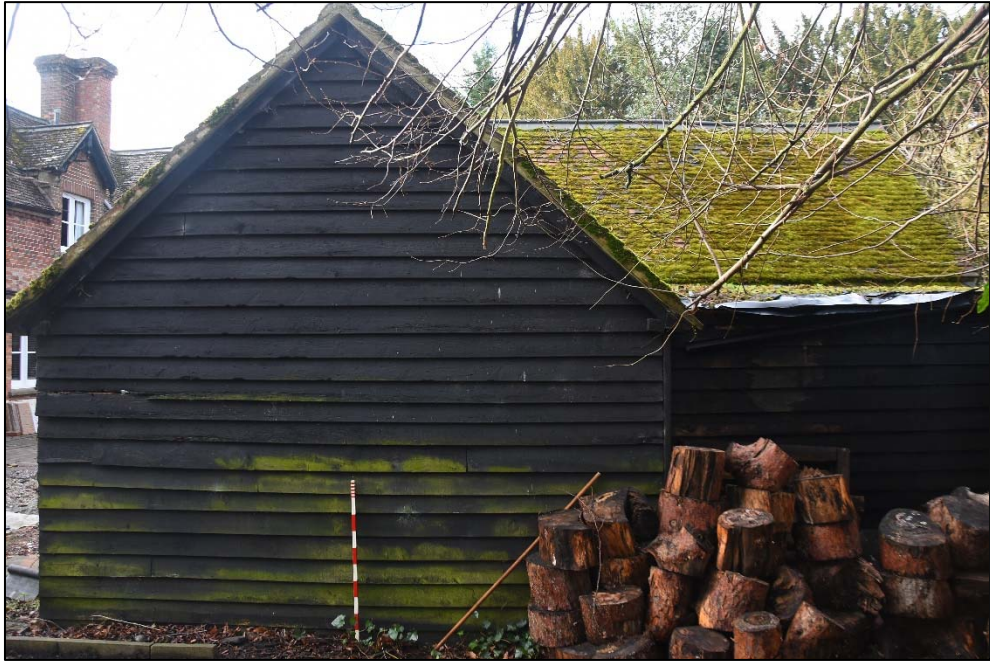
This elevation comprises the end gable of the north range, and flat-roof outshot elevation (Fig 7). Both are weather-boarded and plain. The boards here measure between 11.75cm-14cm in width and are heavily painted. The lower boards have evidence of straight mechanical saw marks, but there are some circular examples too.

The north elevation of the outbuilding, showing the north range and flat-roof outshot, looking south Fig 7

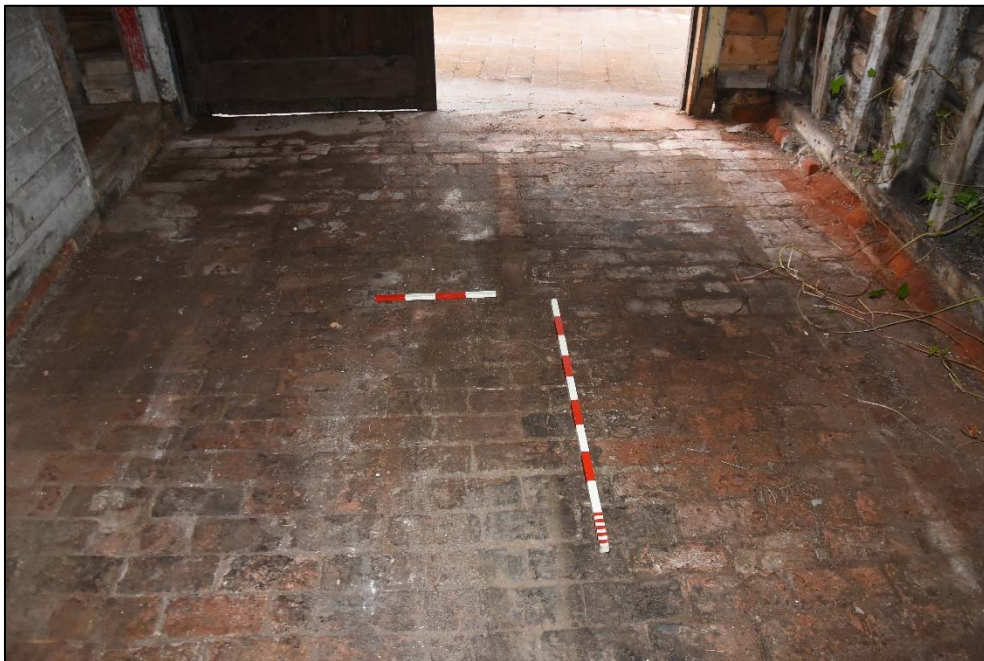
Store A lies to the west and is entered via one of the wide double doors seen on the south elevation. Upon entry from the exterior there is a concrete threshold but the remainder of the floor comprises red bricks laid flat with some minor damage (Fig 8), the bricks measure 22cm by 10.5cm (8½inches by 4inches). There is a timber-frame stud wall to the west with a window, a weather-boarded wall to the east which gives access into the adjacent Store B, and the north wall has been removed to allow access into the flat-roof Store E.

The brick floor to Store A, looking south Fig 8

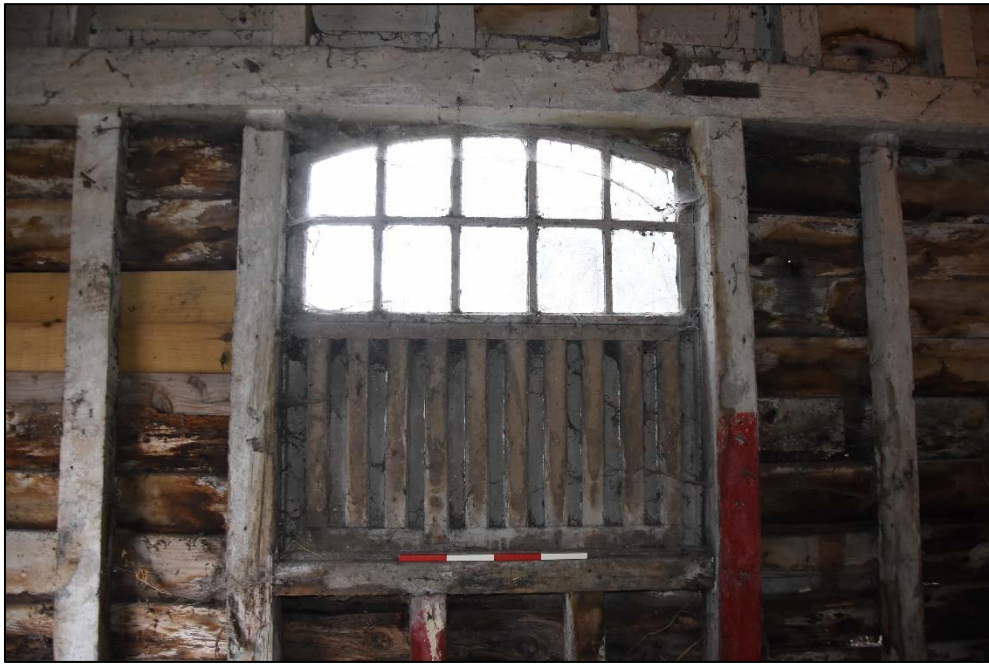
The window to the west wall of Store A, looking north-west Fig 11

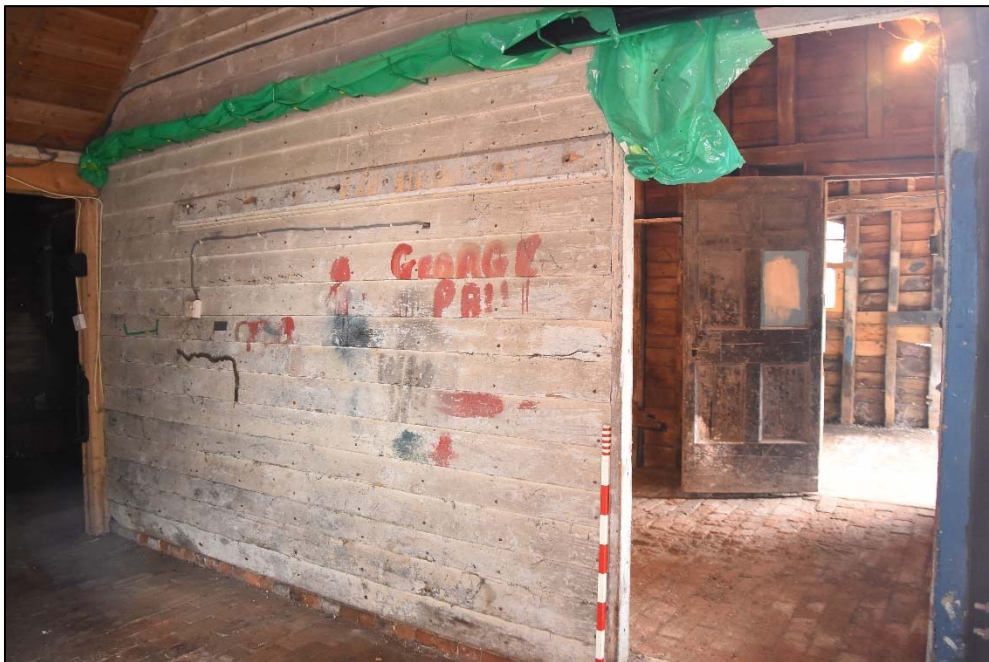
The east wall comprises weather-boarding that has been white-washed and retains little of interest (Fig 12). This sits above a course of red bricks. To the south a single doorway gives access into Store B, which has a higher floor level.

East wall of Store A with weather-boarding and access into Store B, looking north-east Fig 12

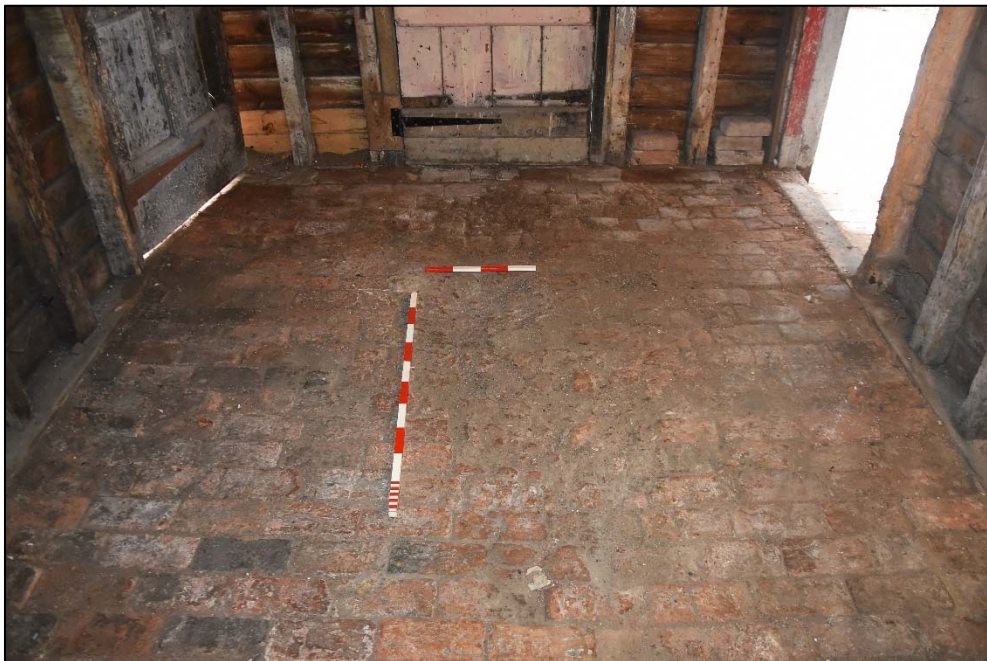
Store B is the central area accessed via the single door seen on the south elevation, and via its adjoining Stores A and C. The floor comprises red bricks laid flat which measure 21.5-22cm by 9.5-11cm (8½inches by 3¾ - 4¼inches) (Fig 14). The walls comprise timber studwork and there is a partial loft over the northern part of the room.

Brick floor in Store B, looking south Fig 14

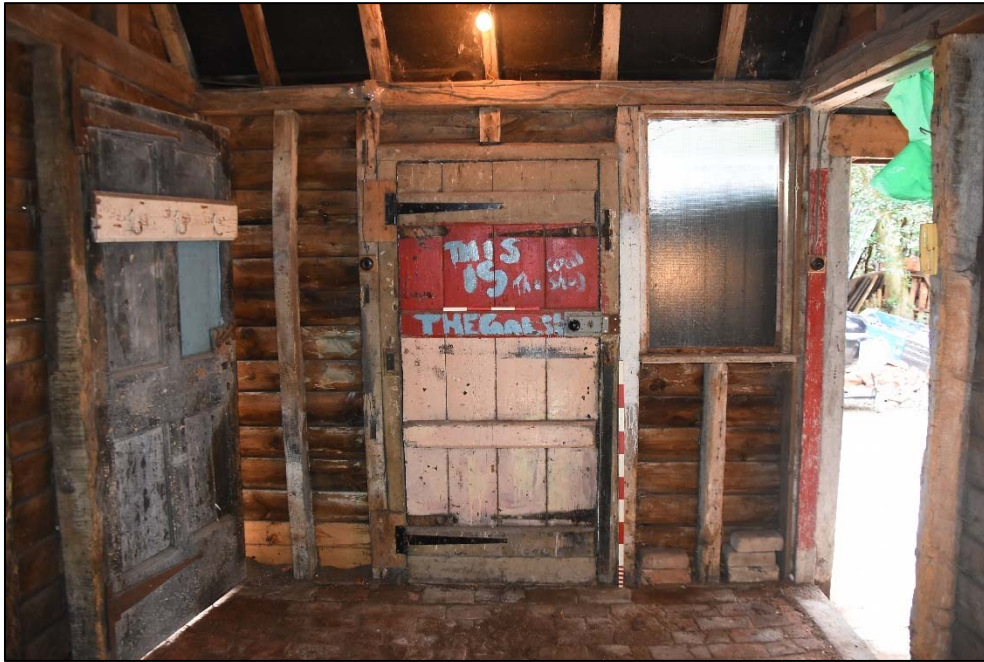
The area is entered via the door noted above, this is ledged to the rear with strap hinges on modern brackets (Fig 15). This also retains a long iron security bar for internal use. There is an early/mid 20th century lock case and evidence that the door has been re-hung within the same frame. The frame sits within two studs with outer examples and corner posts. These rise from the brick floor to the wall-plate. One has been cut above the door and the window to the west also interrupts a single stud, which only survives below.

South wall of Store B, looking south Fig 15

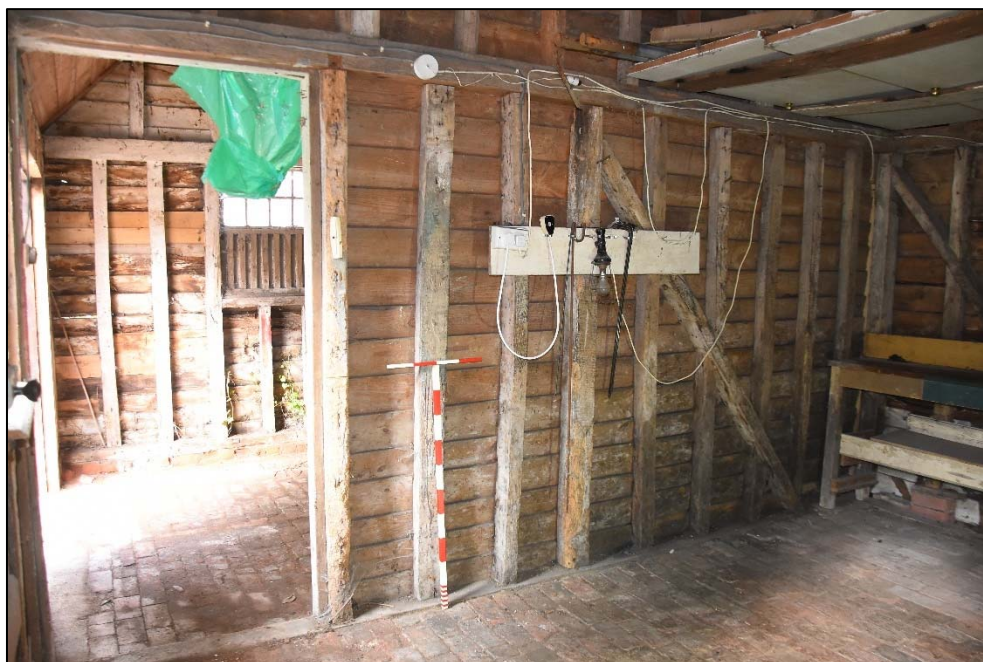
To the west the rear of the weather-boarded wall seen in Store A is visible. There are nine studs with corner posts and a downward brace descending from roughly centre towards the north (Fig 16). Several of the studs retain evidence of former use in a lath and plaster partition with multiple sequences of nails, or nail holes. One retains a scribed timber mark (Fig 17). These rise to a wall-plate and above this there is a closed partition comprising studwork and boards to the rafters (Fig 18). Two wider studs support purlins, the same as seen in Store A, one has notches indicating a former use elsewhere.

West wall of Store B, looking north-west Fig 16

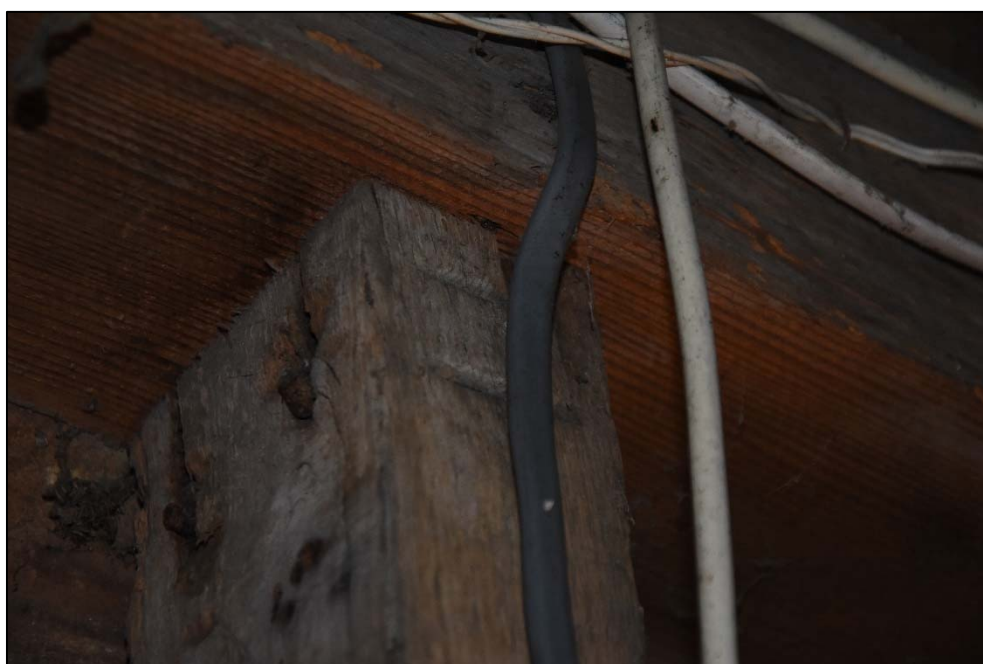
Timber mark at the top of a stud on the west wall, looking north-west Fig 17

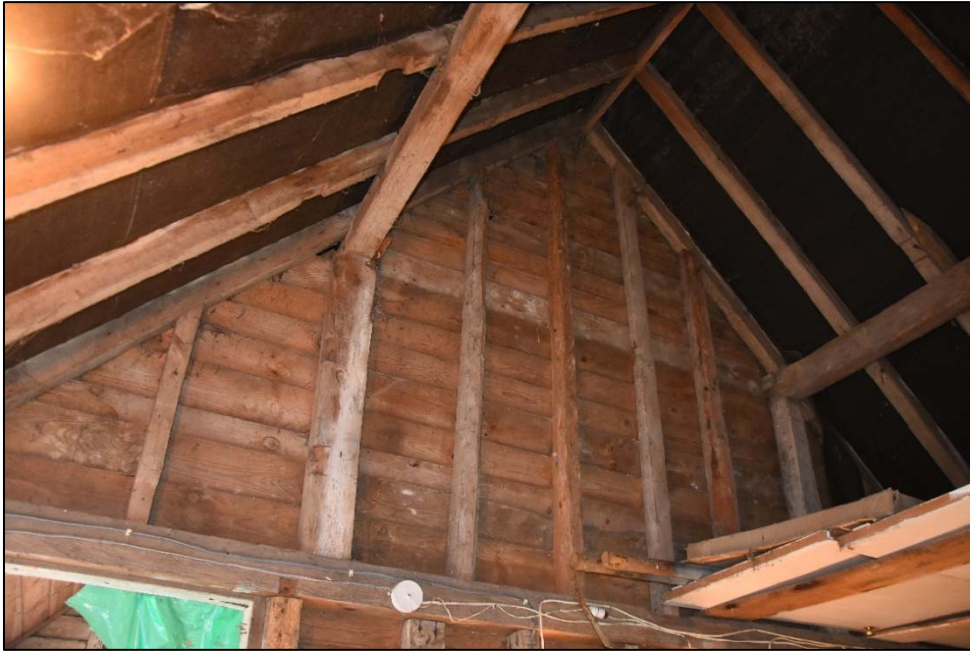
Partition above the wall-plate to the west wall of Store B, looking north-west Fig 18

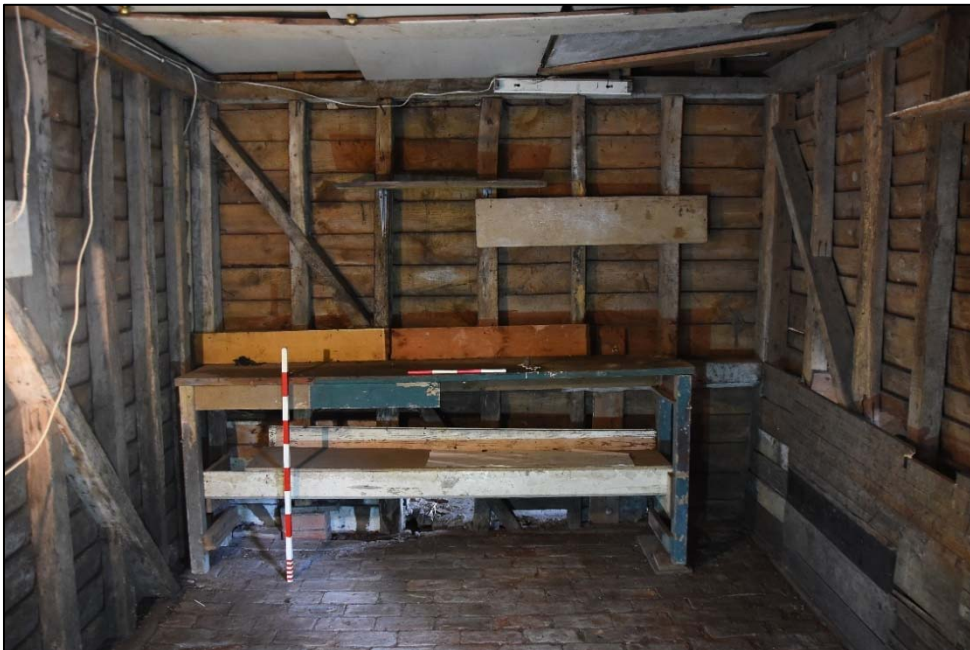
The north wall also comprises studwork with a downward brace descending from the west corner post (Fig 19). A modern bench has been created and sits abutting the wall. To the east the studs are covered by an area of boarding.

Studwork and shelf to the north wall of Store B, looking north Fig 19

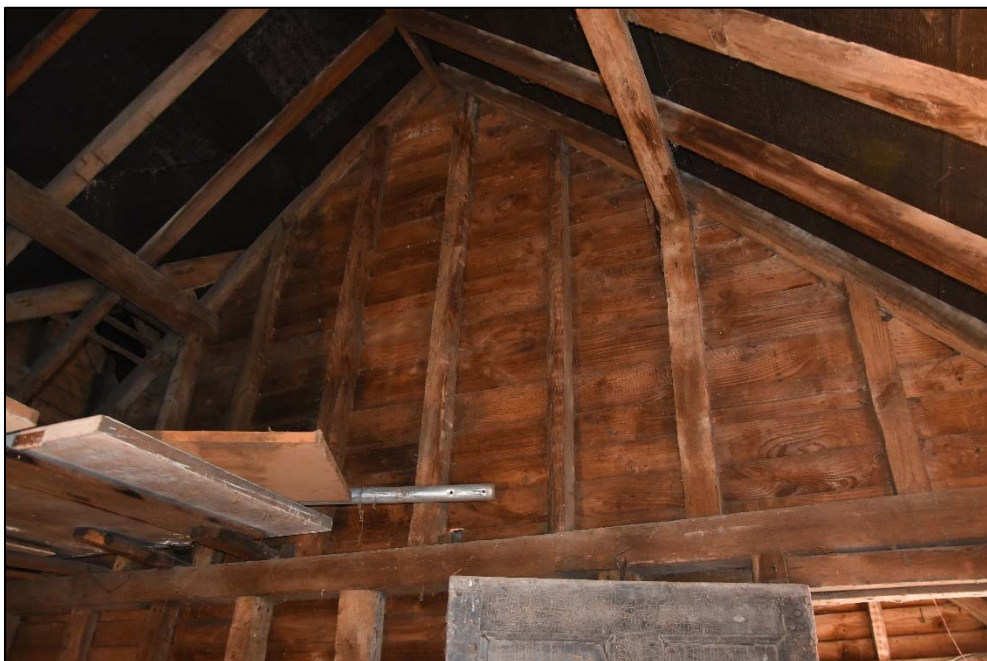
into Store C. This sits on a long iron strap hinge with moulded recessed panels and an iron catch. Above the wall-plate the closed partition matches others to the west (Fig 21).

Closed partition above the wall-plate on the east wall of Store B, looking north-east Fig 21

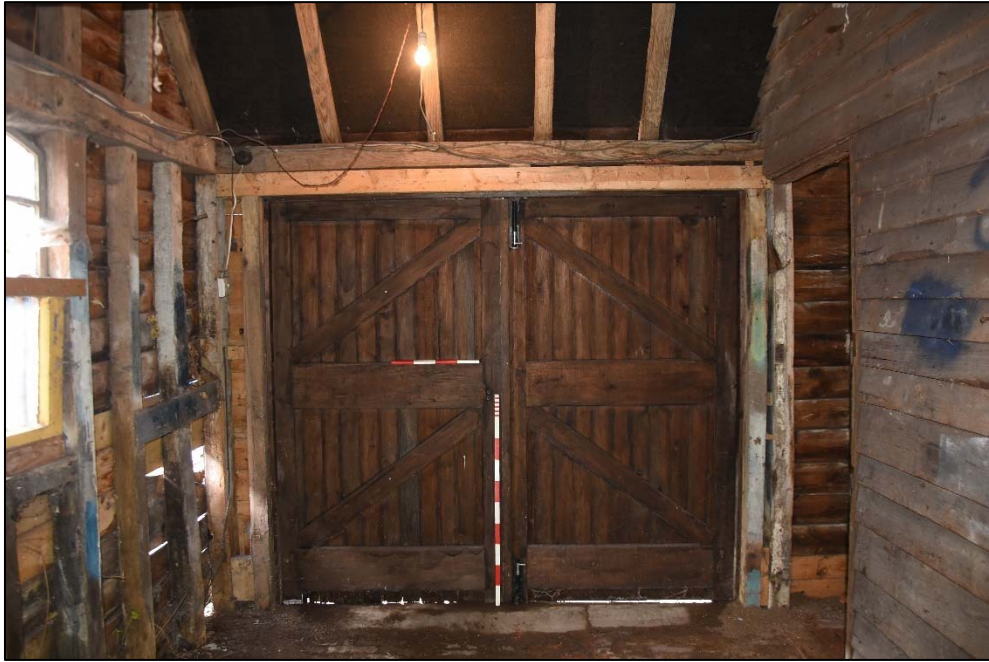
The double doors match those to Store A and are ledged and braced to the rear with a modern lintel below the historic wall-plate (Fig 23). However, here two historic studs form the jambs. To the west, the wall-plate has a scribed timber mark on its face (Fig 24).

South wall of Store C with double doors, looking south Fig 23

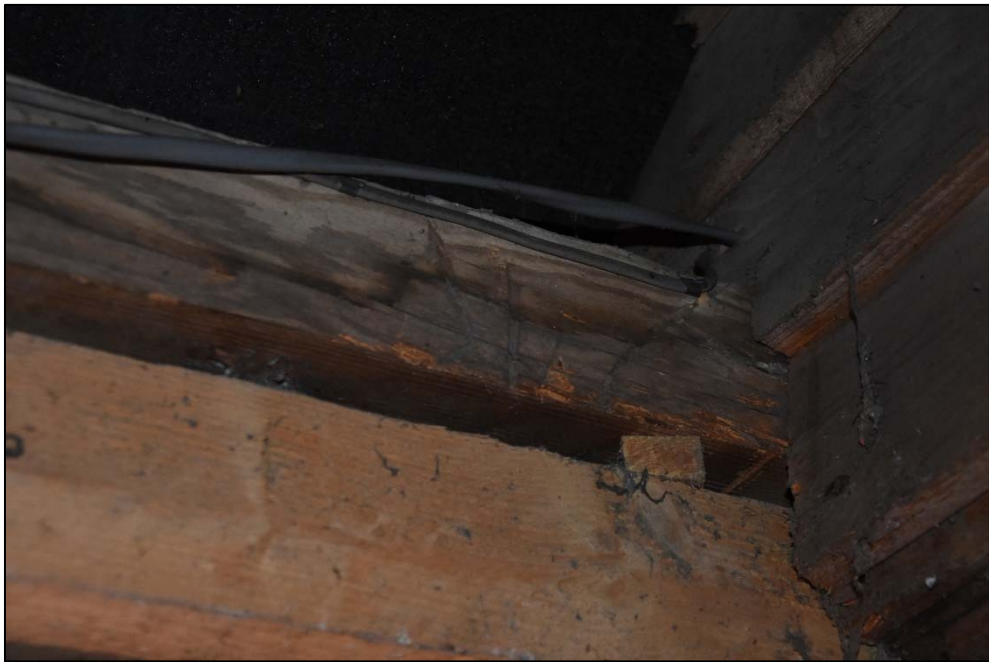
Scribed timber mark to the face of the wall-plate on the south wall of Store C, looking south-east Fig 24

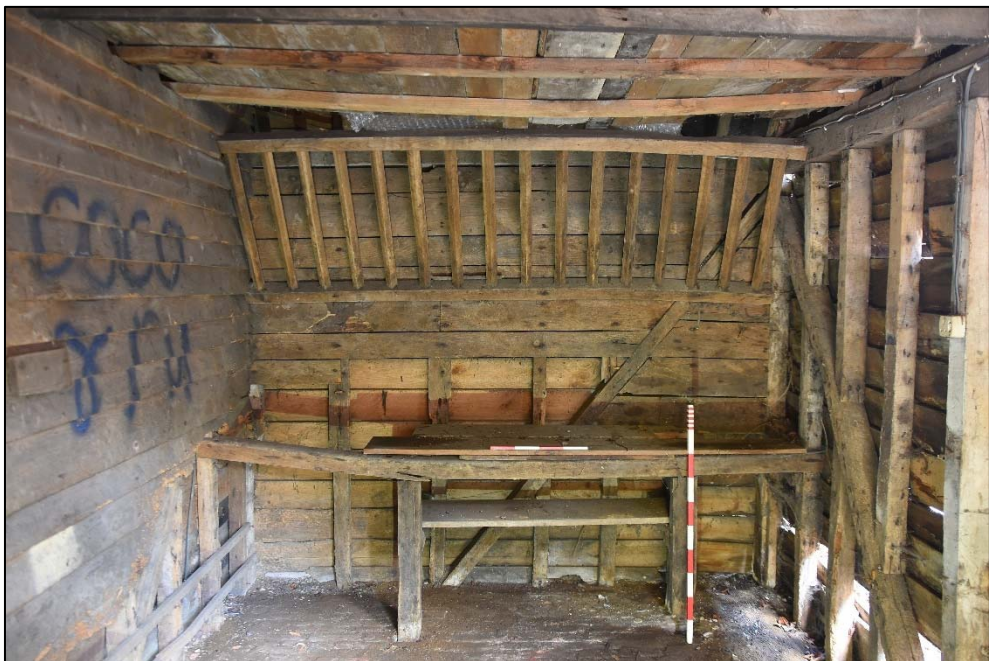
Boarding also partly obscures the north wall where a hay rack and potential former trough survive (Fig 26). The wall retains a downward brace descending from the north-east corner post around which the boards have been cut. The boards are nailed to underlying studwork which is exposed to the base where the boarding has failed. Here the rear of the weather-boarding seen in Store D can be seen. There is a long horizontal supported on posts which might suggest a former trough. Above a hay rack survives with diamond-profile bars and bowed upper rail.

North wall of Store C with hay rack and trough, looking north-east Fig 26

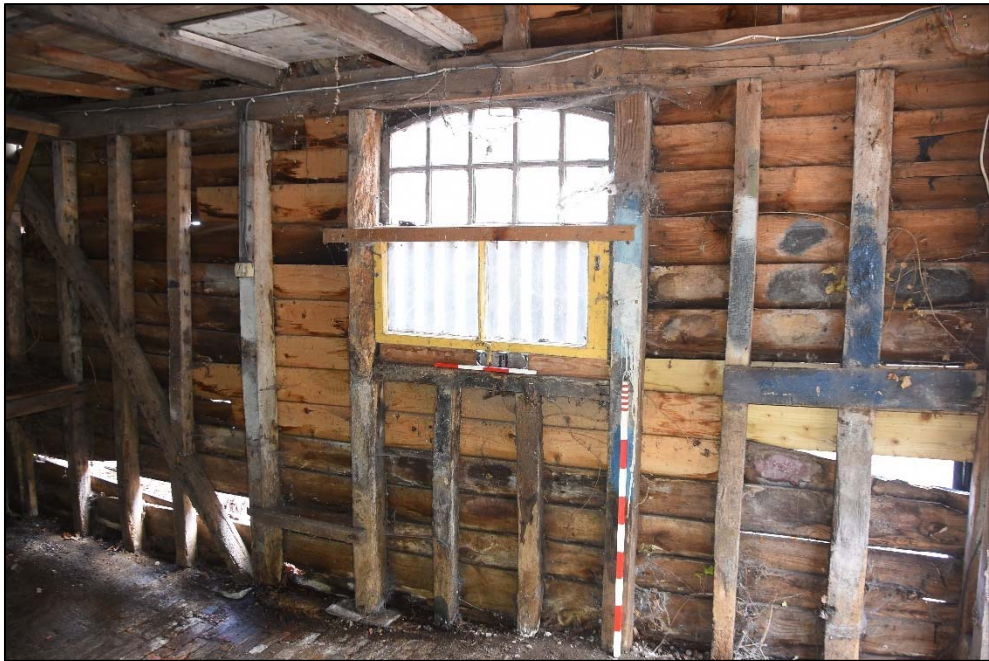
To the east wall a series of studs and downward brace continue the carpentry tradition (Fig 27). To the east the tie-beam retains a series of notches to its face that appear to have been only semi-completed. Between two of the studs to the south is set the other window seen externally (Fig 28). The northern stud is oak, rather than the usual softwood, and is much weathered. The window has lost its sliding vent grille and has been replaced with an additional two-light insertion, clearly reused from elsewhere. Above the tie-beam the studs rise in the same arrangement as elsewhere.

East timber stud wall to Store C, looking north-east Fig 27

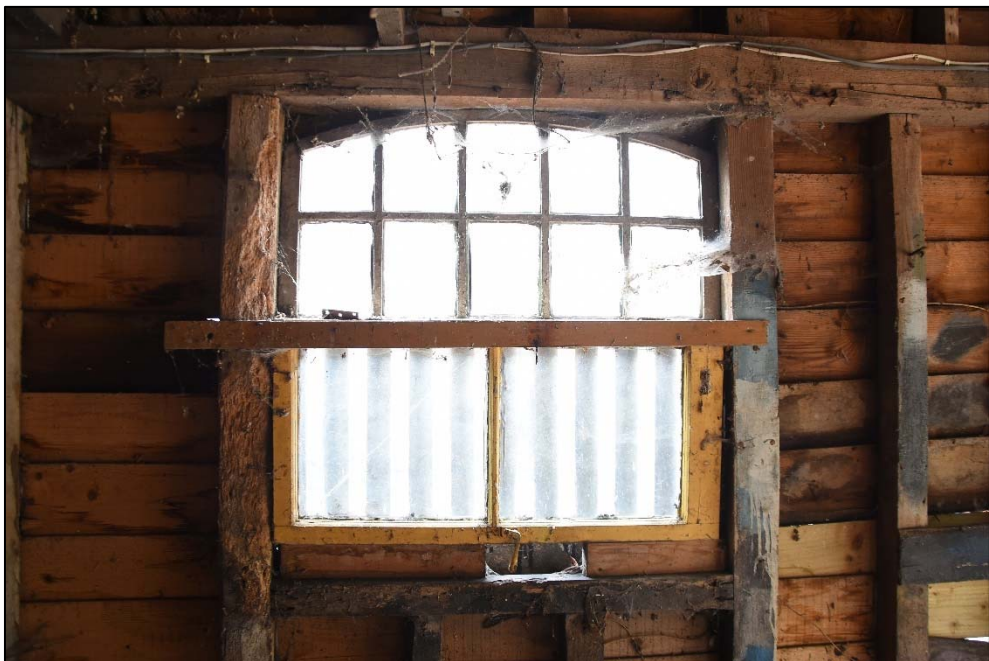
Window in Store C with part of another window inserted over the lower grille, looking north-east Fig 28

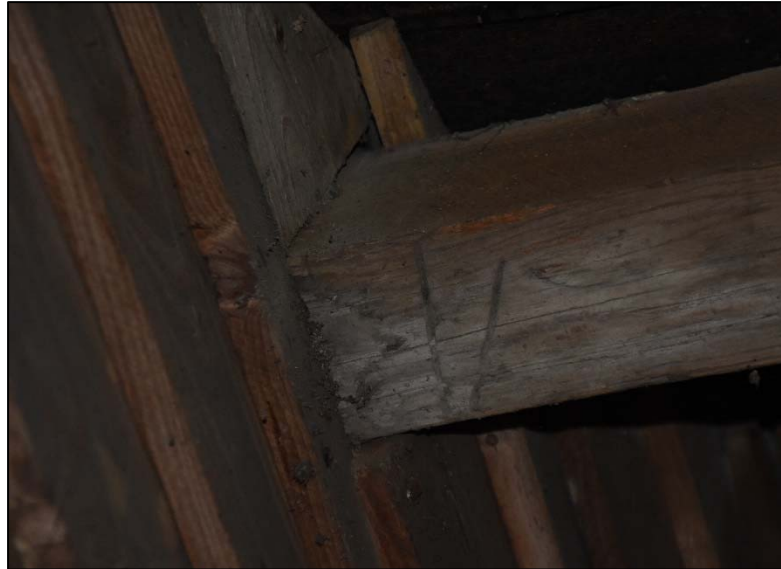
The roof above this store is the same as to the adjoining Store B. The south purlin retains a notch, and a scribed timber mark to its soffit (Fig 29). To the north the abutting roof over Store D can be seen with a ridgeboard supported on rafters but not correspond to the main roof in any way.

Timber mark to the south purlin in Store C, looking south Fig 29

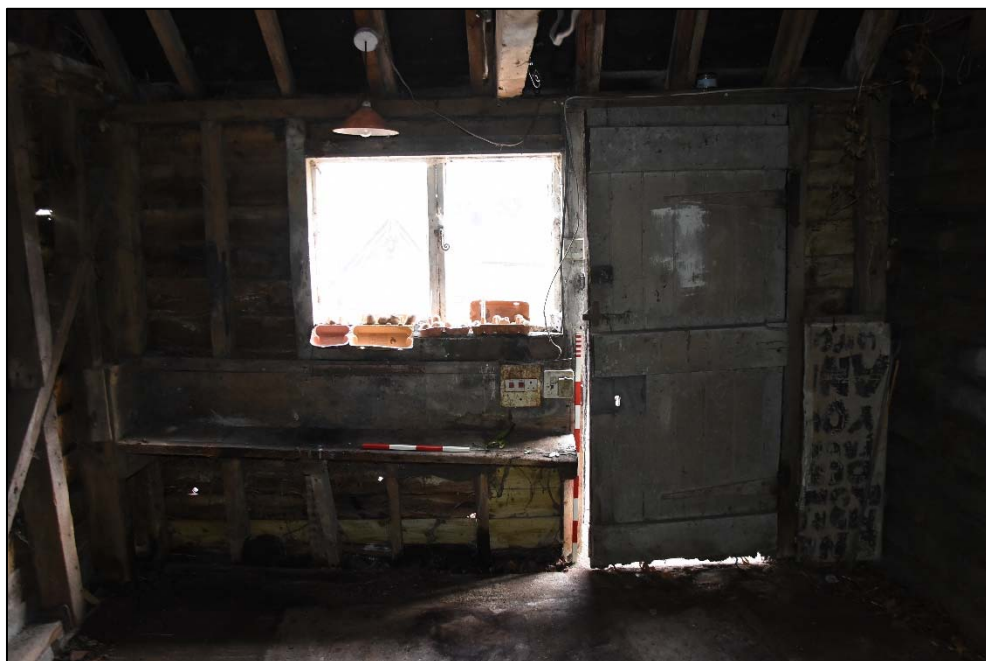
The door it is entered via is ledged to the rear with a wrought-iron catch and modern lock case above. It is hung on strap hinges. The window adjacent is set within a simple timber frame with a curled window catch of some age. Otherwise the timber frame comprises corner posts and four full studs, although they have been utilised as the window/door jambs (Fig 30). A bench stretches across the wall below the window.

East wall of Store D showing door, window and shelf, looking south-east Fig 30

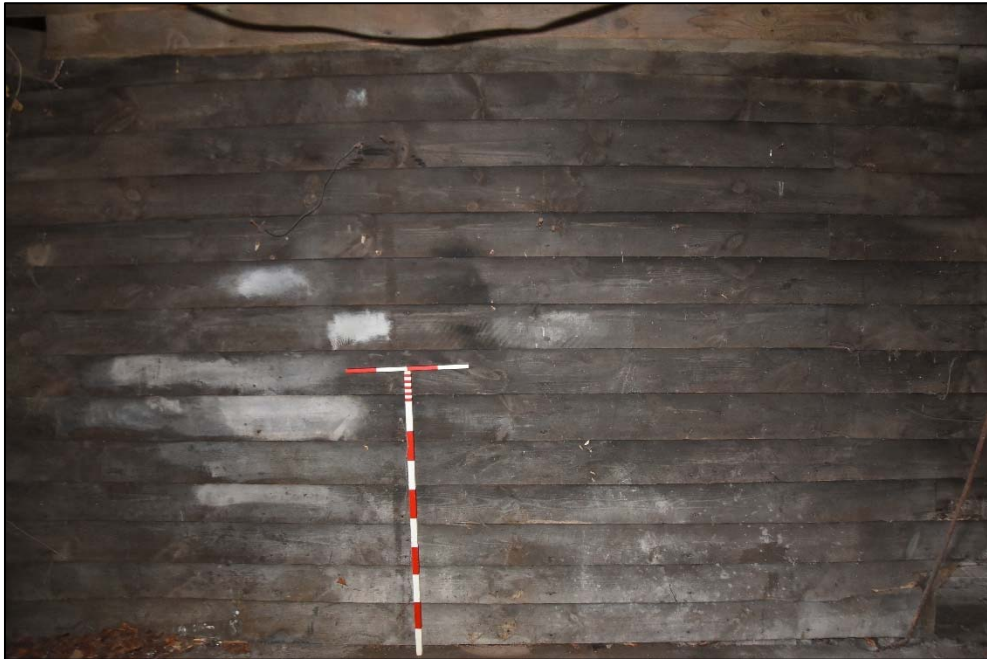
To the south the wall is weather-boarded in softwood (Fig 31). To the upper section the boards retain multiple examples of circular saw marks. Above the level of the tie-beam the boarding has been left unpainted but rises to the apex (Fig 32).

Weather-boarding to the south wall of Store D, looking south-west Fig 31

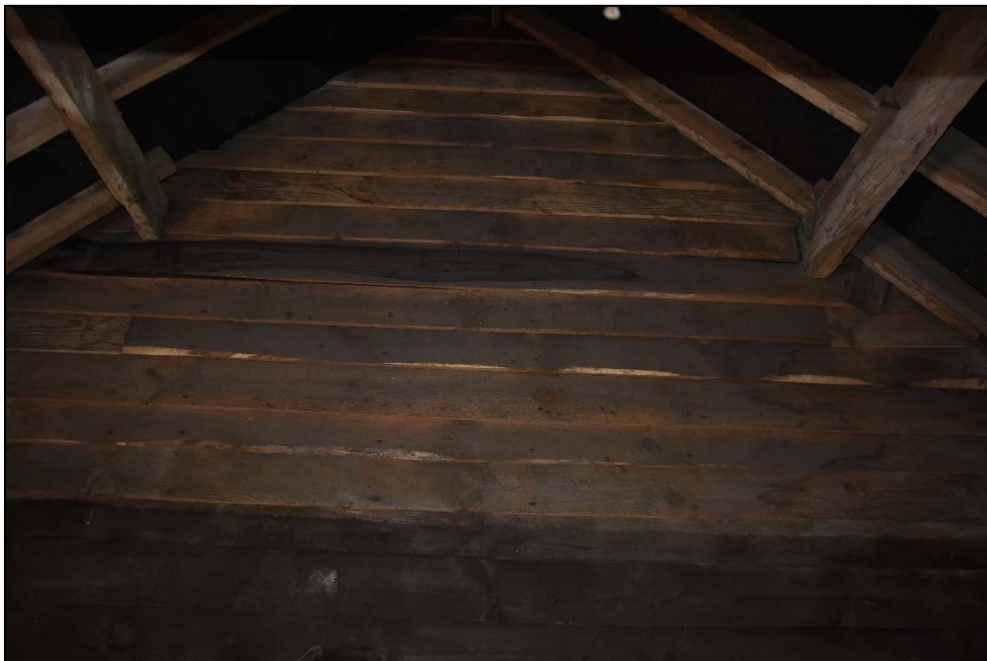
Weather-boarded gable to the south wall of Store D, looking south-west Fig 32

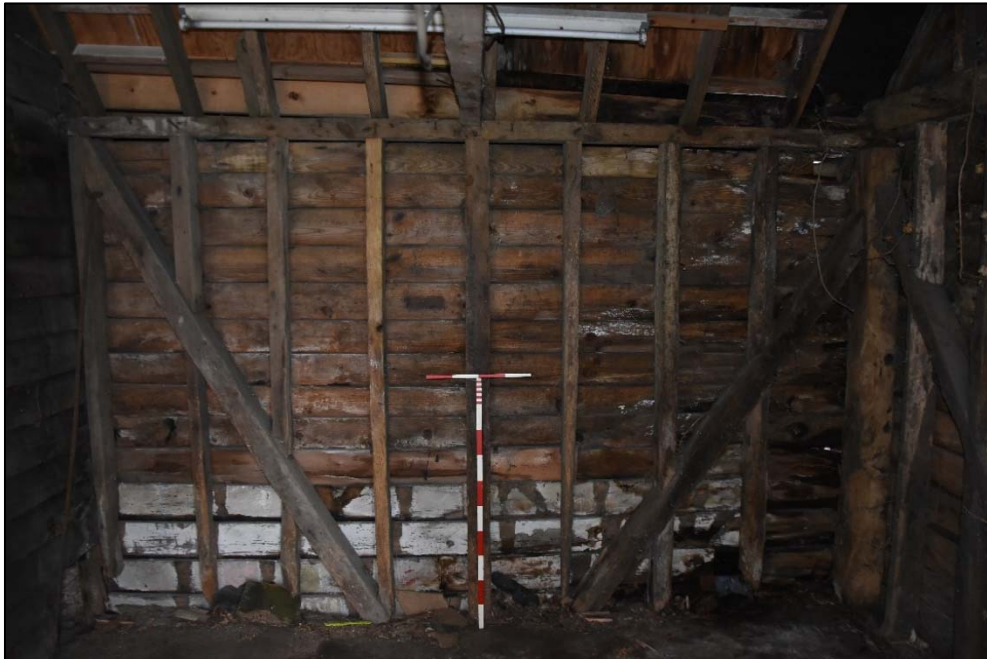
The west wall comprises seven studs with two diagonal braces descending from the corner posts (Fig 33). The corner post to the north is oak and clearly historic displaying weathering from a previous exterior positioning. The carpentry here is simple with the wall-plates notched over the post (Fig 34). The braces cut the studs

as in Stores A-C and they vary in scantling. There is no sole-plate but they all rise to a wall-plate.

The timber-framed west wall of Store D, looking north-west Fig 33

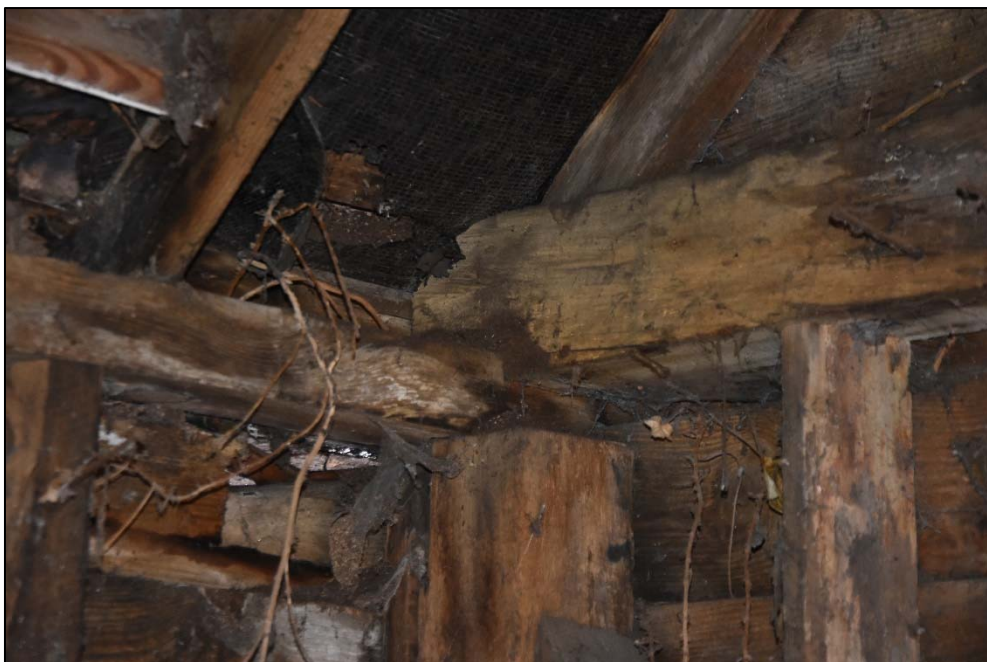
Corner post, wall-plate and tie-beam to the north-west corner of Store D, looking north Fig 34

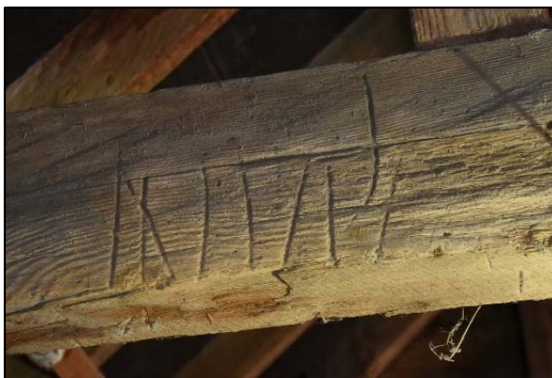
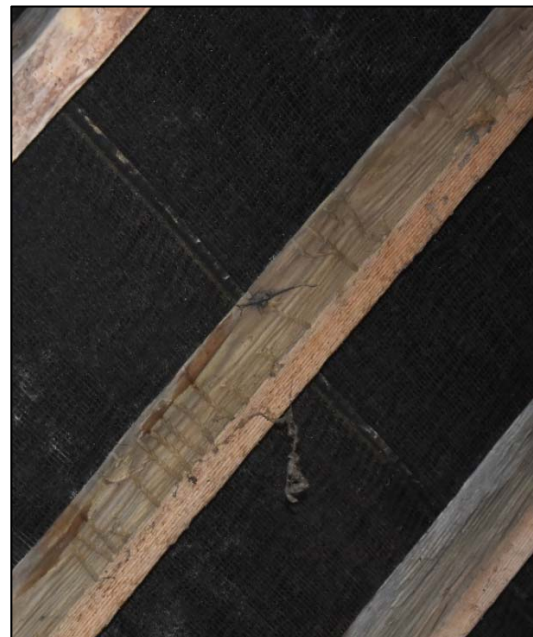
The roof structure is simple and there is a single truss spanning the space. This comprises a tie-beam from which two posts rise and support a purlin in each pitch. The common rafters are all slender and rise to a ridgeboard at the apex. There are several examples of timber marks (Fig 36) including the tie-beams south face, one of the common rafters in the west pitch, and the tie-beam to the north wall.

Timber marks on the south face of the tie-beam (left) and common rafter to the west pitch (right) in Store D, looking north-west Fig 36

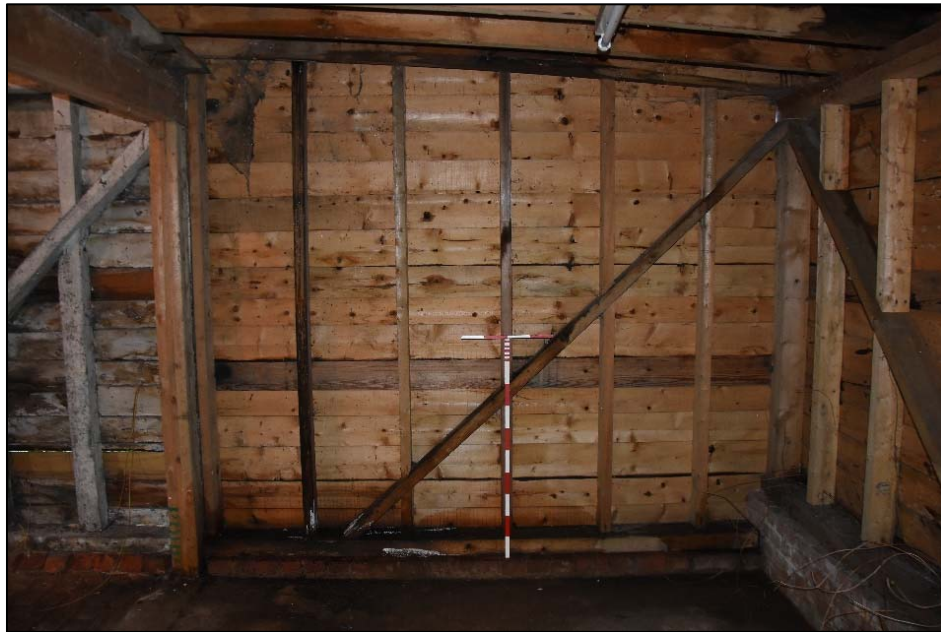
The timber is of regular scantling, all softwood, and is slender. A single course of bricks form the foundation of the west studwork, a brick dwarf wall of four courses lies to the north. The studwork had downward braces from the north-west corner post.

West studwork wall in Store E, looking north-west Fig 37

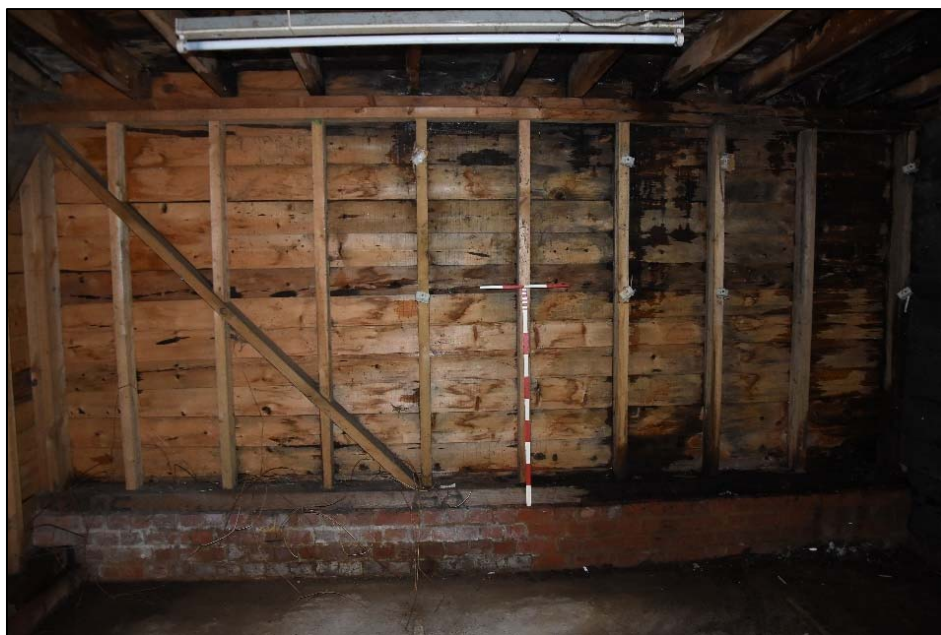
North studwork wall in Store E, looking north-east Fig 38

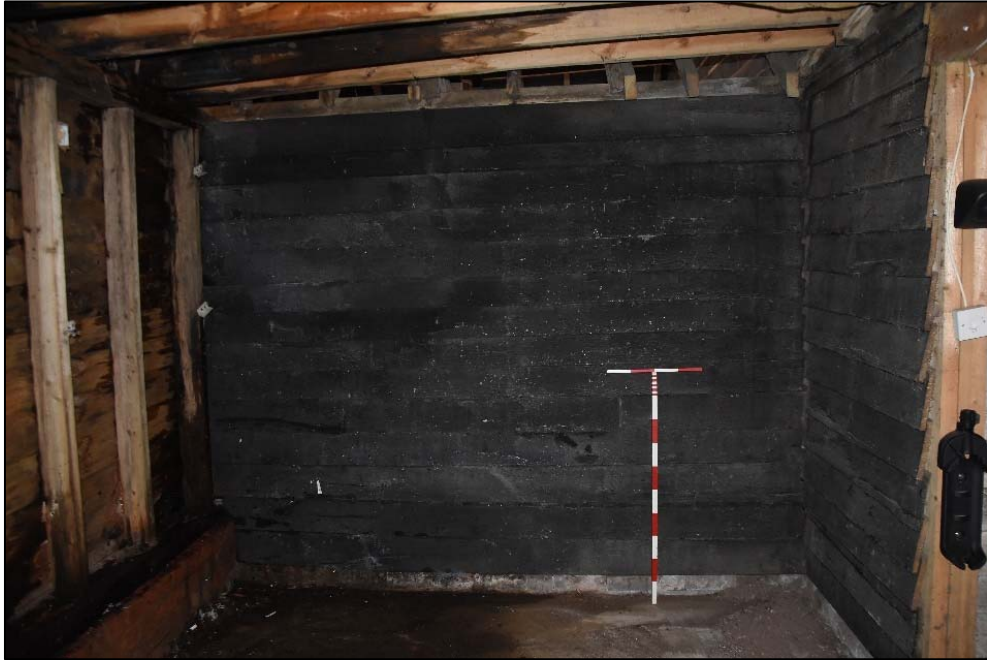
The area has a concrete floor, timber studwork to the west and north walls (Figs 37-38) and the weather-boarded former exterior wall of the north range to the east (Fig 39).

Former exterior weather-boarding to the north range, now housed within Store E, looking east Fig 39
