Archaeological Survey of the North Retaining Wall at St Matthew's Church, Church Hill Walsall, West Midlands

Report No. 14/67

**Archaeological Survey of the North Retaining Wall
at St Matthew's Church, Church Hill
Walsall, West Midlands
February 2014**

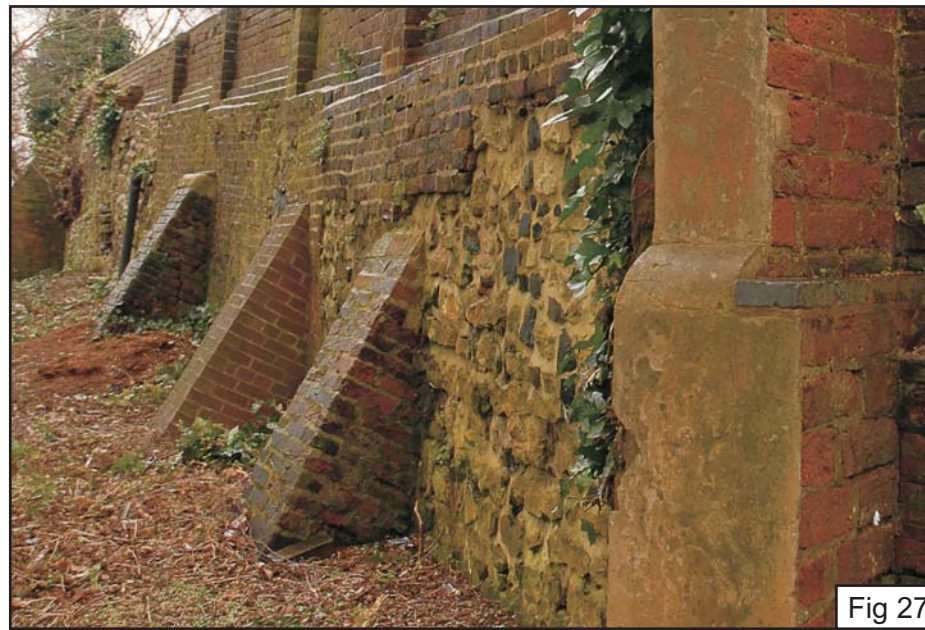
From the remains of the wall return, a 25m stretch of the retaining wall continues on a north-east, south-west alignment ending at a wide, curving buttress which marks a change in angle of the retaining wall (Fig 24). Three leaning brick buttresses, B1 – B3, each of different construction are present at the western extent of this stretch (Figs 24 & 27). None of these buttresses are keyed into the retaining wall and they each represent a different date of construction.

- Fig 27 Buttresses B1, B2 and B3, looking east
- Fig 28 Detail of 18th-century stonework with modern repair and repointing
- Fig 29 Detail of 19th-century brick with modern repairs
- Fig 30 Detail of fabric types east of buttress B2
- Fig 31 Buttress B3, looking east
- Fig 32 Detail of skintling on bricks

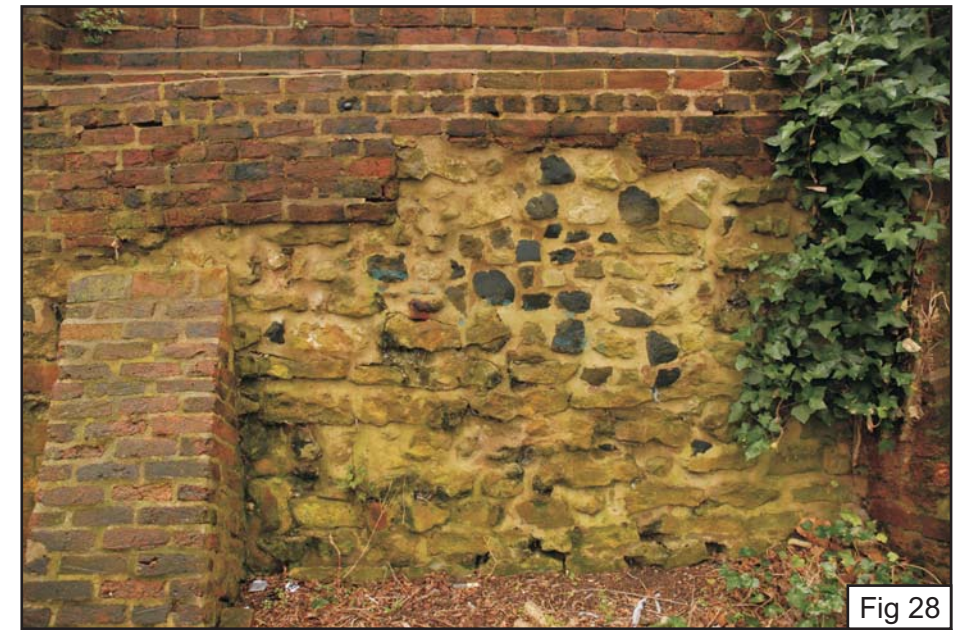
Buttress B1 is approximately 1.3m in height, c0.6m wide and steps out c0.8m at its base. It is constructed of hand-made reddish-purple bricks with pink lime mortar between. The average brick size is 230x55x100mm, with three courses measuring c220mm in height. To the west of and behind B1 is a large patch of coursed, mortared rubble sandstone and limestone, c1.6m in height (Fig 28). This patch of

stone work has been repaired in un-coursed rubble with cement mortar. More patches of un-coursed rubble and cement repair can be seen between B1 and B2 (Fig 29).

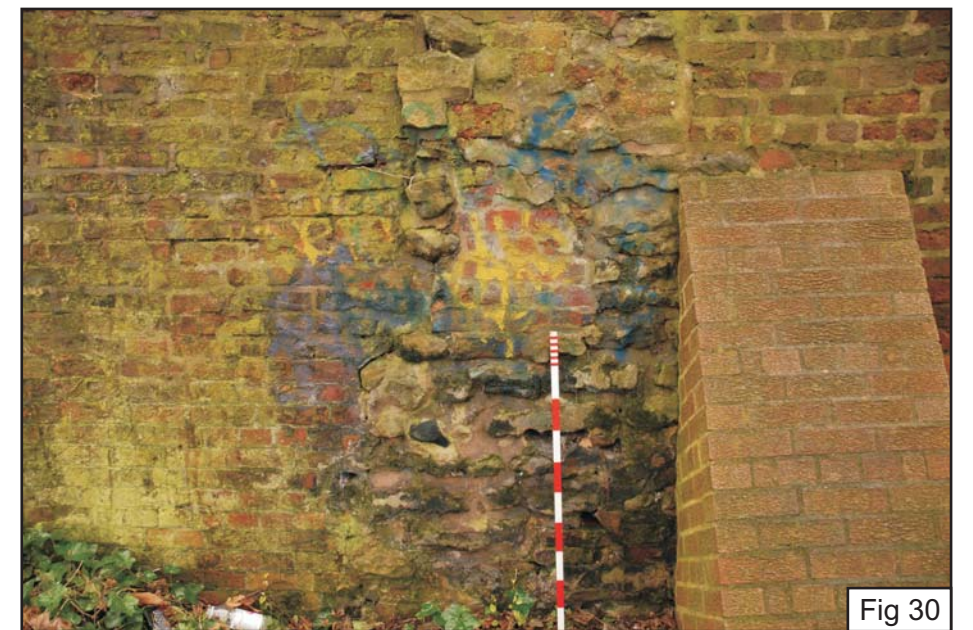
Buttress B2 is clearly mid-late 20th century, measuring c1.4m in height, c0.6m wide and constructed of modern, machine made bricks. Its western edge is located at the edge of a large patch of coursed stone repair on the wall (Fig 30).

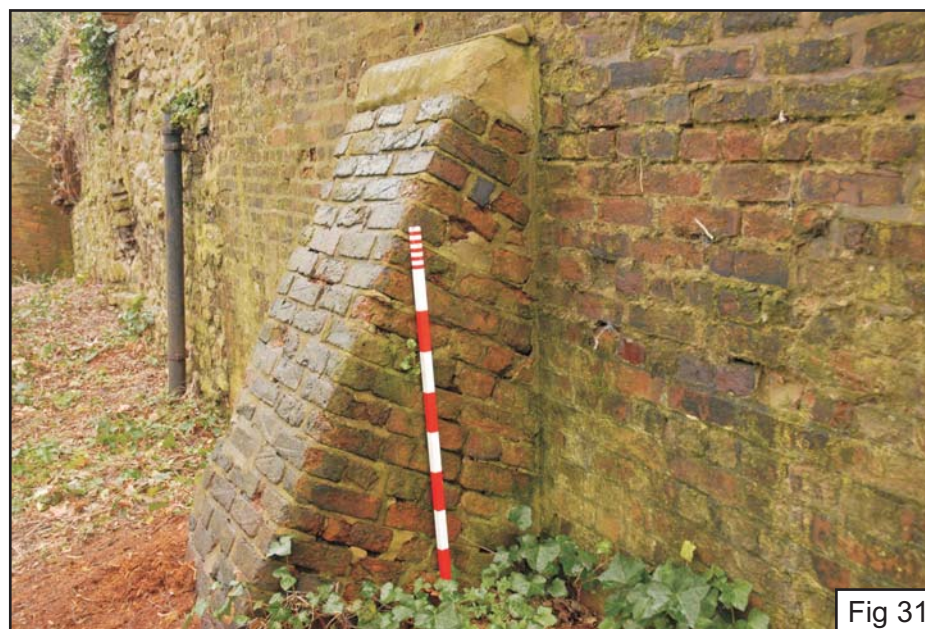
East of B2, buttress B3 is constructed of dark purple, handmade bricks with pink, lime mortar between. Many of the bricks show skintling marks from the stacking process of their original manufacture (Fig 32). The bricks have an average dimension of 230x55x100mm with three courses measuring c220mm in height. As with B1 and B2, buttress B3 does not appear to be keyed into the retaining wall. Buttress B3 has a similar construction and fabric to B1, but unlike B1 which leans into the wall, B3 is capped with a single block of sandstone, shaped to fit the gap between the brickwork (Fig 31).

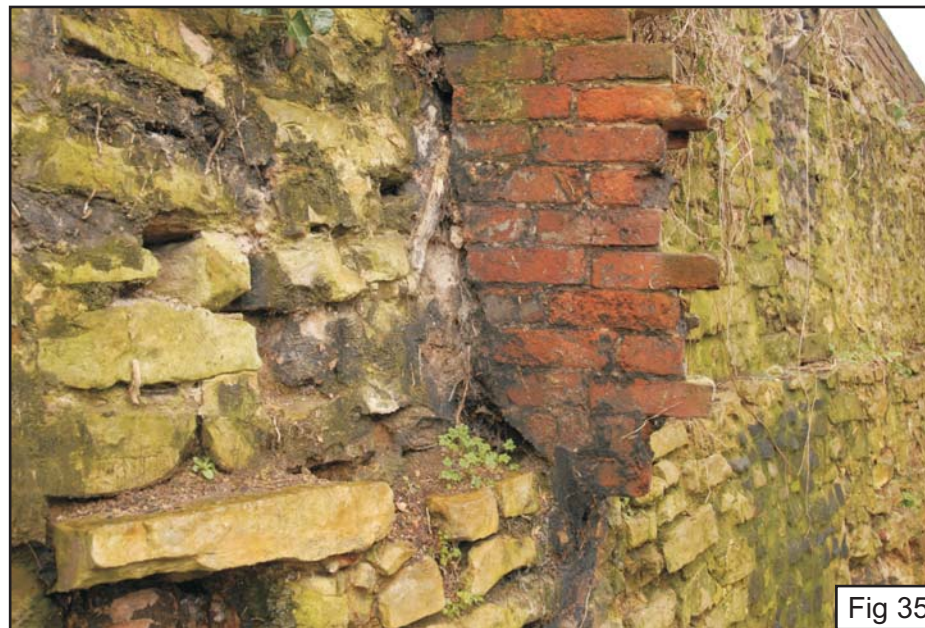
Fig 35 Remains of former property boundary

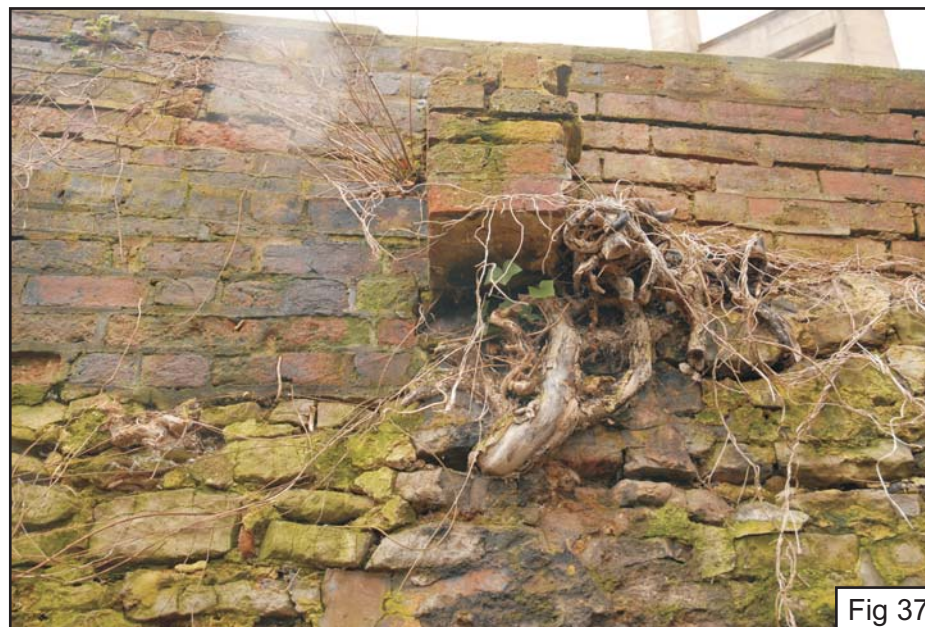
Fig 37 Remains of former property boundary

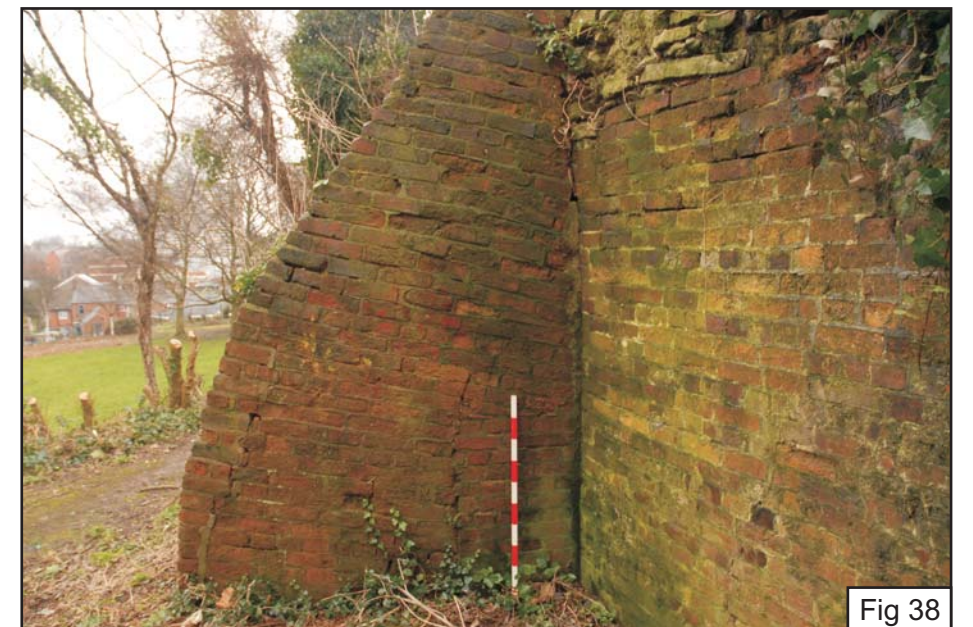
Approximately central to the retaining wall and marking a change in alignment from north-east, south-west to north-west, south-east, buttress B4 is a wide, curving, brick structure which provides increased support where lateral forces are greater (Figs 25, 38 & 39). Average brick dimensions are c240x60x100mm, with three courses measuring 240mm in height. At its base, it projects approximately 2.1m. The buttress has been re-pointed in cement though the original coarse lime mortar with small stone inclusions can still be seen in places. The brickwork of the buttress has not been keyed into that of the wall. B4 supports the full height of the retaining wall. The construction of the outer face of the buttress follows a repeated pattern of six rows of stretchers between single rows of headers (Fig 39).

Fig 38 Side view of buttress B4, looking north-east

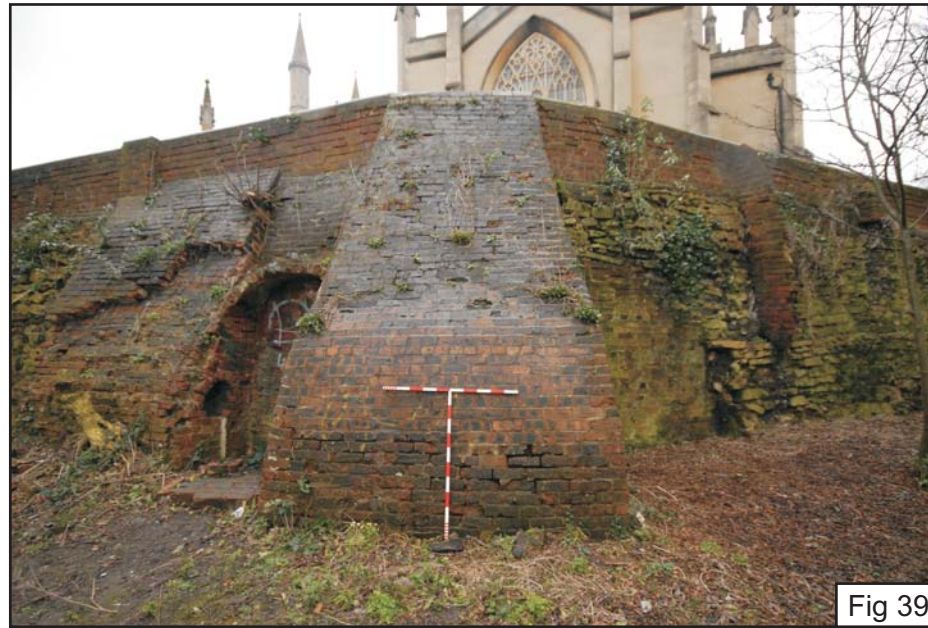
Fig 39 The main face of buttress B4, looking south

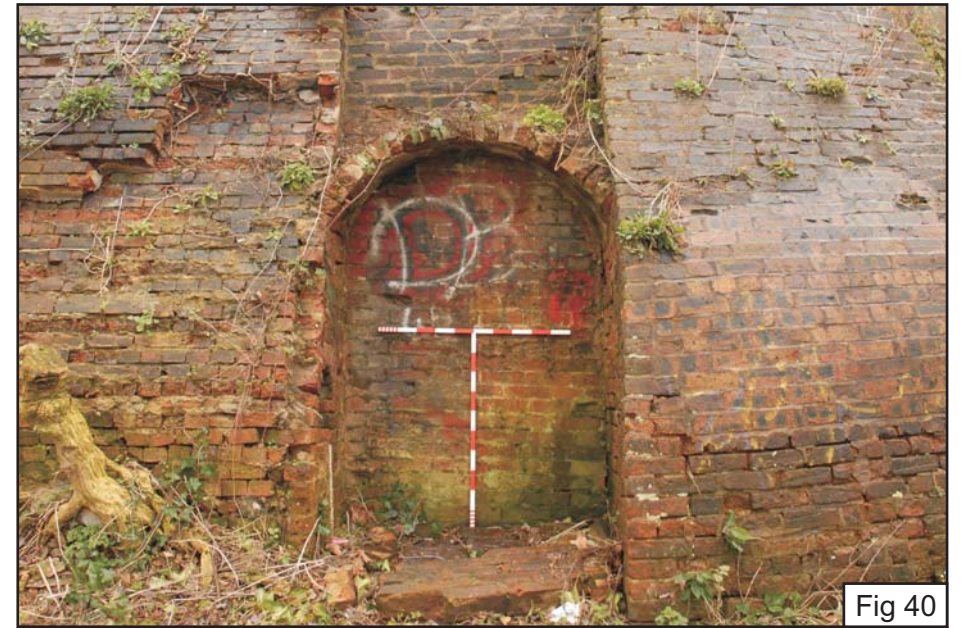
Fig 40 The arch between buttresses B4 and B5

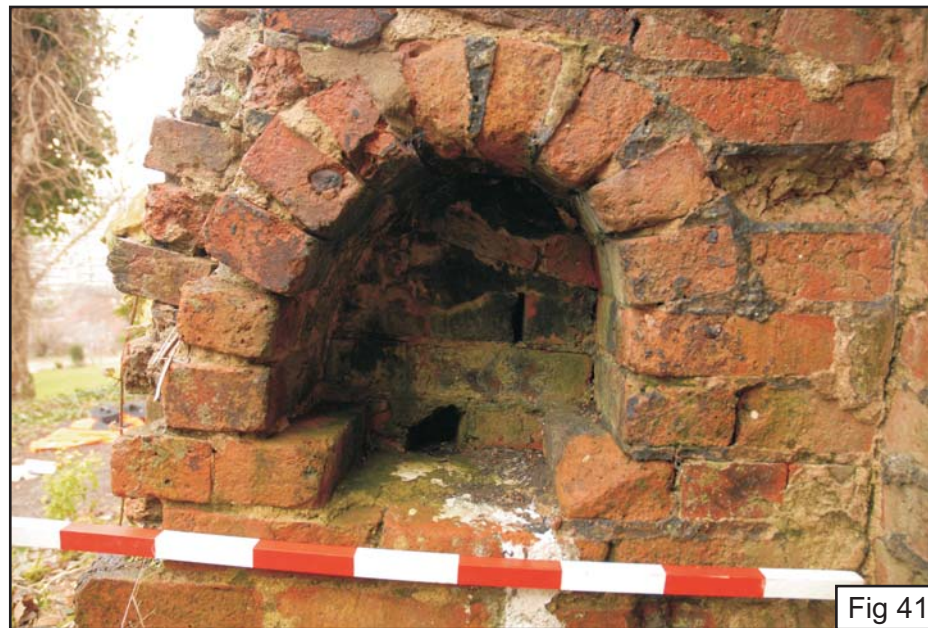
Fig 41 Detail of the lamp niche in buttress B5

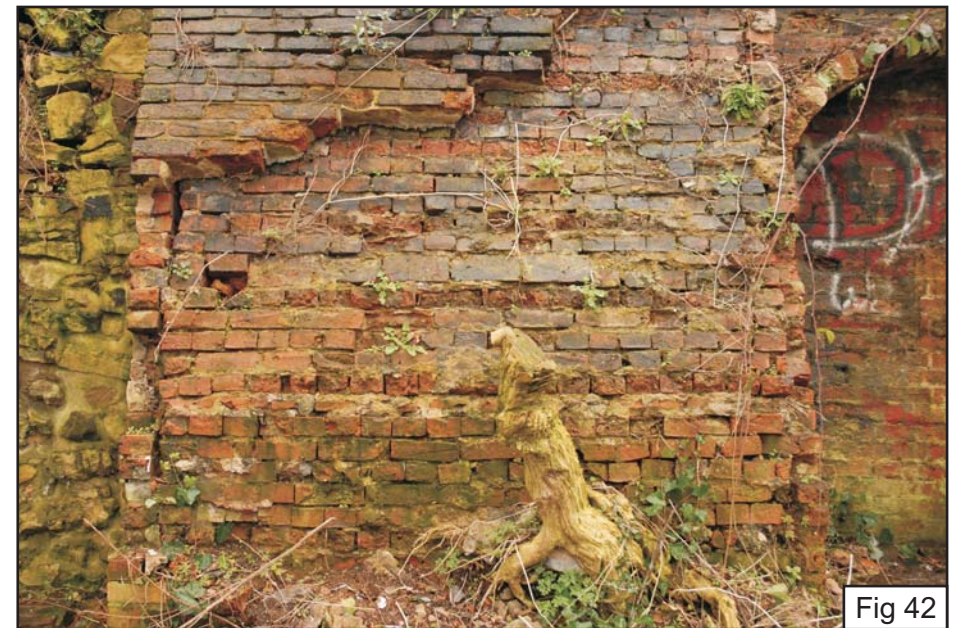
Buttress B5 is constructed of handmade, reddish-purple bricks showing skintling marks with pink lime mortar between (Fig 25). The outer face of the buttress is primarily in stretcher bond but where this has fallen away, the brickwork beneath is in English bond with alternating courses of headers and stretchers (Fig 42). English bond is largely associated with the medieval period and fell out of fashion in early 17th century but was revived in the 19th century for structural purposes. Though the inner cores of the other large buttresses are not visible, it is likely that they were constructed with a core of brick in English bond for strength and faced with an outer layer in stretcher or garden wall bond. B5 was found to be in poor condition with the north face having slipped away from the core. The damage to the brickwork was caused primarily by the growth of a tree at the base of the buttress which forced the bricks apart and began a process of gradual deterioration. A smaller buttress supporting the upper wall level is built into the top left corner of B5 (Fig 25).

Fig 42 Buttress B5, showing the core of English bond with outer face of stretcher bond
