**Historic Building Recording at
Rye Hill Farm Barns, Eydon
Northamptonshire
May 2015**

Report No. 15/104

MOLA was commissioned by Mr G Wood to undertake a Level 2 photographic survey of a complex of agricultural buildings associated with Rye Hill Farm, Eydon, ahead of the conversion of the buildings to a residential dwelling. The surveyed buildings date largely to the mid-19th century with intermittent alterations and repair work in the following years. The buildings had a range of functions and included a barn, stable, cart shed, cow shed and a modern shelter. The buildings were found to be derelict, partly unroofed and overgrown.

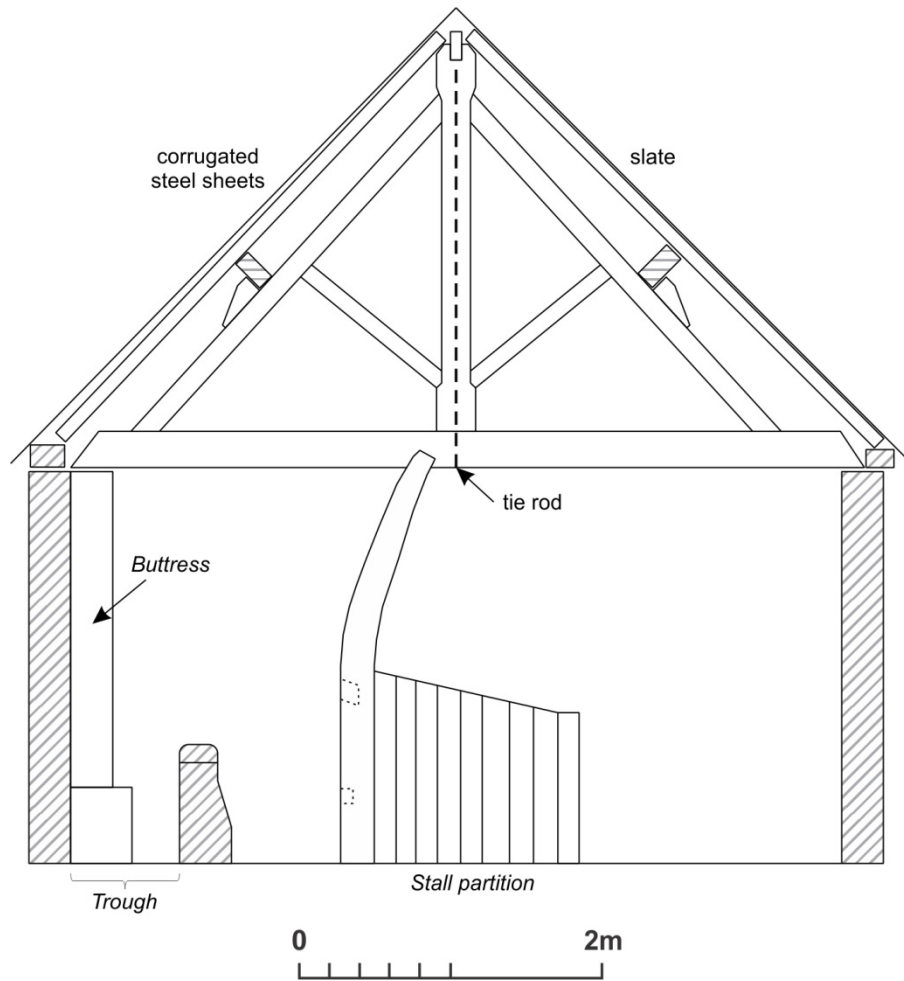
Section through the Stable Fig 6

A brick trough formerly extended the full length of the room, running north-south against the western wall (Figs 6 & 7). This has been largely demolished but survived to full height at the southern end (Fig 27). The trough is c350mm at its widest and c800mm in height, enclosing a space c720mm in width. It is capped with double bullnose bricks to prevent injury to feeding animals, likely horses. A single timber stall divider partly survived below the northernmost truss to which it is fixed (Figs 6 & 25). The divider has a square profile post at its eastern end to which one horizontal and one diagonal brace are jointed. At the west, the braces are jointed to a post which rises to the overlying truss. For this post the carpenter utilised the natural curve of a branch or trunk. A number of planks are nailed to southern side of the braces. These are cut diagonally, in line with the diagonal brace. The stall is aligned with the truss and brick buttress and it is very likely that another was formerly located to the south, in line with the southern truss and buttress.

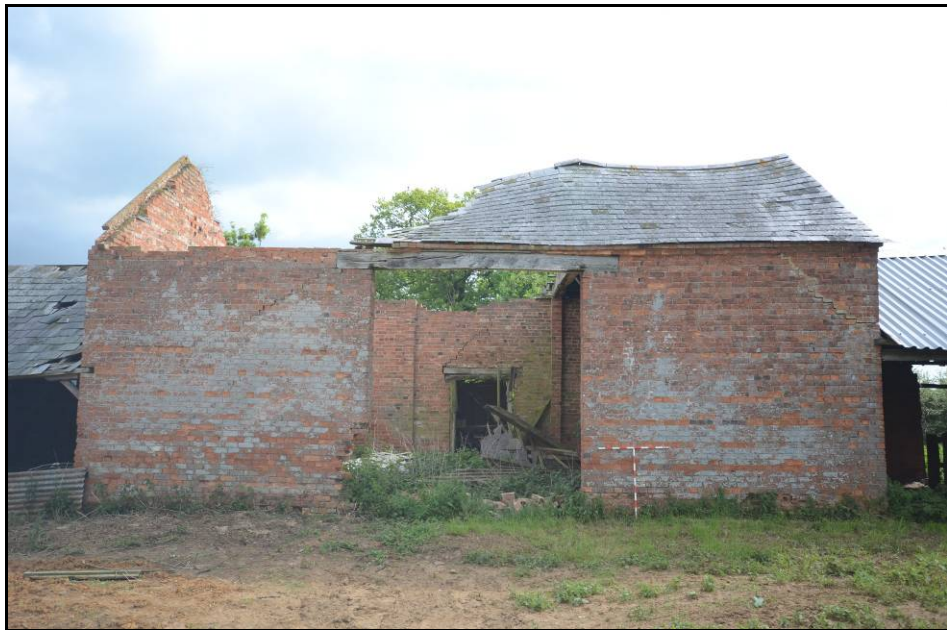
The Barn, the west elevation, looking north-east Fig 15

The main entrance is to the west through a full height double-width opening central to the west wall (Fig 15). A substantial timber lintel carries the wall plate over the doorway (Fig 16). Iron pegs were located at the distal ends of the lintel.

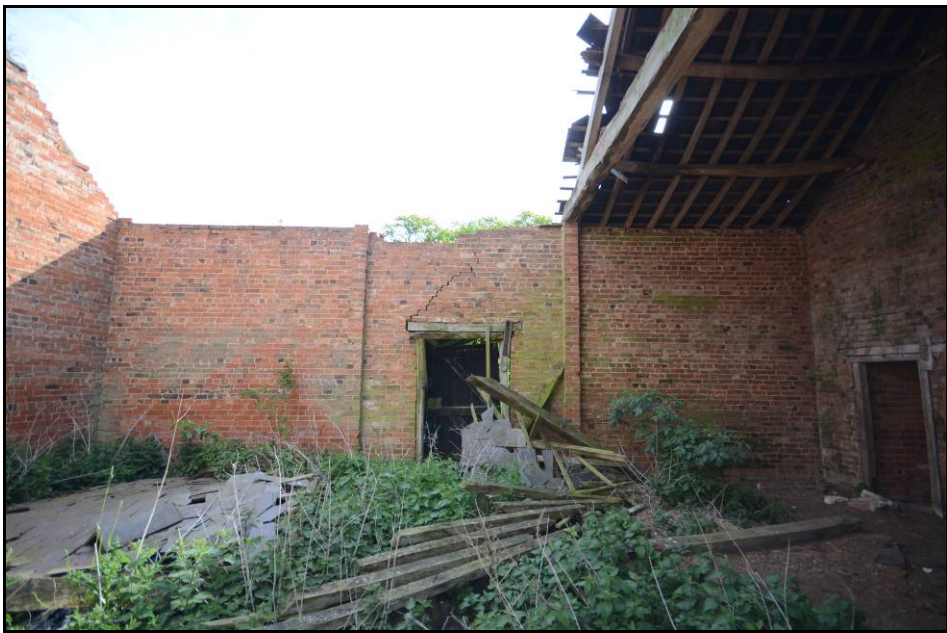
The Barn, interior, looking north-east Fig 17

A smaller, raised door is located in the opposing wall, directly opposite to the main entrance, as would be expected in a threshing barn (Fig 17). This also has a timber lintel as well as a timber door frame. The door itself is a braced, ledged type, painted black, with iron strap hinges. This door opens into the eastern yard, allowing for loading and unloading onto carts etc.

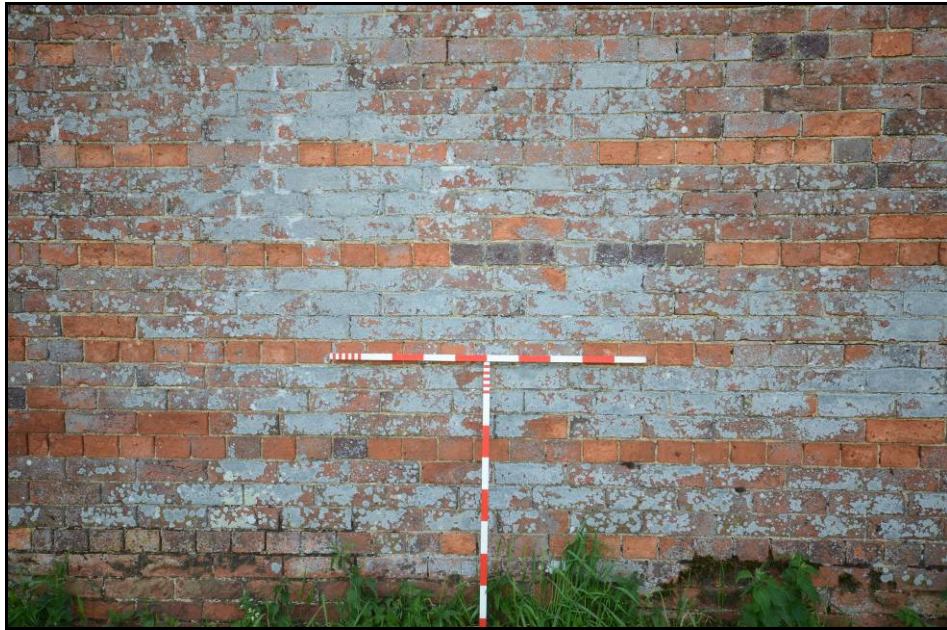
The Barn, detail of the building's construction Fig 20

The largest of the buildings, the Barn is the central core to which the other structures are joined. It comprises a single room of three bays, measuring c6.2x11.5m (Fig 7). The building is constructed of red brick in English Garden bond, having three rows of stretchers to a row of headers (Fig 20). The bricks measure c220x110x70mm with three courses being c225mm in height. The header courses have been picked out by the use of lighter coloured brickwork, creating a decorative enhancement to the walls. At the eaves is a dentil course providing further decorative embellishment. At the top of the north and south elevations are located panels of hit and miss brickwork allowing ventilation to the barn.

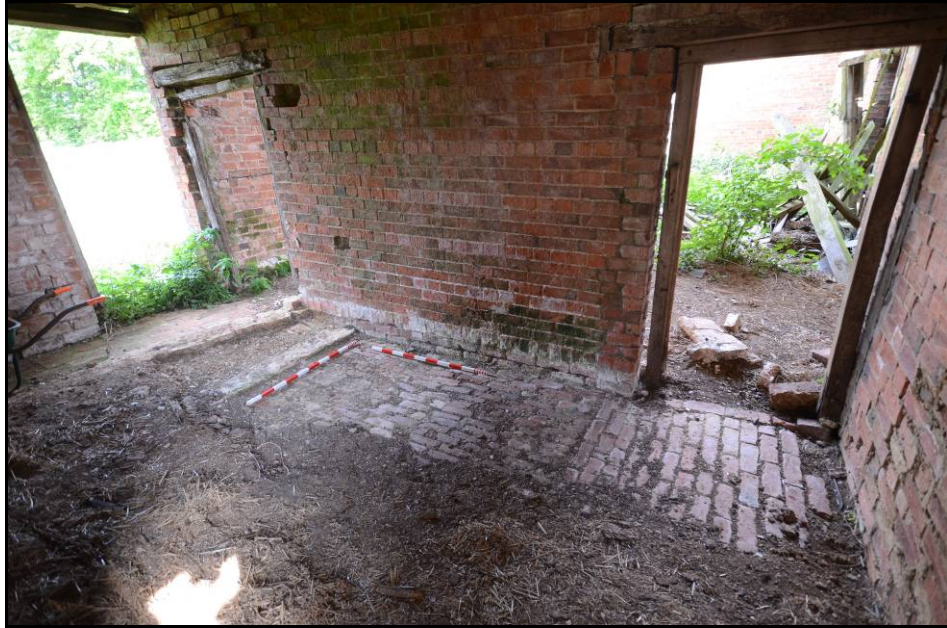
The Stable, the northern door openings, showing the brick floor surfaces Fig 24

The floor was largely obscured by a layer of mixed rubbish, straw and soil at the time of the survey. However, a brick floor can be seen at the northern end of the room (Figs 7 & 24). Adjacent to the eastern wall, in front of the eastern door into the barn, the bricks of the floor are aligned north to south and placed with the broad face upward. The bricks of the central portion of the floor, between the two north doors are aligned east to west and are placed with the stretcher face upward. The western portion of the floor is slightly raised and separated by the brickwork of the trough. Similar to the eastern side, the bricks here are aligned north-south, broad face up.

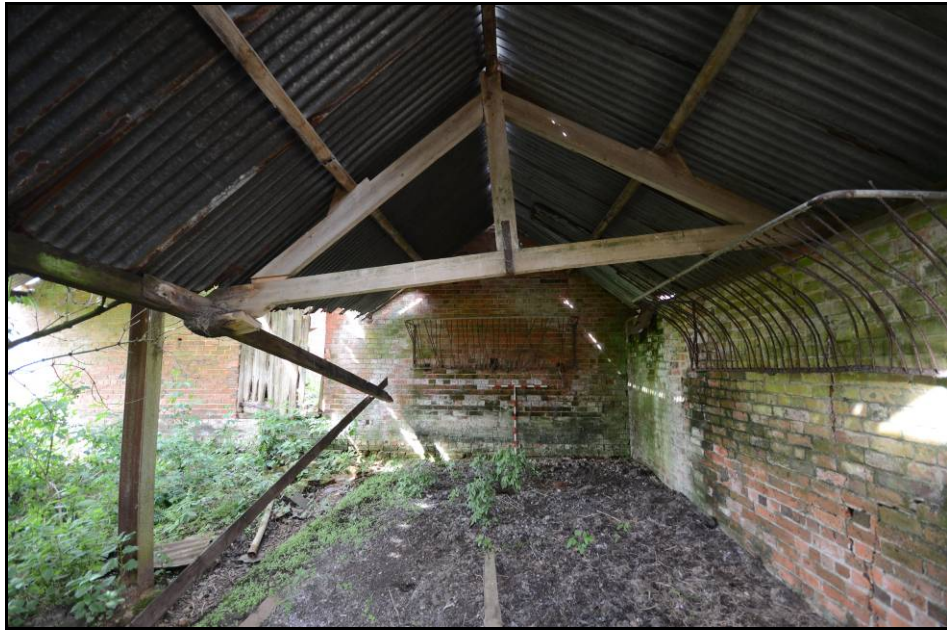
The Cow shed, interior, looking west Fig 36

The cow shed is an open space with an earth floor, measuring c4.2x7.5m (Fig 7). Raised iron mangers are fixed to the west and north walls (Figs 36 & 37). The loose box is a rectangular room measuring c4x3.6m (Fig 7). It has a single doorway to the south which is flanked by a single square window (Fig 38). Both door and window openings have timber lintels and frames. A single beam spans the room, supported to the west on the tie beam of the roof truss, and at the east by a beam which crosses the room north-south, supported over the walls. A number of chains are looped around the central beam. The floor of the room has been dug up but it seems likely that the room formerly had an earth floor.
