**Photographic building recording survey
of the overbridges at M1 Junction 11a
A5-M1 Link Road
January 2016**

Report No. 16/32

Photographic Building Recording Survey of the overbridges at M1 Junction 11a A5-M1 Link Road

January 2016

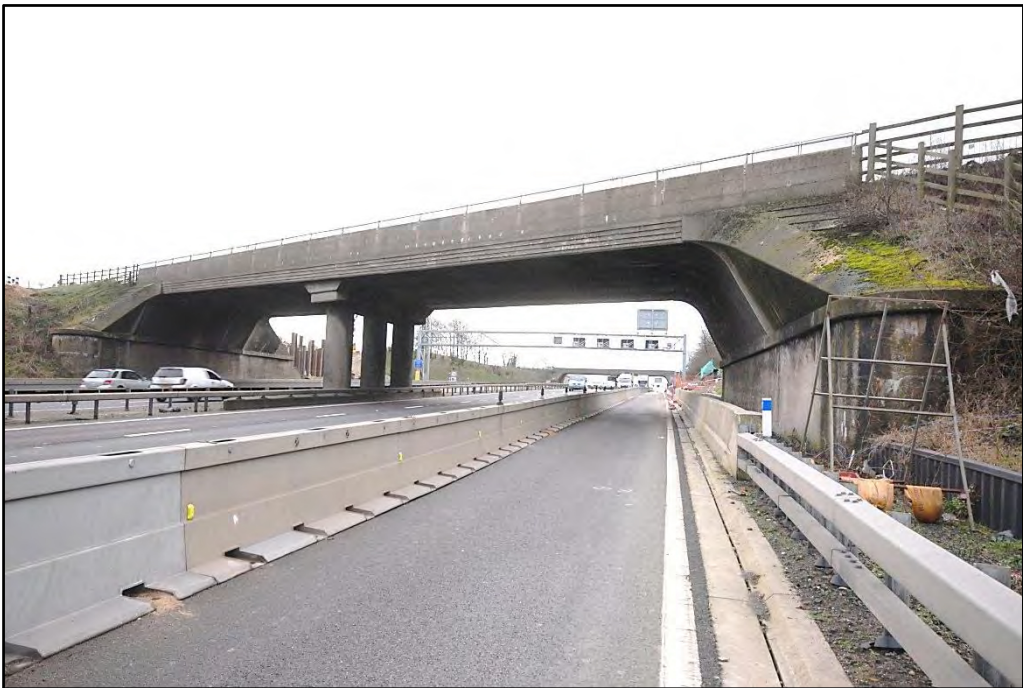
The north elevation of Chalton Bridge, looking south-east Fig 18

In respect to the age of the bridge there was some damage and repairs. Their approximate locations were noted only on the elevations (Figs 18, 19 and 46). The condition of the bridge was such that concrete was flaking off the parapet and exposing some of the steel rebar, some of which have been patched (Figs 27, 33, 47 and 48). Concrete section joints were in-filled with a grey rubber compound, over time cracks were treated the same (Figs 48 and 49).

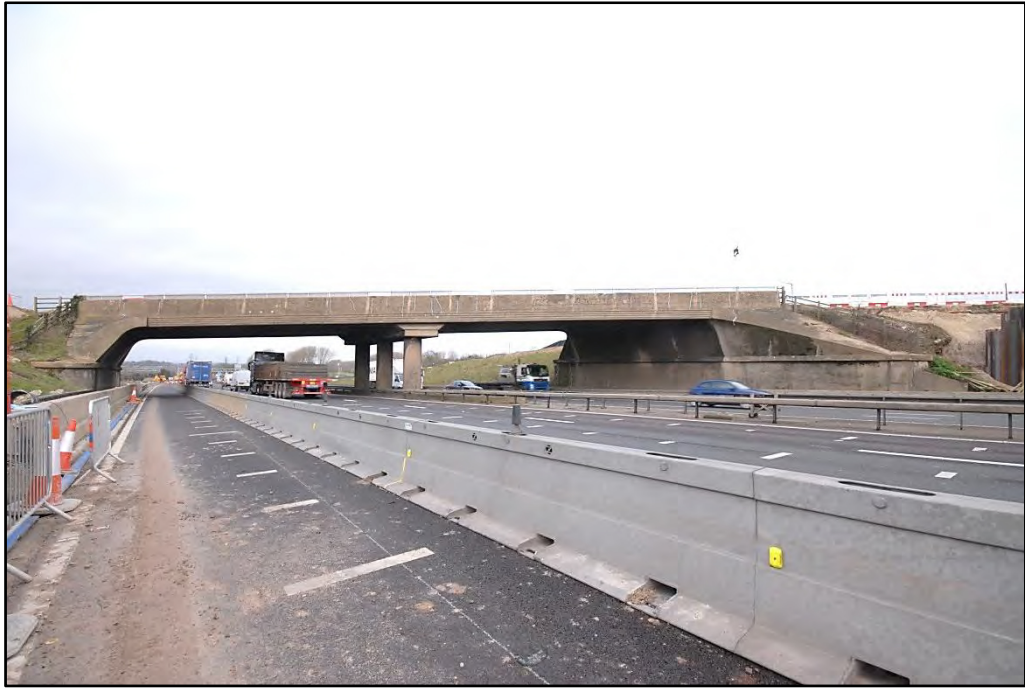
South elevation of Chalton Bridge, looking north Fig 19

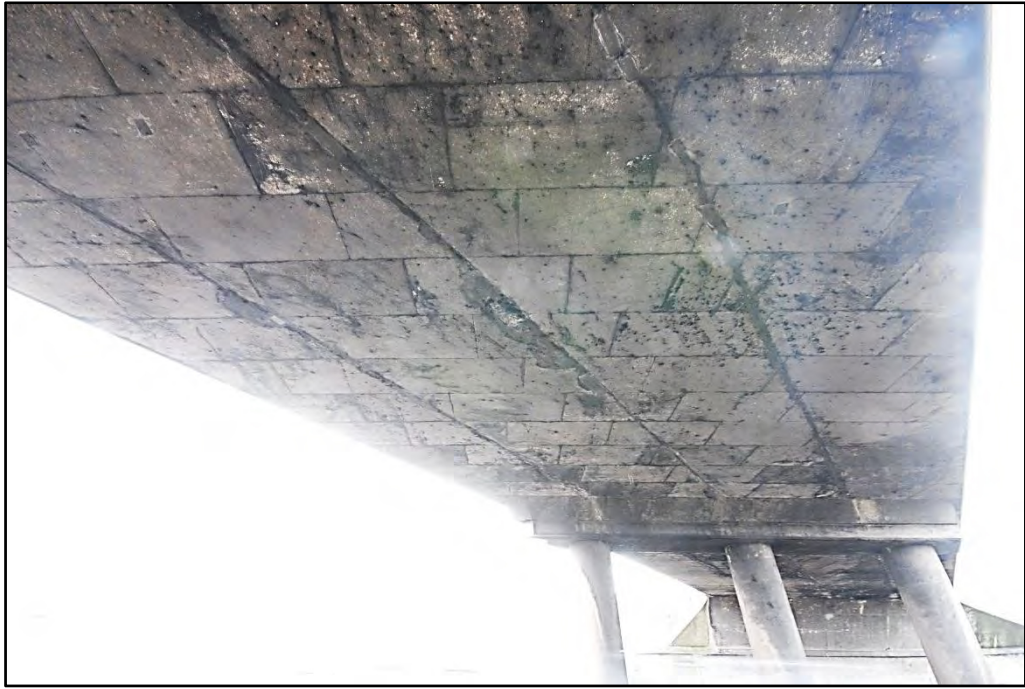
Underside of bridge with patching and columns, looking west Fig 21

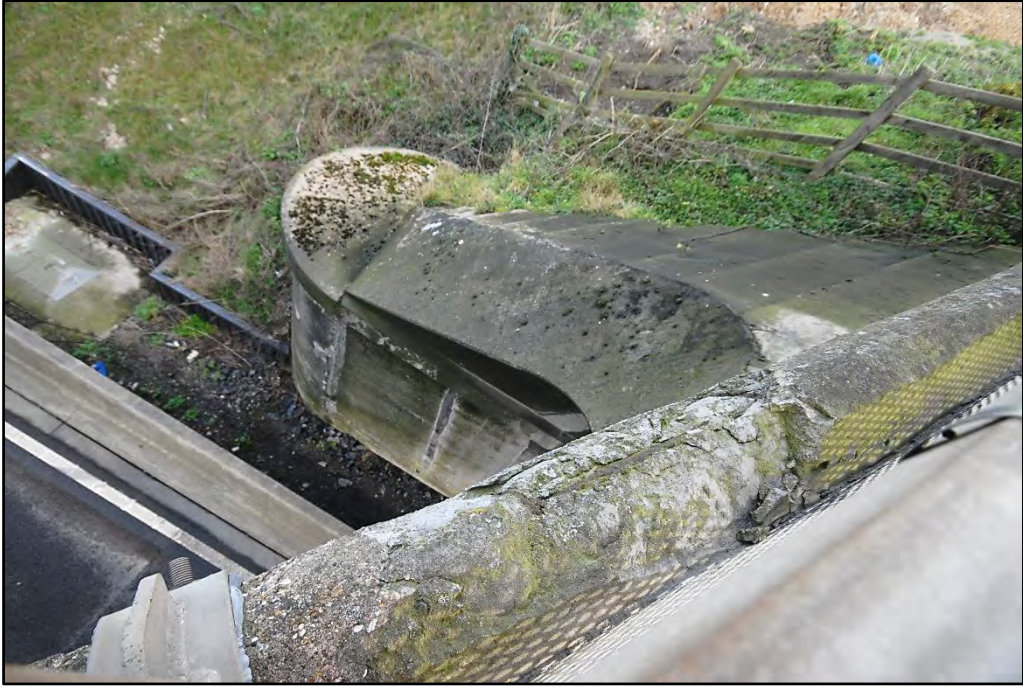
North-eastern scroll, looking down from the deck Fig 27

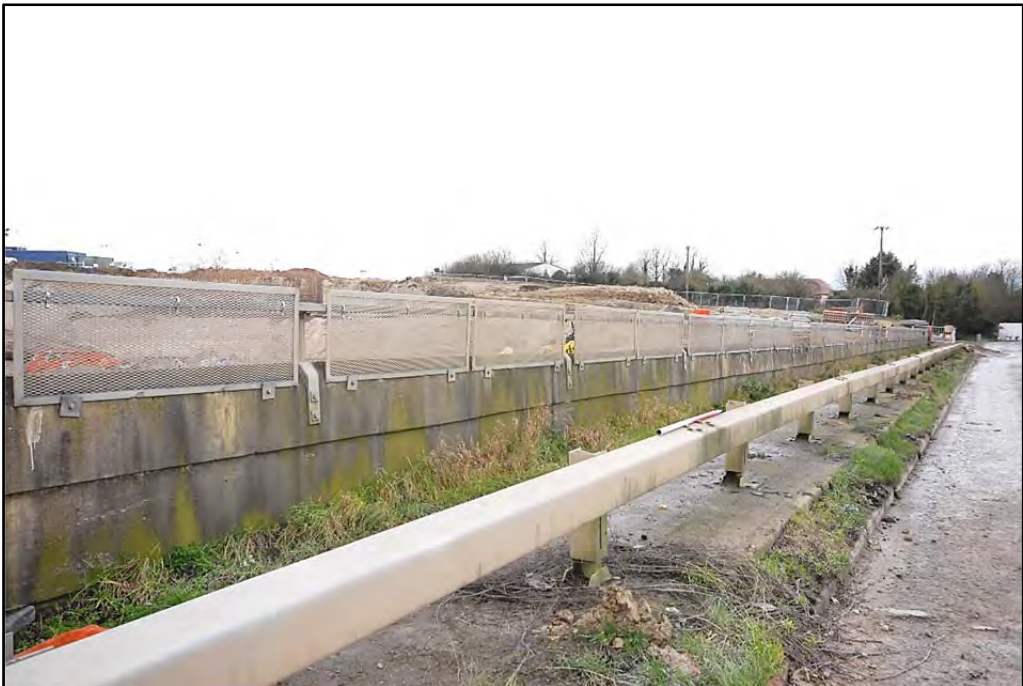
South side parapet guards, path and barrier, looking north-west Fig 37

A recent addition to the handrails was metal grills on both sides of the bridge (Figs 37 and 38). The grills measured 1360mm by 480mm and were fastened by square bolts at their bases and metal bands towards the top to the rail (Fig 42).

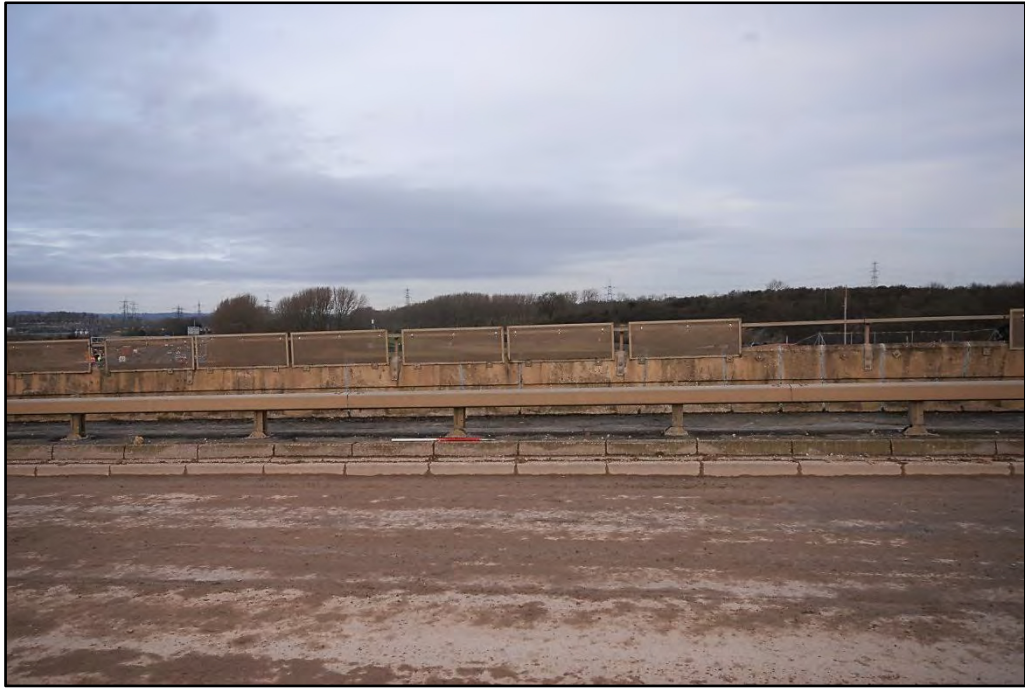
The road, pavements with barrier and north parapet, looking north-east Fig 38

The deck and parapet (Fig 34) were constructed of reinforced concrete with the road, 7.33m wide, laid in tarmac (Figs 35 and 36). The pavement on both sides had been raised (Fig 34). The original pavement on both sides was concrete overlain with a later tarmac pavement on the north side and concrete on the south side (Figs 37 to 39). A galvanised steel crash barrier was later added to both sides, probably for safety reasons (Figs 37 and 38).

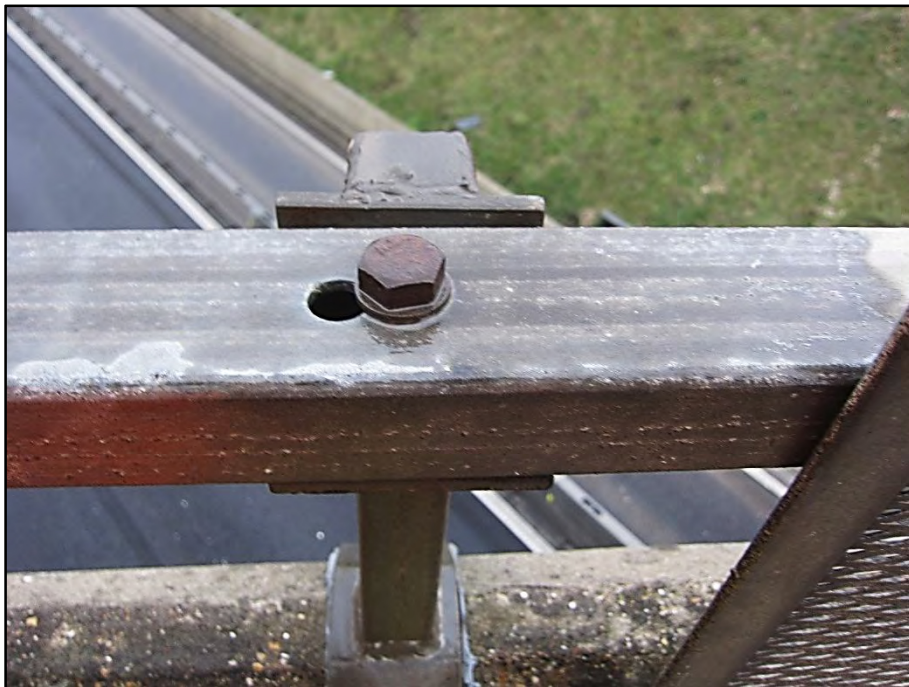
Bolt holes for the railing Fig 41

The parapet comprised three inwards stepping sections that became progressively thinner and with a saddle coping top (Figs 34 and 40). Both parapets were topped with galvanised handrails, which were added shortly after completion of the bridge (Figs 34 and 40 to 42). These were fixed to the concrete through U-shaped fixtures with two bolts, raising the structure by c300mm. The fixtures were fixed at c280mm intervals. Some fixtures were raised and some were set into the concrete, presumably to level the rail. The rail measured 60mm by 35mm and was screwed to the fixture through an L-shaped plate, occasionally two screw holes were present (Fig 41).

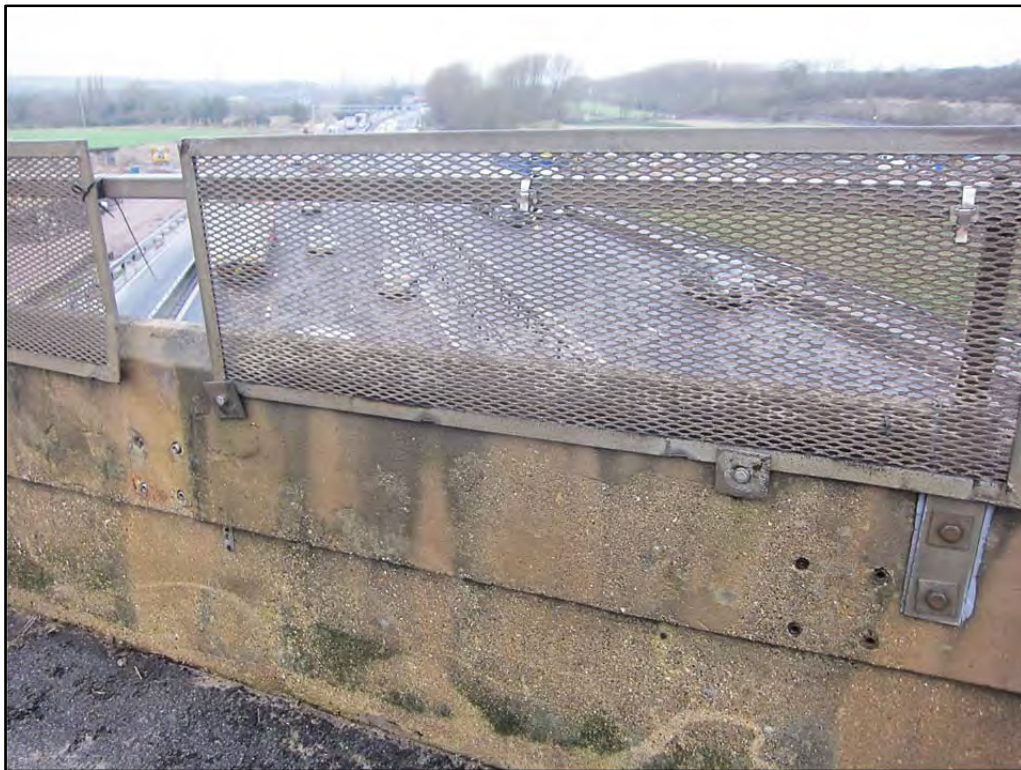
Bolt holes on north parapet, looking north-west Fig 43

On the north side, northbound, were three sets of four bolt holes (Figs 43 to 45). Also below the first step-in are screw holes and small rectangular brackets. Google view of the Chalton Bridge, dating from May 2012, depicts an electrical cable leading to a pole supported by a rectangular bracket fixed to the parapet by four bolts (Fig 44).

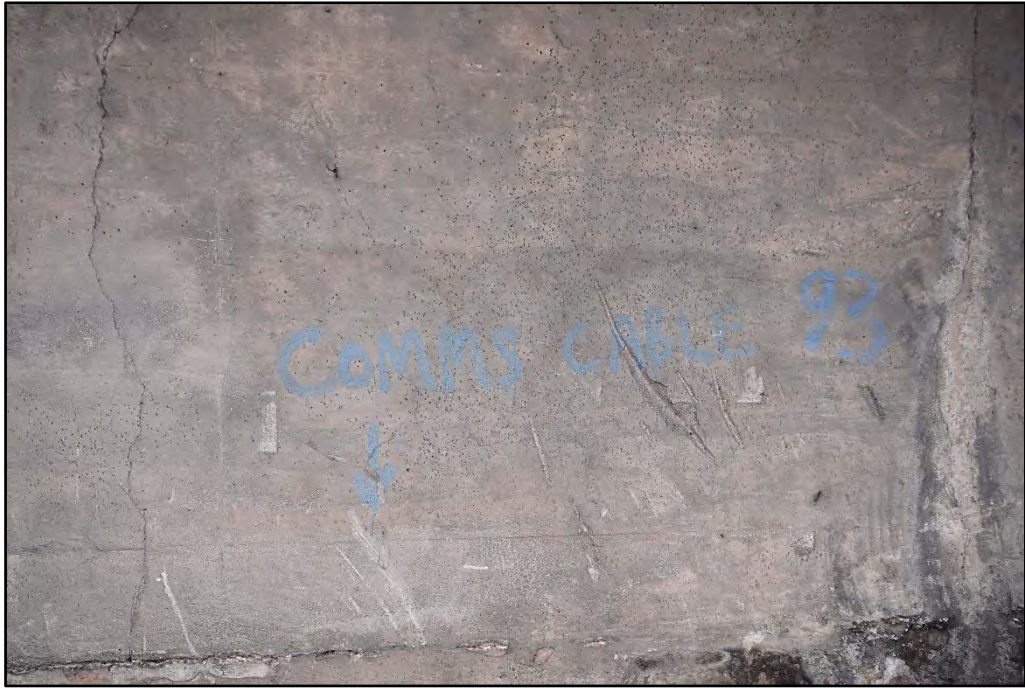
Comms cable 93 marking on southbound side Fig 55

Under the deck on the northbound side frequent parallel scratches could be seen, possibly due to strikes from high-sided vehicles. The underside of the deck has been also patched in the past (Figs 50 and 51). The abutment walls and scrolls all show cracks, areas of blown concrete exposing rebar poles, and water marks from water seepage (Figs 52 to 54). Only one written marking beside the bridge number was noted on the south bound side stating the location of communications cable (Fig 55).

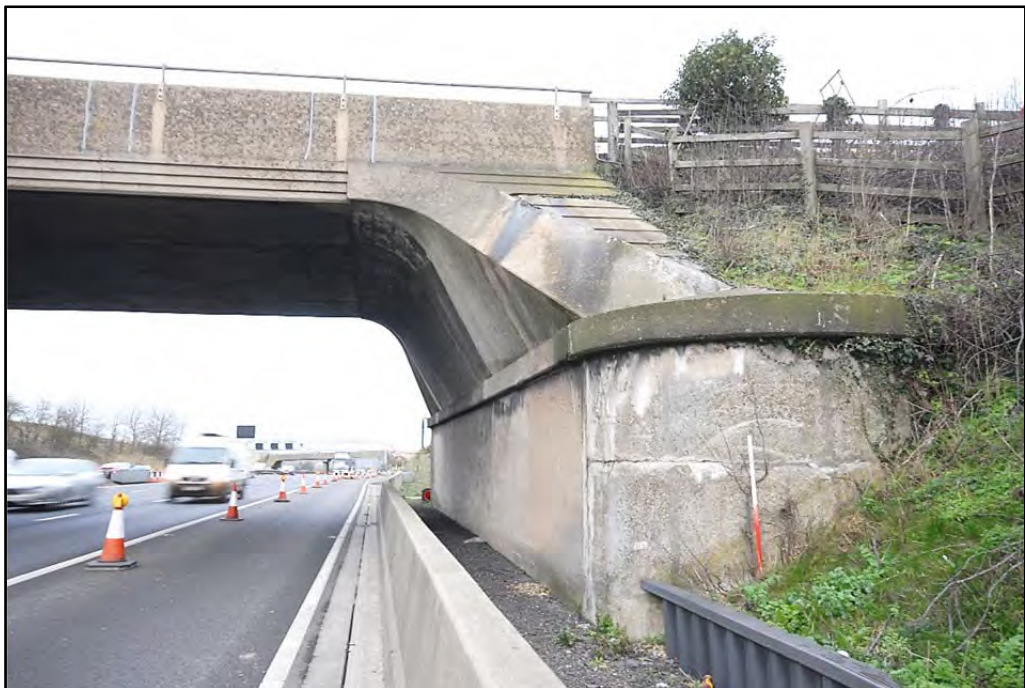
South-east scroll, looking north-east Fig 66

Concrete was flaking off the parapet and exposing some of the steel rebar, some of which have been patched. Concrete section joints were in-filled with a grey rubber compound, over time cracks were treated the same (Figs 66, 69 and 75).
