# Historic Building Recording at the former Anchor Brewery, Mill Road Oundle, Northamptonshire May 2015 – March 2016

Report No. 16/51  
Author & Illustrator: Amir Bassir

© MOLA Northampton 2016  
Project Manager: Amir Bassir  
Planning ref: 15/01967/FUL  
NGR: TL 03740 87920  
Event No. ENN108310

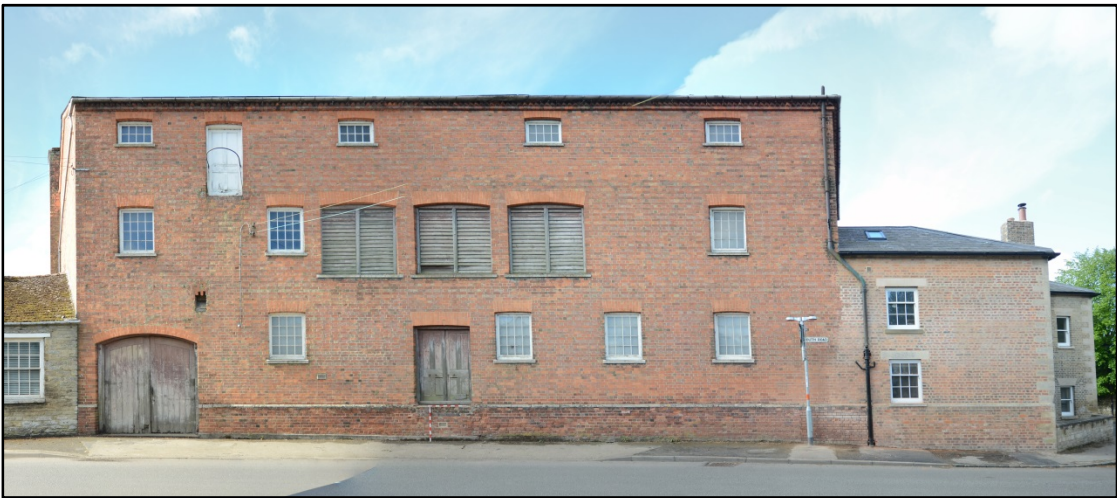
North elevation of the Brewery (photo-composite) Fig 10

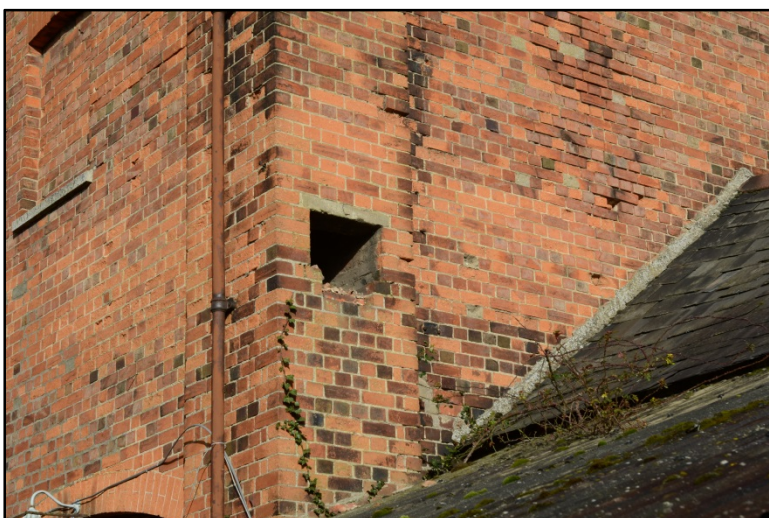
Opening to the firebox, with scar of tank to the right Fig 16

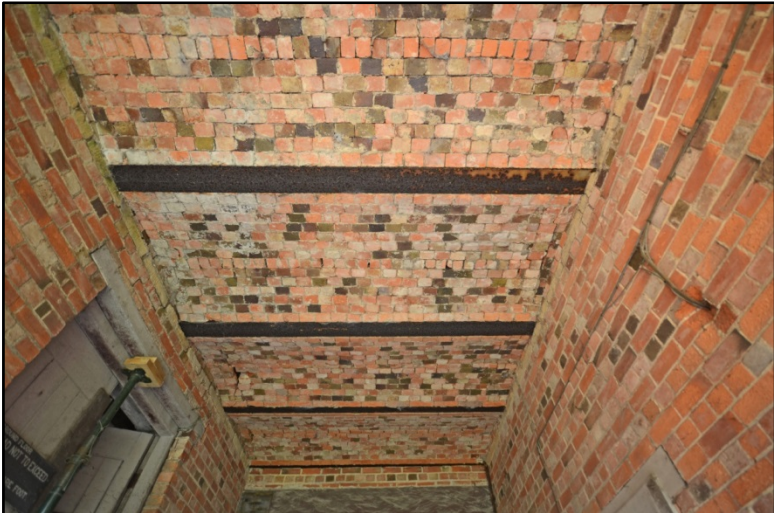
Carriage arch roof, showing supports for the firebox Fig 20

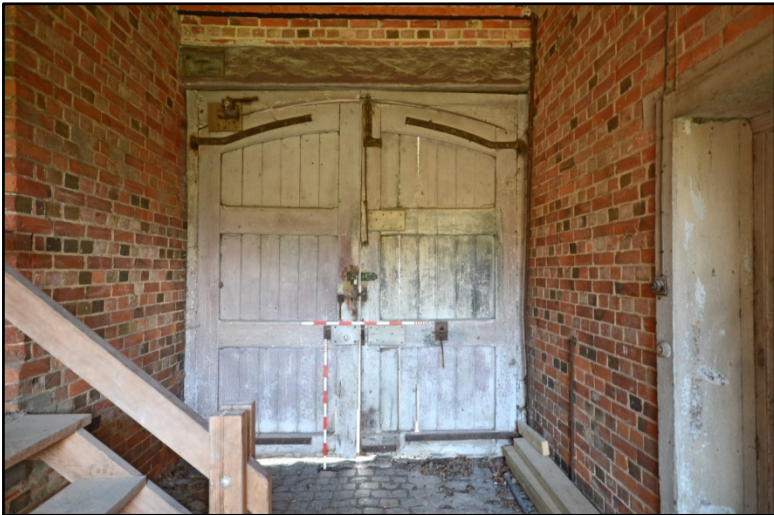
A carriage or coach arch is located at the far east of the elevation. The opening is c2.8m wide and c3m in height, with an arched brick lintel externally. Hidden behind the brick lintel is a large timber beam which carries the weight of the wall over the arch. The double doors are externally constructed of vertical planks and bound with curving top rails that match the curve of the opening. The planks are strengthened by horizontal bracing on the inner face of the door, and custom-made curving strap hinges are installed on the inner side of the top rails. Straight strap hinges are positioned at the bottom rail of each door (Fig 21). The western side door can be opened with an iron vertical thumb latch and the eastern door can be secured at the top by a vertical bolt lock. A rim lock is also installed on one of the horizontal braces or lock-rail, and a padlock and latch are positioned above the thumb latch. A mid-20th-century *Briton B* manual door closer has been installed at the top corner of the western door. The joinery of the door is of a good quality and the door remains in relatively good condition, though with some deterioration of the planks at the very bottom.

Interior face of carriage arch door Fig 21
