Centre for Archaeology Report 50/2005

**Deconstruction and Conservation of Roman Armour from
the Millennium Excavations, Carlisle**

Jennifer Jones

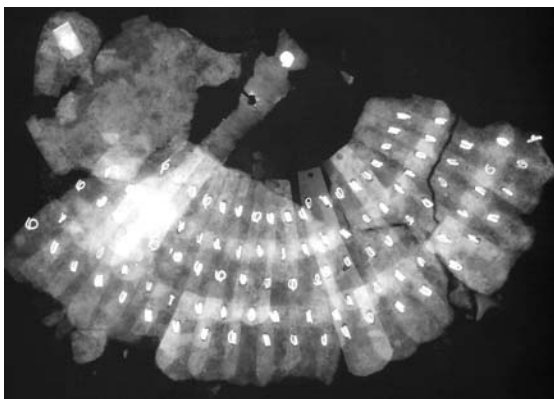
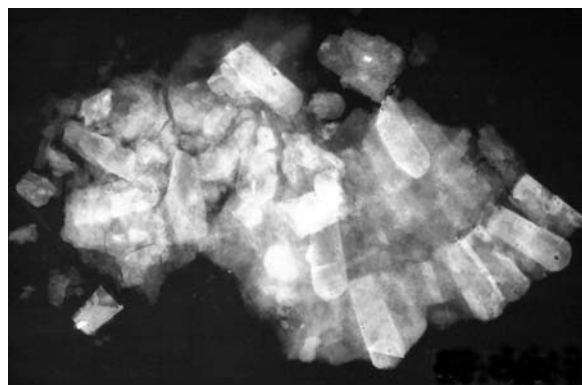
Fig 1 : 3416Δ and 3978Δ

The X-radiographs confirmed that the material was armour, possibly still partly articulated.

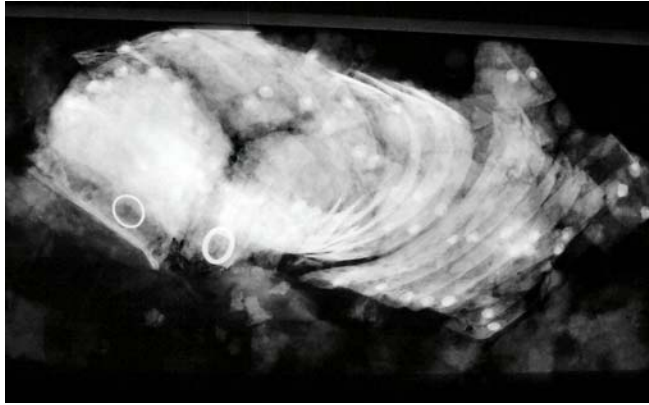
Fig 2 : 3976Δ Parts A and B

3976AΔ Although the initial impression was of an intact artefact, close examination of the X-radiographs of 3976AΔ showed that many of the pieces making up the shoulder guard were broken and/or incomplete. The central area and pieces towards the north end of the complex were particularly damaged and disarranged. Both ends of the piece appeared to be possibly original and complete, though broken – a rolled edge could be seen at the N end. There were also two possible rings in the construction which required investigation, plus a large number of rivets. It was decided to work mainly on the N and S ends of the piece, leaving the more damaged central section unconserved.

3976BΔ The proximity of this area to the shoulder guard suggested that it could be part of the same piece of body armour, and it was therefore important. However X-radiographs showed that large areas were damaged and disarranged, and might yield little evidence. It was decided to begin conservation with the less damaged plates on the upper surface, and then to conserve only the more complete pieces from the layers below.

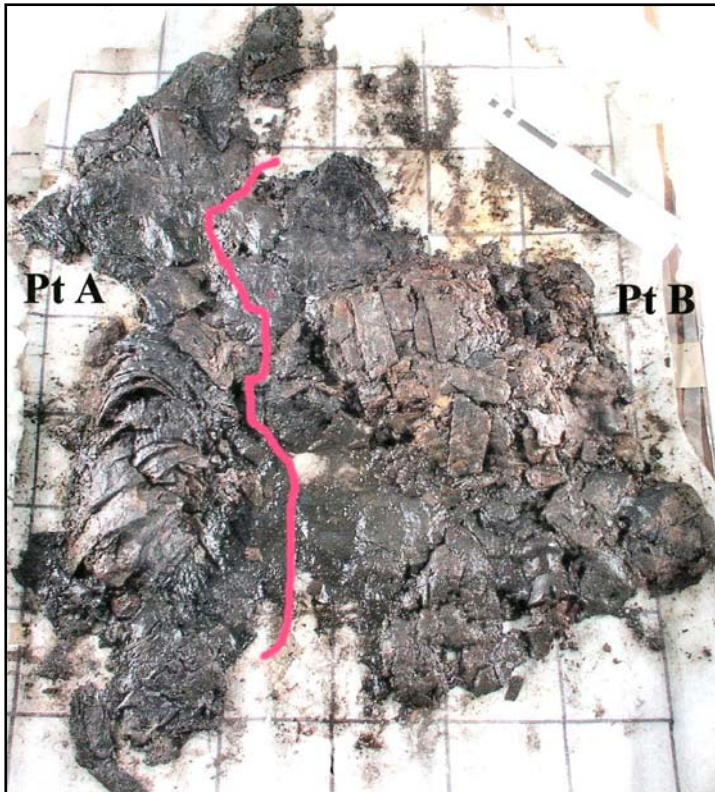
The largest block (3976Δ) caused some problems. Throughout the deconstruction process, the organic material, and consequently the metal, would have to be kept wet. Deconstructing 3976Δ was complicated and would take the longest time, and it would have been unwise to allow the whole wet block to remain exposed to the air throughout. Examination of the X-radiographs showed a 'path' through the block where there seemed to be no metal. To minimise the block's exposure to the atmosphere, it was decided to split 3976Δ into two parts along this path, to allow one half to remain frozen until deconstruction. Another advantage of this was that the resulting smaller blocks then fitted in a domestic freezer. The fragments of leather between the areas of metal in 3976Δ - most of which were small pieces overlying each other - were carefully separated, and the block split into two parts – A and B (see below).

Fig 7 : 3976Δ before deconstruction, showing line of separation into Parts A and B

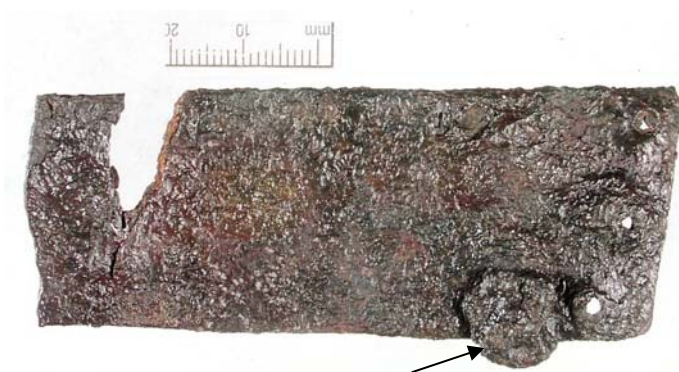
Rivets made from iron and copper alloy were also revealed by air abrasion. 3976Δ had mainly copper alloy rivets, with just a few made of iron - thought to be repairs. 3979Δ, however, had iron rivets. All the rivets were used to hold a leather lining or straps in place, not to join the armour plates together (see below).

Fig 15 : 3979BΔ/9 showing iron rivet

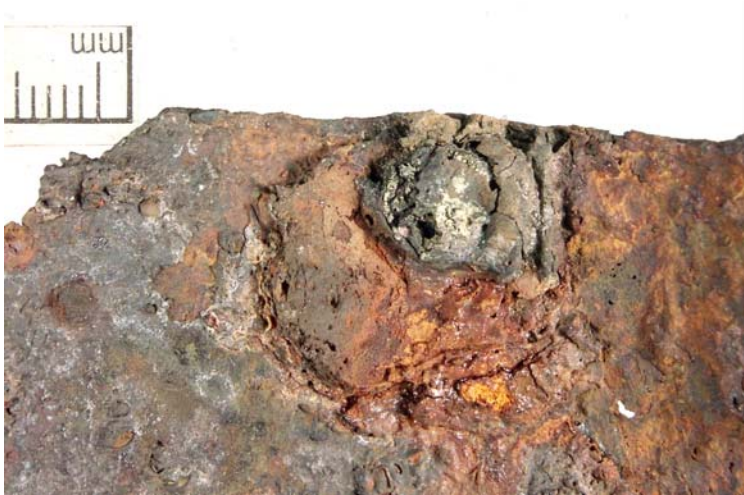
3976AΔ : Mineralised leather was found on 28 out of the 35 pieces conserved. It was present discontinuously on the back of the metal plates, occasionally surviving almost to the full depth of the copper alloy rivets (eg 3976ΔA/20). Traces of a fibrous structure were seen on 3 of the pieces, including 3976A/15, which also had the remains of a possible leather ‘washer’ around the rivet head.

Fig 26 : 3976ΔA/15 back – leather ‘washer’ surrounding copper alloy rivet head

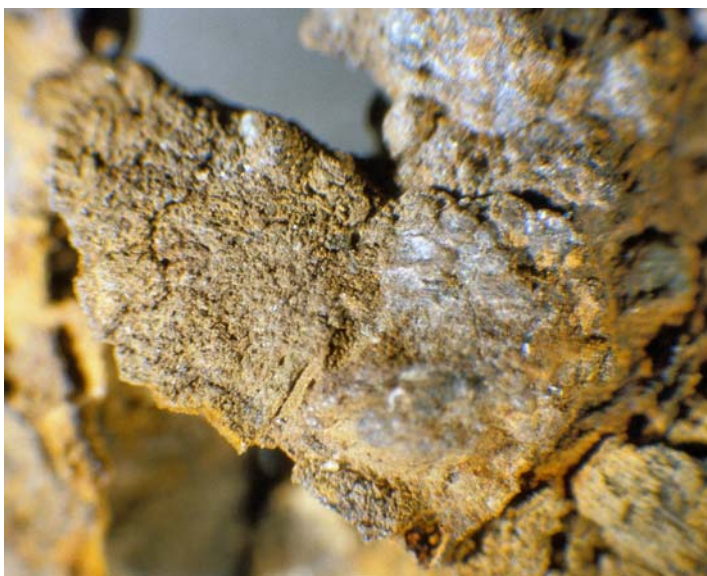
3976BΔ : Thirty nine of the fifty four conserved pieces had evidence of mineralised leather, with seven retaining traces of a fibrous structure. Two pieces were of particular interest –

Fig 27 : 3976ΔB/14 back – mineralised leather retaining fibrous structure

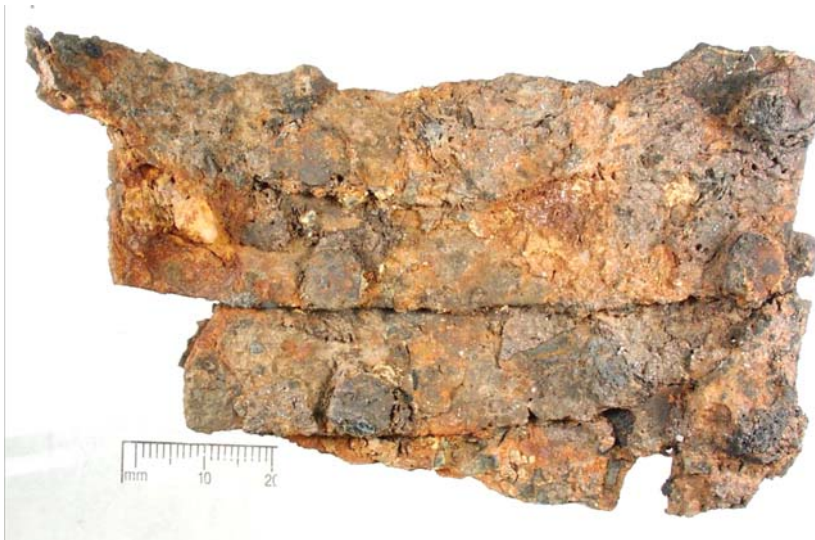
3979Δ : The length of *manica* or arm guard, appeared to have traces of straps running along the inside of its length when first viewed - as would be expected from the method of construction and intended usage. This was not disproved by conservation work, but the mineralised leather seemed to be present over a much wider, and less well-defined area than would have been expected from straps alone. Perhaps the arm guard had a lining of leather as well as the strapping, which was used to keep the iron plates in position and to allow them to articulate. Samples were taken for SEM examination (see below).

Fig 28 : 3979Δ/2 inside, showing the extent of the orange/brown mineralised leather

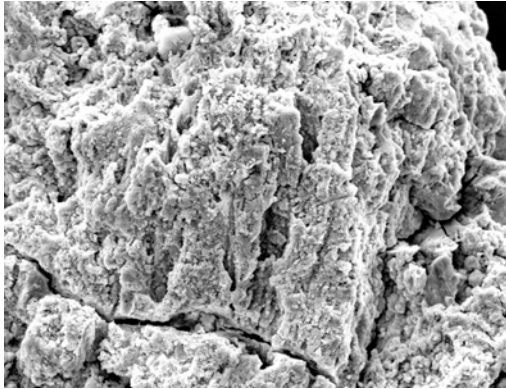
Under SEM, only one sample of mineralised material showed any characteristics which could be positively identified as leather. This sample was taken from the back of 3976ΔB/14A, a fragmentary piece of iron scale armour, which had an area of mineralised material with a visible fibrous structure, surrounding and covering a large

(13mm diameter) iron rivet head. Under SEM, traces of a bundled structure could be seen along the edges of the sample.

Fig 33 : 3976ΔB/14A SEM showing the bundled structure characteristic of leather

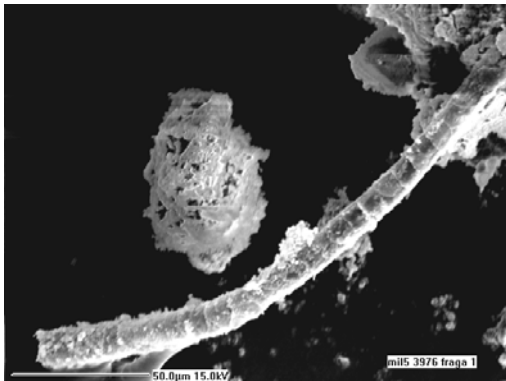
SEM examination of the non-mineralised hair found among iron corrosion on the back of 3976ΔB Fragment A found this to have a scale pattern consistent with calf skin, although a positive identification was not possible.

Fig 34 : Scale pattern on non-mineralised hair from 3976ΔB Frag A

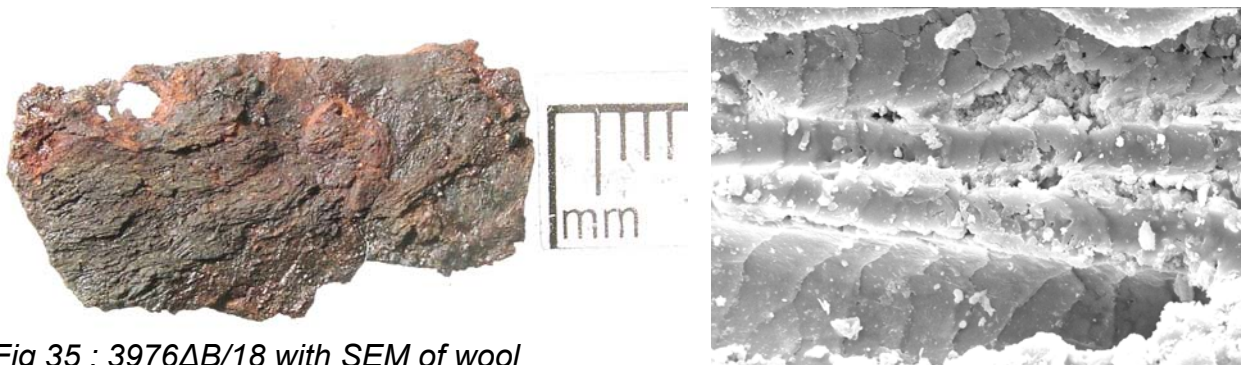
3976ΔB/18 had a substantial area of mineralised hair or fur on the back of the metal, the pattern of the tufts being visible without the aid of a microscope. This was also sampled for SEM work (see below).

The mineralised hair or fur from the back of 3976ΔB/18 showed casts of animal fibres with a scale pattern. Under SEM, these scales looked different to those found on Fragment A, with more curved or undulating boundaries. Their appearance was similar to wool fibres, an identification which would be consistent with the ‘tufted appearance’ of the mineralised material.

Fig 35 : 3976ΔB/18 with SEM of wool

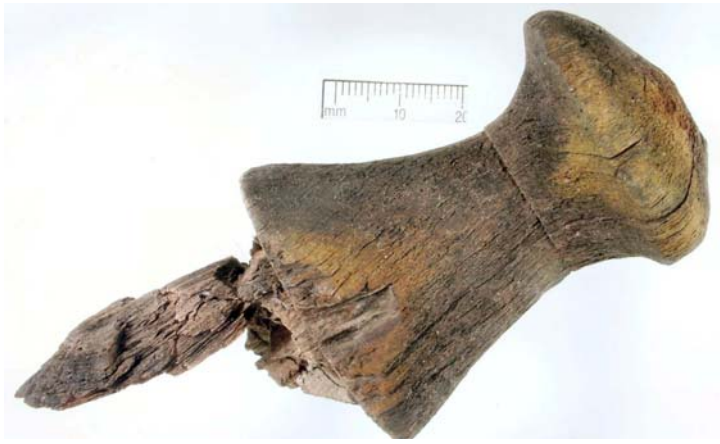
From 3976AΔ came a small chunk of wood with a wedge-shaped end (Wood AX), made of alder. The incomplete handle from 3976BΔ (Wood M, Fig 37), was found to be made of hazel (*Corylus* sp.).

Fig 37 : Wooden handle from 3976ΔB, truncated by the lifting process

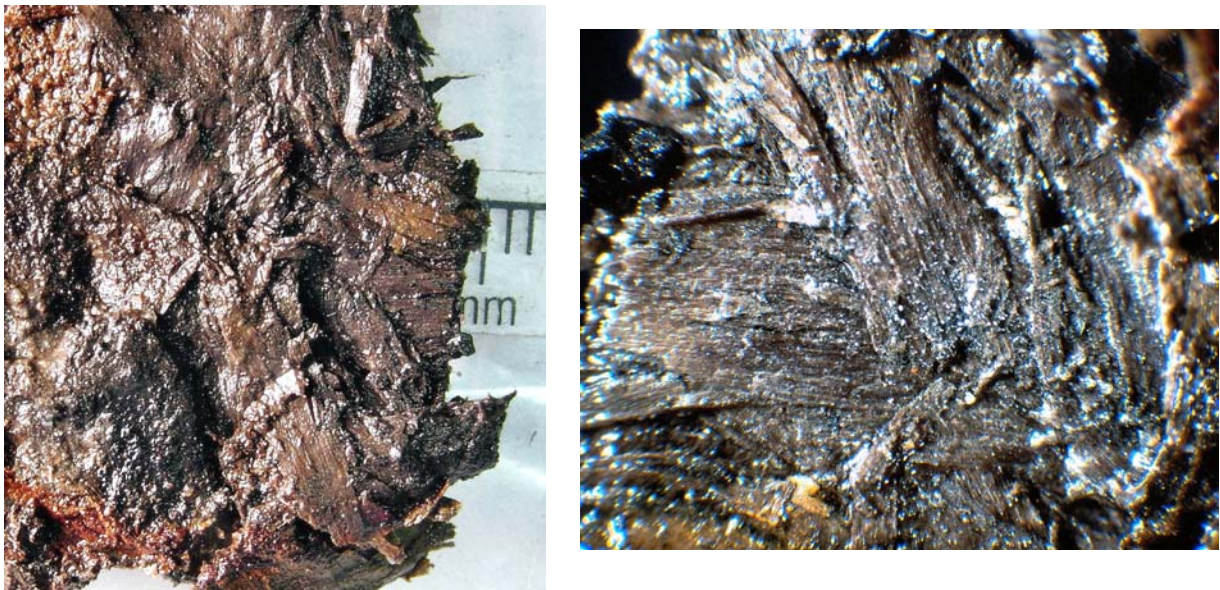
As already mentioned, much of the fragmentary wood recovered during the deconstruction of the blocks was made up of small chips, often with visible tool marks, which appeared to be woodworking debris. There was not time for all these small pieces to be identified microscopically, but they were examined after conservation. Many of the pieces examined were made from oak (*Quercus* sp.), but alder and ash (*Fraxinus* sp.) were also identified.

Fig 38 : Wood working debris from the deposits surrounding the armour

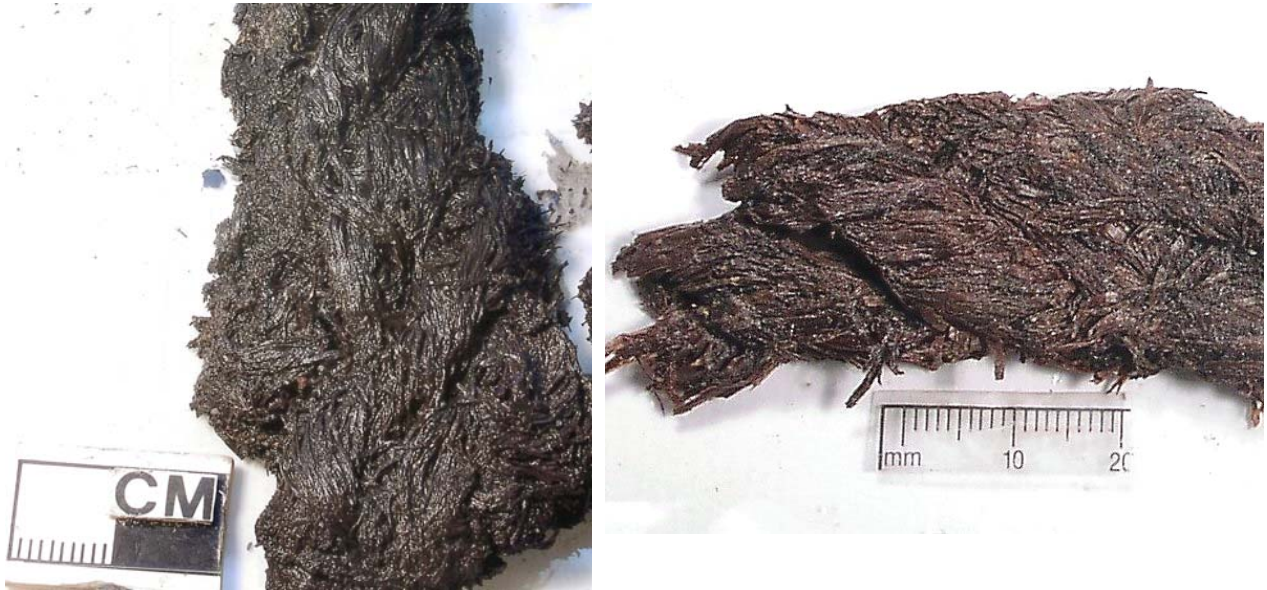
There appeared to be two different sorts of rope present – one type very dark in colour and quite hard and fibrous to the touch (3976AΔ BI and 3976BΔ Z). The other type lighter in colour, softer and more flexible (3976AΔ BO and 3976BΔ AD & AT). The ropes appeared to be made from plant bast fibres, but an identification was not

Fig 39 : Rope Z and Rope AT before stabilisation

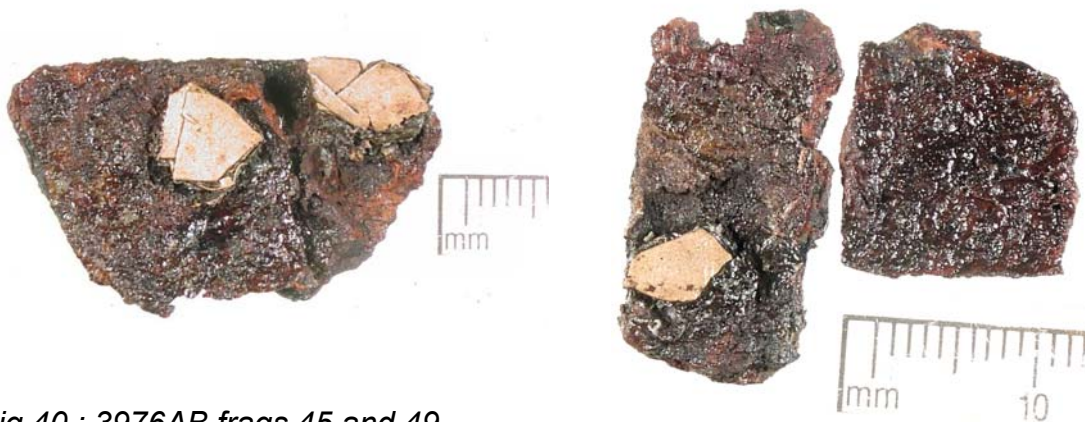
The semi-quantitative EDXRF analyses showed the use of a range of copper alloys in the armour's construction. They also showed quite a high degree of variability among the copper alloy used in the same piece of armour. This was particularly evident in the alloys used for the rivets of 3976ΔB. This variability may be evidence for extensive repairs, carried out either by different workers, or possibly by the owner himself in the field. One end of the copper alloy rivet would have been visible on the outside surface of the armour, and therefore it would be expected that at least the colour of the rivet would be consistent, regardless of its composition. This was not always the case in 3976ΔB, however, where some of the iron plate fragments (45 & 49) had rivets which were different from the majority in both composition and colour.

Fig 40 : 3976ΔB frags 45 and 49

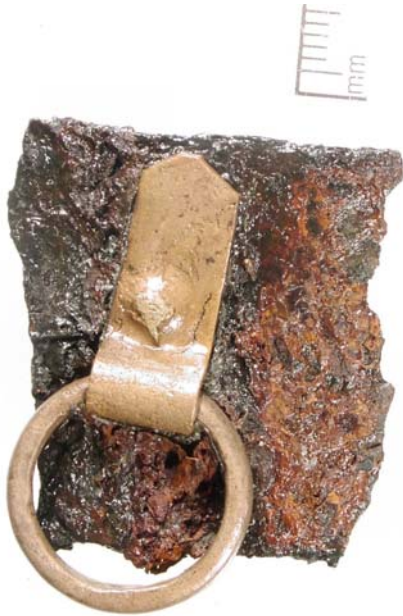
Fig 41 : 3976ΔA/25

The choice of different alloys for different purposes was evident in 3976AΔ/25 (Fig 41), an iron plate fragment with attached copper alloy ring, tag and rivet, where each component of this small assemblage was found to be different in composition (see
