RESEARCH REPORT SERIES no. 36-2012

BEXWELL BARN, BEXWELL, NORFOLK ANALYSIS AND INTERPRETATION

Olivia Horsfall Turner

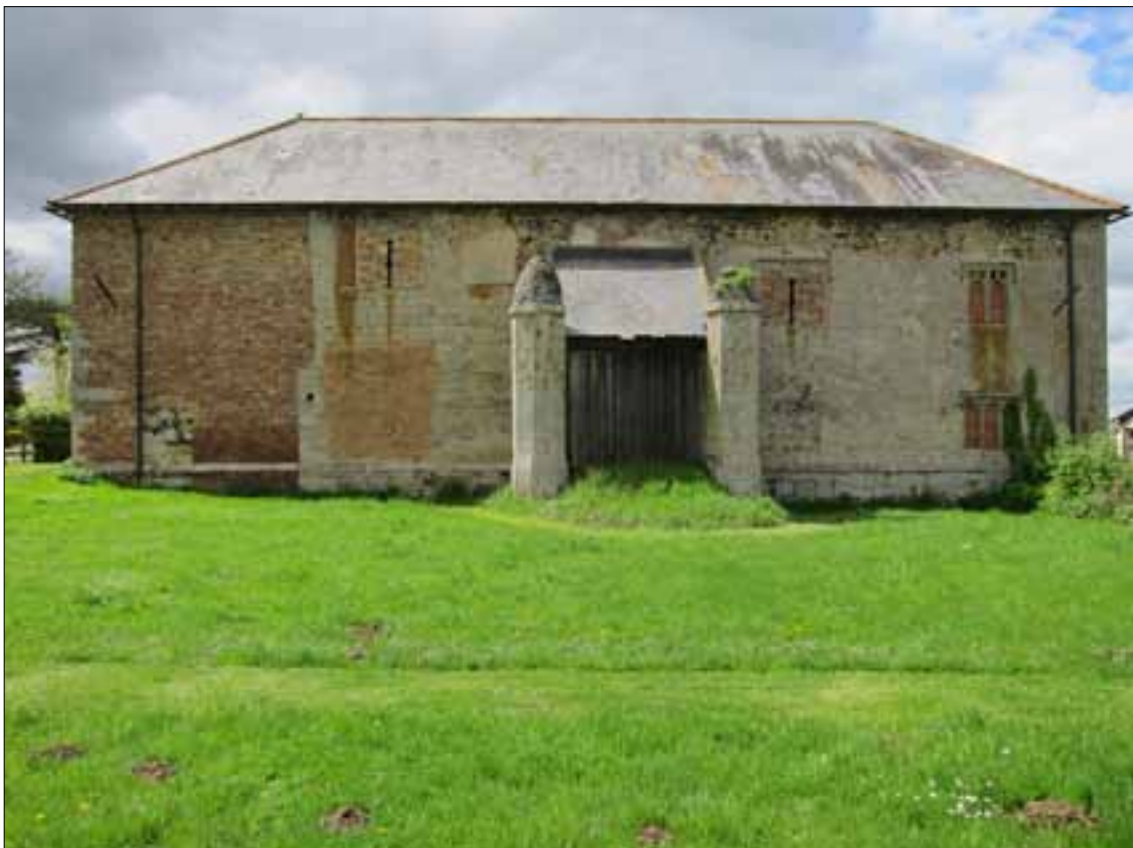
Bexwell Barn, located on the road between Downham Market and Crimplesham, is constructed of rubble, carstone, high-quality ashlar blocks, re-used medieval ashlar features and brick of various periods (Figure 1). The roof is 20th century and therefore offers no diagnostic information. The fabric evidence is particularly complex and ambiguous, while archival sources are almost completely silent. The building has been interpreted either as the surviving 15th-century gatehouse of Bexwell Hall,¹ or as 16th-century lodgings constructed from post-Dissolution spolia.² This report re-assesses the fabric, archival and map evidence. Given the limitations of the known sources, it is not possible to provide a definitive account of the building, but the investigation has resulted in a different interpretation to those proposed previously. It is suggested here that the building was constructed for non-domestic purposes in the very late 18th or early 19th century, probably incorporating dismantled remains, and possibly standing remains, of the manor house of Bexwell Hall and possibly spolia from other sites.

Figure 1. Bexwell Barn, Bexwell, Norfolk, east façade.

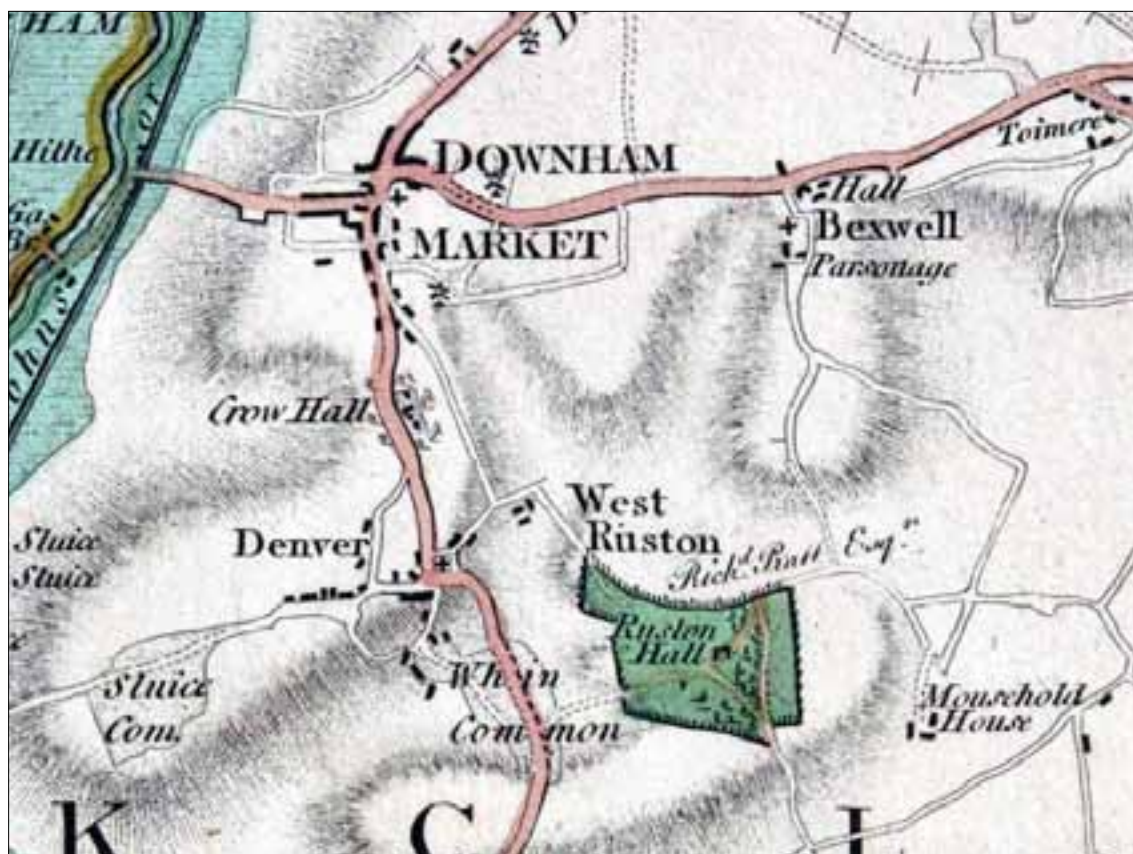
The earliest known map evidence for Bexwell is provided by William Faden's *Map of Norfolk* which was surveyed between 1790 and 1794 and published in 1797. The map shows the settlement of Bexwell with 'Hall' and 'Parsonage' indicated in text and the church represented by a cross (Figure 26). Three buildings appear next to the legend 'Hall': a U-plan building close to the main road from Downham Market to Crimplesham, and two further rectangular-plan buildings to the east. Even though the map is not at a large scale and represents buildings schematically (the U-plan appears to be the generic indication for a hall, rather than documentation of an actual plan), there is no building on Faden's map that corresponds to the current Barn. Equally, the map is unequivocal that there was still a hall there at that time, whereas later maps and current fabric evidence give no indication of the location of a manor house. Unlike other country houses, Bexwell Hall on Faden's map is not accompanied by any owners' or resident's names, nor is there a park or garden indicated around it as there is with most other substantial residential properties, for example, at Ryston (Ruston) Hall owned by Richard Pratt Esq.. This suggests that Bexwell Hall was either unoccupied or tenanted c. 1790. By this time, the Hall may well have been in disrepair, or already in use for non-domestic purposes.

Figure 26. Bexwell, as depicted on William Faden's *Map of Norfolk*, surveyed in 1790–1794 and published in 1797 (Courtesy Warwick Leadley Gallery, London).

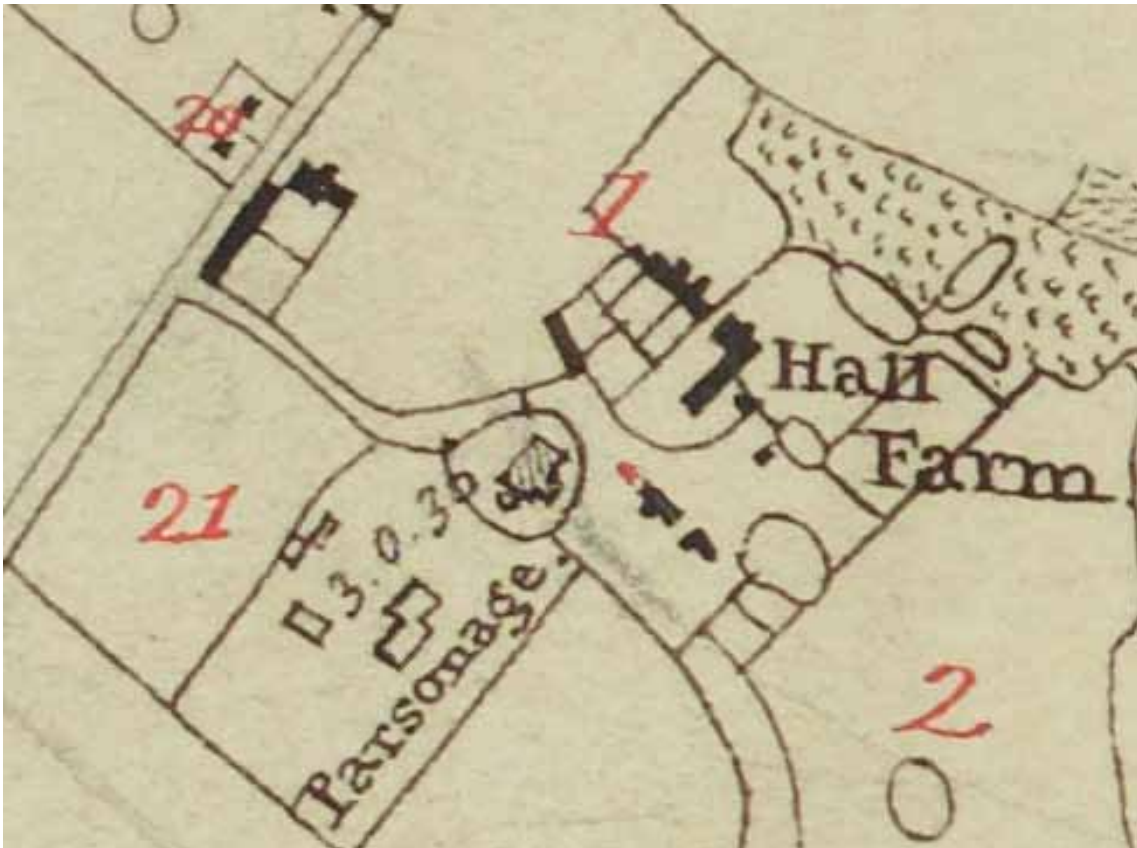
A plan of Bexwell surveyed in 1832 by J G Lenny is the first known map depicting a building that recognisably corresponds to the current footprint of the Barn (Figure 27).¹⁴ The key to the map indicates that at this time the Barn and the surrounding land and buildings were part of a parcel of land called 'Hall Farm' which consisted of 'Farm House, Outbuildings, Yards, Gardens, Pleasure Grounds, and the Hill'.¹⁵ This indicates that by 1832 at the latest, Bexwell Barn had been constructed.

Figure 27. Detail of plan of Bexwell, 1832, surveyed by J G Lenny (NRO PRA 367, 379x6)
(Courtesy Norfolk Record Office).

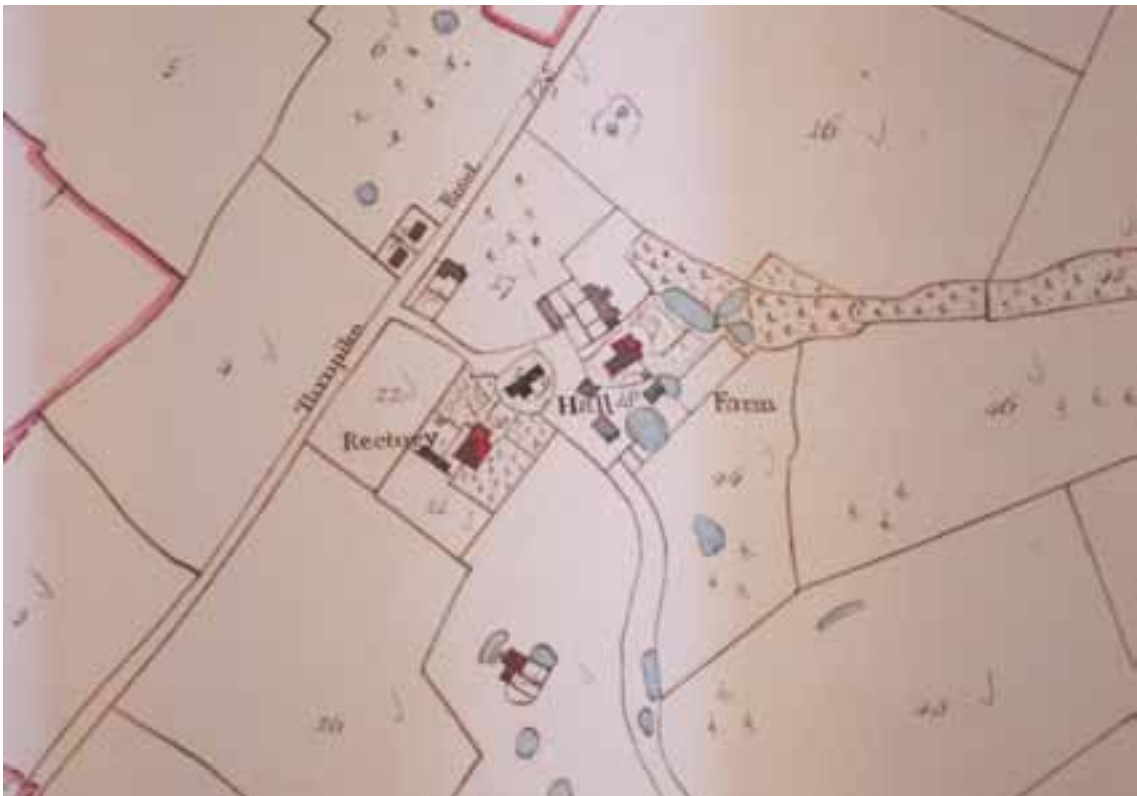
The Barn also appears on the Tithe Map of 1838, surveyed by Lenny and Croft (Figure 28).¹⁶ Coloured in black, it is shown as non-residential. It appears as an L-plan building, with the foot of the L to the north-west and a smaller projection to the east. The latter is not located in the middle of the façade, but probably represents the porch. The building is shown forming the east side of a rectangular enclosure subdivided down the centre. A discrepancy between the 1838 map and the building as it is today is that the map does not show a shallow wing to the southern end of the west façade – it may be that it was deemed too small to record. In addition, the map shows that at the northern end of the west façade there was a substantial wing that projected out beyond the wall line that now exists. This suggests that there was an additional structure against the west façade, which corresponds to the scars on the front of the building, as discussed above.

Figure 28. Detail of Bexwell Tithe Map, 1838, surveyed by Lenny and Croft (NRO DE/TA 3)
(Courtesy Norfolk Record Office).

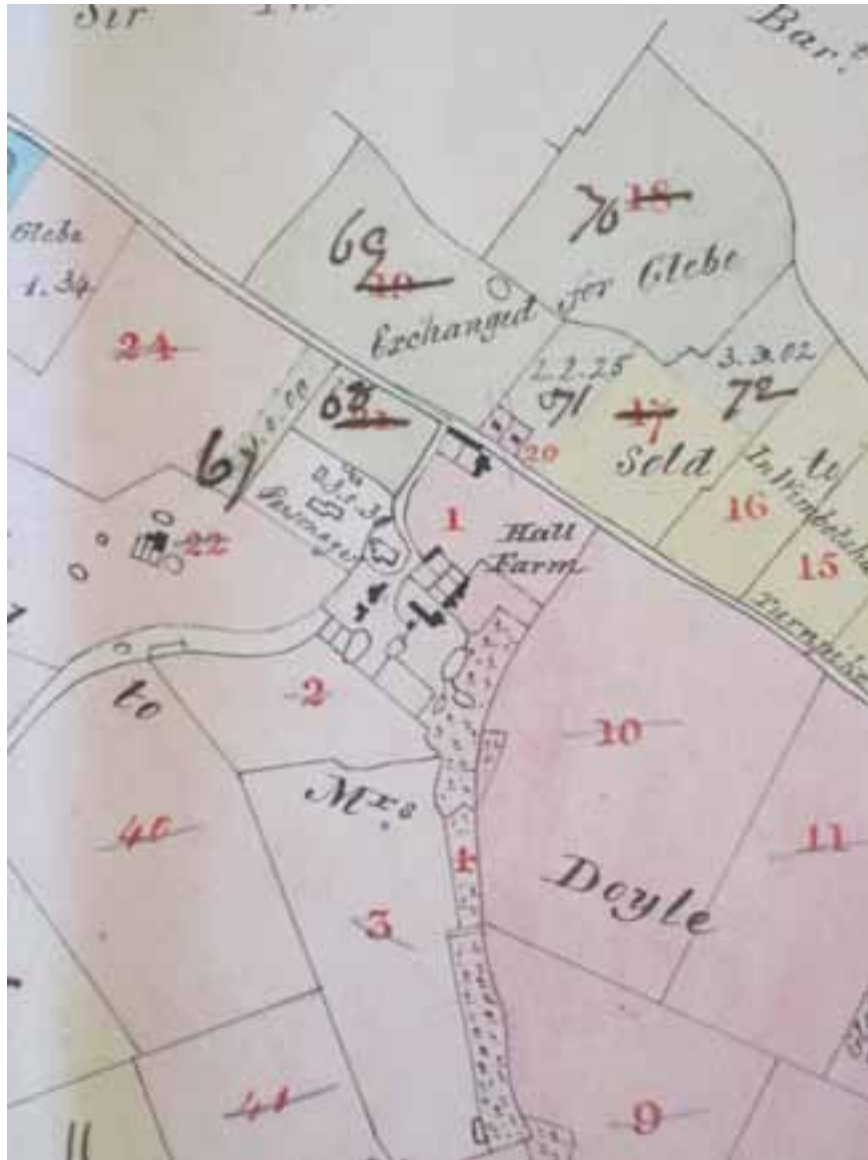
Figure 29. Detail of map for 1840 sale of Bexwell Estate (NRO PRA 369, 379x6).
(Courtesy Norfolk Record Office).

Later maps show subtle changes in the Barn and its ancillary buildings. The map for the 1840 sale is based on the Tithe Map and essentially shows the same information (Figure 29).¹⁷ In addition to the Barn itself, however, it indicates two further long buildings to the west of the Barn, running east-west, which were probably used for storage or stabling. In the 1887 OS map, the representation of the Barn corresponds closely to that of 1840. For the first time, however, the shallow wing is also shown. This probably indicates greater accuracy in the survey rather than implying that the wing was an addition, particularly as it seems likely that the wing in fact contains the only in situ fabric from the former manor house. In the 1887 OS map, the two long buildings to the west are still in evidence and in addition, there is another small square building shown adjoining the south façade. It is possible that this was associated with the now-infilled, ground-floor aperture in the south wall. By the time of the 1928 OS map, both the shallow wing and the projection at the northern end of the west façade are shown, but the westernmost of the two long buildings had been demolished, and the possible addition to the south
