RESEARCH REPORT SERIES no. 19-2013

APETHORPE HALL, APETHORPE, NORTHAMPTONSHIRE DOVECOTE ROOF

HISTORIC BUILDING REPORT

Nick Hill

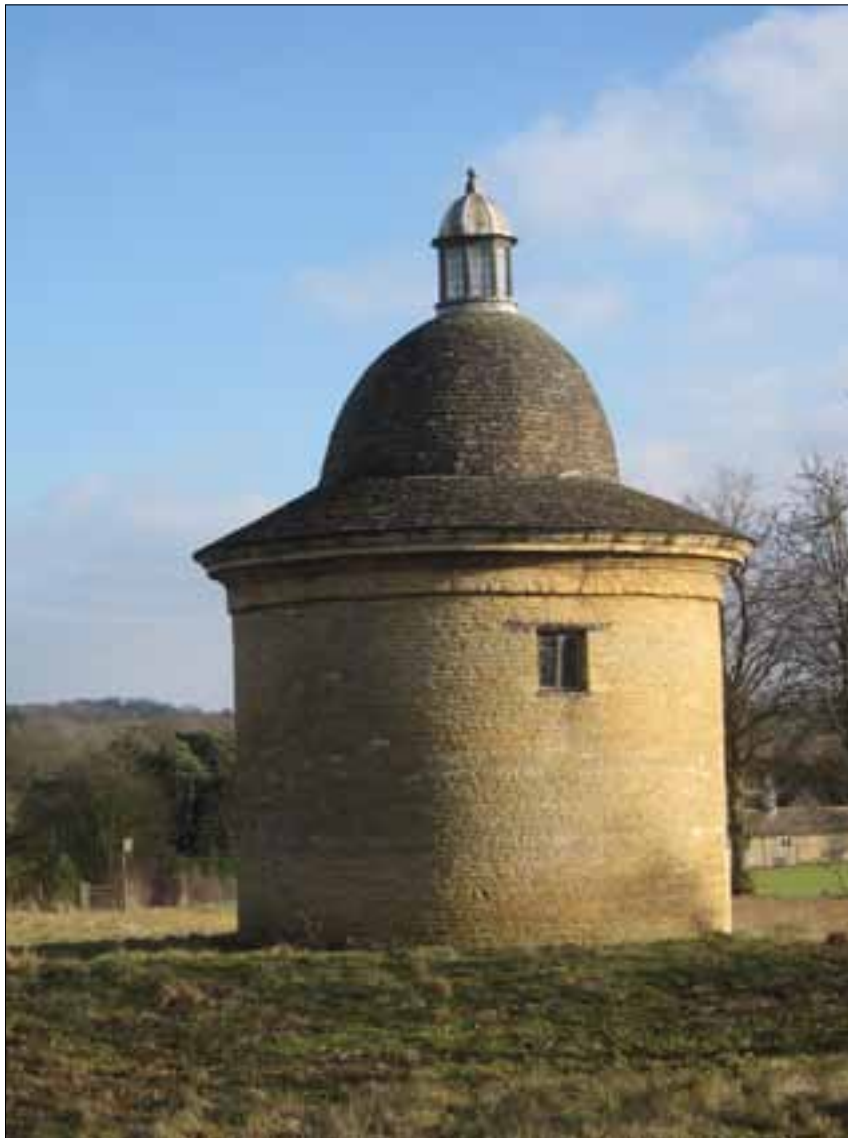
Fig 1 The west side of the Dovecote in January 2011.

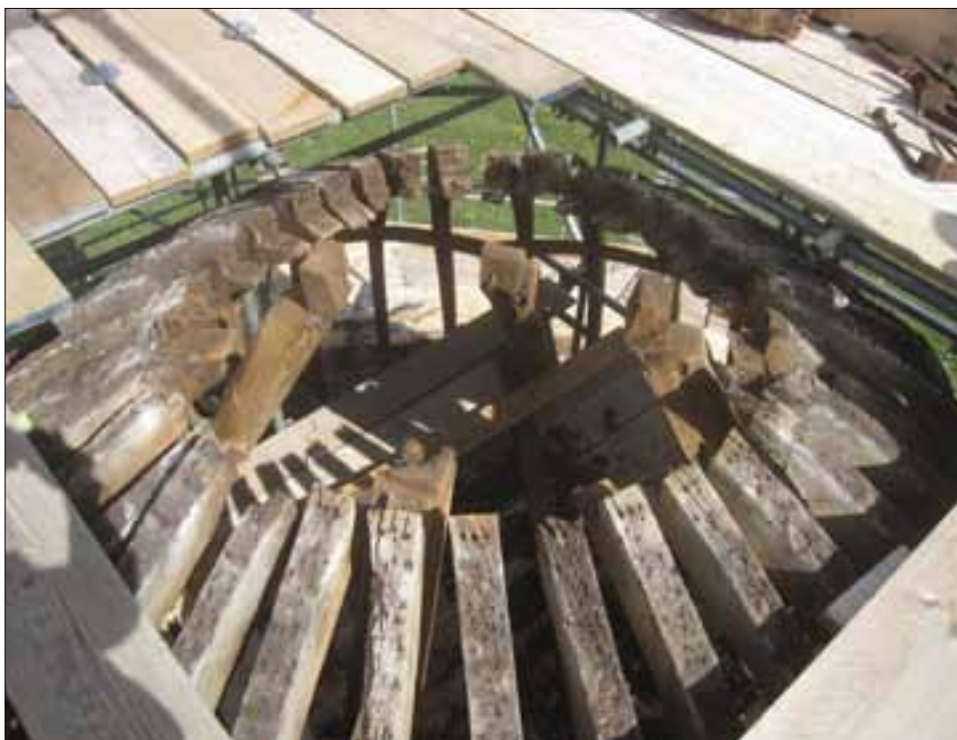
The dome ribs are of carefully shaped oak (c.140mm by 70mm), tenoned and nailed to the dome base beam at the foot, with a nailed birds-mouth joint to the lower ring beam at the top (figs 14-15). Five of the ribs were formed of two sections, an open tenon joint. It was clearly a challenge to obtain enough timber to produce the long, curved ribs in a single piece. There are 32 ribs, with a set of chisel-cut carpenter's marks to the foot, all in sequential order – eg 'XXVII' (fig 17).

Fig 14 The tops of the main dome ribs, after removal of the ring-beams. The tops of the four straight principal rafters can also be seen.

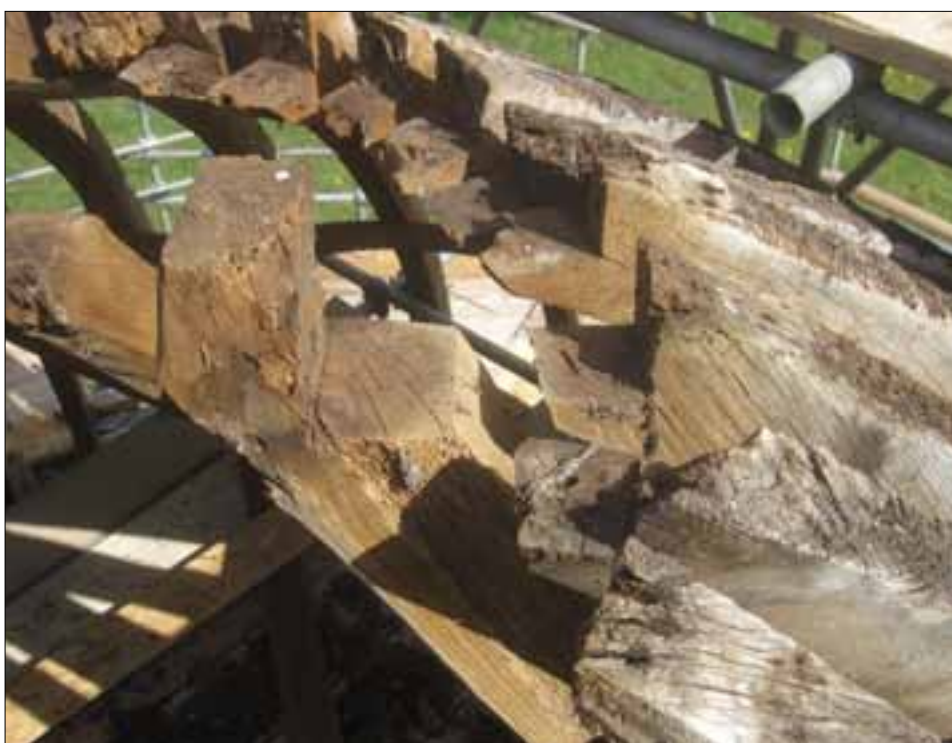
Fig 15 Detail of the birds-mouth joint to the ribs and principal rafters, which fitted against the underside of the lower ring-beam.

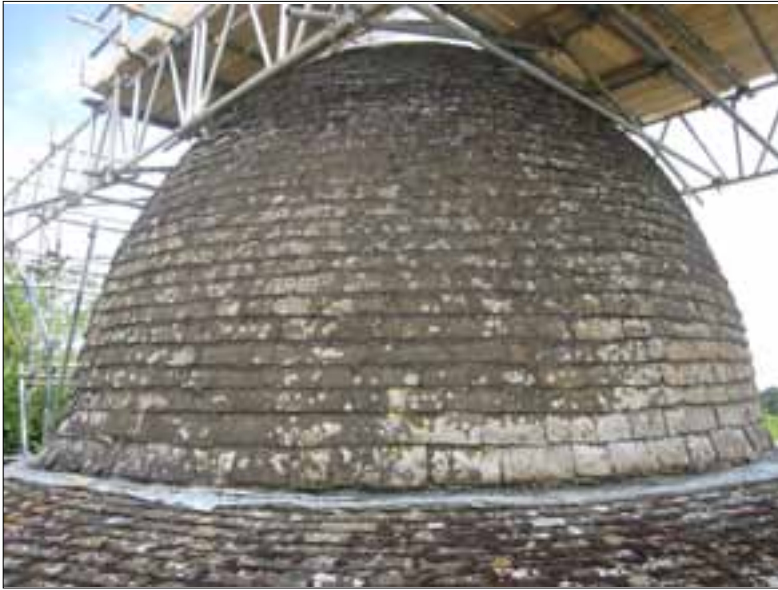
Fig 16 The main dome with Collyweston slate covering.

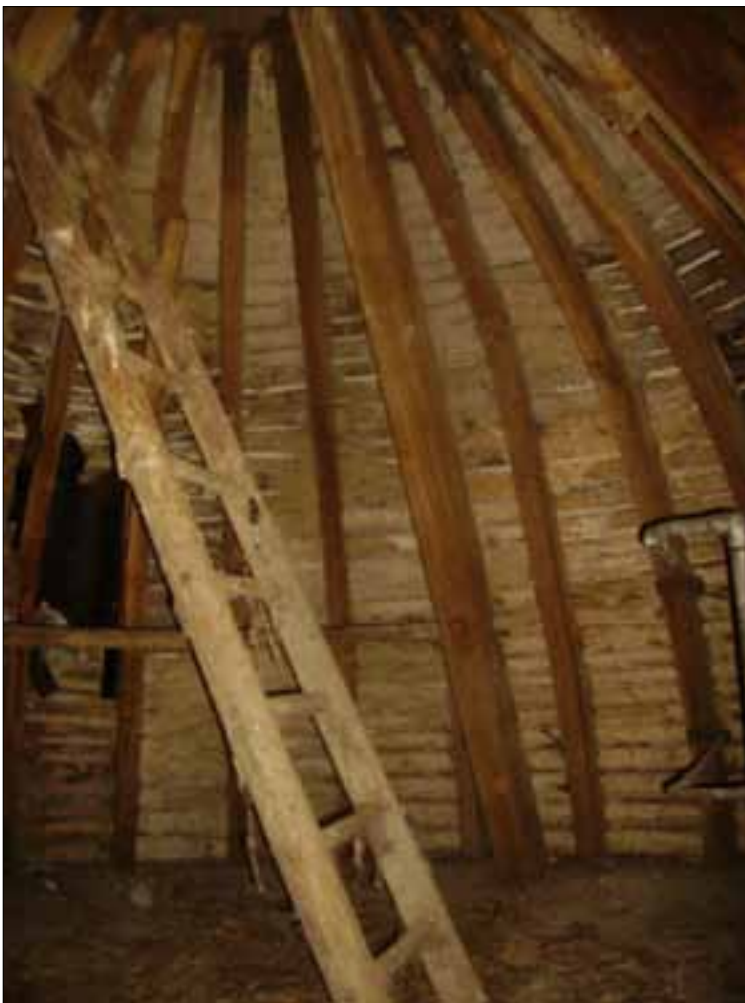
Fig 17 The interior of the main dome before roof stripping. As well as the curved ribs, one of the straight principal rafters is visible.

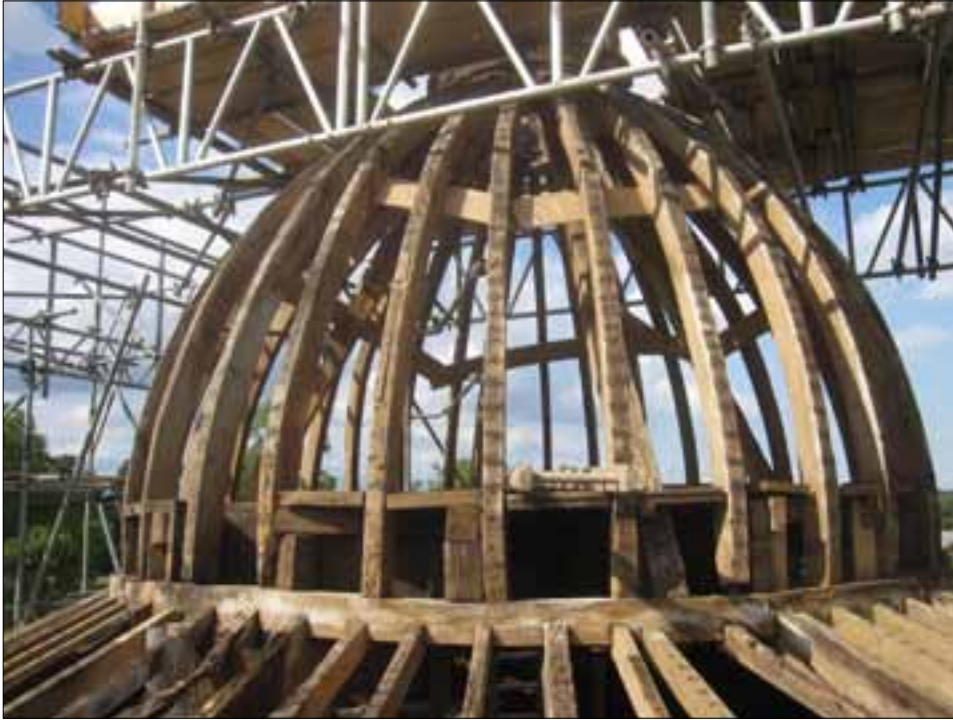
Fig 18 The ribs of the main dome are supported on the dome base plate, which is in turn supported by the lower 'skirt' structure. Some of the straight principal rafters to the dome can also be seen, as well as joist ends of the inserted floor.

However, while the structure of the main dome and lantern/cupola was well-designed and soundly constructed, the support structure of the lower 'skirt' roof was ill-conceived and proved inadequate. The whole weight of the dome had to be supported on the floating dome base plate. The forces imposed on the base plate generated considerable outwards thrust, which was intended to be restrained by the principal rafters of the 'skirt' and the dovetail-jointed ring of wallplate timbers. It was unrealistic to expect the 'skirt' structure, especially given its low pitch, to contain these forces. In spite of their forelock bolts, the wallplate joints failed under the tensile stress, and the dome suffered considerable subsidence. When the water tank structure was added in the early 20th century, with major steel beams, it provided vital support (whether by accident or design) to the dome roof, which by this stage must have been close to collapse.

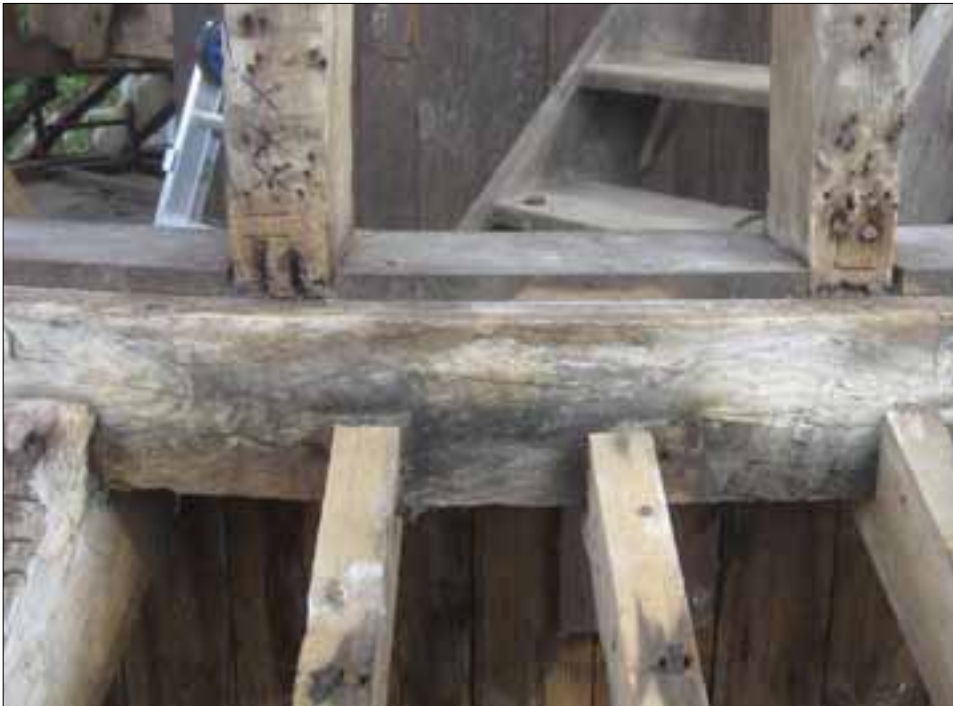
The dome base beam is circular, with an outside diameter of 4.7m (fig 19). It is formed of six curved sections (180mm by 150mm), with half-lap joints, fixed with a forelock bolt. Some chisel-cut carpenter's marks were seen to the beam sections eg 'IIII'.

Fig 19 Detail of the dome base plate, with the first and last dome ribs – marked 'I' and 'XXXII'.

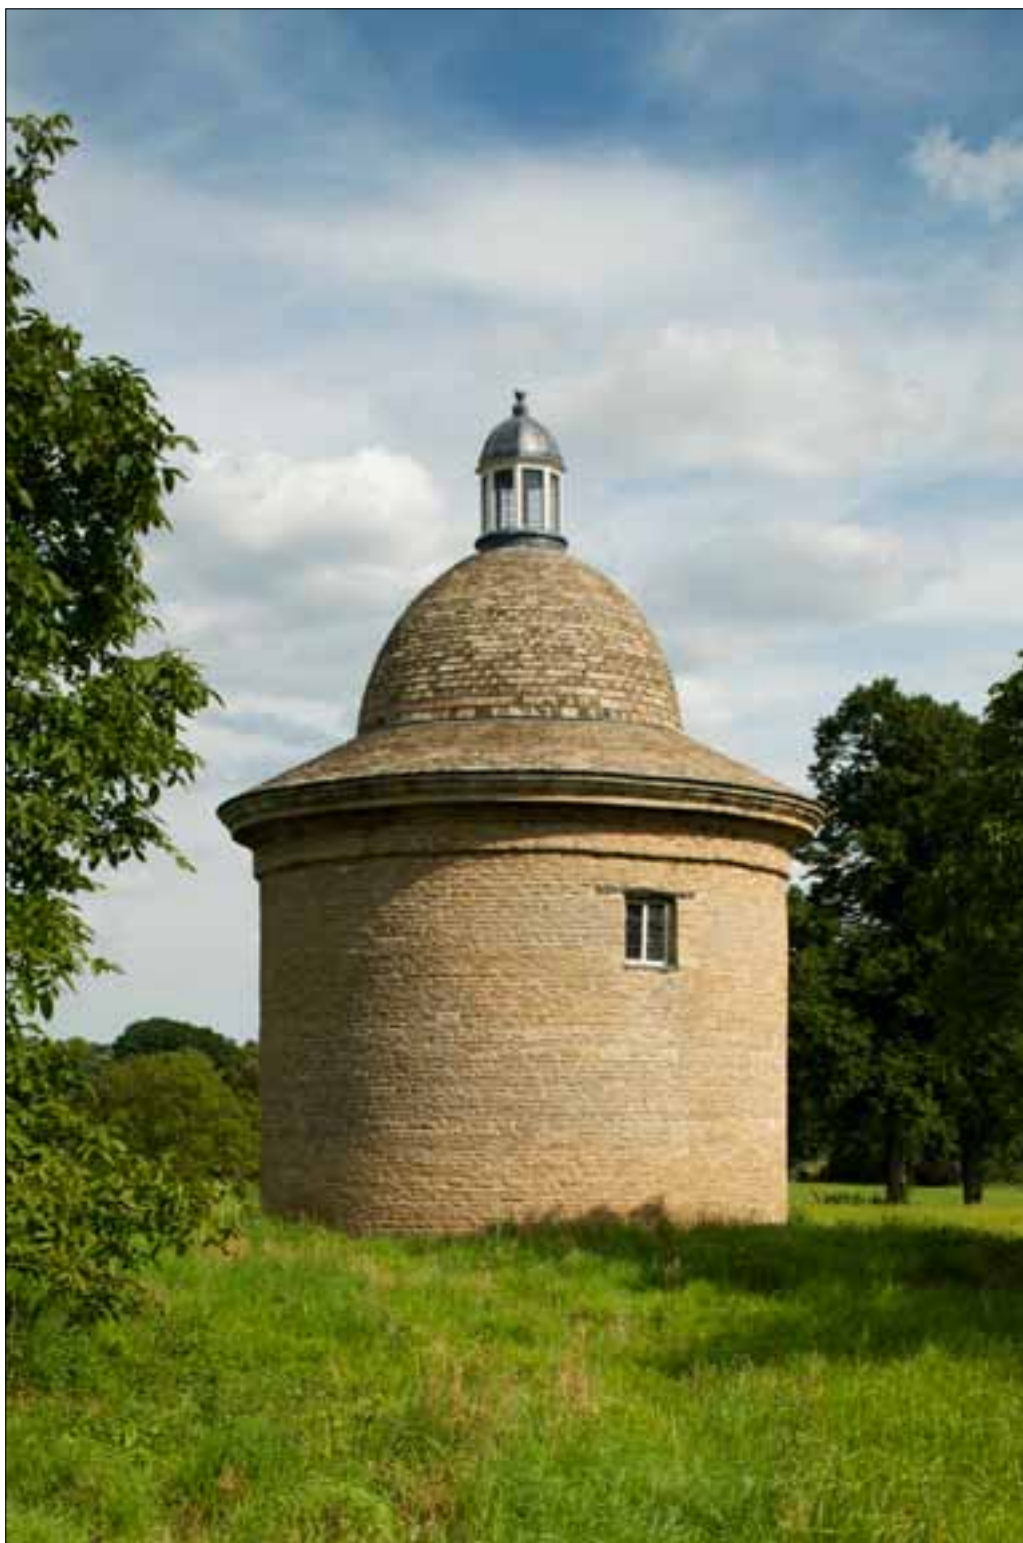
Fig 28 The Dovecote after repair, in 2012 (Pat Payne, DPO152841)

During the recent repairs, the cupola roof structure to the lantern was retained largely intact, including most of the original roof boarding (figs 27-28). The timber of the early 20th-century lantern structure was fully replaced, with the two iron pivot windows and leaded-light glazing reinstated. Both the upper and lower ring-beams had to be fully replaced, though the intact upper ring-beam has been left inside the building, together with a number of forelock bolts. The main dome ribs and base plate required only minor repair and re-fixing. Quite extensive repairs were needed to the lower 'skirt', but the majority of the wallplate and principal rafters remain in situ. The Collyweston slates and leadwork were fully stripped and reinstated. The water tank structure has been retained, and provides vital support to the dome base beam via added props.
