APETHORPE HALL,  
APETHORPE,  
NORTHAMPTONSHIRE  
RECORD OF OPENING UP  
VOLUME TWO

HISTORIC BUILDING REPORT

**APETHORPE HALL  
APETHORPE  
NORTHAMPTONSHIRE**

**RECORD OF AREAS OPENED UP  
VOLUME 2**

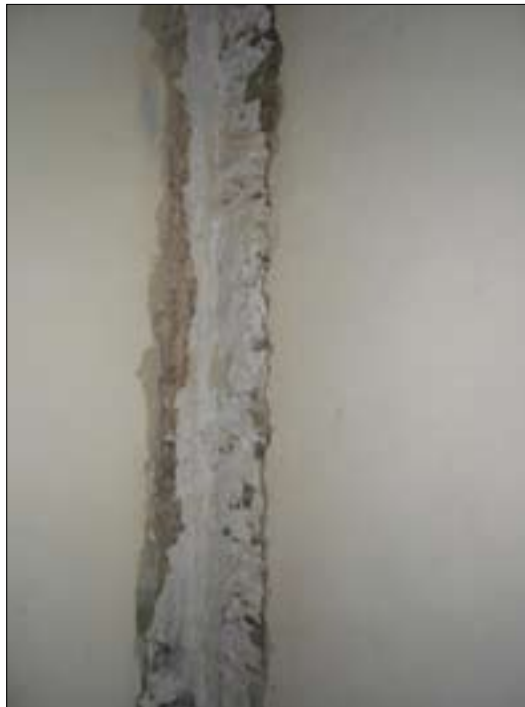
*Figure 11.1 Join of two walls. Taken from the south east.*

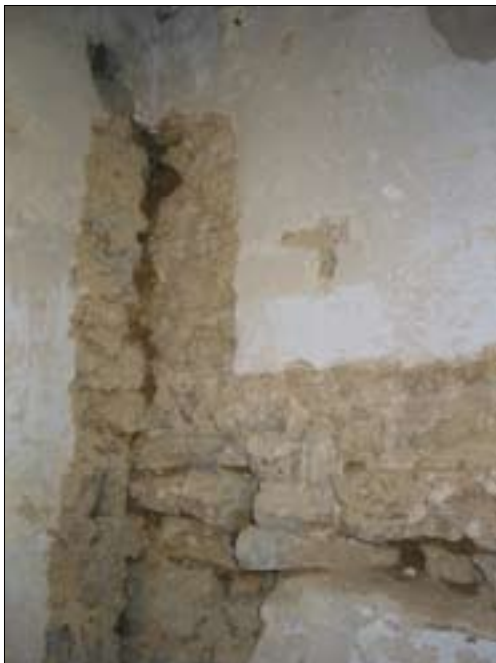
*Figure 12.1 Join of two walls.  
Taken from the south west.*

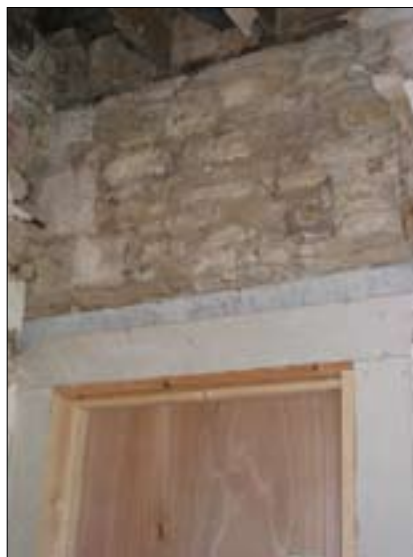
There are 20th-century repairs to the floor above and modern stud wall facing which also interferes with the original make-up of the wall.

**Figure 13.1** *Join between walls.  
Taken from the east.*

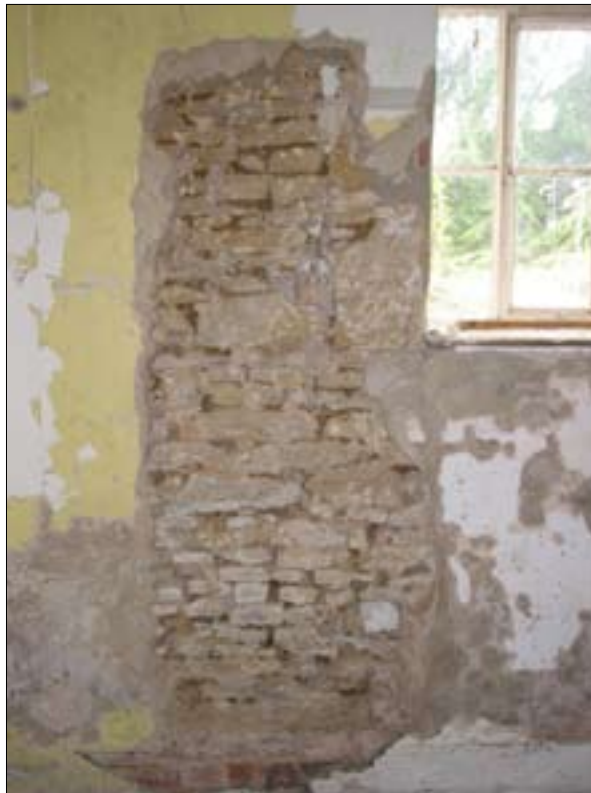
*Figure 15.1 Taken from the north.*

In an area (1.91m high x 0.70m wide) opened up in the south-east corner of the room another coursed rubble wall with clay mortar was revealed beneath successive layers of lime plaster, gypsum plaster and thick 20th-century Portland plaster cement. There are no former joint holes or quoins, but wooden plugs have been inserted into the wall, perhaps to act as fixing points for wainscoting.

The thickness of the Portland cement plaster is also due to the position of the room below ground-floor level. The cement plaster is effective against damp.

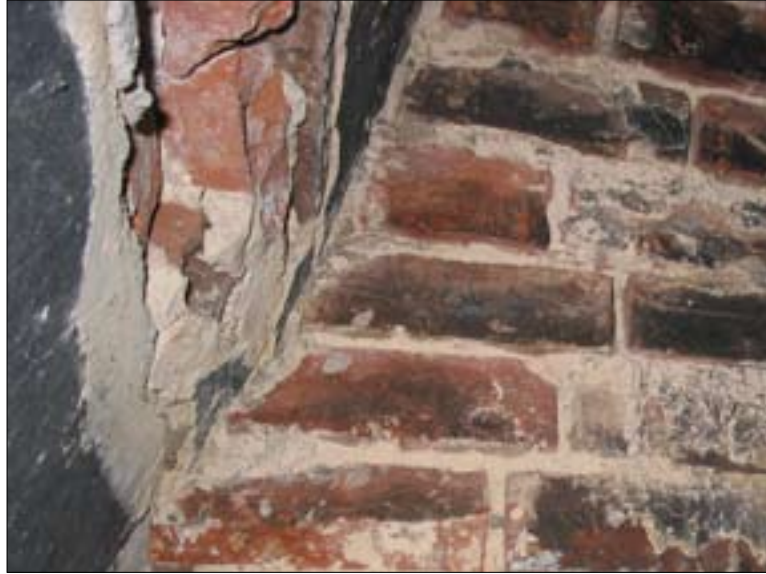
*Figure 17.1 Looking up - the brick built flue.*

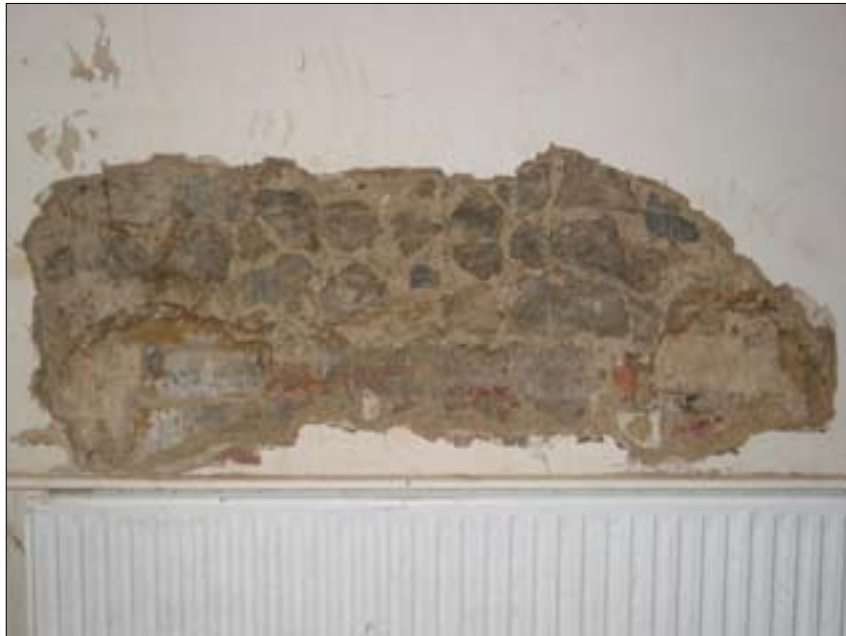
*Figure 19.1 Remains of fireplace. Taken from the south.*

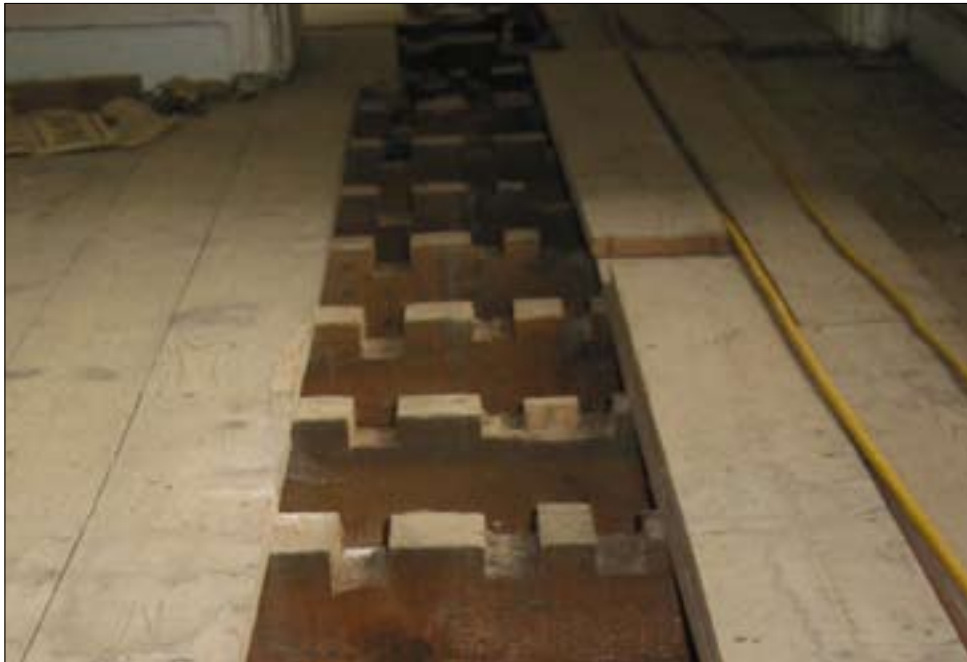
Thirteen joists run north-south across the room. The floor structure was most likely laid down in the 20th-century judging by the regular scantlings of the beams. All joists measure 0.08m wide by 0.22m deep, with an average spacing of 0.43m. They have all been cut down the centre line to receive wires and pipes.

*Figure 21.1 Floor structure. Taken from the west.*

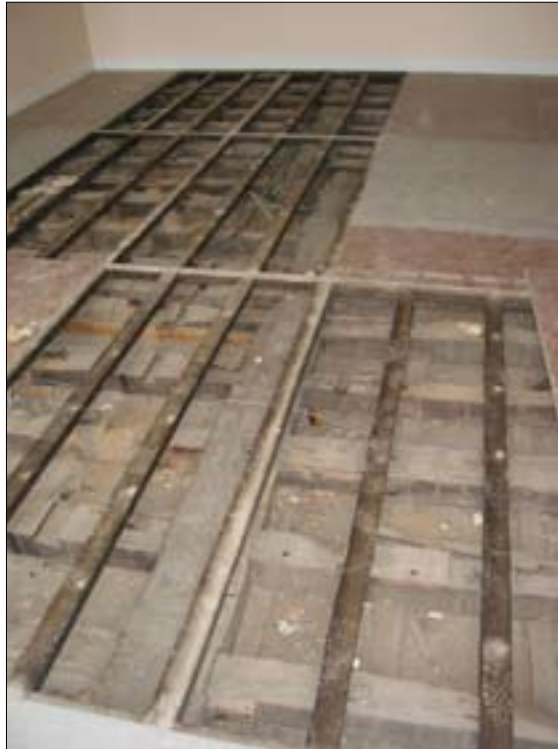
*Figure 22.1 Floor structure in The Old Dining Room. Taken from the north.*

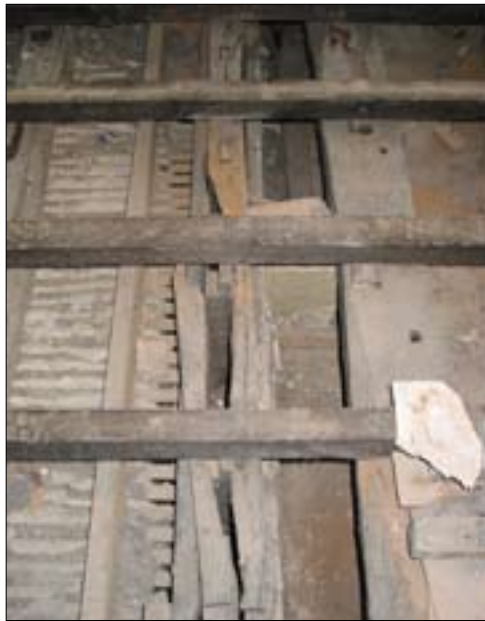
**Figure 22.3** *Timber partition wall slot.  
Taken from the east.*

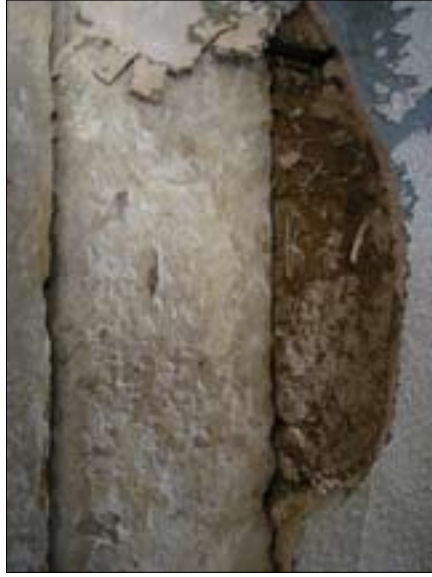
*Figure 24.2 Detail taken from the west.*

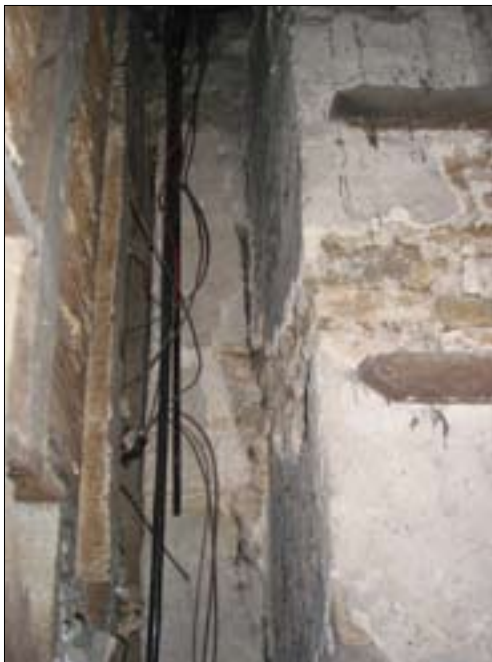
**Figure 25.2** Showing the ashlar door jamb, the rubble constructed wall and wooden shelf brackets.

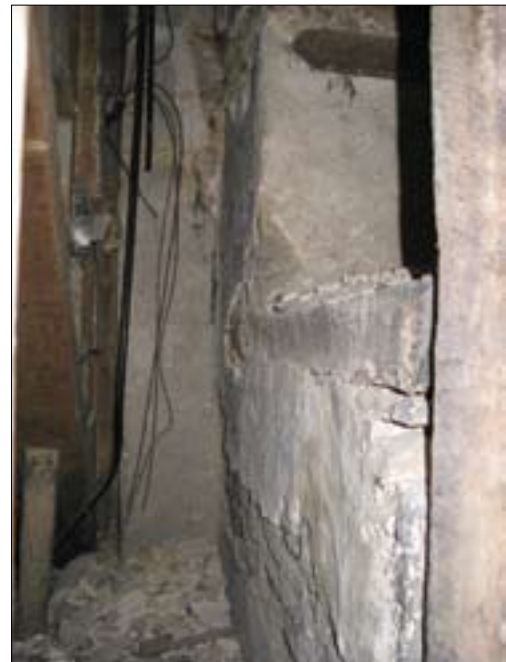
**Figure 25.3** Looking north under the stair to the Cock Loft, showing long beam, embedded in rubble wall.

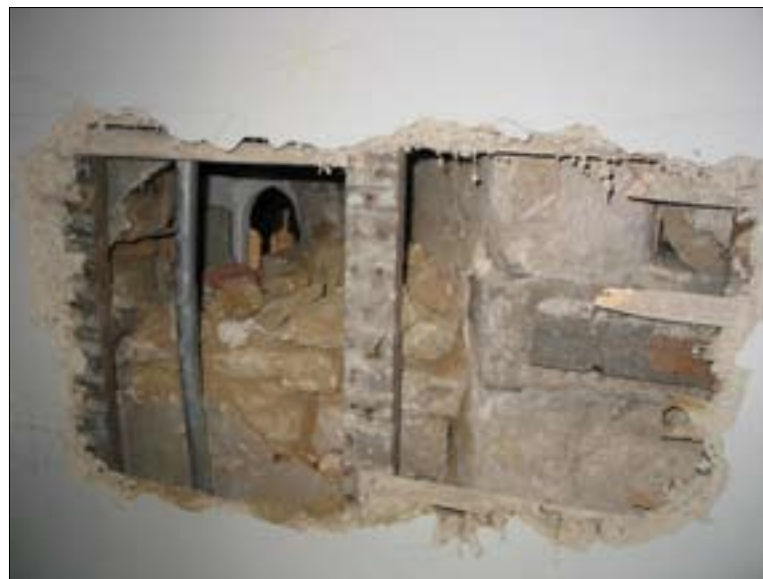
Lime and horsehair plaster still remains to suggest that the infill was once entirely plastered over to disguise the blocking. The presence of 20th-century red brick, forming a niche on the south side, suggests that prior to this, the squint was entirely blocked by the rubble, from front to back.

Prior to the infilling, an aperture would have been visible all the way through. With its small opening on the south side, it would have been barely visible from the hall, but with its wide, sloping reveal on the north side, access to the aperture would have been easy. It is clear therefore, that this small feature was a squint, allowing people to view activities within the hall, unobserved.

*Figure 26.2 Squint from corridor (N2.14).  
Taken from the north.*

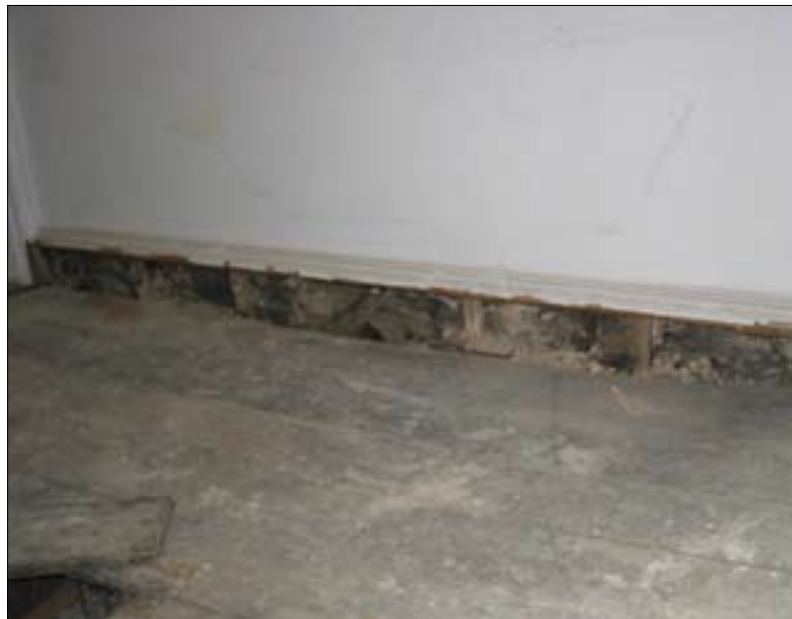
*Figure 27.1 Coursed rubble walling. Taken from the east.*

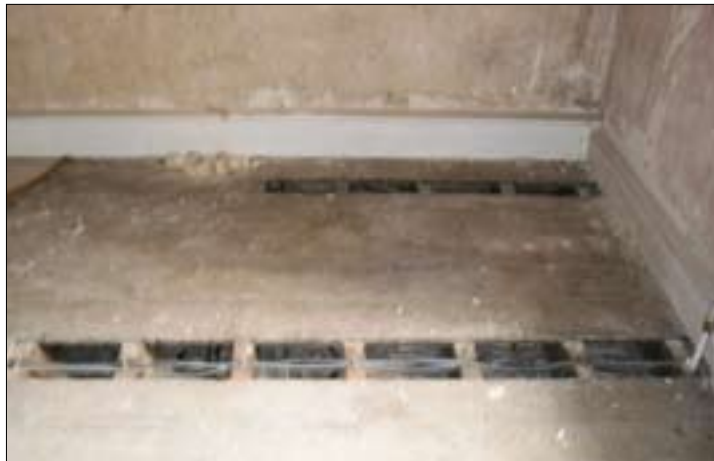
*Figure 28.1 Floor structure. Taken from the south.*

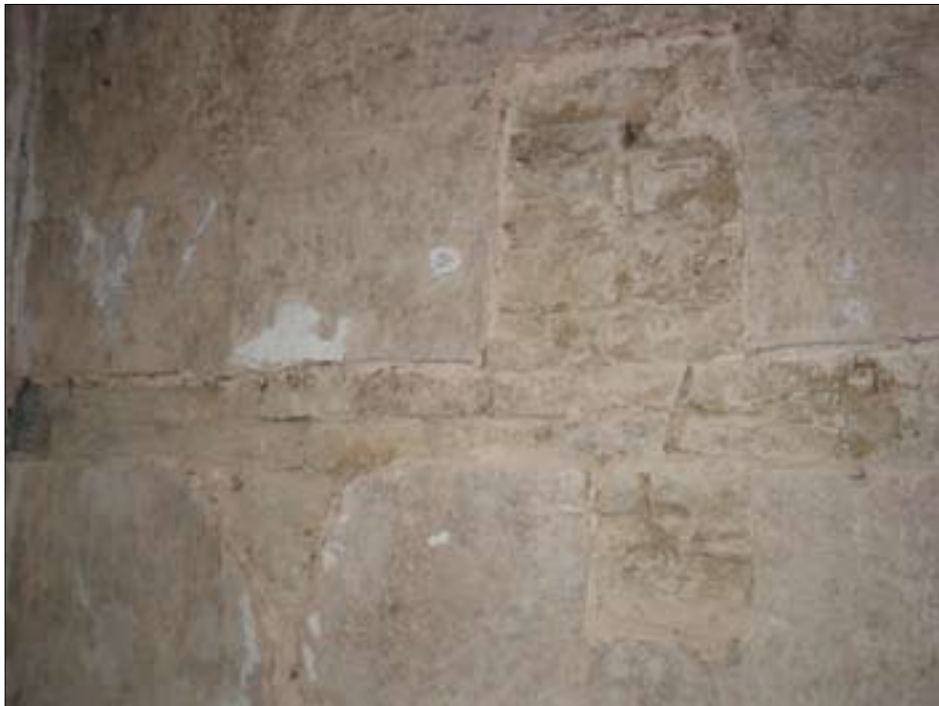
*Figure 29.1 Coursed rubble walling. Taken from the south-west.*

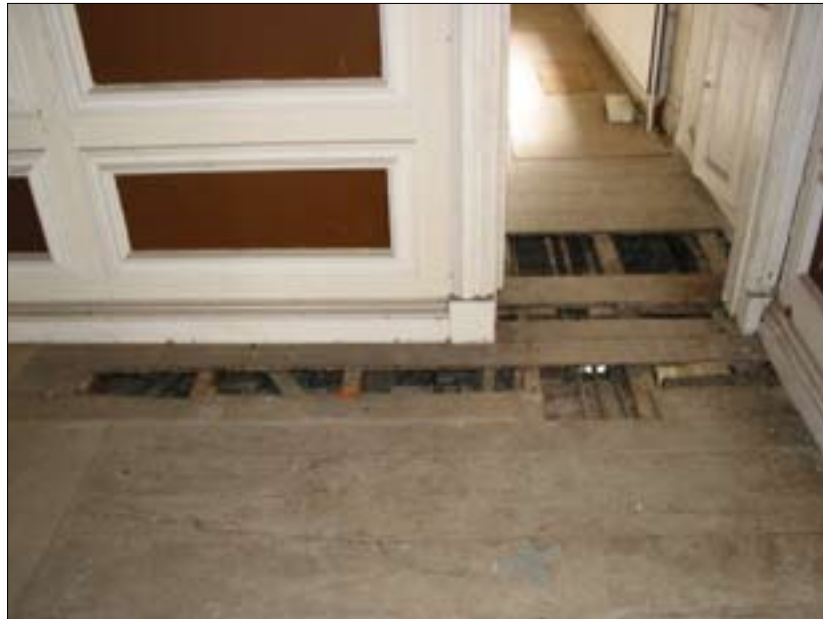
Three areas opened up in this room show the construction of the floor joists between two rooms. Smaller joists have been nailed above the original joists for the purpose of raising the floor level in H2.10 to meet that of H2.12. Early 20th -century electricity cables and wires run under the floorboards.

In the north side of the room the floorboards have been removed across nearly the whole width of the room to reveal three phases of joists. Nine joists have been exposed and they all run north-south. Of these, only seven could be measured. They are all evenly spaced at 0.45m apart, with measurements taken from the centre points.

*Figure 31.1 Floor structure leading from H2.12 to H2.10  
Taken from the south.*

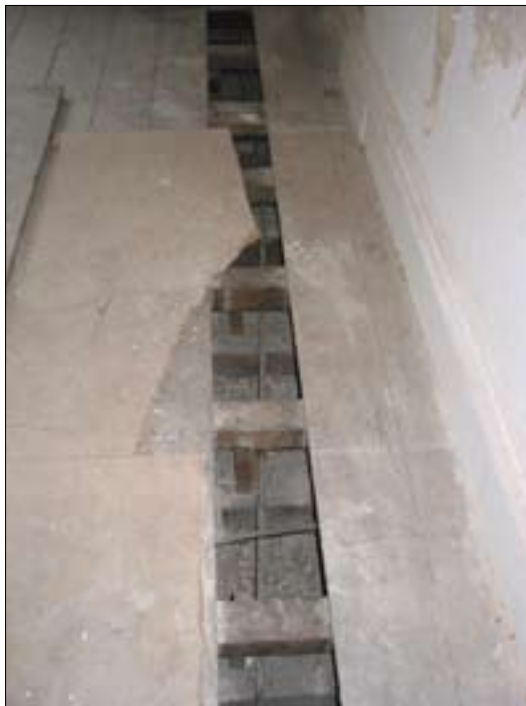
These two sets of joists are not directly one on top of the other. The gaps between them range from 0.03m to 0.12m, depending on the scantlings of the joists. Where the gap is large, a vertical batten provides support.

**Figure 31.2** *Showing levels of floor structure.  
Taken from the west.*

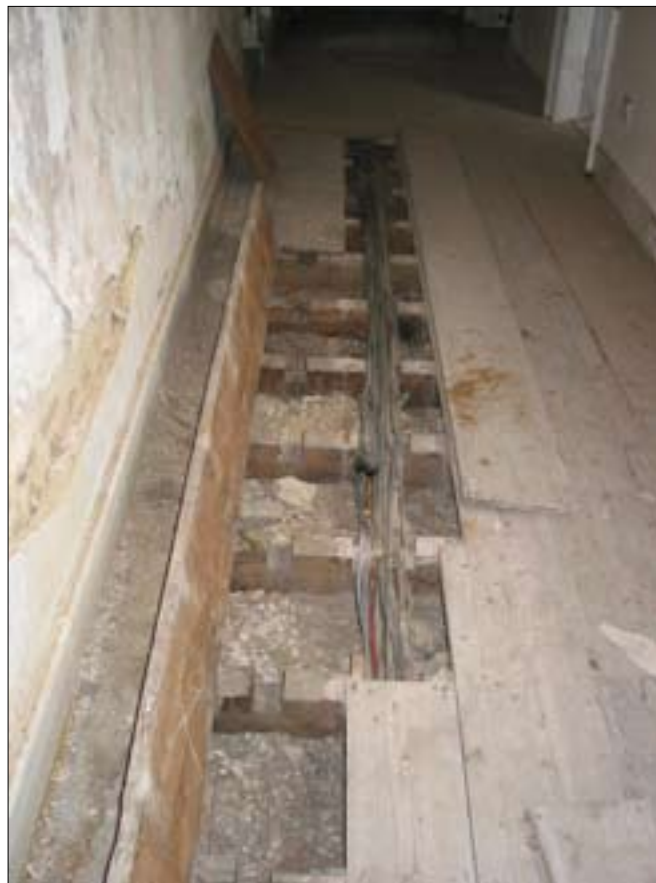
Thirteen joists were revealed by the removal of two large floorboards. The joists are all short, running north-south and the measurements were taken from the east. All joists have had sockets cut into them to receive electric wires and cables.

*Figure 32.1 Floor structure in H2.08.  
Taken from the west.*

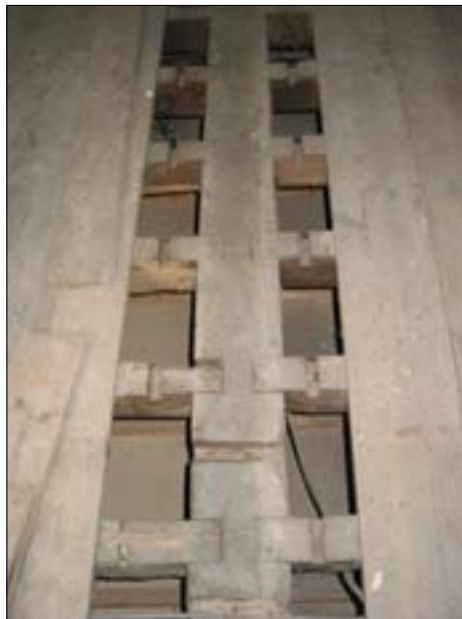
At the east end of the room is a floor structure most likely laid down in the 20th-century, judging by the regular scantlings and neat cut of the beams. The main beam, of this phasing of floor, runs north-south and is 0.17m wide by 0.13m deep. The joists are all 0.32m apart from centre point to centre point and they measure an average of 0.07m wide by 0.11m deep.

*Figure 34.1 Floor structure in H2.11.  
Taken from south.*

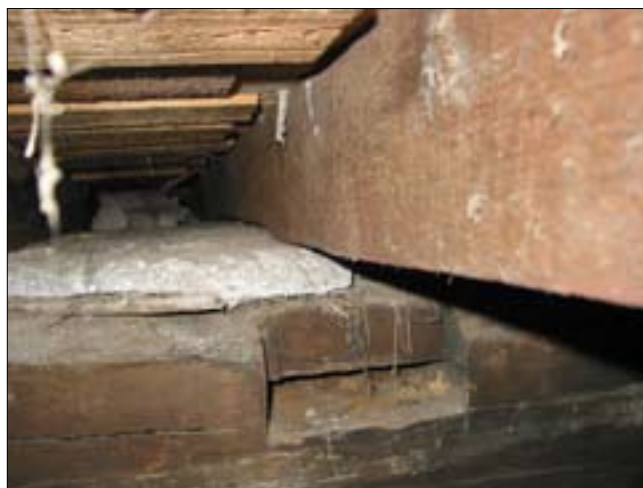
Directly under this lies a plaster floor surface that is 0.03m to 0.04m thick. The plaster has been laid on a thin layer of reed which in turn lies on thin lathe-like joists, measuring only 0.04m wide by 0.01m thick.

*Figure 34.2 Showing the earlier plaster floor surface.*

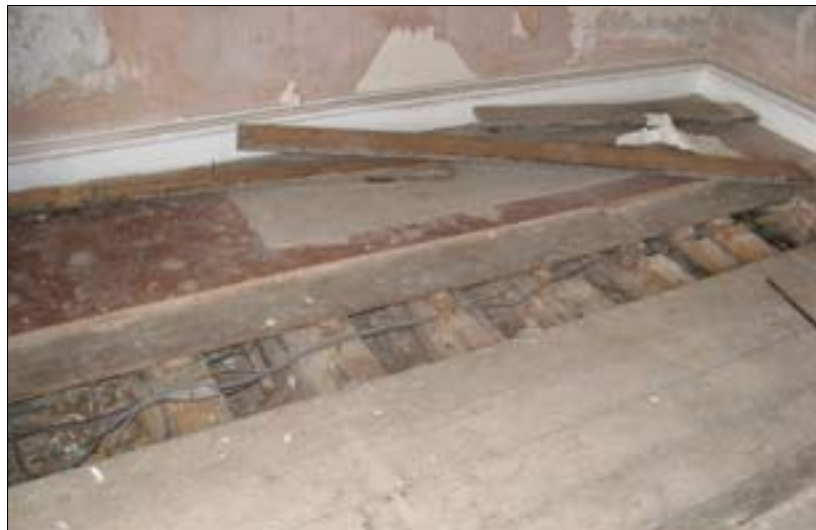
The floor level has been raised with planks with irregular positioning and varied scantlings; 0.13m wide by 0.03m deep or 0.10m wide by 0.05m deep. The irregularity of this suggests that it was a rather a haphazard solution to create space for the insertion of wires and cables.

*Figure 35.1 Floor structure. Taken from the east.*

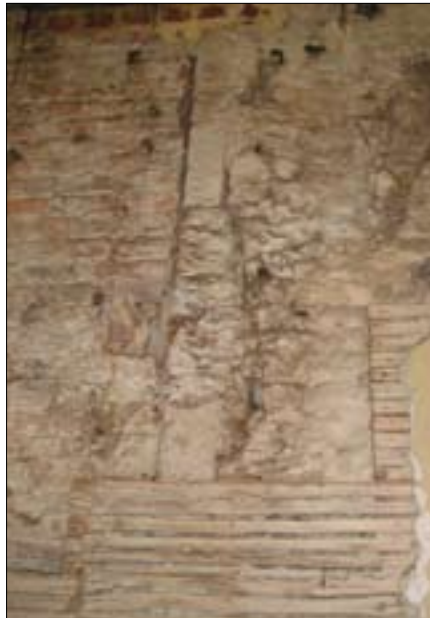
*Figure 37.1 Window jamb.  
Taken from the north.*

A large window jamb was also revealed by the removal of the lathe and plaster wall. It is the west jamb of a window which has subsequently been blocked with red brick. This is the only aspect of the window to be revealed. The splayed jamb has a plain chamfer and has been pecked in order to create a surface for later plastering. Two round peg holes have been made in the surface of the jamb at 1.32m and 1.84m from floor level. Full dimensions could not be measured because the surviving window jamb was only partially revealed and largely beyond reach.

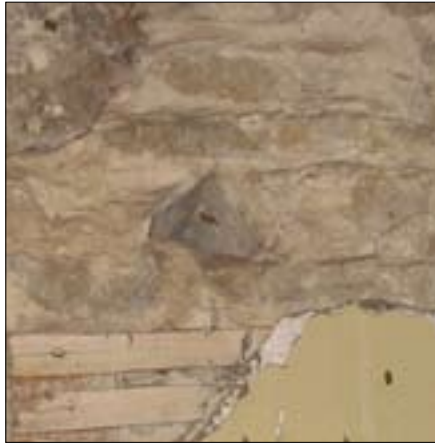
The removal of lathe and plaster has revealed a coursed rubble wall with clay mortar. A triangular void appears to be contemporary with construction of the wall (there is no later disturbance, and the clay mortar respects the void), and would have contained a wooden fixing. It stands at 2.60m from floor level.

*Figure 37.2 Void for wall fixing.  
Taken from the north.*

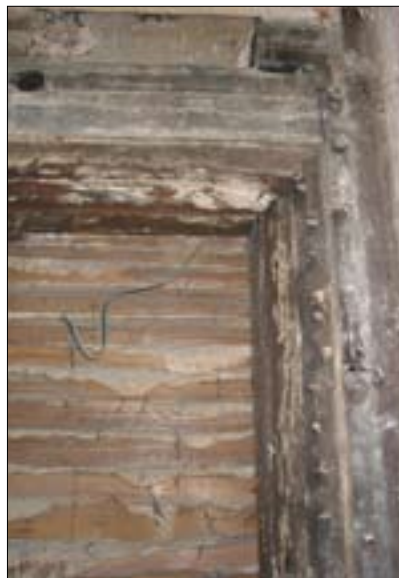
*Figure 38.2 Detail of door jamb incorporated into stud walling. Taken from the west.*

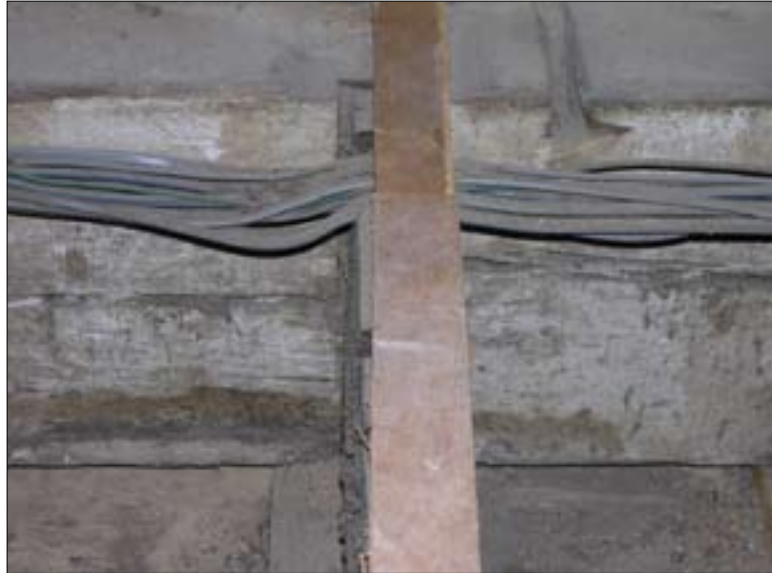
Narrow slits have been cut into the north side of the beam, from above, for floor joists.

This is proof that these mortises are secondary – they can only have been cut from above, if the beam was *in situ* and that therefore, originally there was no floor to the north of this beam. This indicates a void, which from earlier floor plans, has been identified as a stairwell.

**Figure 39.2** Detail showing painted surface on main beam.  
*Taken from the north.*

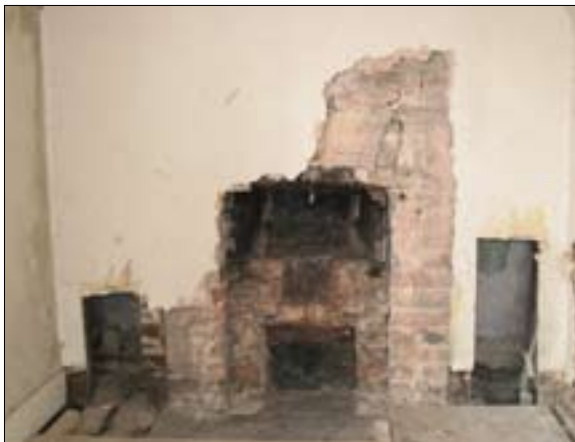
A red brick chimney breast, post-1858 (it does not appear on the floor plan of that date), has an aperture of 0.89m high x 0.62m wide x 0.20m deep. The brick surround is 0.22m thick with a two-course segmental arch above, at 0.25m high. There is a timber lintel 1.28m from floor level and the fireplace stands 0.50m proud of the rubble wall.

The rubble wall appears to have been plastered and painted before the fireplace was built. A straight joint between the two surfaces and patterned wallpaper running behind the inserted fireback is further evidence that the fireplace is a later structural addition, and not an original feature of the room.

*Figure 40.1 Fireplace. Taken from the east.*

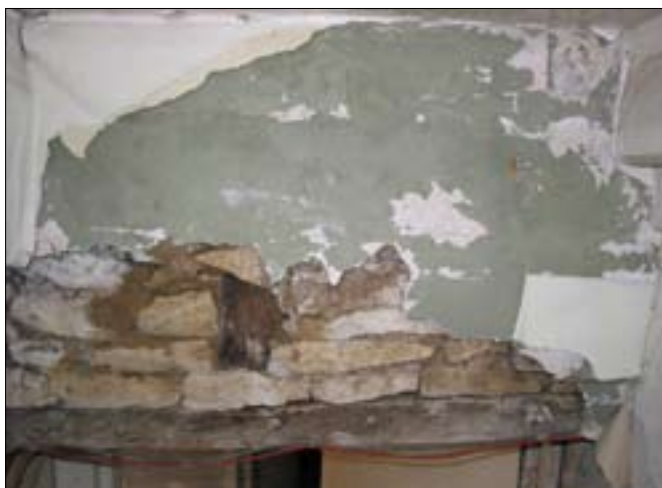
*Figure 41.2 Coursed rubble walling above doorway to Cock Loft stairway, showing the incorporation of floor joists from the room above.*
