An Analysis of Drying Data from a Medieval Hall after Flooding

Prepared for Historic England by
Dr Brian Ridout and Iain McCaig

2016

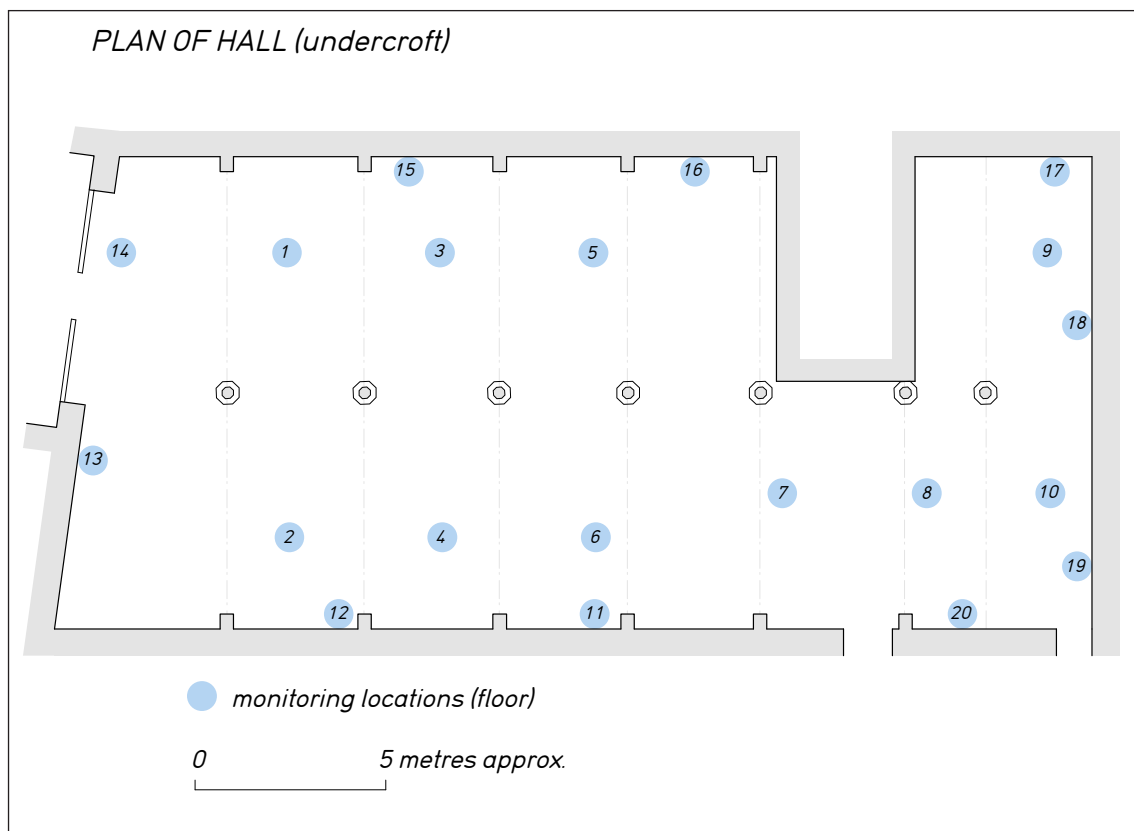
Figure 7: Plan of the Hall.

Figure 7 is taken from the first Hall Drying Sheet.

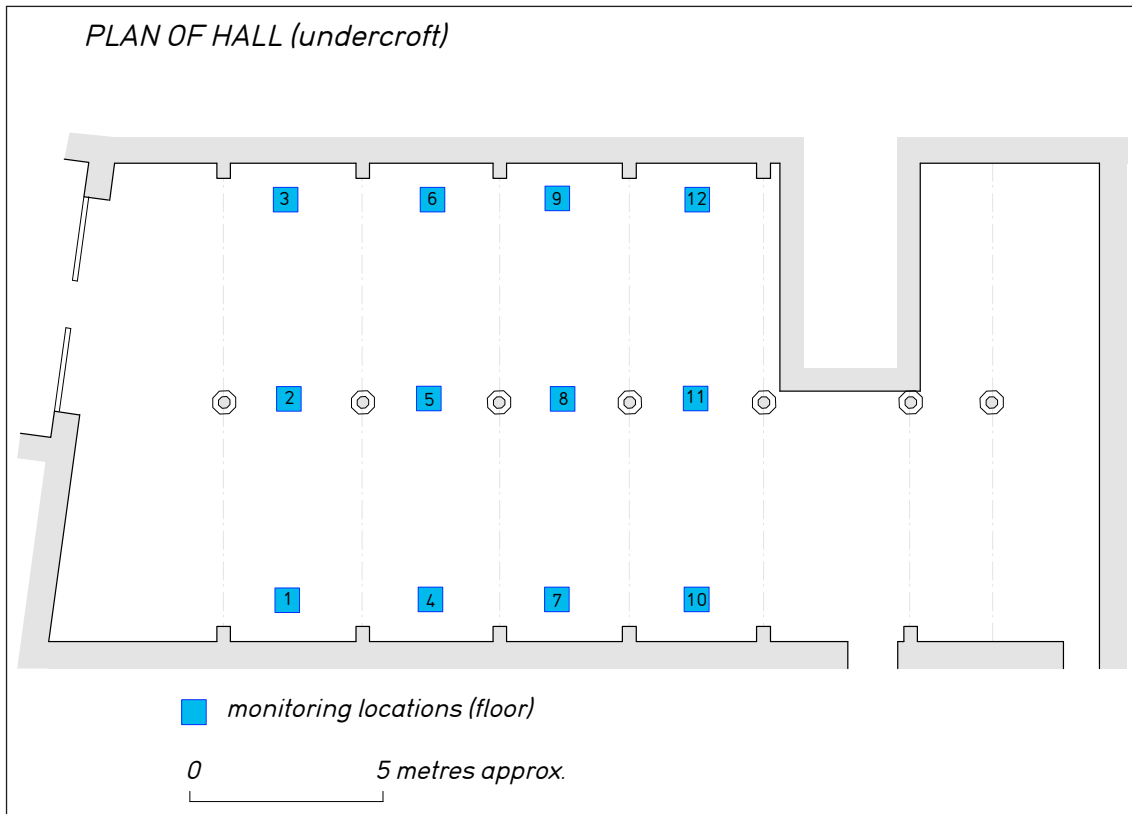
Figure 17: Plan of the Hall (undercroft).

The Hall floor was similarly investigated, taking three readings each floor slab in five rows across the width of the building. The outer slabs were 1m from each side wall and the central reading was mid-way between columns. Readings were very similar and are not tabulated here. There was no gradation across the Hall or from end to end. The dry mean reading was 6.5 ± 0.31 , which is again a little higher than the readings obtained by the drying company.
