A Preliminary Study of Flood Remediation in Hebden Bridge and Appleby

Prepared for Historic England by
Dr Brian Ridout, Chris Wood and Iain McCaig

This report presents some preliminary findings of site visits to properties in Hebden Bridge, West Yorkshire, and Appleby-in-Westmorland, Cumbria, ten months after the severe flooding that occurred in December 2015. The purpose of the visits was to investigate different responses and remediation methods, and assess how successful they have been.

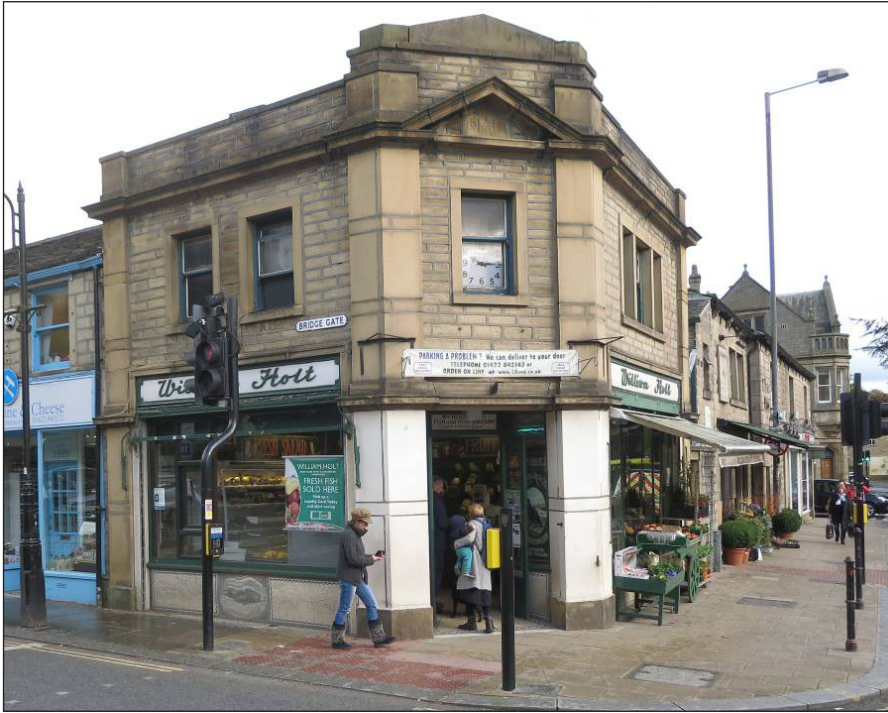
Cleaned out mud and swabbed walls and floor with an agricultural disinfectant. Three dehumidifiers used over a 3-week period. (Back rooms have un-plastered stone walls. All rooms have solid floors).

Figure 2: Shopfront of William Holt, greengrocer.

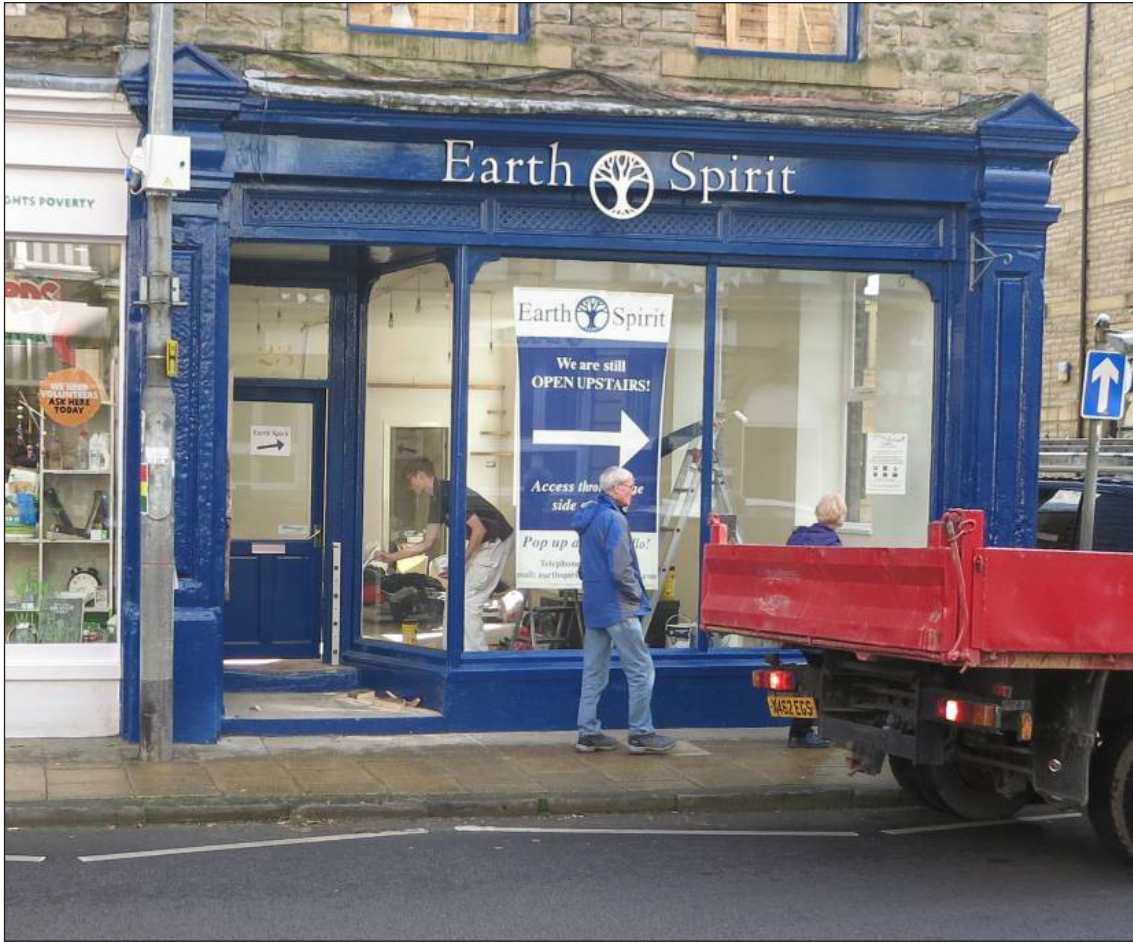
Mud cleared and surfaces disinfected. Laminated floor finish had floated and was easily removed. Dehumidifiers used. (Walls were replastered with a 'waterproof' plaster (?) after the previous flood in 2012).

Figure 4: Shopfront of Earth Spirit, gallery.

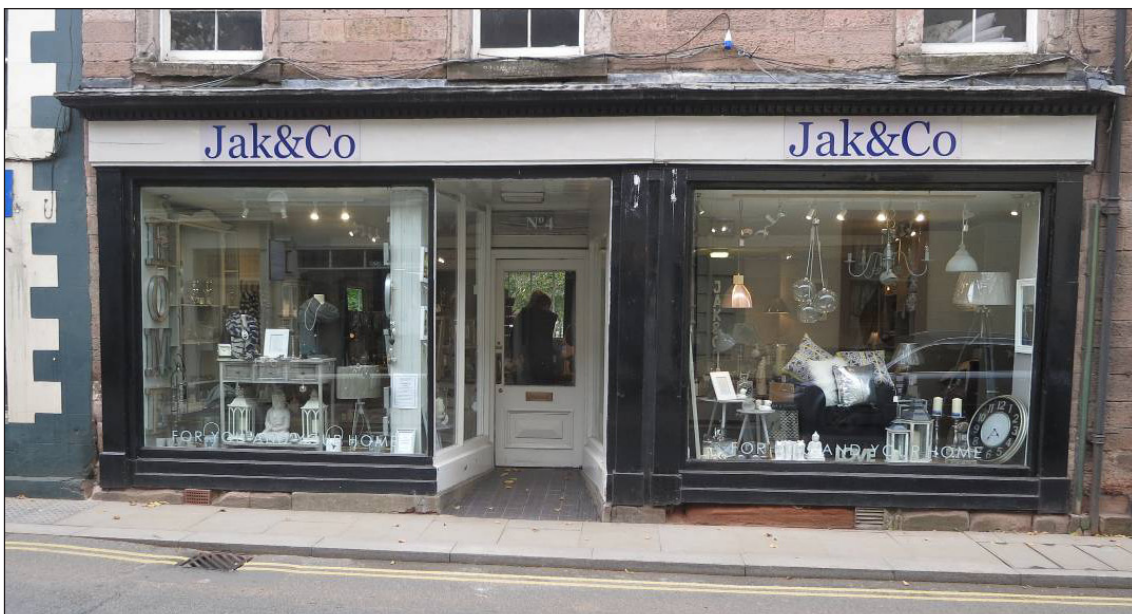
Figure 11: The shopfront of Jak & Co.
