The Use of Multi-Image Photogrammetry to Record At-Risk Archaeological Material from the Wreck of *Invincible*

Dan Pascoe, Ben Jones and Grant Cox

**PROJECT REPORT
2017**

Ref: 7235

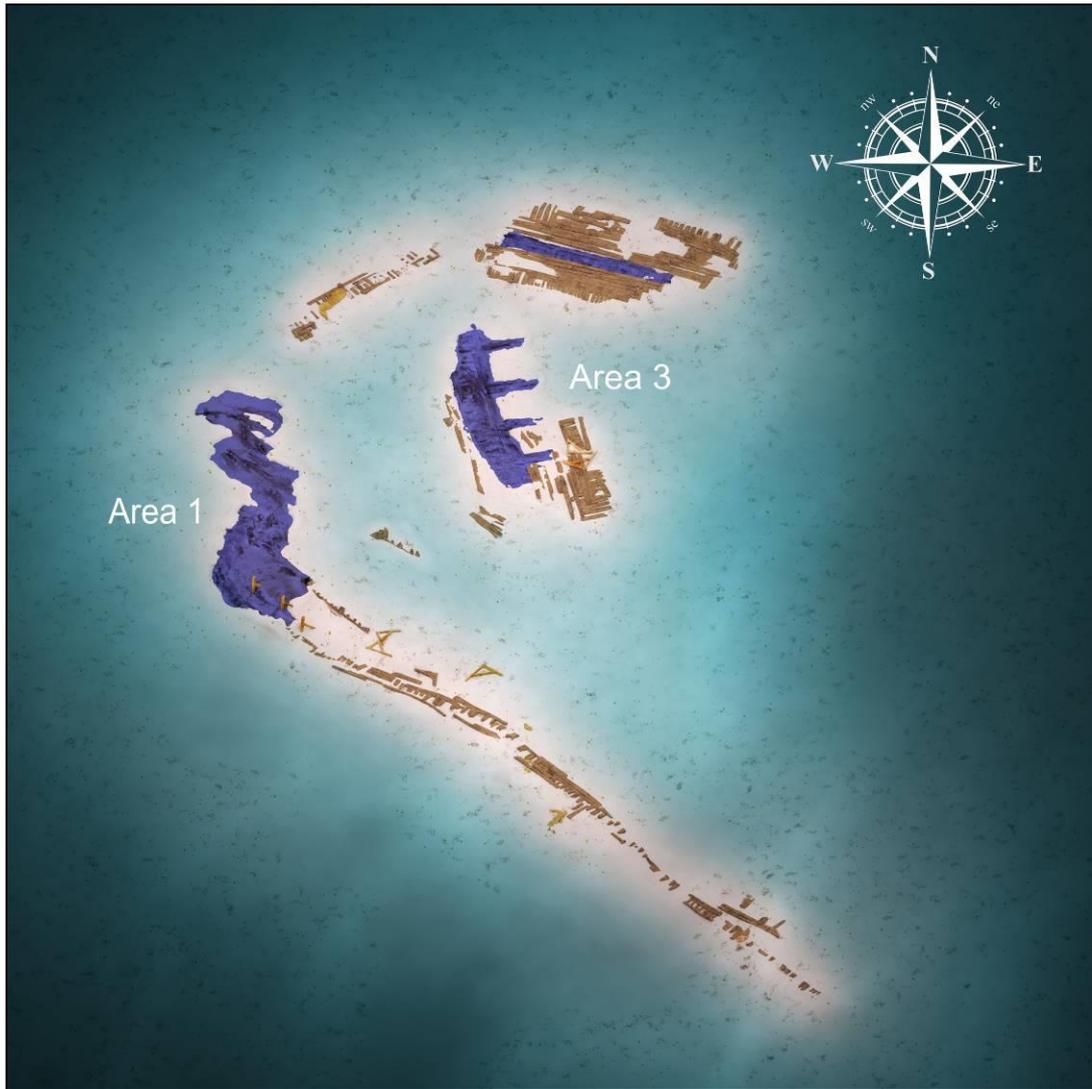
Figure 10: This is a reconstructed plan of the site, the purple shaded areas represent the areas which have been recorded photogrammetrically. Area 1 and 3 are sections recorded in 2016 © PAS.

- 5.3.1. **Area 3** is located 15m NE of the main site and roughly 2m south of **Area 2** (Figure 10). It is a large coherent section of starboard side structure relating to the hold and orlop. It consists of riders, inner and outer planking, frames and wooden and iron knees. This whole section is roughly 14m long by 5m wide.

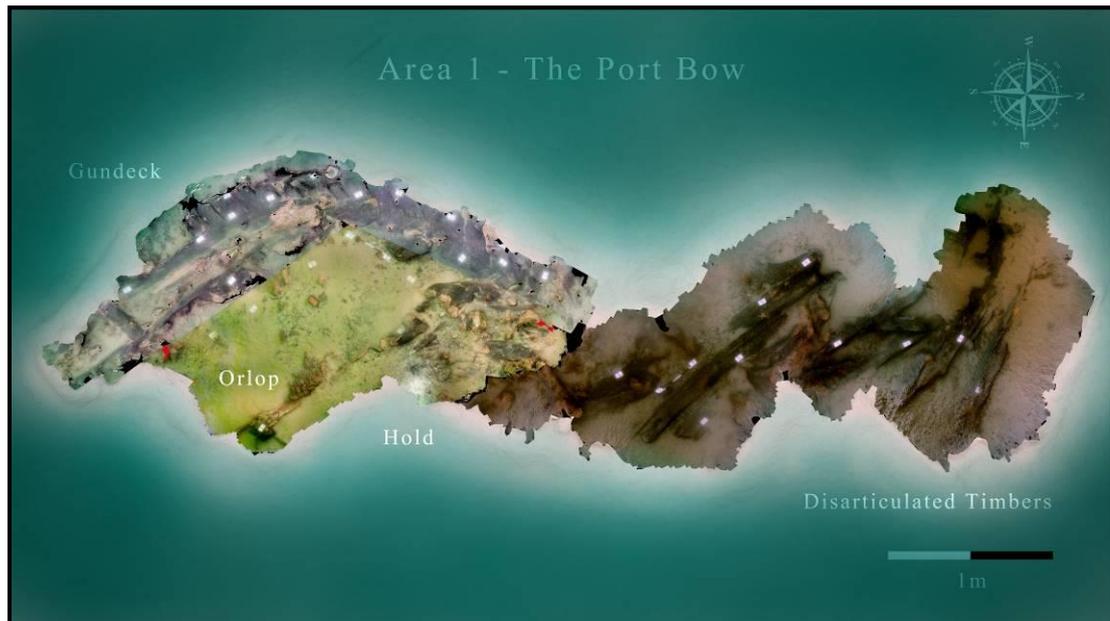
Figure 11: Image showing the original photogrammetry model of Area 1 with Photostan targets. This image also identifies the three separate data sets, which have been merged to form Area 1 © PAS.

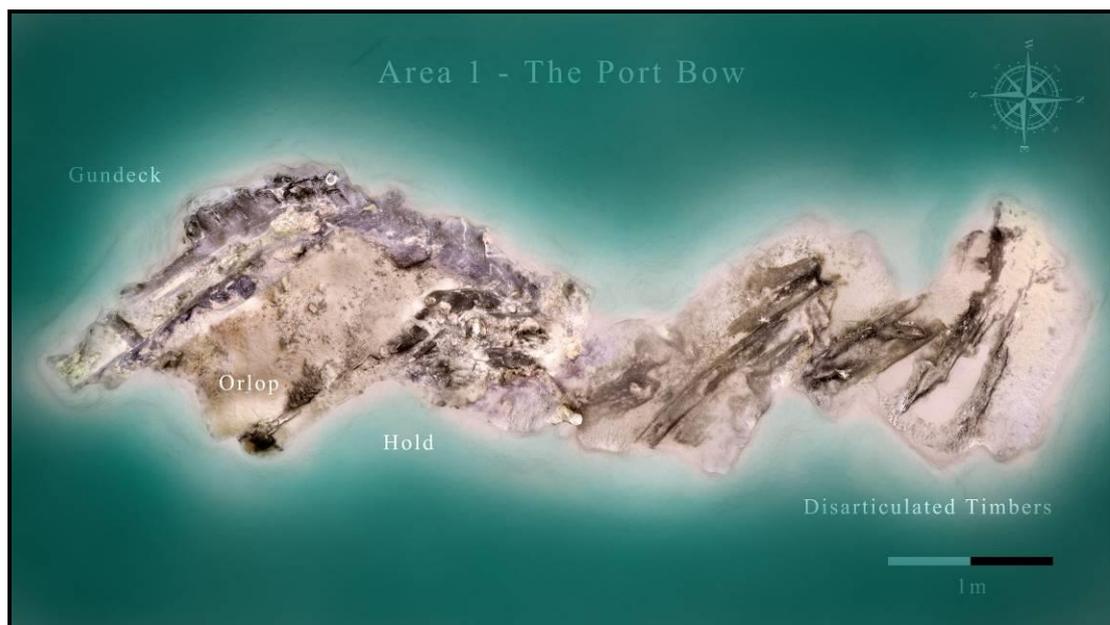
Figure 12: Image showing the reworked and colour corrected model of Area 1 without Photostan targets © PAS.

- 5.2.8. Below the gundeck are the remains of the orlop. The line of the orlop deck can be seen emerging from the sand, parallel to the remains of the gun deck. On top of the deck is a coil of exposed anchor cable. The cable is lying directly on top of the deck which is clad with pine. At the forward end of the orlop, halfway between the decks, are the remains of a wooden breast hook fastened to the inside of the hull. Below the deck of the orlop there are the exposed ends of deck beams and ledges (Figure 12).

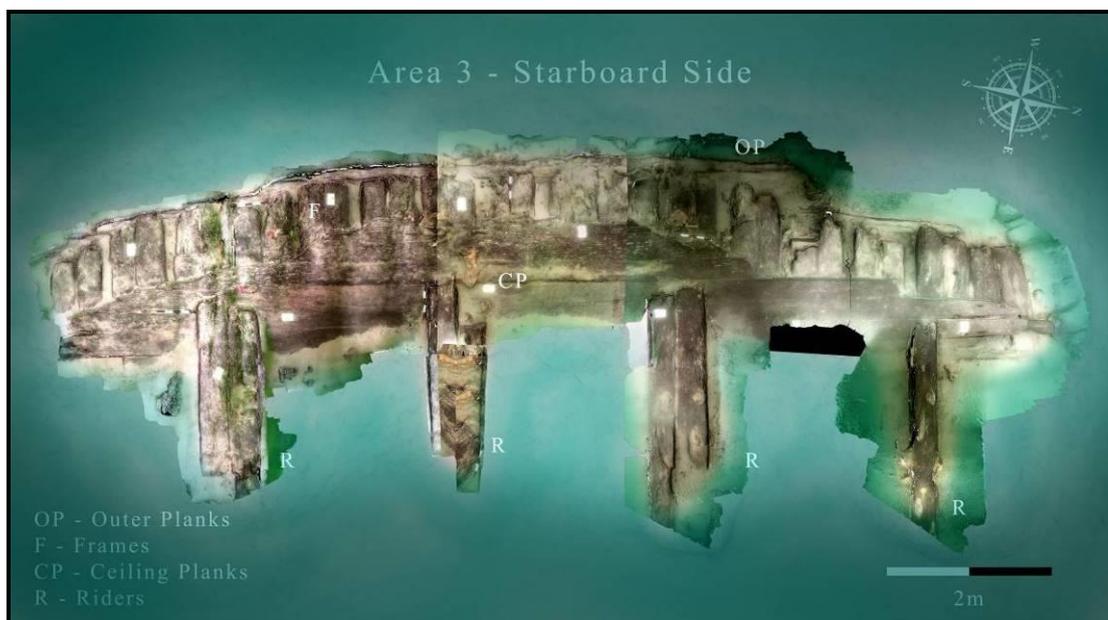
- 5.3.4. The results of the photogrammetry survey of Area 3 come from three individual data-sets which can be seen in Figure 19. The first data-set is at the south end and includes the first 6.5 pairs of frames or 13 individual frames. The second data-set is in the middle and includes six individual frames. The third data-set includes 6.5 pairs of frames or 13 individual frames from the north end. The three data-sets represent three individual dives that were made to complete the survey.

Figure 19: Image showing original processed photogrammetry model of Area 3 with Photoscan targets. The image also shows Area 3 is made from three data sets © PAS.

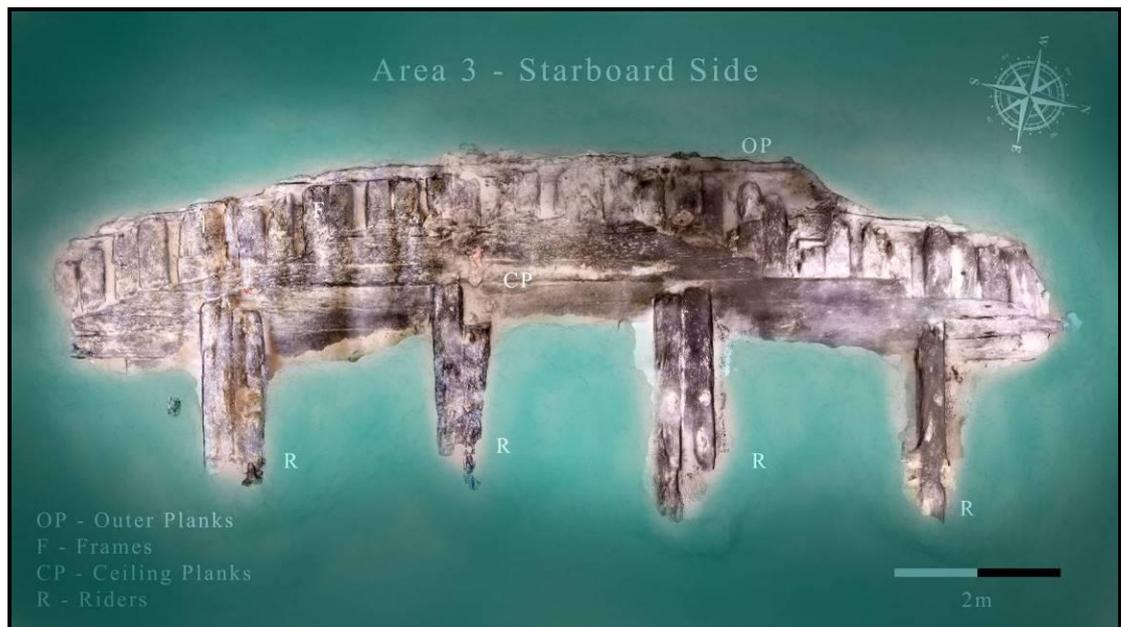
- 5.3.5. The three data-sets have been merged together to form one model representing the total area surveyed. Figure 20 represents the colour-corrected version of the same model. The two models represent the inside of a section of the starboard side hold.

Figure 20: Image showing the colour corrected model of Area 3 © PAS.

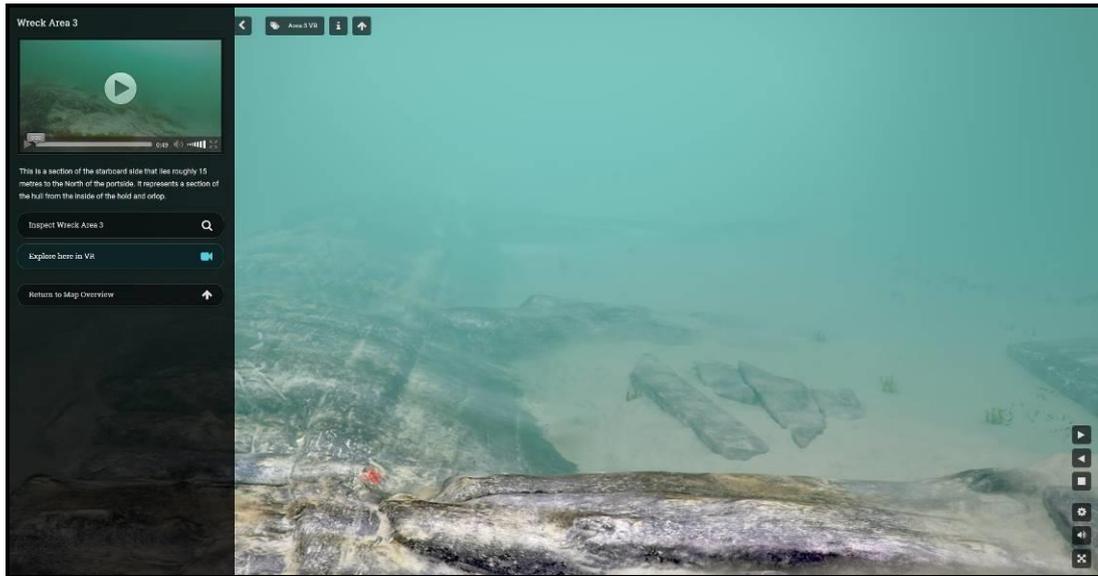
Figure 27: The 3D animation sequence of Area 3 © PAS.

- 6.1.1. Monitoring of the sand levels has revealed that the site has not recovered from the 2014 storms and further reductions in sediments are still occurring, most noticeably in the northern areas (Figure 27). On the western edge (out-board) of the main site from CP1 to CP6 there has been an average loss of sediment of 0.08m. However, the recording of the height above the seabed and the extent of newly exposed structures and artefacts within the hull of the main site (inboard) have revealed a much greater loss. The reduction of sediments within these inboard areas is the most significant, especially towards the bow where it is revealing fragile internal structures and organic artefacts (Figures 1-13). In the northern and eastern areas of the site between CP7 and CP15 there has been an average loss of 0.4m. The loss of 0.4m has exposed large areas of starboard side structure (Figure 27).
