# An Assessment of a Second World War Hangar Structure at Tollerton Airfield, Rushcliffe, Nottinghamshire

TOLLERTON AIRFIELD  
RUSHCLIFFE  
NOTTINGHAMSHIRE

AN ASSESSMENT OF A SECOND WORLD WAR HANGAR  
STRUCTURE AT TOLLERTON AIRFIELD,  
NOTTINGHAMSHIRE

NGR: SK 61544 36017

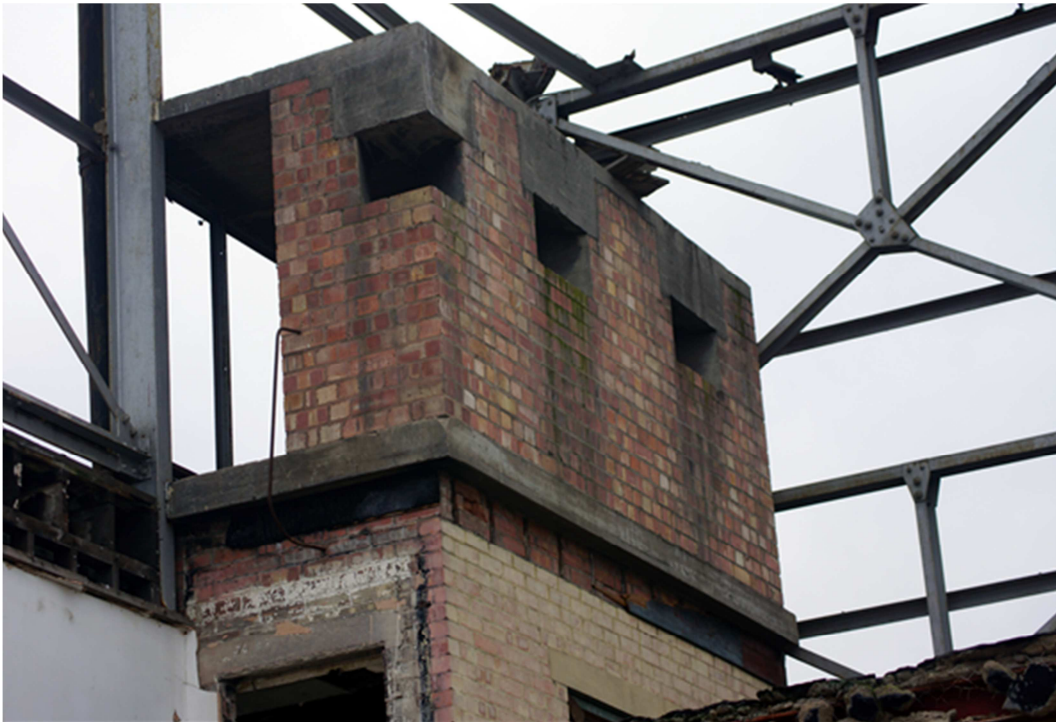
The roof joists of the first-floor offices have been extended in height to just below the concrete slab floor of the fire watcher's shelter. This may indicate that as originally built, the office roof was lower, and the fire watcher's shelter had yet to be built. This difference in construction, may reflect the publishing of Government's mandatory orders and acts of parliament concerning fire watchers and defence against fire on factory premises (see Part 3). The fire watcher's shelter survives in a precarious condition.

*Figure 12: View from the hangar's interior of the fire watcher's shelter. [Paul Francis 5 December 2017]*
