THE BELL FRAME AT ST MARY'S CHURCH, ATTLEBOROUGH, NORFOLK

An historical analysis

By
Richard Bond

Research & Analysis Team
Reports and Papers B/014/2004
2004

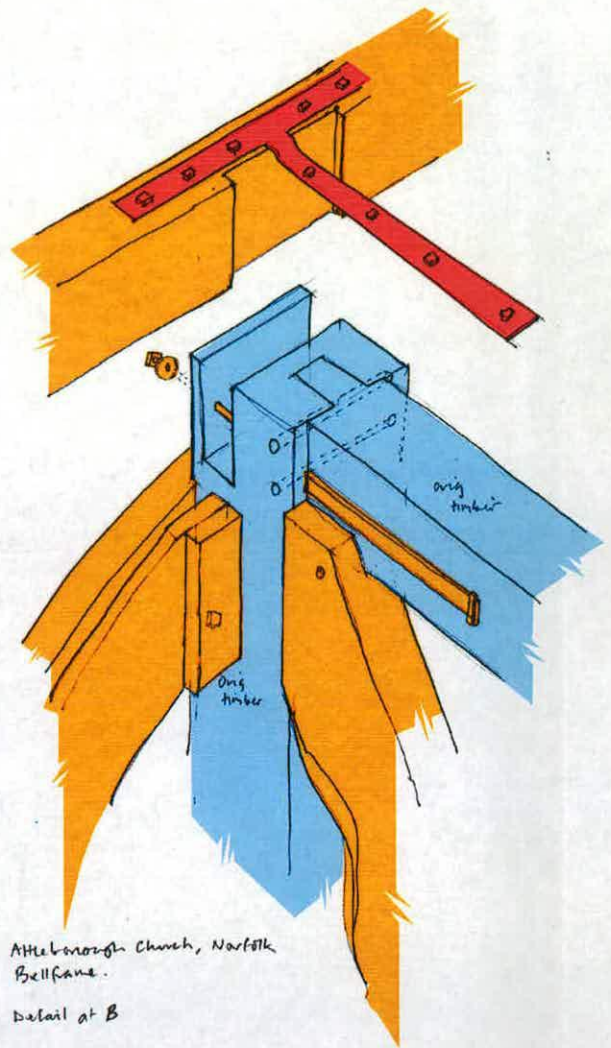
Figure 25 Detail at B.
Original sketch on left; edited sketch showing phasing of timbers on right

Attleborough Church, Norfolk
Bellfane.
Detail at B

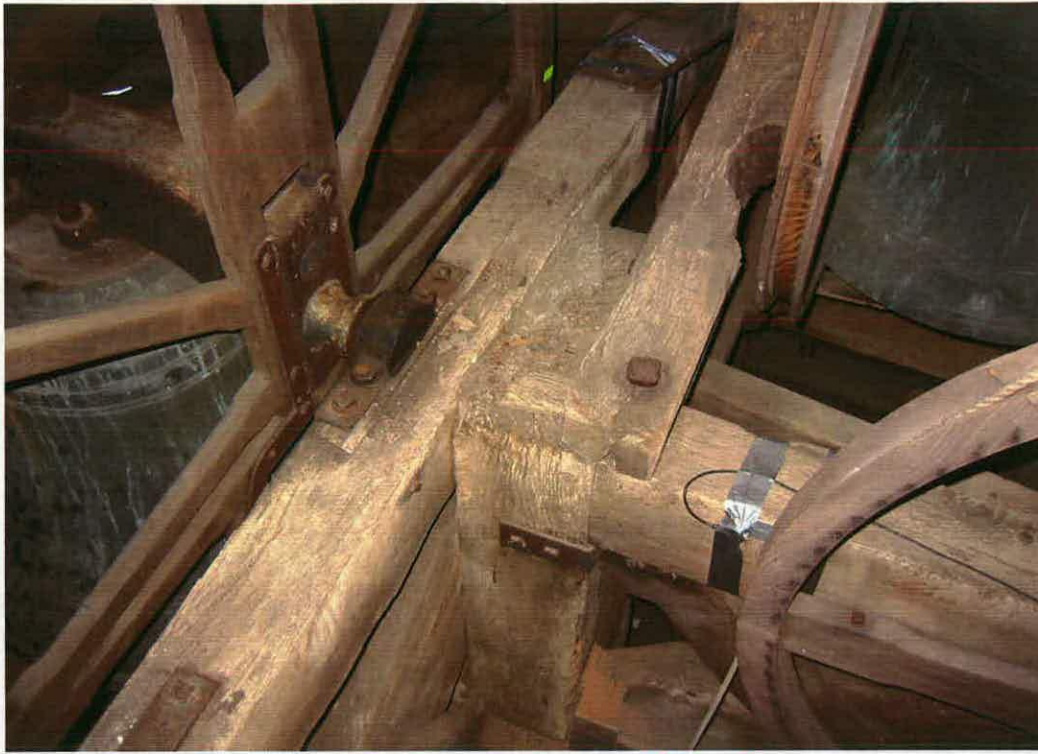
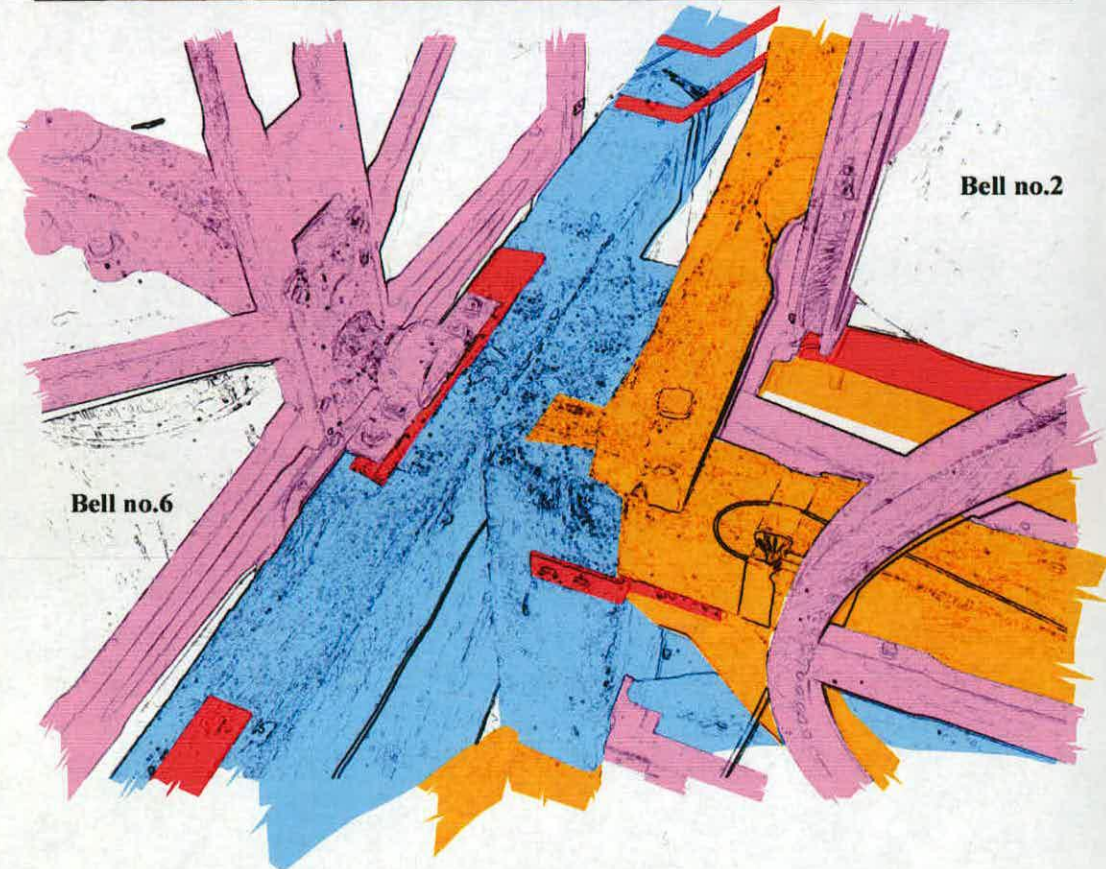
Figure 28 Detail at D.

**Original photo above; edited photo showing phasing of timbers below.
The head-piece of the south side frame is probably an early C16th timber
reset in the early C18th or c.1909**
