Blackbeck Gunpowder Works,
Cumbria:
an archaeological
and architectural survey

SURVEY REPORT

Archaeological Investigation Report Series AI/32/2004

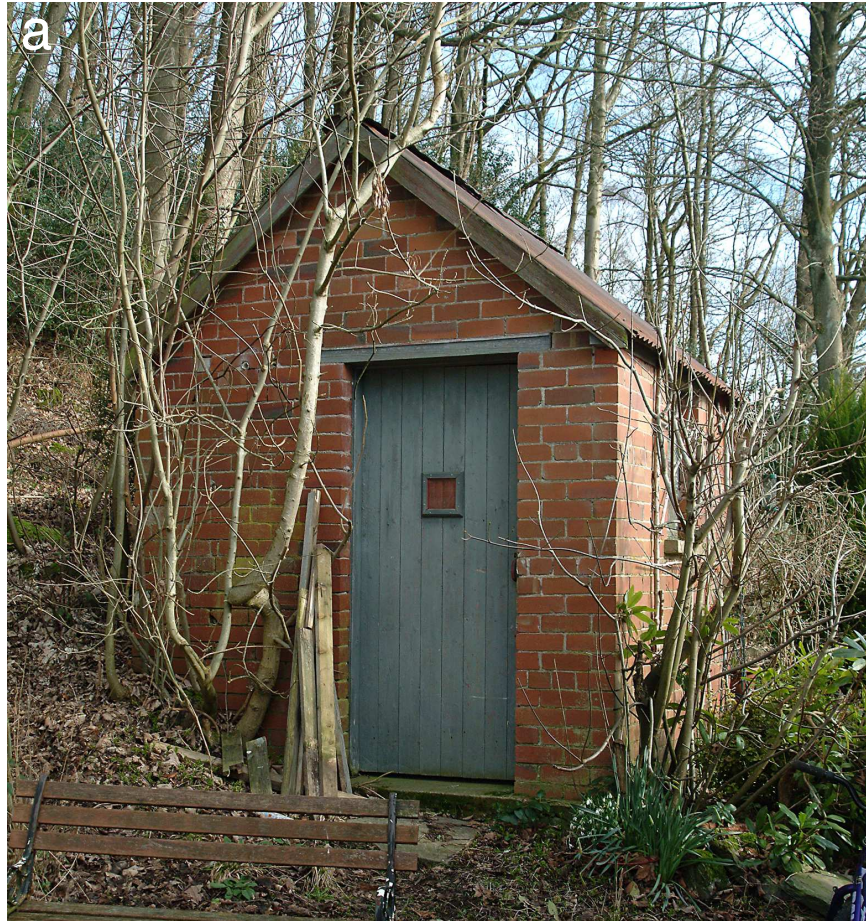
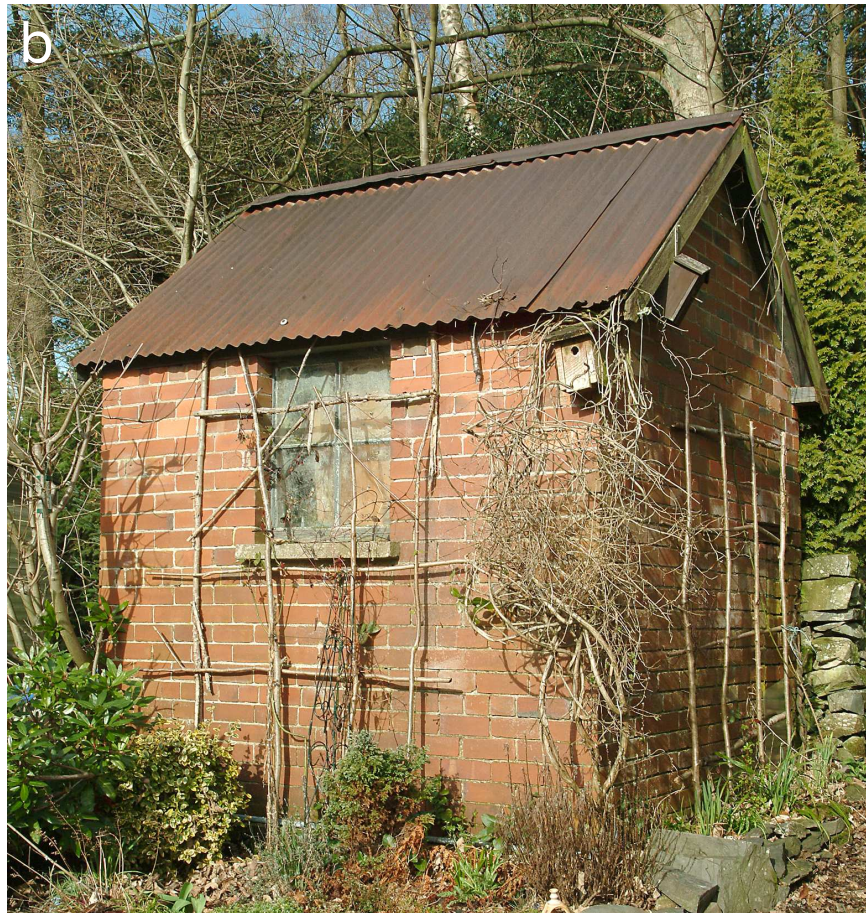
The electric motor house beside the reel house (6) (Fig 15)

The electric motor house, which stands on a concrete base, is a single-storey red brick building, 2.6m square, gabled to east and west. The brickwork is in English garden wall bond, and it has a roof of corrugated-iron sheets. The doorway, off-centre in its west wall, has a timber lintel; the door, of timber plank construction, has a small, formerly glazed frame which probably held a key for emergency use. Left of the doorway four metal pipes, each about 30mm in diameter and arranged in a rectangle (0.68m by 0.49m), may have provided ventilation or have held the fixings for a notice or distribution board. Two holes above these are lined, possibly with ceramic material, and may be connected with the supply of electricity to the building. The south wall has a small window with a fixed four-light frame and a concrete sill, the wall plate acting as its lintel. In the east wall, close to the

Figure 15.
*Electric motor house for
the probable reel house,
from the west (a) and
south (b). (NMR:
DP003373; DP003374)*

north corner and facing the machine beds of the reel house, there is a slot (now blocked) through which the belt which supplied the drive from the electric motor to the reels originally ran (Fig 32). The slot, 1.05m high by 0.36m wide, has a 0.64m length of cast-iron tramway rail reused as a lintel. At the time of survey the interior was being used as a store for the caravan park, but just visible under its contents was the concrete machine bed which held the motor. The 1.3m long block (0.24m high) appeared to be more or less centrally placed against the north wall from which it projected 1.1m into the interior.

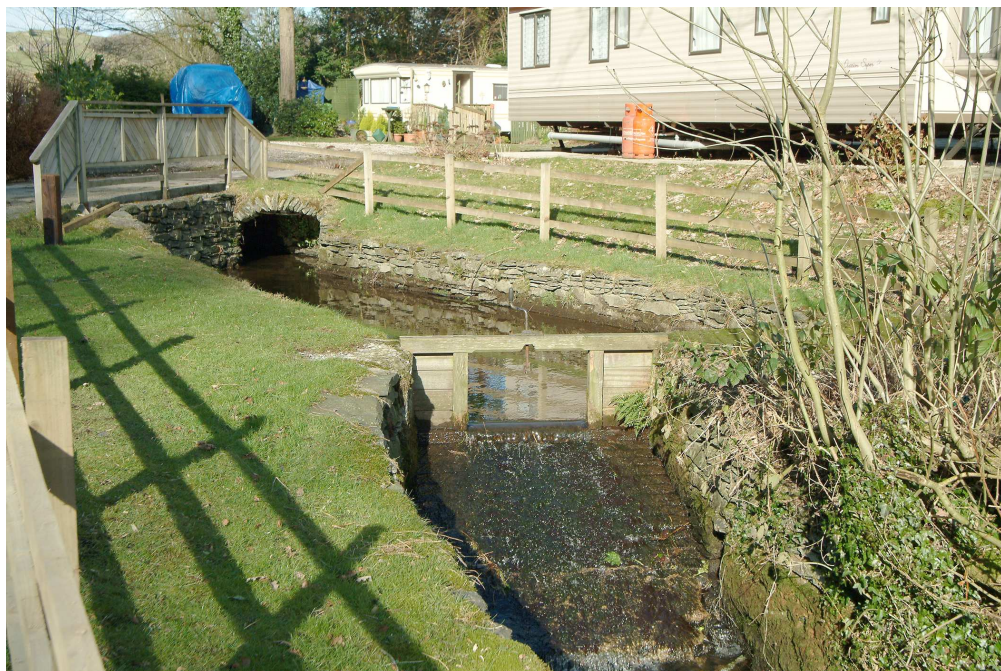
The Black Beck has been confined to a narrow channel for much of its course through the main part of the works; roughly coursed rubble walling still revets its sides in many places. EH measured the depth of the channel at two locations: firstly opposite the site of the lower pond, where it is 1.2m deep; secondly near the oil store where it has a depth of 1m. The OS 25" maps and site plans indicate that the beck was bridged in a number of places to permit access to buildings and to allow the main works tramway (on the site of earlier factory roads) to cross it at both the northern and southern ends of the main part of the works. These last two crossing points are still used by the principal caravan park roads. Immediately south of the northern crossing the beck has been widened, no doubt to provide a good head of water to feed the lower pond. The OS maps indicate that originally this widening extended further up the beck and terminated against the northern boundary of the works (Ordnance Survey 1890a; 1913a). The northern crossing now consists of a skewed stone bridge with a small opening for water to pass through it at its base. However, the beck itself flows out into the widened area from under a stone arch situated just beyond and to one side of the south-east end of the bridge. The floor of the widened channel has a concrete bottom while at the south end the beck channel is crossed by the remains of a sluice. The gate has gone but some timbers, together with a handle to raise and lower the gate, still survive; beyond the sluice the channel assumes its normal width again (Fig 16). The present sluice timbers and handle are clearly much later than the gunpowder works but the presence of a much earlier sluice here is confirmed by the OS 25" maps (Ordnance Survey 1890a; 1913a). On the east, adjacent to this last sluice, the site of a second sluice is also visible. This one

Figure 16.
Widened beck channel
and sluice to the north
west of the former
lower pond.
(NMR: DP003418)

controlled the supply of water into the lower pond and now comprises a large piece of concrete containing a recess for the sluice components; it is uncertain if the surviving remains relate to the gunpowder works or to the conversion of the lower pond into a swimming pool for the caravan park (see this section, below). At the southern end of the works the beck flows through pasture fields and here it is much wider, lacks revetment walls and is clearly cleaned out from time to time - hence the low banks of up-cast along its edges.

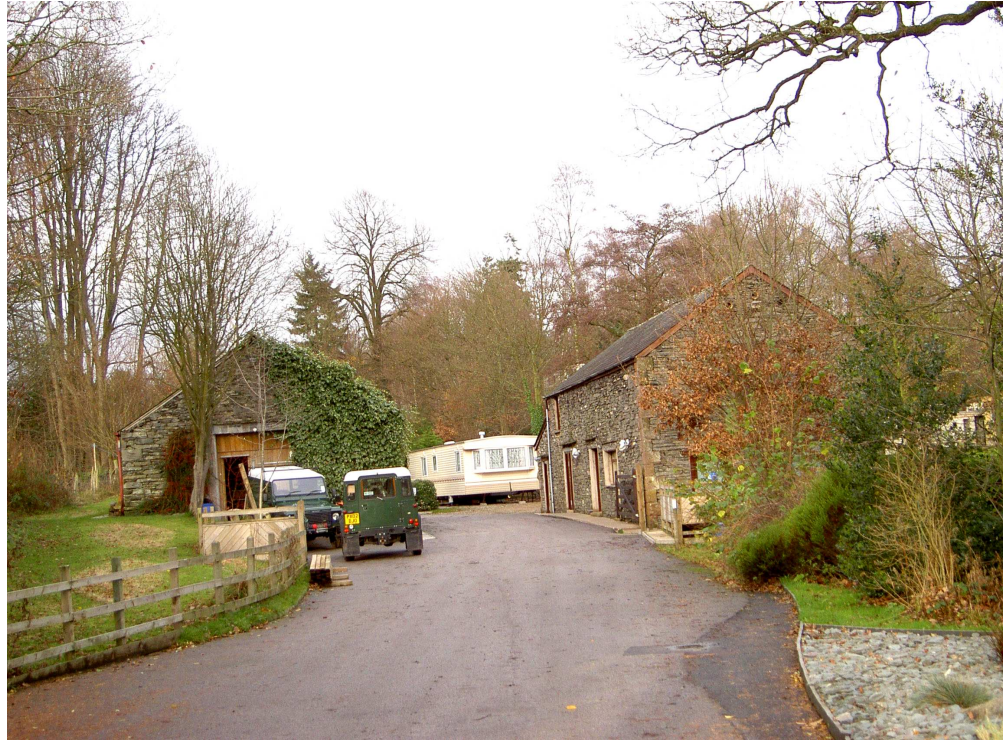
*Figure 18.
Saltpetre house (left)
and store and stable
(right) from the south.
(Christopher Dunn,
November 2003)*

One of the windows of the saltpetre house was broken in September 1928 when an explosion occurred at the incorporating mills (Imperial Chemical Industries 1928, attached list of buildings damaged). The first and 1913 editions of the OS 25" map indicate that it was served on the east by a loop from the tramway. The track from Black Beck Farm to Pool Bridge originally went past the western side of the saltpetre house (Ordnance Survey 1890b) but had been moved further up the hillside by the time of the 1898 site plan. A grassy terrace still marks the course of the former track beside the saltpetre house; to the south of the latter the back scarp defining it on the west has a maximum height of 3m while just beyond the north-west corner of the building the front edge of the terrace consists of an east-facing scarp, about 1.5m high.

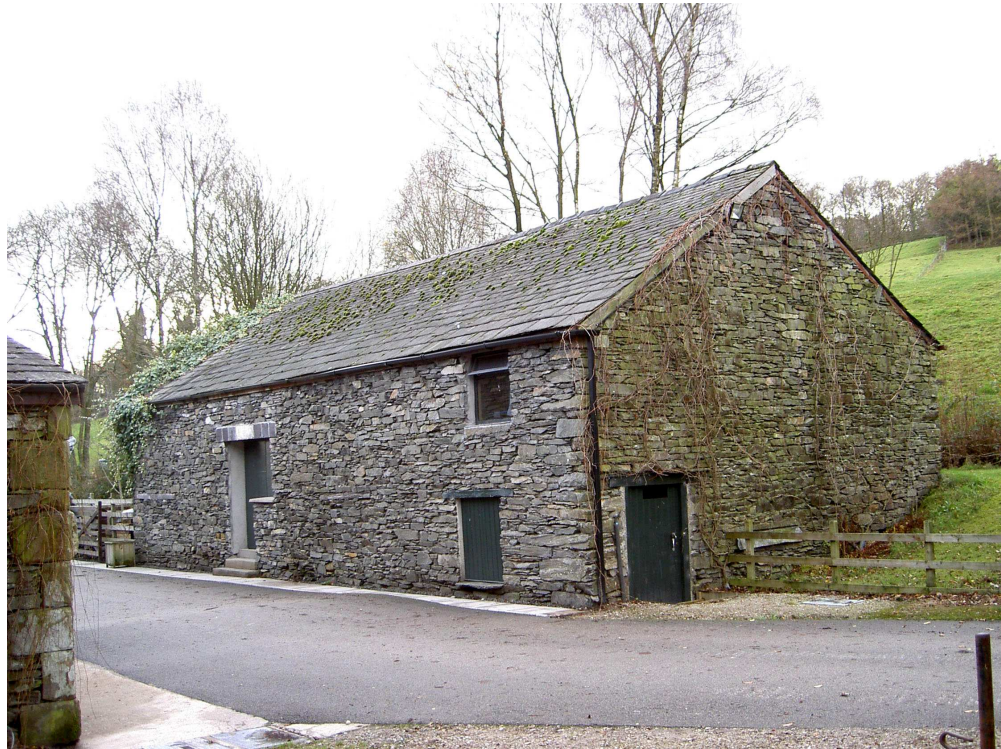
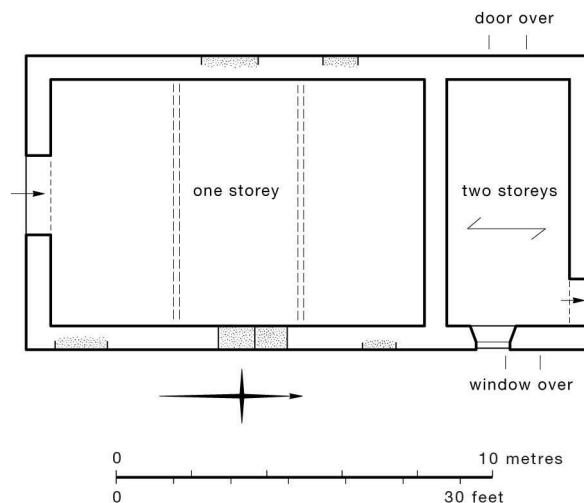
The saltpetre house occupies a site which is cut back into the slope. It is a rectangular building, gabled to north and south, and is built of stone rubble without noticeable quoins. It has a slate roof. All openings have timber lintels, some protected from weathering by nailed slates. The south gable end is partly obscured by ivy but just below the apex of the east gable wall are two brown circular ceramic ventilation pipes. For its larger part it is a tall single-storey building, but at its north end two floors have been created within the same height, the ground floor sunk slightly into the ground, the first floor open to the roof. The main part of the building, open to the roof, is entered from a wide doorway with a slate drip course above it set centrally in the south wall. A similar wide opening in the east wall, perhaps used as a taking-in door, was altered to create a door flanked by a window before these were blocked. This part of the building, which is open full-height inside, has two blocked openings low down in its east wall, and two more higher up in its west wall, where there is also a modern fan. The interior is roofed by two king-post trusses with struts and two sets of purlins on each side. The northern end of the building, which has two floors, does not communicate with the main part. Its ground floor is entered through the gable wall

Figure 19. Saltpetre house from the north east (Christopher Dunn, November 2003) and plan of ground floor by English Heritage.

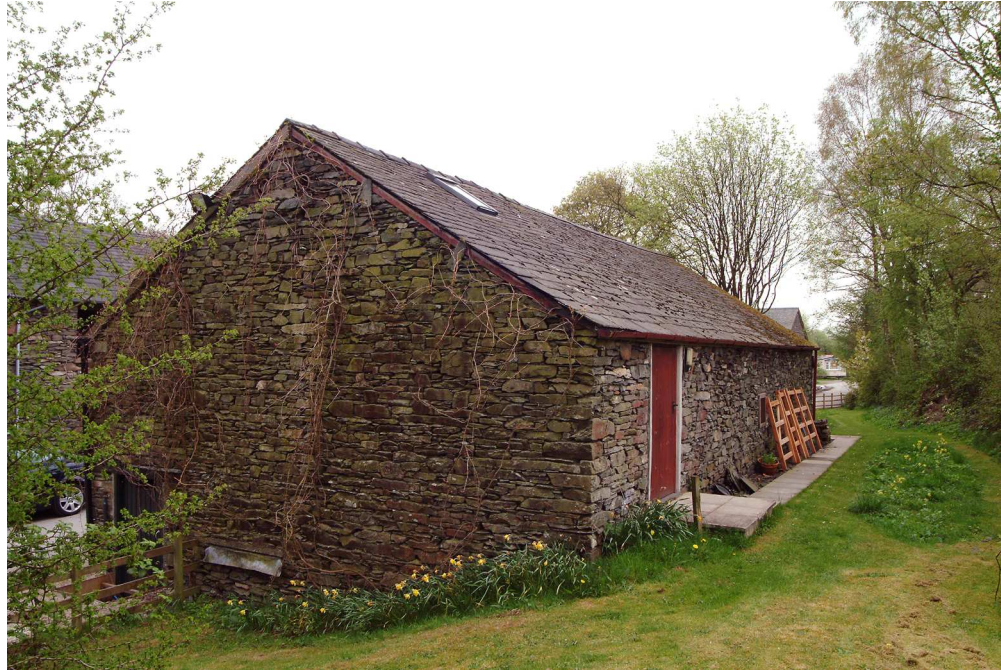
Figure 20.
*North end and west
wall of saltpetre house
from the north west.*
(NMR: DP004102)

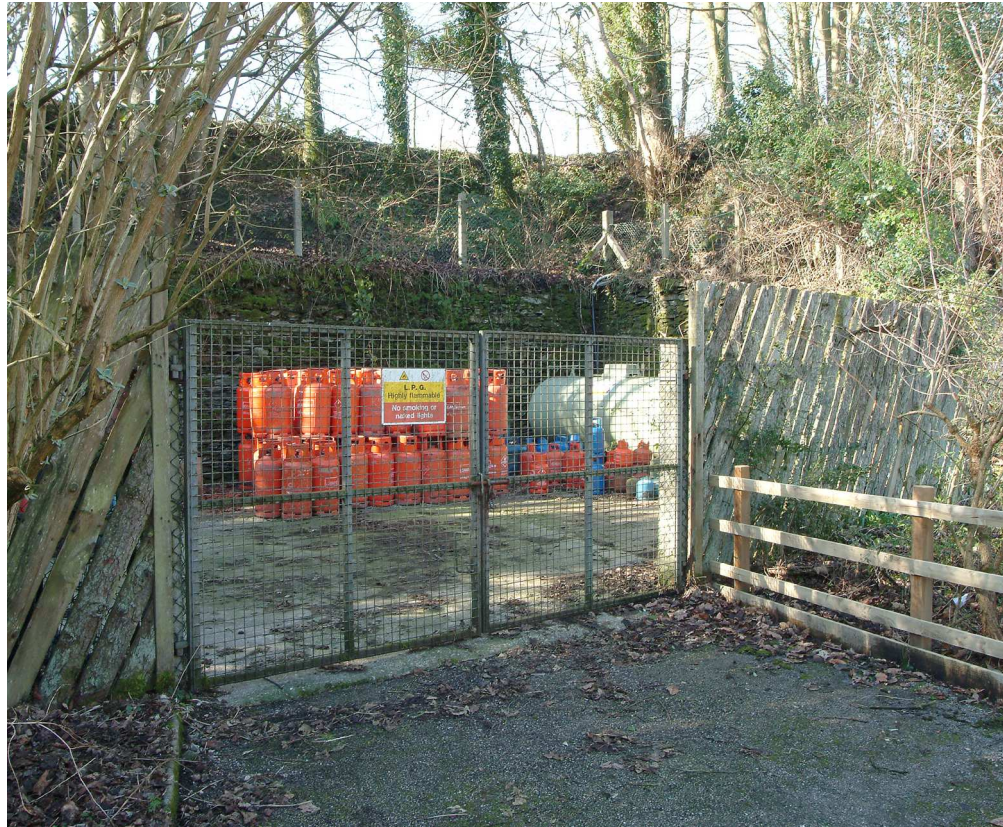
Figure 21.
*Site of the second
 mixing house
 looking west.*
 (NMR: DP003394)

The actual mixing house no longer survives but the rectangular cutting in which it was situated is still remarkably well preserved (Fig 21). It is excavated into the foot of the valley side and the lower parts of its south, west and north sides were revetted by coursed rubble walling which survives intact and stands up to 3.75m in high. At some time a concrete post and wire safety fence (not surveyed by EH) was erected on top of the revetment. A narrow berm separates the revetment from the upper part of the cut into the natural slope; this part of the excavation survives as an earthen scarp up to 2.25m high. The southernmost revetment wall may have been repaired or modified at some stage because there is a straight joint in the stonework near the west corner. At its eastern end this south wall turns through ninety degrees and continues south for a short distance as a 1.1m high revetment to the natural slope. A spur from the works tramway served the mixing house and was situated just in front (east) of this revetment - the spur is depicted on the OS 25" map revised in 1911. This map also shows that the northern revetment wall of the mixing house cutting once continued as a blast wall beyond the north end of the tramway spur and along its eastern side, thus

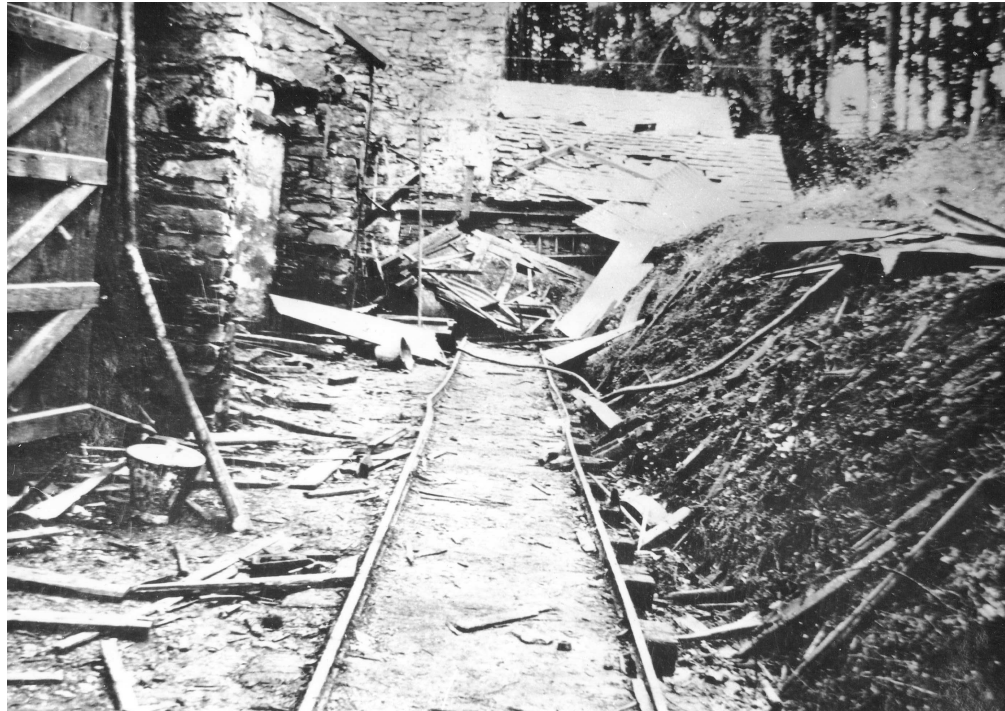
Figure 23.
*Incorporating mills 3-1
(left) and the north
(blast) wall and roofs
of the building range
immediately to the
south. Taken from the
north after the
explosion at the mills
in September 1928.
(NMR: Patterson
Collection)*

The photographs taken of the damaged incorporating mills after the 1928 explosion help to confirm some of the information derived from the documents while also providing additional details (Figs 23-25). Clearly visible are the displaced corrugated iron roof sheets that had been attached to a grid-like framework of purlins and rafters to form a sloping roof. The rubble side walls of the chambers extended both beyond the fronts of the mills and also upwards above the mill roofs in order to act as blast walls between individual mill chambers. The tops of the walls were gabled and capped by flagstone copings. The photographs also

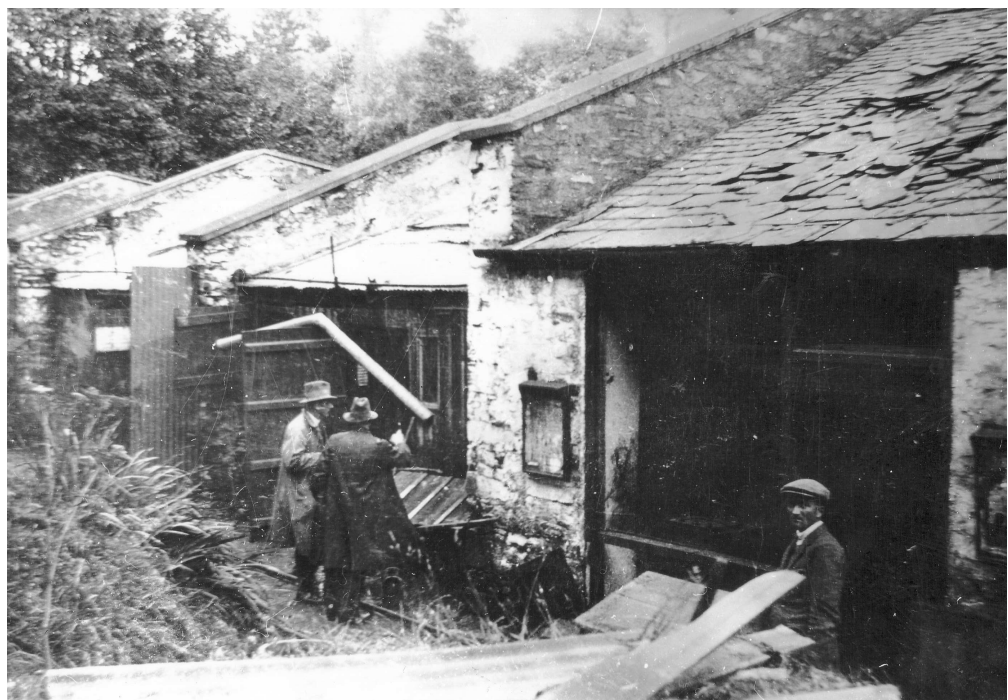
Figure 24.
*Incorporating mills 4-6
(left) and the main
engine house (right)
after the explosion in
September 1928,
looking north. (NMR:
Patterson Collection)*

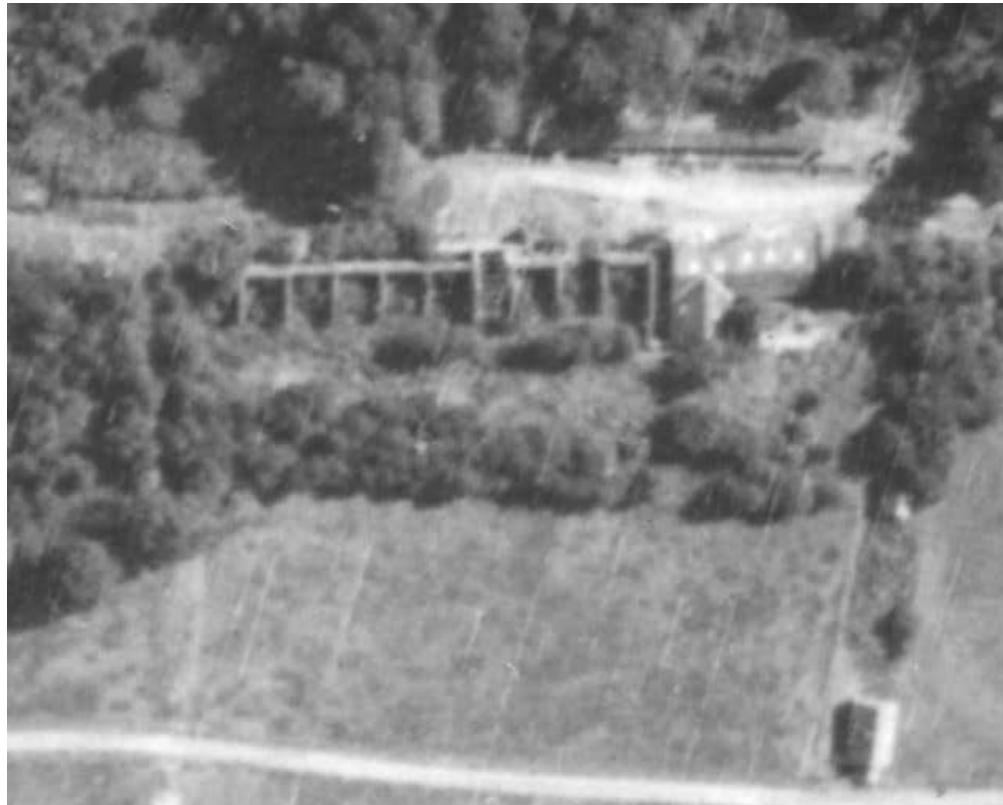
Figure 26.
*Enlarged extract from
RAF air photograph
showing the
incorporating mills in
1945. (NMR Air Photo
Library: RAF106G/
UK.653/13-AUG-1945/
4141)*

The site of the incorporating mill range has been levelled to form caravan pitches. However, air photographs indicate that the mill chambers survived long after closure. The side walls and long end wall of the latter, together with the engine house between mills 3 and 4 (see section 6.1.1, above), were still upstanding and apparently in relatively good condition when the Royal Air Force photographed the area in 1945 (NMR: RAF 106G/UK.653/13-AUG-1945/4140-1) (Fig 26). Later photographs confirm that, although dilapidated, they were still extant in 1957 (NMR: RAF/2151/26-APRIL-1957/0005 and 0058) but must have been demolished sometime between then and May 1966 when Ordnance Survey photographs show caravans on their former site (NMR: OS/66/109/30-MAY-1966/ 478-9).

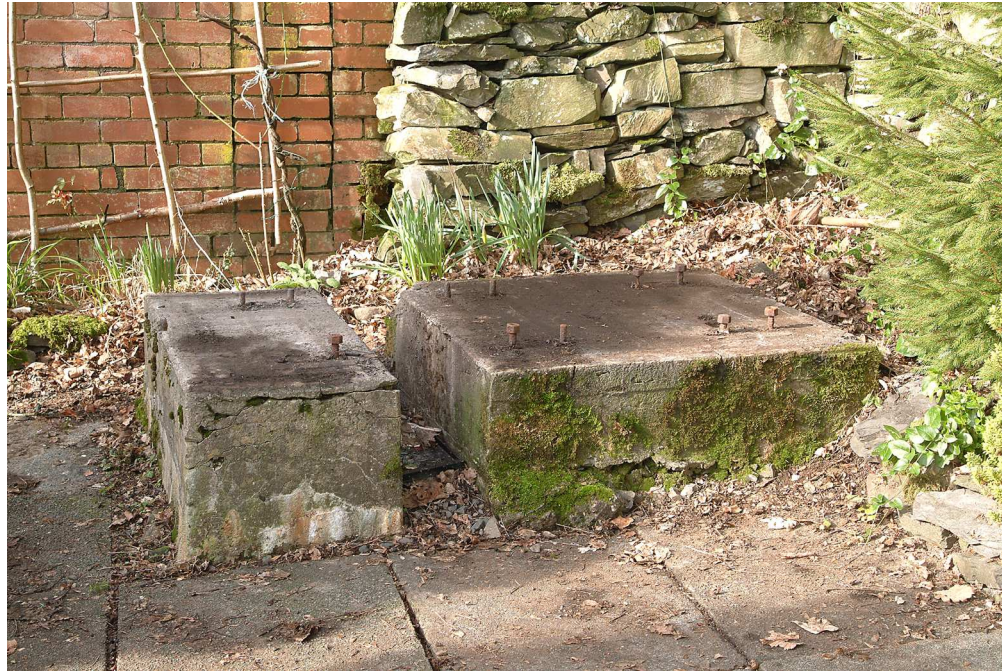
Behind a caravan (15 Hazel Avenue) the lower part of the side of the natural gap has been revetted by a wall, up to 1.7m in height and over 10m long, of coursed rubble with a small, ivy-covered triangular buttress-like feature protruding 0.5m out from the wall near the latter's eastern end. The actual reel house was probably built a metre or so in front of this revetment on the level area which is now the site of a patio. Near the west end of the patio two earth-fast machine beds (currently used as the supports for a low wooden table) survive (Fig 32).

Figure 32.
*Machine beds on site
of the probable reel
house, from the east.
Modern table top
removed for
photograph and
blocked slot in end
wall of electric motor
house visible. (NMR:
DP003375)*

They are both opposite and parallel to one another with the space between them measuring 0.23m in width. They are both 1.1m long (east to west) and 0.4m high; the one to the north is 1.1m wide while its companion is only 0.5m in width. Bolts (some still with nuts) for fixing machinery still protrude from their upper surfaces. The four on top of the southern block form two pairs - one at each end - and are set closer to the north edge of the block than to its southern side; there is also a notch in the southern face of the block near the south-west corner. The eight bolts on top of the northern block form four pairs, one towards each corner an arrangement which may mean that the block supported two machines. Power for the machines on both blocks was delivered by a belt which left the nearby electric motor house through a slot in its east wall and extended into the space between the two machine beds where it presumably went round a pulley wheel which transferred the drive to the machinery. The power would have been used to rotate the reels but EH has found no information about either their number or how they were organised within the reel house.

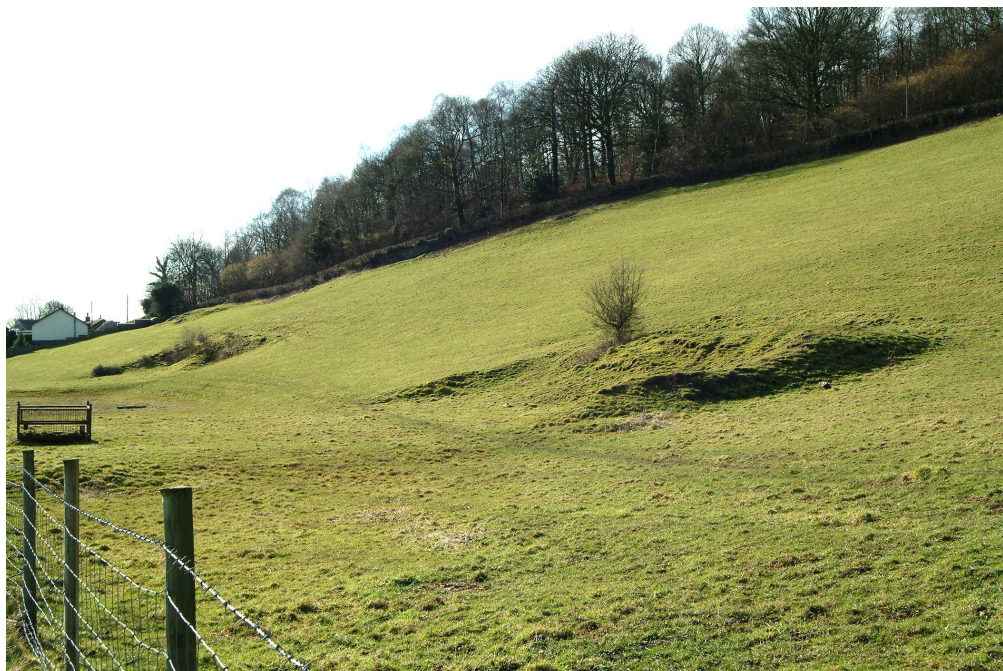
Figure 35.
Sites of cartridge house No. 4 (left) and cartridge house No. 3 (right), from the north-north-east. (NMR: DP003382)

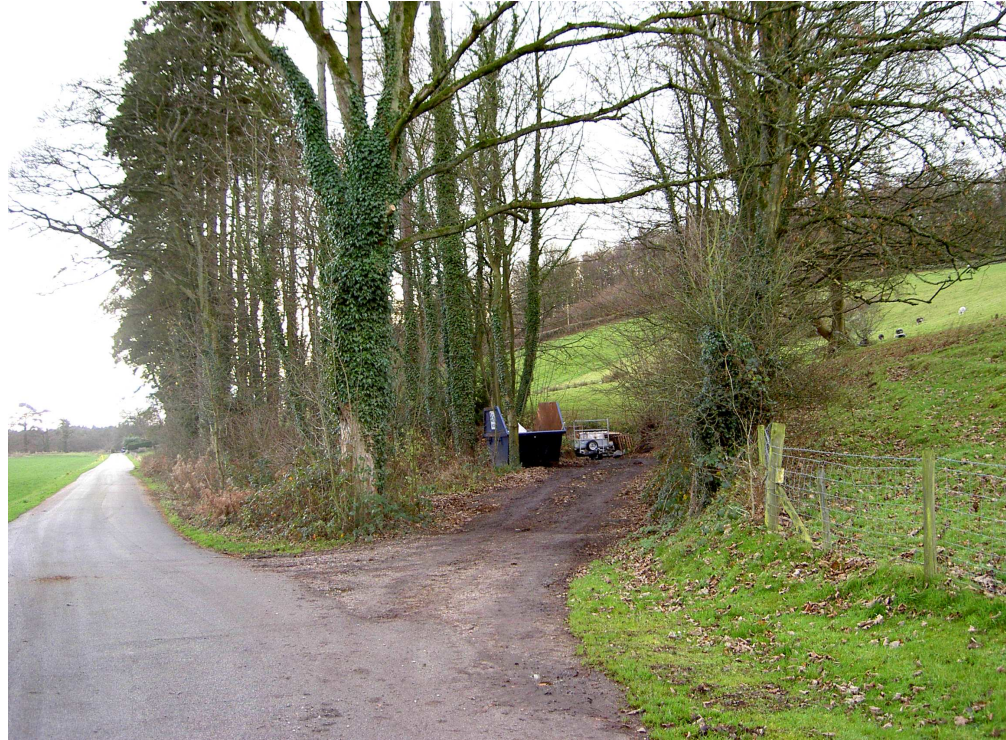
Figure 37.
*Site of store magazine
 from the north east.
 (Christopher Dunn,
 November 2003)*

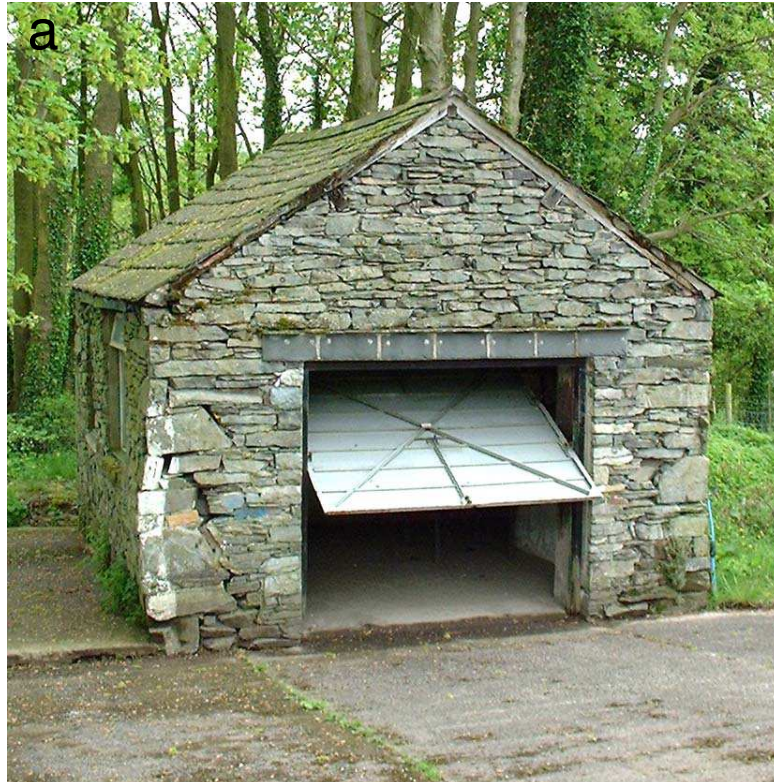
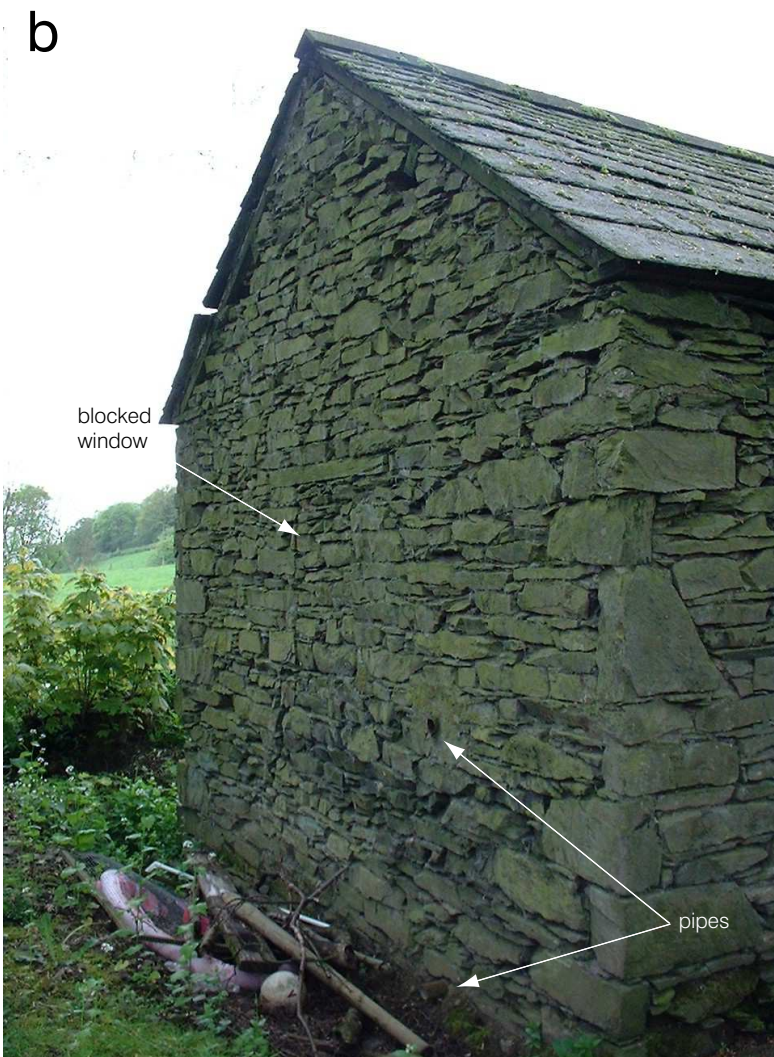
EH visited Blackbeck in May 2002 when the time office and search house still survived, despite having been converted into a garage for Meadow Bank Cottage (the former new watch house to the west). The single-storey rectangular building, gabled east to west, was built of coursed rubble with quoins of crude blocks and had a slate roof. A broad opening for the garage door inserted into the west gable wall must have destroyed the original entrance to the building (Fig 39a). The north wall contained a pair of windows. By November 2003 the time office and search house had been largely demolished, only parts of the east and south walls surviving. These remains indicated that the building had originally measured about 4.8m by 4.35m with walls some 0.5m thick, and a plastered interior. In the outer face of the east wall a blocked central window, photographed by EH in May 2002 (Fig 39b), was still visible (inside the building it had been plastered over) while traces of another blocked window just survived in the centre of the south side. Two cast-iron pipes, each almost 6cms in diameter and arranged one above the other with centres 1.05m apart, pierced the east wall some 1.1m back from the north-east corner; the lower pipe was at ground-level.

Figure 39.
Time office and search house from the west (a) and north east (b). (Abby Hunt, May 2002)

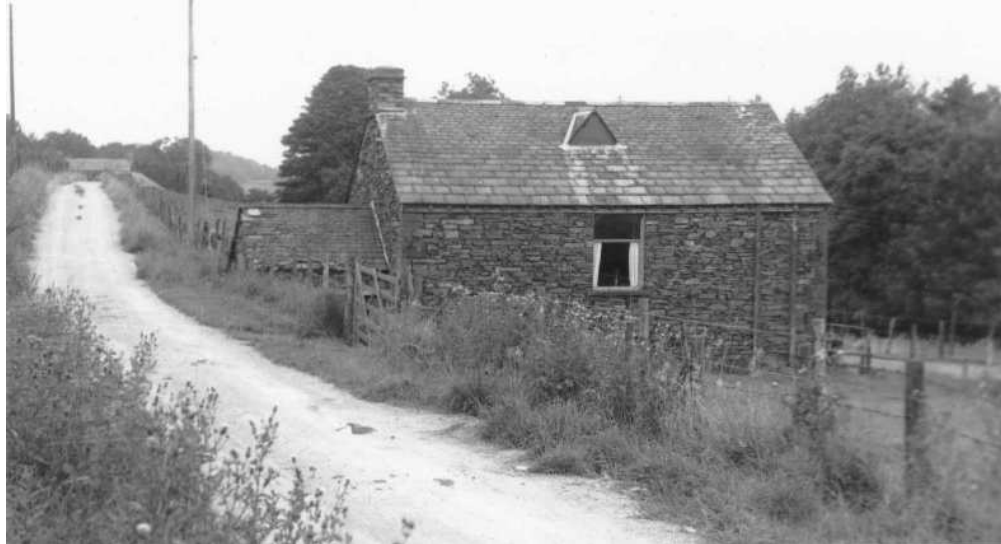
Figure 40.
The watch house in 1958, from the south.
 (Ron Mein Collection, copyright reserved)

The watch house, as shown in a photograph (Fig 40) taken in 1958 before recent major alterations, was a tall single-storey building gabled to east and west, with a low gabled addition against its west, uphill gable. Both parts of the structure are built of coursed stone rubble with red sandstone quoins, and have slate roofs. The main part was entered from a doorway at the downhill end of its north elevation, which opened directly off the road down into the works. The interior was lit by opposed central windows set high in the north and south walls, triangular vents in the roof slopes above them affording ventilation. A chimneystack in the west end wall indicates where the only fireplace to heat the building was. Curtains and a flower vase in the window in the 1958 photograph indicate that it was already being reused as a dwelling, and more recently it was heightened (Figs 41 and 56) to create a two-storey cottage with an upper floor partly in the roof, and is a holiday let known as Meadow Bank Cottage. The original central window positions were retained, but in altered form, and new windows were inserted. The roof vents were also retained in the new, raised roof.

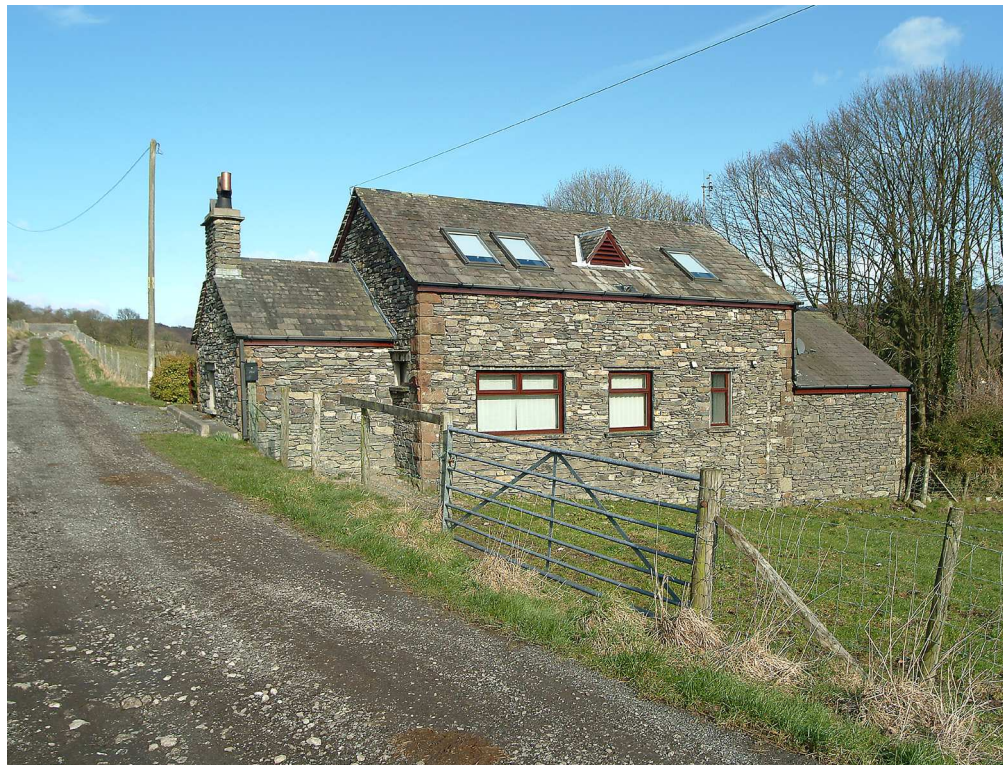
Figure 41.
Watch house (now Meadow Bank Cottage) from the south.
 (NMR: DP003387)

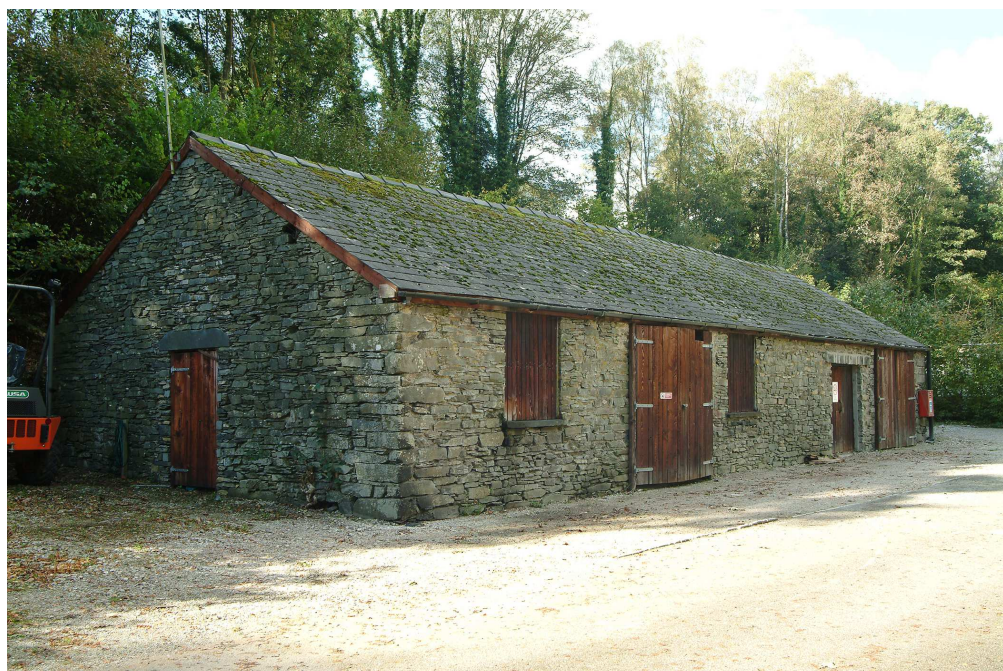
The L-shaped building range shown abutting the south end of the incorporating mills on the 1881 and later site plans (and on the OS 25" maps) still survives (Fig 42) - it was probably erected when the works was established in the early 1860s. It is divided into two compartments on the 1898 site plan, the larger one at the north end annotated 'Engine Saw Mill', the narrower one to the south annotated 'Lathe House'. It is suggested above (section 6.1.1) that the northern compartment, in addition to housing a possible dedicated steam engine for the saw mill, may also have contained the hydraulic pumps for the powder press and cartridge compressing houses during at least the late 19th century. Three compartments are shown on the 1928 site plan and in the accompanying report these compartments are called (from north to south) pump house 29, saw shed 30 and engineers shop 31 (Imperial Chemical Industries 1928, attached list of buildings damaged). Shortened descriptions, together with these numbers, also appear on the site plan - on the latter the engineers shop

Figure 42.
*Building range
immediately south of the
incorporating mills, from
the south east.
(NMR: DP004101)*

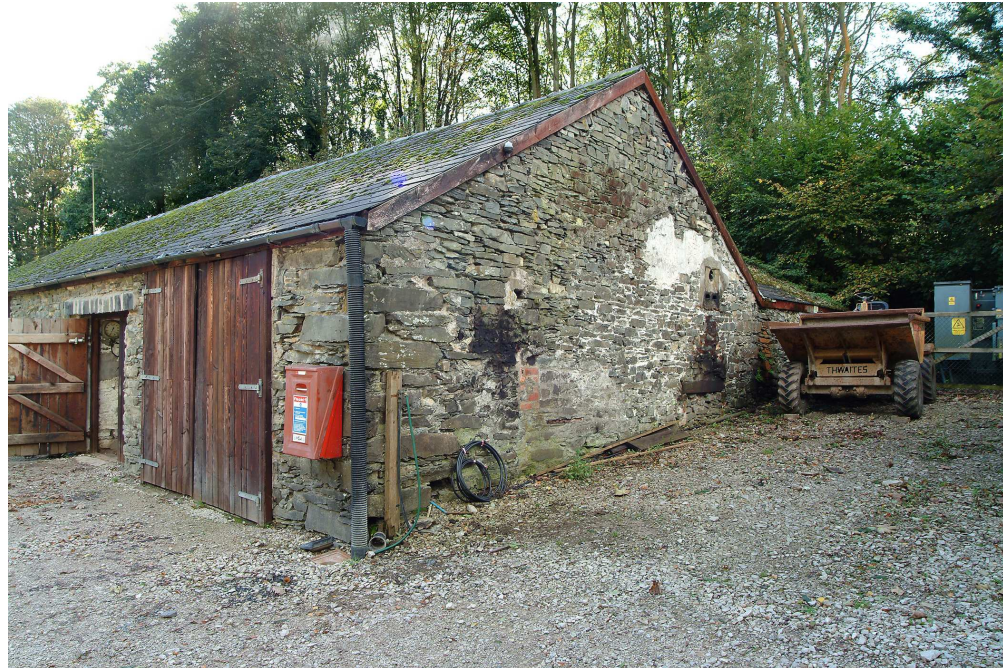
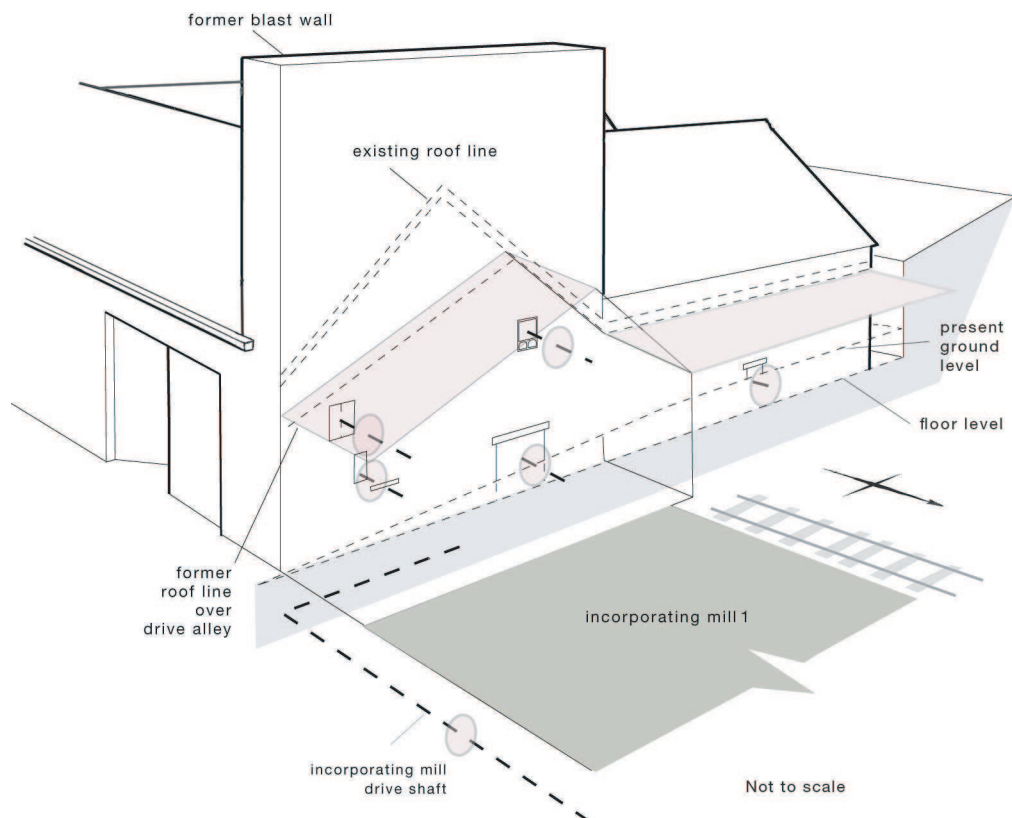
Figure 44.
 Photograph (NMR: DP004100), elevation and partial reconstruction by English Heritage of the outer face of the north wall of the building range immediately south of the incorporating mills. To aid reconstruction the surviving wall boxes have been shown with shafts and pulleys (for drive belts).

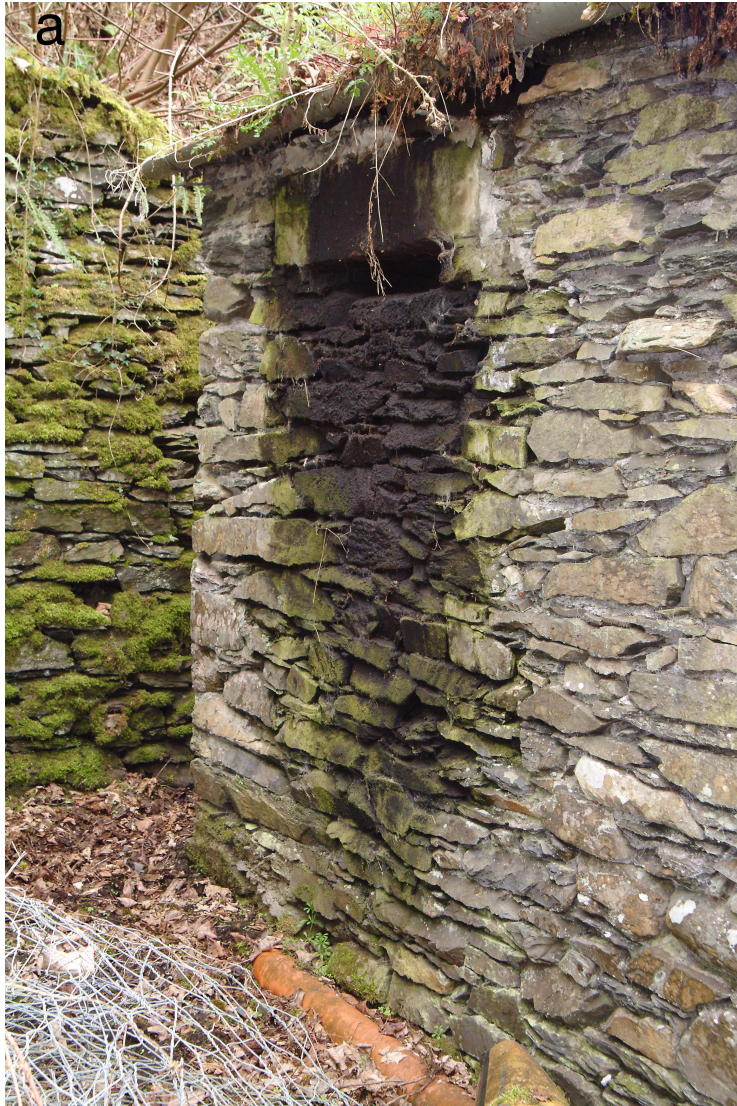
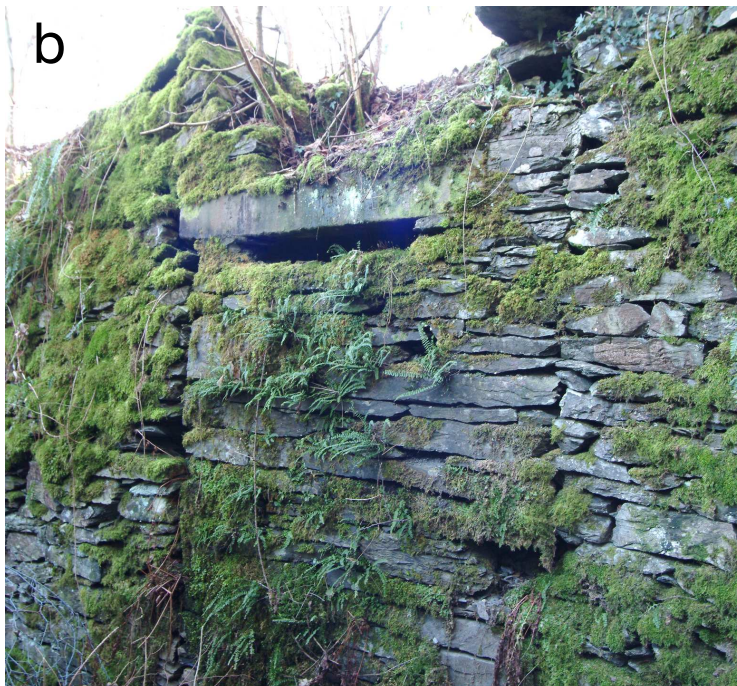
Figure 45.
 Stone slabs
 supporting bearing
 blocks for former
 drive shaft leading to
 second mixing house;
 (a) in south-west
 corner of building, (b)
 in revetment wall
 opposite.
 (NMR: DP003532;
 DP003396)

The Patterson Collection contains a colour photograph (dated July 1993) of the slab in the revetment wall but the caption on the back erroneously links it to the boiler house flue.

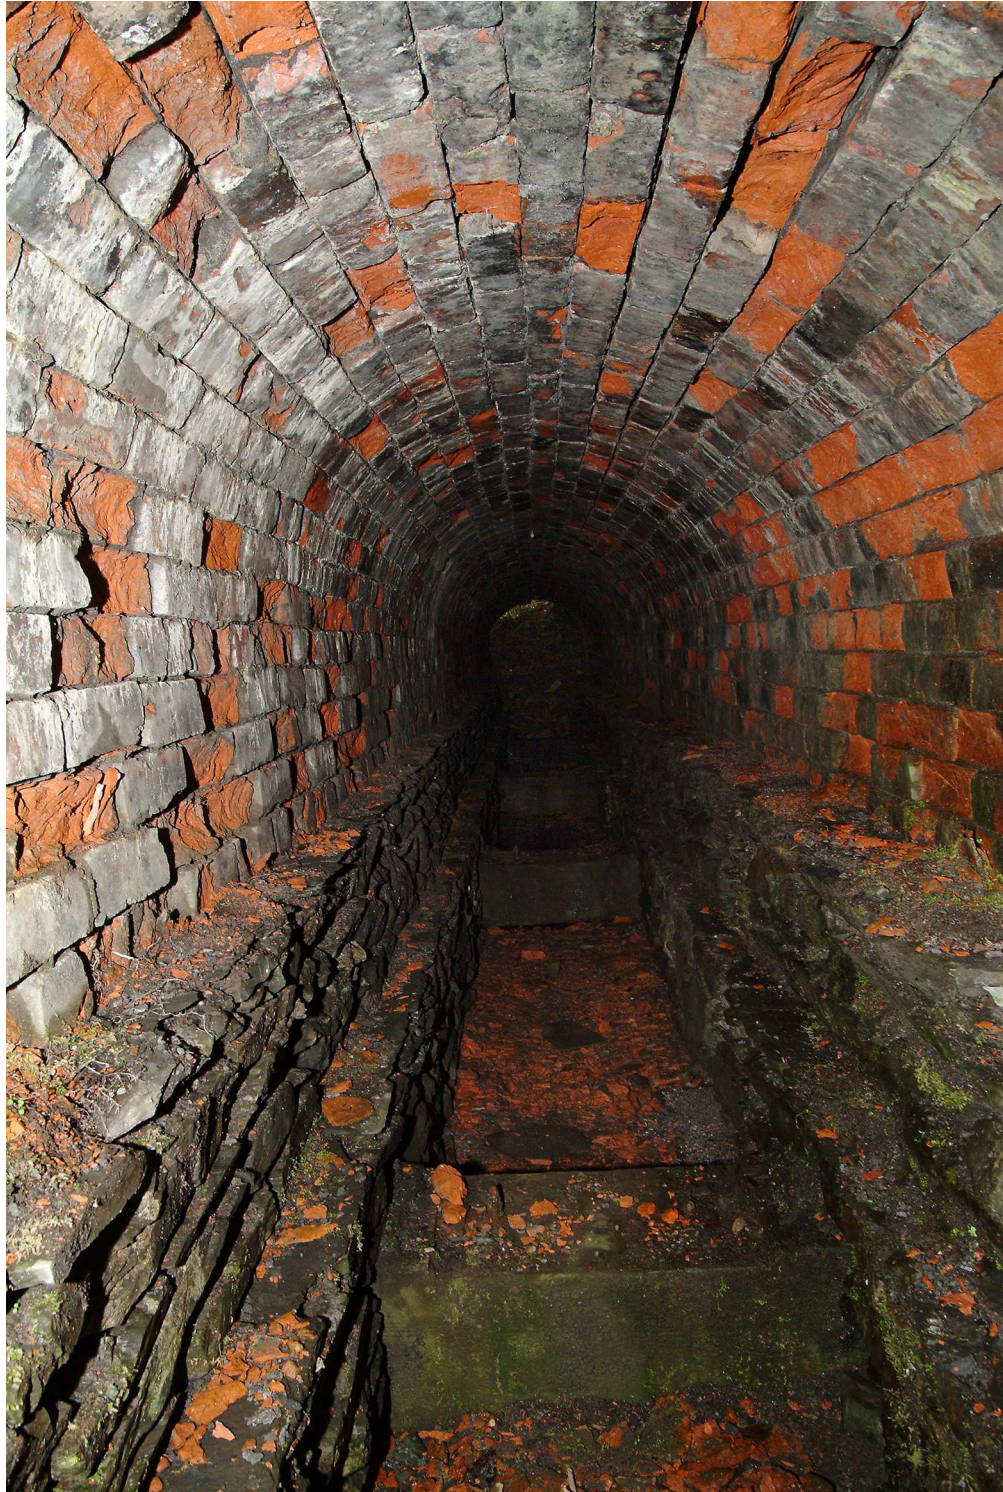
Figure 46.
*Drive shaft tunnel to
second mixing house,
looking south.
(NMR:DP003534)*

Between the revetment wall and the second mixing house the drive shaft was set within a brick-lined tunnel which ran north-south. The northern section still survives and is generally in good condition except that immediately beyond the revetment wall a short section of the tunnel roof has collapsed and a linear hollow therefore marks its course. The tunnel is, however, visible at the southern end of this collapse, from where it survives intact for about

10m (Fig 46). It can be seen to be built with a double skin of orange red common brick and in cross section takes the form of a stilted arch supported on a double-stepped base. The floor of the tunnel is flat and houses the cross bearers or mounting blocks which supported the fixing brackets of the drive shaft (Fig 47). The bearers are 0.61m wide, and some of the bolts which held the brackets in place still survive. Internally the tunnel is about 1.1m wide and 1.6m high from the underside of the arch to the floor. The southern end of the tunnel, near the site of the mixing house, has gone but its base is visible in places as a narrow brick-edged ledge in the eroding cut face of the valley side above the caravans.
